**Flood Control Project Maintenance
Levee Inspections****LMA District Cover Sheet****Spring 2011 Levee Inspection Results****Sutter Maintenance Yard Maintenance Area 0005**

Levee Inspection Report By Mile - Spring 2011

Waterway						Bank	Unit Miles	Inspection Start/End	Inspector	
Unit No. 01 Butte Creek 1						Left	15.29	04/21/2011 04/21/2011	Bob Duffey	
LMR No.	Levee Mile		Category	Item	* Location	** Rating	Action/Comment	GPS Latitude/Longitude		Issue No.
	Start	End						Start	End	Photo
1	0.58	0.58	Earthen Levee	Vegetation	LS	M	Elderberries are blocking visibility and flood fight capability.	39.690745 ° -121.777342 °	39.690745 ° -121.777342 °	903 Y
2	1.68	1.68	Earthen Levee	Encroachments	LS	M	Debris	39.675528 ° -121.778642 °	39.675528 ° -121.778642 °	1 Y
3	2.13	2.13	Earthen Levee	Repair Gates	CR	M		39.670112 ° -121.782012 °	39.670112 ° -121.782012 °	10
4	2.86	2.86	Earthen Levee	Encroachments	LS	M	Prunings	39.660124 ° -121.785136 °	39.660124 ° -121.785136 °	2 Y
5	3.12	3.12	Earthen Levee	Encroachments	LS	M	Prunings	39.656779 ° -121.787127 °	39.656779 ° -121.787127 °	3
6	3.27	3.27	Earthen Levee	Encroachments	LS	M	Prunings	39.654847 ° -121.787893 °	39.654847 ° -121.787893 °	4

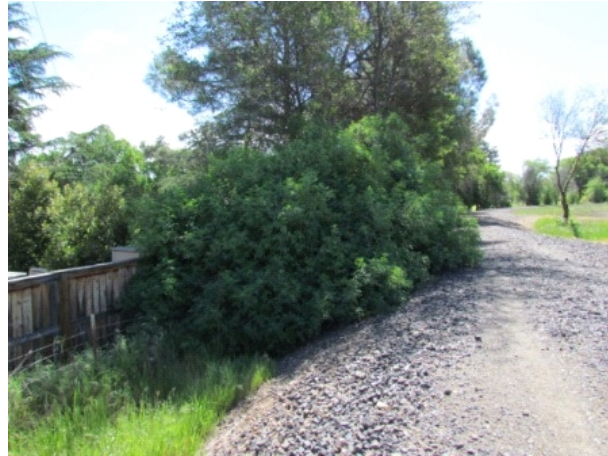
Levee Mile Report Line	1
Start Levee Mile	0.58
End Levee Mile	0.58
Location	Land Side
Category	Earthen Levee
Item	Vegetation

View of the large elderberries along the L/S toe.

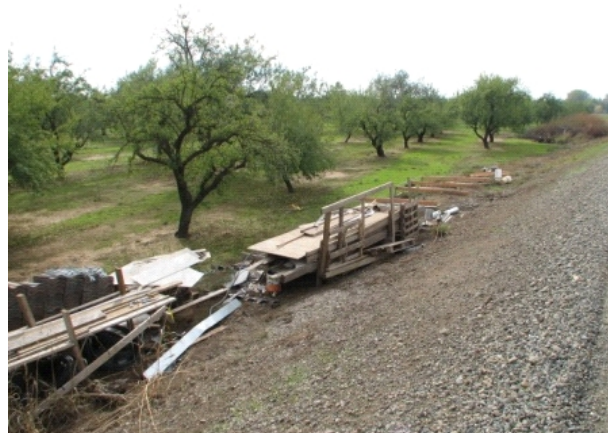
Levee Mile Report Line	2
Start Levee Mile	1.68
End Levee Mile	1.68
Location	Land Side
Category	Earthen Levee
Item	Encroachments

View of the removed garbage but construction supply on pallets.

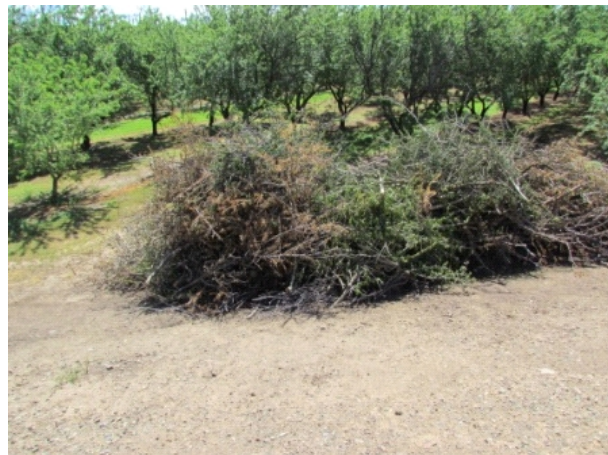
Levee Mile Report Line	4
Start Levee Mile	2.86
End Levee Mile	2.86
Location	Land Side
Category	Earthen Levee
Item	Encroachments

View of the large pruning along the L/S toe.

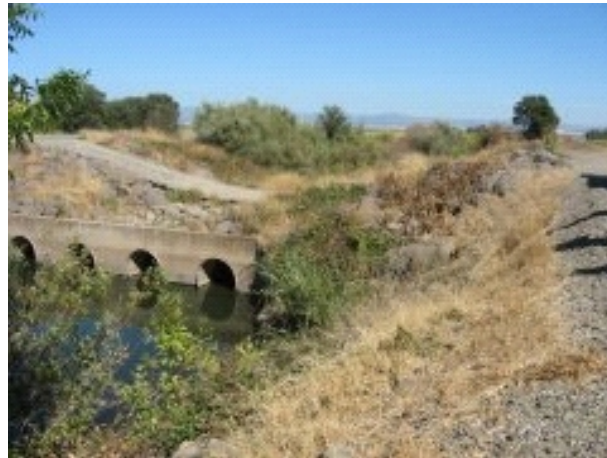
Levee Mile Report Line	7
Start Levee Mile	9.66
End Levee Mile	9.69
Location	Water Side
Category	Supplemental
Item	USACE Erosion Survey
2009: no berm, vertical slope, no stability issues, sands and silts, 3.5 ft/s plus eddy currents [2009 SiteID:BTC_9-6_L]	
rduffey_s_20110228_027.JPG

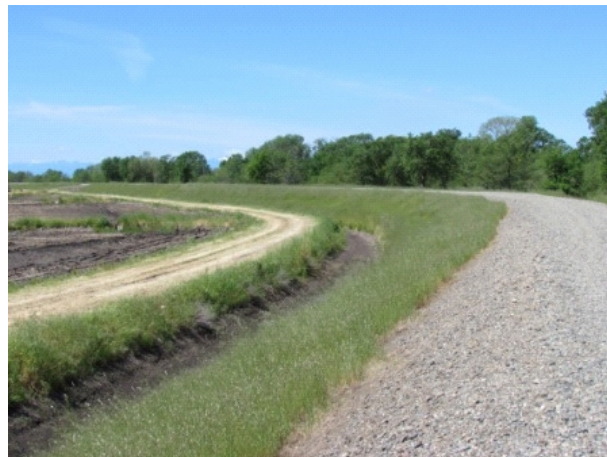
Levee Mile Report Line	8
Start Levee Mile	9.66
End Levee Mile	10.48
Location	Water Side
Category	Earthen Levee
Item	Encroachments
View of the AG ditch along the L/S toe.	
rduffey_s_20110426_278.jpg

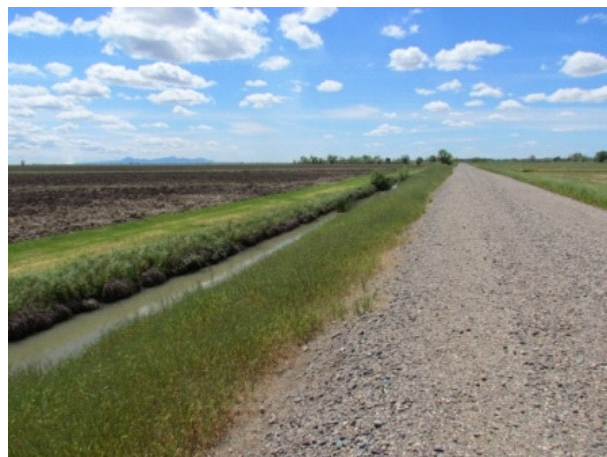
Levee Mile Report Line	9
Start Levee Mile	12.00
End Levee Mile	13.83
Location	Land Side
Category	Earthen Levee
Item	Encroachments
View of the AG ditch along the L/S toe.	
rduffey_s_20110426_279.jpg

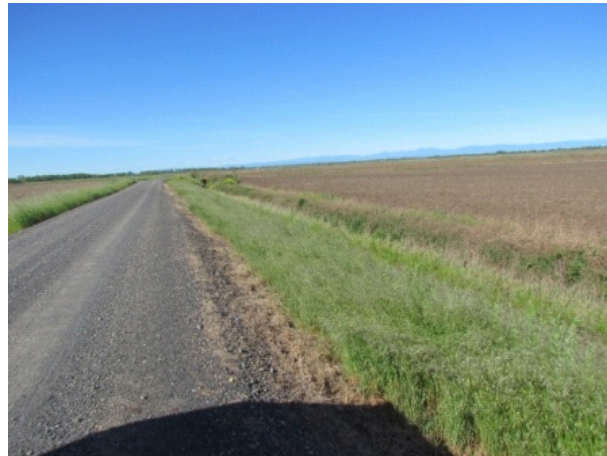
Levee Mile Report Line	1
Start Levee Mile	1.23
End Levee Mile	1.62
Location	Land Side
Category	Earthen Levee
Item	Encroachments
View of the AG ditch along the L/S toe.	
rduffey_s_20110426_272.jpg

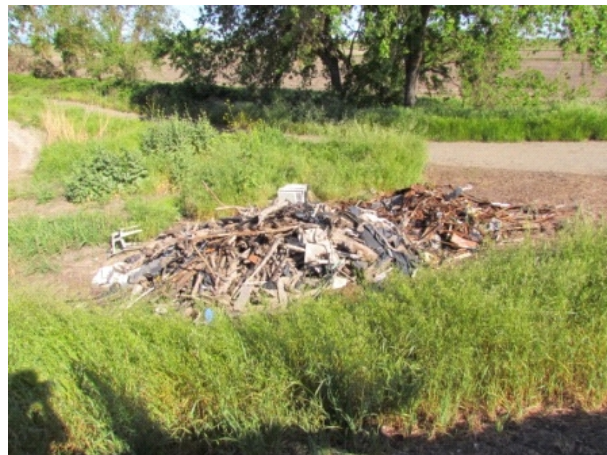
Levee Mile Report Line	2
Start Levee Mile	1.89
End Levee Mile	1.89
Location	Land Side
Category	Earthen Levee
Item	Encroachments
View of the garbage along the L/S toe.	
rduffey_s_20110426_273.jpg

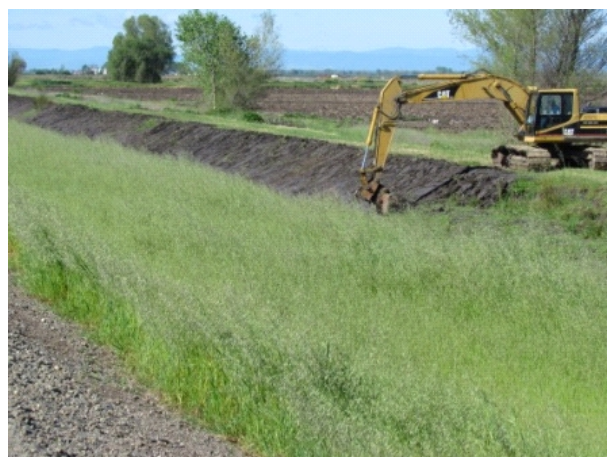
Levee Mile Report Line	4
Start Levee Mile	3.15
End Levee Mile	4.60
Location	Land Side
Category	Earthen Levee
Item	Encroachments
View of the AG ditch along the L/S toe.	
rduffey_s_20110426_274.jpg

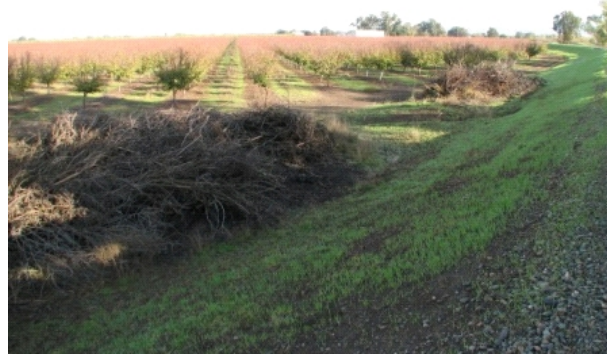
Levee Mile Report Line	8
Start Levee Mile	7.86
End Levee Mile	7.86
Location	Land Side
Category	Earthen Levee
Item	Encroachments
View of the debris and garbage along the landside toe of the levee.	
rduffey_s_20110228_028.jpg

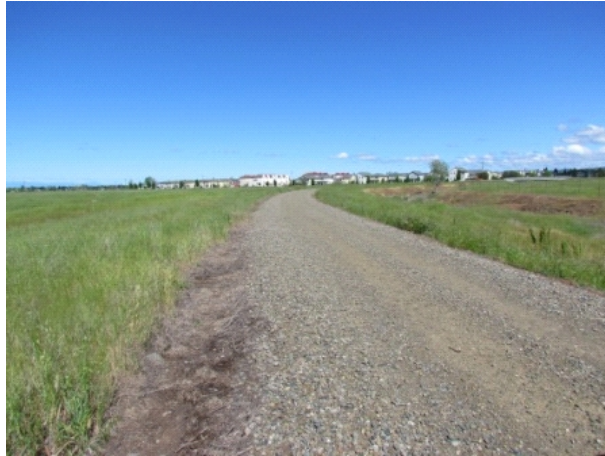
Levee Mile Report Line	1
Start Levee Mile	0.00
End Levee Mile	1.50
Location	Land Side
Category	Earthen Levee
Item	Vegetation

View of the Levee clean of vegetation.

LMR No.	Levee Mile		Category	Item	* Location	** Rating	Action/Comment	GPS Latitude/Longitude		Issue No.
	Start	End						Start	End	Photo
1	0.00	1.50	Earthen Levee	Vegetation	LS	A	Control annual grass and weeds on the levee slopes and easements.	39.724075 ° -121.780800 °	39.724075 ° -121.780800 °	1 Y
