**Flood Control Project Maintenance
Levee Inspections****LMA District Cover Sheet****Spring 2012 Levee Inspection Results****Sutter Maintenance Yard Maintenance Area 0005**

Waterway			Bank	Unit Miles
Unit No. 01 Butte Creek 1			Left	15.29
	Spring (March - May)	Summer (June - August)	(September - November) Fall	Winter (December - February)
Unit Maintenance Rating (Fall Only)				
Date of Inspection	4/24/2012 - 4/24/2012			
DWR Inspector	Bob Duffey			
Accompanied By	Jason Cooper Sutter Yard

Levee Inspection Report By Mile - Spring 2012

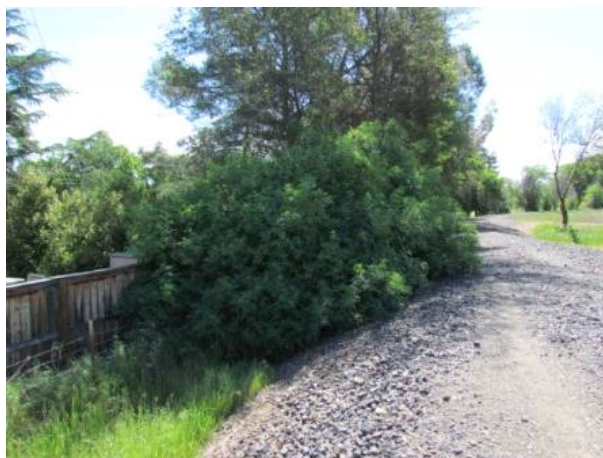
rduffey_s_20120312_302.jpg

Levee Mile Report Line	4
Start Levee Mile	0.58
End Levee Mile	0.58
Location	Land Side
Category	Earthen Levee
Item	Vegetation

View of the large elderberries along the L/S toe.

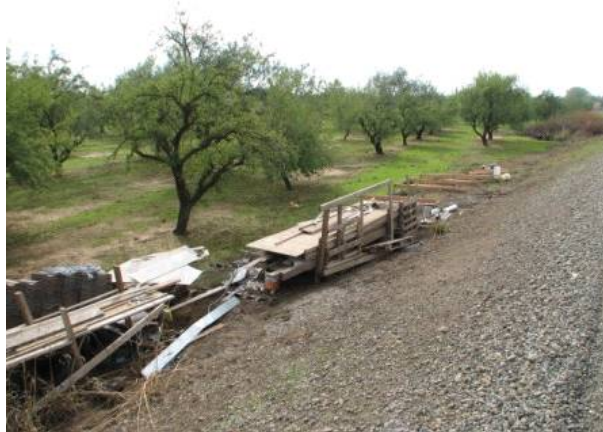
rduffey_s_20120312_297.jpg

Levee Mile Report Line	5
Start Levee Mile	1.68
End Levee Mile	1.68
Location	Land Side
Category	Earthen Levee
Item	Encroachments

View of the removed garbage but construction supply on pallets.

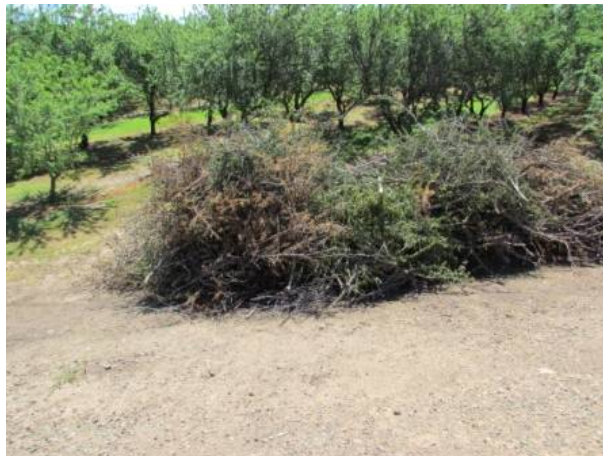
rduffey_s_20120312_298.jpg

Levee Mile Report Line	7
Start Levee Mile	2.86
End Levee Mile	2.86
Location	Land Side
Category	Earthen Levee
Item	Encroachments

View of the large pruning along the L/S toe.

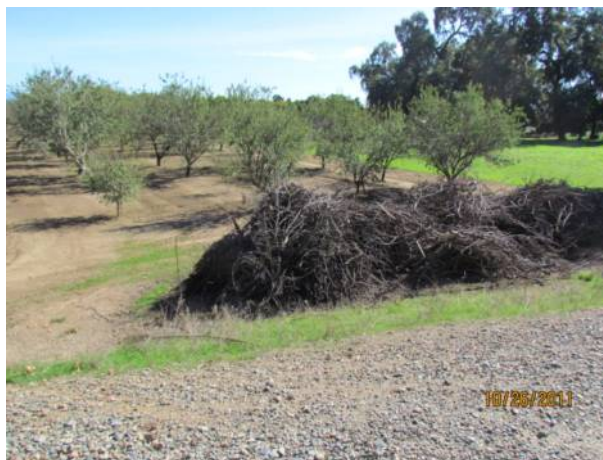
rduffey_s_20120312_299.jpg

Levee Mile Report Line	9
Start Levee Mile	3.27
End Levee Mile	3.27
Location	Land Side
Category	Earthen Levee
Item	Encroachments

View of pruning along the L/S toe.

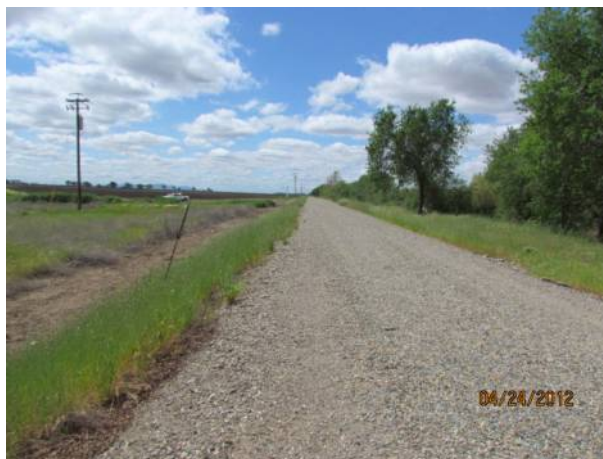
rduffey_s_20120430_616.jpg

Levee Mile Report Line	10
Start Levee Mile	7.26
End Levee Mile	7.26
Location	Land Side
Category	Earthen Levee
Item	Vegetation

View of the grass on both slopes.

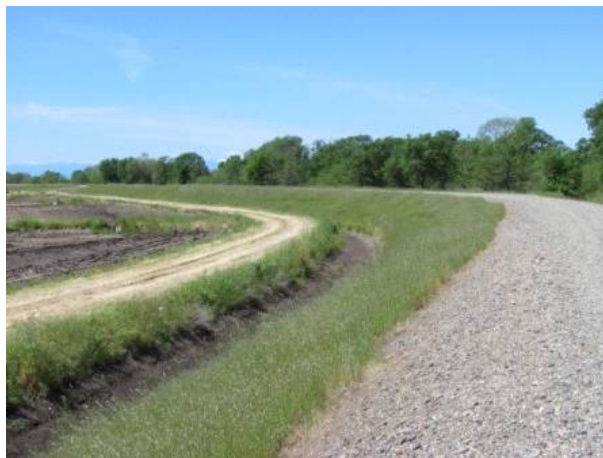
rduffey_s_20120312_300.jpg

Levee Mile Report Line	11
Start Levee Mile	9.66
End Levee Mile	10.48
Location	Water Side
Category	Earthen Levee
Item	Encroachments

View of the AG ditch along the L/S toe.

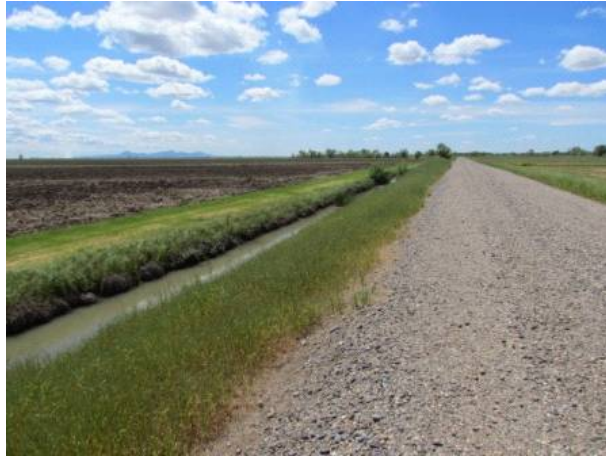
rduffey_s_20120312_301.jpg

Levee Mile Report Line	12
Start Levee Mile	12.00
End Levee Mile	13.83
Location	Land Side
Category	Earthen Levee
Item	Encroachments

View of the AG ditch along the L/S toe.

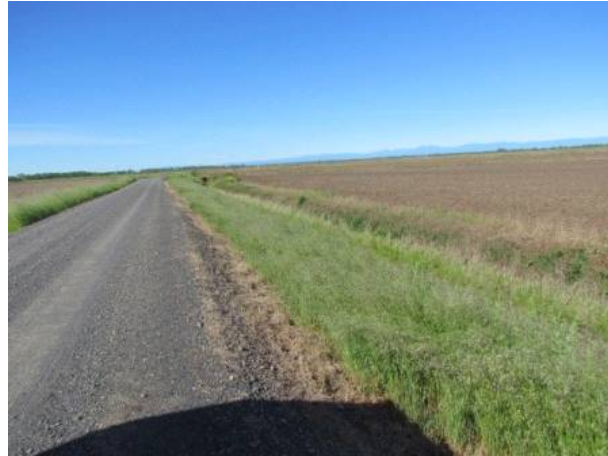
rduffey_s_20120312_303.jpg

Levee Mile Report Line	1
Start Levee Mile	1.23
End Levee Mile	1.62
Location	Land Side
Category	Earthen Levee
Item	Encroachments

View of the AG ditch along the L/S toe.

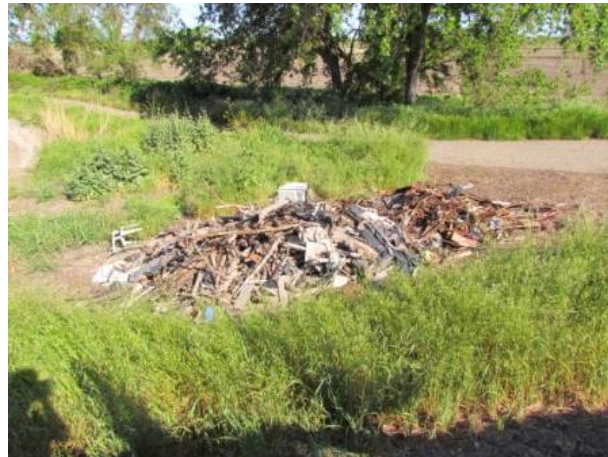
rduffey_s_20120312_305.jpg

Levee Mile Report Line	2
Start Levee Mile	1.89
End Levee Mile	1.89
Location	Land Side
Category	Earthen Levee
Item	Encroachments

View of the garbage along the L/S toe.

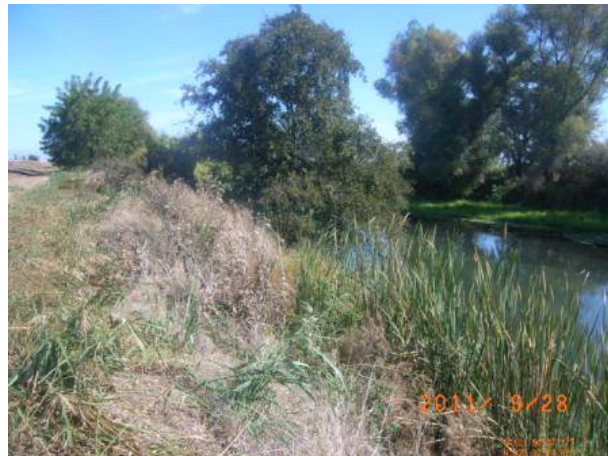
USACE 2011 Photo #1

Levee Mile Report Line	3
Start Levee Mile	2.50
End Levee Mile	2.51
Location	Water Side
Category	Supplemental
Item	USACE Erosion Survey

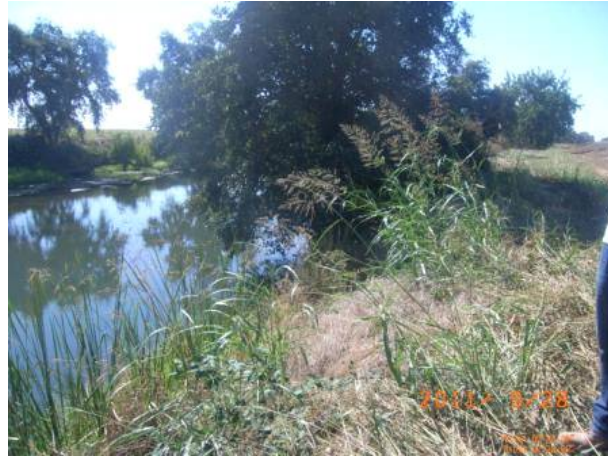
USACE 2011 Photo #2

Levee Mile Report Line	3
Start Levee Mile	2.50
End Levee Mile	2.51
Location	Water Side
Category	Supplemental
Item	USACE Erosion Survey

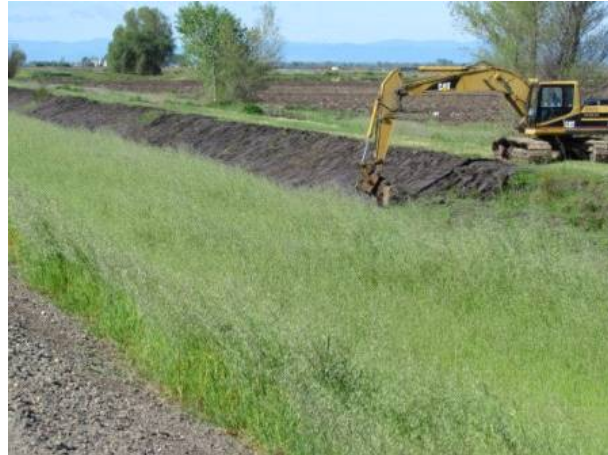
rduffey_s_20120312_307.jpg

Levee Mile Report Line	4
Start Levee Mile	3.15
End Levee Mile	4.60
Location	Land Side
Category	Earthen Levee
Item	Encroachments

View of the AG ditch along the L/S toe.

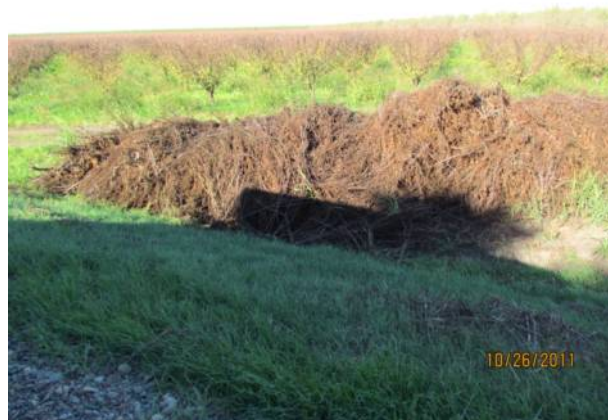
rduffey_s_20120312_310.jpg

Levee Mile Report Line	5
Start Levee Mile	7.38
End Levee Mile	7.38
Location	Land Side
Category	Earthen Levee
Item	Encroachments

View of the pruning along the L/S toe.

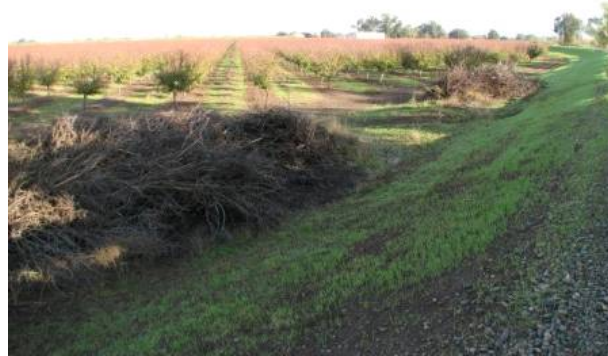
rduffey_s_20120312_304.jpg

Levee Mile Report Line	6
Start Levee Mile	7.86
End Levee Mile	7.86
Location	Land Side
Category	Earthen Levee
Item	Encroachments

View of the debris and garbage along the landside toe of the levee.

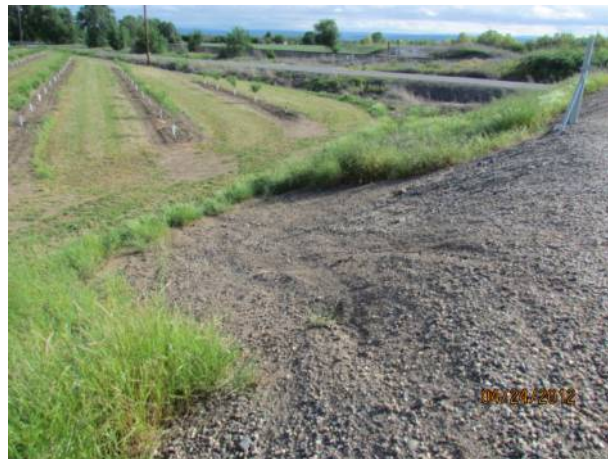
rduffey_s_20120430_610.jpg

Levee Mile Report Line	7
Start Levee Mile	8.10
End Levee Mile	8.10
Location	Land Side
Category	Earthen Levee
Item	Slope Stability

View of the vehicle erosion along the slope.

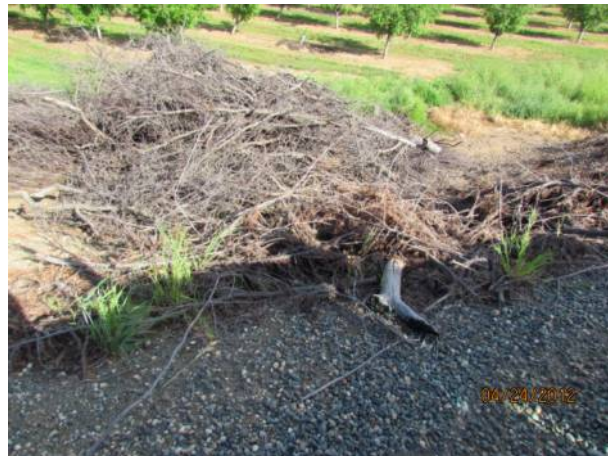
rduffey_s_20120430_611.jpg

Levee Mile Report Line	8
Start Levee Mile	8.45
End Levee Mile	8.45
Location	Land Side
Category	Earthen Levee
Item	Encroachments

View of the brush pile at the toe of the levee.

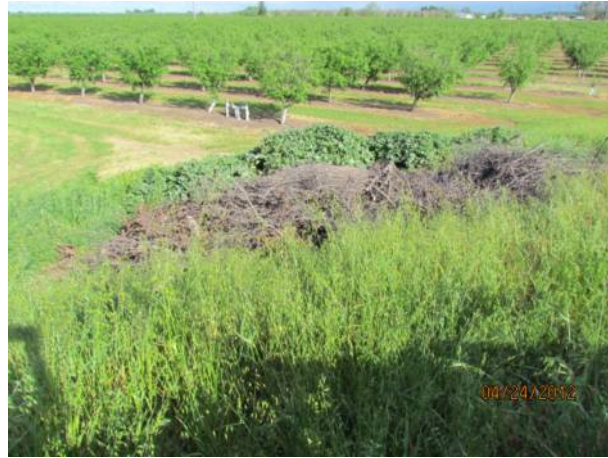
rduffey_s_20120430_612.jpg

Levee Mile Report Line	9
Start Levee Mile	8.80
End Levee Mile	8.80
Location	Land Side
Category	Earthen Levee
Item	Encroachments

View of the brush pile at the toe of the levee.

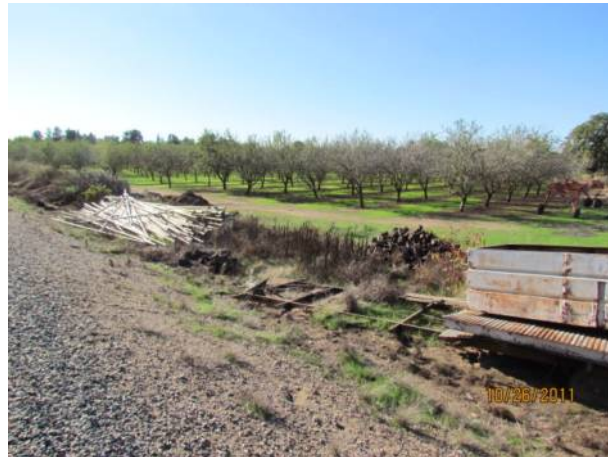
rduffey_s_20120312_311.jpg

Levee Mile Report Line	11
Start Levee Mile	10.61
End Levee Mile	10.61
Location	Land Side
Category	Earthen Levee
Item	Encroachments

View of the equipment along the L/S toe.

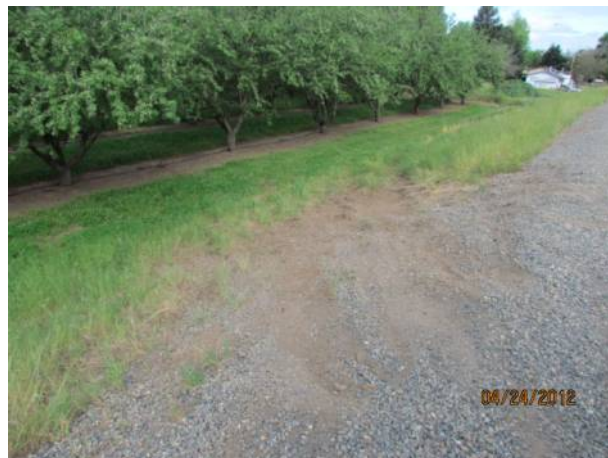
rduffey_s_20120430_613.jpg

Levee Mile Report Line	12
Start Levee Mile	10.79
End Levee Mile	10.79
Location	Land Side
Category	Earthen Levee
Item	Slope Stability

View of the vehicle erosion along the slope of the levee.

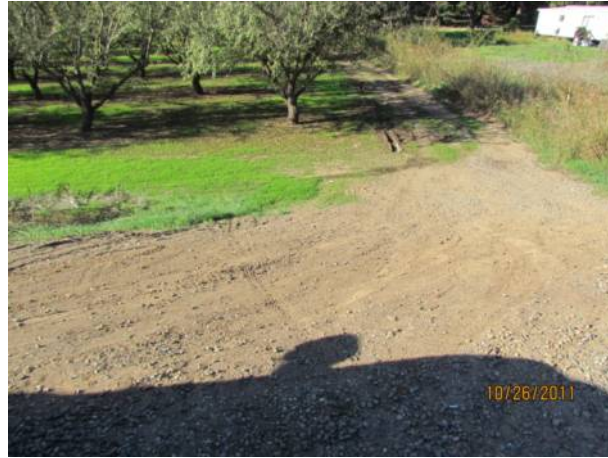
rduffey_s_20120312_312.jpg

Levee Mile Report Line	13
Start Levee Mile	10.81
End Levee Mile	10.81
Location	Land Side
Category	Earthen Levee
Item	Slope Stability

View of the vehicle erosion along the L/S slope.

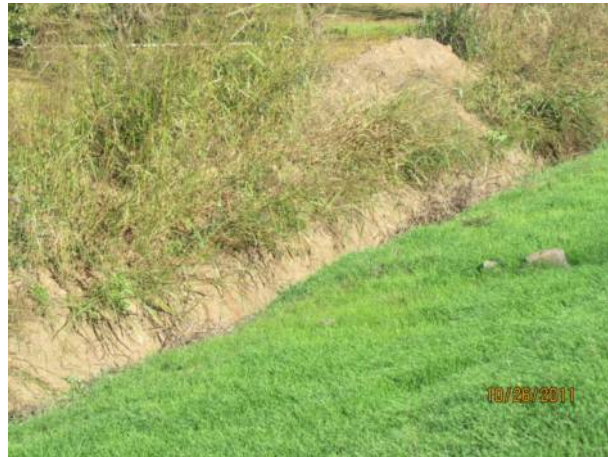
rduffey_s_20120312_306.jpg

Levee Mile Report Line	15
Start Levee Mile	11.74
End Levee Mile	11.95
Location	Land Side
Category	Earthen Levee
Item	Encroachments

View of the ditch along the L/S toe.

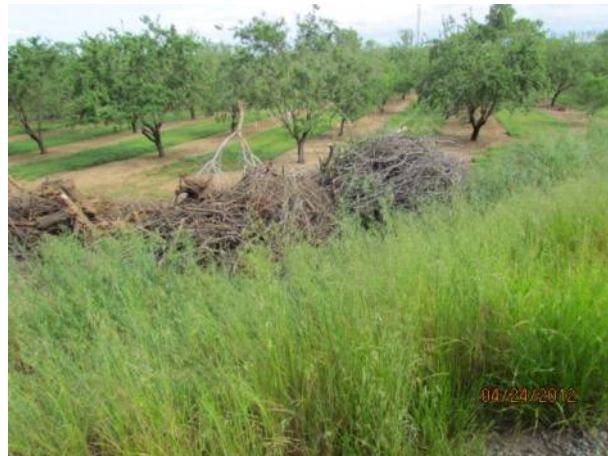
rduffey_s_20120430_614.jpg

Levee Mile Report Line	16
Start Levee Mile	13.03
End Levee Mile	13.03
Location	Land Side
Category	Earthen Levee
Item	Encroachments

View of the brush pile at the toe of the levee.

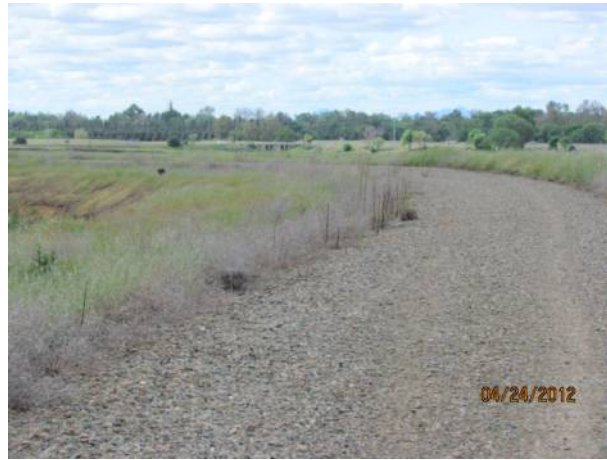
rduffey_s_20120430_615.jpg

Levee Mile Report Line	1
Start Levee Mile	0.68
End Levee Mile	0.68
Location	Water Side
Category	Earthen Levee
Item	Vegetation

View of the grass on both slopes.

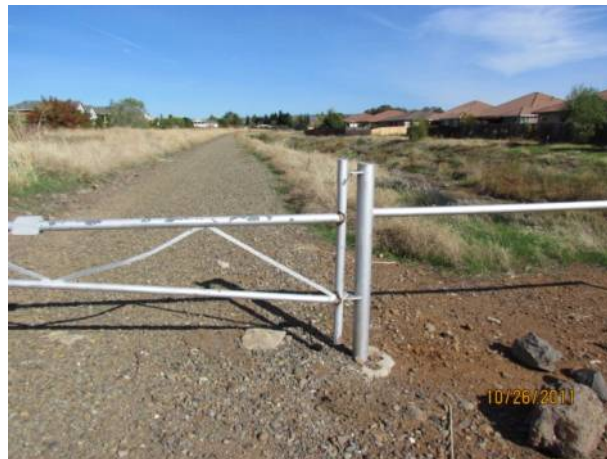
rduffey_s_20120312_313.jpg

Levee Mile Report Line	2
Start Levee Mile	0.70
End Levee Mile	0.70
Location	Crown
Category	Earthen Levee
Item	Repair Gates

View of the gate needing to be repaired. The hinge on this gate has broken.
