**Flood Control Project Maintenance
Levee Inspections****LMA District Cover Sheet****Spring 2013 Levee Inspection Results****Sutter Maintenance Yard Maintenance Area 0005**

Spring 2013 Levee Inspection Results

Sutter Maintenance Yard Maintenance Area 0005

Levee Inspection Report By Mile - Spring 2013

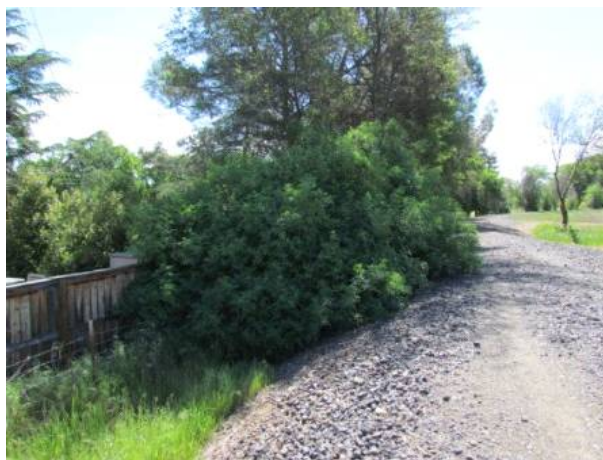
Levee Mile Report Line	4
Start Levee Mile	0.58
End Levee Mile	0.58
Location	Land Side
Category	
Item	Vegetation

View of the large elderberries along the L/S toe.

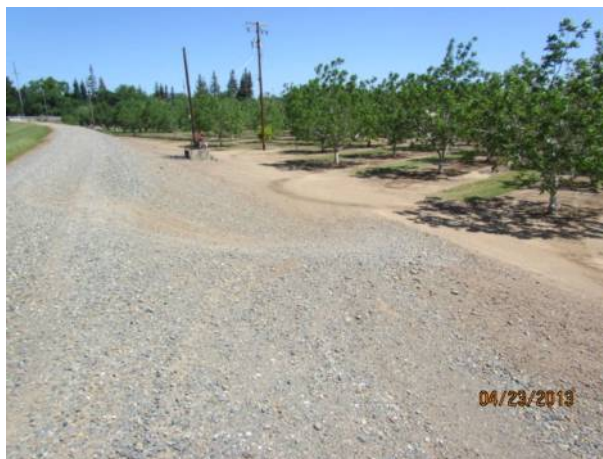
Levee Mile Report Line	5
Start Levee Mile	1.62
End Levee Mile	1.62
Location	Land Side
Category	
Item	Slope Stability

View of the unauthorized vehicle ramp on the landside slope.

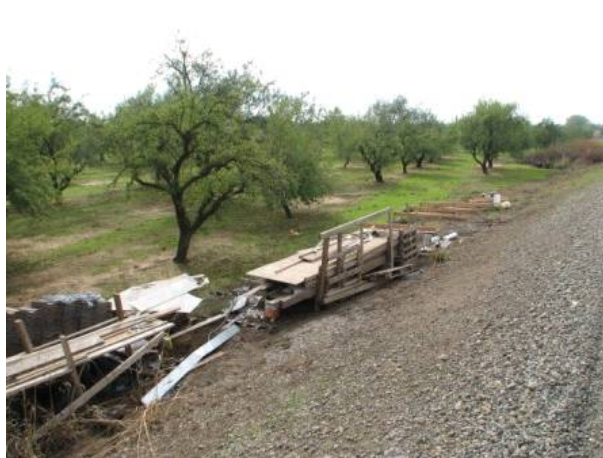
Levee Mile Report Line	6
Start Levee Mile	1.68
End Levee Mile	1.68
Location	Land Side
Category	
Item	Encroachments

View of the removed garbage but construction supply on pallets.

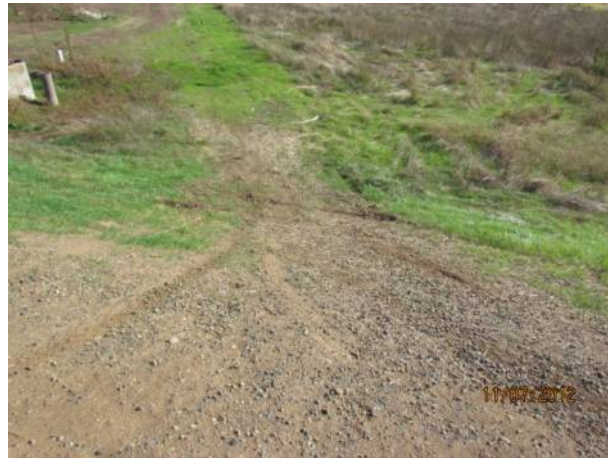
Levee Mile Report Line	8
Start Levee Mile	2.58
End Levee Mile	2.58
Location	Land Side
Category	
Item	Slope Stability

View of the vehicle erosion along the landside slope.

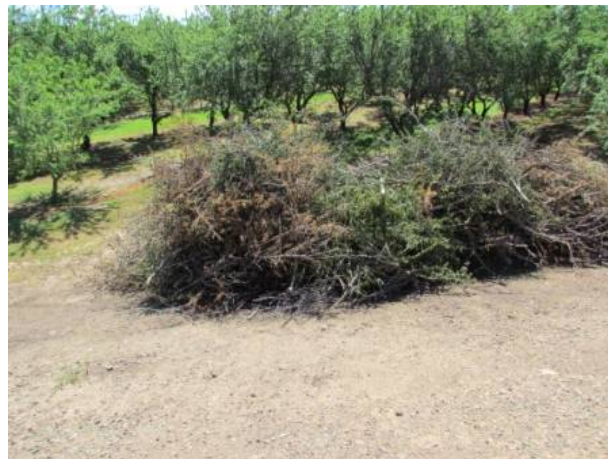
Levee Mile Report Line	9
Start Levee Mile	2.86
End Levee Mile	2.86
Location	Land Side
Category	
Item	Encroachments

View of the large prunings pile along the L/S toe.

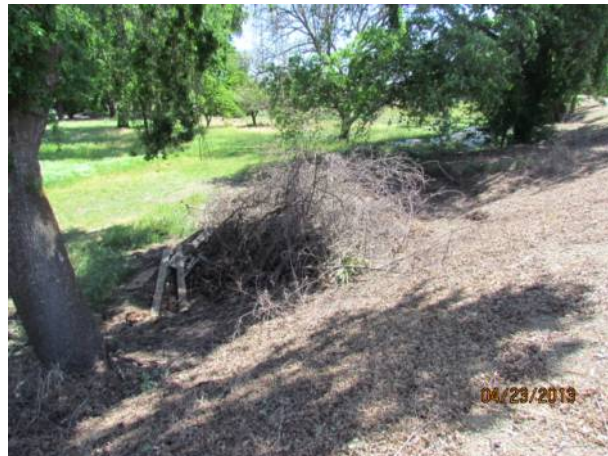
Levee Mile Report Line	12
Start Levee Mile	3.54
End Levee Mile	3.54
Location	Land Side
Category	
Item	Encroachments

View of the prunings along the landside slope.

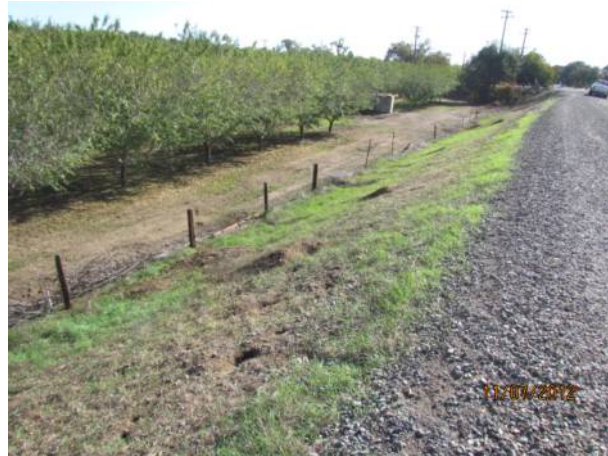
Levee Mile Report Line	13
Start Levee Mile	3.91
End Levee Mile	3.91
Location	Land Side
Category	
Item	Animal Control
View of the rodent activity along the landside slope.	
rduffey_s_20130225_077.JPG

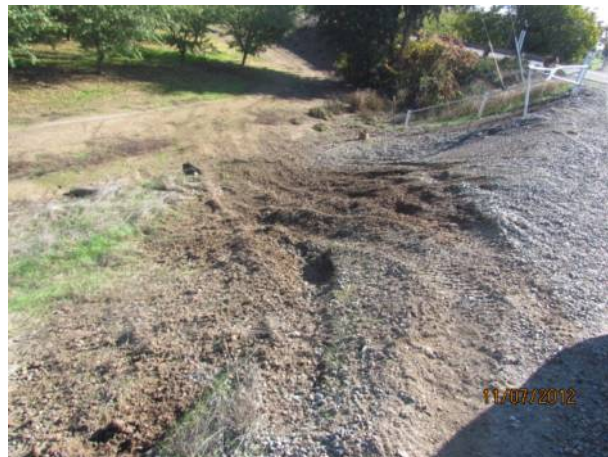
Levee Mile Report Line	14
Start Levee Mile	3.94
End Levee Mile	3.94
Location	Land Side
Category	
Item	Slope Stability
View of the vehicle erosion along the landside slope.	
rduffey_s_20130225_078.JPG

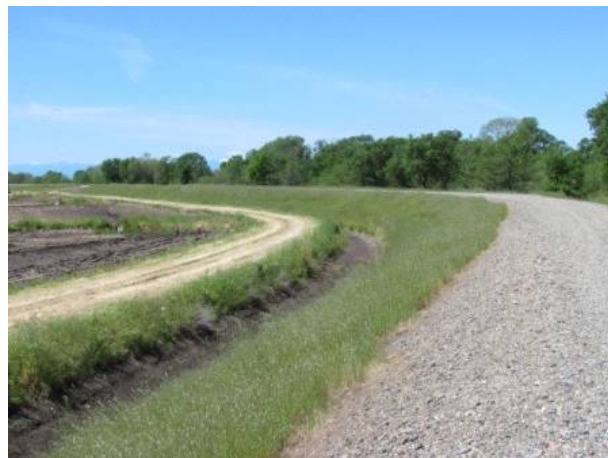
Levee Mile Report Line	15
Start Levee Mile	9.66
End Levee Mile	10.48
Location	Water Side
Category	
Item	Encroachments
View of the AG ditch along the L/S toe.	
rduffey_s_20130225_074.jpg

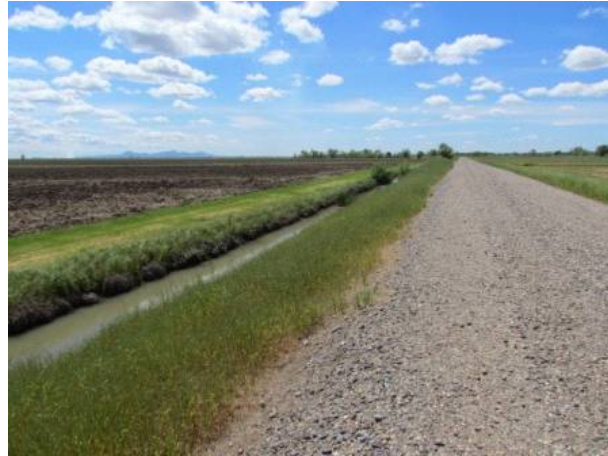
Levee Mile Report Line	16
Start Levee Mile	12.00
End Levee Mile	13.83
Location	Land Side
Category	
Item	Encroachments

View of the AG ditch along the L/S toe.

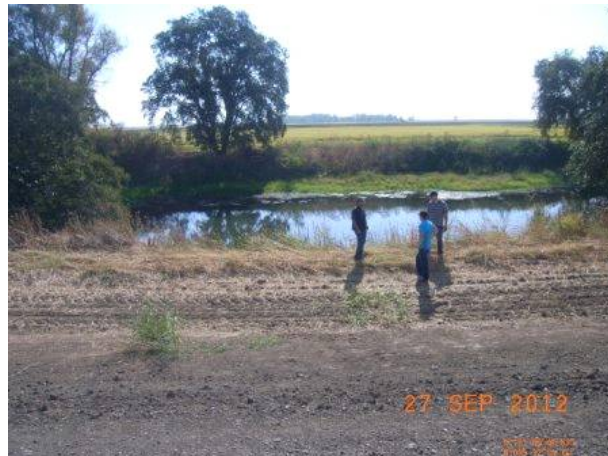
Levee Mile Report Line	3
Start Levee Mile	2.50
End Levee Mile	2.51
Location	Water Side
Category	Supplemental
Item	USACE Erosion Survey

USACE 2012 Photo #1

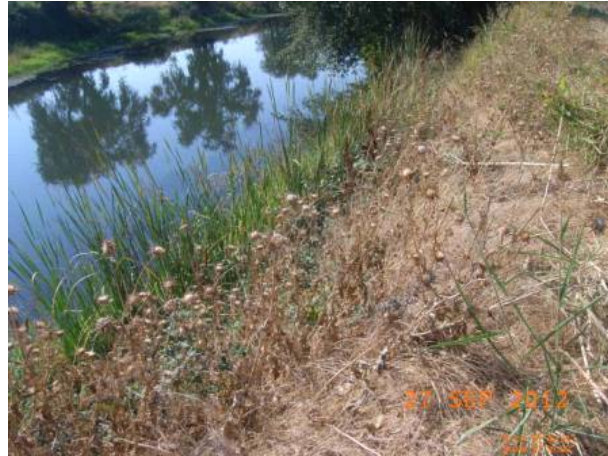
Levee Mile Report Line	3
Start Levee Mile	2.50
End Levee Mile	2.51
Location	Water Side
Category	Supplemental
Item	USACE Erosion Survey

USACE 2012 Photo #2

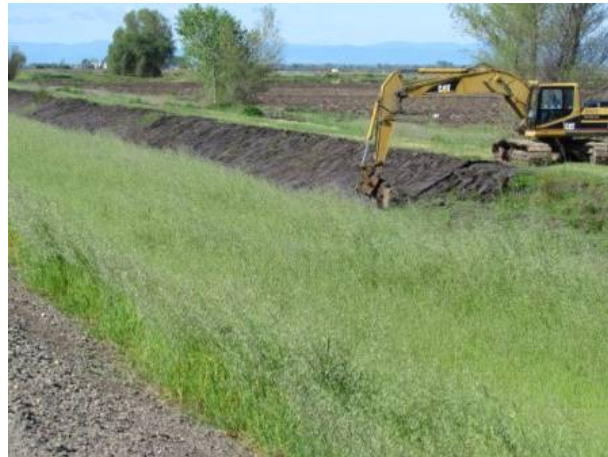
Levee Mile Report Line	4
Start Levee Mile	3.15
End Levee Mile	4.60
Location	Land Side
Category	
Item	Encroachments

View of the AG ditch along the L/S toe.

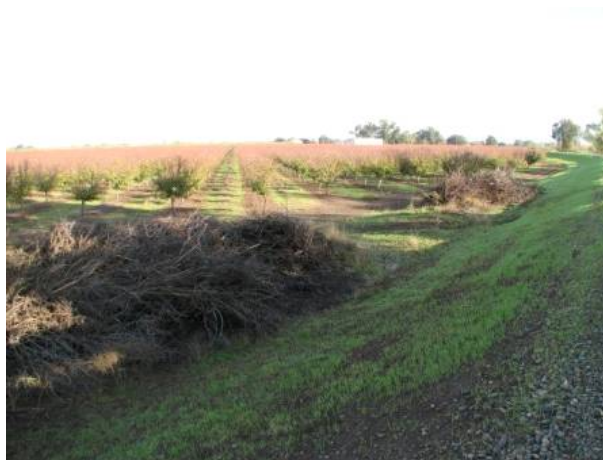
Levee Mile Report Line	6
Start Levee Mile	7.86
End Levee Mile	7.86
Location	Land Side
Category	
Item	Encroachments
View of the debris and garbage along the landside toe of the levee.	
rduffey_s_20130225_081.jpg

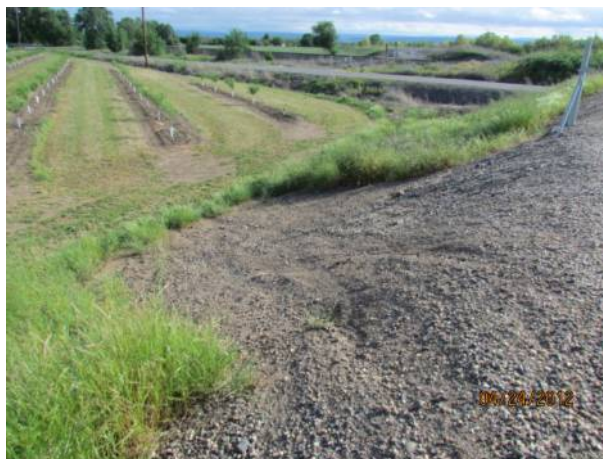
Levee Mile Report Line	7
Start Levee Mile	8.10
End Levee Mile	8.10
Location	Land Side
Category	
Item	Slope Stability
View of the vehicle erosion along the slope.	
rduffey_s_20130225_088.jpg

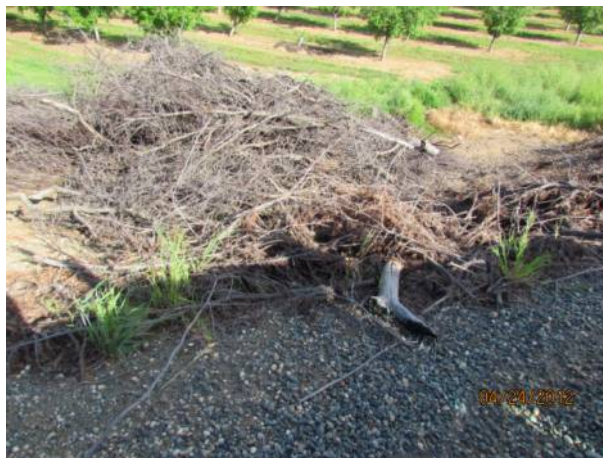
Levee Mile Report Line	8
Start Levee Mile	8.45
End Levee Mile	8.45
Location	Land Side
Category	
Item	Encroachments
View of the brush pile at the toe of the levee.	
rduffey_s_20130225_090.jpg

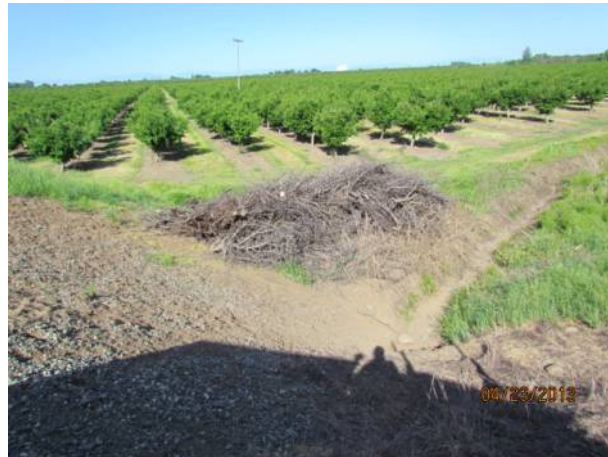
Levee Mile Report Line	10
Start Levee Mile	8.91
End Levee Mile	8.91
Location	Land Side
Category	
Item	Encroachments

View of the prunings along the landside toe.

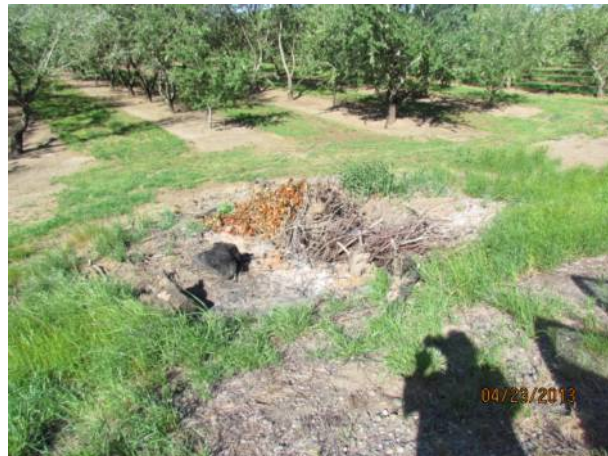
Levee Mile Report Line	11
Start Levee Mile	10.54
End Levee Mile	10.54
Location	Land Side
Category	
Item	Encroachments

View of the prunings along the landside toe.

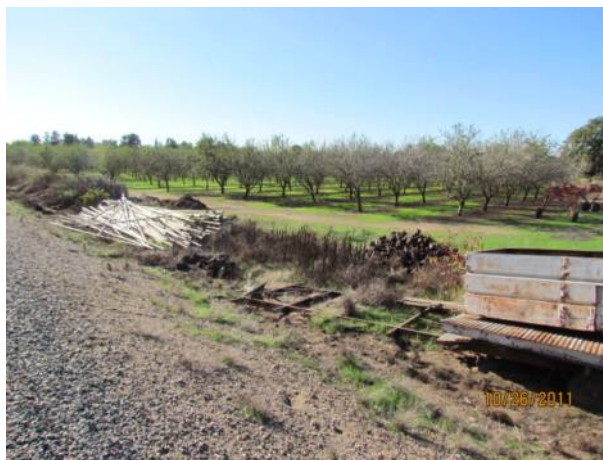
Levee Mile Report Line	12
Start Levee Mile	10.61
End Levee Mile	10.61
Location	Land Side
Category	
Item	Encroachments

View of the equipment along the L/S toe.

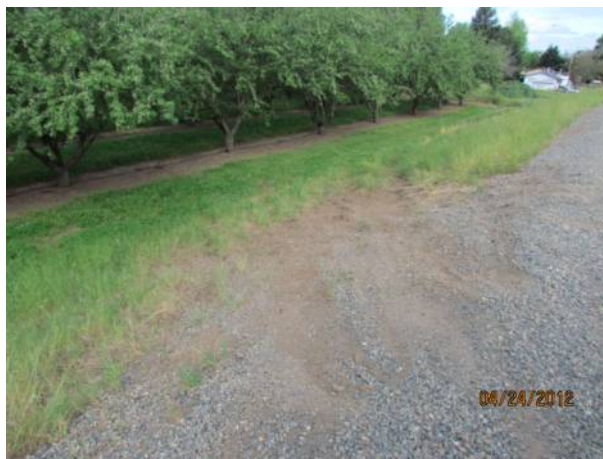
Levee Mile Report Line	13
Start Levee Mile	10.79
End Levee Mile	10.79
Location	Land Side
Category	
Item	Slope Stability

View of the vehicle erosion along the slope of the levee.

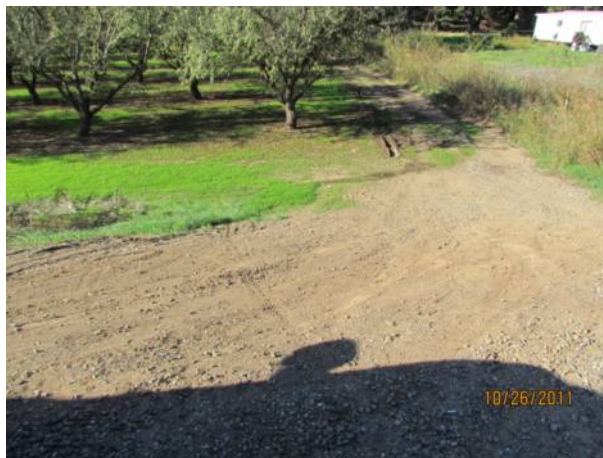
Levee Mile Report Line	14
Start Levee Mile	10.81
End Levee Mile	10.81
Location	Land Side
Category	
Item	Slope Stability

View of the vehicle erosion along the L/S slope.

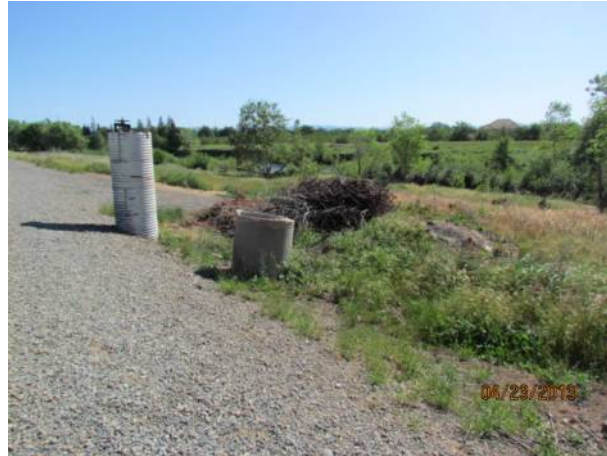
Levee Mile Report Line	20
Start Levee Mile	13.35
End Levee Mile	13.35
Location	Water Side
Category	
Item	Encroachments

View of the prunings along the waterside toe.

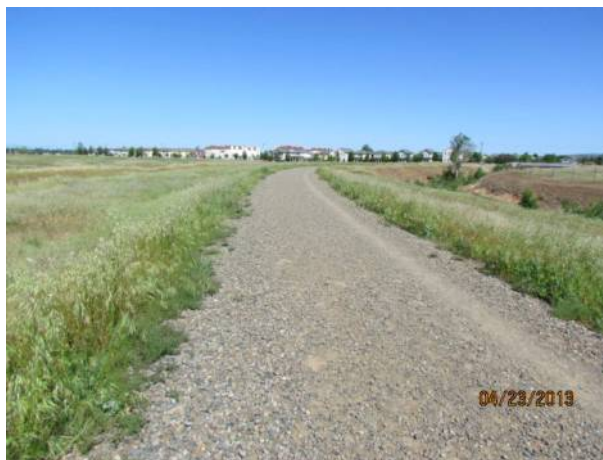
View of the levee with native grasses on both slopes.
