**Flood Control Project Maintenance  
Levee Inspections****LMA District Cover Sheet****Spring 2014 Levee Inspection Results****Sutter Maintenance Yard Maintenance Area 0005**

**Spring 2014 Levee Inspection Results**

**Sutter Maintenance Yard Maintenance Area 0005**

Waterway			Bank	Unit Miles
Unit No. 01 Butte Creek 1			Left	15.29
	Spring (March - May)	Summer (June - August)	(September - November) Fall	Winter (December - February)
Unit Maintenance Rating (Fall Only)				
Date of Inspection	04/29/2014 - 04/29/2014			
DWR Inspector	Bob Duffey			
Accompanied By	Jason Cooper Sutter Maintenance Yard

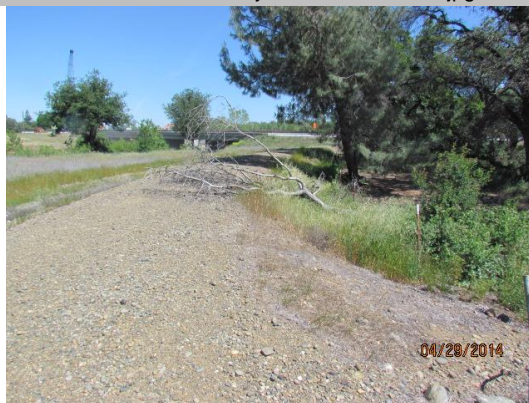
Photo 1 of 1 : rduffey\_s\_20140505\_240.jpg

view of the tree limb laying on the slope and crown.

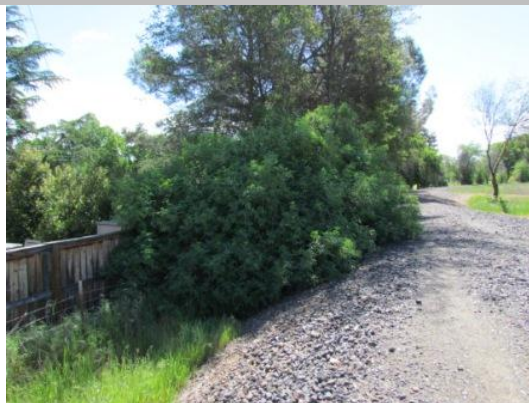
Photo 1 of 1 : rduffey\_s\_20140304\_372.jpg

LM Start	0.58	Rating **	M	Issue No.	903
LM End	0.58	Issue Type +	Ma	Location *	LS
Category	Earthen Levee			GPS Latitude/Longitude	
				Start	End
Item	Vegetation			39.690745 °	39.690745 °
				-121.777342 °	-121.777342 °
DWR ID	DWR_MA0005_01_s _ 2012_903				
Action/Comments					
Elderberries are blocking visibility and flood fight capability.

View of the large elderberries along the L/S toe.

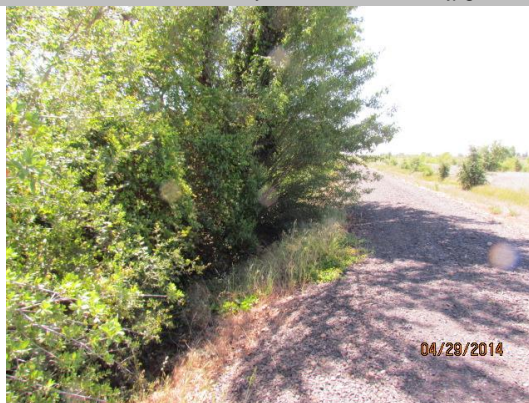
Photo 1 of 1 : rduffey\_s\_20140505\_241.jpg

LM Start	0.78	Rating **	M	Issue No.	32
LM End	0.78	Issue Type +	Ma	Location *	LS
Category	Earthen Levee			GPS Latitude/Longitude	
				Start	End
Item	Trim / Thin Trees			39.687917 °	39.687917 °
				-121.777393 °	-121.777393 °
DWR ID	DWR_MA0005_01_s _ 2014_32				
Action/Comments					
Thin trees to allow visibility of the ground and room to flood fight.

Trim the trees along the landside slope.

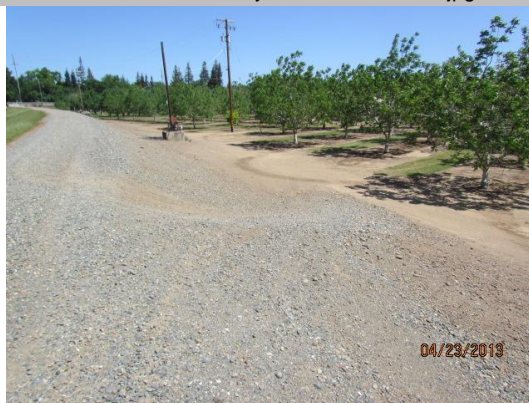
Photo 1 of 1 : rduffey\_s\_20140304\_369.jpg

LM Start	1.62	Rating **	M	Issue No.	16
LM End	1.62	Issue Type +	Ma	Location *	LS
Category	Earthen Levee			GPS Latitude/Longitude	
				Start	End
Item	Slope Stability			39.676129 °	39.676129 °
				-121.778171 °	-121.778171 °
DWR ID	DWR_MA0005_01_s _ 2013_16				
Action/Comments					
Repair the levee slope damaged by vehicle traffic and prevent access where possible.

View of the unauthorized vehicle ramp on the landside slope.

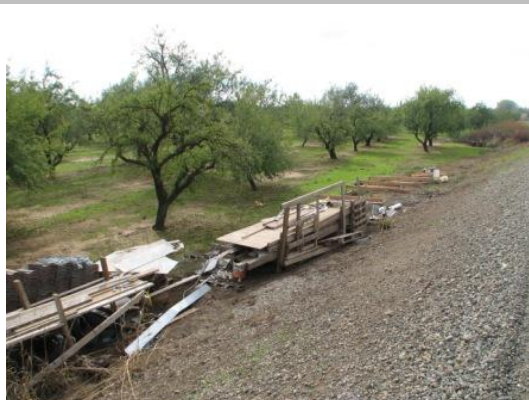
Photo 1 of 1 : rduffey\_s\_20140304\_362.jpg

LM Start	1.68	Rating **	M	Issue No.	1
LM End	1.68	Issue Type +	Ma	Location *	LS
Category	Earthen Levee			GPS Latitude/Longitude	
				Start	End
Item	Encroachments			39.675528 °	39.675528 °
				-121.778642 °	-121.778642 °
DWR ID	DWR_MA0005_01_s _ 2012_1				
Action/Comments					
Debris

View of the removed garbage but construction supply on pallets.

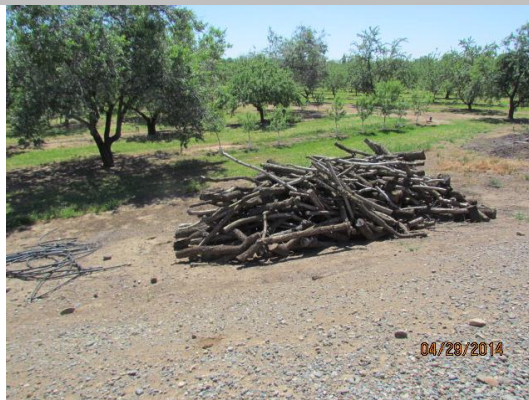
Photo 1 of 1 : rduffey\_s\_20140505\_242.jpg

LM Start	1.72	Rating **	M	Issue No.	33
LM End	1.72	Issue Type +	En	Location *	LS
Category	Earthen Levee			GPS Latitude/Longitude	
				Start	End
Item	Encroachments			39.675158 °	39.675158 °
				-121.779025 °	-121.779025 °
DWR ID	DWR_MA0005_01_s _ 2014_33				
Action/Comments					
Firewood

View of the firewood along the landside toe.

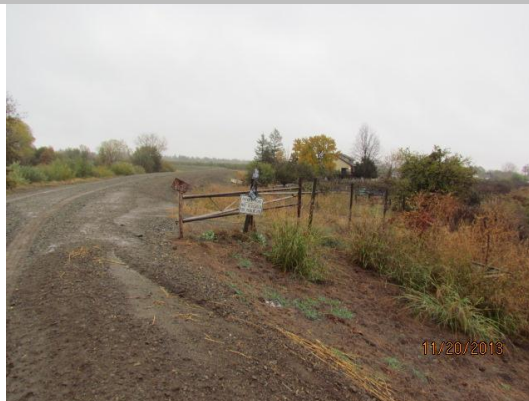
Photo 1 of 1 : rduffey\_s\_20140304\_367.jpg

LM Start	2.13	Rating **	M	Issue No.	10
LM End	2.13	Issue Type +	Ma	Location *	CR
Category	Earthen Levee			GPS Latitude/Longitude	
				Start	End
Item	Repair Gates			39.670112 °	39.670112 °
				-121.782012 °	-121.782012 °
DWR ID	DWR_MA0005_01_s _ 2012_10				
Action/Comments					
Inspector Comments: No Permit.

View of the gate with no permit.

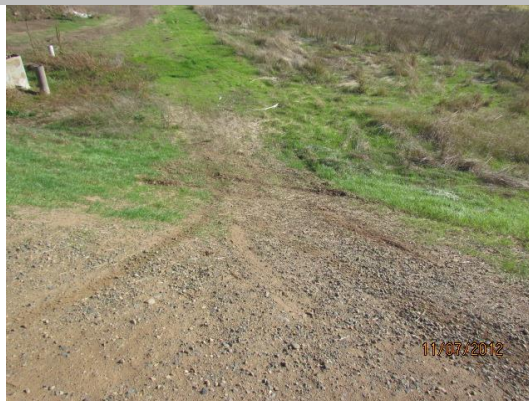
Photo 1 of 1 : rduffey\_s\_20140304\_366.jpg

LM Start	2.58	Rating **	M	Issue No.	9
LM End	2.58	Issue Type +	Ma	Location *	LS
Category	Earthen Levee			GPS Latitude/Longitude	
				Start	End
Item	Slope Stability			39.663876 °	39.663876 °
				-121.784014 °	-121.784014 °
DWR ID	DWR_MA0005_01_f _ 2012_9				
Action/Comments					
Repair the levee slope damaged by vehicle traffic and prevent access where possible.

View of the vehicle erosion along the landside slope.

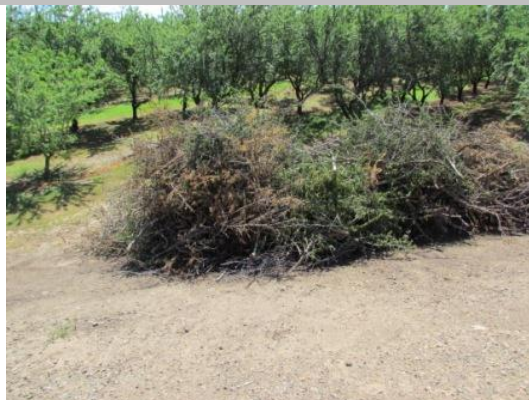
Photo 1 of 1 : rduffey\_s\_20140304\_363.jpg

LM Start	2.86	Rating **	M	Issue No.	2
LM End	2.86	Issue Type +	Ma	Location *	LS
Category	Earthen Levee			GPS Latitude/Longitude	
				Start	End
Item	Encroachments			39.660124 °	39.660124 °
				-121.785136 °	-121.785136 °
DWR ID	DWR_MA0005_01_s _ 2012_2				
Action/Comments					
Prunings

View of the large prunings pile along the L/S toe.

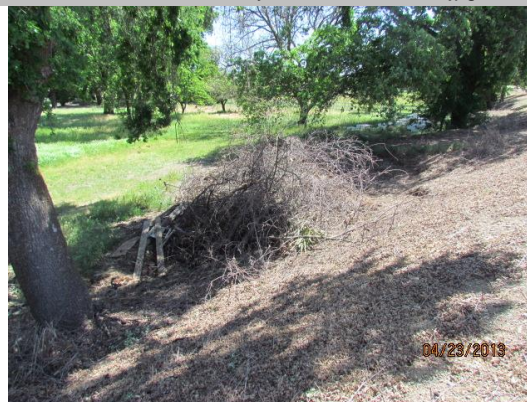
Photo 1 of 1 : rduffey\_s\_20140304\_370.jpg

View of the prunings along the landside slope.

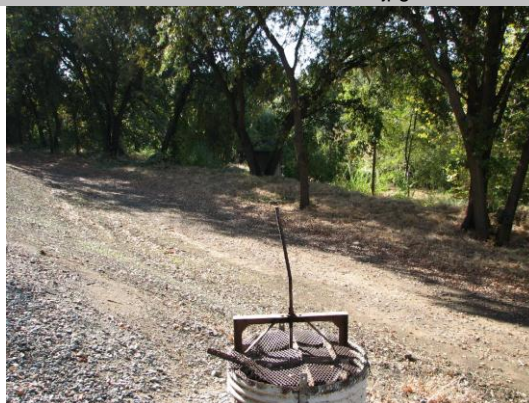
Photo 1 of 1 : UCIP\_4137.jpg

LM Start	3.67	Rating **	M	Issue No.	4
LM End	3.67	Issue Type +	En	Location *	LS
Category	Supplemental			GPS Latitude/Longitude	
				Start	End
Item	DWR UCIP Field Study			39.649522 °	39.649522 °
				-121.787965 °	-121.787965 °
DWR ID	DWR_MA0005_01_s_2014_4				
Action/Comments					
Inspector Comments: FS_ID:24532					
EP_NO: N/A					
Repair Type:					
Crossing Status:					
UCIP Comments: Pipe appears to be abandoned. Slide gate open and inoperable. Pipe should be properly abandoned5/29/2013 Same as last inspection1/20/2013 Same as last inspection.					
FIELD_STRUCT_DESC: 30-inch corrugated metal siphon through levee, 10.5 feet below crown. Slide gate in corrugated metal riser on waterward slope. Concrete distribution box on LS toe and concrete overflow and siphon box at edge of berm. (USCE 1958)					
FS Date: 11/21/2013 12:34:21 PM

CMP riser with slide gate on WS shoulder. Notice bent screw in open position.

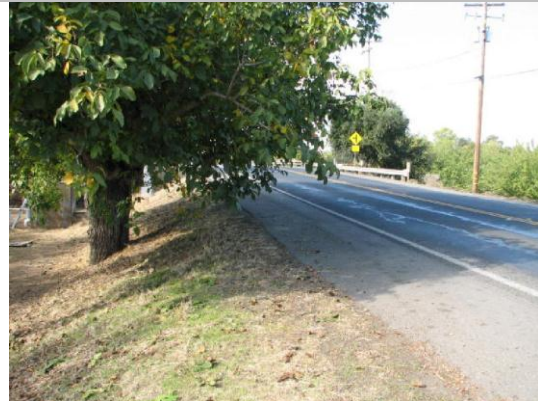
Photo 1 of 1 : UCIP\_4139.jpg

LM Start	3.97	Rating **	M	Issue No.	15
LM End	3.97	Issue Type +	En	Location *	LS
Category	Supplemental			GPS Latitude/Longitude	
				Start	End
Item	DWR UCIP Field Study			39.645846 °	39.645846 °
				-121.785155 °	-121.785155 °
DWR ID	DWR_MA0005_01_s_2014_15				
Action/Comments					
Inspector Comments: FS_ID:24535					
EP_NO: 6544A					
Repair Type:					
Crossing Status:					
UCIP Comments: Pipeline should be marked where pipe crosses levee as it is 4-feet below the surface5/29/2013 Same as last inspection11/20/2013 Same as last inspection.					
FIELD_STRUCT_DESC: 6-inch concrete encased high pressure steel gas line through the levee, 4.0 feet below the crown. 8-inch diameter PG&E gas access manhole located on south side of road 250-feet east of levee crown. (Permit No. 6544A)					
FS Date: 11/21/2013 12:36:27 PM

Location of PG&amp;E access lid 250-feet east of levee crown on south side of roadway.

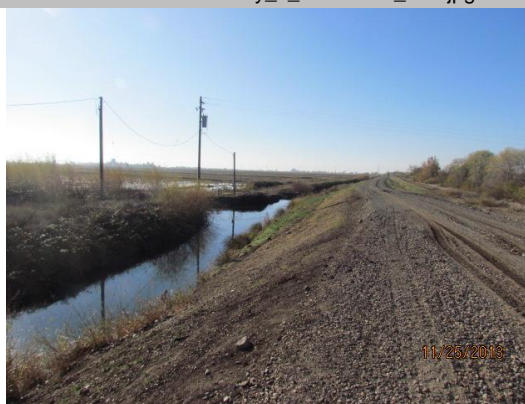
Photo 1 of 1 : rduffey\_s\_20140304\_371.jpg

LM Start	5.79	Rating **	M	Issue No.	55
LM End	6.34	Issue Type +	En	Location *	LS
Category	Earthen Levee			GPS Latitude/Longitude	
				Start	End
Item	Encroachments			39.622766 °	39.615666 °
				-121.773159 °	-121.777353 °

View of the irrigation ditch along the landside toe.

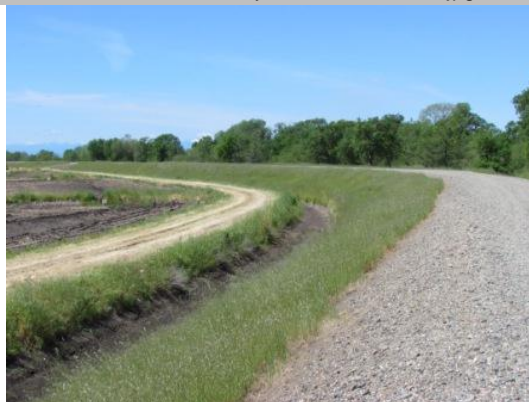
Photo 1 of 1 : rduffey\_s\_20140304\_364.jpg

View of the AG ditch along the L/S toe.

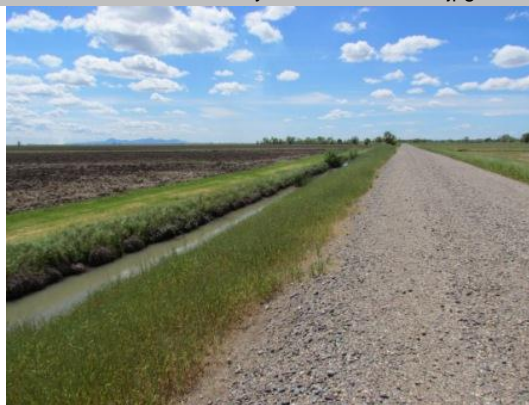
Photo 1 of 1 : rduffey\_s\_20140304\_365.jpg

LM Start	12.00	Rating **	M	Issue No.	6
LM End	13.83	Issue Type +	En	Location *	LS
Category	Earthen Levee			GPS Latitude/Longitude	
				Start	End
Item	Encroachments			39.551235 °	39.531462 °
				-121.837697 °	-121.856165 °
DWR ID	DWR_MA0005_01_s_2012_6				
Action/Comments					
Ditch

View of the AG ditch along the L/S toe.

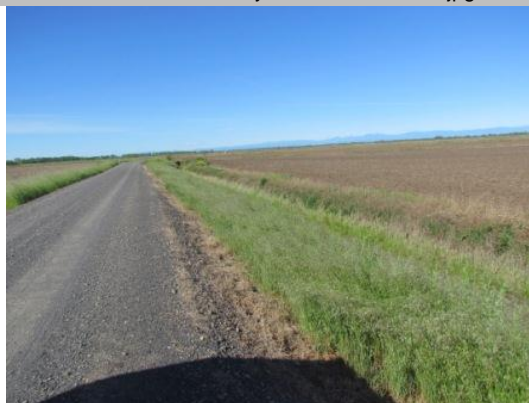
Photo 1 of 1 : rduffey\_s\_20140304\_384.jpg

View of the AG ditch along the L/S toe.

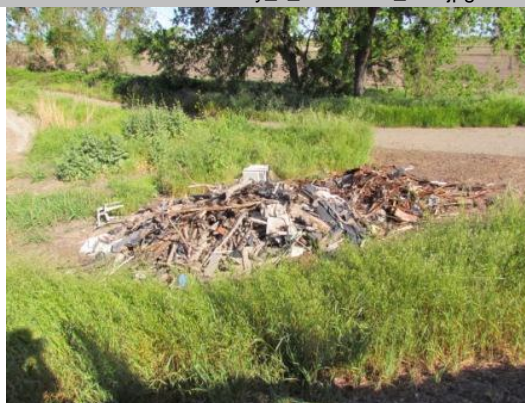
Photo 1 of 1 : rduffey\_s\_20140304\_387.jpg

LM Start	1.89	Rating **	M	Issue No.	4
LM End	1.89	Issue Type +	Ma	Location *	LS
Category	Earthen Levee			GPS Latitude/Longitude	
				Start	End
Item	Encroachments			39.536923 °	39.536923 °
				-121.853638 °	-121.853638 °
DWR ID	DWR_MA0005_02_s _ 2012_4				
Action/Comments					
Garbage

View of the garbage along the L/S toe.

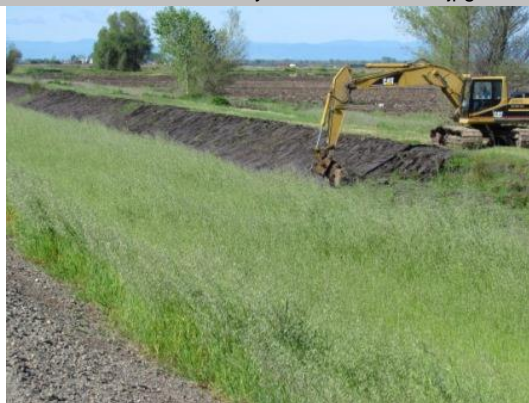
Photo 1 of 1 : rduffey\_s\_20140304\_389.jpg

View of the AG ditch along the L/S toe.

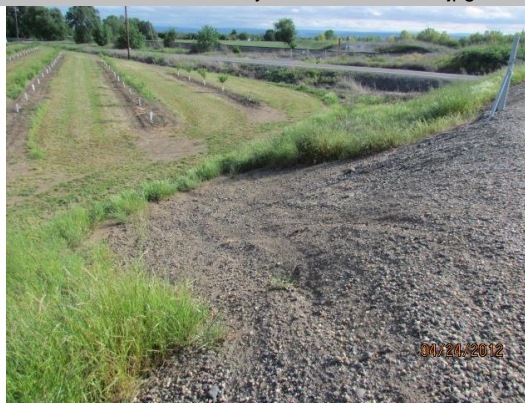
Photo 1 of 1 : rduffey\_s\_20140304\_394.jpg

LM Start	8.10	Rating **	M	Issue No.	13
LM End	8.10	Issue Type +	Ma	Location *	LS
Category	Earthen Levee			GPS Latitude/Longitude	
				Start	End
Item	Slope Stability			39.607710 °	39.607710 °
				-121.785868 °	-121.785868 °
DWR ID	DWR_MA0005_02_s _ 2012_13				
Action/Comments					
Repair the levee slope damaged by vehicle traffic and prevent access where possible.

View of the vehicle erosion along the slope.

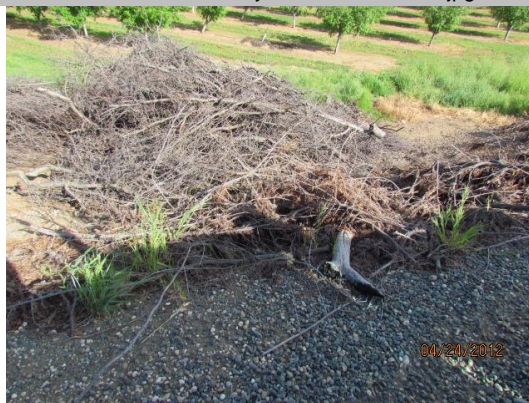
Photo 1 of 1 : rduffey\_s\_20140304\_396.jpg

View of the brush pile at the toe of the levee.

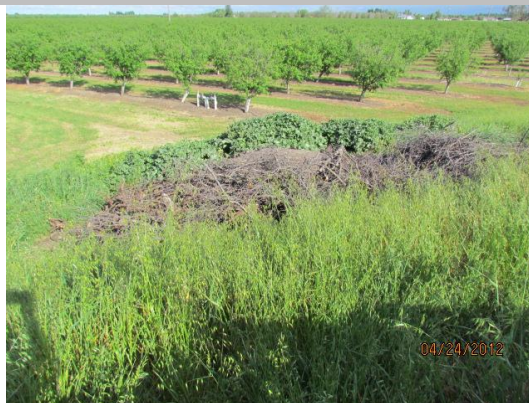
Photo 1 of 1 : rduffey\_s\_20140304\_398.jpg

View of the brush pile at the toe of the levee.

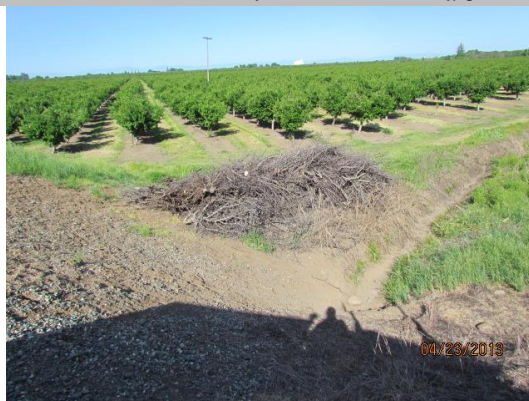
Photo 1 of 1 : rduffey\_s\_20140304\_393.jpg

View of the prunings along the landside toe.

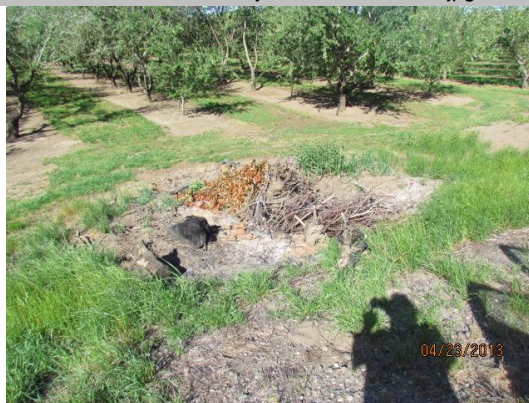
Photo 1 of 1 : rduffey\_s\_20140304\_386.jpg

View of the prunings along the landside toe.

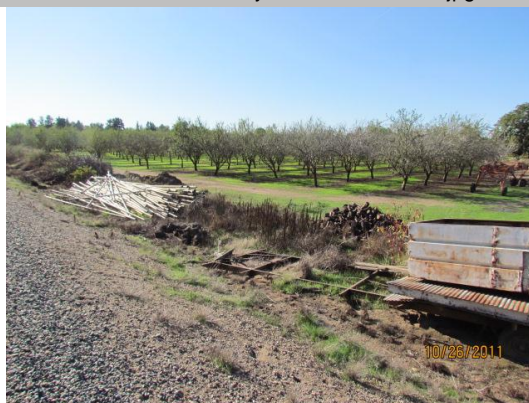
Photo 1 of 1 : rduffey\_s\_20140304\_395.jpg

View of the equipment along the L/S toe.

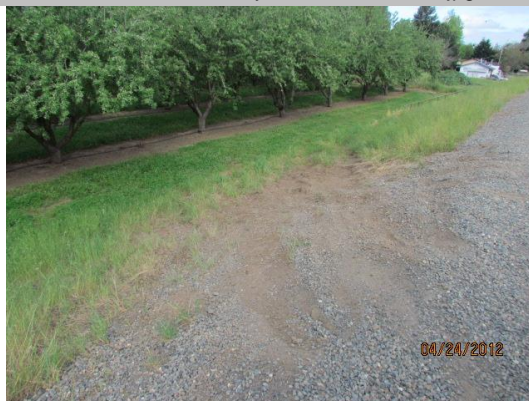
Photo 1 of 1 : rduffey\_s\_20140304\_399.jpg

LM Start	10.79	Rating **	M	Issue No.	18
LM End	10.79	Issue Type +	Ma	Location *	LS
Category	Earthen Levee			GPS Latitude/Longitude	
				Start	End
Item	Slope Stability			39.642061 °	39.642061 °
				-121.783861 °	-121.783861 °
DWR ID	DWR_MA0005_02_s _ 2012_18				
Action/Comments					
Repair the levee slope damaged by vehicle traffic and prevent access where possible.

View of the vehicle erosion along the slope of the levee.

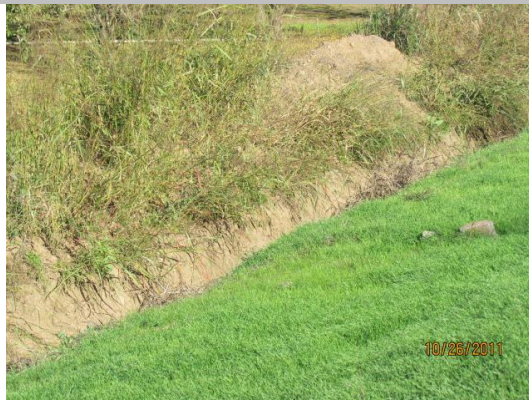
Photo 1 of 1 : rduffey\_s\_20140304\_388.jpg

View of the ditch along the L/S toe.

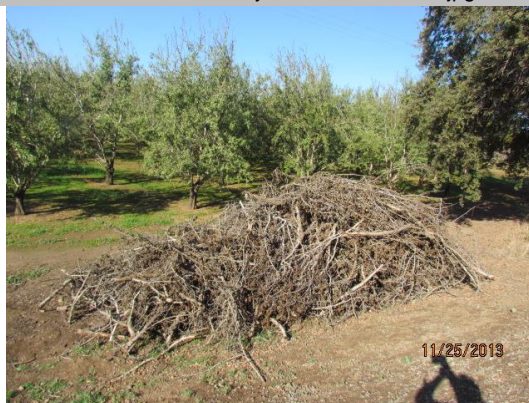
Photo 1 of 1 : rduffey\_s\_20140304\_397.jpg

View of the prunings at the toe of the levee.

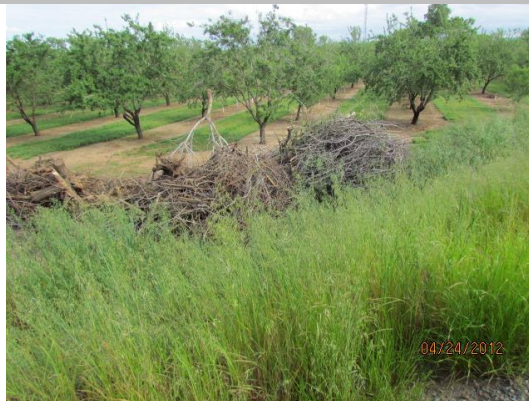
Photo 1 of 1 : rduffey\_s\_20140304\_400.jpg

View of the brush pile at the toe of the levee.

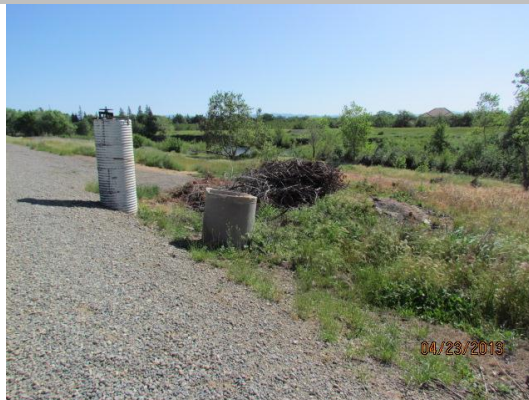
Photo 1 of 1 : rduffey\_s\_20140304\_402.jpg

View of the prunings along the waterside toe.
