**Flood Control Project Maintenance  
Levee Inspections****LMA District Cover Sheet****Spring 2015 Levee Inspection Results****Sutter Maintenance Yard Maintenance Area 0005**

**Spring 2015 Levee Inspection Results**

**Sutter Maintenance Yard Maintenance Area 0005**

Waterway			Bank	Unit Miles
Unit No. 01 Butte Creek 1			Left	15.08
	Spring (March - May)	Summer (June - August)	(September - November) Fall	Winter (December - February)
Unit Maintenance Rating (Fall Only)				
Date of Inspection	05/12/2015 - 05/12/2015			
DWR Inspector	Bob Duffey			
Accompanied By	Shawn Freitag Sutter Maintenance Yard

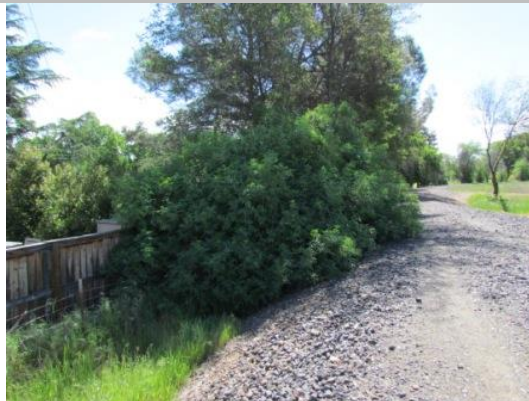
Photo 1 of 1 : SP\_2015\_MA0005\_196\_903\_20150310\_00016.jpg

View of the large elderberries along the L/S toe.

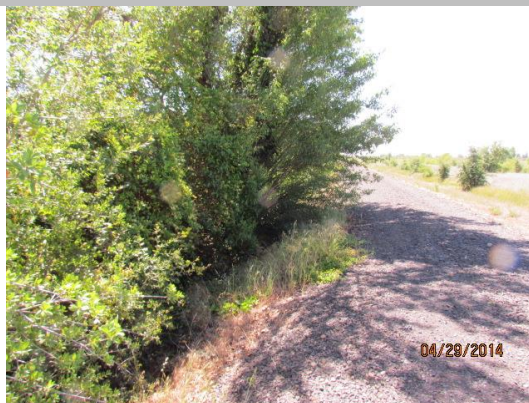
Photo 1 of 1 : SP\_2015\_MA0005\_196\_32\_20150310\_00011.jpg

LM Start	0.77	Rating **	M	Issue No.	32
LM End	0.77	Issue Type +	Ma	Location *	LS
Category	Earthen Levee			GPS Latitude/Longitude	
				Start	End
Item	Trim / Thin Trees			39.687917 °	39.687917 °
				-121.777393 °	-121.777393 °
DWR ID	DWR_MA0005_01_s_2014_32				
Action/Comments					
Thin trees to allow visibility of the ground and room to flood fight.

Trim the trees along the landside slope.

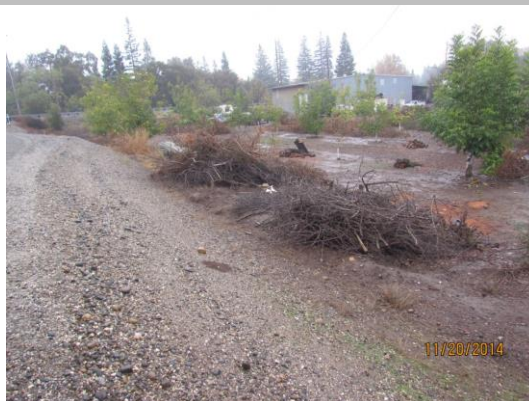
Photo 1 of 1 : SP\_2015\_MA0005\_196\_29\_20150310\_00009.jpg

LM Start	1.53	Rating **	M	Issue No.	29
LM End	1.53	Issue Type +	En	Location *	LS
Category	Earthen Levee			GPS Latitude/Longitude	
				Start	End
Item	Encroachments			39.677130 °	39.677130 °
				-121.777583 °	-121.777583 °
DWR ID	DWR_MA0005_01_f_2014_29				
Action/Comments					
Prunings

View of the prunings along the landside toe.

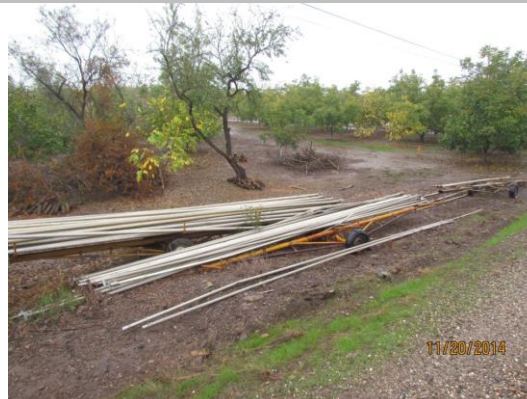
Photo 1 of 1 : SP\_2015\_MA0005\_196\_30\_20150310\_00010.jpg

View of the sprinkler pipe and equipment along the landside toe.

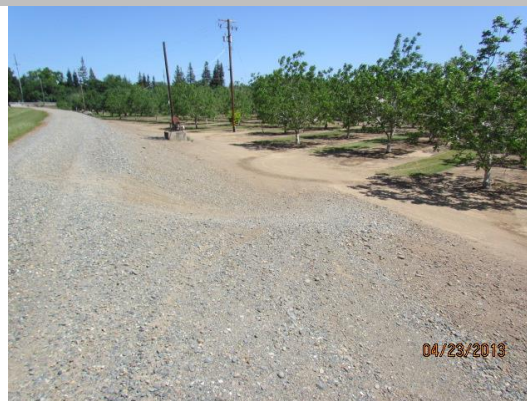
Photo 1 of 1 : SP\_2015\_MA0005\_196\_16\_20150310\_00008.jpg

LM Start	1.61	Rating **	M	Issue No.	16
LM End	1.61	Issue Type +	Ma	Location *	LS
Category	Earthen Levee			GPS Latitude/Longitude	
				Start	End
Item	Slope Stability			39.676129 °	39.676129 °
				-121.778171 °	-121.778171 °
DWR ID	DWR_MA0005_01_s_2013_16				
Action/Comments					
Repair the levee slope damaged by vehicle traffic and prevent access where possible.

View of the unauthorized vehicle ramp on the landside slope.

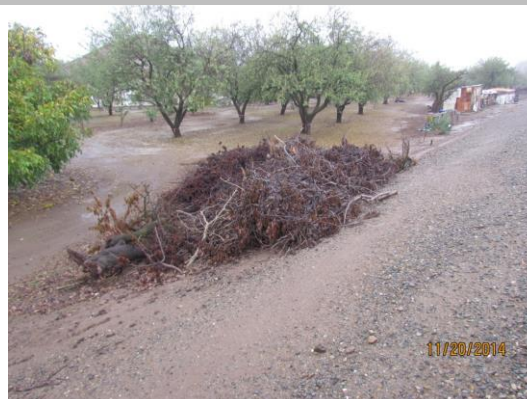
Photo 1 of 1 : SP\_2015\_MA0005\_196\_34\_20150310\_00013.jpg

LM Start	1.64	Rating **	M	Issue No.	34
LM End	1.64	Issue Type +	En	Location *	LS
Category	Earthen Levee			GPS Latitude/Longitude	
				Start	End
Item	Encroachments			39.675763 °	39.675763 °
				-121.778485 °	-121.778485 °
DWR ID	DWR_MA0005_01_f_2014_34				
Action/Comments					
Prunings

View of the prunings along the landside toe.

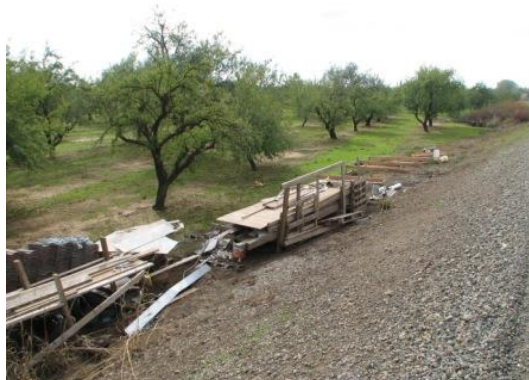
Photo 1 of 1 : SP\_2015\_MA0005\_196\_1\_20150310\_00001.jpg

View of the removed garbage but construction supply on pallets.

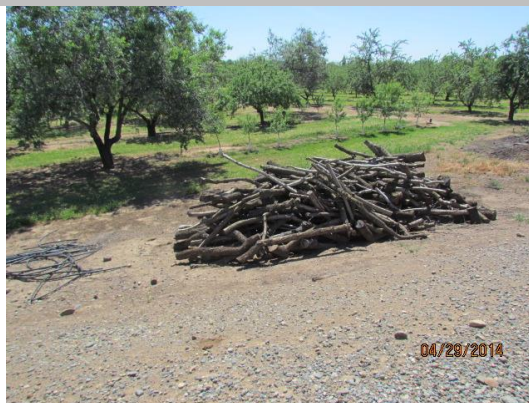
Photo 1 of 1 : SP\_2015\_MA0005\_196\_33\_20150310\_00012.jpg

LM Start	1.69	Rating **	M	Issue No.	33
LM End	1.69	Issue Type +	En	Location *	LS
Category	Earthen Levee			GPS Latitude/Longitude	
				Start	End
Item	Encroachments			39.675158 °	39.675158 °
				-121.779025 °	-121.779025 °
DWR ID	DWR_MA0005_01_s_2014_33				
Action/Comments					
Firewood

View of the firewood along the landside toe.

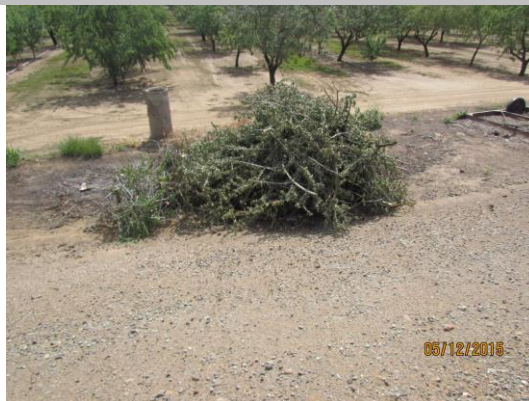
Photo 1 of 1 : SP\_2015\_MA0005\_196\_28\_20150518\_00017.jpg

LM Start	1.82	Rating **	M	Issue No.	28
LM End	1.82	Issue Type +	En	Location *	LS
Category	Earthen Levee			GPS Latitude/Longitude	
				Start	End
Item	Encroachments			39.673390 °	39.673390 °
				-121.779830 °	-121.779830 °
DWR ID	DWR_MA0005_01_s_2015_28				
Action/Comments					
Prunings					
Inspector Comments: Remove the prunings from the landside toe.

View of the prunings along the landside toe.

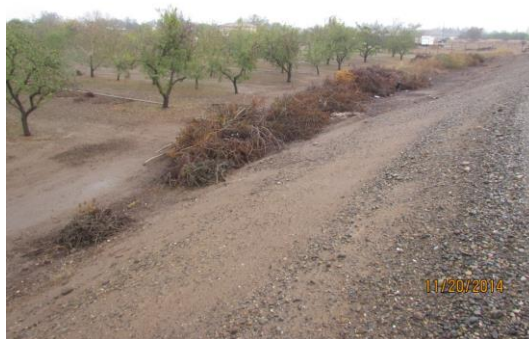
Photo 1 of 1 : SP\_2015\_MA0005\_196\_35\_20150310\_00014.jpg

View of the prunings along the landside toe.

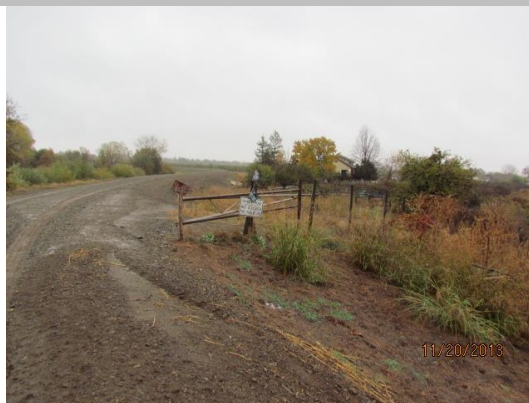
Photo 1 of 1 : SP\_2015\_MA0005\_196\_10\_20150310\_00007.jpg

LM Start	2.09	Rating **	M	Issue No.	10
LM End	2.09	Issue Type +	Ma	Location *	LS
Category	Earthen Levee			GPS Latitude/Longitude	
				Start	End
Item	Repair Gates			39.670112 °	39.670112 °
				-121.782012 °	-121.782012 °
DWR ID	DWR_MA0005_01_s_2012_10				
Action/Comments					
Inspector Comments: No permit.

View of the unpermitted gate.

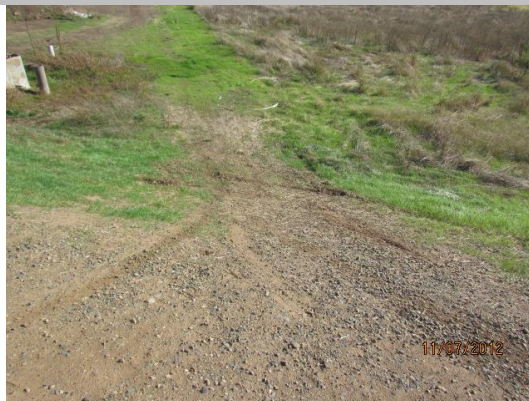
Photo 1 of 1 : SP\_2015\_MA0005\_196\_9\_20150310\_00006.jpg

LM Start	2.54	Rating **	M	Issue No.	9
LM End	2.54	Issue Type +	Ma	Location *	LS
Category	Earthen Levee			GPS Latitude/Longitude	
				Start	End
Item	Slope Stability			39.663876 °	39.663876 °
				-121.784014 °	-121.784014 °
DWR ID	DWR_MA0005_01_f_2012_9				
Action/Comments					
Repair the levee slope damaged by vehicle traffic and prevent access where possible.

View of the vehicle erosion along the landside slope.

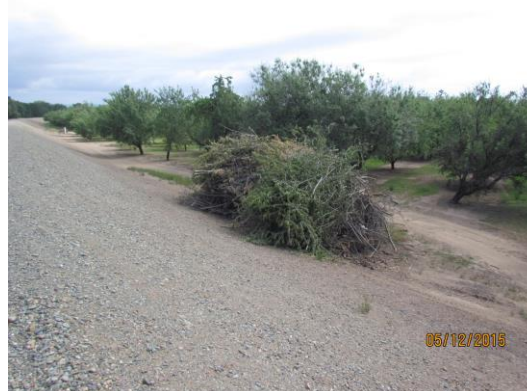
Photo 1 of 1 : SP\_2015\_MA0005\_196\_2\_20150518\_00018.jpg

View of the prunings along the landside toe.

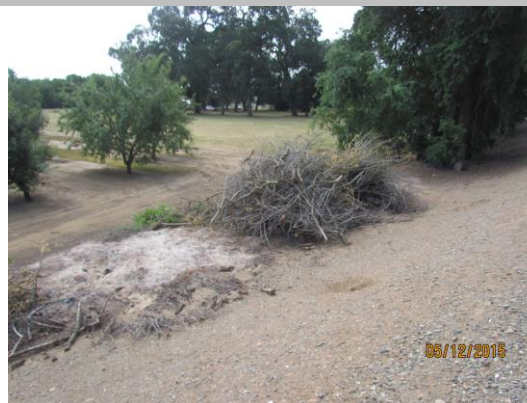
Photo 1 of 1 : SP\_2015\_MA0005\_196\_31\_20150518\_00019.jpg

LM Start	3.42	Rating **	M	Issue No.	31
LM End	3.42	Issue Type +	En	Location *	LS
Category	Earthen Levee			GPS Latitude/Longitude	
				Start	End
Item	Encroachments			39.652028 °	39.652028 °
				-121.789090 °	-121.789090 °
DWR ID	DWR_MA0005_01_s_2015_31				
Action/Comments					
Prunings					
Inspector Comments: Remove the prunings from the landside toe.

View of the prunings along the landside toe.

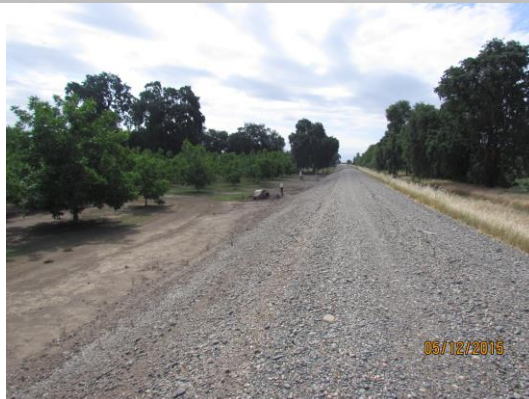
Photo 1 of 1 : SP\_2015\_MA0005\_196\_36\_20150518\_00020.jpg

View of the levee with no vegetation on both slopes.

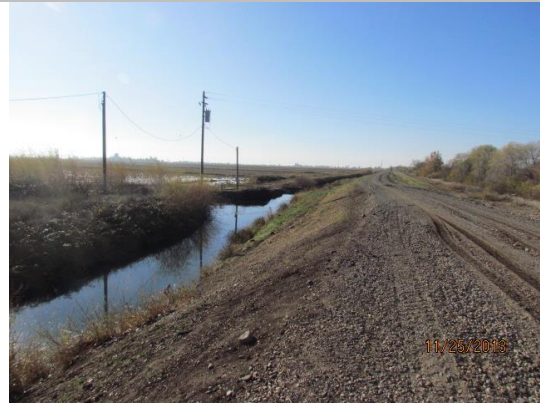
Photo 1 of 1 : SP\_2015\_MA0005\_196\_55\_20150310\_00015.jpg

View of the irrigation ditch along the landside toe.

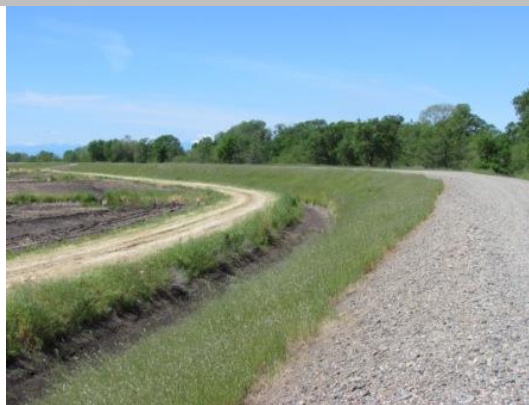
Photo 1 of 1 : SP\_2015\_MA0005\_196\_5\_20150310\_00004.jpg

View of the agricultural ditch along the L/S toe.

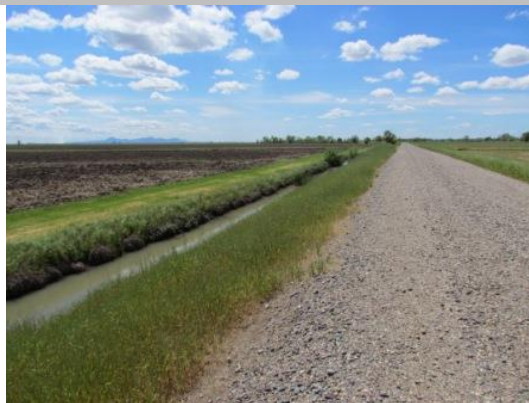
Photo 1 of 1 : SP\_2015\_MA0005\_196\_6\_20150310\_00005.jpg

View of the agricultural ditch along the L/S toe.

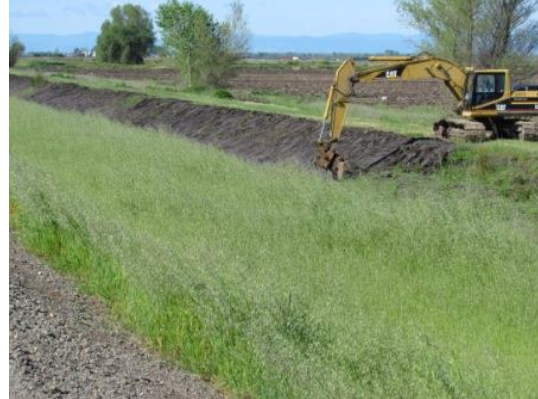
Photo 1 of 1 : SP\_2015\_MA0005\_197\_7\_20150310\_00004.jpg

View of the agricultural ditch along the L/S toe.

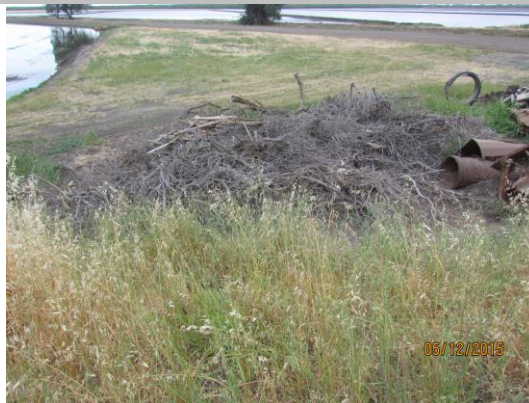
Photo 1 of 1 : SP\_2015\_MA0005\_197\_34\_20150518\_00016.jpg

View of the prunings along the landside toe.

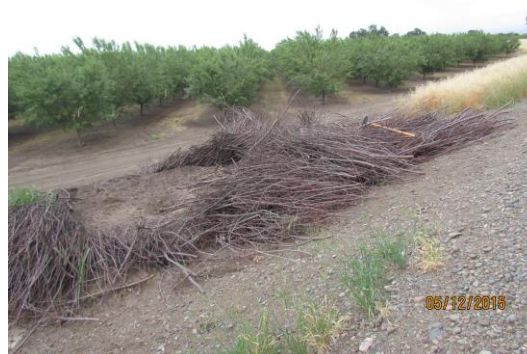
Photo 1 of 1 : SP\_2015\_MA0005\_197\_35\_20150518\_00017.jpg

View other prunings along the landside slope.

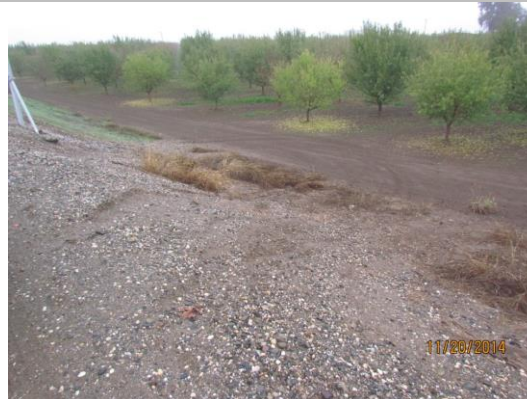
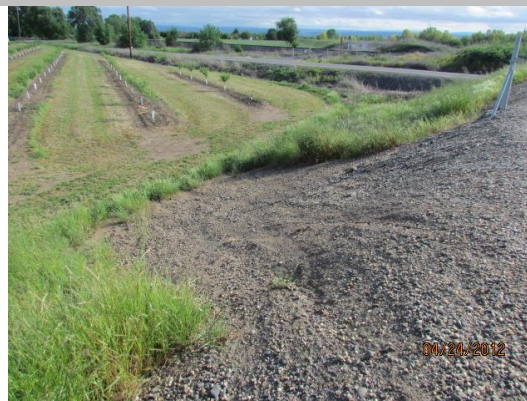
Photo 1 of 2 : SP\_2015\_MA0005\_197\_13\_20150310\_00005.jpg

LM Start	7.98	Rating **	M	Issue No.	13
LM End	7.98	Issue Type +	Ma	Location *	LS
Category	Earthen Levee			GPS Latitude/Longitude	
				Start	End
Item	Slope Stability			39.607710 °	39.607710 °
				-121.785868 °	-121.785868 °
DWR ID	DWR_MA0005_02_s_2012_13				
Action/Comments					
Repair the levee slope damaged by vehicle traffic and prevent access where possible.

View of the vehicle erosion along the landside slope.

View of the vehicle erosion along the slope.

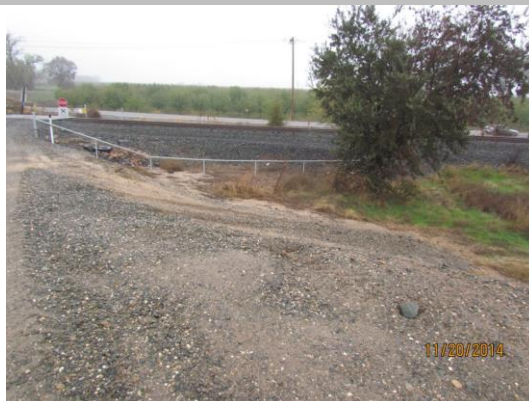
Photo 1 of 1 : SP\_2015\_MA0005\_197\_40\_20150310\_00013.jpg

View of the vehicle erosion along the landside slope.

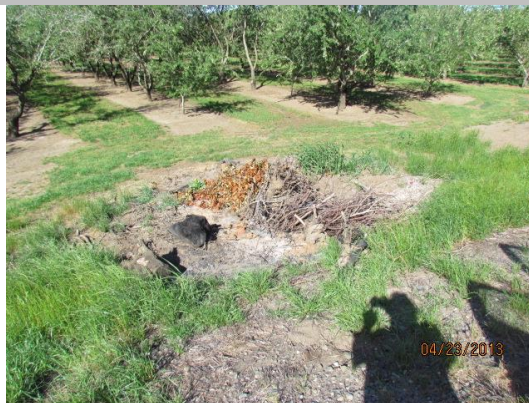
Photo 1 of 1 : SP\_2015\_MA0005\_197\_3\_20150310\_00002.jpg

View of the prunings along the landside toe.

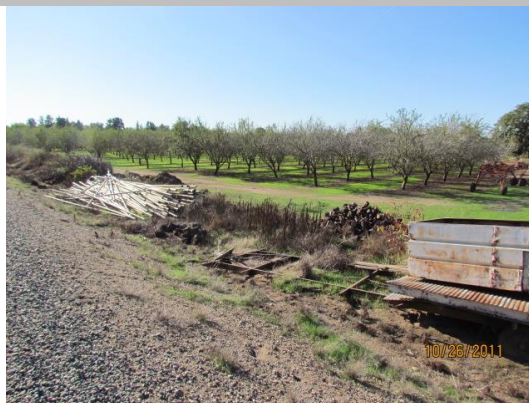
Photo 1 of 1 : SP\_2015\_MA0005\_197\_14\_20150310\_00007.jpg

LM Start	10.46	Rating **	M	Issue No.	14
LM End	10.46	Issue Type +	En	Location *	LS
Category	Earthen Levee			GPS Latitude/Longitude	
				Start	End
Item	Encroachments			39.639967 °	39.639967 °
				-121.782152 °	-121.782152 °
DWR ID	DWR_MA0005_02_s_2012_14				
Action/Comments					
Equipment

View of the equipment along the L/S toe.

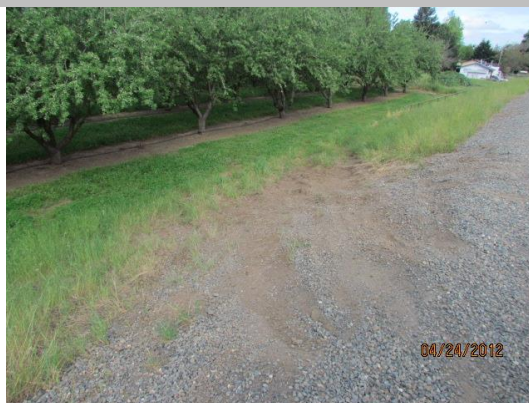
Photo 1 of 1 : SP\_2015\_MA0005\_197\_18\_20150310\_00008.jpg

LM Start	10.63	Rating **	M	Issue No.	18
LM End	10.63	Issue Type +	Ma	Location *	LS
Category	Earthen Levee			GPS Latitude/Longitude	
				Start	End
Item	Slope Stability			39.642061 °	39.642061 °
				-121.783861 °	-121.783861 °
DWR ID	DWR_MA0005_02_s_2012_18				
Action/Comments					
Repair the levee slope damaged by vehicle traffic and prevent access where possible.

View of the vehicle erosion along the slope of the levee.

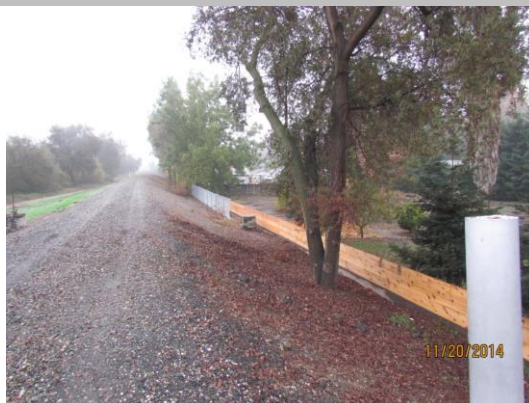
Photo 1 of 1 : SP\_2015\_MA0005\_197\_41\_20150310\_00014.jpg

LM Start	10.89	Rating **	M	Issue No.	41
LM End	10.93	Issue Type +	En	Location *	LS
Category	Earthen Levee			GPS Latitude/Longitude	
				Start	End
Item	Encroachments			39.645318 °	39.645858 °
				-121.786345 °	-121.786742 °
DWR ID	DWR_MA0005_02_f_2014_41				
Action/Comments					
Fence

View of the new fence along the landside toe.

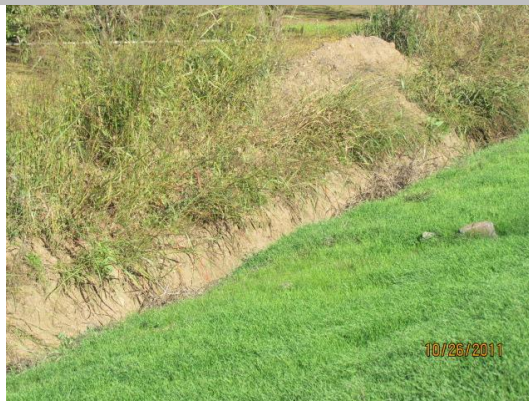
Photo 1 of 1 : SP\_2015\_MA0005\_197\_6\_20150310\_00003.jpg

View of the ditch along the L/S toe.

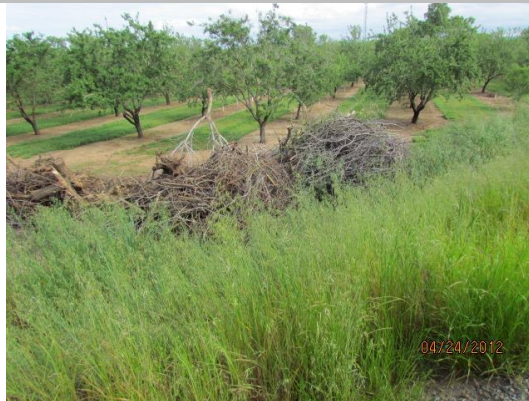
Photo 1 of 1 : SP\_2015\_MA0005\_197\_19\_20150310\_00009.jpg

View of the brush pile at the toe of the levee.

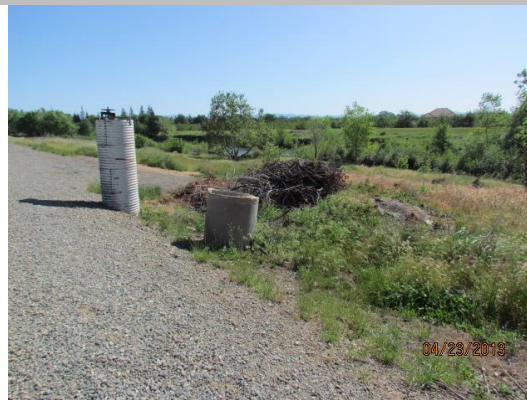
Photo 1 of 1 : SP\_2015\_MA0005\_197\_22\_20150310\_00011.jpg

View of the prunings along the waterside toe.

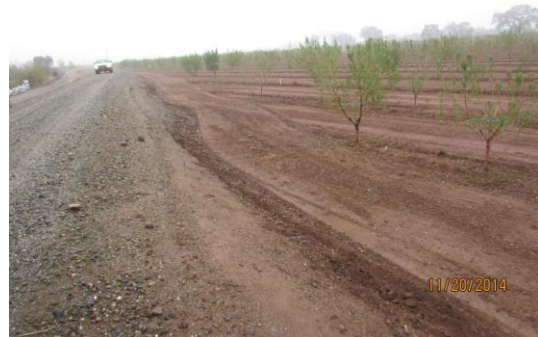
Photo 1 of 1 : SP\_2015\_MA0005\_197\_43\_20150310\_00015.jpg

View of where the landowner is disking into the landside slope.

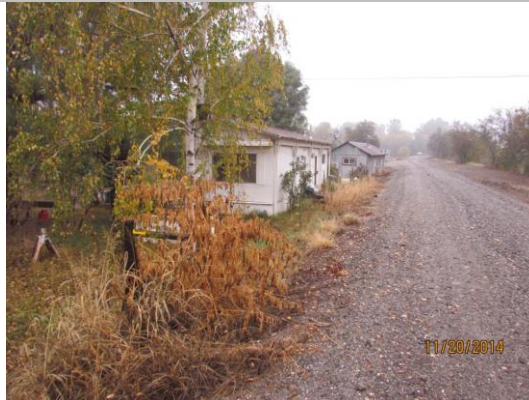
Photo 1 of 1 : SP\_2015\_MA0005\_197\_25\_20150310\_00012.jpg

View of the buildings at the landside toe.

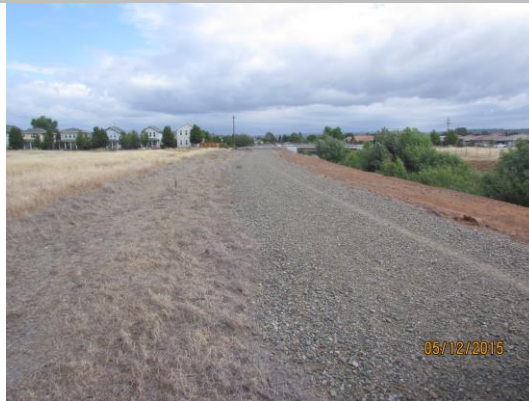
Photo 1 of 1 : SP\_2015\_MA0005\_198\_1\_20150518\_00001.jpg

View of the levee with no vegetation on both slope.
