**Flood Control Project Maintenance  
Levee Inspections**  
**LMA District Cover Sheet**  
**Spring 2016 Levee Inspection Results**

**Sutter Maintenance Yard Maintenance Area 0005**

**Spring 2016 Levee Inspection Results**

Waterway	Bank	Unit Miles
Unit No. 01 Butte Creek	Left	15.08

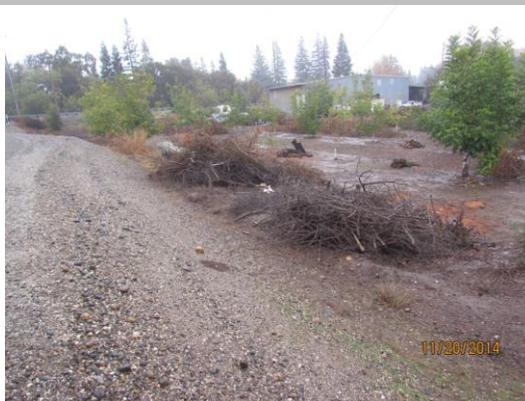
Photo 1 of 1 : SP\_2016\_MA0005\_196\_29\_20160321\_00009.jpg

View of the prunings along the landside toe.

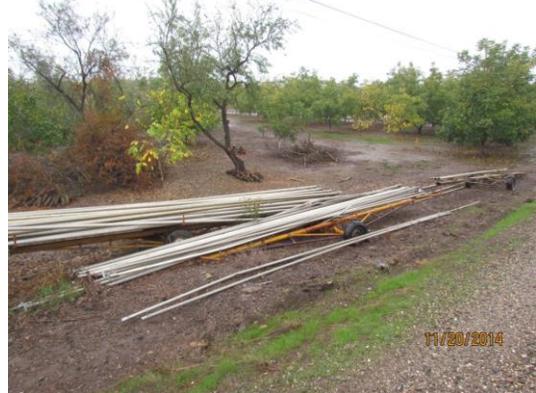
Photo 1 of 1 : SP\_2016\_MA0005\_196\_30\_20160321\_00010.jpg

View of the sprinkler pipe and equipment along the landside toe.

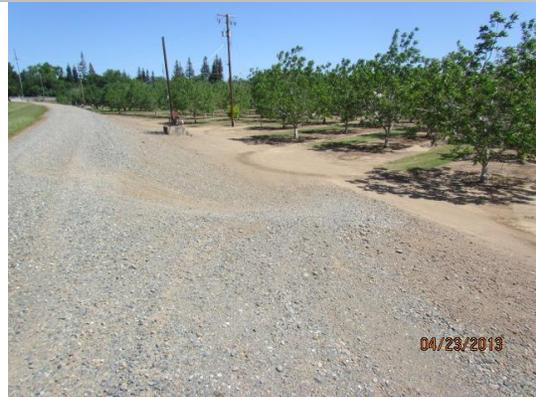
Photo 1 of 1 : SP\_2016\_MA0005\_196\_16\_20160321\_00007.jpg

LM Start	<b>1.61</b>	Rating **	M	Issue No.	<b>16</b>
LM End	<b>1.61</b>	Issue Type +	Ma	Location *	LS
Category	Earthen Levee		GPS Latitude/Longitude		
			Start	End	
Item	Slope Stability		39.676129 °	39.676129 °	
			-121.778171 °	-121.778171 °	
DWR ID	DWR_MA0005_01_s_2013_16				
Comment Code					
S3 : Repair the levee slope damaged by vehicle traffic and prevent access where possible.					
Inspector Comment

View of the unauthorized vehicle ramp on the landside slope.

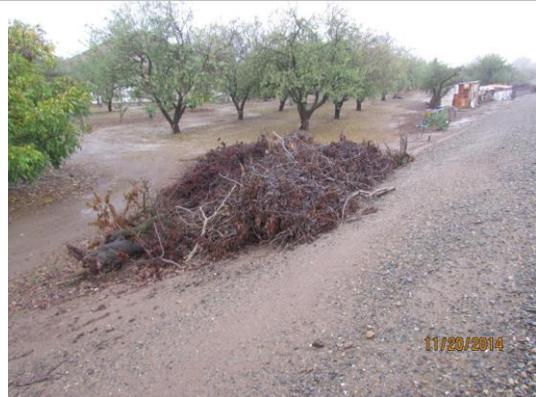
Photo 1 of 1 : SP\_2016\_MA0005\_196\_34\_20160321\_00014.jpg

LM Start	<b>1.64</b>	Rating **	U	Issue No.	<b>34</b>
LM End	<b>1.64</b>	Issue Type +	En	Location *	LS
Category	Earthen Levee		GPS Latitude/Longitude		
			Start	End	
Item	Encroachments		39.675763 °	39.675763 °	
			-121.778485 °	-121.778485 °	
DWR ID	DWR_MA0005_01_f_2014_34				
Comment Code					
PR : Prunings					
Inspector Comment

View of the prunings along the landside toe.

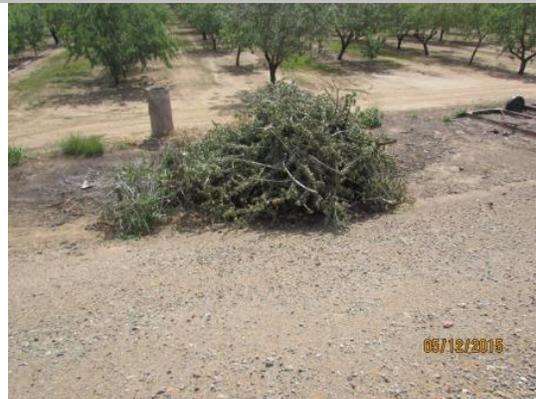
Photo 1 of 1 : SP\_2016\_MA0005\_196\_28\_20160321\_00008.jpg

View of the prunings along the landside toe.

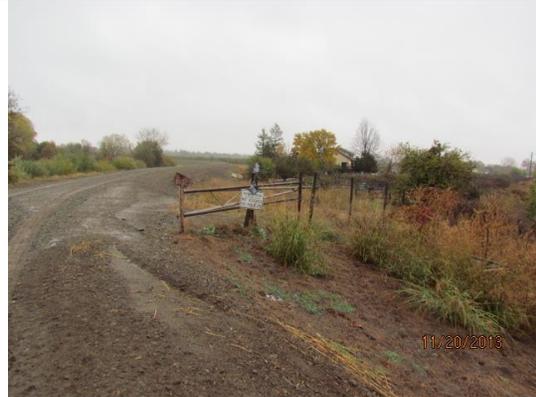
Photo 1 of 1 : SP\_2016\_MA0005\_196\_10\_20160321\_00006.jpg

LM Start	<b>2.09</b>	Rating **	M	Issue No.	<b>10</b>
LM End	<b>2.09</b>	Issue Type +	En	Location *	LS
Category	Earthen Levee		GPS Latitude/Longitude		
			Start	End	
Item	Encroachments		39.670112 °	39.670112 °	
			-121.782012 °	-121.782012 °	
DWR ID	DWR_MA0005_01_s_2016_10				
Comment Code					
FE : Fence					
Inspector Comment					
No perm was found for the gate

View of the unpermitted gate.

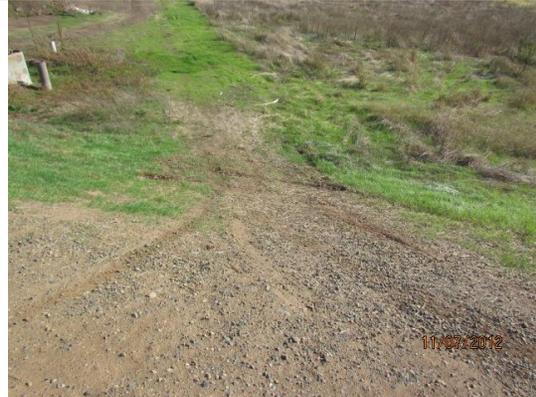
Photo 1 of 1 : SP\_2016\_MA0005\_196\_9\_20160321\_00005.jpg

LM Start	<b>2.54</b>	Rating **	M	Issue No.	<b>9</b>
LM End	<b>2.54</b>	Issue Type +	Ma	Location *	LS
Category	Earthen Levee		GPS Latitude/Longitude		
			Start	End	
Item	Slope Stability		39.663876 °	39.663876 °	
			-121.784014 °	-121.784014 °	
DWR ID	DWR_MA0005_01_f_2012_9				
Comment Code					
S3 : Repair the levee slope damaged by vehicle traffic and prevent access where possible.					
Inspector Comment

View of the vehicle erosion along the landside slope.

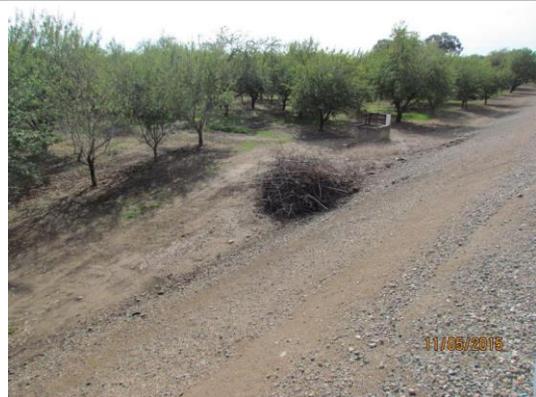
Photo 1 of 1 : SP\_2016\_MA0005\_196\_37\_20160321\_00017.jpg

View of the prunings along the landside toe.

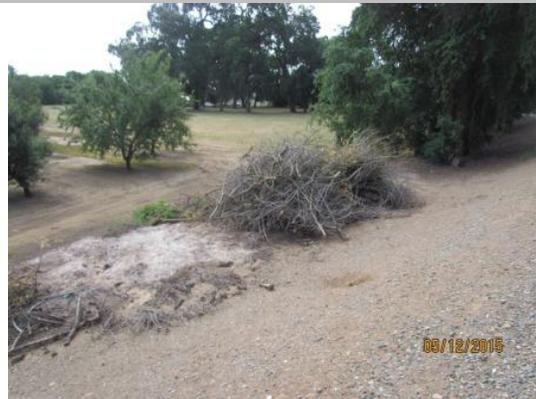
Photo 1 of 1 : SP\_2016\_MA0005\_196\_31\_20160321\_00011.jpg

View of the prunings along the landside toe.

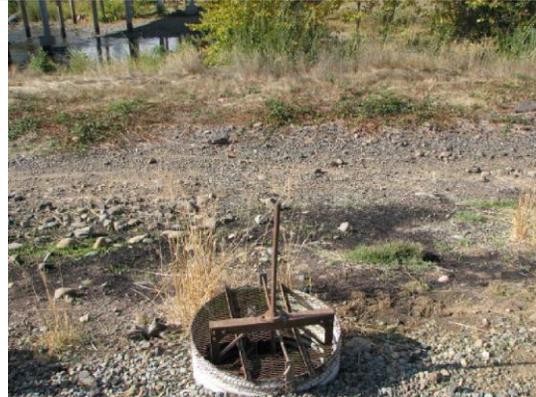
Photo 1 of 2 : UCIP\_SP\_2016\_48267\_67931.jpg

Item	DWR UCIP Field Study		39.646217 °	39.646217 °	
			-121.785431 °	-121.785431 °	
DWR ID					
Comment Code					
Inspector Comment					
<p>FS_ID:48267                  DS_ID:1616                  EP_NO: N/A                  Repair Type: Non-Urgent                  Crossing Status: Found                  UCIP Comments: 5/9/2016 Crossing appears to be in good condition.8/5/2015 WS pipe end is being overgrown by trees and other vegetation. Needs to be cleared back.12/8/2014 Same as last inspection.6/11/2014 Same as last inspection.11/20/2013 Same as last inspection.5/29/2013 Same as last inspection.                  FIELD_STRUCT_DESC: 24-inch drainage pipe through the levee, 16.5 feet below the crown. Slide gate in CMP riser on waterside (WS) slope. Flap gate at waterside toe. Inlet on landside (LS) toe, not found.                  [Additional Reference(s): DWR Levee Log, 1990. Sacramento O&amp;M Manual 515, April 1955 (Station 717+50)].                  FS Date: 5/25/2016 7:41:08 AM</p>

CMP riser and slide gate on WS shoulder.

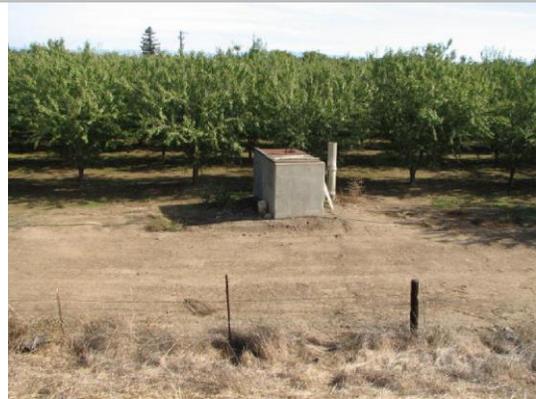
Photo 2 of 2 : UCIP\_SP\_2016\_48267\_67930.jpg

Unable to locate inlet on LS.

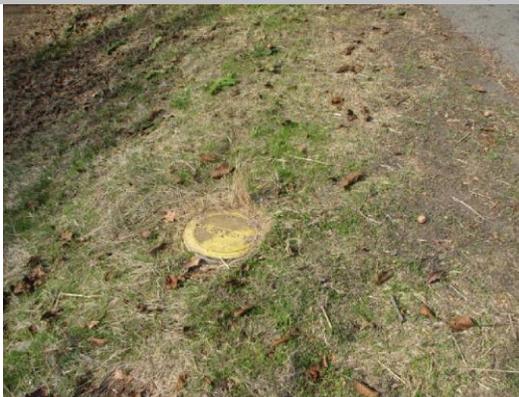
Photo 1 of 2 : UCIP\_SP\_2016\_48269\_67936.jpg

Item	DWR UCIP Field Study			39.645846 °	39.645846 °
				-121.785155 °	-121.785155 °
DWR ID					
Comment Code					
Inspector Comment					
FS_ID:48269 DS_ID:1619 EP_NO: 6544-A Repair Type: Non-Urgent Crossing Status: Indicator Found UCIP Comments: 5/9/2016 Crossing appears to be in good condition.8/5/2015 Pipe is suspected to cross inside of bridge.12/8/2014 Same as last inspection.6/11/2014 Same as last inspection.11/20/2013 Same as last inspection.5/29/2013 Same as last inspection.10/30/2012 Pipeline should be marked where pipe crosses levee as it is 4-feet below the surface. FIELD_STRUCT_DESC: 6-inch concrete encased steel high pressure gas pipe through the levee, 4.0 feet below the crown. 8-inch diameter PG&E gas access manhole located on south side of road 250-feet east of levee crown. (Permit No. 6544A, 1969 - PG&E) [Additional Reference(s): DWR Levee Log, 1990]. FS Date: 5/25/2016 7:44:52 AM

PG&E access lid on south edge of roadway.

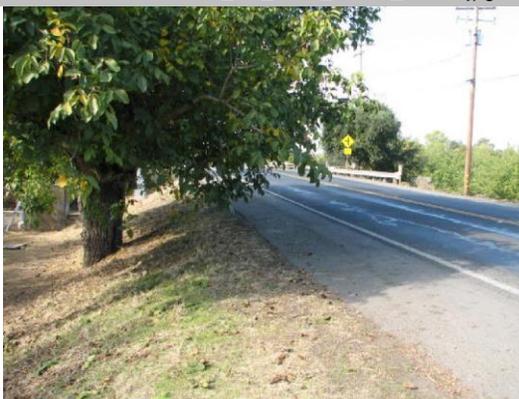
Photo 2 of 2 : UCIP\_SP\_2016\_48269\_67935.jpg

Location of PG&E access lid 250-feet east of levee crown on south side of roadway.

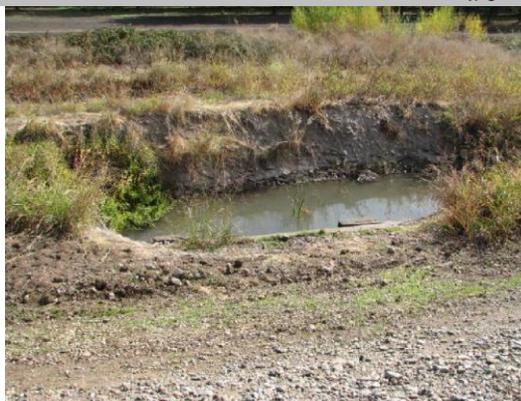
Photo 1 of 2 : UCIP\_SP\_2016\_48271\_67939.jpg

Item	DWR UCIP Field Study			39.624559 °	39.624559 °
				-121.772141 °	-121.772141 °
DWR ID					
Comment Code					
Inspector Comment					
FS_ID:48271 DS_ID:1768 EP_NO: N/A Repair Type: Non-Urgent Crossing Status: Found UCIP Comments: 5/9/2016 Abandoned pipe. Needs a cover for standpipe.8/5/2015 Abandoned pipes. Need covers made for tops of standpipes to prevent falls. Pipe 1/2 filled with soil at slide gate on WS.5/29/2013 Same as last inspection. Land owner said pipes are abandoned and no longer used. Covers should be made for top of standpipe to prevent falls. Pipes should be properly abandoned.11/19/2013 Same as last inspection.6/11/2014 Same as last inspection.12/8/2014 Same as last inspection. FIELD_STRUCT_DESC: 2 of 2. 36-inch pipe through levee 11.0 feet below crown. Slide gate in 54-inch corrugated metal riser on waterward slope and concrete "U" headwall on the landward side. (USACE 1957) FS Date: 5/25/2016 7:46:45 AM

Headwall at LS toe.

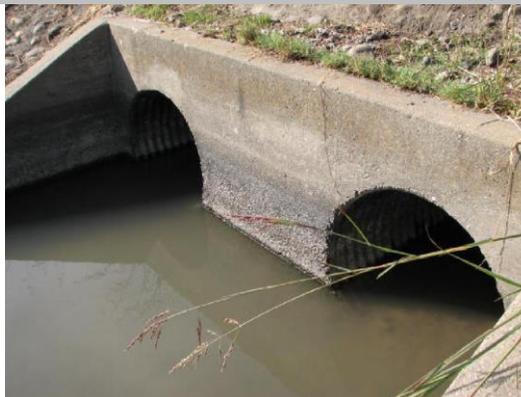
Photo 2 of 2 : UCIP\_SP\_2016\_48271\_67938.jpg

Item	DWR UCIP Field Study			39.624559 °	39.624559 °
				-121.772141 °	-121.772141 °
DWR ID					
Comment Code					
Inspector Comment					
FS_ID:48271 DS_ID:1768 EP_NO: N/A Repair Type: Non-Urgent Crossing Status: Found UCIP Comments: 5/9/2016 Abandoned pipe. Needs a cover for standpipe.8/5/2015 Abandoned pipes. Need covers made for tops of standpipes to prevent falls. Pipe 1/2 filled with soil at slide gate on WS.5/29/2013 Same as last inspection. Land owner said pipes are abandoned and no longer used. Covers should be made for top of standpipe to prevent falls. Pipes should be properly abandoned.11/19/2013 Same as last inspection.6/11/2014 Same as last inspection.12/8/2014 Same as last inspection. FIELD_STRUCT_DESC: 2 of 2. 36-inch pipe through levee 11.0 feet below crown. Slide gate in 54-inch corrugated metal riser on waterward slope and concrete "U" headwall on the landward side. (USACE 1957) FS Date: 5/25/2016 7:46:45 AM

Headwall at LS toe.

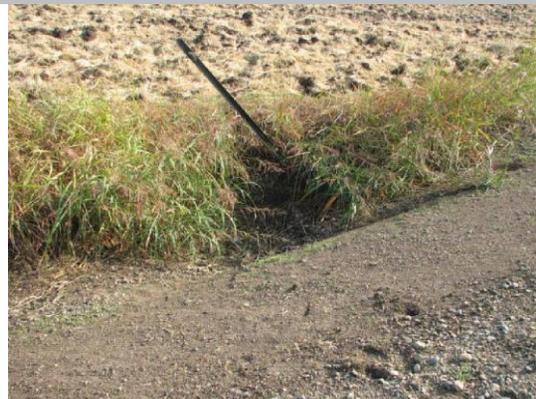
Photo 1 of 2 : UCIP\_SP\_2016\_48429\_67970.jpg

Item	DWR UCIP Field Study		39.597725 °	39.597725 °	
			-121.787257 °	-121.787257 °	
DWR ID					
Comment Code					
Inspector Comment					
<p>FS_ID:48429                  DS_ID:1628                  EP_NO: N/A                  Repair Type: Non-Urgent                  Crossing Status: Found                  UCIP Comments: 5/11/2016 Possibly an abandoned crossing. LS inlet was over 50% buried and nothing was found on the WS.8/4/2015 LS pipe end filled about 50% with soil and WS pipe end is buried.12/8/2014 Same as last inspection.6/11/2014 Same as last inspection.11/19/2013 Same as last inspection.5/29/2013 Same as last inspection.10/30/2012 Pipe filled with soil and outlet/appurtances are burried.                  FIELD_STRUCT_DESC: 24-inch steel drainage pipe through the levee, 8.5 feet below the crown. Flap gate on the waterside (WS). Concrete "U" shaped headwall on landside (LS) toe. [Additional Reference(s): DWR Levee Log, 1990. Sacramento O&amp;M Manual 515, April 1955 (Station 576+72)].                  FS Date: 5/25/2016 8:43:00 AM</p>

Headwall at LS toe.

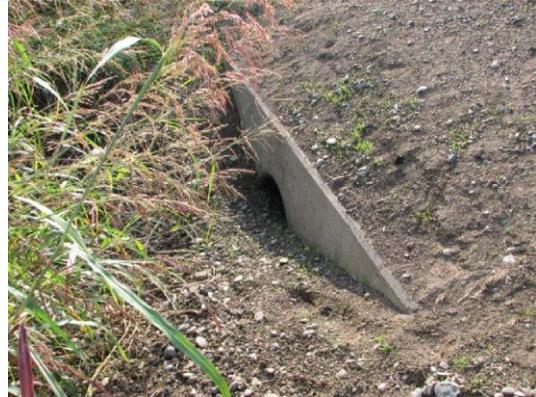
Photo 2 of 2 : UCIP\_SP\_2016\_48429\_67969.jpg

Item	DWR UCIP Field Study			39.597725 °	39.597725 °
				-121.787257 °	-121.787257 °
DWR ID					
Comment Code					
Inspector Comment					
FS_ID:48429 DS_ID:1628 EP_NO: N/A Repair Type: Non-Urgent Crossing Status: Found UCIP Comments: 5/11/2016 Possibly an abandoned crossing. LS inlet was over 50% buried and nothing was found on the WS.8/4/2015 LS pipe end filled about 50% with soil and WS pipe end is buried.12/8/2014 Same as last inspection.6/11/2014 Same as last inspection.11/19/2013 Same as last inspection.5/29/2013 Same as last inspection.10/30/2012 Pipe filled with soil and outlet/appurtances are burried. FIELD_STRUCT_DESC: 24-inch steel drainage pipe through the levee, 8.5 feet below the crown. Flap gate on the waterside (WS). Concrete "U" shaped headwall on landside (LS) toe. [Additional Reference(s): DWR Levee Log, 1990. Sacramento O&M Manual 515, April 1955 (Station 576+72)]. FS Date: 5/25/2016 8:43:00 AM

Headwall at LS toe.

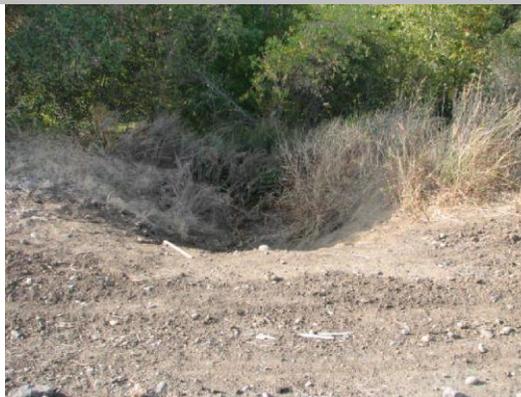
Photo 1 of 2 : UCIP\_SP\_2016\_48432\_67973.jpg

Item	DWR UCIP Field Study			39.589751 °	39.589751 °
				-121.792818 °	-121.792818 °
DWR ID					
Comment Code					
Inspector Comment					
<p>FS_ID:48432                  DS_ID:1629                  EP_NO: N/A                  Repair Type: Non-Urgent                  Crossing Status: Found                  UCIP Comments: 5/11/2016 WS flap gate was about 50% buried and LS was 100% buried. Appears to be an abandoned crossing.8/4/2015 WS flap gate is partially buried by soil and being overgrown with vegetation. LS pipe end was underwater and suspected to still be completely buried with soil.12/8/2014 Same as last inspection.6/11/2014 Same as last inspection.11/19/2013 Same as last inspection.5/29/2013 Same as last inspection.10/30/2012 Pipe filled with soil.                  FIELD_STRUCT_DESC: 24-inch corrugated metal drainage pipe through the levee, 9.3 feet below the crown. Flap gate on the waterside (WS). Concrete headwall at landside (LS) and waterside toes.                  [Additional Reference(s): DWR Levee Log, 1990. Sacramento O&amp;M 515, April 1955 (Station 609+79)].                  FS Date: 5/25/2016 8:50:00 AM</p>

Outlet at WS toe.

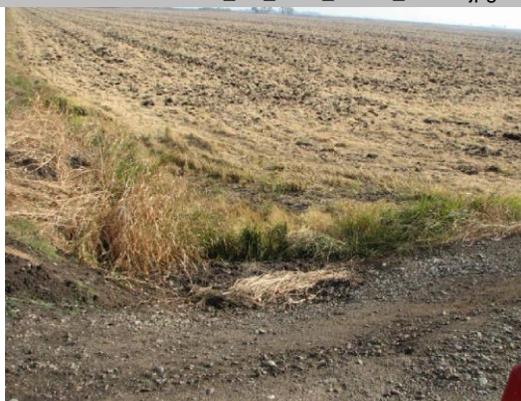
Photo 2 of 2 : UCIP\_SP\_2016\_48432\_67972.jpg

Buried inlet at LS toe.

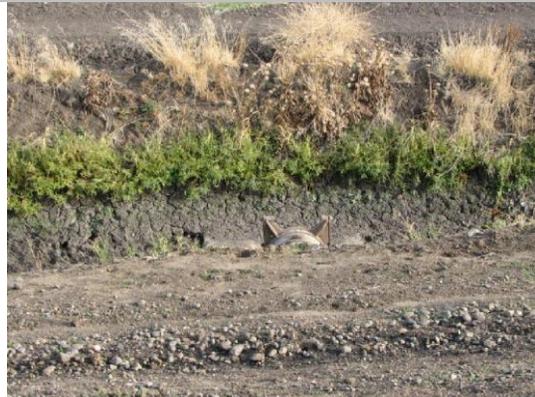
Photo 1 of 1 : UCIP\_SP\_2016\_48498\_67986.jpg

Item	DWR UCIP Field Study		39.570596 °	39.570596 °	
			-121.815215 °	-121.815215 °	
DWR ID					
Comment Code					
Inspector Comment					
<p>FS_ID:48498                  DS_ID:1633                  EP_NO: N/A                  Repair Type: Non-Urgent                  Crossing Status: Found                  UCIP Comments: 5/11/2016 Abandoned crossing.8/4/2015                  Abandoned pipe. Casey Wilder has started the steps to have the pipe properly abandoned and removed from the levee.12/8/2014 Same as last inspection.6/11/2014 Same as last inspection.11/19/2013 Same as last inspection.5/29/2013 Same as last inspection.10/30/2012 Pipe and headwall buried on WS, no access to slide gate.                  FIELD_STRUCT_DESC: 24-inch corrugated metal pipe through the levee, 12.5 feet below the crown. Slide gate on the waterside (WS). Flap gate and headwall on the landside (LS). Concrete headwall at the WS toe. [Additional Reference(s): DWR Levee Log, 1990. Sacramento O&amp;M Manual 515, April 1955 (Station 706+00)].                  FS Date: 5/25/2016 9:12:00 AM</p>

Flap gate and headwall at LS toe in irrigation or drainage ditch.

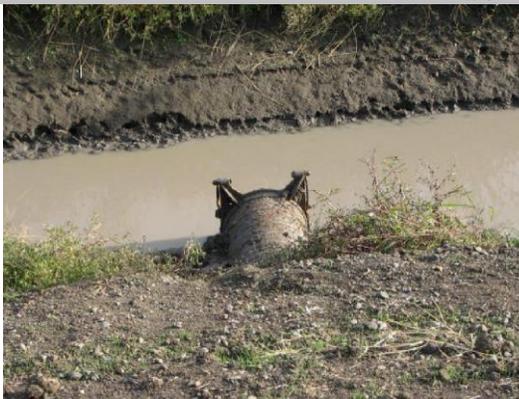
Photo 1 of 2 : UCIP\_SP\_2016\_48497\_67989.jpg

Item	DWR UCIP Field Study			39.568523 °	39.568523 °
				-121.818232 °	-121.818232 °
DWR ID					
Comment Code					
Inspector Comment					
FS_ID:48497 DS_ID:1634 EP_NO: N/A Repair Type: Non-Urgent Crossing Status: Found UCIP Comments: 5/11/2016 Abandoned crossing.8/4/2015 Abandoned pipe. Casey Wilder has started the steps to have the pipe properly abandoned and removed from the levee.12/8/2014 Same as last inspection.6/11/2014 Same as last inspection.11/19/2013 Same as last inspection.5/29/2013 Same as last inspection. FIELD_STRUCT_DESC: 24-inch corrugated metal irrigation pipe through the levee, 14.5 feet below the crown. Slide gate on the waterside (WS) on concrete headwall. Flap gate on the landside (LS). [Additional Reference(s): DWR Levee Log, 1990. Sacramento O&M Manual 515, April 1955 (Station 717+50)]. FS Date: 5/25/2016 9:24:00 AM

Pipe and flap gate on LS toe.

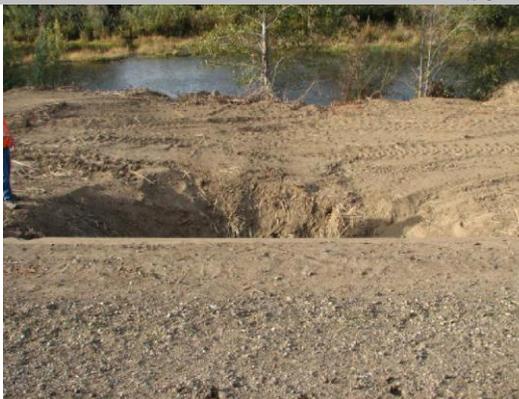
Photo 2 of 2 : UCIP\_SP\_2016\_48497\_67988.jpg

headwall at WS toe.

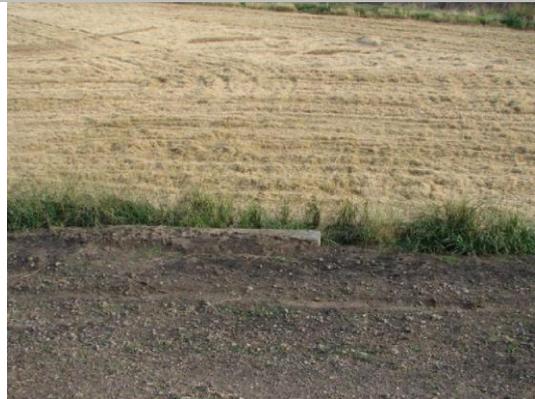
Photo 1 of 2 : UCIP\_SP\_2016\_48499\_67991.jpg

Item	DWR UCIP Field Study		39.562559 °	39.562559 °	
			-121.825808 °	-121.825808 °	
DWR ID					
Comment Code					
Inspector Comment					
FS_ID:48499 DS_ID:1635 EP_NO: N/A Repair Type: Non-Urgent Crossing Status: Found UCIP Comments: 5/11/2016 Abandoned crossing.8/4/2015 Abandoned pipe. Casey Wilder has started the steps to have the pipe properly abandoned and removed from the levee.12/8/2014 Same as last inspection.6/11/2014 Same as last inspection.11/19/2013 Same as last inspection.5/29/2013 Same as last inspection.10/30/2012 Pipe buried on both sides of levee. FIELD_STRUCT_DESC: 30-inch corrugated metal drainage pipe through the levee, 12.2 feet below the crown. Flap gate on the waterside (WS) end. [Additional Reference(s): DWR Levee Log, 1990. USACE Sacramento O&M Manual 515 (Station 748+53)]. FS Date: 5/25/2016 9:29:00 AM

Concrete headwall at LS toe.

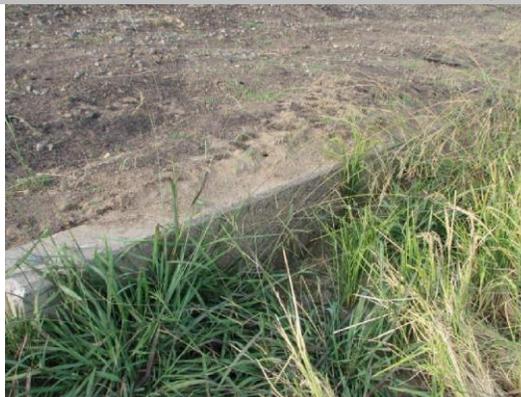
Photo 2 of 2 : UCIP\_SP\_2016\_48499\_67990.jpg

Item	DWR UCIP Field Study			39.562559 °	39.562559 °
				-121.825808 °	-121.825808 °
DWR ID					
Comment Code					
Inspector Comment					
FS_ID:48499 DS_ID:1635 EP_NO: N/A Repair Type: Non-Urgent Crossing Status: Found UCIP Comments: 5/11/2016 Abandoned crossing.8/4/2015 Abandoned pipe. Casey Wilder has started the steps to have the pipe properly abandoned and removed from the levee.12/8/2014 Same as last inspection.6/11/2014 Same as last inspection.11/19/2013 Same as last inspection.5/29/2013 Same as last inspection.10/30/2012 Pipe buried on both sides of levee. FIELD_STRUCT_DESC: 30-inch corrugated metal drainage pipe through the levee, 12.2 feet below the crown. Flap gate on the waterside (WS) end. [Additional Reference(s): DWR Levee Log, 1990. USACE Sacramento O&M Manual 515 (Station 748+53)]. FS Date: 5/25/2016 9:29:00 AM

Concrete headwall at LS toe.

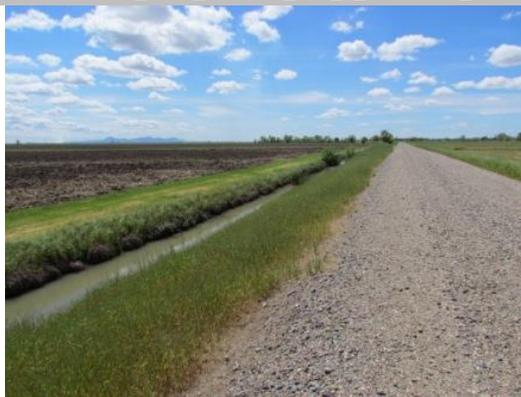
Photo 1 of 1 : SP\_2016\_MA0005\_196\_6\_20160321\_00004.jpg

View of the agricultural ditch along the L/S toe.

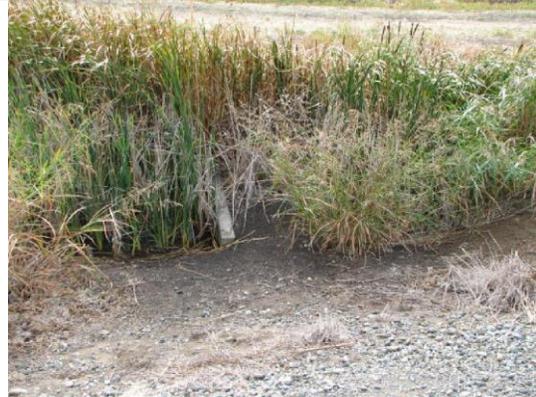
Photo 1 of 1 : UCIP\_SP\_2016\_48314\_68025.jpg

LM Start	<b>11.85</b>	Rating **	M	Issue No.	<b>913</b>
LM End	<b>11.85</b>	Issue Type +	En	Location *	LS
Category	Supplemental			GPS Latitude/Longitude	
				Start	End
Item	DWR UCIP Field Study			39.551212 °	39.551212 °
				-121.837724 °	-121.837724 °
DWR ID					
Comment Code					
Inspector Comment					
FS_ID:48314 DS_ID:1747 EP_NO: N/A Repair Type: Non-Urgent Crossing Status: Indicator Found UCIP Comments: 5/11/2016 Buried pipe.8/4/2015 Pipe is buried on both ends.Pipe burried on both LS and WS.5/29/2013 Same as last inspection.11/19/2013 Same as last inspection.6/11/2014 Same as last inspection. FIELD_STRUCT_DESC: 48" Corrugated Metal Pipe riser and sparling water meter/irrigation structure. 4-foot by 6-foot concrete outlet box on LS toe.(USACE 1952) FS Date: 5/25/2016 10:06:43 AM

Buried pipe at concrete box, LS toe.

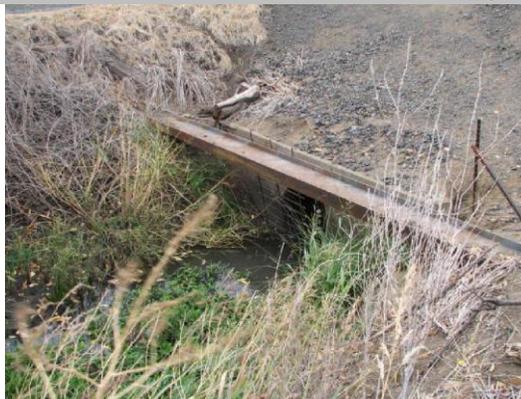
Photo 1 of 2 : UCIP\_SP\_2016\_48503\_68033.jpg

Headwall at inlet on LS toe.

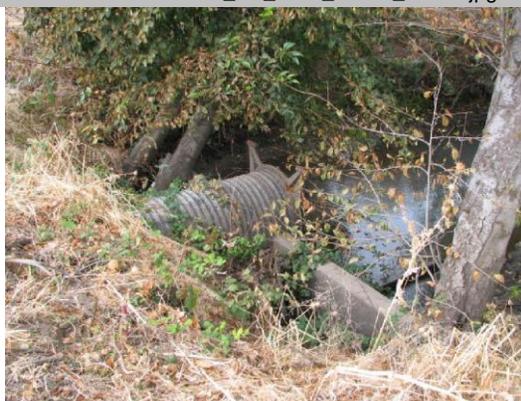
Photo 2 of 2 : UCIP\_SP\_2016\_48503\_68032.jpg

CMP pipe, flap gate, and headwall on WS toe.

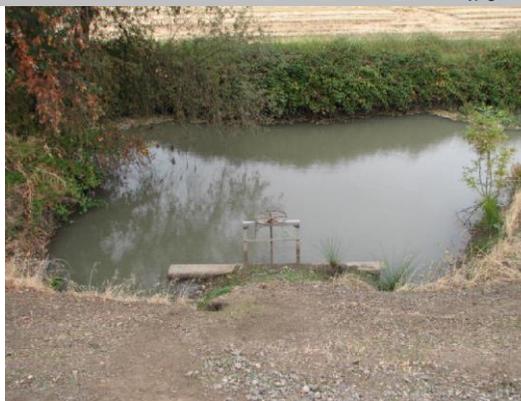
Photo 1 of 2 : UCIP\_SP\_2016\_48520\_68498.jpg

Concrete headwall and slide gate on LS toe.

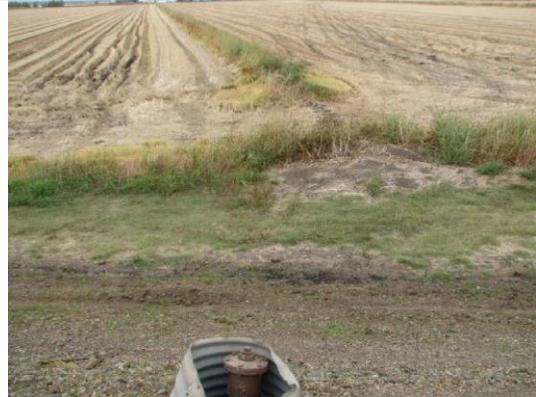
Photo 1 of 2 : UCIP\_SP\_2016\_48521\_68057.jpg

Air vent in 24-inch CMP riser on LS shoulder.

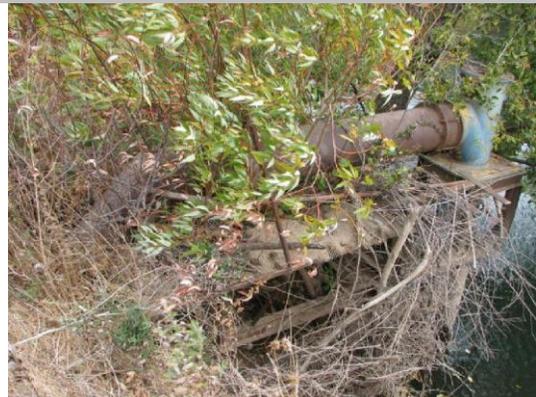
Photo 2 of 2 : UCIP\_SP\_2016\_48521\_68056.jpg

Pump on metal pier at WS toe.

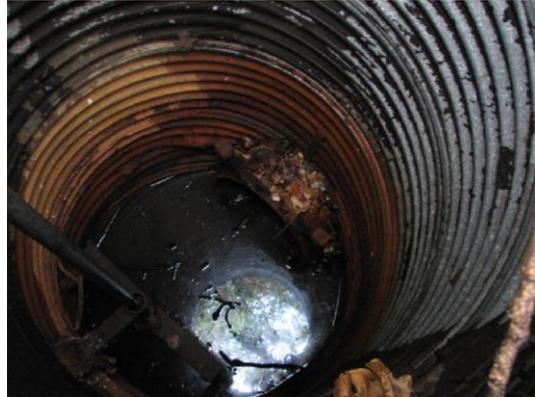
Photo 1 of 2 : UCIP\_SP\_2016\_48353\_68105.jpg

Slide gate and flap gate inside CMP riser on WS berm.

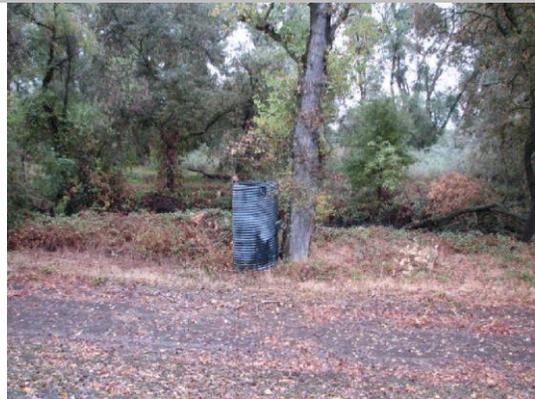
Photo 2 of 2 : UCIP\_SP\_2016\_48353\_68104.jpg

56-inch CMP riser on WS berm.

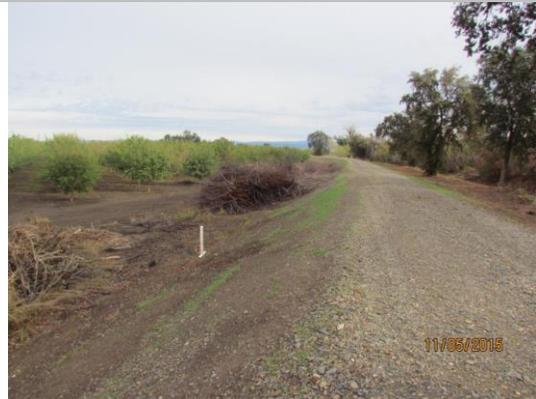
Photo 1 of 1 : SP\_2016\_MA0005\_197\_35\_20160321\_00014.jpg

View of the prunings along the landside slope.

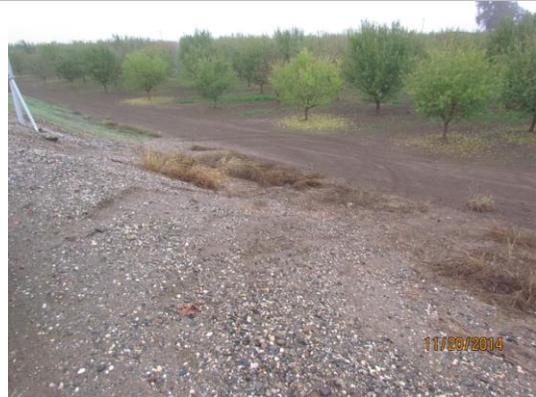
Photo 1 of 2 : SP\_2016\_MA0005\_197\_13\_20160321\_00005.jpg

View of the vehicle erosion along the landside slope.

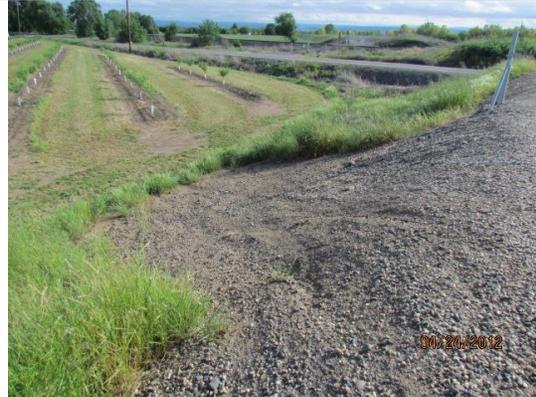
Photo 2 of 2 : SP\_2016\_MA0005\_197\_13\_20160321\_00006.jpg

View of the vehicle erosion along the slope.

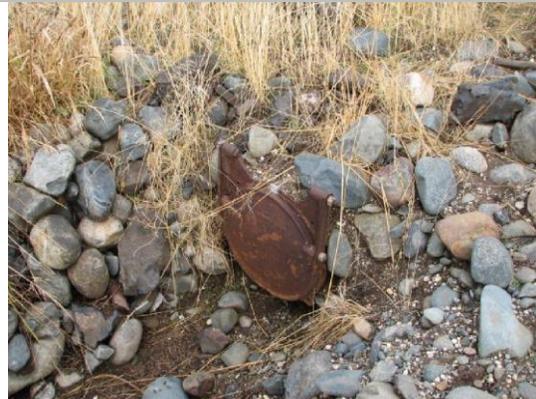
Photo 1 of 2 : UCIP\_SP\_2016\_48363\_68129.jpg

Flap gate at WS toe.

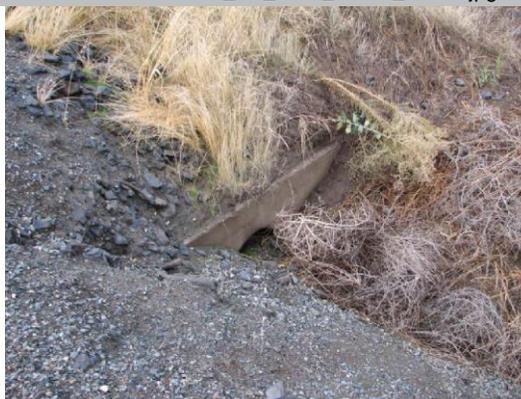
Photo 2 of 2 : UCIP\_SP\_2016\_48363\_68128.jpg

Concrete headwall on LS toe.

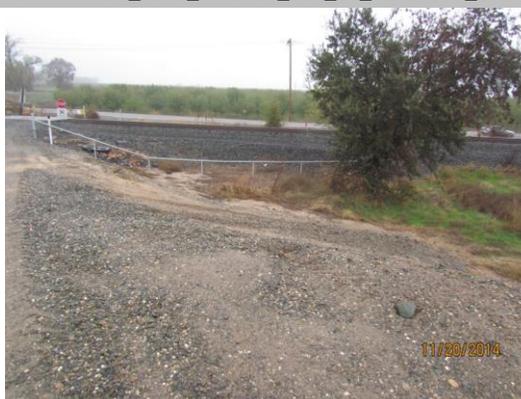
Photo 1 of 1 : SP\_2016\_MA0005\_197\_40\_20160321\_00016.jpg

View of the vehicle slope instability along the landside slope.

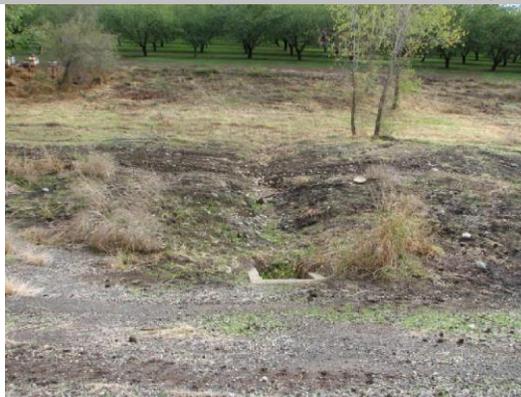
Photo 1 of 2 : UCIP\_SP\_2016\_48373\_68406.jpg

WS outlet and concrete U shaped headwall.

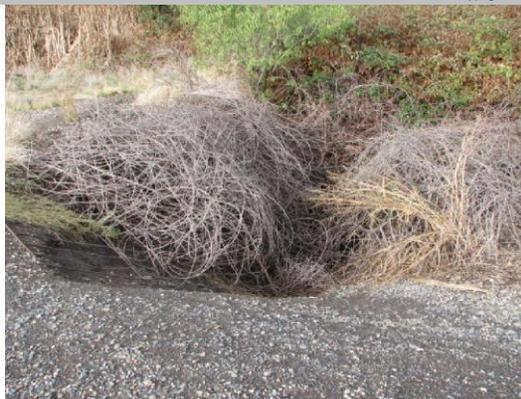
Photo 2 of 2 : UCIP\_SP\_2016\_48373\_68404.jpg

Brambles and soil over pipe at inlet.

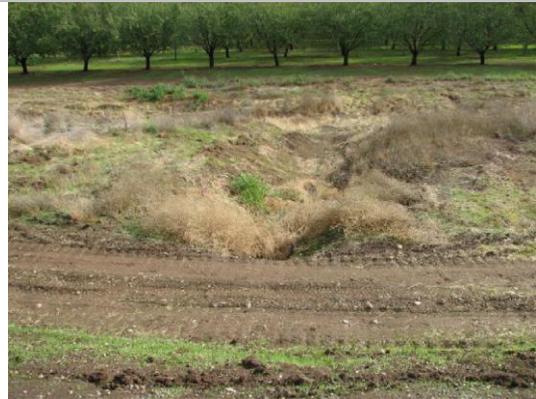
Photo 1 of 2 : UCIP\_SP\_2016\_48375\_68417.jpg

View of outlet looking toward WS toe.

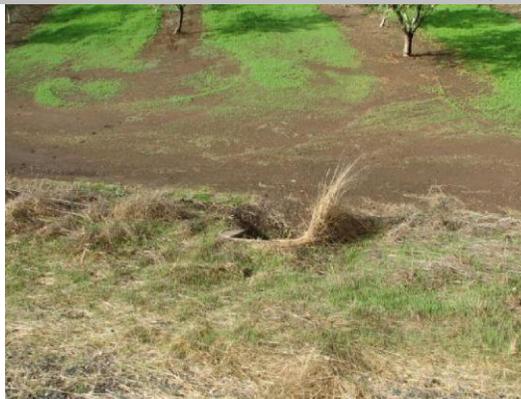
Photo 2 of 2 : UCIP\_SP\_2016\_48375\_68416.jpg

View of inlet on LS toe.

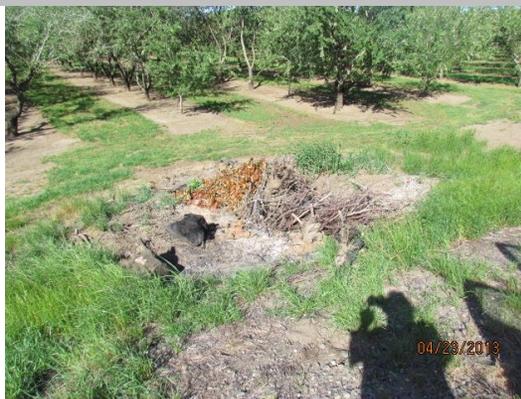
Photo 1 of 1 : SP\_2016\_MA0005\_197\_3\_20160321\_00002.jpg

View of the prunings along the landside toe.

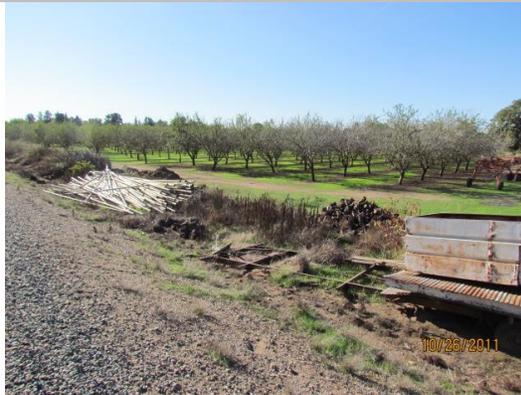
Photo 1 of 1 : SP\_2016\_MA0005\_197\_14\_20160321\_00007.jpg

View of the equipment along the Landside toe.

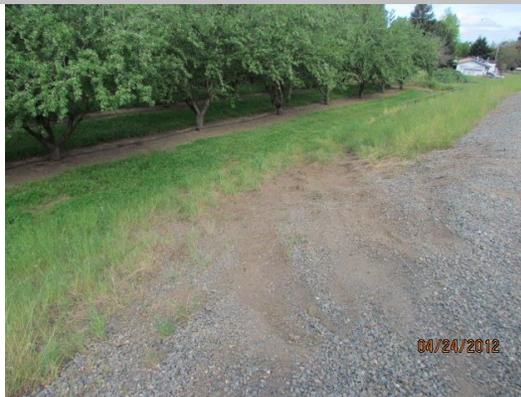
Photo 1 of 1 : SP\_2016\_MA0005\_197\_18\_20160321\_00008.jpg

View of the vehicle erosion along the slope of the levee.

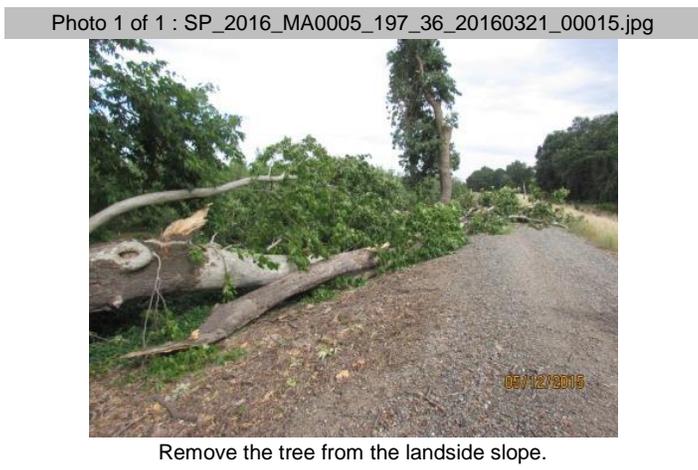
LM Start	<b>11.10</b>	Rating **	U	Issue No.	<b>36</b>
LM End	<b>11.10</b>	Issue Type +	Ma	Location *	LS
Category	Earthen Levee		GPS Latitude/Longitude		
			Start	End	
Item	Encroachments		39.647913 °	39.647913 °	
			-121.788330 °	-121.788330 °	
DWR ID	DWR_MA0005_02_s_2015_36				
Comment Code					
TR : Tree or limb					
Inspector Comment					
Fallen tree has been trimmed back since Spring 2015 inspection, but large pieces still remain which should be removed.

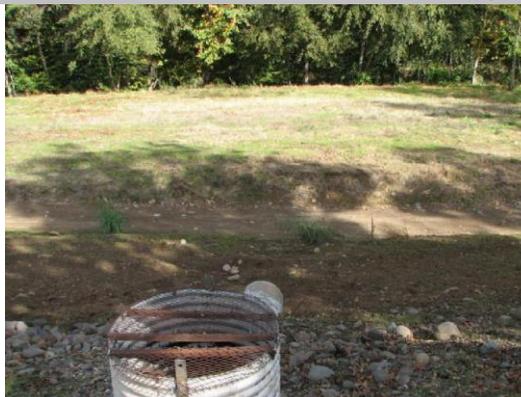
Photo 1 of 2 : UCIP\_SP\_2016\_48389\_68429.jpg

CM riser on WS shoulder-missing slide gate.

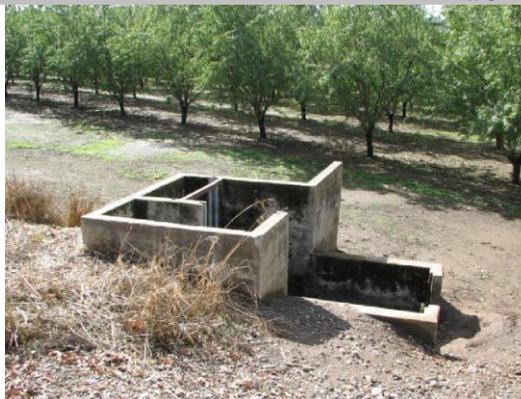
Photo 2 of 2 : UCIP\_SP\_2016\_48389\_68433.jpg

Distribution box on LS toe. Missing slide gate at pipe entrance.

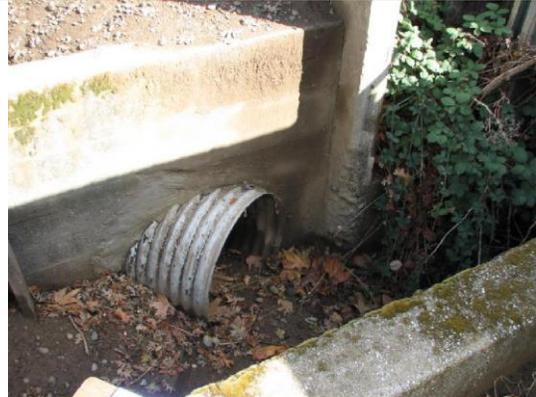
Photo 1 of 2 : UCIP\_SP\_2016\_48390\_68436.jpg

Pipe at concrete distribution box on LS toe.

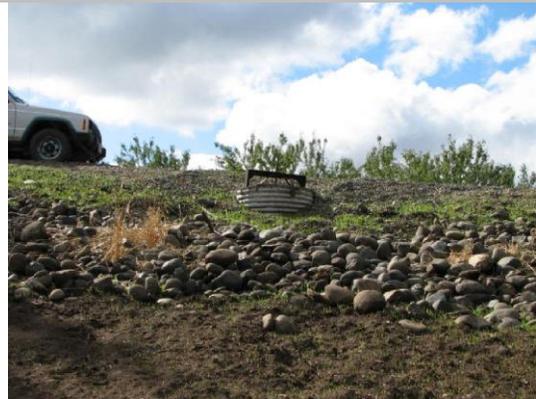
Photo 2 of 2 : UCIP\_SP\_2016\_48390\_68435.jpg

CM riser with slide gate on WS shoulder.

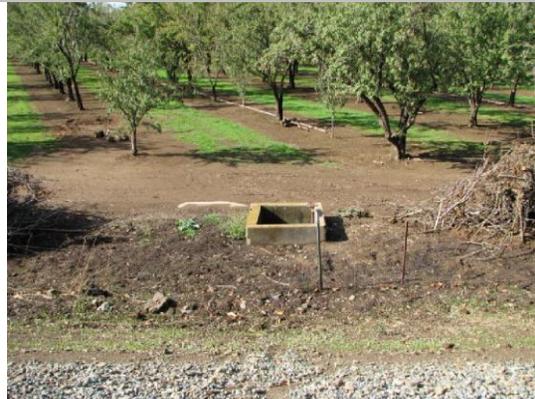
Photo 1 of 2 : UCIP\_SP\_2016\_48391\_68439.jpg

5X5 concrete distribution box at LS toe.

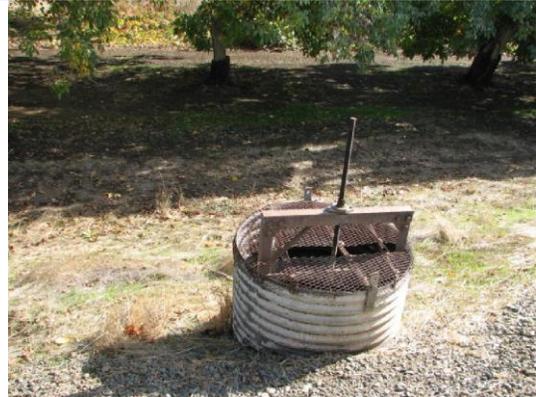
Photo 2 of 2 : UCIP\_SP\_2016\_48391\_68438.jpg

42-inch CMP riser on WS shoulder with slide gate.

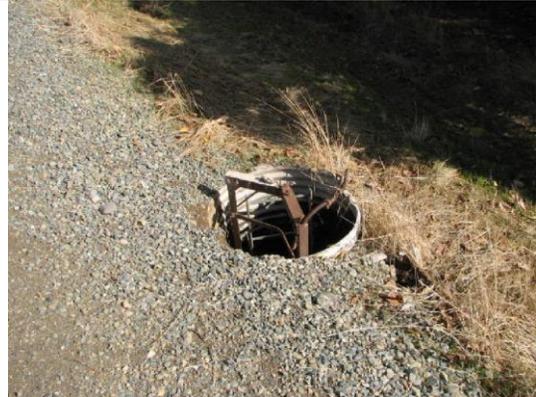
Photo 1 of 2 : UCIP\_SP\_2016\_48392\_68465.jpg

Broken slide gate in CM riser on WS slope.

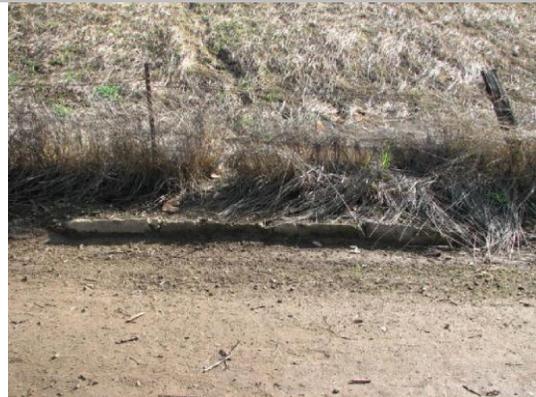
Photo 2 of 2 : UCIP\_SP\_2016\_48392\_68464.jpg

Abandoned headwall on LS toe.

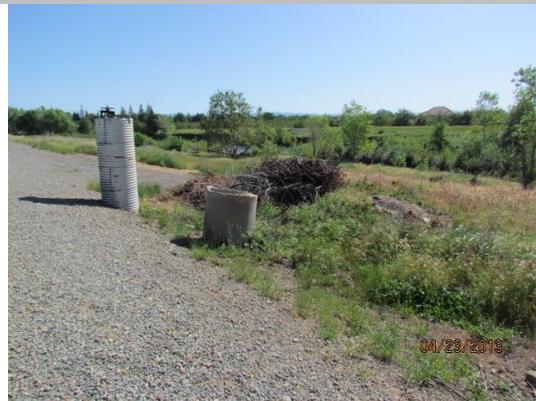
Photo 1 of 1 : SP\_2016\_MA0005\_197\_22\_20160321\_00011.jpg

View of the prunings along the waterside toe.

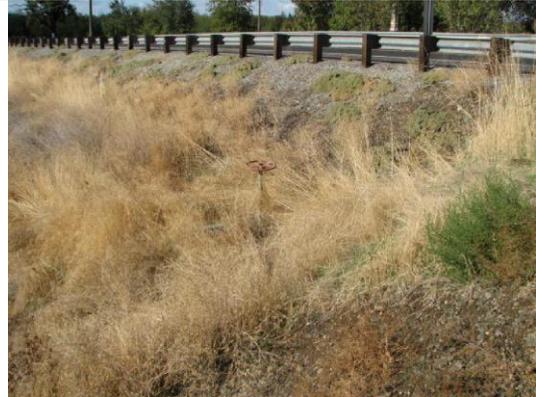
Photo 1 of 2 : UCIP\_SP\_2016\_48395\_68491.jpg

Slide gate at 4X4 concrete box on LS slope.

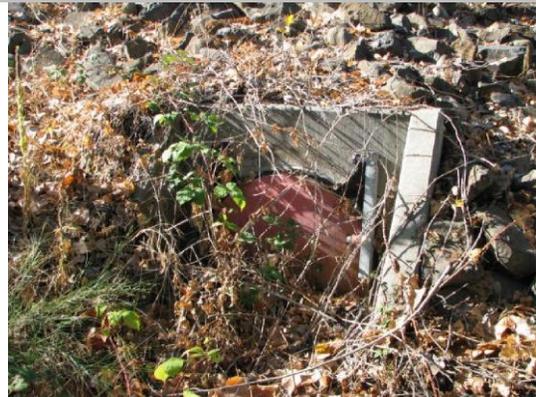
Photo 2 of 2 : UCIP\_SP\_2016\_48395\_68490.jpg

Concrete headwall and flap gate on WS slope below line of rip-rap.

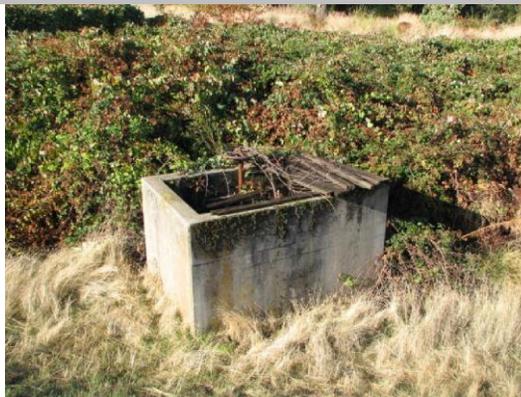
Photo 1 of 2 : UCIP\_SP\_2016\_48410\_68570.jpg

Concrete distribution box with slide gate on LS toe.

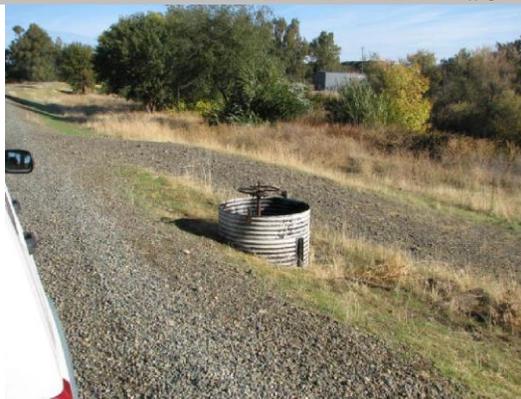
Photo 2 of 2 : UCIP\_SP\_2016\_48410\_68569.jpg

CMP riser on WS shoulder with slide gate.

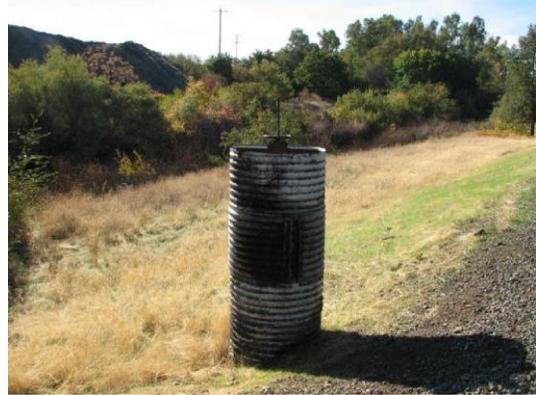
Photo 1 of 2 : UCIP\_SP\_2016\_48411\_68572.jpg

CMP riser on WS slope with slide gate.

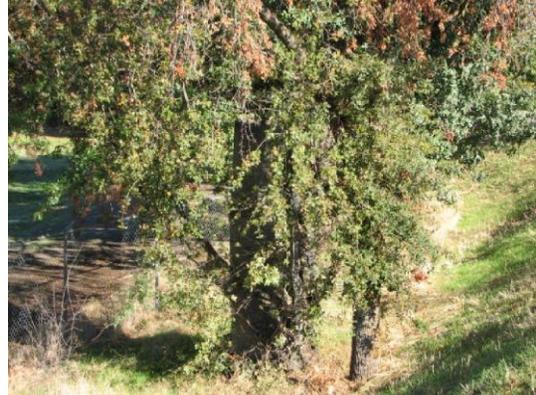
Photo 2 of 2 : UCIP\_SP\_2016\_48411\_68571.jpg

Concrete riser on LS toe.

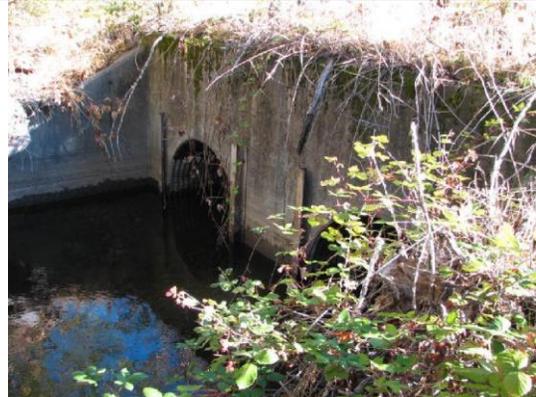
Photo 1 of 2 : UCIP\_SP\_2016\_48413\_68579.jpg

Concrete headwall at LS toe.

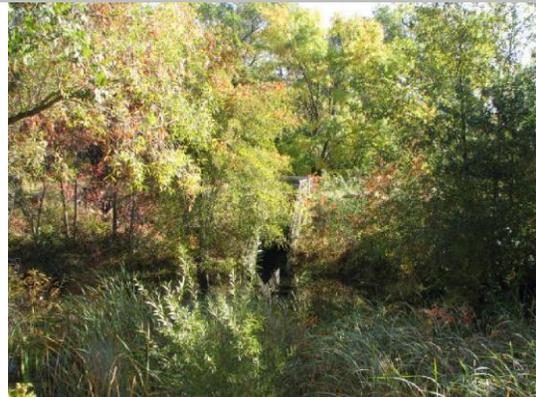
Photo 2 of 2 : UCIP\_SP\_2016\_48413\_68578.jpg

Related structure out in floodway.

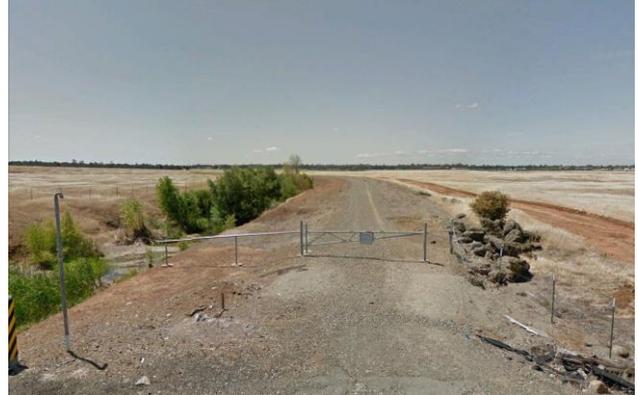
Photo 1 of 1 : SP\_2016\_MA0005\_198\_2\_20160517\_00001.jpg

2016/05/05: Minimal vegetation on levee.
