**Flood Control Project Maintenance
Levee Inspections**
LMA District Cover Sheet
Spring 2017 Levee Inspection Results

Sutter Maintenance Yard Maintenance Area 0005

Spring 2017 Levee Inspection Results

Waterway			Bank	Unit Miles
Unit No. 01 Butte Creek			Left	15.08
	Spring (March - May)	Summer (June - August)	(September - November) Fall	Winter (December - February)
Unit Maintenance Rating (Fall Only)				
Date of Inspection	5/2/2017 - 5/2/2017			
DWR Inspector	Bob Duffey			
Accompanied By	Shawn Freitag Sutter Maintenance Yard

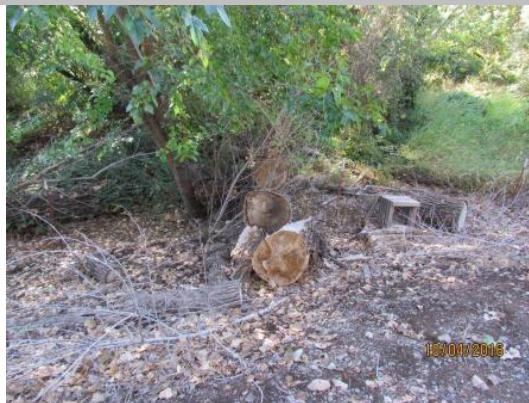
Photo 1 of 1 : SP_2017_MA0005_196_45_20170315_00022.jpg

View of the wood logs on the landside slope.

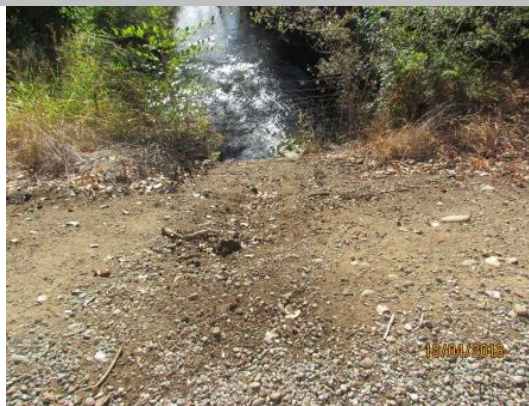
Photo 1 of 1 : SP_2017_MA0005_196_46_20170315_00023.jpg

LM Start	0.07	Rating **	M	Issue No.	46
LM End	0.07	Issue Type +	Ma	Location *	LS
Category	Earthen Levee			GPS Latitude/Longitude	
				Start	End
Item	Slope Stability			39.696611 °	39.696611 °
				-121.774349 °	-121.774349 °
DWR ID	DWR_MA0005_01_f_2016_46				
Comment Code					
S2 : Repair the levee slope damaged by foot traffic and prevent access where possible.					
Inspector Comment

View of the damaged slope by foot traffic.

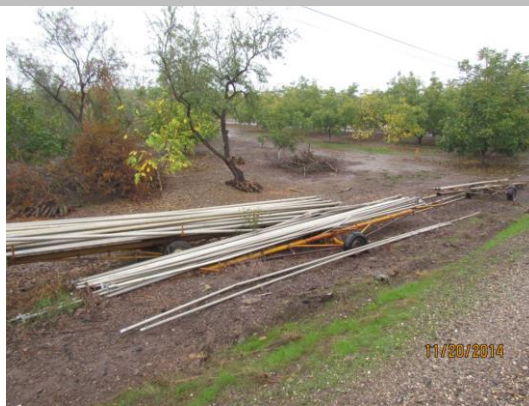
Photo 1 of 1 : SP_2017_MA0005_196_30_20170315_00010.jpg

View of the sprinkler pipe and equipment along the landside toe.

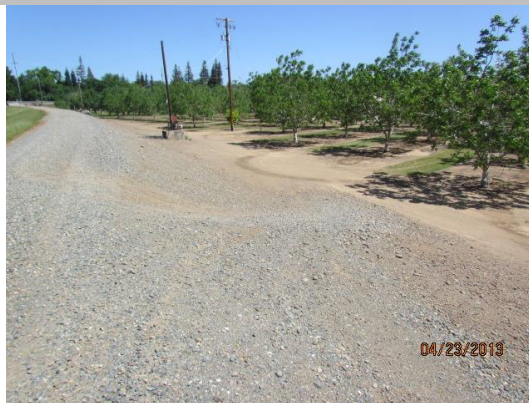
Photo 1 of 1 : SP_2017_MA0005_196_16_20170315_00006.jpg

LM Start	1.61	Rating **	M	Issue No.	16
LM End	1.61	Issue Type +	Ma	Location *	LS
Category	Earthen Levee			GPS Latitude/Longitude	
				Start	End
Item	Slope Stability			39.676129 °	39.676129 °
				-121.778171 °	-121.778171 °
DWR ID	DWR_MA0005_01_s_2013_16				
Comment Code					
S3 : Repair the levee slope damaged by vehicle traffic and prevent access where possible.					
Inspector Comment

View of the unauthorized vehicle ramp on the landside slope.

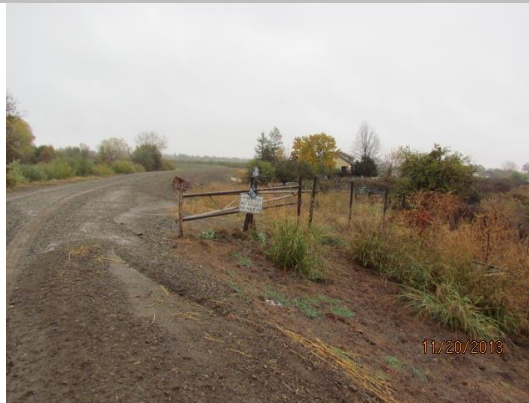
Photo 1 of 1 : SP_2017_MA0005_196_10_20170315_00005.jpg

LM Start	2.09	Rating **	M	Issue No.	10
LM End	2.09	Issue Type +	En	Location *	LS
Category	Earthen Levee			GPS Latitude/Longitude	
				Start	End
Item	Encroachments			39.670112 °	39.670112 °
				-121.782012 °	-121.782012 °
DWR ID	DWR_MA0005_01_s_2016_10				
Comment Code					
FE : Fence					
Inspector Comment					
No permit was found for the gate.

View of the unpermitted gate.

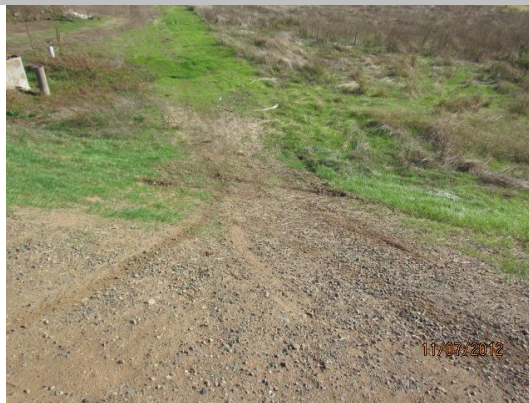
Photo 1 of 1 : SP_2017_MA0005_196_9_20170315_00004.jpg

LM Start	2.54	Rating **	M	Issue No.	9
LM End	2.54	Issue Type +	Ma	Location *	LS
Category	Earthen Levee			GPS Latitude/Longitude	
				Start	End
Item	Slope Stability			39.663876 °	39.663876 °
				-121.784014 °	-121.784014 °
DWR ID	DWR_MA0005_01_f_2012_9				
Comment Code					
S3 : Repair the levee slope damaged by vehicle traffic and prevent access where possible.					
Inspector Comment

View of the vehicle erosion along the landside slope.

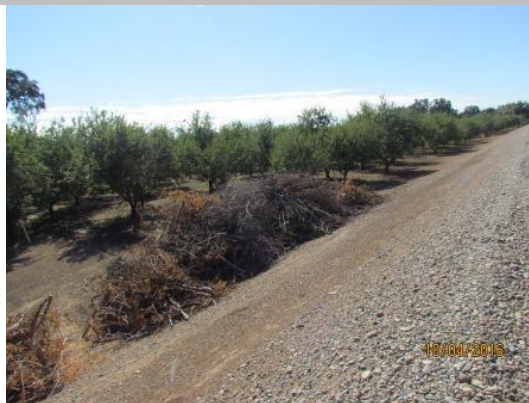
Photo 1 of 1 : SP_2017_MA0005_196_38_20170315_00016.jpg

LM Start	3.06	Rating **	U	Issue No.	37
LM End	3.06	Issue Type +	En	Location *	LS
Category	Earthen Levee			GPS Latitude/Longitude	
				Start	End
Item	Encroachments			39.656911 °	39.656911 °
				-121.787097 °	-121.787097 °
DWR ID	DWR_MA0005_01_f_2015_37				
Comment Code					
PR : Prunings					
Inspector Comment					
Remove the prunings from the landside toe.

View of the prunings along the landside toe.

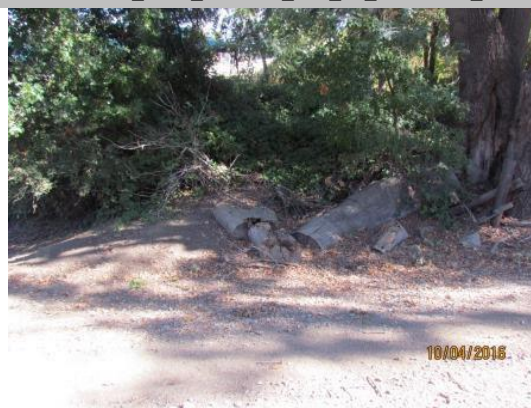
Photo 1 of 1 : SP_2017_MA0005_196_39_20170315_00017.jpg

View of the wood logs and soil along the landside toe.

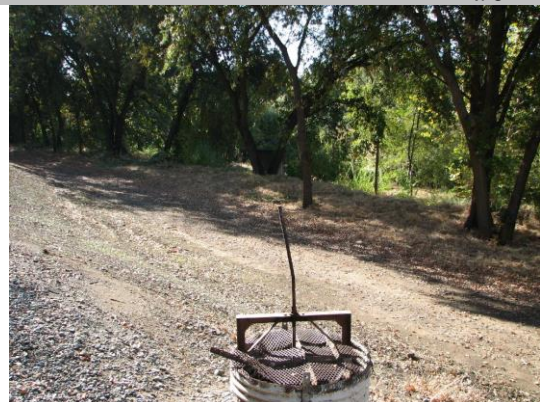
Photo 2 of 3 : UCIP_SP_2017_50841_67927.jpg

FS_ID:50841
DS_ID:1615
EP_NO: N/A
Repair Type: Non-Urgent
Crossing Status: Found
UCIP Comments: 11/15/2016 Abandoned- slide gate is opened and inoperable. Needs to be properly abandoned. (DWR Sutter Yard-AFreitag)5/9/2016 Abandoned crossing. Slide gate stem bent and wheel is missing.8/5/2015 Abandoned crossing. Slide gate stem is bent and gate is inoperable. Needs to be properly abandoned.12/8/2014 Same as last inspection.6/11/2014 Same as last inspection.11/20/2013 Same as last inspection.5/29/2013 Same as last inspection.10/30/2012 Pipe appears to be abandoned. Slide gate open and inoperable. Pipe should be properly abandoned. FIELD_STRUCT_DESC: 30-inch corrugated metal irrigation pipe (siphon) through the levee, 10.5 feet below the crown. Slide gate in a corrugated metal riser on the waterside (WS) slope. Concrete distribution box on the landside (LS) toe and concrete overflow and siphon box at the edge of berm. [Additional Reference(s): DWR Levee Log, 1990. USACE Sacramento O&M Manual 516, April 1960 (Station 368+17)].

CMP riser with slide gate on WS shoulder. Notice bent screw in open position.

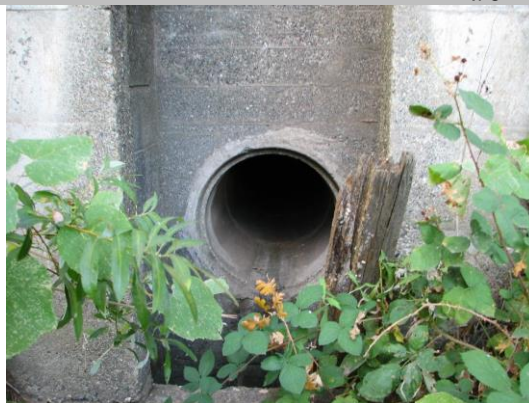
Photo 3 of 3 : UCIP_SP_2017_50841_67926.jpg

Item	DWR UCIP Field Study			39.649522 °		39.649522 °
				-121.787965 °		-121.787965 °
DWR ID						
Comment Code						
Inspector Comment						
FS_ID:50841						
DS_ID:1615						
EP_NO: N/A						
Repair Type: Non-Urgent						
Crossing Status: Found						
UCIP Comments: 11/15/2016 Abandoned- slide gate is opened and inoperable. Needs to be properly abandoned. (DWR Sutter Yard-AFreitag)5/9/2016 Abandoned crossing. Slide gate stem bent and wheel is missing.8/5/2015 Abandoned crossing. Slide gate stem is bent and gate is inoperable. Needs to be properly abandoned.12/8/2014 Same as last inspection.6/11/2014 Same as last inspection.11/20/2013 Same as last inspection.5/29/2013 Same as last inspection.10/30/2012 Pipe appears to be abandoned. Slide gate open and inoperable. Pipe should be properly abandoned.						
FIELD_STRUCT_DESC: 30-inch corrugated metal irrigation pipe (siphon) through the levee, 10.5 feet below the crown. Slide gate in a corrugated metal riser on the waterside (WS) slope. Concrete distribution box on the landside (LS) toe and concrete overflow and siphon box at the edge of berm. [Additional Reference(s): DWR Levee Log, 1990. USACE Sacramento O&M Manual 516, April 1960 (Station 368+17)].

Outlet in Concrete overflow box at WS berm.

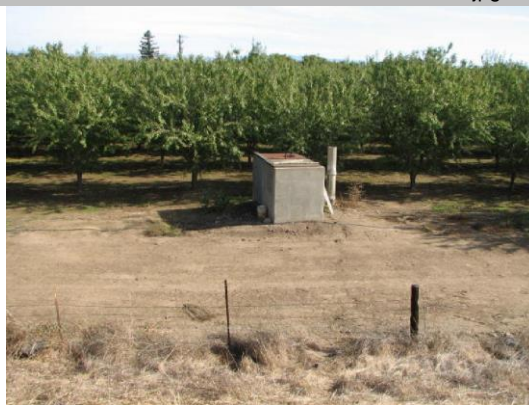
Photo 2 of 3 : UCIP_SP_2017_50843_67930.jpg

Unable to locate inlet on LS.

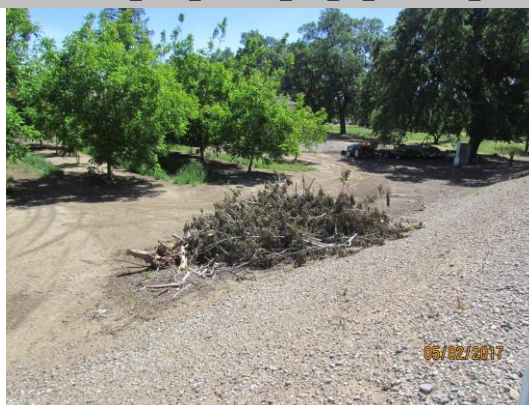
Photo 1 of 1 : SP_2017_MA0005_196_65_20170508_00084.jpg

View of the prunings along the landside toe.

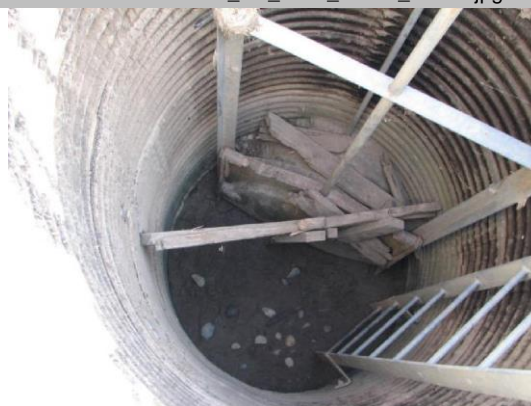
Photo 3 of 3 : UCIP_SP_2017_50847_67937.jpg

Item	DWR UCIP LMA Responsibility			39.624559 °		39.624559 °
				-121.772141 °		-121.772141 °
DWR ID						
Comment Code						
Inspector Comment						
FS_ID:50847 DS_ID:1768 EP_NO: N/A Repair Type: Non-Urgent Crossing Status: Found UCIP Comments: 11/15/2016 Abandoned. Needs standpipe cover. (DWR Sutter Yard- A Freitag) 5/9/2016 Abandoned pipe. Needs a cover for standpipe. 8/5/2015 Abandoned pipes. Need covers made for tops of standpipes to prevent falls. 12/8/2014 Same as last inspection. 6/11/2014 Same as last inspection. 11/19/2013 Same as last inspection. 5/29/2013 Same as last inspection. Land owner said pipes are abandoned and no longer used. Covers should be made for top of standpipe to prevent falls. Pipes should be properly abandoned. 10/30/2012 Pipe 1/2 filled with soil at slide gate on WS. FIELD_STRUCT_DESC: *ABANDONED* 2 of 2: 36-inch corrugated metal drainage pipe through the levee, 11 feet below the crown. Slide gate in a 54-inch corrugated metal riser on the waterside (WS) slope. Concrete "U" shaped headwall on the landside (LS). [Additional Reference(s): DWR Levee Log, 1990. Sacramento O&M Manual 516, April 1960 (Station 470+00)]. FS Date: 11/21/2016 1:38:13 PM

Slide gate at bottom of cmp riser.

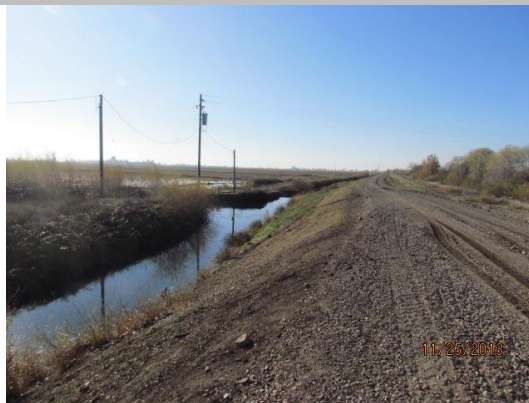
Photo 1 of 1 : SP_2017_MA0005_196_55_20170315_00028.jpg

View of the irrigation ditch along the landside toe.

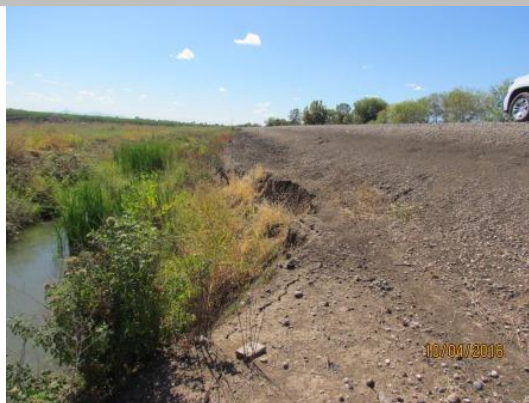
Photo 1 of 2 : SP_2017_MA0005_196_56_20170315_00029.jpg

LM Start	5.81	Rating **	U	Issue No.	56
LM End	5.81	Issue Type +	Ma	Location *	LS
Category	Earthen Levee			GPS Latitude/Longitude	
				Start	End
Item	Erosion / Bank Caving			39.621261 °	39.621261 °
				-121.773973 °	-121.773973 °
DWR ID	DWR_MA0005_01_f_2016_56				
Comment Code					
E2 : Schedule repair of erosion site prior to the next inspection.					
Inspector Comment

View of the landside toe erosion.

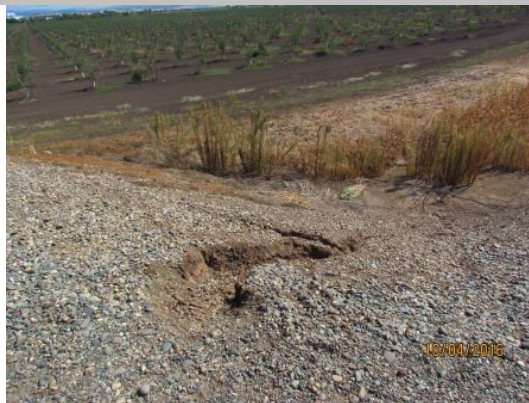
Photo 1 of 1 : SP_2017_MA0005_196_57_20170315_00031.jpg

LM Start	7.08	Rating **	M	Issue No.	57
LM End	7.08	Issue Type +	Ma	Location *	LS
Category	Earthen Levee			GPS Latitude/Longitude	
				Start	End
Item	Erosion / Bank Caving			39.604357 °	39.604357 °
				-121.783665 °	-121.783665 °
DWR ID	DWR_MA0005_01_f_2016_57				
Comment Code					
E2 : Schedule repair of erosion site prior to the next inspection.					
Inspector Comment

View of the landside slope erosion.

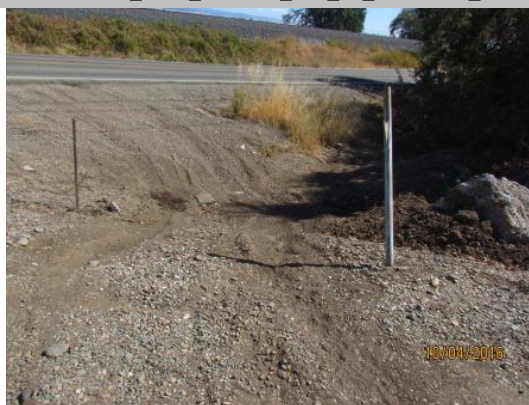
Photo 1 of 1 : SP_2017_MA0005_196_58_20170315_00032.jpg

LM Start	7.14	Rating **	M	Issue No.	58
LM End	7.14	Issue Type +	Ma	Location *	LS
Category	Earthen Levee			GPS Latitude/Longitude	
				Start	End
Item	Slope Stability			39.603648 °	39.603648 °
				-121.784114 °	-121.784114 °
DWR ID	DWR_MA0005_01_f_2016_58				
Comment Code					
S3 : Repair the levee slope damaged by vehicle traffic and prevent access where possible.					
Inspector Comment

View of the damaged landside slope by vehicle traffic.

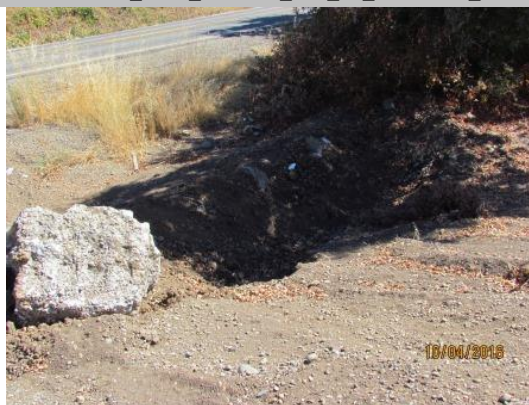
Photo 1 of 1 : SP_2017_MA0005_196_59_20170315_00033.jpg

LM Start	7.14	Rating **	M	Issue No.	59
LM End	7.14	Issue Type +	Ma	Location *	LS
Category	Earthen Levee			GPS Latitude/Longitude	
				Start	End
Item	Slope Stability			39.603611 °	39.603611 °
				-121.784132 °	-121.784132 °
DWR ID	DWR_MA0005_01_f_2016_59				
Comment Code					
S1 : Repair slope instability.					
Inspector Comment

View of the rocks and cut in the landside levee toe.

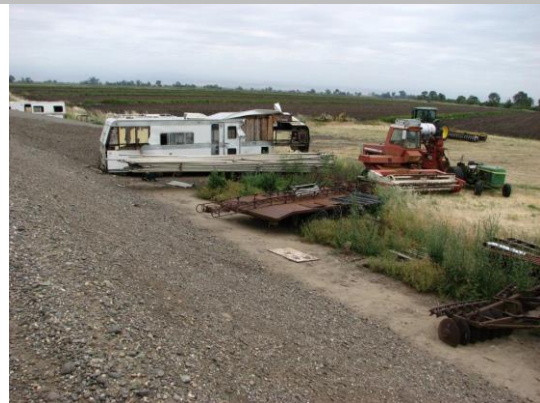
Photo 1 of 1 : SP_2017_MA0005_196_26_20170315_00007.jpg

5/5/2016: Remove abandoned motorhome and equipment from L/S toe.

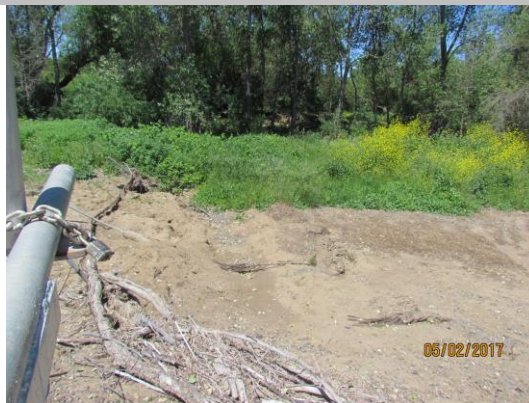
Photo 1 of 1 : SP_2017_MA0005_196_67_20170508_00086.jpg

View of erosion along the waterside slope.

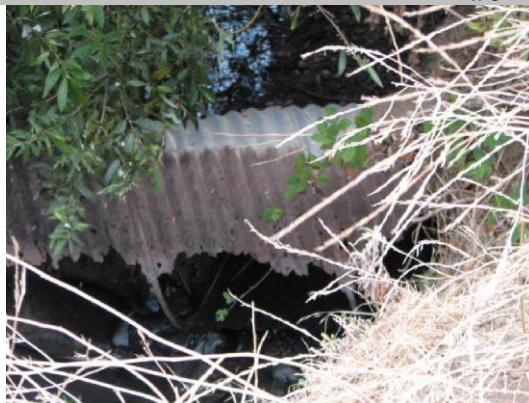
Photo 3 of 3 : UCIP_SP_2017_50886_68015.jpg

Heavily corroded CMP pipe at WS toe.

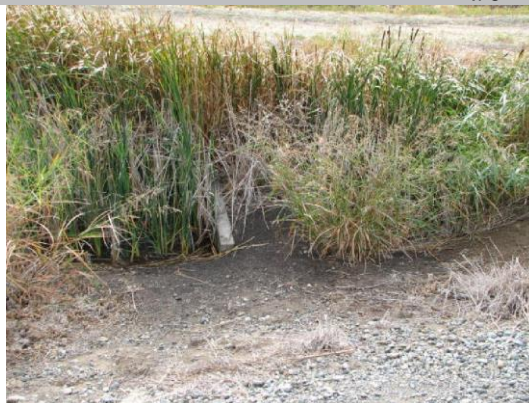
Photo 1 of 1 : UCIP_SP_2017_50888_68025.jpg

Buried pipe at concrete box, LS toe.

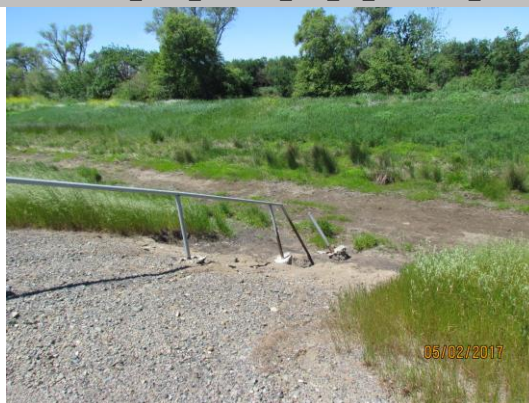
Photo 1 of 1 : SP_2017_MA0005_196_69_20170508_00087.jpg

Repair the erosion along the landside slope and toe.

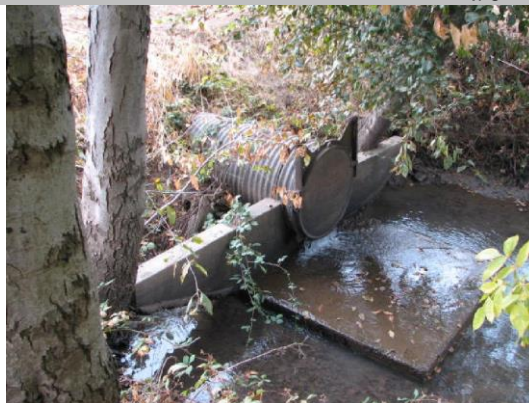
Photo 3 of 3 : UCIP_SP_2017_50891_68031.jpg

Wingwalls of headwall not supported by soil.

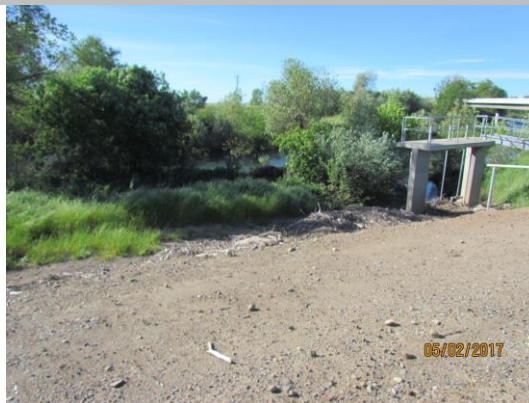
Photo 1 of 1 : SP_2017_MA0005_197_70_20170508_00107.jpg

View of the debris along the waterside toe.

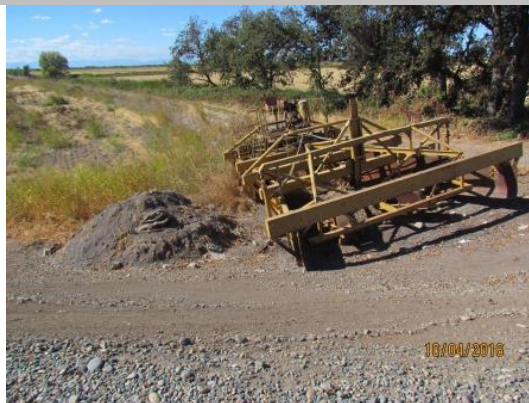
Photo 1 of 1 : SP_2017_MA0005_197_48_20170315_00023.jpg

View of soil pile, rocks, and ag equipment.

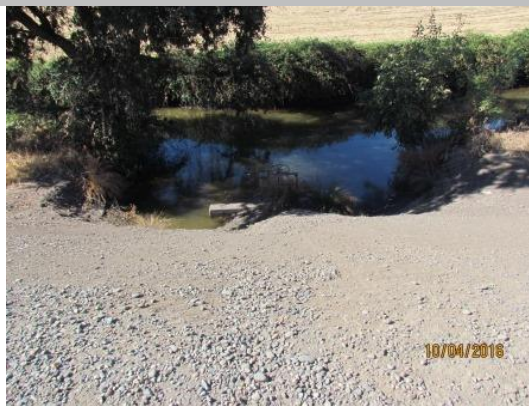
Photo 1 of 1 : SP_2017_MA0005_197_49_20170315_00024.jpg

View of the landside toe erosion.

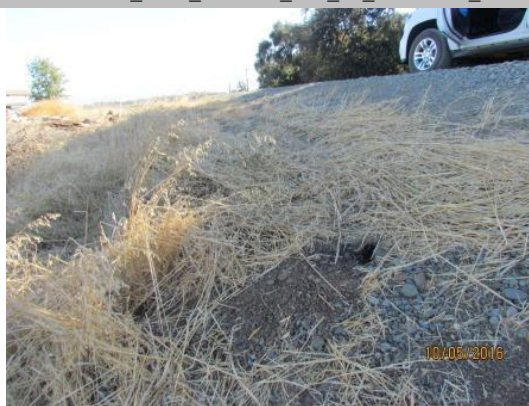
Photo 1 of 1 : SP_2017_MA0005_197_52_20170315_00027.jpg

View of the rodent holes along the landside slope.

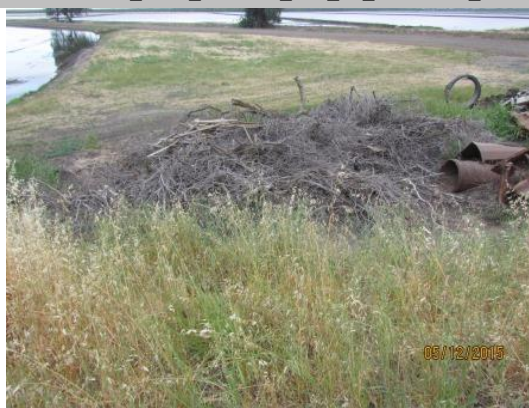
Photo 1 of 1 : SP_2017_MA0005_197_34_20170315_00011.jpg

View of the prunings along the landside toe.

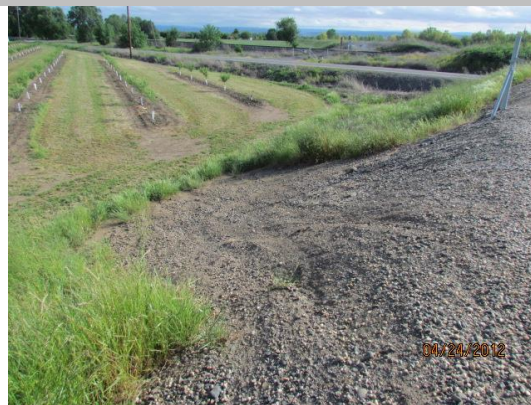
Photo 2 of 2 : SP_2017_MA0005_197_13_20170315_00006.jpg

View of the vehicle erosion along the slope.

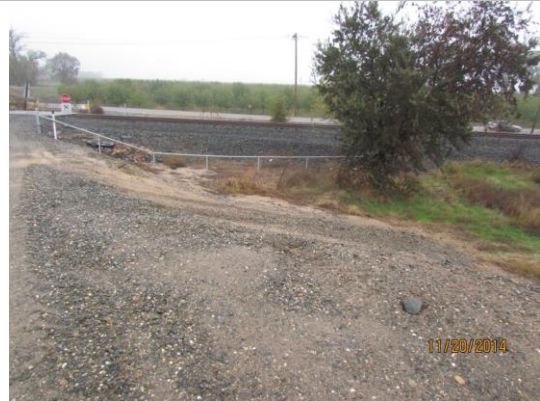
Photo 1 of 1 : SP_2017_MA0005_197_40_20170315_00016.jpg

View of the vehicle slope instability along the landside slope.

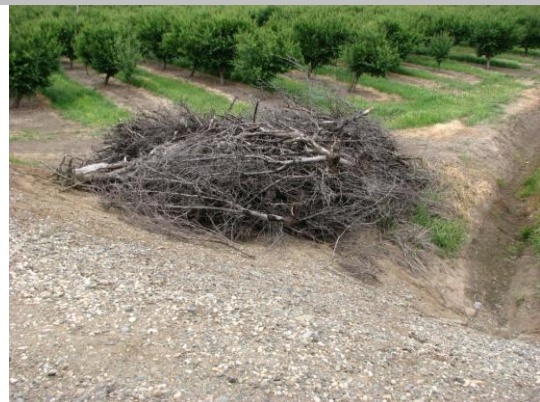
Photo 1 of 1 : SP_2017_MA0005_197_46_20170315_00021.jpg

View of the prunings along the landside toe.

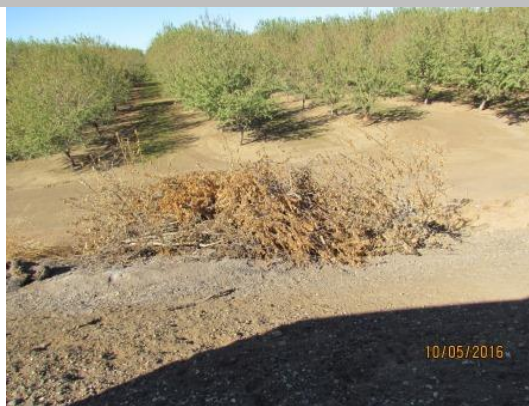
Photo 1 of 1 : SP_2017_MA0005_197_55_20170315_00031.jpg

View of the prunings along the landside toe.

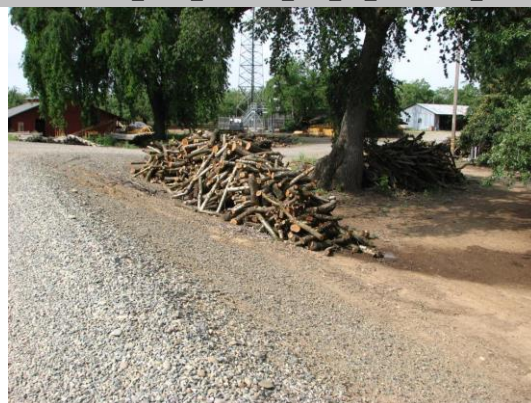
Photo 1 of 1 : SP_2017_MA0005_197_42_20170315_00018.jpg

View of the firewood pile at the landside toe.

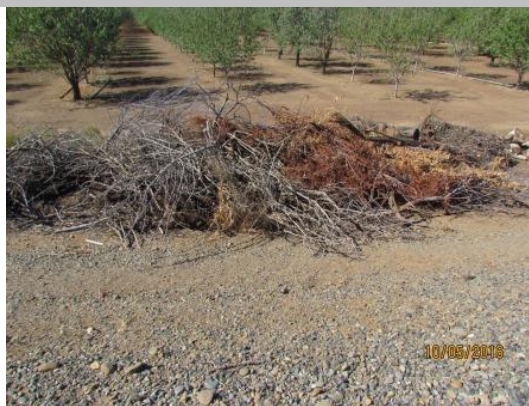
Photo 1 of 1 : SP_2017_MA0005_197_61_20170315_00036.jpg

View of the prunings along the landside toe.

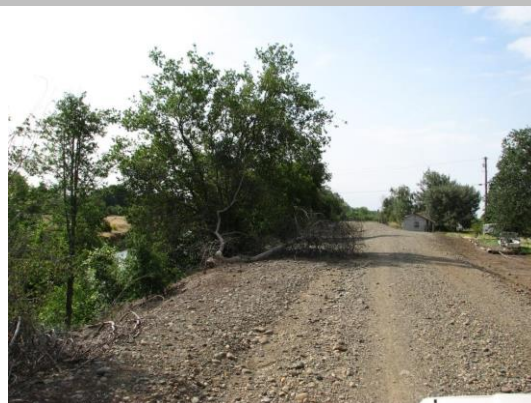
Photo 1 of 1 : SP_2017_MA0005_197_38_20170315_00014.jpg

5/5/2016: Remove fallen tree from W/S slope.

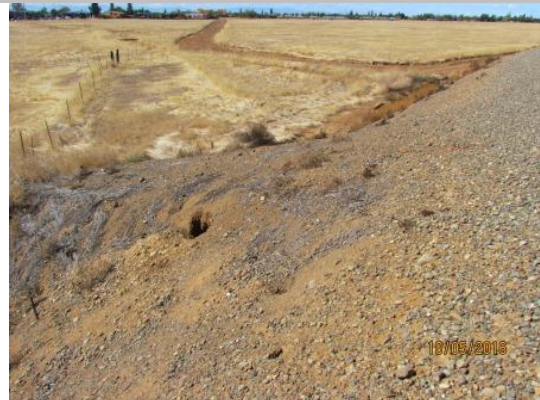
Photo 1 of 1 : SP_2017_MA0005_197_39_20170315_00015.jpg

View of the rodent holes along the landside slope.
