**Flood Control Project Maintenance  
Levee Inspections**  
**LMA District Cover Sheet**  
**Spring 2018 Levee Inspection Results**

**Sutter Maintenance Yard Maintenance Area 0005**

**Spring 2018 Levee Inspection Results**

Waterway			Bank	Unit Miles
Unit No. 01 Butte Creek			Left	15.08
	Spring (March - May)	Summer (June - August)	(September - November) Fall	Winter (December - February)
Unit Maintenance Rating (Fall Only)				
Date of Inspection	3/14/2018 - 3/14/2018			
DWR Inspector	Bob Duffey			
Accompanied By	Shawn Freitag Sutter Maintenance Yard

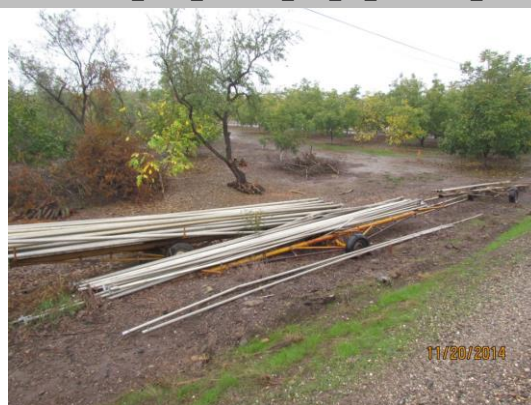
Photo 1 of 1 : SP\_2018\_MA0005\_196\_30\_20180305\_00010.jpg

View of the sprinkler pipe and equipment along the landside toe.

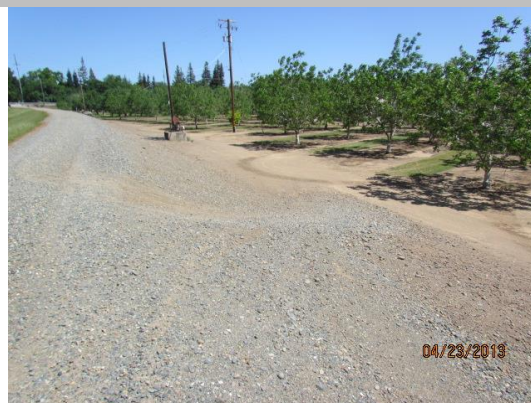
Photo 1 of 1 : SP\_2018\_MA0005\_196\_16\_20180305\_00006.jpg

LM Start	1.61	Rating **	M	Issue No.	16
LM End	1.61	Issue Type +	Ma	Location *	LS
Category	Earthen Levee			GPS Latitude/Longitude	
				Start	End
Item	Slope Stability			39.676129 °	39.676129 °
				-121.778171 °	-121.778171 °
DWR ID	DWR_MA0005_01_s_2013_16				
Comment Code					
S3 : Repair the levee slope damaged by vehicle traffic and prevent access where possible.					
Inspector Comment

View of the unauthorized vehicle ramp on the landside slope.

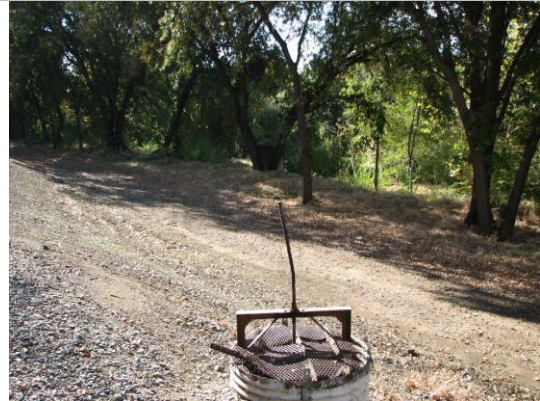
Photo 2 of 3 : UCIP\_SP\_2018\_51947\_67927.jpg

FS\_ID:51947  
DS\_ID:1615  
EP\_NO: N/A  
Repair Type: Urgent  
Crossing Status: Found  
UCIP Comments: 5/15/2017 WS slide gate stem bent and gate is stuck in the open position. Outlet in the the concrete box on the WS berm is opened and allowed water to free flow through the pipe during the Jan/Feb 2017 high water events. Either the screw gate needs to be repaired or a flap gate added to the outlet in the concrete box to not allow high water flows though the levee. Pipe is believed to be owned and operated by Duhram Mutual Water Company at 1807 Duhram Dayton HWY, PO Box 612, Duhram CA 95938 (530)342-9324. (DWR Sutter Yard- A Freitag) 11/15/2016 Abandoned- slide gate is opened and inoperable. Needs to be properly abandoned. (DWR Sutter Yard- A Freitag) 5/9/2016 Abandoned crossing. Slide gate stem bent and wheel is missing. 8/5/2015 Abandoned crossing. Slide gate stem is bent and gate is inoperable. Needs to be properly abandoned. 12/8/2014 Same as last inspection. 6/11/2014 Same as last inspection. 11/20/2013 Same as last inspection. 5/29/2013 Same as last inspection. 10/30/2012 Pipe appears to be abandoned. Slide gate open and inoperable. Pipe should be properly abandoned. FIELD\_STRUCT\_DESC: 30-inch corrugated metal irrigation pipe (siphon) through the levee, 10.5 feet below the crown. Slide gate in a corrugated metal riser on the waterside (WS) slope. Concrete distribution box on the landside (LS) toe and concrete overflow and siphon box at the edge of berm. [Additional Reference(s): DWR Levee Log, 1990. USACE Sacramento O&M Manual 516, April 1960 (Station 368+17)].

CMP riser with slide gate on WS shoulder. Notice bent screw in open position.

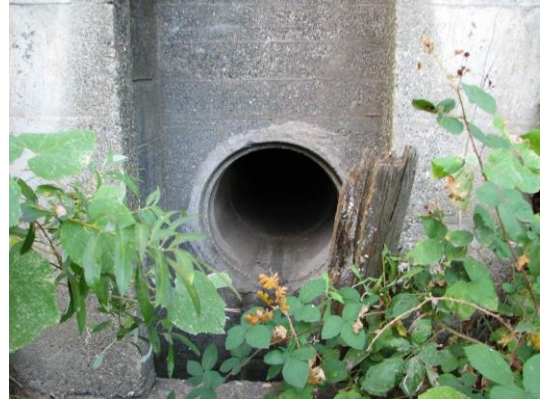
Photo 3 of 3 : UCIP\_SP\_2018\_51947\_67926.jpg

Comment Code						
Inspector Comment						
FS_ID:51947 DS_ID:1615 EP_NO: N/A Repair Type: Urgent Crossing Status: Found UCIP Comments: 5/15/2017 WS slide gate stem bent and gate is stuck in the open position. Outlet in the the concrete box on the WS berm is opened and allowed water to free flow through the pipe during the Jan/Feb 2017 high water events. Either the screw gate needs to be repaired or a flap gate added to the outlet in the concrete box to not allow high water flows though the levee. Pipe is believed to be owned and operated by Duhram Mutual Water Company at 1807 Duhram Dayton HWY, PO Box 612, Duhram CA 95938 (530)342-9324. (DWR Sutter Yard- AFreitag) 11/15/2016 Abandoned- slide gate is opened and inoperable. Needs to be properly abandoned. (DWR Sutter Yard- AFreitag)5/9/2016 Abandoned crossing. Slide gate stem bent and wheel is missing.8/5/2015 Abandoned crossing. Slide gate stem is bent and gate is inoperable. Needs to be properly abandoned.12/8/2014 Same as last inspection.6/11/2014 Same as last inspection.11/20/2013 Same as last inspection.5/29/2013 Same as last inspection.10/30/2012 Pipe appears to be abandoned. Slide gate open and inoperable. Pipe should be properly abandoned. FIELD_STRUCT_DESC: 30-inch corrugated metal irrigation pipe (siphon) through the levee, 10.5 feet below the crown. Slide gate in a corrugated metal riser on the waterside (WS) slope. Concrete distribution box on the landside (LS) toe and concrete overflow and siphon box at the edge of berm. [Additional Reference(s): DWR Levee Log, 1990. USACE Sacramento O&M Manual 516, April 1960 (Station 368+17)]. FS Date: 5/31/2017 12:22:58 PM

Outlet in Concrete overflow box at WS berm.

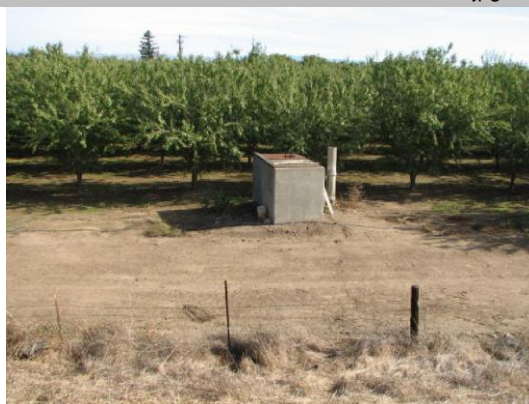
Photo 2 of 3 : UCIP\_SP\_2018\_51949\_67930.jpg

Unable to locate inlet on LS.

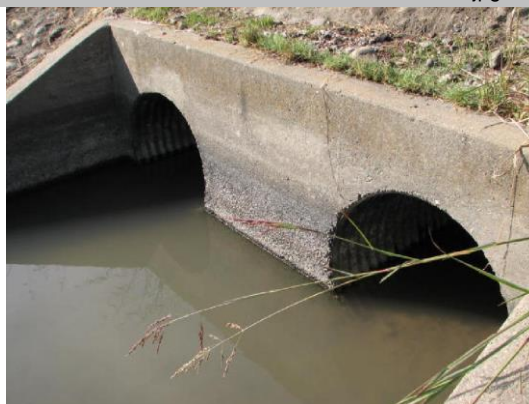
Photo 2 of 3 : UCIP\_SP\_2018\_51954\_67938.jpg

Headwall at LS toe.

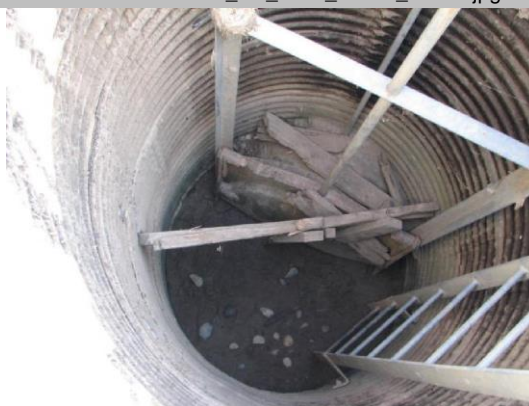
Photo 3 of 3 : UCIP\_SP\_2018\_51954\_67937.jpg

Comment Code						
Inspector Comment						
FS_ID:51954 DS_ID:1768 EP_NO: N/A Repair Type: Non-Urgent Crossing Status: Found UCIP Comments: 5/15/2017 Abandoned and needs to be done properly. A sink hole formed in the WS toe road and revealed the location of the WS pipe end. Sink hole will ned to be repaired before the next high water season but the pipe has been selected to be internally cleaned and camera inspected as part of the DMP project so it will have needed to be excavated along the WS end anyways. (DWR Sutter Yard- A Freitag)11/15/2016 Abandoned. Needs standpipe cover. (DWR Sutter Yard- A Freitag)5/9/2016 Abandoned pipe. Needs a cover for standpipe.8/5/2015 Abandoned pipes. Need covers made for tops of standpipes to prevent falls. 12/8/2014 Same as last inspection.6/11/2014 Same as last inspection.11/19/2013 Same as last inspection.5/29/2013 Same as last inspection. Land owner said pipes are abandoned and no longer used. Covers should be made for top of standpipe to prevent falls. Pipes should be properly abandoned.10/30/2012 Pipe 1/2 filled with soil at slide gate on WS. FIELD_STRUCT_DESC: *ABANDONED* 2 of 2: 36-inch corrugated metal drainage pipe through the levee, 11 feet below the crown. Slide gate in a 54-inch corrugated metal riser on the waterside (WS) slope. Concrete ""U"" shaped headwall on the landside (LS). [Additional Reference(s): DWR Levee Log, 1990. Sacramento O&M Manual 516, April 1960, (Station 470+00)]. FS Date: 5/31/2017 12:52:00 PM

Slide gate at bottom of cmp riser.

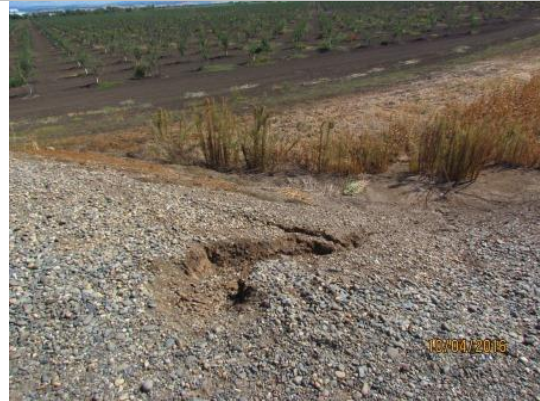
Photo 1 of 1 : SP\_2018\_MA0005\_196\_57\_20180305\_00031.jpg

View of the landside slope erosion.

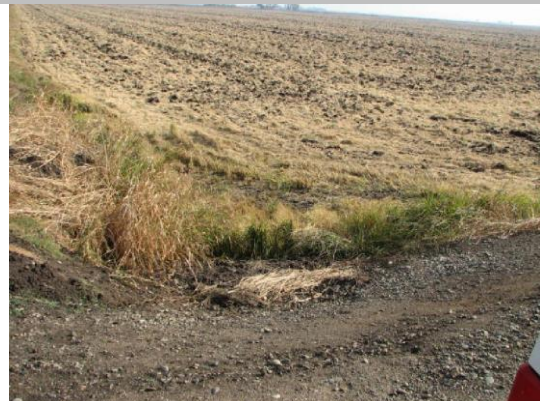
Photo 2 of 3 : UCIP\_SP\_2018\_51972\_67972.jpg

Buried inlet at LS toe.

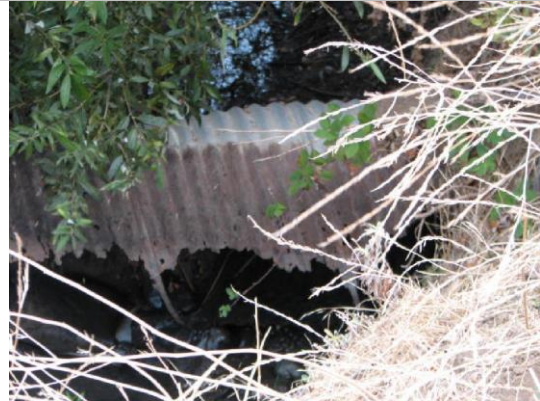
Photo 3 of 3 : UCIP\_SP\_2018\_51994\_68015.jpg

Heavily corroded CMP pipe at WS toe.

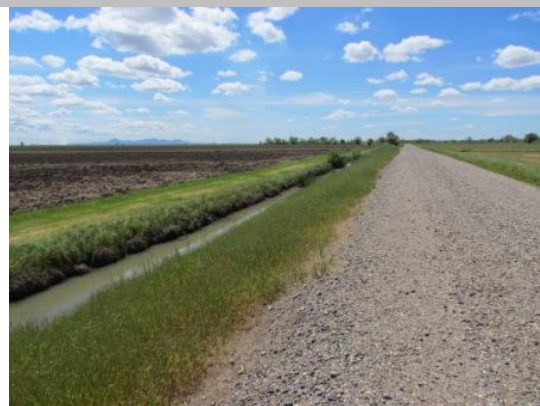
Photo 1 of 1 : SP\_2018\_MA0005\_196\_6\_20180305\_00003.jpg

View of the agricultural ditch along the landside toe.

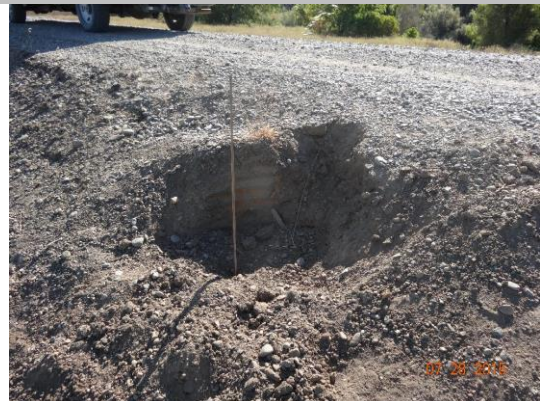
Photo 3 of 3 : UCIP\_SP\_2018\_52013\_74602.jpg

Spot where CMP riser was on the LS shoulder.

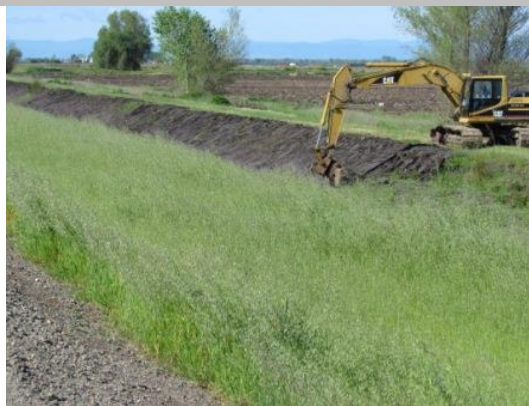
Photo 1 of 1 : SP\_2018\_MA0005\_197\_7\_20180305\_00004.jpg

View of the agricultural ditch along the landside toe.

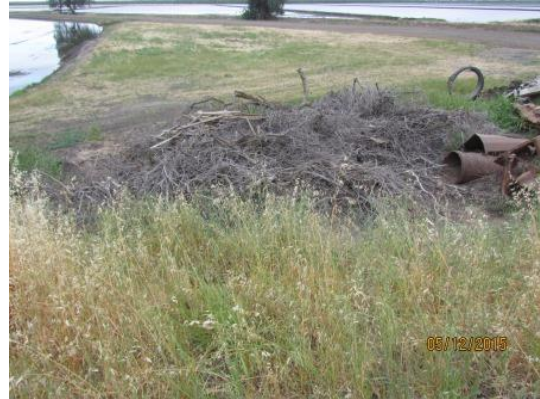
Photo 1 of 1 : SP\_2018\_MA0005\_197\_34\_20180305\_00011.jpg

View of the prunings along the landside toe.

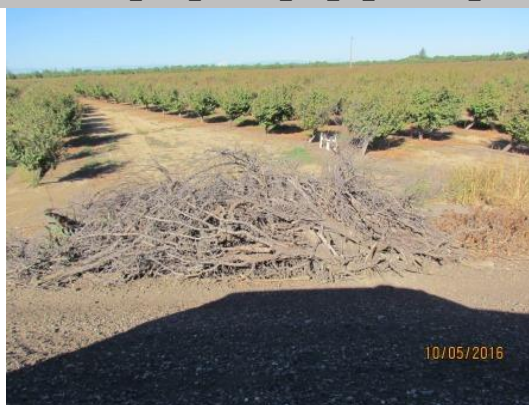
Photo 1 of 1 : SP\_2018\_MA0005\_197\_47\_20180305\_00022.jpg

View of the prunings along the landside toe.

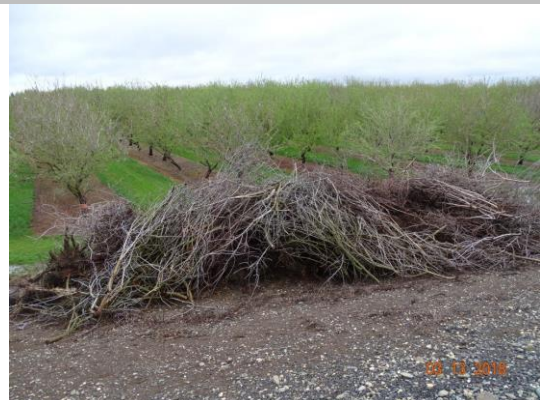
Photo 1 of 1 : SP\_2018\_MA0005\_197\_66\_20180402\_00101.jpg

View of the prunings along the landside toe.

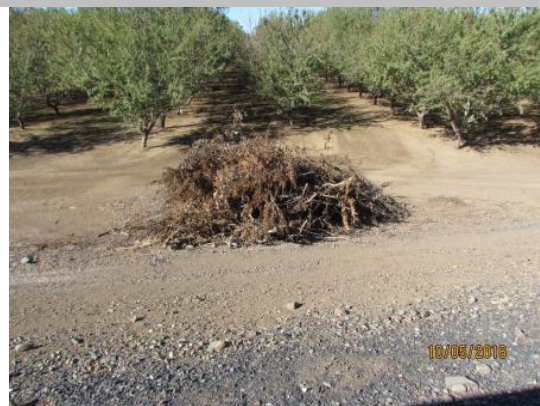
Photo 1 of 1 : SP\_2018\_MA0005\_197\_56\_20180305\_00028.jpg

View of the prunings along the landside toe.

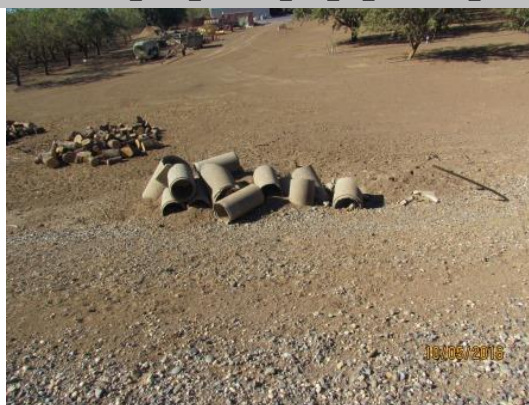
Photo 1 of 1 : SP\_2018\_MA0005\_197\_57\_20180305\_00029.jpg

View of the broken concrete pipes along the landside toe.

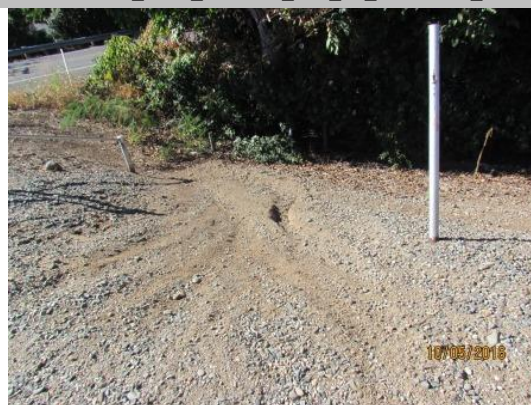
Photo 1 of 1 : SP\_2018\_MA0005\_197\_58\_20180305\_00030.jpg

View of the damaged landside slope.

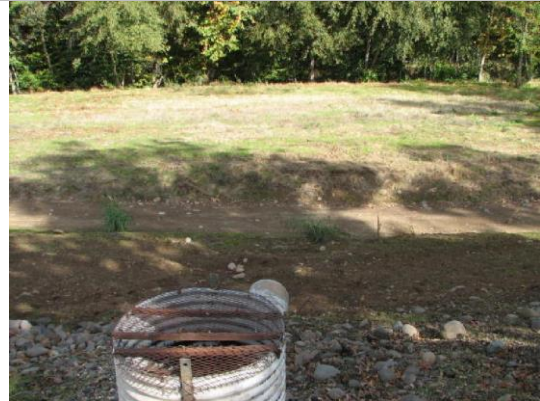
Photo 1 of 3 : UCIP\_SP\_2018\_52069\_68429.jpg

CM riser on WS shoulder-missing slide gate.

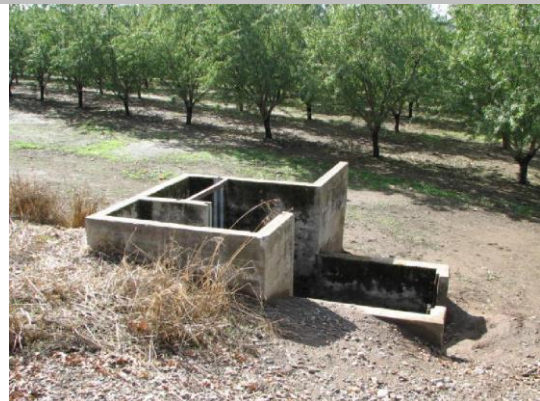
Photo 2 of 3 : UCIP\_SP\_2018\_52069\_68433.jpg

Distribution box on LS toe. Missing slide gate at pipe entrance.

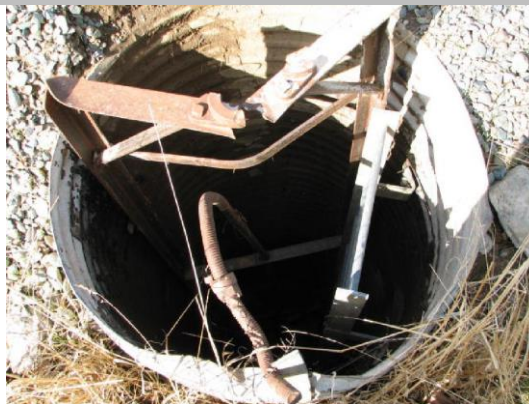
Photo 3 of 3 : UCIP\_SP\_2018\_52072\_68463.jpg

Broken slide gate in CM riser on WS slope.

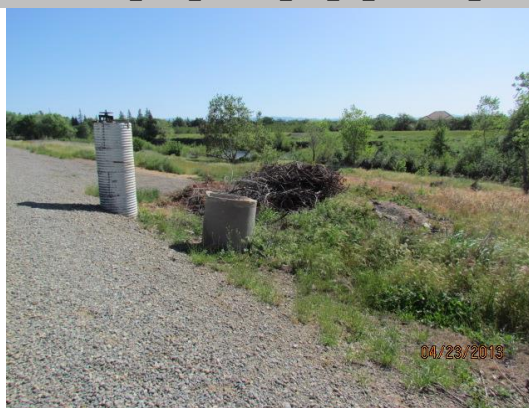
Photo 1 of 1 : SP\_2018\_MA0005\_197\_22\_20180305\_00009.jpg

View of the prunings along the waterside toe.

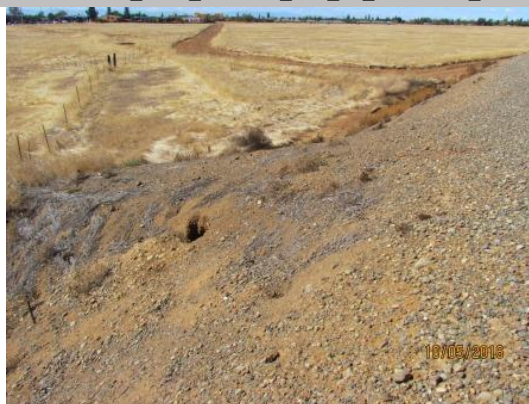
Photo 1 of 1 : SP\_2018\_MA0005\_197\_39\_20180305\_00015.jpg

View of the rodent holes along the landside slope.
