**Flood Control Project Maintenance
Levee Inspections**
LMA District Cover Sheet
Spring 2019 Levee Inspection Results

Sutter Maintenance Yard Maintenance Area 0005

Spring 2019 Levee Inspection Results

Waterway			Bank	Unit Miles
Unit No. 01 Butte Creek			Left	15.08
	Spring (March - May)	Summer (June - August)	(September - November) Fall	Winter (December - February)
Unit Maintenance Rating (Fall Only)				
Date of Inspection	5/14/2019 - 5/14/2019			
DWR Inspector	Makar Sokol			
Accompanied By	Shawn Freitag Sutter Maintenance Yard

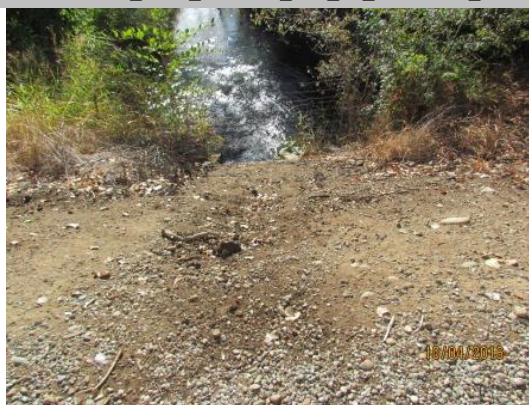
Photo 1 of 1 : SP_2019_MA0005_196_46_20190327_00023.jpg

LM Start	0.07	Rating **	M	Issue No.	46
LM End	0.07	Issue Type +	Ma	Location *	LS
Category	Earthen Levee			GPS Latitude/Longitude	
				Start	End
Item	Slope Stability			39.696611 °	39.696611 °
				-121.774349 °	-121.774349 °
DWR ID	DWR_MA0005_01_f_2016_46				
Comment Code					
S2 : Repair the levee slope damaged by foot traffic and prevent access where possible.					
Inspector Comment

View of the damaged slope by foot traffic.

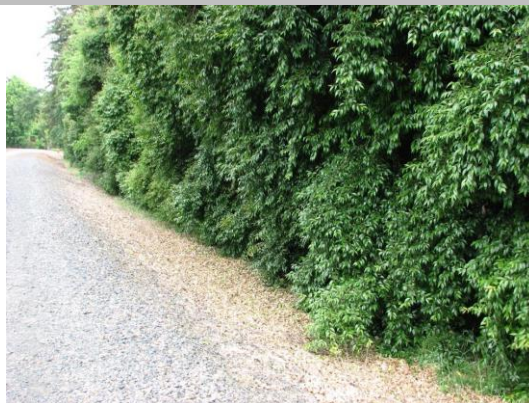
Photo 1 of 1 : SP_2019_MA0005_196_43_20190327_00020.jpg

View of the overgrown vegetation at the landside toe.

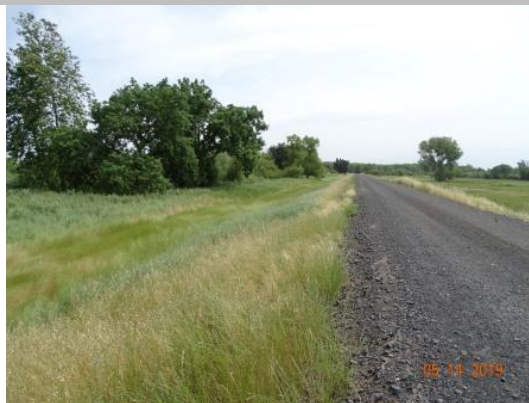
Photo 1 of 1 : SP_2019_MA0005_196_8_20190520_00088.jpg

View of the vegetation on the waterside slope. Spring 2019.

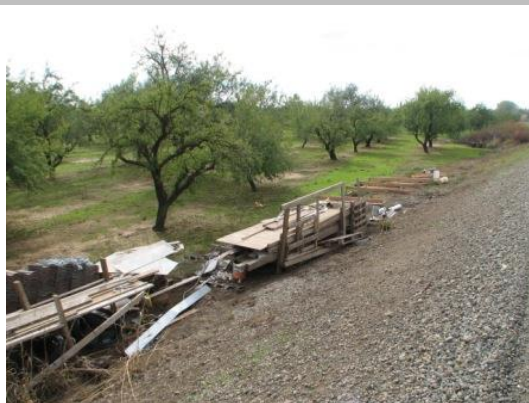
Photo 1 of 1 : SP_2019_MA0005_196_1_20190327_00001.jpg

View of the construction supply on pallets.

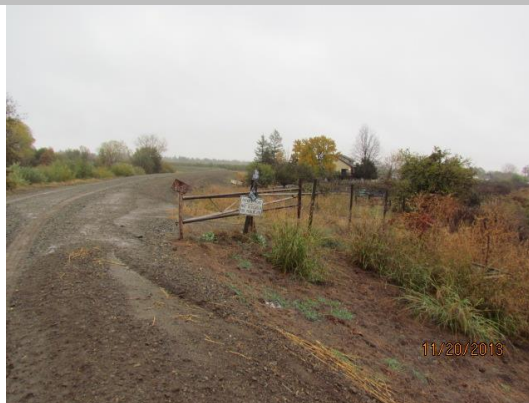
Photo 1 of 1 : SP_2019_MA0005_196_10_20190327_00005.jpg

LM Start	2.09	Rating **	M	Issue No.	10
LM End	2.09	Issue Type +	En	Location *	LS
Category	Earthen Levee			GPS Latitude/Longitude	
				Start	End
Item	Encroachments			39.670112 °	39.670112 °
				-121.782012 °	-121.782012 °
DWR ID	DWR_MA0005_01_s_2016_10				
Comment Code					
FE : Fence					
Inspector Comment					
No permit was found for the gate.

View of the unpermitted gate.

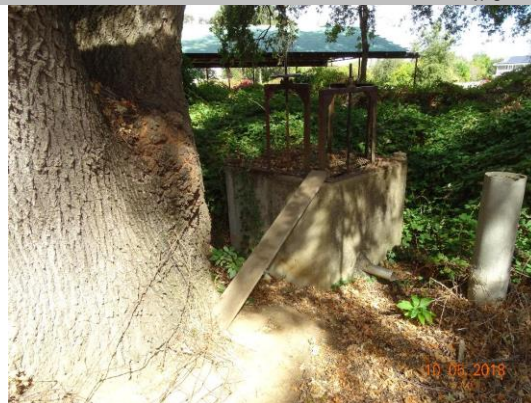
Photo 1 of 3 : UCIP_SP_2019_53003_78145.jpg

UCIP Comments: 10/5/2018 Observed pipe running during inspection. Pipe is used to drain water from LS concrete box to WS. Field structure description was updated to show structure type as drainage pipe. Confirmed that the concrete box on LS receives water from a pipe running along the LS toe from orchards upstream and distributes water between 3 pipes, one of which crosses levee at an angle. Missing closure device on WS. Screw gate stuck in open position inside CMP riser located on WS shoulder and is not operable. (O.Yakimov - DWR)5/15/2017 WS slide gate stem bent and gate is stuck in the open position. Outlet in the the concrete box on the WS berm is opened and allowed water to free flow through the pipe during the Jan/Feb 2017 high water events. Either the screw gate needs to be repaired or a flap gate added to the outlet in the concrete box to not allow high water flows though the levee. Pipe is believed to be owned and operated by Duhram Mutual Water Company at 1807 Duhram Dayton HWY, PO Box 612, Duhram CA 95938 (530)342-9324. (DWR Sutter Yard- AFreitag)

11/15/2016 Abandoned- slide gate is opened and inoperable. Needs to be properly abandoned. (DWR Sutter Yard- AFreitag)5/9/2016 Abandoned crossing. Slide gate stem bent and wheel is missing.8/5/2015 Abandoned crossing. Slide gate stem is bent and gate is inoperable. Needs to be properly abandoned.12/8/2014 Same as last inspection.6/11/2014 Same as last inspection.11/20/2013 Same as last inspection.5/29/2013 Same as last inspection.10/30/2012 Pipe appears to be abandoned. Slide gate open and inoperable. Pipe should be properly abandoned. FIELD_STRUCT_DESC: 30-inch corrugated metal drainage pipe through the levee, 10.5 feet below the crown. Slide gate in a corrugated metal riser on the waterside (WS) slope. Concrete distribution box on the landside (LS) toe and concrete overflow and siphon box at the edge of berm. [Additional Reference(s): DWR Levee Log, 1990 (HLM 3.69). USACE Sacramento O&M Manual, Unit 516 - Upper Butte Creek - Part No. 2, April 1960 (Station 368+17)]. FS Date: 10/8/2018 2:06:36 PM

Concrete distribution box at LS toe.

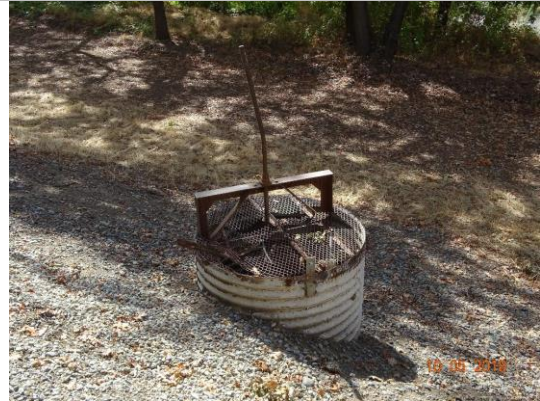
Photo 2 of 3 : UCIP_SP_2019_53003_78147.jpg

11/15/2016 Abandoned- slide gate is opened and inoperable. Needs to be properly abandoned. (DWR Sutter Yard- AFreitag)5/9/2016 Abandoned crossing. Slide gate stem bent and wheel is missing.8/5/2015 Abandoned crossing. Slide gate stem is bent and gate is inoperable. Needs to be properly abandoned.12/8/2014 Same as last inspection.6/11/2014 Same as last inspection.11/20/2013 Same as last inspection.5/29/2013 Same as last inspection.10/30/2012 Pipe appears to be abandoned. Slide gate open and inoperable. Pipe should be properly abandoned.

CMP riser with slide gate on WS shoulder. Notice bent screw in open position.

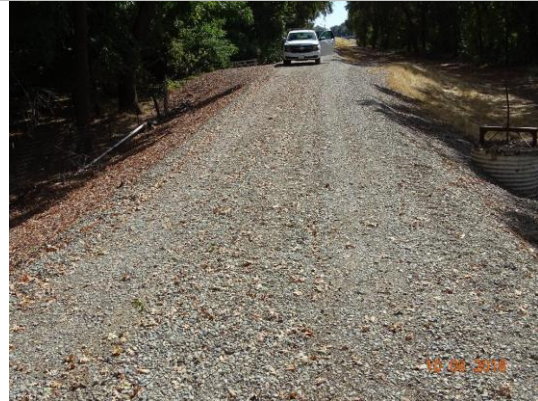
Photo 3 of 3 : UCIP_SP_2019_53003_78148.jpg

View of levee crown at crossing.

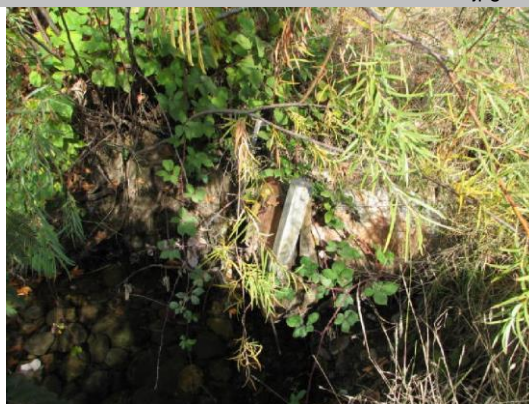
Photo 3 of 3 : UCIP_SP_2019_51949_67929.jpg

Flap gate in channel at WS toe.

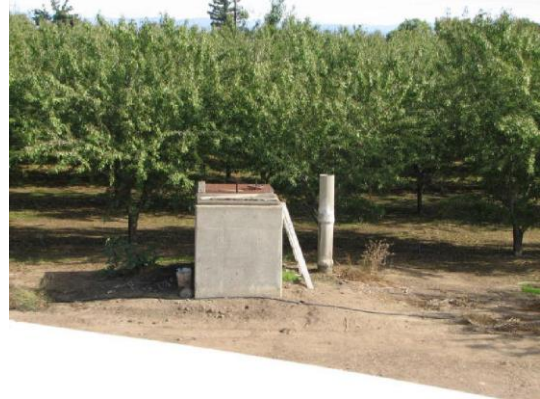
Photo 3 of 3 : UCIP_SP_2019_51950_67932.jpg

Concrete distribution box on LS, 40-feet from LS toe.

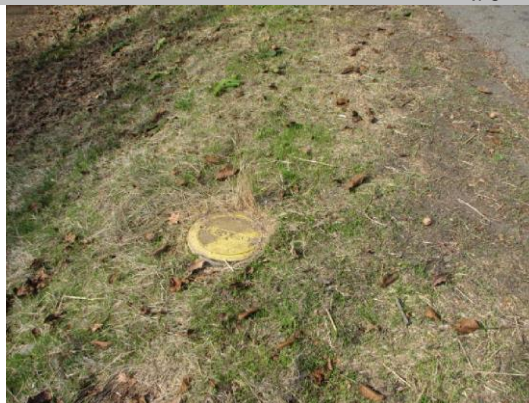
Photo 1 of 2 : UCIP_SP_2019_51952_67936.jpg

PG&E access lid on south edge of roadway.

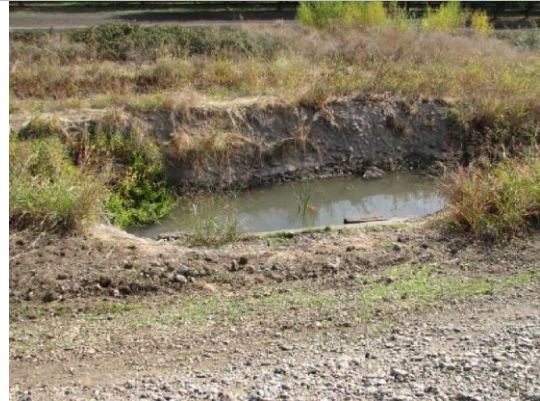
Photo 1 of 3 : UCIP_SP_2019_54039_67939.jpg

FS_ID:54039
DS_ID:1768
EP_NO: N/A
Repair Type: Non-Urgent
Crossing Status: Found
UCIP Comments: 05/23/2019 (O. Magana - DWR UCIP)05/15/2017 Abandoned and needs to be done properly. A sink hole formed in the WS toe road and revealed the location of the WS pipe end. Sink hole will need to be repaired before the next high water season but the pipe has been selected to be internally cleaned and camera inspected as part of the DMP project so it will have needed to be excavated along the WS end anyways. (DWR Sutter Yard- AFreitag)11/15/2016 Abandoned. Needs standpipe cover. (DWR Sutter Yard- AFreitag)05/09/2016 Abandoned pipe. Needs a cover for standpipe.08/05/2015 Abandoned pipes. Need covers made for tops of standpipes to prevent falls. 12/08/2014 Same as last inspection.06/11/2014 Same as last inspection.11/19/2013 Same as last inspection.05/29/2013 Same as last inspection. Land owner said pipes are abandoned and no longer used. Covers should be made for top of standpipe to prevent falls. Pipes should be properly abandoned.10/30/2012 Pipe 1/2 filled with soil at slide gate on WS. FIELD_STRUCT_DESC: *ABANDONED* 2 of 2: 36-inch corrugated metal drainage pipe through the levee, 11 feet below the crown. Slide gate in a 54-inch corrugated metal riser on the waterside (WS) slope. Concrete "U" shaped headwall on the landside (LS). [Additional Reference(s): DWR Levee Log, 1990 (HLM 5.66). Sacramento O&M Manual, Unit 516 - Upper Butte Creek - Part No. 2, April 1960 (Station 470+00)].

Headwall at LS toe.

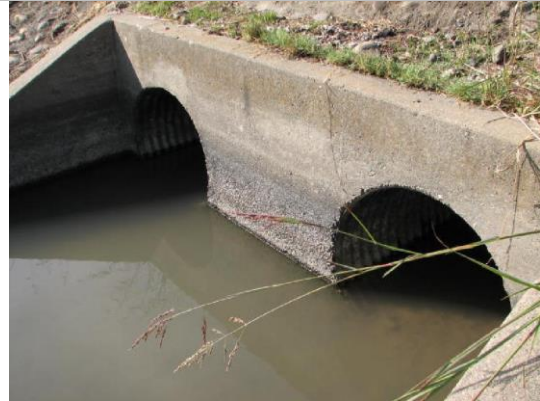
Photo 2 of 3 : UCIP_SP_2019_54039_67938.jpg

Headwall at LS toe.

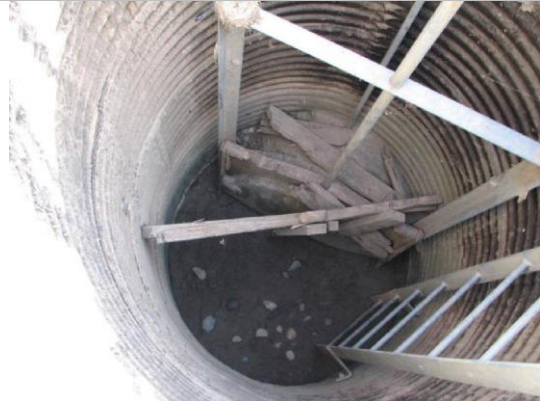
Photo 3 of 3 : UCIP_SP_2019_54039_67937.jpg

Slide gate at bottom of cmp riser.

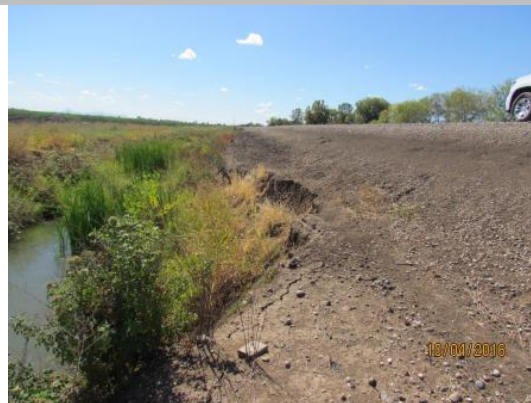
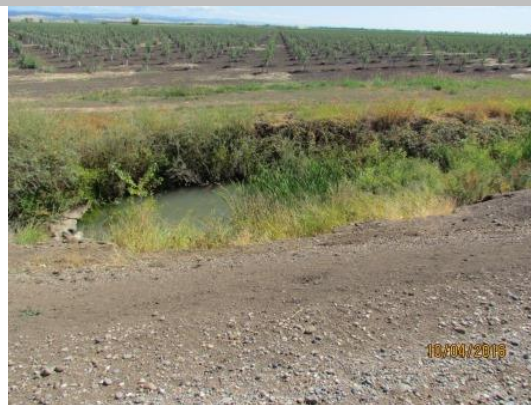
View of the landside toe erosion.

LM Start	5.81	Rating **	U	Issue No.	56 (cont)
LM End	5.81	Issue Type +	Ma	Location *	LS

Another view of the landside toe erosion.

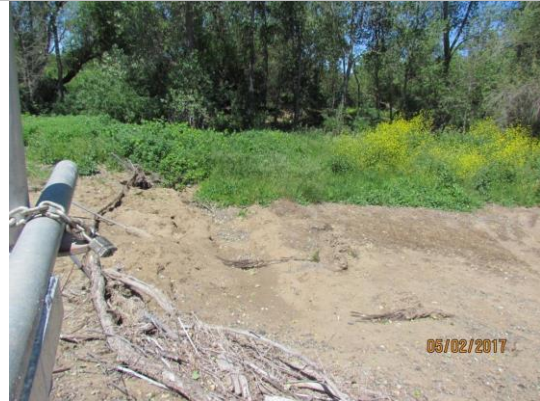
Photo 1 of 1 : SP_2019_MA0005_196_67_20190327_00032.jpg

View of erosion along the waterside slope.

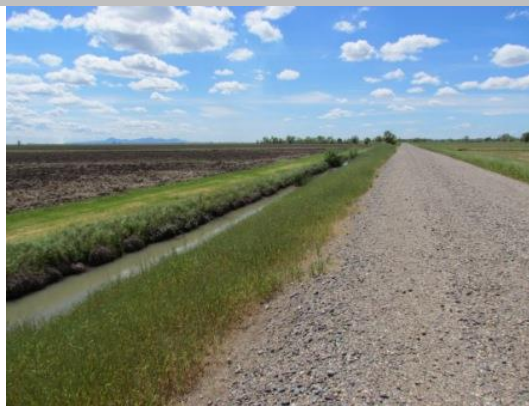
Photo 1 of 1 : SP_2019_MA0005_196_6_20190327_00003.jpg

View of the agricultural ditch along the landside toe.

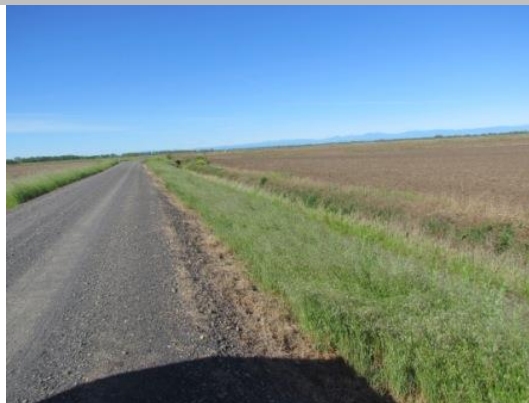
Photo 1 of 1 : SP_2019_MA0005_197_1_20190327_00001.jpg

View of the agricultural ditch along the landside toe.

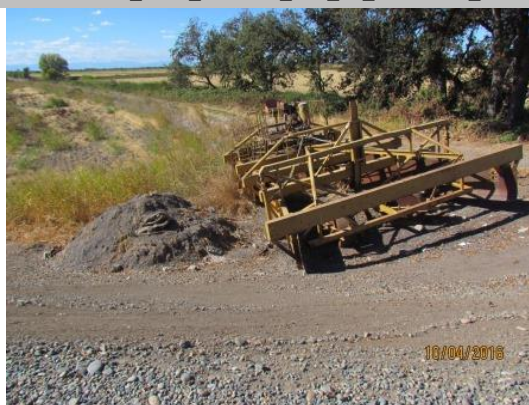
Photo 1 of 1 : SP_2019_MA0005_197_48_20190327_00023.jpg

View of soil pile, rocks, and ag equipment.

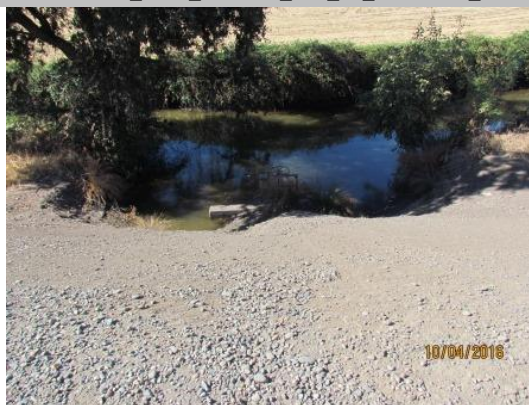
Photo 1 of 1 : SP_2019_MA0005_197_49_20190327_00024.jpg

View of the landside toe erosion.

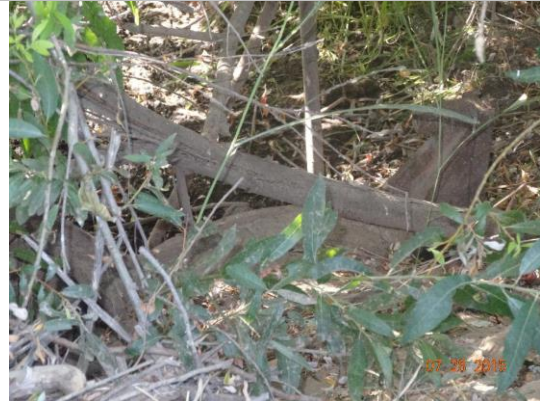
Photo 3 of 3 : UCIP_SP_2019_53009_74600.jpg

WS flap gate overgrown with vegetation.

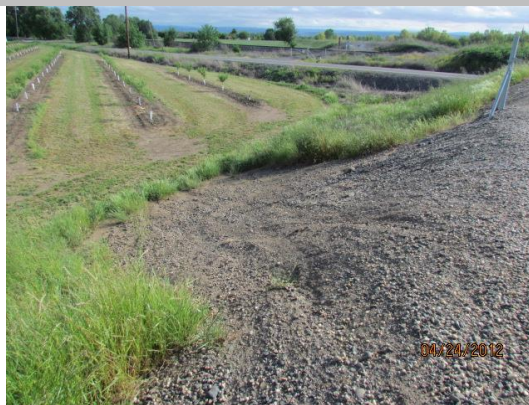
Photo 2 of 2 : SP_2019_MA0005_197_13_20190327_00006.jpg

View of the vehicle erosion along the slope.

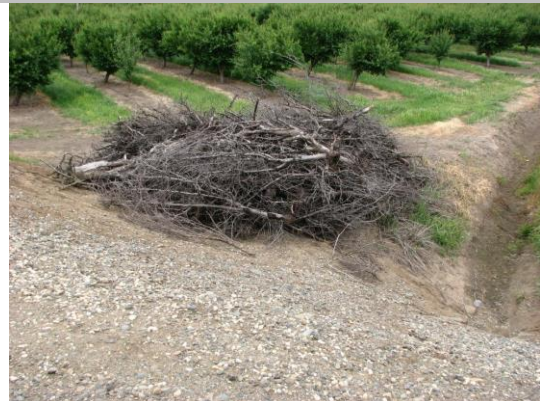
Photo 1 of 1 : SP_2019_MA0005_197_46_20190327_00021.jpg

View of the prunings along the landside toe.

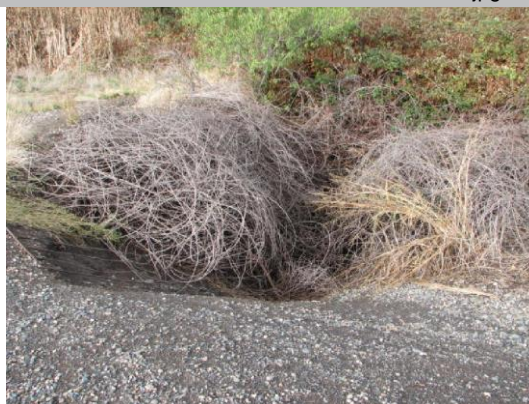
Photo 2 of 3 : UCIP_SP_2019_52062_68404.jpg

Brambles and soil over pipe at inlet.

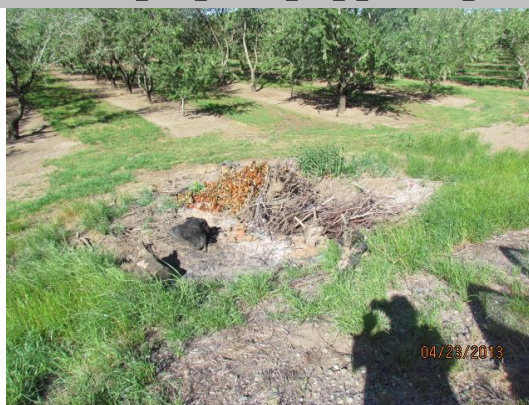
Photo 1 of 1 : SP_2019_MA0005_197_3_20190327_00002.jpg

View of the prunings along the landside toe.

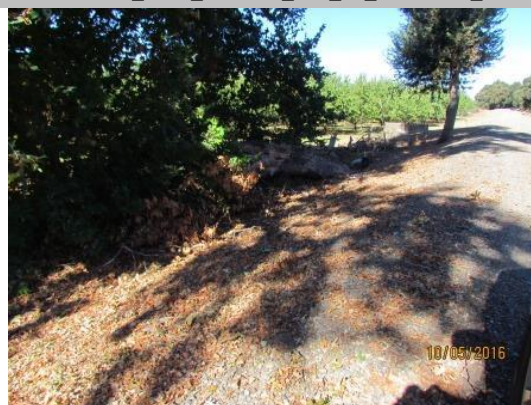
Photo 1 of 1 : SP_2019_MA0005_197_36_20190327_00013.jpg

View of the tree log at the landside toe.

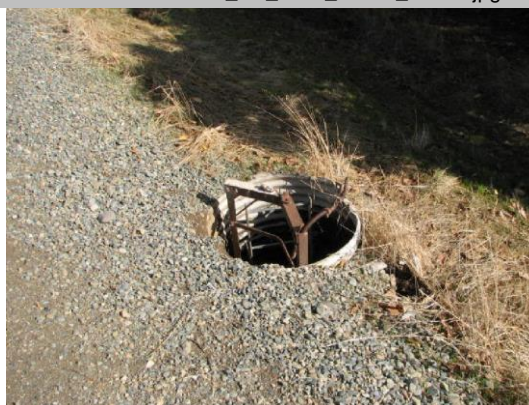
Photo 1 of 3 : UCIP_SP_2019_54048_68465.jpg

Broken slide gate in CM riser on WS slope.

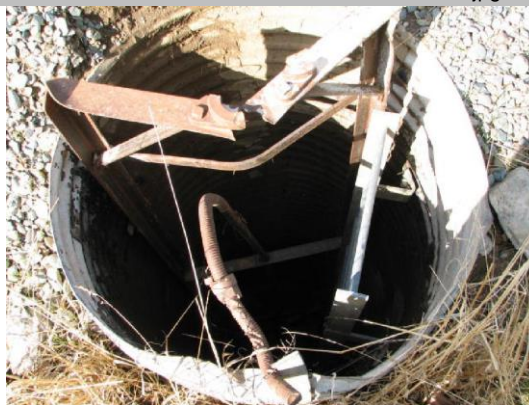
Photo 3 of 3 : UCIP_SP_2019_54048_68463.jpg

Broken slide gate in CM riser on WS slope.

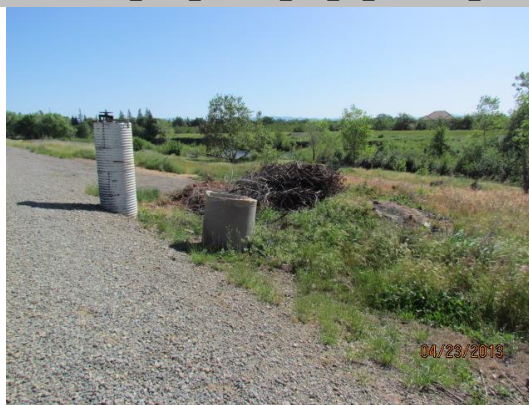
Photo 1 of 1 : SP_2019_MA0005_197_22_20190327_00009.jpg

View of the prunings along the waterside toe.

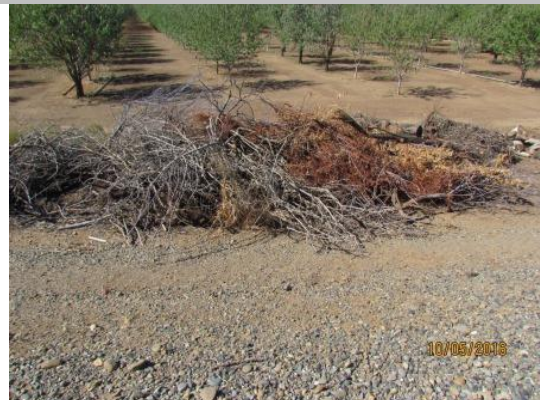
Photo 1 of 1 : SP_2019_MA0005_197_61_20190327_00032.jpg

View of the prunings along the landside toe.

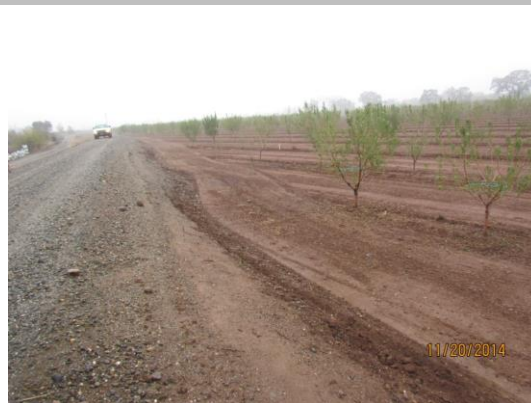
Photo 1 of 1 : SP_2019_MA0005_197_43_20190327_00019.jpg

View of the tilling into the landside slope.
