**Flood Control Project Maintenance
Levee Inspections**
LMA District Cover Sheet
Spring 2020 Levee Inspection Results

Spring 2020 Levee Inspection Results

Sutter Maintenance Yard Maintenance Area 0005

Waterway			Bank	Unit Miles
Unit No. 01 Butte Creek			Left	15.08
	Spring (March - May)	Summer (June - August)	(September - November) Fall	Winter (December - February)
Unit Maintenance Rating (Fall Only)				
Date of Inspection	4/8/2020 - 4/8/2020			
DWR Inspector	Makar Sokol			
Accompanied By	Bob Duffey Sutter Maintenance Yard

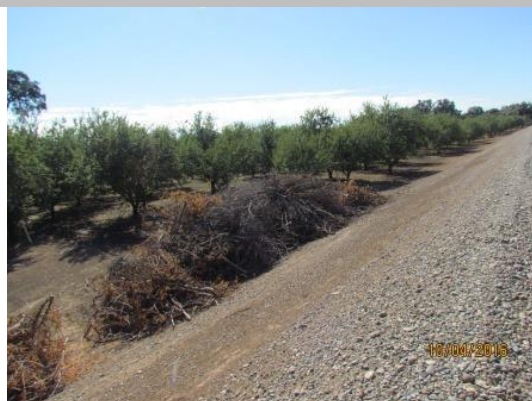
Photo 1 of 1 : SP_2020_MA0005_196_38_20200226_00013.jpg

View of the prunings along the landside toe.

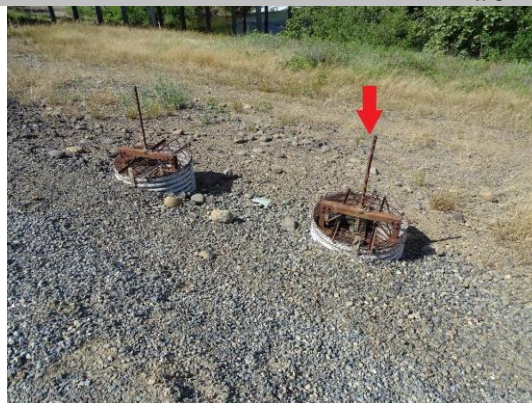
Photo 1 of 3 : UCIP_SP_2020_54141_79700.jpg

Comment Code						
Inspector Comment						
DS_ID:1616 FS_ID:54141 EP_NO: N/A Repair Type: Non-Urgent Crossing Status: Found UCIP Comments: 06/05/2019 No issues recorded during inspection. (O.Yakimov - DWR UCIP) 05/15/2017 Crossing appears to be in good condition. LS inlet is located in the Distribution box on the LS toe. This is an overflow pipe used to regulate water levels in side the box. Pipe has been selected to be internally cleaned and inspected as part fo the DMP project. (DWR Sutter Yard- AFreitag)11/15/2016 Crossing appears to be in good condition. (DWR Sutter Yard- AFreitag)5/9/2016 Crossing appears to be in good condition.8/5/2015 WS pipe end is being overgrown by trees and other vegetation. Needs to be cleared back.12/8/2014 Same as last inspection.6/11/2014 Same as last inspection.11/20/2013 Same as last inspection.5/29/2013 Same as last inspection. FIELD_STRUCT_DESC: 24-inch corrugated metal drainage pipe through the levee, 12.0 feet below the crown. Slide gate in a corrugated metal riser on the waterside (WS) slope. Flap gate on the WS toe. Inlet on the landside (LS) toe. [Additional Reference(s): DWR Levee Log, 1990 (HLM 3.95). USACE Sacramento O&M Manual, Unit 516 - Upper Butte Creek - Part No. 2, April 1960, (Station 381+36)]. FS Date: 6/5/2019 2:07:47 PM

CMP riser and slide gate on WS shoulder

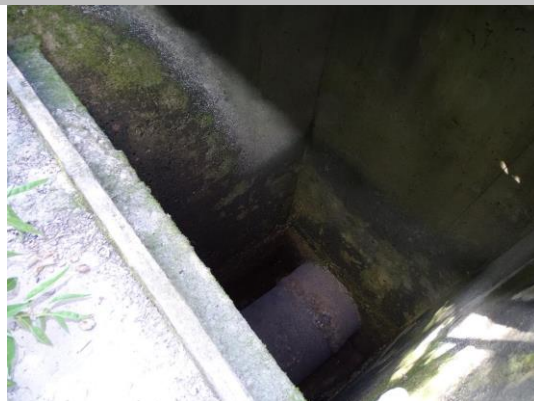
Photo 3 of 3 : UCIP_SP_2020_54141_79699.jpg

Steel welded pipe inside of concrete distribution box on LS goes toward the levee

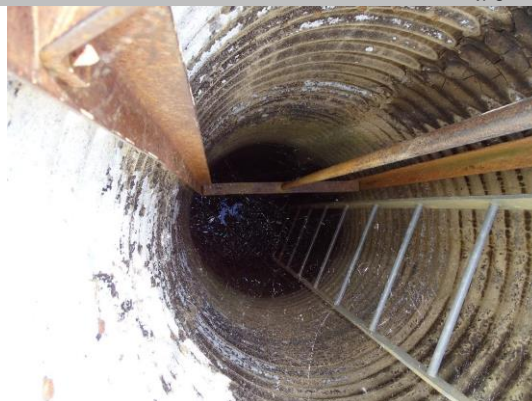
Photo 2 of 3 : UCIP_SP_2020_54142_79703.jpg

Inside view of CMP riser on WS shoulder

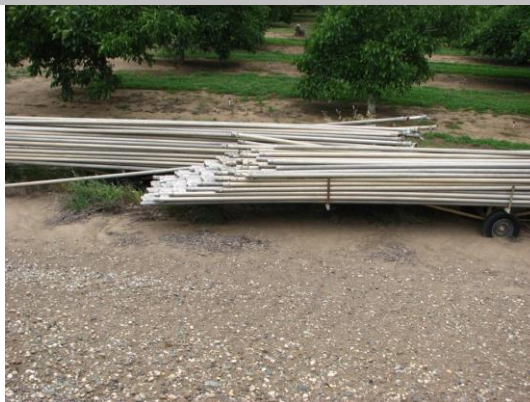
Photo 1 of 1 : SP_2020_MA0005_196_27_20200226_00007.jpg

5/5/2016: Remove equipment from LS toe.

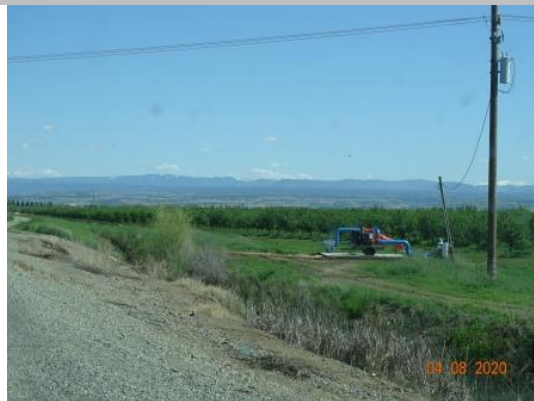
Photo 1 of 1 : SP_2020_MA0005_196_55_20200415_00085.jpg

View of the irrigation ditch along the landside toe. Spring 2020.

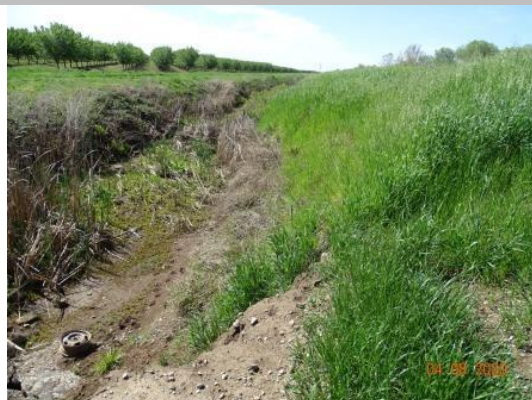
Photo 1 of 1 : SP_2020_MA0005_196_56_20200415_00086.jpg

LM Start	5.81	Rating **	U	Issue No.	56
LM End	5.81	Issue Type +	Ma	Location *	LS
Category	Earthen Levee			GPS Latitude/Longitude	
				Start	End
Item	Erosion / Bank Caving			39.621261 °	39.621261 °
				-121.773973 °	-121.773973 °
DWR ID	DWR_MA0005_01_f_2016_56				
Comment Code					
E2 : Schedule repair of erosion site prior to the next inspection.					
Inspector Comment

View of the erosion at the landside toe. Spring 2020.

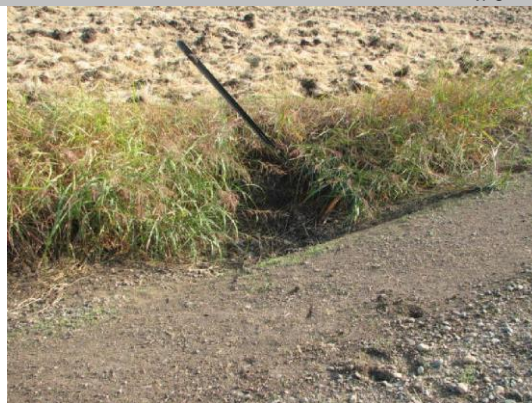
Photo 1 of 2 : UCIP_SP_2020_51970_67970.jpg

Comment Code						
Inspector Comment						
DS_ID:1628 FS_ID:51970 EP_NO: N/A Repair Type: Non-Urgent Crossing Status: Found UCIP Comments: 5/16/2017 LS inlet is almost completely buried. Nothing visible on the WS. Pipe has been selected to be internally cleaned and inspected as part of the DMP poject. (DWR Sutter Yard-AFreitag)11/15/2016 Appears abandoned and should be done so properly. (DWR Sutter Yard-AFreitag)5/11/2016 Possibly an abandoned crossing. LS inlet was over 50% buried and nothing was found on the WS.8/4/2015 LS pipe end filled about 50% with soil and WS pipe end is buried.12/8/2014 Same as last inspection.6/11/2014 Same as last inspection.11/19/2013 Same as last inspection.5/29/2013 Same as last inspection.10/30/2012 Pipe filled with soil and outlet/appurtances are burried. FIELD_STRUCT_DESC: *ABANDONED* 24-inch corrugated metal drainage pipe through the levee, 8.5 feet below the crown. Flap gate on the waterside (WS). Concrete "U" shaped headwall on the landside (LS) toe. [Additional Reference(s): DWR Levee Log, 1990 (HLM 7.70). USACE Sacramento O&M Manual, Unit 515 - Upper Butte Creek - Part No. 1, April 1955, (Station 576+72). USACE As-Built Drawing No. 50-4-2637, Exhibit B, Sheet 2, April 1950, (Station 576+72.4)]. FS Date: 5/31/2017 1:58:05 PM

Headwall at LS toe.

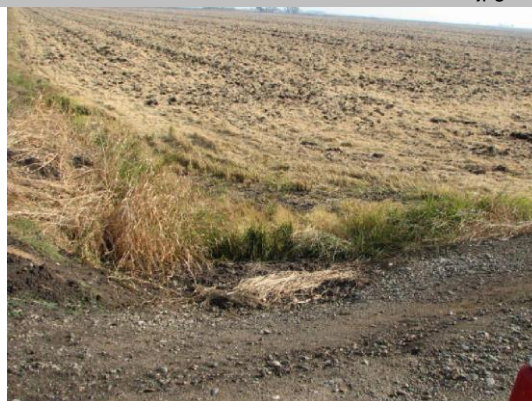
Photo 2 of 3 : UCIP_SP_2020_51972_67972.jpg

DS_ID:1629
FS_ID:51972
EP_NO: N/A
Repair Type: Non-Urgent
Crossing Status: Found
UCIP Comments: 5/16/2017 LS inlet is half blocked off by flash boards and sediment. WS flap gate is blocked closed by sediment. Pipe has been selected to be internally cleaned and inspected as part of the DMP project. (DWR Sutter Yard- A/Freitag)11/15/2016 LS inlet was unburied and entire pipe is about 25% full of soil. WS flapgate was shut and partially buried. (DWR Sutter Yard- A/Freitag)5/11/2016 WS flap gate was about 50% buried and LS was 100% buried. Appears to be an abandoned crossing.8/4/2015 WS flap gate is partially buried by soil and being overgrown with vegetation. LS pipe end was underwater and suspected to still be completely buried with soil.12/8/2014 Same as last inspection.6/11/2014 Same as last inspection.11/19/2013 Same as last inspection.5/29/2013 Same as last inspection.10/30/2012 Pipe filled with soil.

Buried inlet at LS toe.

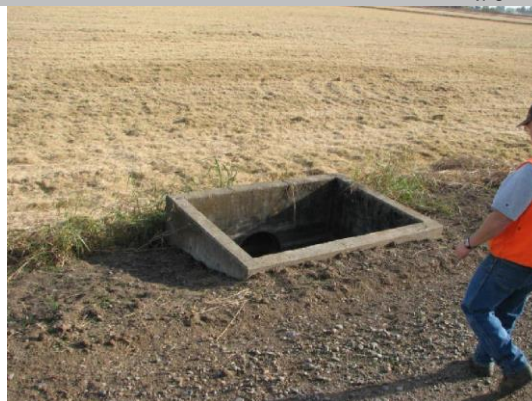
Photo 1 of 3 : UCIP_SP_2020_51975_67976.jpg

DS_ID:1631
 FS_ID:51975
 EP_NO: N/A
 Repair Type: Non-Urgent
 Crossing Status: Found
 UCIP Comments: 5/16/2017 Abandoned and needs to be done so properly. (DWR Sutter Yard- A Freitag) 11/15/2016 Abandoned. (DWR Sutter Yard- A Freitag) 5/11/2016 Abandoned pipe. 8/4/2015 Abandoned pipe. Casey Wilder has started the steps to have the pipe properly abandoned and removed from the levee. 12/8/2014 Same as last inspection. 6/11/2014 Same as last inspection. 11/19/2013 Same as last inspection. 5/29/2013 Same as last inspection. 10/30/2012 Need to confirm proper abandonment of pipe. Pipe should be plugged on LS.
 FIELD_STRUCT_DESC: 16-inch steel irrigation pipe through the levee, 11.5 feet below the crown. Pump located on the waterside (WS). Distribution box at the landside (LS) toe. [Additional Reference(s): DWR Levee Log, 1990 (HLM 9.21). USACE Sacramento O&M Manual, Unit 515 - Upper Butte Creek - Part No. 1, April 1955, (Station 655+68). USACE As-Built Drawing No. 50-4-2637, Exhibit B, Sheet 3, April 1950, (Station 655+68.2)].

Concrete distribution box at LS toe.

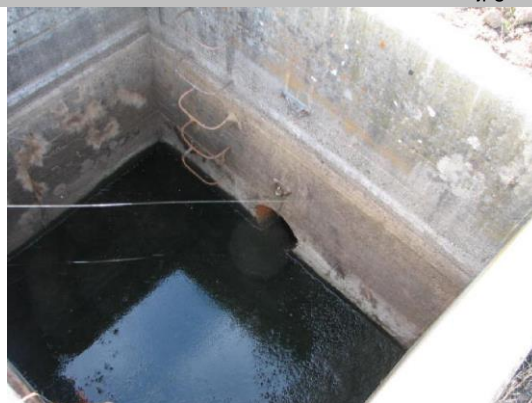
Photo 3 of 3 : UCIP_SP_2020_51975_67974.jpg

Pipe at bottom of concrete distribution box.

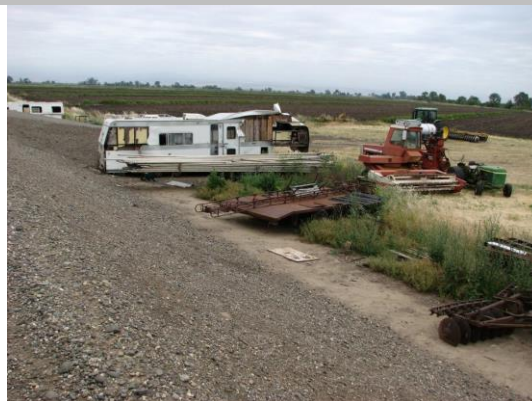
Photo 1 of 1 : SP_2020_MA0005_196_26_20200226_00006.jpg

5/5/2016: Remove abandoned motorhome and equipment from LS toe.

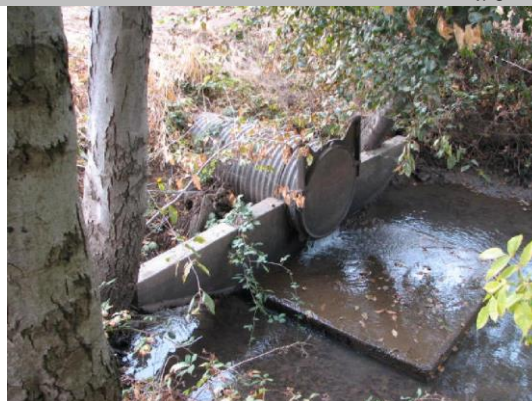
Photo 3 of 3 : UCIP_SP_2020_51999_68031.jpg

Wingwalls of headwall not supported by soil.

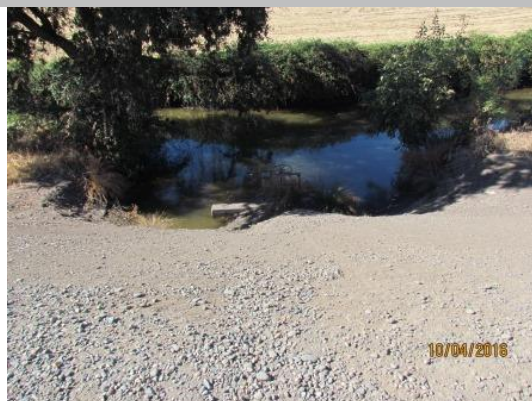
Photo 1 of 1 : SP_2020_MA0005_197_49_20200226_00019.jpg

View of the landside toe erosion.

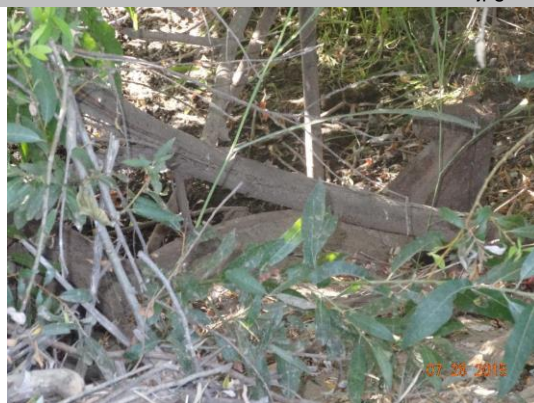
Photo 3 of 3 : UCIP_SP_2020_53009_74600.jpg

WS flap gate overgrown with vegetation.

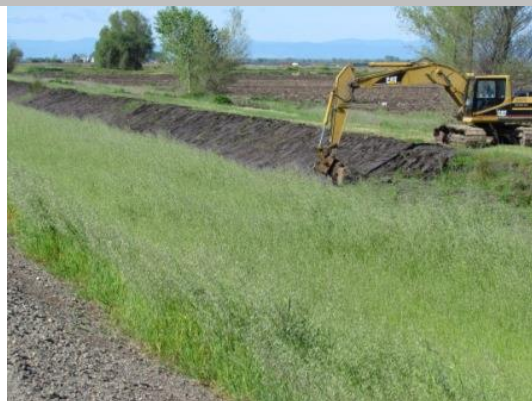
Photo 1 of 1 : SP_2020_MA0005_197_7_20200226_00004.jpg

View of the agricultural ditch along the landside toe.

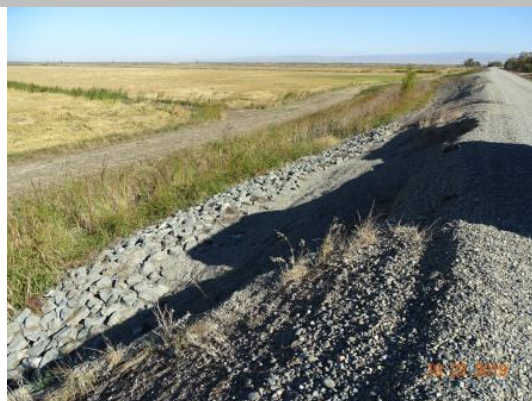
Photo 1 of 1 : SP_2020_MA0005_197_55_20200226_00022.jpg

View of sloughing on the landside slope. Fall 2019.

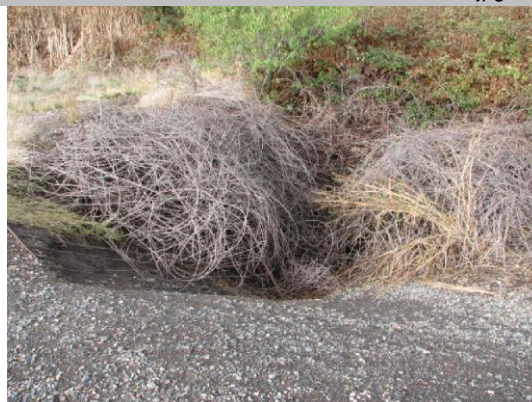
Photo 2 of 3 : UCIP_SP_2020_52062_68404.jpg

Brambles and soil over pipe at inlet.

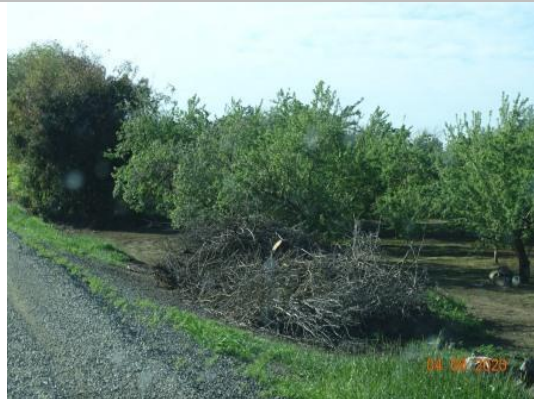
Photo 1 of 1 : SP_2020_MA0005_197_3_20200415_00094.jpg

View of the prunings along the landside toe. Spring 2020.

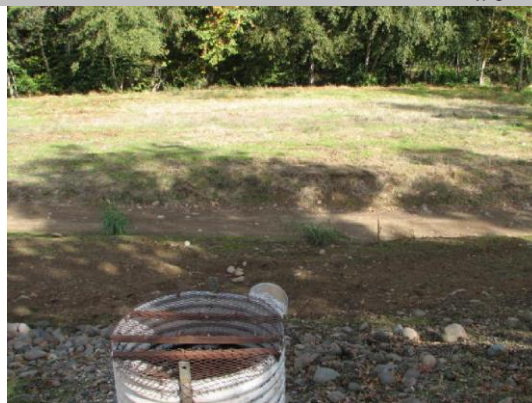
Photo 1 of 3 : UCIP_SP_2020_52069_68429.jpg

CM riser on WS shoulder-missing slide gate.

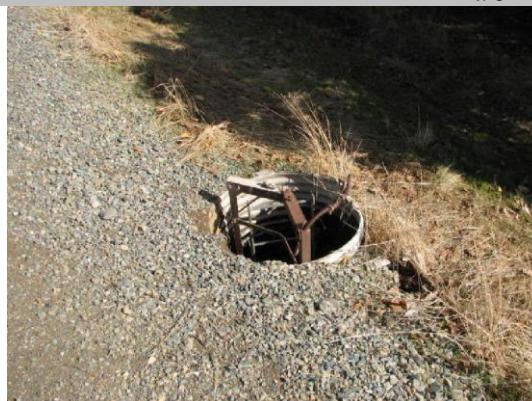
Photo 1 of 3 : UCIP_SP_2020_54048_68465.jpg

Broken slide gate in CM riser on WS slope.

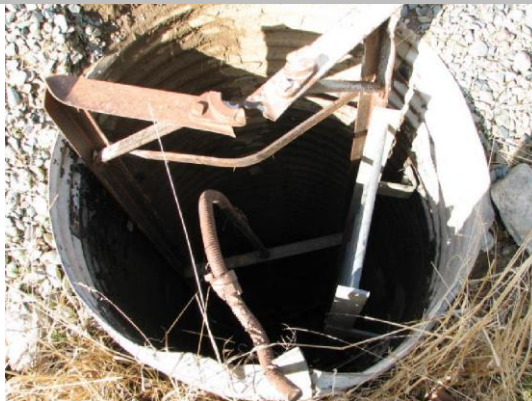
Photo 3 of 3 : UCIP_SP_2020_54048_68463.jpg

Broken slide gate in CM riser on WS slope.

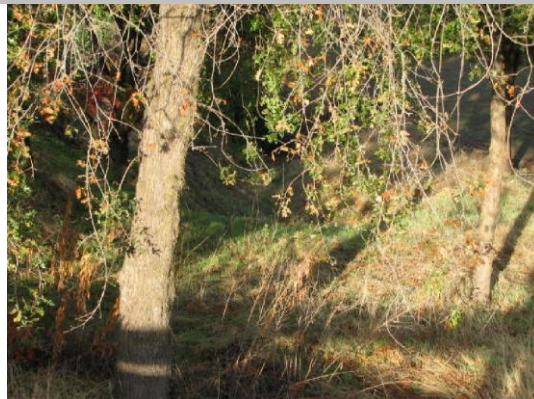
Photo 1 of 3 : UCIP_SP_2020_52083_68531.jpg

Inlet relocated after bridge replacement away from LS toe.
