Flood Control Project Maintenance Levee Inspections LMA District Cover Sheet

Sutter Maintenance Yard Maintenance Area 0005

Waterway			Bank	Unit Miles
Unit No. 01 Butte Creek			Left	15.08
	Spring (March - May)	Summer (June - August)	(September - November) Fall	Winter (December - February)
Unit Maintenance Rating (Fall Only)				
Date of Inspection	3/24/2021 - 3/24/2021			
DWR Inspector	Makar Sokol			
Accompanied By	Bob Duffey Sutter Maintenance Yard

Levee Inspection Report By Mile - Spring 2021

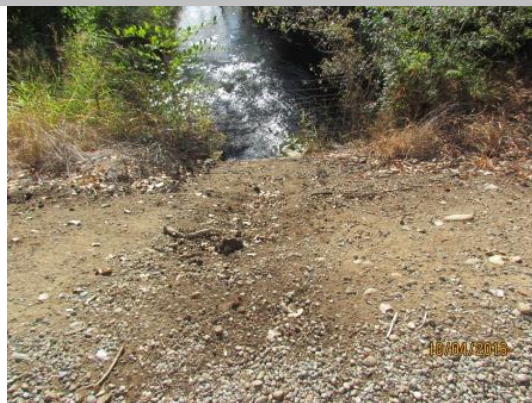
Photo 1 of 1 : SP_2021_MA0005_196_46_20210224_00016.jpg

LM Start	0.07	Rating **	M	Issue No.	46
LM End	0.07	Issue Type +	Ma	Location *	LS
Category	Earthen Levee			GPS Latitude/Longitude	
				Start	End
Item	Slope Stability			39.696611 °	39.696611 °
				-121.774349 °	-121.774349 °
DWR ID	DWR_MA0005_01_f _ 2016_46				
Comment Code					
S2 : Repair the levee slope damaged by foot traffic and prevent access where possible.					
Inspector Comment

View of the damaged slope by foot traffic.

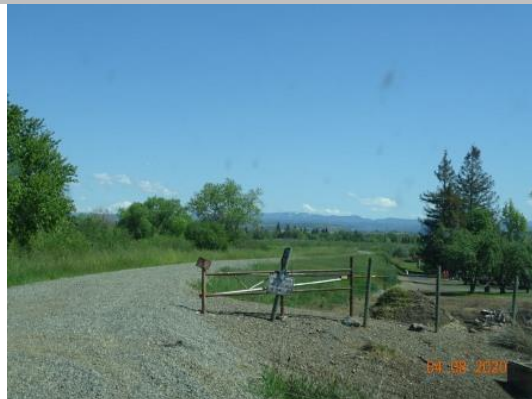
Photo 1 of 1 : SP_2021_MA0005_196_10_20210224_00005.jpg

LM Start	2.09	Rating **	M	Issue No.	10
LM End	2.09	Issue Type +	En	Location *	LS
Category	Earthen Levee			GPS Latitude/Longitude	
				Start	End
Item	Encroachments			39.670112 °	39.670112 °
				-121.782012 °	-121.782012 °
DWR ID	DWR_MA0005_01_s_2016_10				
Comment Code					
FE : Fence					
Inspector Comment					
No permit was found for the gate.

View of the unpermitted gate. Spring 2020.

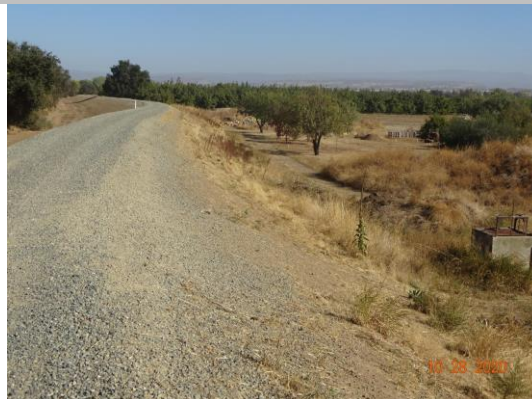
Photo 1 of 1 : SP_2021_MA0005_196_9_20210224_00004.jpg

LM Start	2.54	Rating **	M	Issue No.	9
LM End	2.54	Issue Type +	Ma	Location *	LS
Category	Earthen Levee			GPS Latitude/Longitude	
				Start	End
Item	Slope Stability			39.663876 °	39.663876 °
				-121.784014 °	-121.784014 °
DWR ID	DWR_MA0005_01_f_2012_9				
Comment Code					
S3 : Repair the levee slope damaged by vehicle traffic and prevent access where possible.					
Inspector Comment

View of the damaged landside slope due to vehicle traffic. Fall 2020.

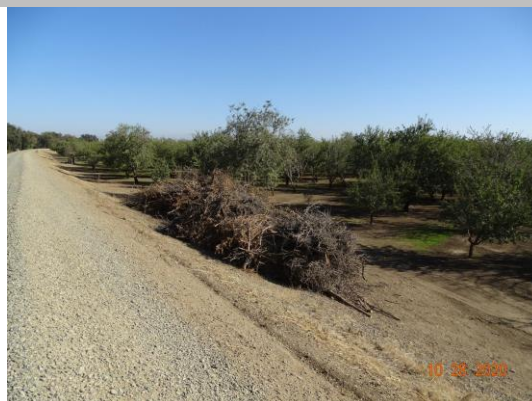
Photo 1 of 1 : SP_2021_MA0005_196_37_20210224_00010.jpg

View of the prunings along the landside toe. Fall 2020.

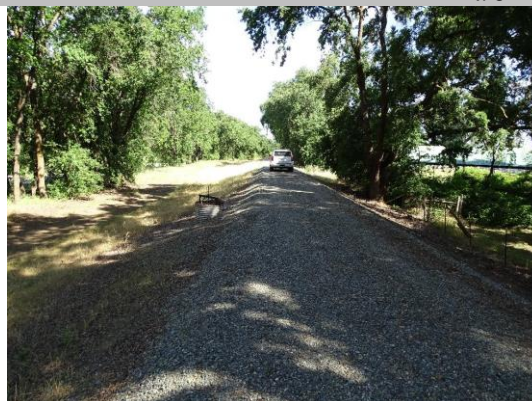
Photo 1 of 3 : UCIP_SP_2021_59679_79693.jpg

FS_ID:59679
DS_ID:1615
EP_NO: N/A
Repair Type: Non-Urgent
Crossing Status: Found
UCIP Comments: 07/30/2020 UCIP staff received CVFPB Enforcement Case No. 9708 Compliance Letter confirming repair of screw gate by Durham Mutual Water Company. CVFPB Enforcement Case No. 2019-9708 has been closed. Owner is seeking permit for 30-inch pipe. UCIP record will be update the UCIP record when the permit is issued by the CVFPB. (O. Magana - DWR UCIP)06/05/2019 Durham Mutual Water Company fixed broken slide gate by replacing a stem. Operating wheel is missing. Crossing downgraded to non-urgent. (O. Yakimov - DWR UCIP)10/5/2018 Observed pipe running during inspection. Pipe is used to drain water from LS concrete box to WS. Field structure description was updated to show structure type as drainage pipe. Confirmed that the concrete box on LS receives water from a pipe running along the LS toe from orchards upstream and distributes water between 3 pipes, one of which crosses levee at an angle. Missing closure device on WS. Screw gate stuck in open position inside CMP riser located on WS shoulder and is not operable. (O. Yakimov - DWR)5/15/2017 WS slide gate stem bent and gate is stuck in the open position. Outlet in the the concrete box on the WS berm is opened and allowed water to free flow through the pipe during the Jan/Feb 2017 high water events. Either the screw gate needs to be repaired or a flap gate added to the outlet in the concrete box to not allow high water flows though the levee. Pipe is believed to be owned and operated by Duhram Mutual Water Company at 1807 Duhram Dayton HWY, PO Box 612, Duhram CA 95938 (530)342-9324. (A. Freitag - DWR Sutter Yard) 11/15/2016 Abandoned- slide gate is opened and inoperable. Needs to be properly abandoned. (A. Freitag - DWR Sutter Yard)05/09/2016 Abandoned crossing. Slide gate stem bent and wheel is missing. (A. Freitag - DWR Sutter Yard)08/05/2015 Abandoned crossing. Slide gate stem is bent and gate is inoperable. Needs to be properly abandoned. (A. Freitag - DWR Sutter Yard)12/08/2014 Same as last inspection. (A. Freitag - DWR Sutter Yard)06/11/2014 Same as last inspection. (A. Freitag - DWR Sutter Yard)11/20/2013 Same as last inspection. (A. Freitag - DWR Sutter Yard)05/29/2013 Same as last inspection. (A. Freitag - DWR Sutter Yard)10/30/2012 Pipe appears to be abandoned. Slide gate open and inoperable. Pipe should be properly abandoned. (W. Wylie - DWR UCIP)

View of levee crown at crossing

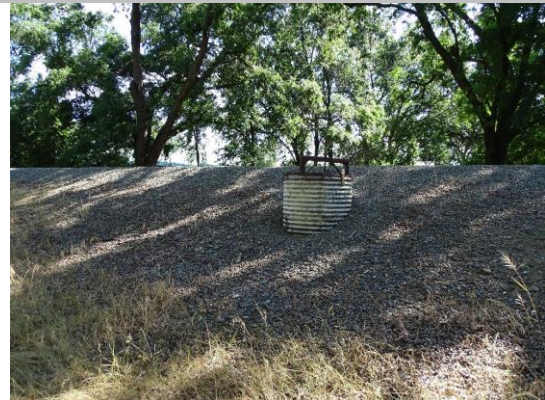
Photo 3 of 3 : UCIP_SP_2021_59679_79690.jpg

CMP riser WS shoulder

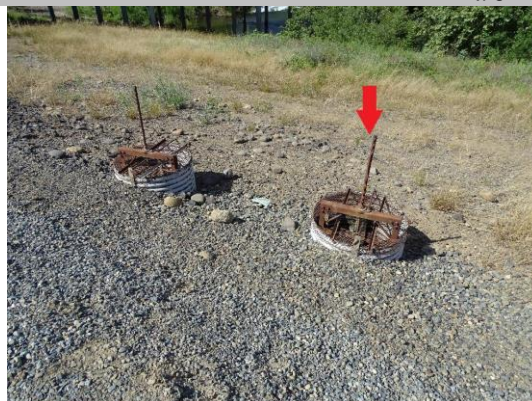
Photo 1 of 3 : UCIP_SP_2021_58165_79700.jpg

FS_ID:58165
DS_ID:1616
EP_NO: N/A
Repair Type: Non-Urgent
Crossing Status: Found
UCIP Comments: 06/05/2019 No issues recorded during inspection. (O.Yakimov - DWR UCIP)
05/15/2017 Crossing appears to be in good condition. LS inlet is located in the Distribution box on the LS toe. This is an overflow pipe used to regulate water levels in side the box. Pipe has been selected to be internally cleaned and inspected as part fo the DMP project. (A. Freitag - DWR Sutter Yard)11/15/2016 Crossing appears to be in good condition. (A. Freitag - DWR Sutter Yard)05/09/2016 Crossing appears to be in good condition. (A. Freitag - DWR Sutter Yard)08/05/2015 WS pipe end is being overgrown by trees and other vegetation. Needs to be cleared back. (A. Freitag - DWR Sutter Yard)12/08/2014 Same as last inspection. (A. Freitag - DWR Sutter Yard)06/11/2014 Same as last inspection. (A. Freitag - DWR Sutter Yard)11/20/2013 Same as last inspection. (A. Freitag - DWR Sutter Yard)05/29/2013 Same as last inspection. (A. Freitag - DWR Sutter Yard)

CMP riser and slide gate on WS shoulder

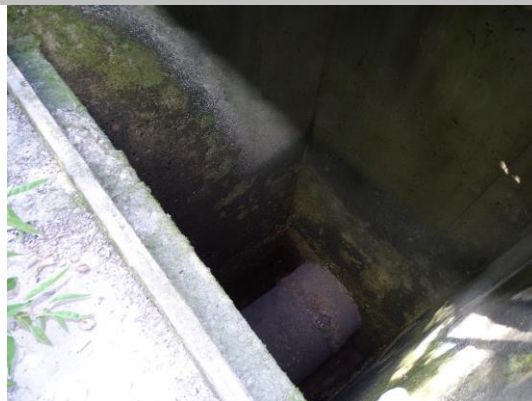
Photo 3 of 3 : UCIP_SP_2021_58165_79699.jpg

Steel welded pipe inside of concrete distribution box on LS goes toward the levee

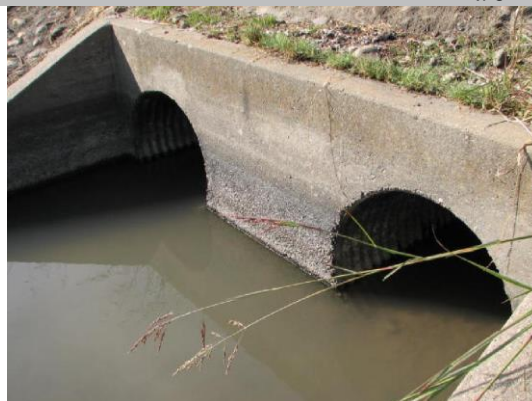
Photo 1 of 2 : UCIP_SP_2021_58207_67941.jpg

FS_ID:58207
DS_ID:1620
EP_NO: N/A
Repair Type: Non-Urgent
Crossing Status: Found
UCIP Comments: 05/23/2019 (O. Magana - DWR UCIP)05/15/2017 Abandoned and needs to be done properly. A sink hole formed in the WS toe road and revealed the location of the WS pipe end. Sink hole will need to be repaired before the next high water season but the pipe has been selected to be internally cleaned and camera inspected as part of the DMP project so it will have needed to be excavated along the WS end anyways. (A. Freitag - DWR Sutter Yard)11/15/2016 Abandoned. Needs cover for the standpipe. (A. Freitag - DWR Sutter Yard)05/09/2016 Abandoned pipe. Needs a cover for the standpipe. (A. Freitag - DWR Sutter Yard)08/05/2015 Abandoned crossing. Covers need to be made for tops of standpipes to prevent falls. (A. Freitag - DWR Sutter Yard)12/08/2014 Same as last inspection. (A. Freitag - DWR Sutter Yard)06/11/2014 Same as last inspection. (A. Freitag - DWR Sutter Yard)11/19/2013 Same as last inspection. (A. Freitag - DWR Sutter Yard)05/29/2013 Same as last inspection. Land owner said pipes are abandoned and no longer used. Covers should be made for top of standpipe to prevent falls. Pipes should be properly abandoned. (A. Freitag - DWR Sutter Yard)10/30/2012 Pipe 1/2 filled with soil at slide gate end. (W. Wylie - DWR UCIP) FIELD_STRUCT_DESC: *ABANDONED* 1 of 2: 36-inch drainage pipe through the levee, 11 feet below the crown. Slide gate in a 54-inch corrugated metal riser on the waterside (WS) slope. Concrete "U" headwall on the landside (LS). [Additional Reference(s): DWR Levee Log, 1990 (HLM 5.66). Sacramento O&M Manual, Unit 516 - Upper Butte Creek - Part No. 2, April 1960 (Station 470+00)].

Headwall at LS toe.

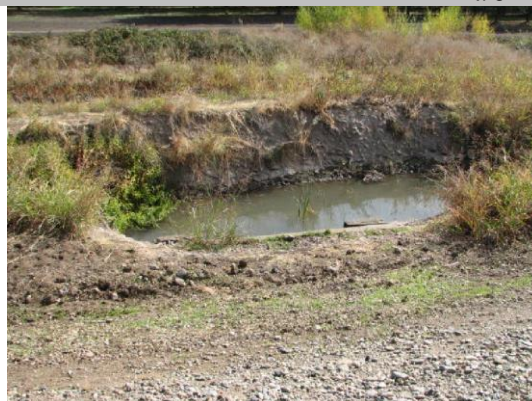
Photo 1 of 3 : UCIP_SP_2021_58212_67939.jpg

FS_ID:58212
DS_ID:1768
EP_NO: N/A
Repair Type: Non-Urgent
Crossing Status: Found
UCIP Comments: 05/23/2019 (O. Magana - DWR UCIP)05/15/2017 Abandoned and needs to be done properly. A sink hole formed in the WS toe road and revealed the location of the WS pipe end. Sink hole will need to be repaired before the next high water season but the pipe has been selected to be internally cleaned and camera inspected as part of the DMP project so it will have needed to be excavated along the WS end anyways. (A. Freitag - DWR Sutter Yard)11/15/2016 Abandoned. Needs standpipe cover. (A. Freitag - DWR Sutter Yard)05/09/2016 Abandoned pipe. Needs a cover for standpipe. (A. Freitag - DWR Sutter Yard)08/05/2015 Abandoned pipes. Need covers made for tops of standpipes to prevent falls. (A. Freitag - DWR Sutter Yard) 12/08/2014 Same as last inspection. (A. Freitag - DWR Sutter Yard)06/11/2014 Same as last inspection. (A. Freitag - DWR Sutter Yard)11/19/2013 Same as last inspection. (A. Freitag - DWR Sutter Yard)05/29/2013 Same as last inspection. Land owner said pipes are abandoned and no longer used. Covers should be made for top of standpipe to prevent falls. Pipes should be properly abandoned. (A. Freitag - DWR Sutter Yard)10/30/2012 Pipe 1/2 filled with soil at slide gate on WS. (W. Wylie - DWR UCIP)

Headwall at LS toe.

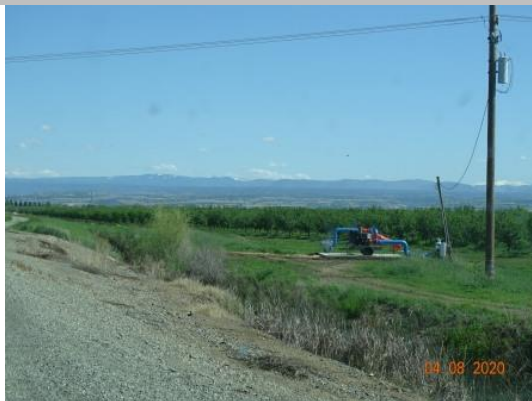
Photo 1 of 1 : SP_2021_MA0005_196_55_20210224_00021.jpg

View of the irrigation ditch along the landside toe. Spring 2020.

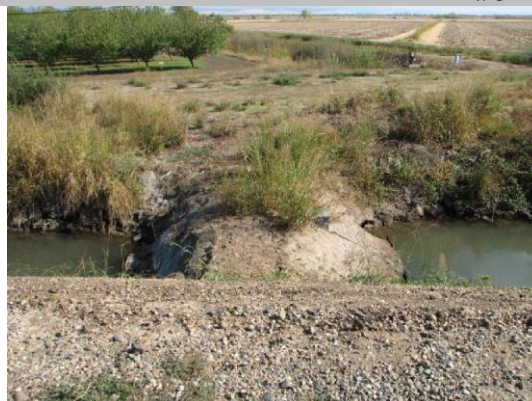
Photo 1 of 1 : UCIP_SP_2021_58173_11616.jpg

Comment Code					
Inspector Comment					
FS_ID:58173 DS_ID:1622 EP_NO: N/A Repair Type: Non-Urgent Crossing Status: Indicator Found UCIP Comments: 05/15/2017 Unable to locate. (A. Freitag - DWR Sutter Yard)11/15/2016 Unable to locate. The concrete fill in the LS toe channel appears to just be erosion protection. (A. Freitag - DWR Sutter Yard)08/05/2015 Unable to locate. (A. Freitag - DWR Sutter Yard)12/08/2014 Same as last inspection. (A. Freitag - DWR Sutter Yard)06/11/2014 Same as last inspection. (A. Freitag - DWR Sutter Yard)11/19/2013 Same as last inspection. (A. Freitag - DWR Sutter Yard)05/29/2013 Same as last inspection. (A. Freitag - DWR Sutter Yard) FIELD_STRUCT_DESC: 18-inch corrugated metal drainage pipe through the levee, 15 feet below the crown, indicator found. Concrete headwall and flap gate on the waterside (WS). Concrete fill in channel on the landside (LS) toe is a good indicator of the pipe location. [Additional Reference(s): DWR Levee Log, 1990 (HLM 5.85). Sacramento O&M Manual, Unit 516 - Upper Butte Creek - Part No. 2, April 1960, 18-inch pipe referenced only in USACE As-Built Drawing No. 50-4-3367, Exhibit B, Sheet 8, April 1957, (Station 480+25)]. FS Date: 5/31/2017 1:06:00 PM

Concrete fill on LS toe a good indicator for location of pipe.

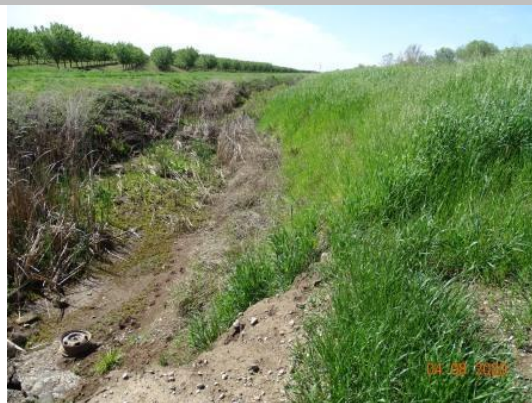
Photo 1 of 1 : SP_2021_MA0005_196_56_20210224_00022.jpg

LM Start	5.81	Rating **	U	Issue No.	56
LM End	5.81	Issue Type +	Ma	Location *	LS
Category	Earthen Levee			GPS Latitude/Longitude	
				Start	End
Item	Erosion / Bank Caving			39.621261 °	39.621261 °
				-121.773973 °	-121.773973 °
DWR ID	DWR_MA0005_01_f_2016_56				
Comment Code					
E2 : Schedule repair of erosion site prior to the next inspection.					
Inspector Comment

View of the erosion at the landside toe. Spring 2020.

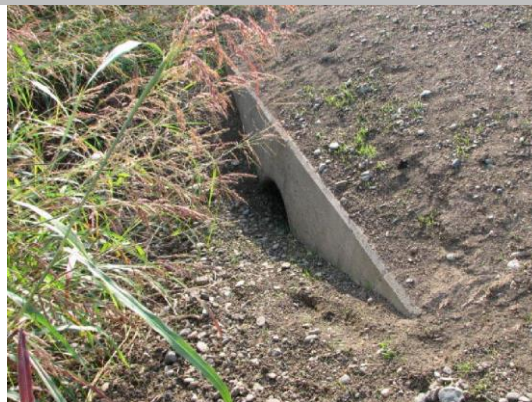
Photo 2 of 2 : UCIP_SP_2021_58208_67969.jpg

FS_ID:58208
DS_ID:1628
EP_NO: N/A
Repair Type: Non-Urgent
Crossing Status: Found
UCIP Comments: 05/16/2017 LS inlet is almost completely buried. Nothing visible on the WS. Pipe has been selected to be internally cleaned and inspected as part of the DMP project. (A. Freitag - DWR Sutter Yard)11/15/2016 Appears abandoned and should be done so properly. (A. Freitag - DWR Sutter Yard)05/11/2016 Possibly an abandoned crossing. LS inlet was over 50% buried and nothing was found on the WS. (A. Freitag - DWR Sutter Yard)08/04/2015 LS pipe end filled about 50% with soil and WS pipe end is buried. (A. Freitag - DWR Sutter Yard)12/08/2014 Same as last inspection. (A. Freitag - DWR Sutter Yard)06/11/2014 Same as last inspection. (A. Freitag - DWR Sutter Yard)11/19/2013 Same as last inspection. (A. Freitag - DWR Sutter Yard)05/29/2013 Same as last inspection. (A. Freitag - DWR Sutter Yard)10/30/2012 Pipe filled with soil and outlet/appurtenances are buried. (W. Wylie - DWR UCIP)

Headwall at LS toe.

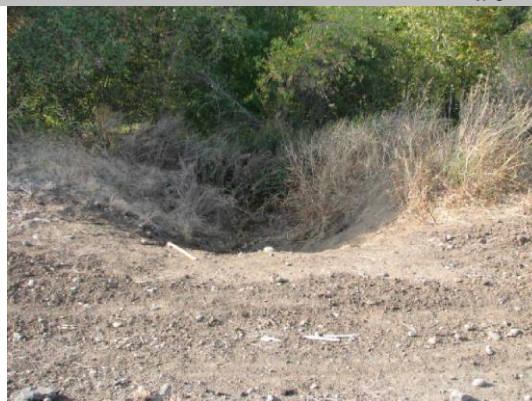
Photo 1 of 3 : UCIP_SP_2021_58209_67973.jpg

FS_ID:58209
DS_ID:1629
EP_NO: N/A
Repair Type: Non-Urgent
Crossing Status: Found
UCIP Comments: 05/16/2017 LS inlet is half blocked off by flash boards and sediment. WS flap gate is blocked closed by sediment. Pipe has been selected to be internally cleaned and inspected as part of the DMP project. (A. Freitag - DWR Sutter Yard)11/15/2016 LS inlet was unburied and entire pipe is about 25% full of soil. WS flapgate was shut and partially buried. (A. Freitag - DWR Sutter Yard)05/11/2016 WS flap gate was about 50% buried and LS was 100% buried. Appears to be an abandoned crossing. (A. Freitag - DWR Sutter Yard)08/04/2015 WS flap gate is partially buried by soil and being overgrown with vegetation. LS pipe end was underwater and suspected to still be completely buried with soil. (A. Freitag - DWR Sutter Yard)12/08/2014 Same as last inspection. (A. Freitag - DWR Sutter Yard)06/11/2014 Same as last inspection. (A. Freitag - DWR Sutter Yard)11/19/2013 Same as last inspection. (A. Freitag - DWR Sutter Yard)05/29/2013 Same as last inspection. (A. Freitag - DWR Sutter Yard)10/30/2012 Pipe filled with soil. (W. Wylie - DWR UCIP) FIELD_STRUCT_DESC: 24-inch corrugated metal drainage pipe through the levee, 9.3 feet below the crown. Flap gate on the waterside (WS). Concrete headwalls at the landside (LS) and the WS toes. [Additional Reference(s): DWR Levee Log, 1990 (HLM 8.35). USACE Sacramento O&M Manual, Unit 515 - Upper Butte Creek - Part No. 1, April 1955, (Station 609+79). USACE As-Built Drawing No. 50-4-2637, Exhibit B, Sheet 3, April 1950, (Station 609+78.5)].

Outlet at WS toe.

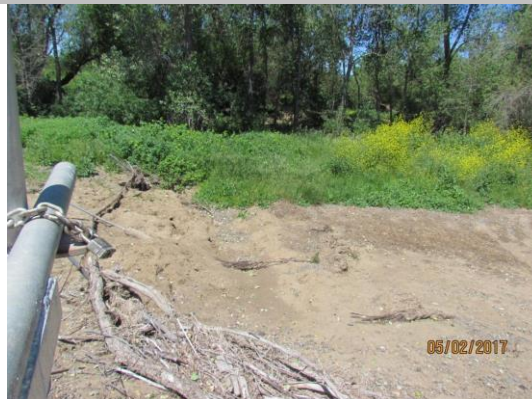
Photo 1 of 1 : SP_2021_MA0005_196_67_20210224_00023.jpg

View of erosion along the waterside slope.

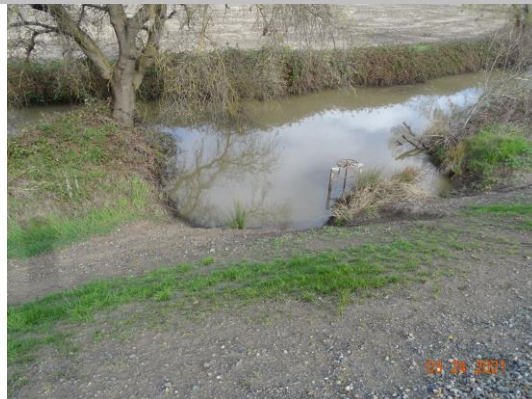
Photo 1 of 1 : SP_2021_MA0005_197_49_20210407_00081.jpg

View of the erosion at the landside toe. Spring 2021.

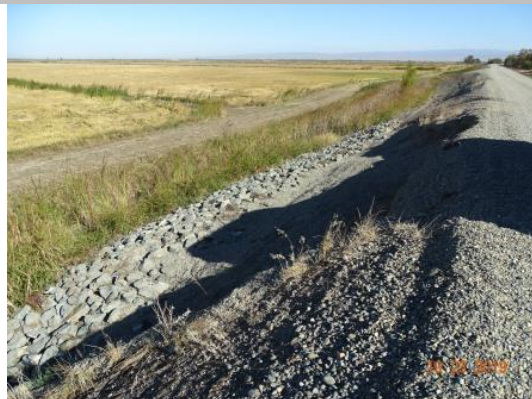
Photo 1 of 1 : SP_2021_MA0005_197_55_20210224_00014.jpg

View of sloughing on the landside slope. Fall 2019.

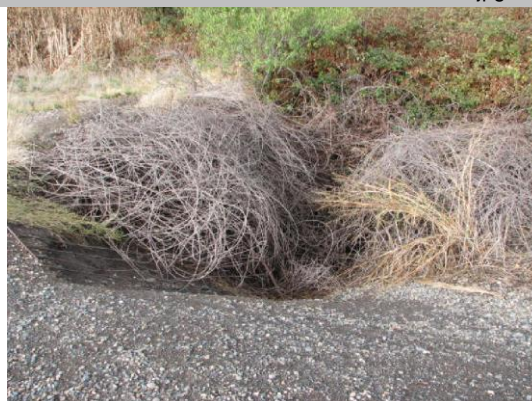
Photo 2 of 3 : UCIP_SP_2021_58280_68404.jpg

Brambles and soil over pipe at inlet.

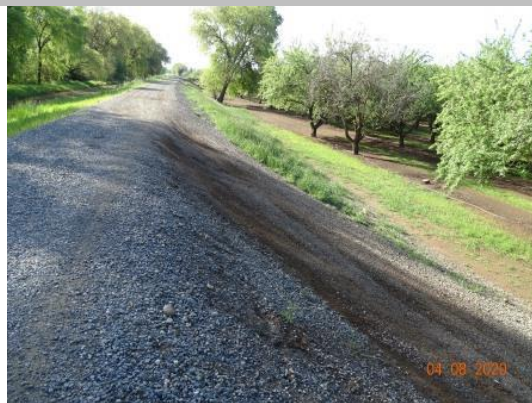
Photo 1 of 1 : SP_2021_MA0005_197_18_20210224_00005.jpg

View of the vehicle erosion along the landside slope. Spring 2020.

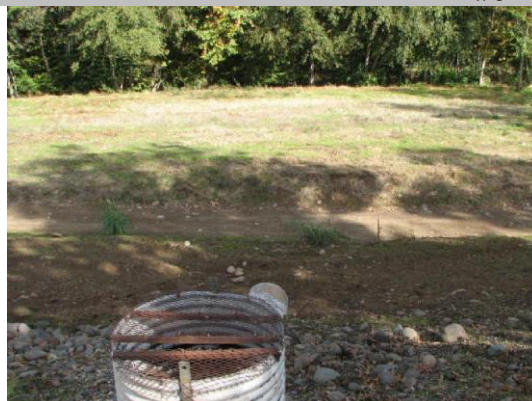
Photo 1 of 3 : UCIP_SP_2021_58287_68429.jpg

CM riser on WS shoulder-missing slide gate.

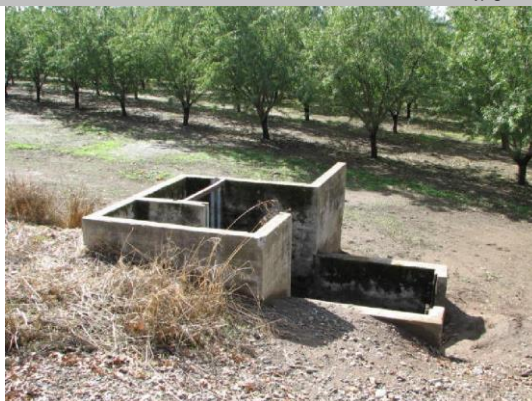
Photo 2 of 3 : UCIP_SP_2021_58287_68433.jpg

Distribution box on LS toe. Missing slide gate at pipe entrance.

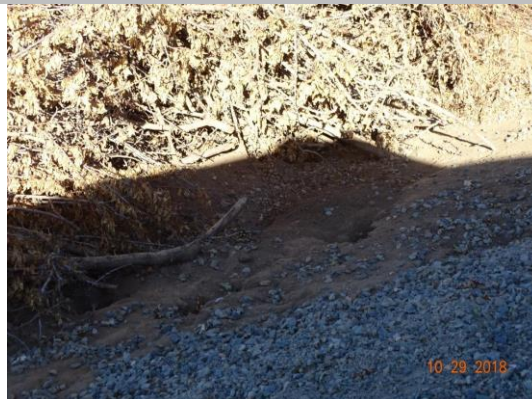
Photo 1 of 1 : SP_2021_MA0005_197_71_20210224_00017.jpg

View of the rodent holes along the landside slope.

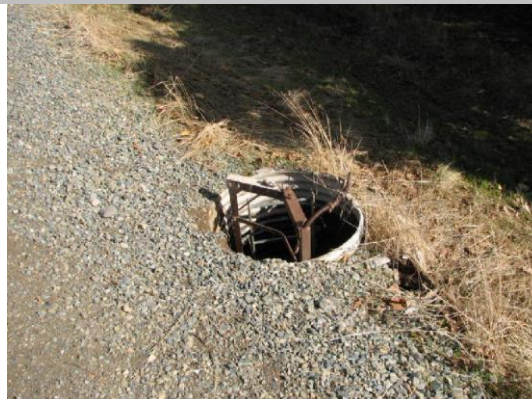
Photo 1 of 3 : UCIP_SP_2021_58290_68465.jpg

Broken slide gate in CM riser on WS slope.

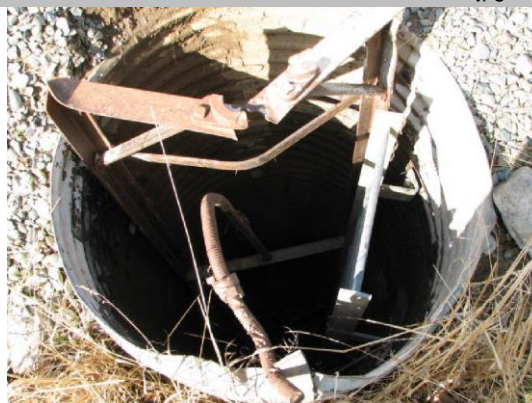
Photo 3 of 3 : UCIP_SP_2021_58290_68463.jpg

Broken slide gate in CM riser on WS slope.

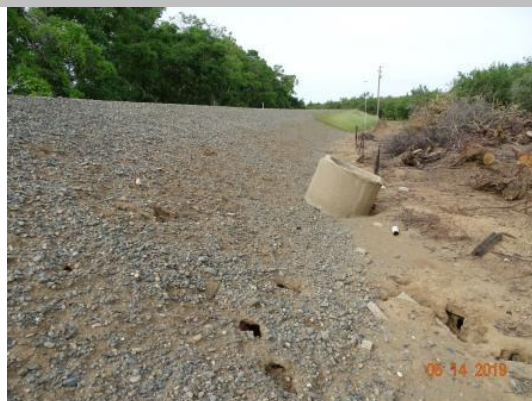
Photo 1 of 1 : SP_2021_MA0005_197_9_20210224_00004.jpg

View of the animal burrows on the landside slope. Spring 2019.
