# Flood Control Project Maintenance Levee Inspections LMA District Cover Sheet

## Sutter Maintenance Yard Maintenance Area 0005

**Flood Control Project Maintenance  
Levee Inspections  
Unit Cover Sheet**

Waterway			Bank	Unit Miles
Unit No. 01 Butte Creek			Left	15.08
	Spring (March - May)	Summer (June - August)	(September - November) Fall	Winter (December - February)
Unit Maintenance Rating (Fall Only)				
Date of Inspection	3/23/2022 - 3/23/2022			
DWR Inspector	Makar Sokol			
Accompanied By	Shawn Freitag DWR Sutter Yard

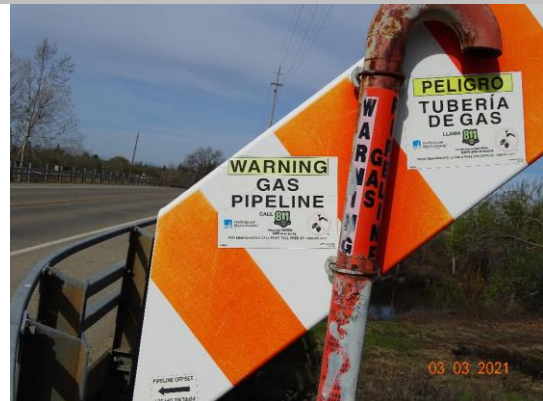
Photo 3 of 3 : UCIP\_SP\_2022\_64992\_97292.jpg

Comment Code						
Inspector Comment						
FS_ID:64992 DS_ID:1613 EP_NO: N/A Repair Type: Non-Urgent Crossing Status: Found UCIP Comments: 03/03/2021 Record updated from No Action Needed to Non-Urgent. No inspection records were available to determine status of line through the levee. No permit has been found authorizing this pipe through the levee. Gas line sign installed only on waterside shoulder. Cathodic protection testing point attached to the sign. (O.Yakimov - DWR UCIP) 05/15/2017 Crossing appears to be in good condition. (A. Freitag - DWR Sutter Yard)11/15/2016 Crossing appears to be in good condition. (A. Freitag - DWR Sutter Yard)05/09/2016 Crossing appears to be in good condition. (A. Freitag - DWR Sutter Yard)08/05/2015 Pipeline is located inside of bridge. (A. Freitag - DWR Sutter Yard) 12/08/2014 Same as last inspection. (A. Freitag - DWR Sutter Yard)06/11/2014 Same as last inspection. (A. Freitag - DWR Sutter Yard)11/20/2013 Same as last inspection. (A. Freitag - DWR Sutter Yard)05/29/2013 Same as last inspection. (A. Freitag - DWR Sutter Yard) FIELD_STRUCT_DESC: 7-inch gas line of an unknown material through the levee, 3 feet below the crown. Vent located on the waterside (WS) shoulder. Plans for bridge replacement show the utility crossing under the westbound lane inside the bridge. (Existing bridge replacement authorized under Permit No. 14301, 1986 - Butte County Department of Public Works). [Additional Reference(s): DWR Levee Log, 1990 (HLM 1.50)]. FS Date: 3/3/2021 2:36:42 PM

Water-Side: Contact information on the sign

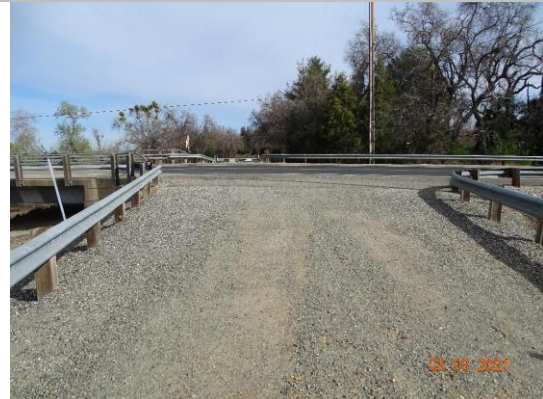
Photo 1 of 3 : UCIP\_SP\_2022\_65002\_97302.jpg

Comment Code						
Inspector Comment						
FS_ID:65002 DS_ID:1640 EP_NO: 13778 Repair Type: Non-Urgent Crossing Status: Not Found UCIP Comments: 03/03/2021 Record updated from No Action Needed to Non-Urgent. Crossing not found. According to description conduit could be located inside the bridge under the east bound lane. (O.Yakimov - DWR UCIP) 05/15/2017 Conduit ran inside of bridge. Not visible from the levee. (A. Freitag - DWR Sutter Yard)11/15/2016 Crossing description says conduit is ran inside of the bridge. (A. Freitag - DWR Sutter Yard)05/09/2016 Unable to locate. (A. Freitag - DWR Sutter Yard)  08/05/2015 Crossing is said to be located inside of the bridge. (A. Freitag - DWR Sutter Yard)12/08/2014 Unable to locate. (A. Freitag - DWR Sutter Yard)06/11/2014 Same as last inspection. (A. Freitag - DWR Sutter Yard)11/20/2013 Same as last inspection. (A. Freitag - DWR Sutter Yard)05/29/2013 Same as last inspection. (A. Freitag - DWR Sutter Yard) FIELD_STRUCT_DESC: 4-inch fiberglass communication conduit through the levee, 4 feet below the crown, not found. Conduit crosses at the downstream side of the bridge. Plans for bridge replacement indicate utilities were relocated inside the bridge under the east bound lane. (4-inch fiber glass duct through both levees authorized under Permit No. 13778, 1984 - Pacific Bell). [Additional Reference(s): DWR Levee Log, 1990 (HLM 1.50)]. FS Date: 3/3/2021 3:07:42 PM

Top of Levee: View of levee crown looking upstream

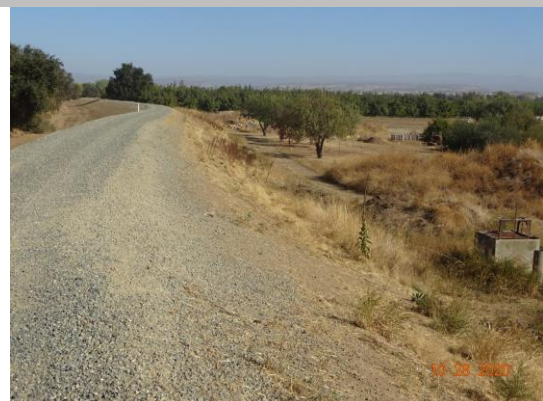
Photo 1 of 1 : SP\_2022\_MA0005\_196\_9\_20220307\_00004.jpg

LM Start	2.54	Rating **	M	Issue No.	9
LM End	2.54	Issue Type +	Ma	Location *	LS
Category	Earthen Levee			GPS Latitude/Longitude	
				Start	End
Item	Erosion / Vehicle Traffic			39.663876 °	39.663876 °
				-121.784014 °	-121.784014 °
DWR ID	DWR_MA0005_01_f_2012_9				
Comment Code					
E6 : Repair the levee slope damaged by vehicle traffic and prevent access where possible.					
Inspector Comment

View of the damaged landside slope due to vehicle traffic. Fall 2020.

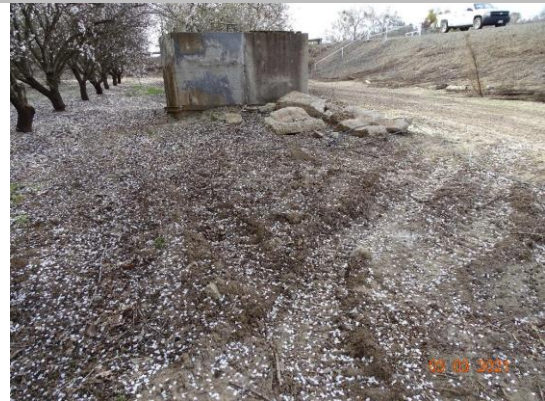
Photo 3 of 3 : UCIP\_SP\_2022\_65178\_97383.jpg

Land-Side: Backfilled excavation near distribution box

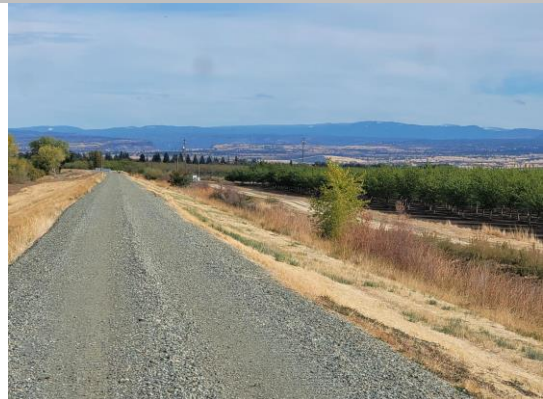
Photo 1 of 1 : SP\_2022\_MA0005\_196\_55\_20220307\_00018.jpg

View of the irrigation ditch along the landside toe. Fall 2021.

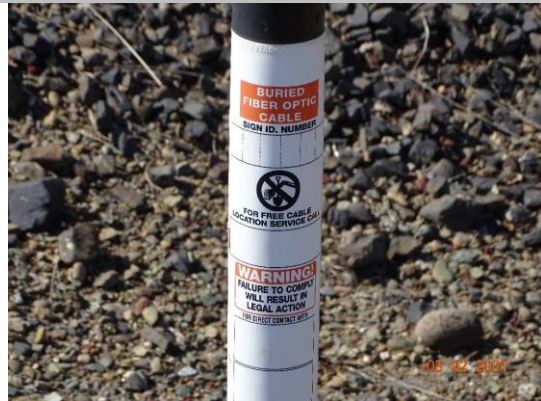
Photo 3 of 3 : UCIP\_SP\_2022\_65356\_97495.jpg

Water-Side: No contact information on marker installed at levee toe

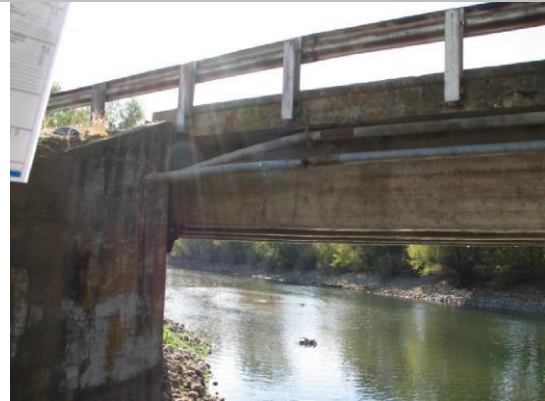
Photo 2 of 2 : UCIP\_SP\_2022\_65368\_67955.jpg

4.5-inch pipes attached to upstream side of bridge.

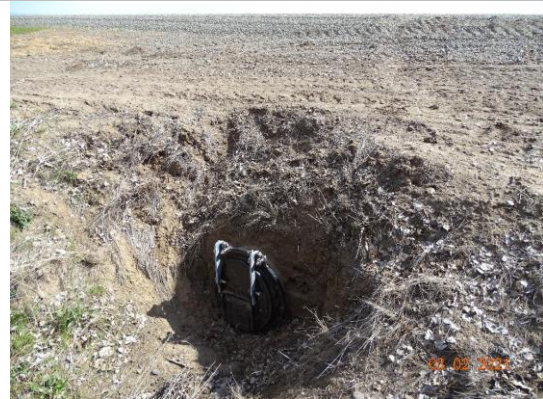
Photo 3 of 3 : UCIP\_SP\_2022\_65470\_97558.jpg

Water-Side: Pipe end with new flap gate installed

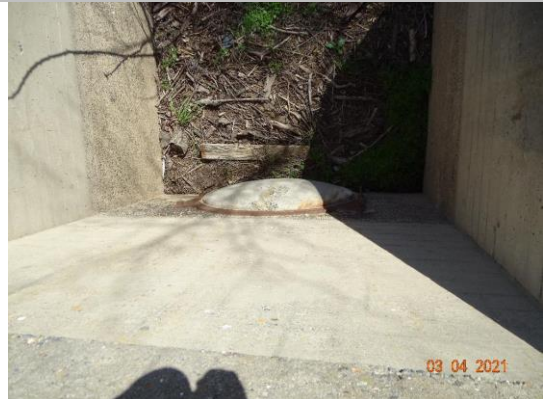
Photo 3 of 3 : UCIP\_SP\_2022\_66376\_98807.jpg

Water-Side: View of headwall and abandoned pipe at levee toe

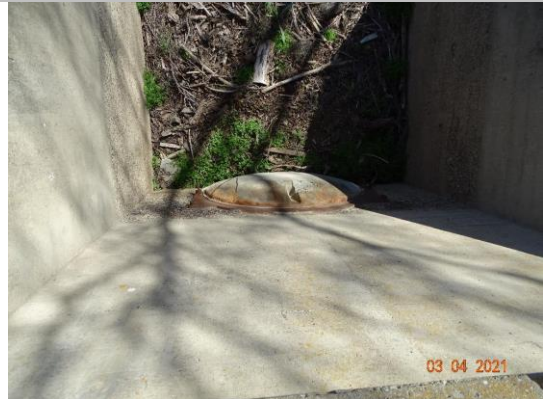
Photo 3 of 3 : UCIP\_SP\_2022\_66377\_98817.jpg

Water-Side: View of headwall and abandoned pipe at levee toe

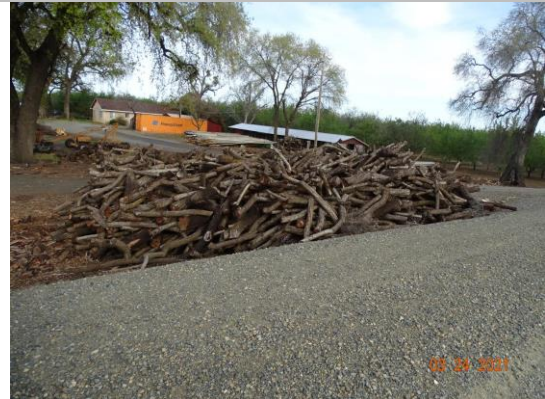
Photo 1 of 1 : SP\_2022\_MA0005\_197\_50\_20220307\_00011.jpg

View of the pile of firewood at the landside toe. Spring 2021.

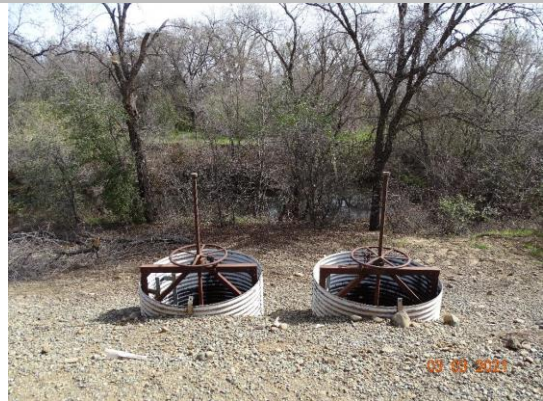
Photo 3 of 3 : UCIP\_SP\_2022\_67144\_99109.jpg

Water-Side: View of levee slope looking from crown. CMP riser needs a top cover
