**Flood Control Project Maintenance
Levee Inspections
LMA District Cover Sheet**

**Flood Control Project Maintenance
Levee Inspections
Unit Cover Sheet**

Waterway			Bank	Unit Miles
Unit No. 01 Butte Creek			Left	15.08
	Spring (March - May)	Summer (June - August)	(September - November) Fall	Winter (December - February)
Unit Maintenance Rating (Fall Only)				
Date of Inspection	4/26/2023 - 4/26/2023			
DWR Inspector	Makar Sokol			
Accompanied By	Shawn Freitag DWR Sutter Yard

Levee Inspection Report By Mile - Spring 2023

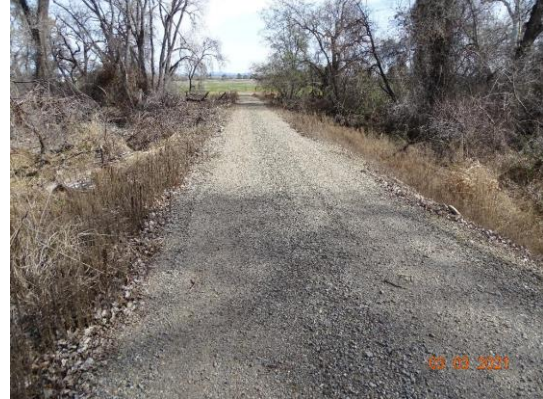
Photo 1 of 3 : UCIP_SP_2023_64542_96648.jpg

Comment Code						
Inspector Comment						
DS_ID:1609 FS_ID:64542 EP_NO: N/A Repair Type: Non-Urgent EVAL Issue: 4b, Safety Issue Crossing Status: Found UCIP Comments: 03/03/2021 Crossing changed from No Action Needed to Non-Urgent. Missing cover on 48-inch riser on waterside slope. No permit found authorizing this crossing. Legacy irrigation pipe. (O.Yakimov - UCIP DWR)05/15/2017 Crossing appears to be in good condition. Pipe has been selected for to be internally cleanded and inspected as part of the DMP project. (A. Freitag - DWR Sutter Yard)11/15/2016 Crossing appears to be in good condition. (A. Freitag - DWR Sutter Yard)05/09/2016 Crossing appeaers to be in good condition. (A. Freitag - DWR Sutter Yard)08/05/2015 Crossing appears in good condition. No noticeable issues to report. (A. Freitag - DWR Sutter Yard)12/08/2014 Same as last inspection. (A. Freitag - DWR Sutter Yard)06/11/2014 Same as last inspection. (A. Freitag - DWR Sutter Yard)11/20/2013 Same as last inspection. (A. Freitag - DWR Sutter Yard)05/29/2013 Same as last inspection. (A. Freitag - DWR Sutter Yard) FIELD_STRUCT_DESC: 36-inch corrugated metal irrigation pipe through the levee, 8 feet below the crown. Slide gate in a 48-inch corrugated metal riser on the waterside (WS) slope. Concrete "U" shaped headwalls at the toe of each slope. [Additional Reference(s): DWR Levee Log, 1990 (HLM 0.07). USACE Sacramento O&M Manual, Unit 516, April 1960, Revised 3 February 2011, (Station 5+92), listed as 36-inch pipe. FS Date: 3/3/2021 9:12:51 AM

Top of Levee: View of crown at the crossing.

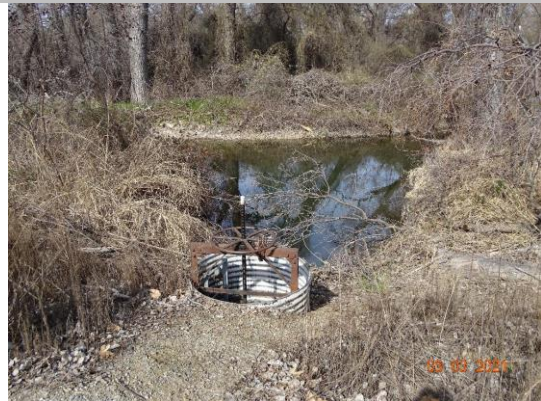
Photo 3 of 3 : UCIP_SP_2023_64542_96650.jpg

Water-Side: View of levee slope at the crossing. Slide gate in CMP riser

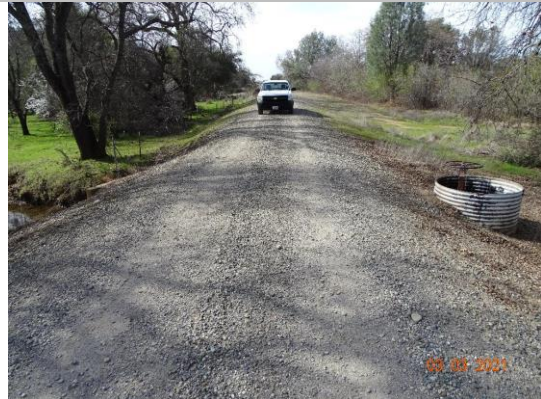
Photo 1 of 3 : UCIP_SP_2023_64543_96659.jpg

DS_ID:1610
FS_ID:64543
EP_NO: N/A
Repair Type: Non-Urgent
EVAL Issue: 4b, Safety Issue
Crossing Status: Found
UCIP Comments: 03/03/2021 Record updated from No Action Needed to Non-Urgent. Missing cover on 36-inch CMP riser on waterside slope. No permit has been identified authorizing pipe. DMP internal video inspection has not found pipe integrity issues. LOF of crossing is less or equal to 4.0. Recommend next video inspection in 5 years.
(O.Yakimov - DWR UCIP)
05/15/2017 Crossing appears to be in good condition. Pipe has been selected to be internally cleaned and inspected as part of the DMP project. (A. Freitag - DWR Sutter Yard)11/15/2016 Crossing appears to be in good condition. (A. Freitag - DWR Sutter Yard)05/09/2016 Crossing appears to be in good condition. (A. Freitag - DWR Sutter Yard)08/05/2015 Crossing appears in good condition. No noticeable issues to report. (A. Freitag - DWR Sutter Yard)12/08/2014 Same as last inspection. (A. Freitag - DWR Sutter Yard)06/11/2014 Same as last inspection. (A. Freitag - DWR Sutter Yard)11/20/2013 Same as last inspection. (A. Freitag - DWR Sutter Yard)05/29/2013 Same as last inspection. (A. Freitag - DWR Sutter Yard)

Top of Levee: View of levee crown looking downstream

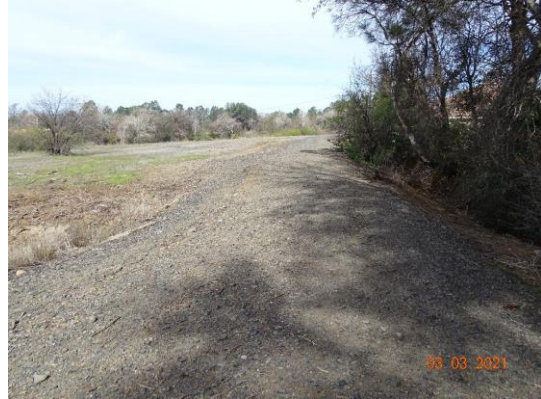
Photo 1 of 3 : UCIP_SP_2023_64548_96679.jpg

Comment Code						
Inspector Comment						
DS_ID:1611 FS_ID:64548 EP_NO: N/A Repair Type: Non-Urgent EVAL Issue: Crossing Status: Found UCIP Comments: 03/03/2021 Record updated from No Action Needed to Non-Urgent. No permit has been identified authorizing pipe. Pipe has been CIPP lined. (O.Yakimov - DWR UCIP) 05/15/2017 Crossing appears to be in good condition. Pipe has been selected to be internally cleaned and inspected as part of the DMP project. (A. Freitag - DWR Sutter Yard)11/15/2016 Crossing appears to be in good condition. (A. Freitag - DWR Sutter Yard)05/09/2016 Crossing appears to be in good condition. (A. Freitag - DWR Sutter Yard)08/05/2015 Crossing appears in good condition. No noticeable issues to report. (A. Freitag - DWR Sutter Yard)12/08/2014 Same as last inspection. (A. Freitag - DWR Sutter Yard)06/11/2014 Same as last inspection. (A. Freitag - DWR Sutter Yard)11/20/2013 Same as last inspection. (A. Freitag - DWR Sutter Yard)05/29/2013 Same as last inspection. (A. Freitag - DWR Sutter Yard) FIELD_STRUCT_DESC: 24-inch CIPP-lined corrugated metal drainage pipe through the levee, 6 feet below the crown. Flap gate on the waterside (WS). Concrete "U" shaped headwalls at the toe of the landside (LS) and the waterside (WS) slopes. [Additional Reference(s): DWR Levee Log, 1990 (HLM 0.60).USACE Sacramento O&M Manual, Unit 516, April 1960, Revised 3 February 2011, (Station 205+60), listed as 24-inch pipe]. FS Date: 3/3/2021 10:15:11 AM

Top of Levee: View of levee crown looking downstream

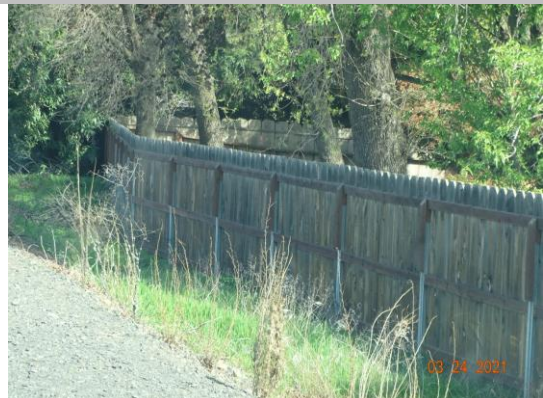
Photo 1 of 1 : SP_2023_MA0005_196_49_20230417_00014.jpg

View of the wood plank fence at the landside toe. Spring 2021.

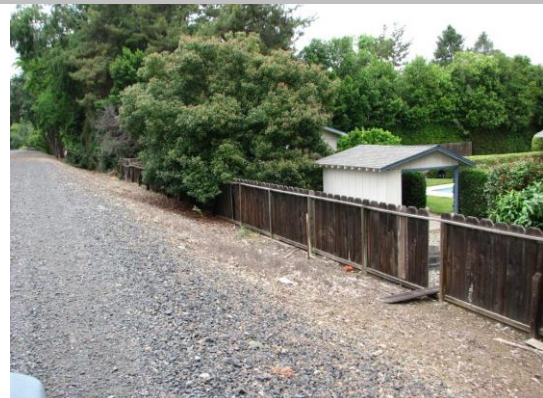
Photo 1 of 1 : SP_2023_MA0005_196_42_20230417_00011.jpg

View of the wood plank fence at the landside toe.

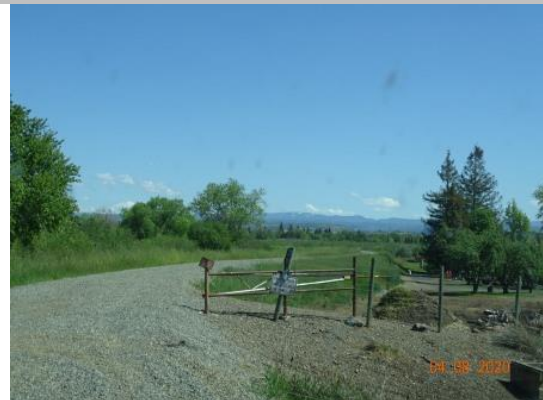
Photo 1 of 1 : SP_2023_MA0005_196_10_20230417_00004.jpg

LM Start	2.09	Rating **	M	Issue No.	10
LM End	2.09	Issue Type +	En	Location *	LS
Category	Earthen Levee			GPS Latitude/Longitude	
				Start	End
Item	Access Gates			39.670112°	39.670112°
				-121.782012°	-121.782012°
DWR ID	DWR_MA0005_01_s_2016_10				
Comment Code					
AG : Access Gates					
Inspector Comment					
No permit was found for the gate.

View of the unpermitted gate. Spring 2020.

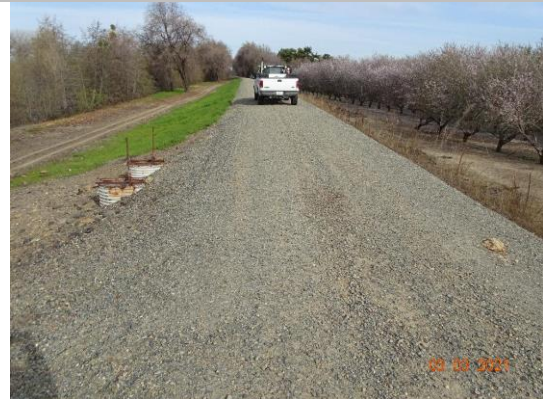
Photo 1 of 3 : UCIP_SP_2023_65178_97384.jpg

Comment Code						
Inspector Comment						
DS_ID:1616 FS_ID:65178 EP_NO: N/A Repair Type: Non-Urgent EVAL Issue: Crossing Status: Found UCIP Comments: 03/03/2021 Record remains Non-Urgent. Excavation on landside near concrete distribution box has been backfilled. No permit has been identified authorizing pipe. (O.Yakimov - DWR UCIP) 06/05/2019 No issues recorded during inspection. (O.Yakimov - DWR UCIP) 05/15/2017 Crossing appears to be in good condition. LS inlet is located in the Distribution box on the LS toe. This is an overflow pipe used to regulate water levels in side the box. Pipe has been selected to be internally cleaned and inspected as part fo the DMP project. (A. Freitag - DWR Sutter Yard)11/15/2016 Crossing appears to be in good condition. (A. Freitag - DWR Sutter Yard)05/09/2016 Crossing appears to be in good condition. (A. Freitag - DWR Sutter Yard)08/05/2015 WS pipe end is being overgrown by trees and other vegetation. Needs to be cleared back. (A. Freitag - DWR Sutter Yard)12/08/2014 Same as last inspection. (A. Freitag - DWR Sutter Yard)06/11/2014 Same as last inspection. (A. Freitag - DWR Sutter Yard)11/20/2013 Same as last inspection. (A. Freitag - DWR Sutter Yard)05/29/2013 Same as last inspection. (A. Freitag - DWR Sutter Yard) FIELD_STRUCT_DESC: 24-inch corrugated metal drainage pipe through the levee, 12.0 feet below the crown. Slide gate in a corrugated metal riser on the waterside (WS) slope. Flap gate on the WS toe. Inlet on the landside (LS) toe. [Additional Reference(s): DWR Levee Log, 1990 (HLM 3.95). USACE Sacramento O&M Manual, Unit 516, April 1960, Revised 3 February 2011, (381+36), listed as 24-inch pipe]. FS Date: 3/3/2021 3:22:22 PM

Top of Levee: View of levee crown looking upstream

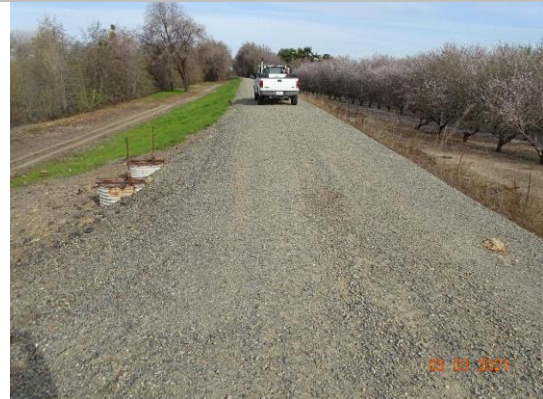
Photo 1 of 3 : UCIP_SP_2023_65180_97393.jpg

DS_ID:1617
FS_ID:65180
EP_NO: N/A
Repair Type: Non-Urgent
EVAL Issue:
Crossing Status: Found
UCIP Comments: 03/03/2021 Record remains Non-Urgent. No permit has been identified authorizing pipe. (O.Yakimov - DWR UCIP) 06/05/2019 No issues recorded during inspection. (O.Yakimov - DWR UCIP)05/15/2017 Crossing appears to be in good condition. (A. Freitag - DWR Sutter Yard)11/15/2016 Crossing appears to be in good condition. (A. Freitag - DWR Sutter Yard)05/09/2016 Crossing appears to be in good condition. (A. Freitag - DWR Sutter Yard)08/05/2015 Crossing appears in good condition. No noticeable issues to report. (A. Freitag - DWR Sutter Yard)12/08/2014 Same as last inspection. (A. Freitag - DWR Sutter Yard)06/11/2014 Same as last inspection. (A. Freitag - DWR Sutter Yard)11/20/2013 Same as last inspection. (A. Freitag - DWR Sutter Yard)05/29/2013 Same as last inspection. (A. Freitag - DWR Sutter Yard)

FIELD_STRUCT_DESC: 24-inch corrugated metal irrigation siphon pipe through the levee, 16.5 feet below the crown. Slide gate in corrugated metal riser on the waterside (WS) slope. Pipe appears to be currently used for irrigation purposes. Pipe penetrates both levees and goes under Butte Creek channel at angle. 4-foot by 8-foot concrete distribution box on the landside (LS), 40 feet from the LS toe. (Replacement a portion of existing 24-inch CMP pipe with class III 24-inch reinforced concrete pipe (RCP) under Butte Creek between levee toes with a cleanout installed in the center of Butte Creek authorized under Permit No. 4064, 1962 - Durham Mutual WaterCompany).
[Additional Reference(s): DWR Levee Log, (HLM 3.95). USACE Sacramento O&M Manual, Unit 516, April 1960, Revised 3 February 2011, (381+42), listed as 24-inch pipe. USACE As-Built Drawing No. 50-4-3367, upstream of Station 227+55, Sheets 2 and 7, April 1958, pipe varies in size: 24-inch pipe (right bank), 24-inch through Butte Creek, and 3-foot by 3-foot (36-inch by 36-inch) culvert (left bank)].

Top of Levee: View of levee crown looking upstream

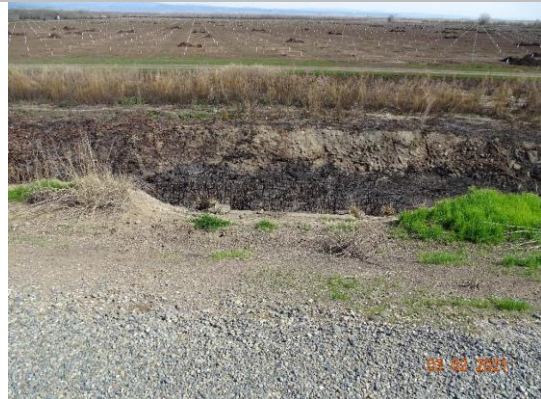
Photo 1 of 3 : UCIP_SP_2023_65267_97442.jpg

DS_ID:1620
FS_ID:65267
EP_NO: N/A
Repair Type: Non-Urgent
EVAL Issue: 4b, Safety Issue
Crossing Status: Found
UCIP Comments: 03/02/2021 Record remains Non-Urgent. Missing CMP cover on waterside slope - possible fall hazard. No permit has been identified authorizing pipe. Slide gate in CMP riser closed, crossing doesn't look abandoned. DMP internal video inspection has found pipe integrity issues. LOF of crossing is between 4.1 and 5. Crossing will be monitored until funding becomes available for rehabilitation. (O.Yakimov - DWR UCIP)
05/23/2019 (O. Magana - DWR UCIP)05/15/2017 Abandoned and needs to be done properly. A sink hole formed in the WS toe road and revealed the location of the WS pipe end. Sink hole will need to be repaired before the next high water season but the pipe has been selected to be internally cleaned and camera inspected as part of the DMP project so it will have needed to be excavated along the WS end anyways. (A. Freitag - DWR Sutter Yard)11/15/2016 Abandoned. Needs cover for the standpipe. (A. Freitag - DWR Sutter Yard)05/09/2016 Abandoned pipe. Needs a cover for the standpipe. (A. Freitag - DWR Sutter Yard)08/05/2015 Abandoned crossing. Covers need to be made for tops of standpipes to prevent falls. (A. Freitag - DWR Sutter Yard)12/08/2014 Same as last inspection. (A. Freitag - DWR Sutter Yard)06/11/2014 Same as last inspection. (A. Freitag - DWR Sutter Yard)11/19/2013 Same as last inspection. (A. Freitag - DWR Sutter Yard)05/29/2013 Same as last inspection. Land owner said pipes are abandoned and no longer used. Covers should be made for top of standpipe to prevent falls. Pipes should be properly abandoned. (A. Freitag - DWR Sutter Yard)10/30/2012 Pipe 1/2 filled with soil at slide gate end. (W. Wylie - DWR UCIP)

Land-Side: View of levee slope looking from crown

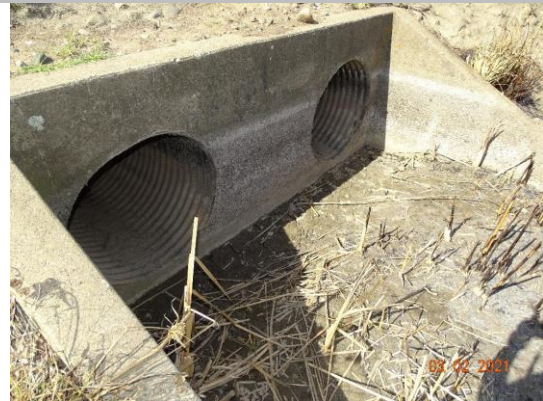
Photo 3 of 3 : UCIP_SP_2023_65267_97445.jpg

Land-Side: Headwall and CMP pipe at levee toe

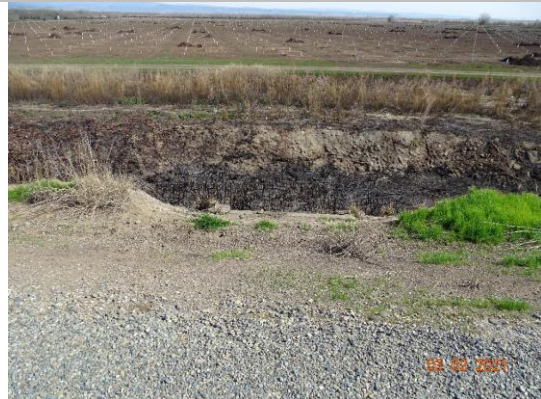
Photo 1 of 3 : UCIP_SP_2023_65271_97449.jpg

DS_ID:1768
FS_ID:65271
EP_NO: N/A
Repair Type: Urgent
EVAL Issue: 2b, Levee Integrity
Crossing Status: Found
UCIP Comments: 03/02/2021 Record updated from Non-Urgent to Urgent. Sinkhole 4-feet in diameter and 2-feet deep located at waterside toe in pipe alignment. Missing CMP cover on waterside slope - possible fall hazard. No permit has been identified authorizing pipe. Slide gate in CMP riser closed, crossing doesn't look abandoned. (O.Yakimov - DWR UCIP)
05/23/2019 (O. Magana - DWR UCIP)05/15/2017 Abandoned and needs to be done properly. A sink hole formed in the WS toe road and revealed the location of the WS pipe end. Sink hole will need to be repaired before the next high water season but the pipe has been selected to be internally cleaned and camera inspected as part of the DMP project so it will have needed to be excavated along the WS end anyways. (A. Freitag - DWR Sutter Yard)11/15/2016 Abandoned. Needs standpipe cover. (A. Freitag - DWR Sutter Yard)05/09/2016 Abandoned pipe. Needs a cover for standpipe. (A. Freitag - DWR Sutter Yard)08/05/2015 Abandoned pipes. Need covers made for tops of standpipes to prevent falls. (A. Freitag - DWR Sutter Yard)

Land-Side: View of levee slope looking from crown

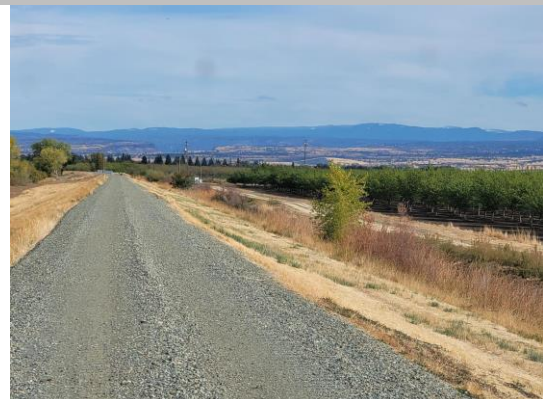
Photo 1 of 1 : SP_2023_MA0005_196_55_20230417_00016.jpg

View of the irrigation ditch along the landside toe. Fall 2021.

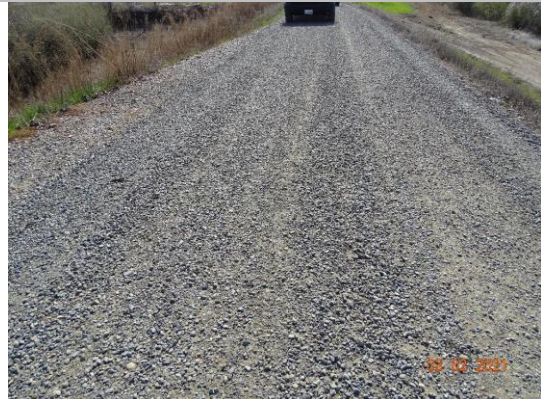
Photo 1 of 3 : UCIP_SP_2023_65315_97469.jpg

Comment Code						
Inspector Comment						
DS_ID:1622 FS_ID:65315 EP_NO: N/A Repair Type: Non-Urgent EVAL Issue: Crossing Status: Not Found UCIP Comments: 03/02/2021 Record remains Non-Urgent. Crossing not found. Geophysical results did not confirm presence of pipe through levee. Record will remain in UCIP's inspection records until future Levee Improvement Project can confirm no crossing was found through the levee. No permit has been identified authorizing pipe. (O.Yakimov - DWR UCIP) 05/15/2017 Unable to locate. (A. Freitag - DWR Sutter Yard) 11/15/2016 Unable to locate. The concrete fill in the LS toe channel appears to just be erosion protection. (A. Freitag - DWR Sutter Yard) 08/05/2015 Unable to locate. (A. Freitag - DWR Sutter Yard) 12/08/2014 Same as last inspection. (A. Freitag - DWR Sutter Yard) 06/11/2014 Same as last inspection. (A. Freitag - DWR Sutter Yard) 11/19/2013 Same as last inspection. (A. Freitag - DWR Sutter Yard) 05/29/2013 Same as last inspection. (A. Freitag - DWR Sutter Yard) FIELD_STRUCT_DESC: 18-inch corrugated metal drainage pipe through the levee, 15 feet below the crown, indicator found. Concrete headwall and flap gate on the waterside (WS). Concrete fill in channel on the landside (LS) toe is a good indicator of the pipe location. [Additional Reference(s): DWR Levee Log, 1990 (HLM 5.85). USACE As-Built Drawing No. 50-04-3367, Sheet 8, just upstream of Station 480+50, July 22, 1957, listed as 18-inch pipe]. FS Date: 3/2/2021 9:39:12 AM

Top of Levee: View of levee crown looking downstream

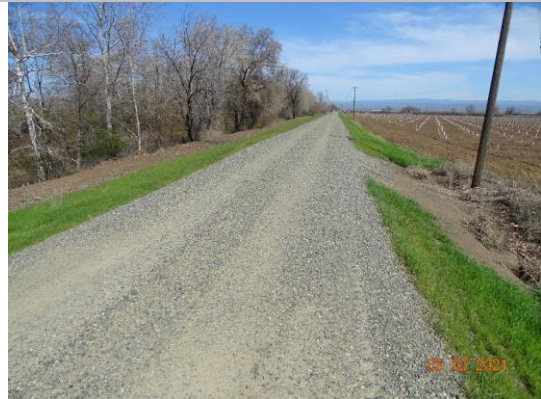
Photo 1 of 3 : UCIP_SP_2023_65433_97531.jpg

DS_ID:1628
FS_ID:65433
EP_NO: N/A
Repair Type: Non-Urgent
EVAL Issue:
Crossing Status: Found
UCIP Comments: 03/02/2021 Record remains Non-Urgent. No permit has been identified authorizing pipe. Crossing appears abandoned. Headwall on landside and pipe inlet have been cleared from dirt. Pipe end is still burried in soil on waterside and not found. DMP internal video inspection has not found pipe integrity issues. LOF of crossing is less or equal to 4.0. Recommend next video inspection in 5 years.
(O.Yakimov - DWR UCIP)
05/16/2017 LS inlet is almost completely buried. Nothing visible on the WS. Pipe has been selected to be internally cleaned and inspected as part of the DMP project. (A. Freitag - DWR Sutter Yard)11/15/2016 Appears abandoned and should be done so properly. (A. Freitag - DWR Sutter Yard)05/11/2016 Possibly an abandoned crossing. LS inlet was over 50% buried and nothing was found on the WS. (A. Freitag - DWR Sutter Yard)08/04/2015 LS pipe end filled about 50% with soil and WS pipe end is buried. (A. Freitag - DWR Sutter Yard)12/08/2014 Same as last inspection. (A. Freitag - DWR Sutter Yard)06/11/2014 Same as last inspection. (A. Freitag - DWR Sutter Yard)11/19/2013 Same as last inspection. (A. Freitag - DWR Sutter Yard)05/29/2013 Same as last inspection. (A. Freitag - DWR Sutter Yard)10/30/2012 Pipe filled with soil and outlet/appurtances are burried. (W. Wylie - DWR UCIP)

Top of Levee: View of levee crown looking upstream

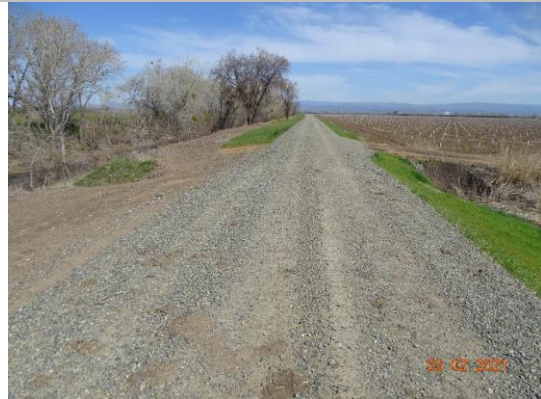
Photo 1 of 3 : UCIP_SP_2023_65470_97555.jpg

Comment Code					
Inspector Comment					
DS_ID:1629 FS_ID:65470 EP_NO: N/A Repair Type: Non-Urgent EVAL Issue: Crossing Status: Found UCIP Comments: 03/02/2021 Record remains Non-Urgent. No permit has been identified authorizing pipe. Crossing has been CIPP-lined, new flap gate installed on waterside. (O.Yakimov - DWR UCIP) 05/16/2017 LS inlet is half blocked off by flash boards and sediment. WS flap gate is blocked closed by sediment. Pipe has been selected to be internally cleaned and inspected as part of the DMP project. (A. Freitag - DWR Sutter Yard)11/15/2016 LS inlet was unburied and entire pipe is about 25% full of soil. WS flapgate was shut and partially buried. (A. Freitag - DWR Sutter Yard)05/11/2016 WS flap gate was about 50% buried and LS was 100% buried. Appears to be an abandoned crossing. (A. Freitag - DWR Sutter Yard)08/04/2015 WS flap gate is partially buried by soil and being overgrown with vegetation. LS pipe end was underwater and suspected to still be completely buried with soil. (A. Freitag - DWR Sutter Yard)12/08/2014 Same as last inspection. (A. Freitag - DWR Sutter Yard)06/11/2014 Same as last inspection. (A. Freitag - DWR Sutter Yard)11/19/2013 Same as last inspection. (A. Freitag - DWR Sutter Yard)05/29/2013 Same as last inspection. (A. Freitag - DWR Sutter Yard)10/30/2012 Pipe filled with soil. (W. Wylie - DWR UCIP) FIELD_STRUCT_DESC: 24-inch CIPP-lined corrugated metal drainage pipe through the levee, 9.3 feet below the crown. Flap gate on the waterside (WS). Concrete headwalls at the landside (LS) and the WS toes. [Additional Reference(s): DWR Levee Log, 1990 (HLM 8.35). USACE Sacramento O&M Manual, Unit 515, April 1955, Revised 28 December 2010, (Station 609+79), listed as 24-inch pipe. USACE As-Built Drawing No. 50-04-2637, Sheet 3, Station 609+78.5, 7 January 1953]. FS Date: 3/2/2021 3:05:29 PM

Top of Levee: View of levee crown looking upstream

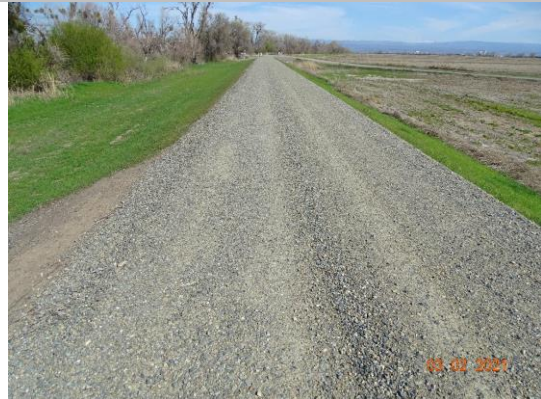
Photo 1 of 3 : UCIP_SP_2023_65495_97570.jpg

Comment Code						
Inspector Comment						
DS_ID:1630 FS_ID:65495 EP_NO: N/A Repair Type: Non-Urgent EVAL Issue: Crossing Status: Indicator Found UCIP Comments: 03/02/2021 Record updated from No Action Needed to Non-Urgent. Crossing not found. Geophysical study indicates possible presence of pipe through levee. Coordinates of crossing have been updated to match geophysical report. Location of this crossing also confirmed by calculating Station Number relatively to upstream and downstream crossings. Owner needs to coordinate with the CVFPB to remove or abandon crossing according to Title 23 requirements. No permit has been identified authorizing pipe. (O.Yakimov - DWR UCIP) 06/13/2019 DSID 1744 is duplicate of DSID 1630. This record should not be used for 24-inch pipe updates -- refer to DSID 1744 for updates. (O. Magana - DWR UCIP) 05/16/2017 Unable to locate. (A. Freitag - DWR Sutter Yard) 11/15/2016 Unable to locate. (A. Freitag - DWR Sutter Yard) 05/11/2016 Unable to locate. (A. Freitag - DWR Sutter Yard) 08/04/2015 Unable to locate. (A. Freitag - DWR Sutter Yard) 12/08/2014 Unable to locate. (A. Freitag - DWR Sutter Yard) 06/11/2014 Same as last inspection. (A. Freitag - DWR Sutter Yard) 11/19/2013 Unable to locate. (A. Freitag - DWR Sutter Yard) 05/29/2013 Same as last inspection. Unable to locate. (A. Freitag - DWR Sutter Yard) FIELD_STRUCT_DESC: 24-inch drainage pipe of an unknown material through the levee, 9.8 feet below the crown, not found. Flap gate on the waterside (WS). [Additional Reference(s): DWR Levee Log, 1990 (HLM 8.99). USACE Sacramento O&M Manual, Unit 515, April 1955, Revised 28 December 2010, (Station 644+27), listed as 24-inch pipe. USACE As-Built Drawing No. 50-04-2637, Sheet 3, Station 644+27, 7 January 1953]. FS Date: 3/2/2021 3:36:08 PM

Top of Levee: View of levee crown looking upstream

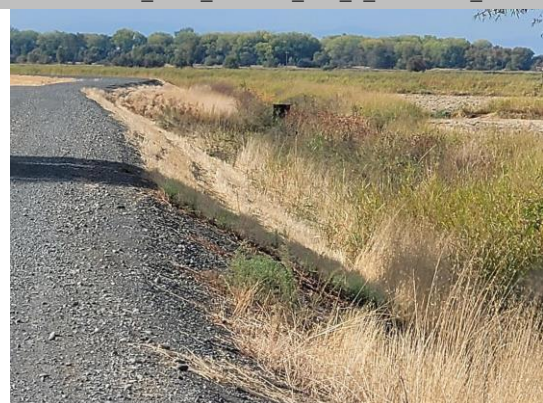
Photo 1 of 1 : SP_2023_MA0005_197_1_20230417_00001.jpg

View of the agricultural ditch along the landside toe. Fall 2021.

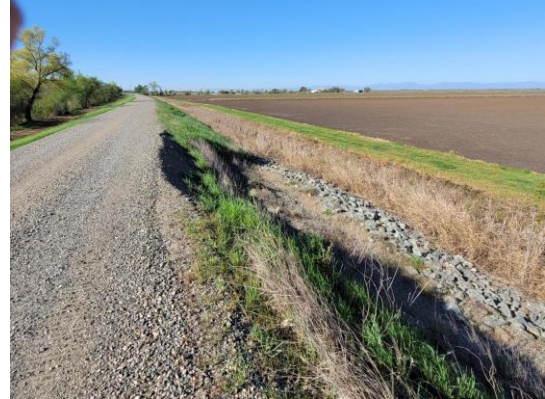
Photo 1 of 1 : SP_2023_MA0005_197_55_20230417_00011.jpg

View of sloughing on the landside slope. Spring 2022.

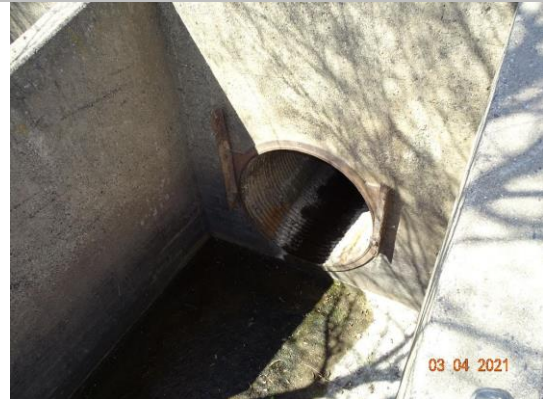
Photo 2 of 3 : UCIP_SP_2023_66081_98386.jpg

Water-Side: Pipe missing flap gate at headwall

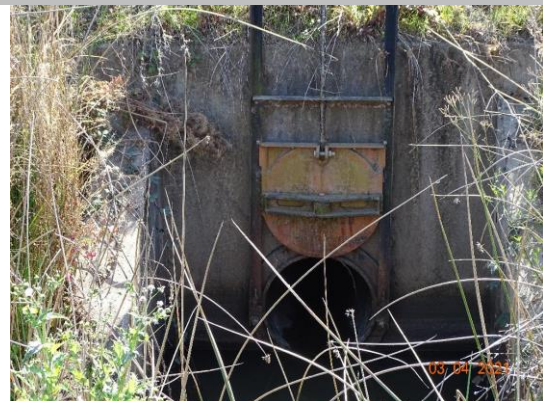
Photo 3 of 3 : UCIP_SP_2023_66081_98388.jpg

Land-Side: Closeup view of slide gate, and pipe end in drainage ditch
150 feet from levee

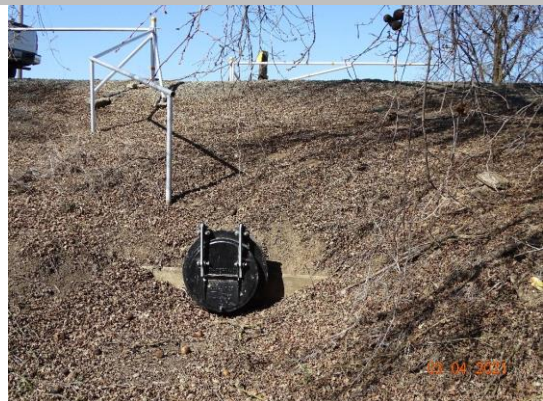
Photo 3 of 3 : UCIP_SP_2023_66463_98879.jpg

Water-Side: New flap gate installed on pipe end

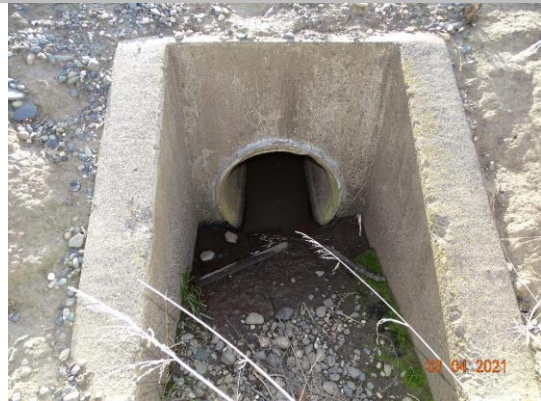
Photo 3 of 3 : UCIP_SP_2023_66671_98959.jpg

Land-Side: CIPP-lined pipe at headwall

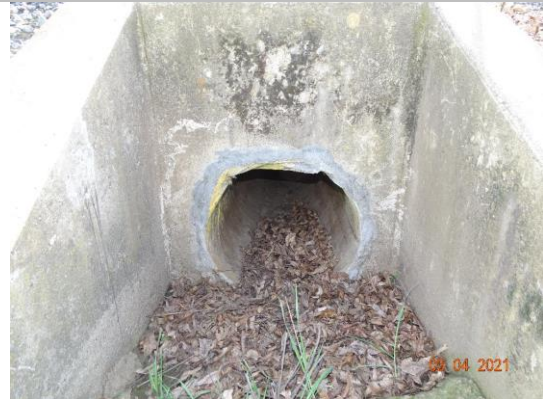
Photo 3 of 3 : UCIP_SP_2023_66673_98973.jpg

Land-Side: CIPP-lined pipe at headwall

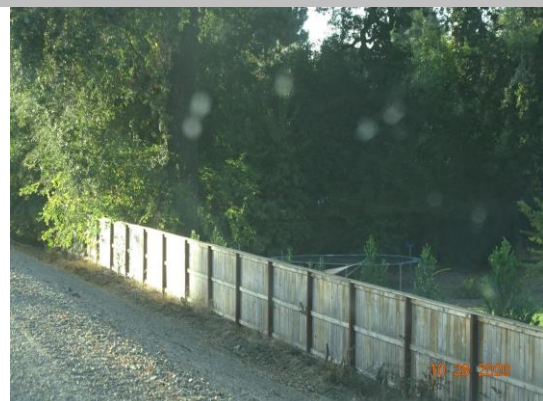
Photo 1 of 1 : SP_2023_MA0005_197_60_20230417_00012.jpg

View of a wooden fence along the landside toe. Fall 2020.

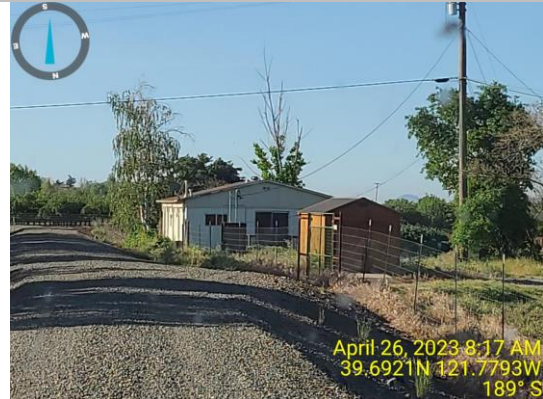
Photo 1 of 1 : SP_2023_MA0005_197_25_20230427_00099.jpg

View of the buildings at the landside toe. Spring 2023.

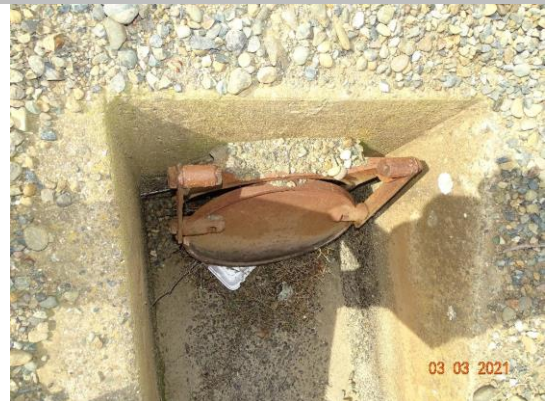
Photo 3 of 3 : UCIP_SP_2023_67139_99904.jpg

Water-Side: Flap gate not properly closed due to debris inside pipe

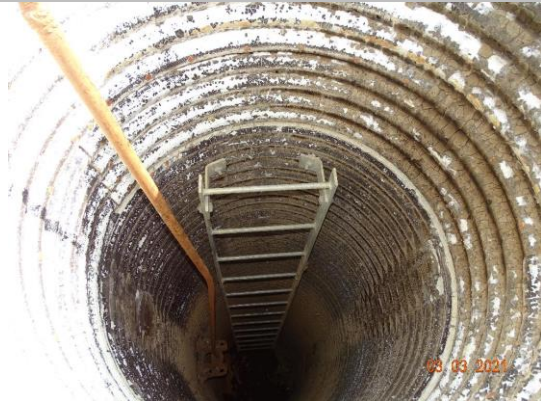
Photo 3 of 3 : UCIP_SP_2023_67143_99106.jpg

Water-Side: View inside of CMP riser. Bent stem

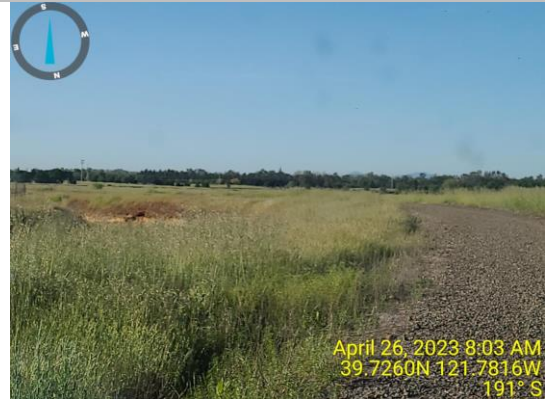
Photo 1 of 1 : SP_2023_MA0005_198_1_20230427_00001.jpg

View of the vegetation along the waterside slope. Spring 2023.
