Flood Control Project Maintenance
Levee Inspections
LMA District Cover Sheet

Sutter Maintenance Yard Maintenance Area 0005

**Flood Control Project Maintenance
Levee Inspections
Unit Cover Sheet**

Waterway			Bank	Unit Miles
Unit No. 01 Butte Creek			Left	15.08
	Spring (March - May)	Summer (June - August)	(September - November) Fall	Winter (December - February)
Unit Maintenance Rating (Fall Only)				
Date of Inspection	4/17/2024 - 4/17/2024			
DWR Inspector	Makar Sokol			
Accompanied By	Shawn Freitag DWR Sutter

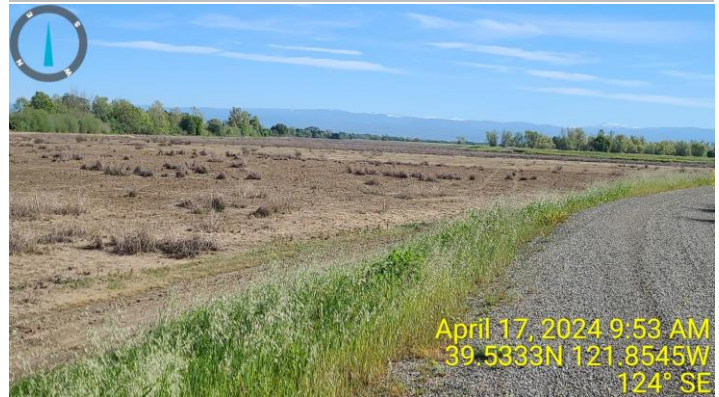
Photo 1 of 1 : SP_2024_MA0005_196_39_20240422_00089.jpg

View of the vegetation along the waterside slope. Spring 2024.

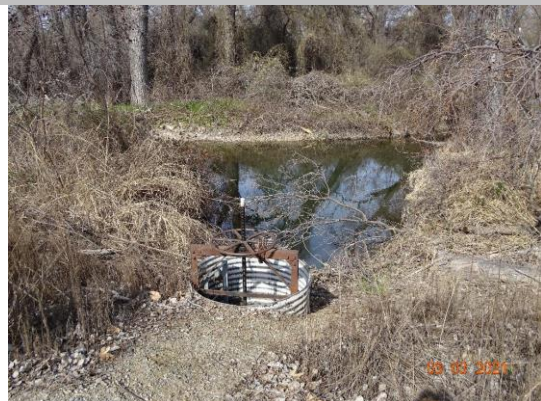
Photo 3 of 3 : UCIP_SP_2024_64542_96650.jpg

Comment Code						
Inspector Comment						
DS_ID:1609 FS_ID:64542 EP_NO: N/A Repair Type: Non-Urgent EVAL Issue: 4b, Safety Issue Crossing Status: Found UCIP Comments: 03/03/2021 Crossing changed from No Action Needed to Non-Urgent. Missing cover on 48-inch riser on waterside slope. No permit found authorizing this crossing. Legacy irrigation pipe. (O.Yakimov - UCIP DWR)05/15/2017 Crossing appears to be in good condition. Pipe has been selected for to be internally cleanded and inspected as part of the DMP project. (A. Freitag - DWR Sutter Yard)11/15/2016 Crossing appears to be in good condition. (A. Freitag - DWR Sutter Yard)05/09/2016 Crossing appeears to be in good condition. (A. Freitag - DWR Sutter Yard)08/05/2015 Crossing appears in good condition. No noticeable issues to report. (A. Freitag - DWR Sutter Yard)12/08/2014 Same as last inspection. (A. Freitag - DWR Sutter Yard)06/11/2014 Same as last inspection. (A. Freitag - DWR Sutter Yard)11/20/2013 Same as last inspection. (A. Freitag - DWR Sutter Yard)05/29/2013 Same as last inspection. (A. Freitag - DWR Sutter Yard) FIELD_STRUCT_DESC: 36-inch corrugated metal irrigation pipe through the levee, 8 feet below the crown. Slide gate in a 48-inch corrugated metal riser on the waterside (WS) slope. Concrete "U" shaped headwalls at the toe of each slope. [Additional Reference(s): DWR Levee Log, 1990 (HLM 0.07). USACE Sacramento O&M Manual, Unit 516, April 1960, Revised 3 February 2011, (Station 5+92), listed as 36-inch pipe. FS Date: 3/3/2021 9:12:51 AM

Water-Side: View of levee slope at the crossing. Slide gate in CMP riser

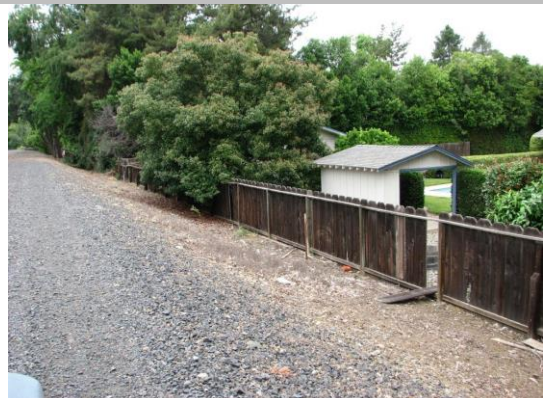
Photo 1 of 1 : SP_2024_MA0005_196_42_20240212_00009.jpg

View of the wood plank fence at the landside toe.

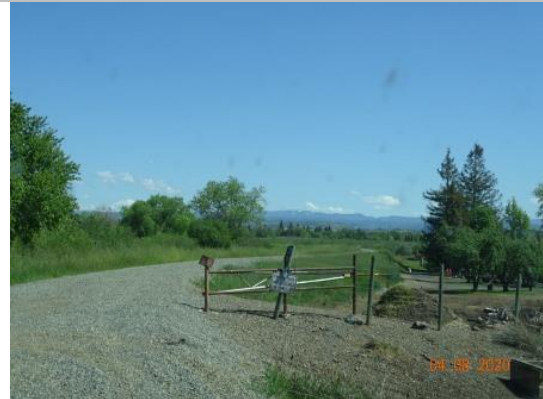
Photo 1 of 1 : SP_2024_MA0005_196_10_20240212_00003.jpg

LM Start	2.09	Rating **	M	Issue No.	10
LM End	2.09	Issue Type +	En	Location *	LS
Category	Earthen Levee			GPS Latitude/Longitude	
				Start	End
Item	Access Gates			39.670112°	39.670112°
				-121.782012°	-121.782012°
DWR ID	DWR_MA0005_01_s_2016_10				
Comment Code					
AG : Access Gates					
Inspector Comment					
No permit was found for the gate.

View of the unpermitted gate. Spring 2020.

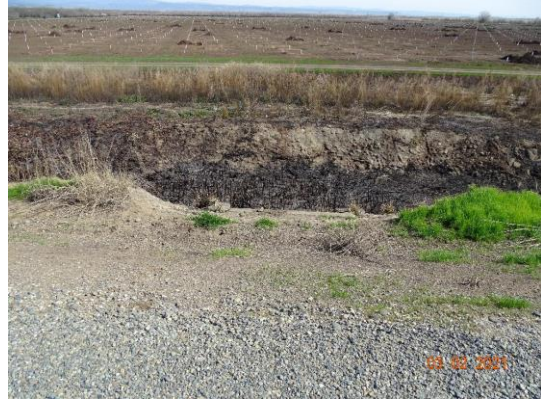
Photo 1 of 3 : UCIP_SP_2024_65271_97449.jpg

DS_ID:1768
FS_ID:65271
EP_NO: N/A
Repair Type: Urgent
EVAL Issue: 2b, Levee Integrity
Crossing Status: Found
UCIP Comments: 03/02/2021 Record updated from Non-Urgent to Urgent. Sinkhole 4-feet in diameter and 2-feet deep located at waterside toe in pipe alignment. Missing CMP cover on waterside slope - possible fall hazard. No permit has been identified authorizing pipe. Slide gate in CMP riser closed, crossing doesn't look abandoned. (O.Yakimov - DWR UCIP)
05/23/2019 (O. Magana - DWR UCIP)05/15/2017 Abandoned and needs to be done properly. A sink hole formed in the WS toe road and revealed the location of the WS pipe end. Sink hole will need to be repaired before the next high water season but the pipe has been selected to be internally cleaned and camera inspected as part of the DMP project so it will have needed to be excavated along the WS end anyways. (A. Freitag - DWR Sutter Yard)11/15/2016 Abandoned. Needs standpipe cover. (A. Freitag - DWR Sutter Yard)05/09/2016 Abandoned pipe. Needs a cover for standpipe. (A. Freitag - DWR Sutter Yard)08/05/2015 Abandoned pipes. Need covers made for tops of standpipes to prevent falls. (A. Freitag - DWR Sutter Yard)

Land-Side: View of levee slope looking from crown

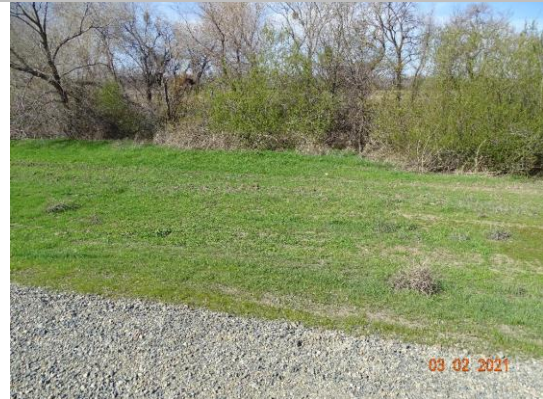
Photo 2 of 3 : UCIP_SP_2024_65744_98030.jpg

Water-Side: View of levee slope looking from crown. Pipe not found

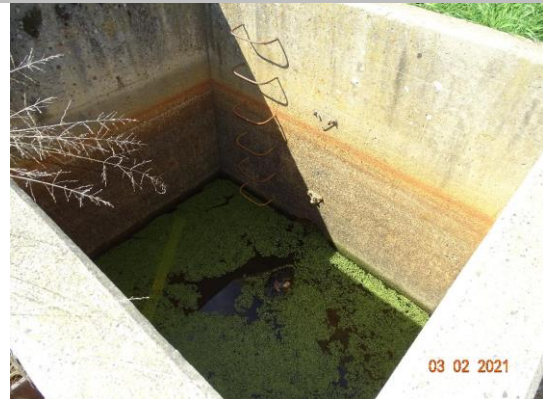
Photo 3 of 3 : UCIP_SP_2024_65744_98032.jpg

Land-Side: Overview of concrete distribution box. Missing slide gate from levee side

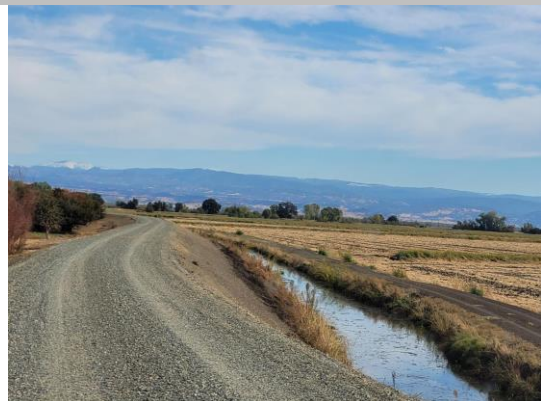
Photo 1 of 1 : SP_2024_MA0005_196_5_20240212_00001.jpg

View of the agricultural ditch along the landside toe. Fall 2021.

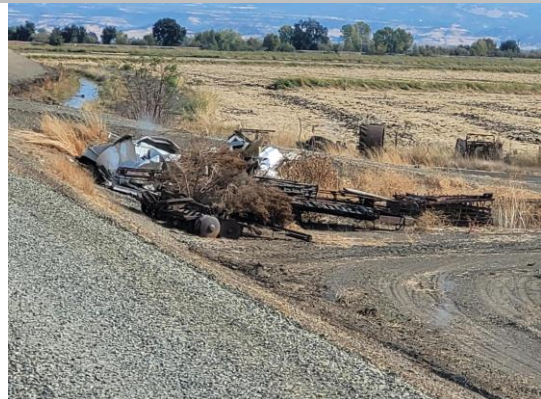
Photo 1 of 1 : SP_2024_MA0005_196_26_20240212_00004.jpg

View of the farm equipment at the landside toe. Fall 2021.

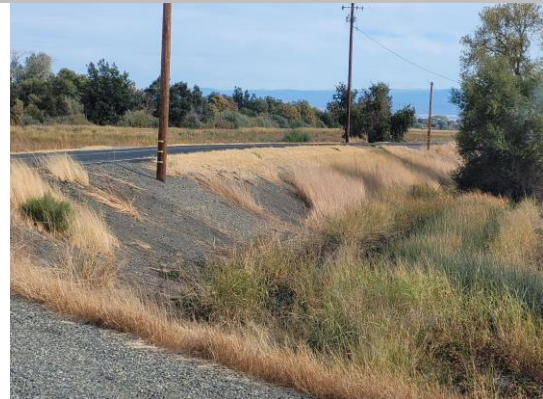
Photo 1 of 1 : SP_2024_MA0005_196_6_20240212_00002.jpg

View of the agricultural ditch along the landside toe. Fall 2021.

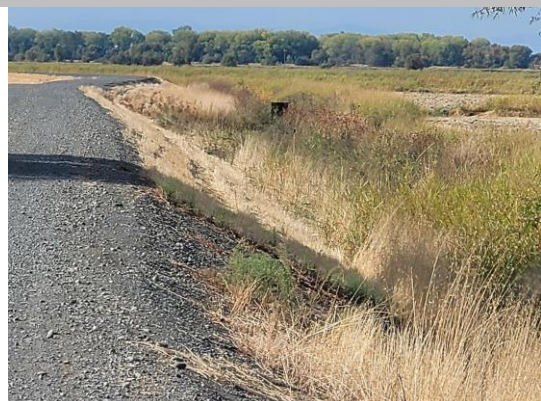
Photo 1 of 1 : SP_2024_MA0005_197_1_20240212_00001.jpg

View of the agricultural ditch along the landside toe. Fall 2021.

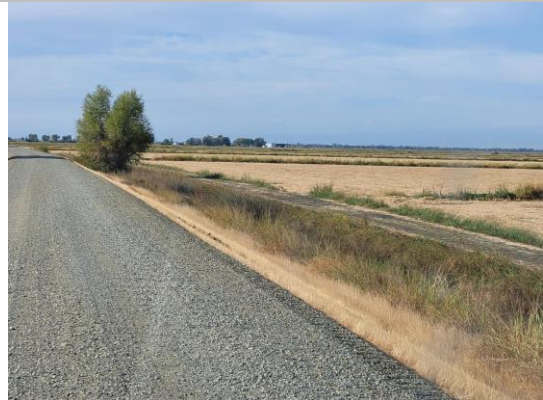
Photo 1 of 1 : SP_2024_MA0005_197_7_20240212_00003.jpg

View of the agricultural ditch along the landside toe. Fall 2021.

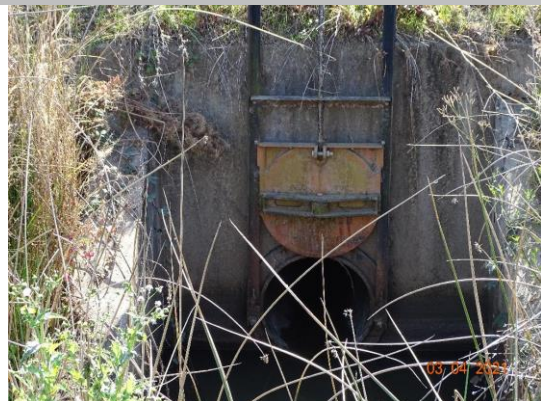
Photo 3 of 3 : UCIP_SP_2024_66081_98388.jpg

Land-Side: Closeup view of slide gate, and pipe end in drainage ditch
150 feet from levee

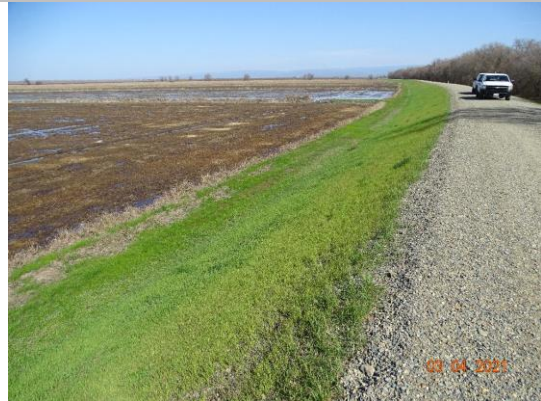
Photo 3 of 3 : UCIP_SP_2024_66386_98833.jpg

Land-Side: Overview of levee slope. Pipe not found on landside

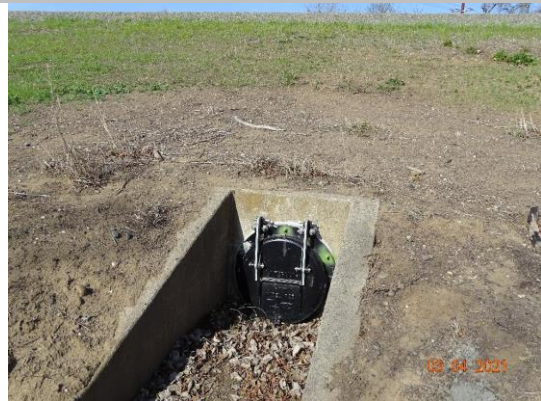
Photo 3 of 3 : UCIP_SP_2024_81090_98967.jpg

Water-Side: New flap gate installed

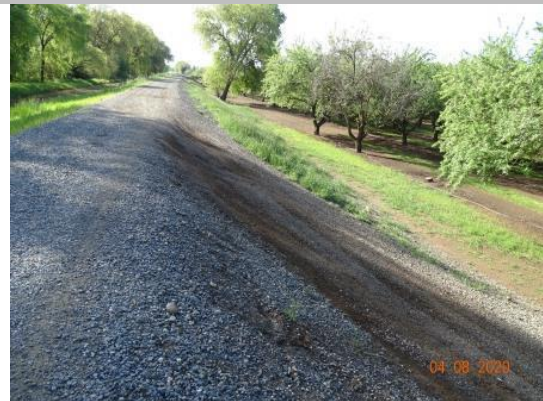
Photo 1 of 1 : SP_2024_MA0005_197_18_20240212_00004.jpg

View of the vehicle erosion along the landside slope. Spring 2020.

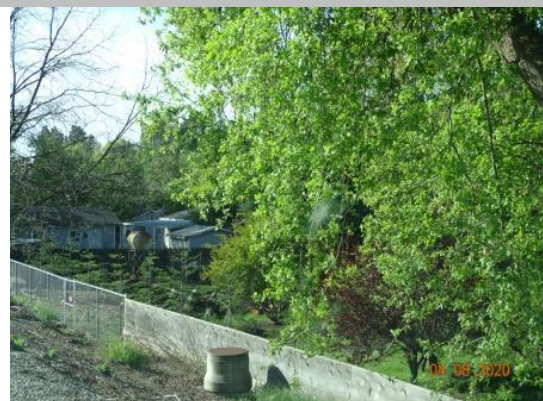
Photo 1 of 1 : SP_2024_MA0005_197_41_20240212_00006.jpg

View of the fence along the landside toe. Spring 2020.

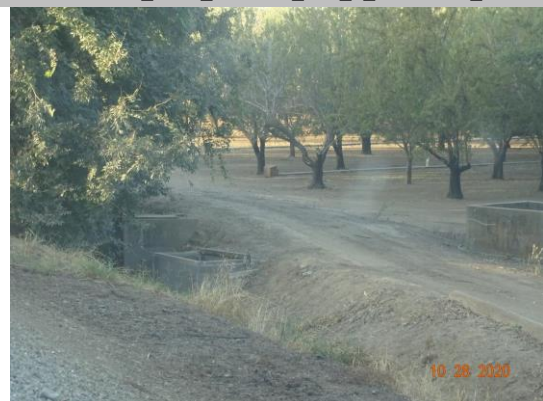
Photo 1 of 1 : SP_2024_MA0005_197_6_20240212_00002.jpg

View of the ditch along the landside toe. Fall 2020.

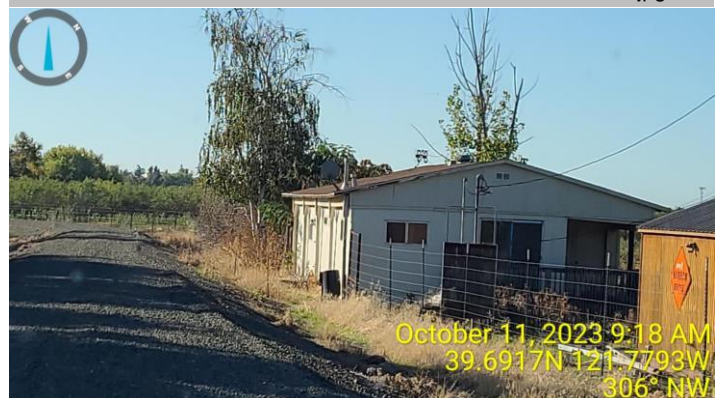
Photo 1 of 1 : SP_2024_MA0005_197_25_20240212_00005.jpg

View of the buildings at the landside toe. Fall 2023.

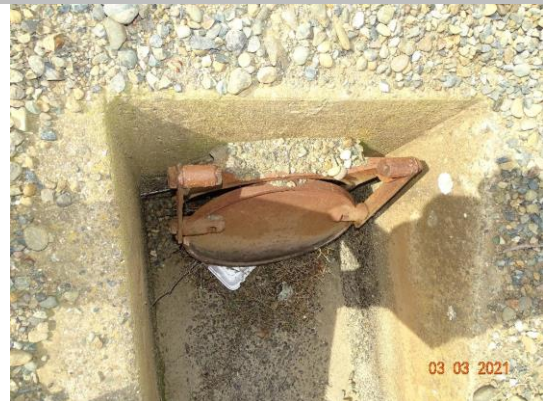
Photo 3 of 3 : UCIP_SP_2024_67139_99904.jpg

Water-Side: Flap gate not properly closed due to debris inside pipe

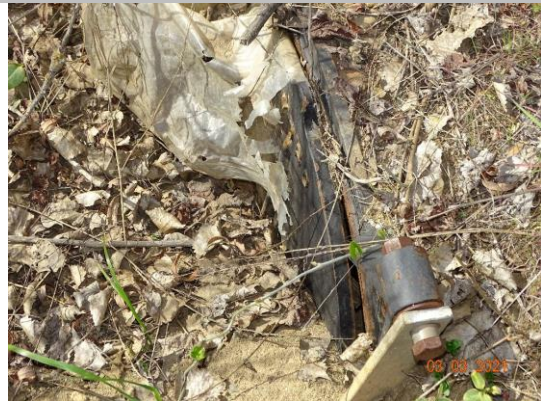
Photo 3 of 3 : UCIP_SP_2024_67141_99097.jpg

Water-Side: Closeup view of flap gate buried in soil

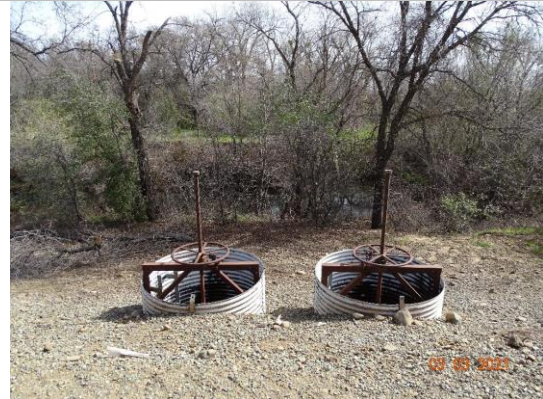
Photo 3 of 3 : UCIP_SP_2024_67144_99109.jpg

Water-Side: View of levee slope looking from crown. CMP riser needs a top cover

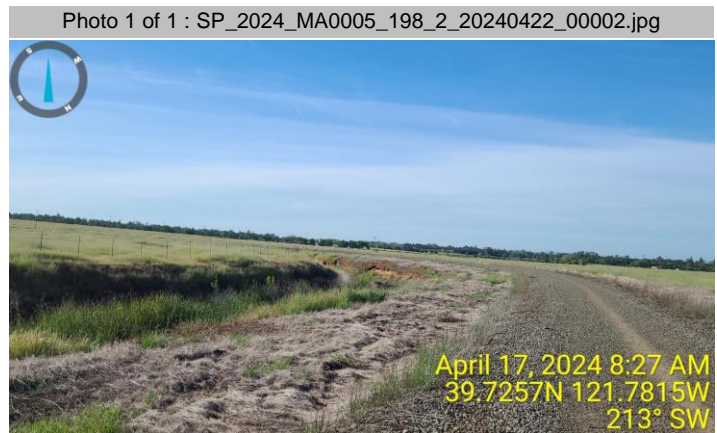
LM Start	0.66	Rating **	A	Issue No.	2
LM End	0.66	Issue Type +	Ma	Location *	WS
Category	Earthen Levee			GPS Latitude/Longitude	
				Start	End
Item	Vegetation			39.725713°	39.725713°
				-121.781537°	-121.781537°
DWR ID	DWR_MA0005_03_s_2024_2				
Comment Code					
V1 : Control annual grass and weeds on the levee slopes and easements.					
Inspector Comment					
Good vegetation control along both slopes of the levee.

View of good vegetation control along the waterside slope. Spring 2024.
