**Flood Control Project Maintenance
Levee Inspections**

Fall 2009 Levee Maintenance Deficiency Summary Report

Sacramento River Basin

Sutter Maintenance Yard Maintenance Area 0007

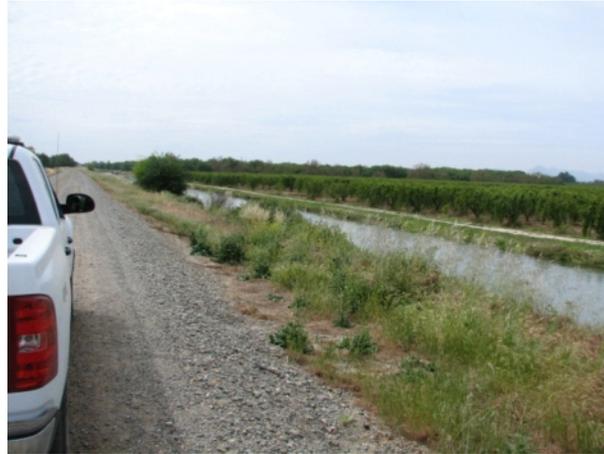
Levee Mile Report Line	1
Start Levee Mile	0.01
End Levee Mile	1.73
Location	Land Side
Category	Earthen Levee
Item	Encroachments
AG ditch land side slope and toe.	
cathom_20090924_2.jpg

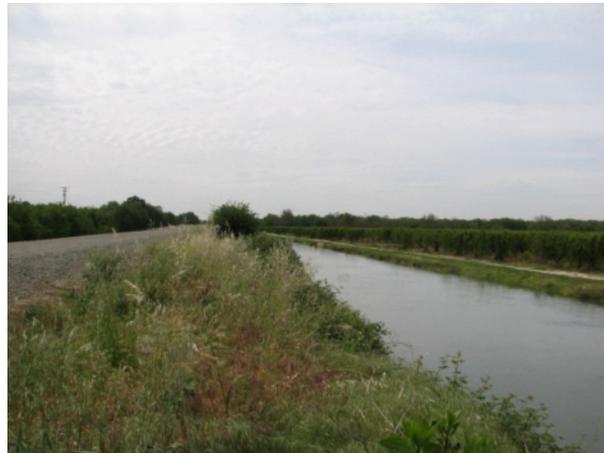
Levee Mile Report Line	11
Start Levee Mile	3.85
End Levee Mile	5.37
Location	Land Side
Category	Earthen Levee
Item	Encroachments
AG ditch land side slope and toe.	
cathom_20090924_1.jpg
