**Flood Control Project Maintenance
Levee Inspections**

Fall 2010 Levee Maintenance Deficiency Summary Report

Sutter Maintenance Yard Maintenance Area 0007

Waterway	Bank	Unit Miles
Unit No. 01 Feather River	Right	12.07

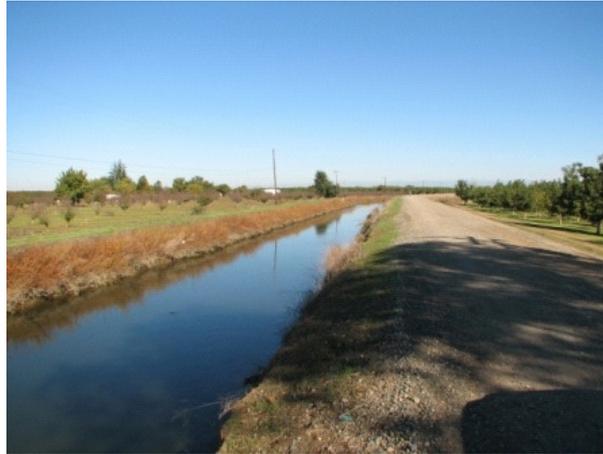
Levee Mile Report Line	1
Start Levee Mile	0.01
End Levee Mile	1.73
Location	Land Side
Category	Earthen Levee
Item	Encroachments
AG ditch land side slope and toe.	
rduffey_f_20101110_286.jpg

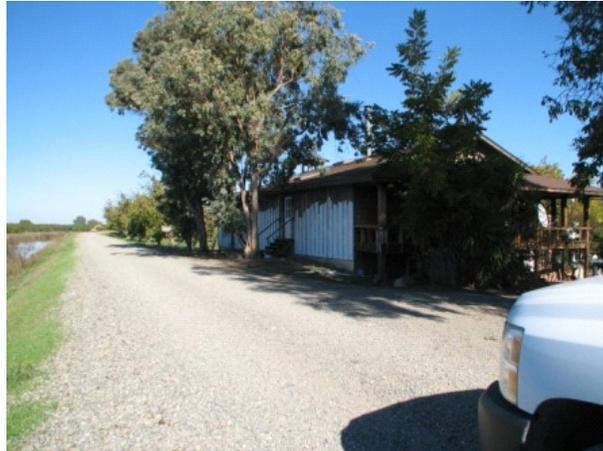
Levee Mile Report Line	2
Start Levee Mile	1.21
End Levee Mile	1.21
Location	Water Side
Category	Earthen Levee
Item	Encroachments
Water side levee mile 1.21.	
rduffey_f_20101110_287.jpg

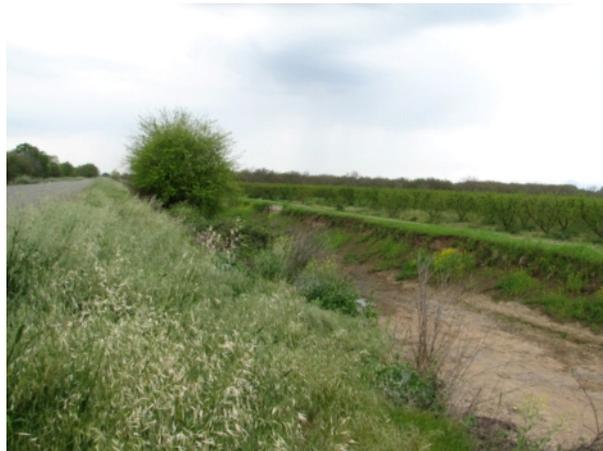
Levee Mile Report Line	5
Start Levee Mile	3.85
End Levee Mile	5.37
Location	Land Side
Category	Earthen Levee
Item	Encroachments
Land side levee mile 5.37.	
rduffey_f_20101007_192.jpg

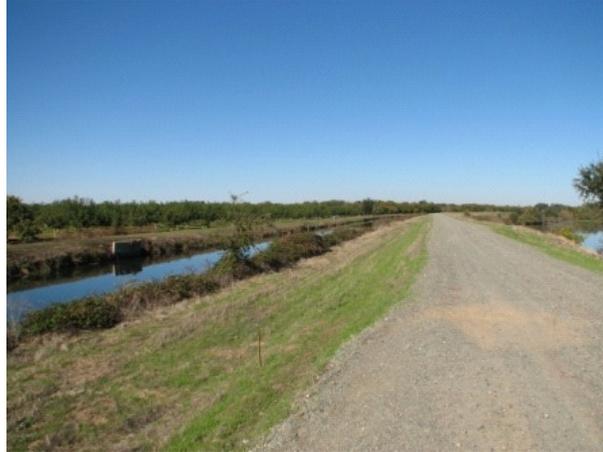
Levee Mile Report Line	5
Start Levee Mile	3.85
End Levee Mile	5.37
Location	Land Side
Category	Earthen Levee
Item	Encroachments
AG ditch land side slope and toe.	
rduffey_f_20101115_292.jpg

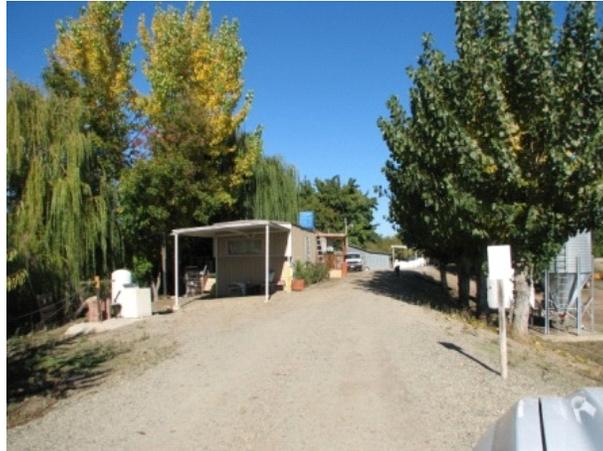
Levee Mile Report Line	6
Start Levee Mile	5.42
End Levee Mile	5.42
Location	Land Side
Category	Earthen Levee
Item	Encroachments
Crown and land side levee mile 5.42.	
rduffey_f_20101115_293.jpg

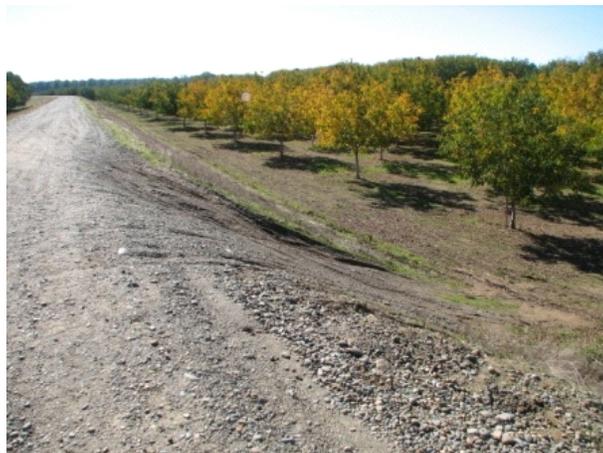
Levee Mile Report Line	9
Start Levee Mile	8.00
End Levee Mile	8.00
Location	Land Side
Category	Earthen Levee
Item	Erosion / Bank Caving
Land side levee mile 8.00.	
rduffey_f_20101110_291.jpg

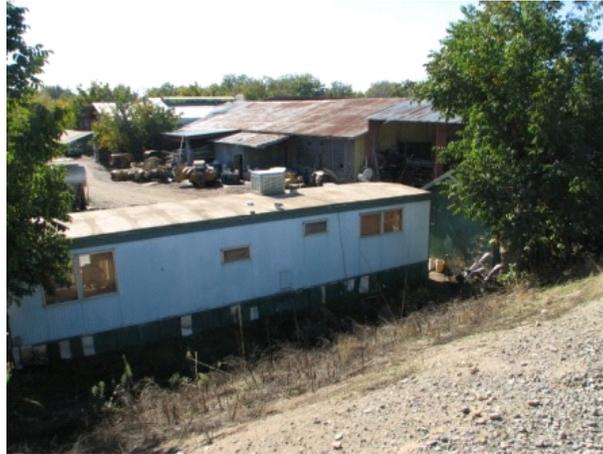
Levee Mile Report Line	11
Start Levee Mile	9.79
End Levee Mile	9.79
Location	Land Side
Category	Earthen Levee
Item	Encroachments
Land side levee mile 9.79.	
rduffey_f_20101115_294.jpg

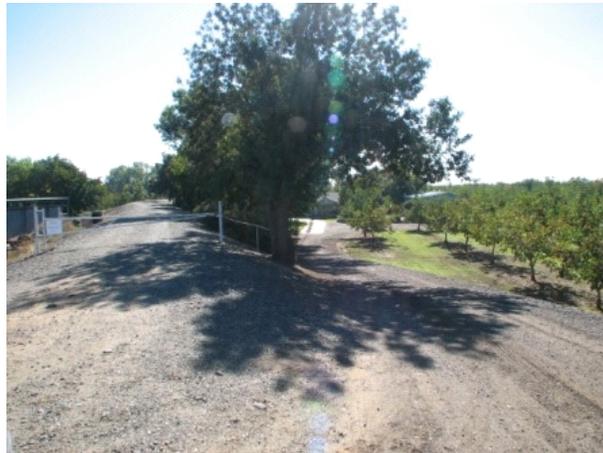
Levee Mile Report Line	13
Start Levee Mile	11.63
End Levee Mile	11.69
Location	Land Side
Category	Earthen Levee
Item	Encroachments
Land side landscaping levee mile 11.63.	
rduffey_f_20101115_295.jpg
