**Flood Control Project Maintenance
Levee Inspections**

Fall 2015 Levee Maintenance Deficiency Summary Report

Sutter Maintenance Yard Maintenance Area 0007

Waterway		Bank	Unit Miles	
Unit No. 01 Feather River		Right	11.90	
	Spring (March - May)	Summer (June - August)	(September - November) Fall	Winter (December - February)
Unit Maintenance Rating (Fall Only)			M	
Date of Inspection	05/05/2015 - 05/05/2015		11/16/2015 - 11/16/2015	
DWR Inspector	Michael Pitta		Bob Duffey	
Accompanied By	Sean Freitag		Sean Freitag

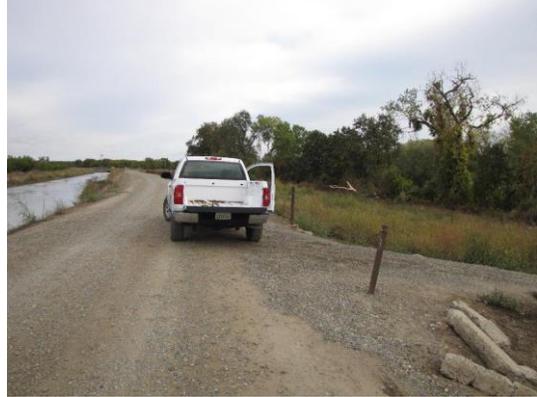
Photo 3 of 3 : UCIP_FA_2015_5362.jpg

LM Start	1.55	Rating **	M	Issue No.	218 (cont)
LM End	1.55	Issue Type +	En	Location *	WS
Category	Supplemental			GPS Latitude/Longitude	
				Start	End
Item	DWR UCIP Field Study			39.331934 °	39.331934 °
				-121.633246 °	-121.633246 °
DWR ID					
Action/Comments					
Inspector Comments: FS_ID:46095 DS_ID:16928 EP_NO: N/A FS_HLM: 1.544 Repair Type: Non-Urgent Crossing Status: Found UCIP Comments: 6/10/2015 Same as last inspection.crossing appears abandoned, slide gate is missing on landward side; wood frame remains on LS; scour hole present on LS, 3 feet by 3 feet, near wood frame.5/10/2013 Same as last inspection. LS scour behind structure needs to be repaired.5/13/2013 SBFCA project recommends replacing in accordance with title 23.11/6/2013 Same as last inspection.5/19/2014 Same as last inspection.12/29/2014 Same as last inspection. FIELD_STRUCT_DESC: Abandoned 12-inch CM pipe through the levee, 8.2 feet below the crown. Slide gate on the landward is no longer present. Concrete "U" headwall at the waterward toe. Irrigation ditch located on landward side. FS Date: 07/01/2015

Overview of levee crown looking upstream.

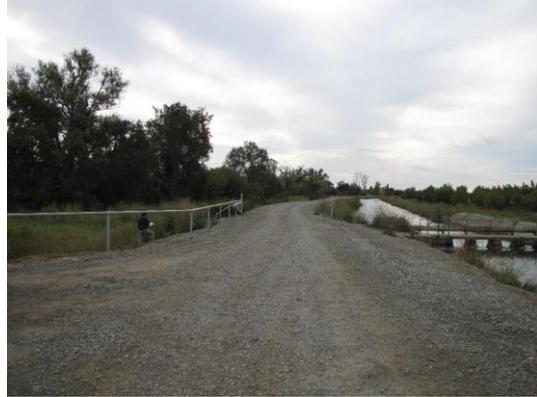
Photo 1 of 3 : UCIP_FA_2015_5363.jpg

LM Start	1.71	Rating **	M	Issue No.	219
LM End	1.71	Issue Type +	En	Location *	WS
Category	Supplemental			GPS Latitude/Longitude	
				Start	End
Item	DWR UCIP Field Study			39.334294 °	39.334294 °
				-121.634008 °	-121.634008 °
DWR ID					
Action/Comments					
Inspector Comments: FS_ID:46096 DS_ID:20816 EP_NO: N/A FS_HLM: 1.716 Repair Type: Non-Urgent Crossing Status: Found UCIP Comments: 6/10/2015 Crossing has been modified since last inspection. 3' black plastic pipe is now running through the metal pipe and the difference was capped and welded. Crossing was installed about 1 foot deep--need permit authorizing work5/7/2013 Same as last inspection. Recommend finding owner.5/13/2013 SBFCA project recommends removal. Permit number and owner in detailed report book.11/6/2013 Same as last inspection.5/19/2014 Same as last inspection.12/29/2014 Same as last inspection. FIELD_STRUCT_DESC: 12 inch irrigation pipe through the levee 1 foot below the crown. Crossing on landward side is attached to weir above ground. Siphon breaker on waterward side. No opening on waterward side. FS Date: 07/01/2015

View of levee crown looking downstream at crossing.

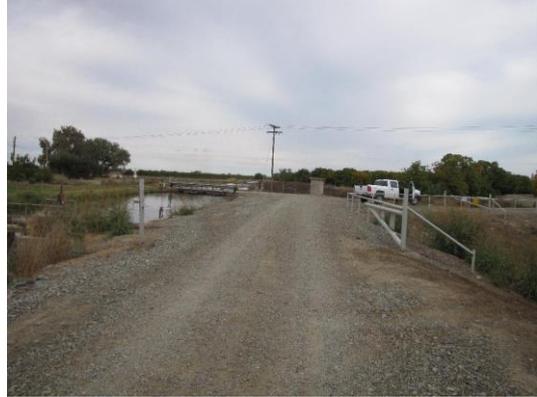
Photo 3 of 3 : UCIP_FA_2015_5365.jpg

LM Start	1.71	Rating **	M	Issue No.	219 (cont)
LM End	1.71	Issue Type +	En	Location *	WS
Category	Supplemental			GPS Latitude/Longitude	
				Start	End
Item	DWR UCIP Field Study			39.334294 °	39.334294 °
				-121.634008 °	-121.634008 °
DWR ID					
Action/Comments					
Inspector Comments: FS_ID:46096 DS_ID:20816 EP_NO: N/A FS_HLM: 1.716 Repair Type: Non-Urgent Crossing Status: Found UCIP Comments: 6/10/2015 Crossing has been modified since last inspection. 3' black plastic pipe is now running through the metal pipe and the difference was capped and welded. Crossing was installed about 1 foot deep--need permit authorizing work5/7/2013 Same as last inspection. Recommend finding owner.5/13/2013 SBFCA project recommends removal. Permit number and owner in detailed report book.11/6/2013 Same as last inspection.5/19/2014 Same as last inspection.12/29/2014 Same as last inspection. FIELD_STRUCT_DESC: 12 inch irrigation pipe through the levee 1 foot below the crown. Crossing on landward side is attached to weir above ground. Siphon breaker on waterward side. No opening on waterward side. FS Date: 07/01/2015

Overview of levee crown looking upstream at crossing.

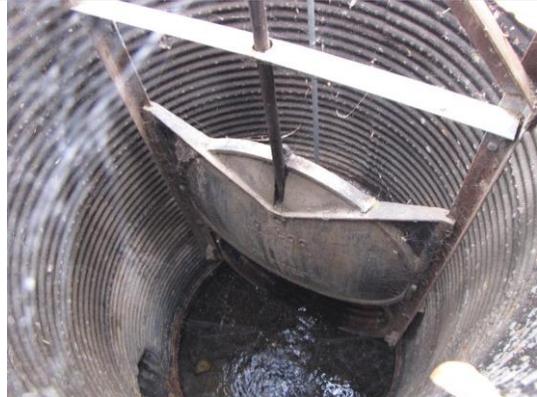
Photo 1 of 3 : UCIP_FA_2015_5366.jpg

Inspector Comments: FS_ID:46098
 DS_ID:16926
 EP_NO: N/A
 FS_HLM: 1.76
 Repair Type: Non-Urgent
 Crossing Status: Found
 UCIP Comments: 6/10/2015 Debris still present in risers and pipes were not replaced with the SBFCA project. Debris inside riser could prevent slide gate from closing. This crossing was listed in the USACE Periodic Inspections as ID# USACE_CESPK_MA07_2010_a_0060 however, no issues noted. 5/7/2013 Same debris issue as last inspection. Recommend repairing top cover to prevent falls. Wheel to open gate chained and locked so could not verify gate operation. 5/13/2013 SBFCA project recommends replacing in accordance with title 23. 11/6/2013 Same as last inspection. 5/19/2014 Same as last inspection. 12/29/2014 Same as last inspection.
 FIELD_STRUCT_DESC: 60-inch drain pipe through the levee, 1 of 2 pipes, two (2) 60 inch pipes, 12.5 feet below the crown. Slide gates in 78-inch CM pipe wells on the waterward slope. Concrete bulkhead on both ends. Reinforced concrete spillway on the waterward end. This entry matches the Drainage or Irrigation Structure referenced in O&M manual (Historic Station 1+90). (USACE O&M Manual, 1957)

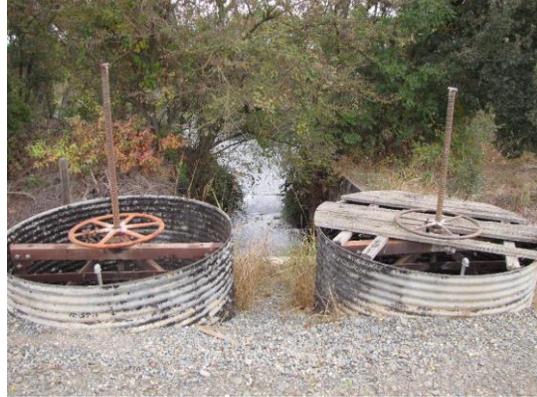
Photo 2 of 3 : UCIP_FA_2015_5367.jpg

Inspector Comments: FS_ID:46098
 DS_ID:16926
 EP_NO: N/A
 FS_HLM: 1.76
 Repair Type: Non-Urgent
 Crossing Status: Found
 UCIP Comments: 6/10/2015 Debris still present in risers and pipes were not replaced with the SBFCA project. Debris inside riser could prevent slide gate from closing. This crossing was listed in the USACE Periodic Inspections as ID# USACE_CESPK_MA07_2010_a_0060 however, no issues noted. 5/7/2013 Same debris issue as last inspection. Recommend repairing top cover to prevent falls. Wheel to open gate chained and locked so could not verify gate operation. 5/13/2013 SBFCA project recommends replacing in accordance with title 23. 11/6/2013 Same as last inspection. 5/19/2014 Same as last inspection. 12/29/2014 Same as last inspection.
 FIELD_STRUCT_DESC: 60-inch drain pipe through the levee, 1 of 2 pipes, two (2) 60 inch pipes, 12.5 feet below the crown. Slide gates in 78-inch CM pipe wells on the waterward slope. Concrete bulkhead on both ends. Reinforced concrete spillway on the waterward end. This entry matches the Drainage or Irrigation Structure referenced in O&M manual (Historic Station 1+90). (USACE O&M Manual, 1957)

78-inch CMP risers located on waterward slope. Upstream riser (far left) missing riser cover. Reinforced concrete spillway also located on waterward end.

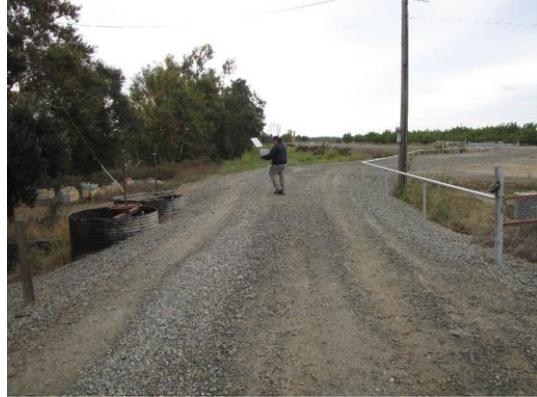
Photo 3 of 3 : UCIP_FA_2015_5368.jpg

Inspector Comments: FS_ID:46098
 DS_ID:16926
 EP_NO: N/A
 FS_HLM: 1.76
 Repair Type: Non-Urgent
 Crossing Status: Found
 UCIP Comments: 6/10/2015 Debris still present in risers and pipes were not replaced with the SBFCA project. Debris inside riser could prevent slide gate from closing. This crossing was listed in the USACE Periodic Inspections as ID# USACE_CESPK_MA07_2010_a_0060 however, no issues noted. 5/7/2013 Same debris issue as last inspection. Recommend repairing top cover to prevent falls. Wheel to open gate chained and locked so could not verify gate operation. 5/13/2013 SBFCA project recommends replacing in accordance with title 23. 11/6/2013 Same as last inspection. 5/19/2014 Same as last inspection. 12/29/2014 Same as last inspection.
 FIELD_STRUCT_DESC: 60-inch drain pipe through the levee, 1 of 2 pipes, two (2) 60 inch pipes, 12.5 feet below the crown. Slide gates in 78-inch CM pipe wells on the waterward slope. Concrete bulkhead on both ends. Reinforced concrete spillway on the waterward end. This entry matches the Drainage or Irrigation Structure referenced in O&M manual (Historic Station 1+90). (USACE O&M Manual, 1957)

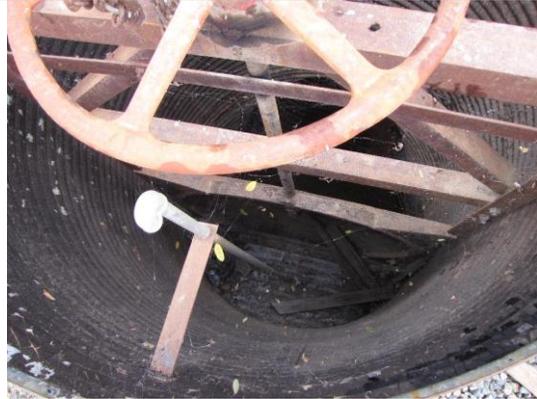
Photo 1 of 3 : UCIP_FA_2015_5369.jpg

Inspector Comments: FS_ID:46099
 DS_ID:17011
 EP_NO: N/A
 FS_HLM: 1.761
 Repair Type: Non-Urgent
 Crossing Status: Found
 UCIP Comments: 6/10/2015 Debris still present inside riser and pipe was not replaced with the SBFCA project.no cover; debris inside riser could prevent slide gate from closing. This crossing was listed in the USACE Periodic Inspections as ID# USACE_CESPK_MA07_2010_a_0060 however, no issues noted.5/7/2013 Same as last inspection. Recommend constructing cover to prevent falls. Wheel to operate gate chained and locked so gate operation could not be verified.5/13/2013 SBFCA project recommends replacing in accordance with title 23.11/6/2013 Same as last inspection.5/19/2014 Same as last inspection.12/29/2014 Same as last inspection.
 FIELD_STRUCT_DESC: 60-inch drain pipe through the levee, 2 of 2 pipes, two (2) 60 inch pipes, 12.5 feet below the crown. Slide gates in 78-inch CM pipe wells on the waterward slope. Concrete bulkhead on both ends. Reinforced concrete spillway on the waterward end. This entry matches the Drainage or Irrigation Structure referenced in O&M manual (Historic Station 1+90). (USACE O&M Manual, 1957)

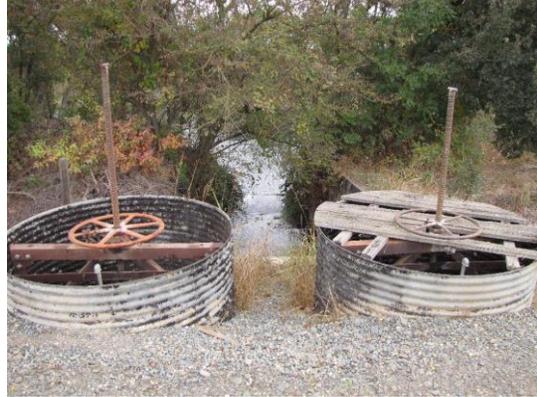
Photo 2 of 3 : UCIP_FA_2015_5370.jpg

Inspector Comments: FS_ID:46099
 DS_ID:17011
 EP_NO: N/A
 FS_HLM: 1.761
 Repair Type: Non-Urgent
 Crossing Status: Found
 UCIP Comments: 6/10/2015 Debris still present inside riser and pipe was not replaced with the SBFCA project.no cover; debris inside riser could prevent slide gate from closing. This crossing was listed in the USACE Periodic Inspections as ID# USACE_CESPK_MA07_2010_a_0060 however, no issues noted.5/7/2013 Same as last inspection. Recommend constructing cover to prevent falls. Wheel to operate gate chained and locked so gate operation could not be verified.5/13/2013 SBFCA project recommends replacing in accordance with title 23.11/6/2013 Same as last inspection.5/19/2014 Same as last inspection.12/29/2014 Same as last inspection.
 FIELD_STRUCT_DESC: 60-inch drain pipe through the levee, 2 of 2 pipes, two (2) 60 inch pipes, 12.5 feet below the crown. Slide gates in 78-inch CM pipe wells on the waterward slope. Concrete bulkhead on both ends. Reinforced concrete spillway on the waterward end. This entry matches the Drainage or Irrigation Structure referenced in O&M manual (Historic Station 1+90). (USACE O&M Manual, 1957)

78-inch CMP risers located on waterward slope. Upstream riser (far left) missing riser cover. Reinforced concrete spillway also located on waterward end.

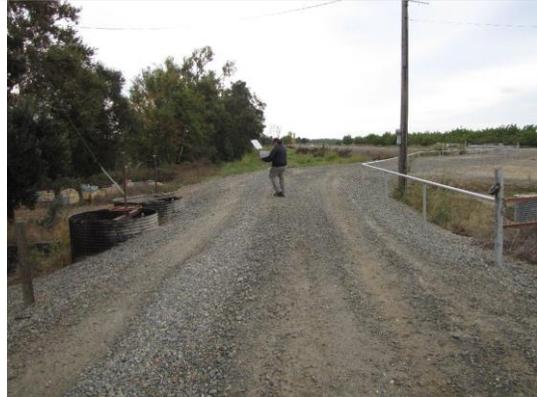
Photo 3 of 3 : UCIP_FA_2015_5371.jpg

LM Start	1.76	Rating **	M	Issue No.	221 (cont)
LM End	1.76	Issue Type +	En	Location *	WS
Category	Supplemental			GPS Latitude/Longitude	
				Start	End
Item	DWR UCIP Field Study			39.334886 °	39.334886 °
				-121.633783 °	-121.633783 °
DWR ID					
Action/Comments					
Inspector Comments: FS_ID:46099 DS_ID:17011 EP_NO: N/A FS_HLM: 1.761 Repair Type: Non-Urgent Crossing Status: Found UCIP Comments: 6/10/2015 Debris still present inside riser and pipe was not replaced with the SBFCA project.no cover; debris inside riser could prevent slide gate from closing. This crossing was listed in the USACE Periodic Inspections as ID# USACE_CESPK_MA07_2010_a_0060 however, no issues noted.5/7/2013 Same as last inspection. Recommend constructing cover to prevent falls. Wheel to operate gate chained and locked so gate operation could not be verified.5/13/2013 SBFCA project recommends replacing in accordance with title 23.11/6/2013 Same as last inspection.5/19/2014 Same as last inspection.12/29/2014 Same as last inspection. FIELD_STRUCT_DESC: 60-inch drain pipe through the levee, 2 of 2 pipes, two (2) 60 inch pipes, 12.5 feet below the crown. Slide gates in 78-inch CM pipe wells on the waterward slope. Concrete bulkhead on both ends. Reinforced concrete spillway on the waterward end. This entry matches the Drainage or Irrigation Structure referenced in O&M manual (Historic Station 1+90). (USACE O&M Manual, 1957) FS Date: 07/01/2015

View of levee crown looking downstream.

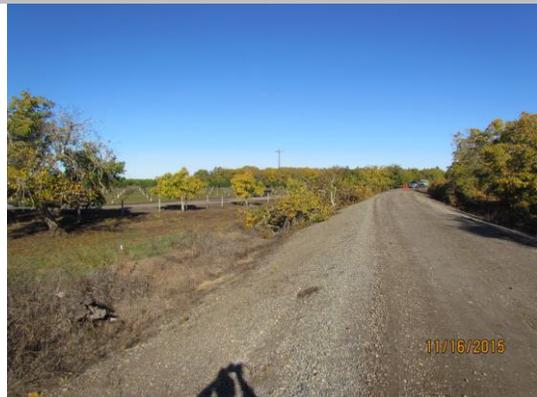
Photo 1 of 1 : FA_2015_MA0007_200_41_20151118_00014.jpg

LM Start	1.77	Rating **	M	Issue No.	41
LM End	1.93	Issue Type +	En	Location *	LS
Category	Earthen Levee			GPS Latitude/Longitude	
				Start	End
Item	Encroachments			39.334962 °	39.337363 °
				-121.633793 °	-121.633517 °
DWR ID	DWR_MA0007_01_f_2015_41				
Action/Comments					
Prunings Inspector Comments: SBFCA Is removing the trees as part of their ongoing construction project.

View of the down trees along the landside slope and toe.

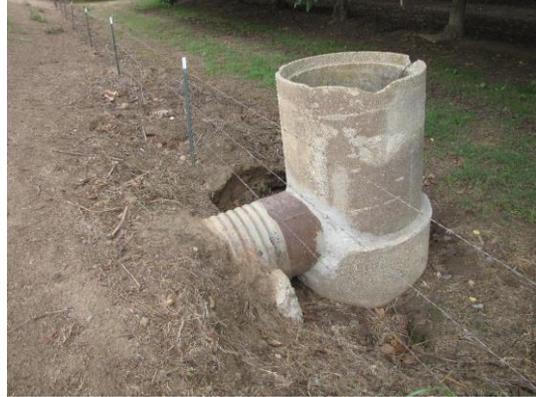
Photo 1 of 2 : UCIP_FA_2015_5395.jpg

Inspector Comments: FS_ID:46105
 DS_ID:16923
 EP_NO: N/A
 FS_HLM: 2.247
 Repair Type: Non-Urgent
 Crossing Status: Found
 UCIP Comments: 6/10/2015 Small erosion still present around concrete standpipe. Think its just caused by rain runoff. Erosion on waterward side around concrete standpipe--might be leaking. Burrow activity present on waterward slope, unable to determine if structure is still being used. This crossing was listed in the USACE Periodic Inspections as ID# USACE_CESPK_MA07_2010_a_0075 however, no issues noted.5/7/2013 Same as last inspection. Need to investigate source of WS erosion.5/13/2013 SBFCA project recommends removal.11/6/2013 Same as last inspection.5/19/2014 Same as last inspection.12/29/2014 Same as last inspection.
 FIELD_STRUCT_DESC: 24-inch CM irrigation through the levee 12.7 feet below the crown. Flap gate on the waterward end. Concrete distribution box at the waterward toe. Second concrete distribution box connected to deep well pump located 400-500 feet from landward toe. This entry matches the Drainage or Irrigation Structure referenced in O&M manual (Historic Station 28+00). (USACE O&M Manual, 1957) Permit No. 18710 issued in 2011 to continue using existing 24-inch irrigation pipe.

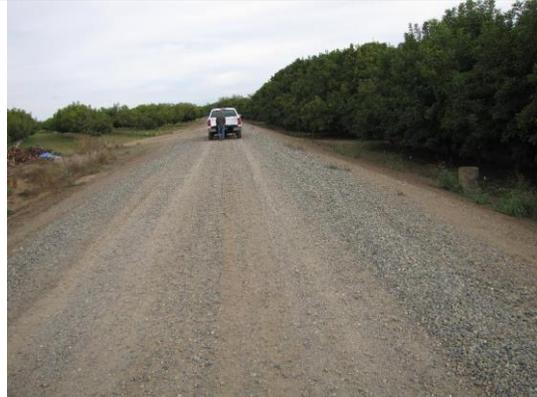
Photo 2 of 2 : UCIP_FA_2015_5396.jpg

Inspector Comments: FS_ID:46105
 DS_ID:16923
 EP_NO: N/A
 FS_HLM: 2.247
 Repair Type: Non-Urgent
 Crossing Status: Found
 UCIP Comments: 6/10/2015 Small erosion still present around concrete standpipe. Think its just caused by rain runoff. Erosion on waterward side around concrete standpipe--might be leaking. Burrow activity present on waterward slope, unable to determine if structure is still being used. This crossing was listed in the USACE Periodic Inspections as ID# USACE_CESPK_MA07_2010_a_0075 however, no issues noted.5/7/2013 Same as last inspection. Need to investigate source of WS erosion.5/13/2013 SBFCA project recommends removal.11/6/2013 Same as last inspection.5/19/2014 Same as last inspection.12/29/2014 Same as last inspection.
 FIELD_STRUCT_DESC: 24-inch CM irrigation through the levee 12.7 feet below the crown. Flap gate on the waterward end. Concrete distribution box at the waterward toe. Second concrete distribution box connected to deep well pump located 400-500 feet from landward toe. This entry matches the Drainage or Irrigation Structure referenced in O&M manual (Historic Station 28+00). (USACE O&M Manual, 1957) Permit No. 18710 issued in 2011 to continue using existing 24-inch irrigation pipe.

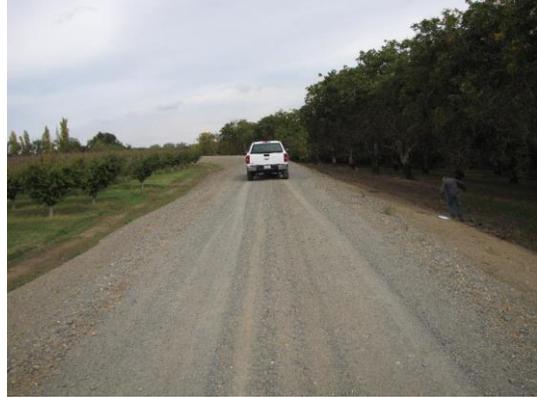
Photo 1 of 3 : UCIP_FA_2015_5460.jpg

LM Start	2.56	Rating **	M	Issue No.	224
LM End	2.56	Issue Type +	En	Location *	LS
Category	Supplemental			GPS Latitude/Longitude	
				Start	End
Item	DWR UCIP Field Study			39.345638 °	39.345638 °
				-121.629607 °	-121.629607 °
DWR ID					
Action/Comments					
Inspector Comments: FS_ID:46107 DS_ID:16910 EP_NO: N/A FS_HLM: 2.569 Repair Type: Non-Urgent Crossing Status: Found

View of levee crown looking upstream.

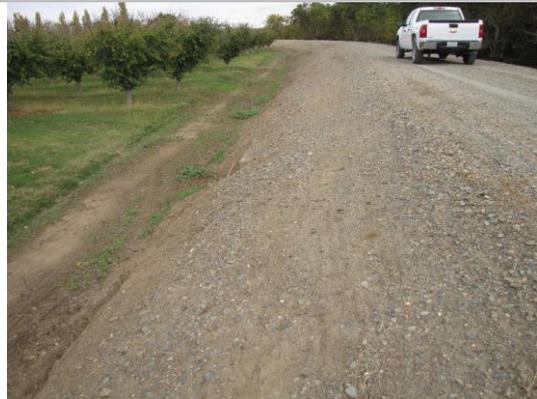
Photo 2 of 3 : UCIP_FA_2015_5461.jpg

View of landward slope.

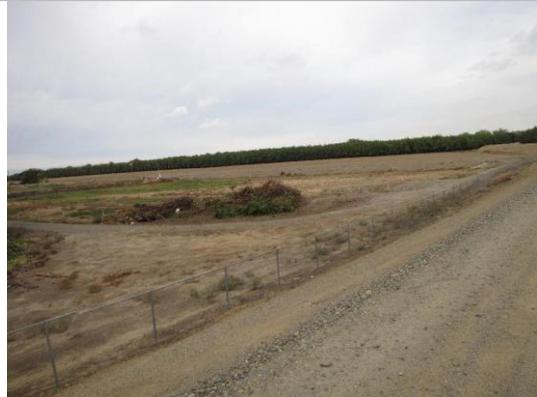
Photo 1 of 3 : UCIP_FA_2015_5463.jpg

LM Start	2.73	Rating **	M	Issue No.	225
LM End	2.73	Issue Type +	En	Location *	LS
Category	Supplemental			GPS Latitude/Longitude	
				Start	End
Item	DWR UCIP Field Study			39.347977 °	39.347977 °
				-121.630337 °	-121.630337 °
DWR ID					
Action/Comments					
Inspector Comments: FS_ID:46109 DS_ID:16921 EP_NO: N/A FS_HLM: 2.742 Repair Type: Non-Urgent Crossing Status: Found UCIP Comments: 6/10/2015 Riser is still damaged and cant locate signs of pipe on LS.CMP riser damage-repair needed. Unable to locate pipe on landward side. This crossing was listed in the USACE Periodic Inspections as ID# USACE_CESPK_MA07_2010_a_0090 however, no issues noted.5/7/2013 Same as last inspection, rodent activity near crossing, need to repair rodent hole on WS.5/13/2013 SBFCA project recommends relacing in accordance with title 23.11/6/2013 Same as last inspection.5/19/2014 Same as last inspection.12/29/2014 Same as last inspection. FIELD_STRUCT_DESC: 24-inch CM drain pipe through the levee, 25.5 feet below the crown. Slide gate in 36-inch CM pipe riser on the waterward slope. This entry matches the Drainage or Irrigation Structure referenced in O&M manual (Historic Station 52+50). (USACE O&M Manual, 1957) FS Date: 07/01/2015

View of landward side.

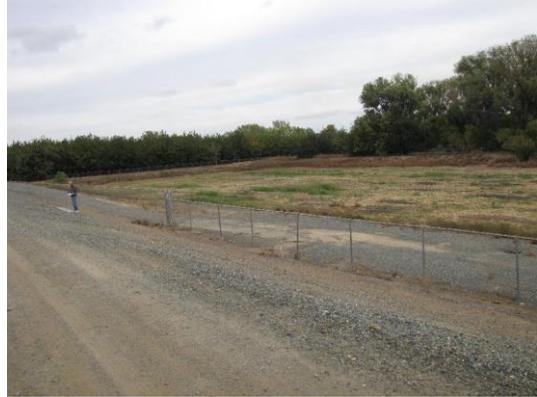
Photo 2 of 3 : UCIP_FA_2015_5464.jpg

Inspector Comments: FS_ID:46109
 DS_ID:16921
 EP_NO: N/A
 FS_HLM: 2.742
 Repair Type: Non-Urgent
 Crossing Status: Found
 UCIP Comments: 6/10/2015 Riser is still damaged and cant locate signs of pipe on LS.CMP riser damage-repair needed. Unable to locate pipe on landward side. This crossing was listed in the USACE Periodic Inspections as ID# USACE_CESPK_MA07_2010_a_0090 however, no issues noted.5/7/2013 Same as last inspection, rodent activity near crossing, need to repair rodent hole on WS.5/13/2013 SBFCA project recommends relacing in accordance with title 23.11/6/2013 Same as last inspection.5/19/2014 Same as last inspection.12/29/2014 Same as last inspection.
 FIELD_STRUCT_DESC: 24-inch CM drain pipe through the levee, 25.5 feet below the crown. Slide gate in 36-inch CM pipe riser on the waterward slope. This entry matches the Drainage or Irrigation Structure referenced in O&M manual (Historic Station 52+50). (USACE O&M Manual, 1957)

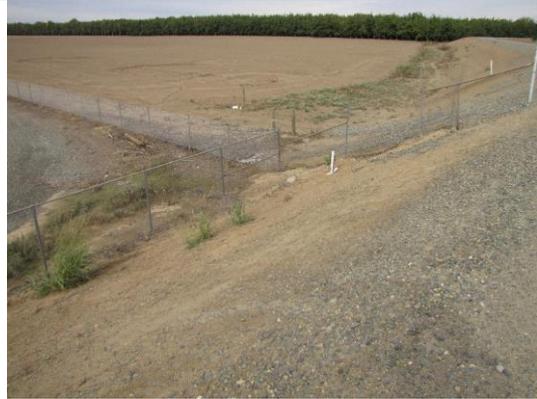
Photo 1 of 3 : UCIP_FA_2015_5527.jpg

Inspector Comments: FS_ID:46110
 DS_ID:16919
 EP_NO: 5722
 FS_HLM: 2.825
 Repair Type: Non-Urgent
 Crossing Status: Indicator Found
 UCIP Comments: 6/10/2015 Same as last inspection.dense burrow activity on crown and slopes;5/7/2013 Same as last inspection. WS sediment drop above concrete stand pipe. Coordinate with owner and levee inspector to address issue.5/13/2013 SBFCA project recommends relacing in accordance with title 23.11/6/2013 Same as last inspection.5/19/2014 Same as last inspection.12/29/2014 Same as last inspection.
 FIELD_STRUCT_DESC: 1-12 inch cement coated and lined steel sewer pipe sleeved through the existing 24-inch CM pipe. Annular space pressure grouted. A 36 inch diameter reinforced concrete pipe riser is located on the waterward side. (Permit No. 5722-1968) The existing 24-inch CMP matches the Drainage or Irrigation structure referenced in the O&M manual (historic station 56+90, USACE O&M Manual, 1957) 24-inch CM pipe goes through levee at a depth of 21.4 feet below the crown. Slide gate in 36-inch reinforced concrete pipe riser located on the waterward slope. Crossing 2 of 2 see levee mile 3.35 entry.

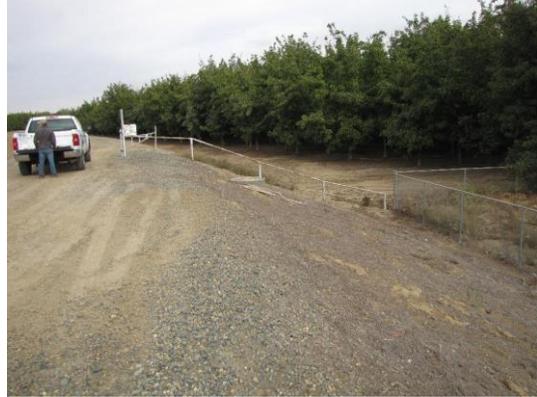
Photo 2 of 3 : UCIP_FA_2015_5528.jpg

Inspector Comments: FS_ID:46110
 DS_ID:16919
 EP_NO: 5722
 FS_HLM: 2.825
 Repair Type: Non-Urgent
 Crossing Status: Indicator Found
 UCIP Comments: 6/10/2015 Same as last inspection.dense burrow activity on crown and slopes;5/7/2013 Same as last inspection. WS sediment drop above concrete stand pipe. Coordinate with owner and levee inspector to address issue.5/13/2013 SBFCA project recommends relacing in accordance with title 23.11/6/2013 Same as last inspection.5/19/2014 Same as last inspection.12/29/2014 Same as last inspection.
 FIELD_STRUCT_DESC: 1-12 inch cement coated and lined steel sewer pipe sleeved through the existing 24-inch CM pipe. Annular space pressure grouted. A 36 inch diameter reinforced concrete pipe riser is located on the waterward side. (Permit No. 5722-1968) The existing 24-inch CMP matches the Drainage or Irrigation structure referenced in the O&M manual (historic station 56+90, USACE O&M Manual, 1957) 24-inch CM pipe goes through levee at a depth of 21.4 feet below the crown. Slide gate in 36-inch reinforced concrete pipe riser located on the waterward slope. Crossing 2 of 2 see levee mile 3.35 entry.

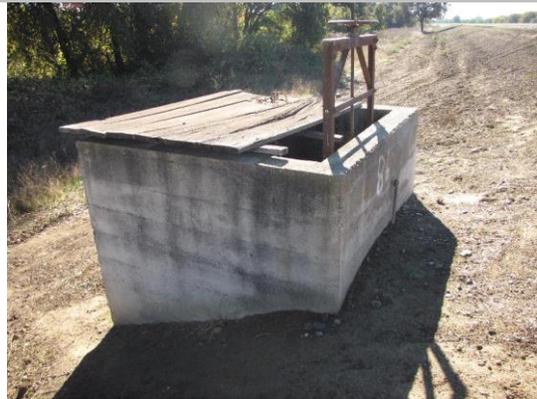
Photo 1 of 3 : UCIP_FA_2015_5604.jpg

Close up view of distribution box on landward side.

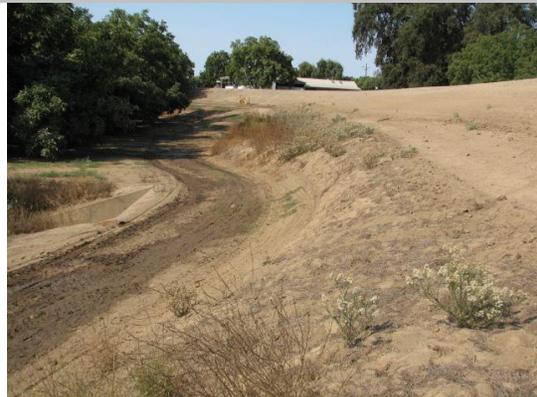
Photo 1 of 1 : FA_2015_MA0007_200_5_20151109_00001.jpg

This photo shows vehicle traffic has cut into the toe of the levee.

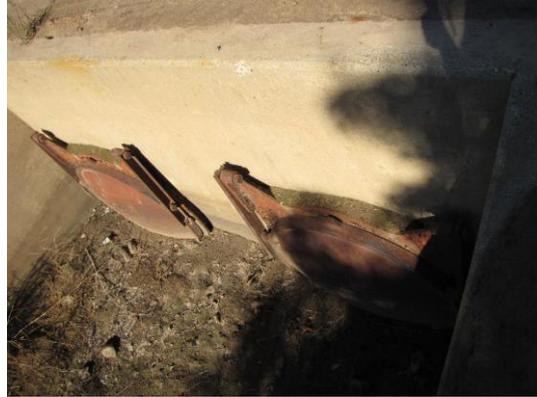
Photo 1 of 3 : UCIP_FA_2015_5624.jpg

Sediment build up against flap gates.

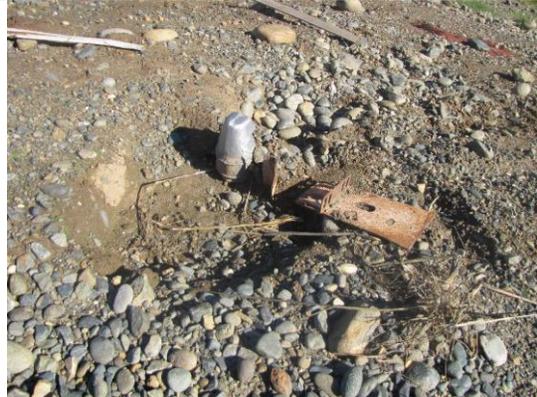
Photo 1 of 3 : UCIP_FA_2015_5721.jpg

Photo 1 of 2. View of localized erosion at air vent located on waterward shoulder.

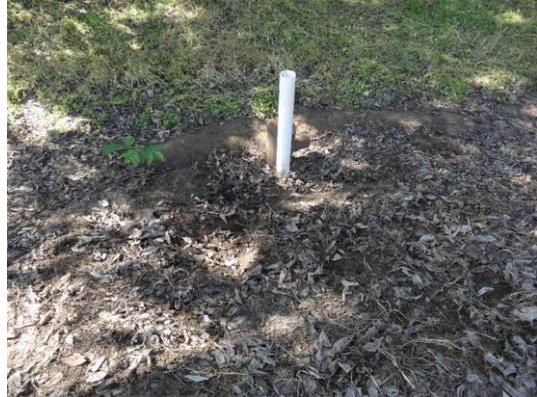
Photo 1 of 3 : UCIP_FA_2015_5724.jpg

PVC and steel pipe on LS toe

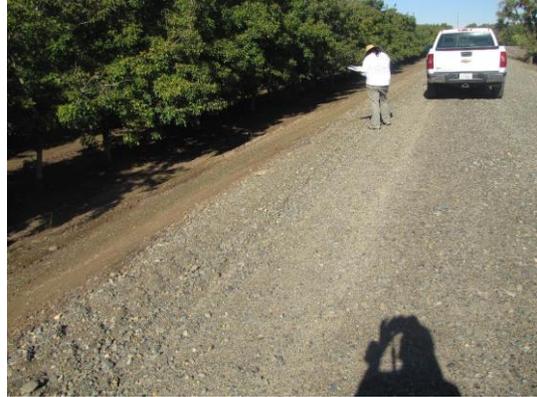
Photo 3 of 3 : UCIP_FA_2015_5731.jpg

View of landward side and levee crown looking upstream at crossing. Staff is standing adjacent to cavity located on landward shoulder.

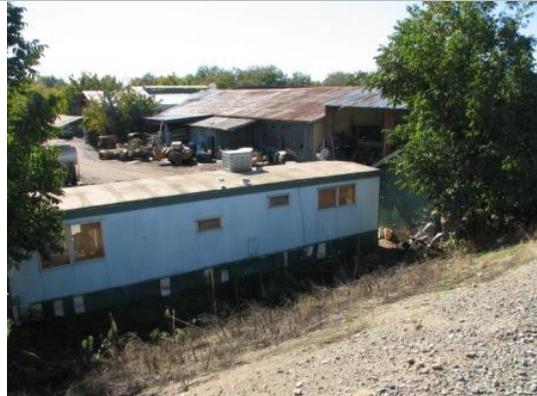
Photo 1 of 1 : FA_2015_MA0007_200_45_20151109_00008.jpg

This photo shows a building at the landside toe.

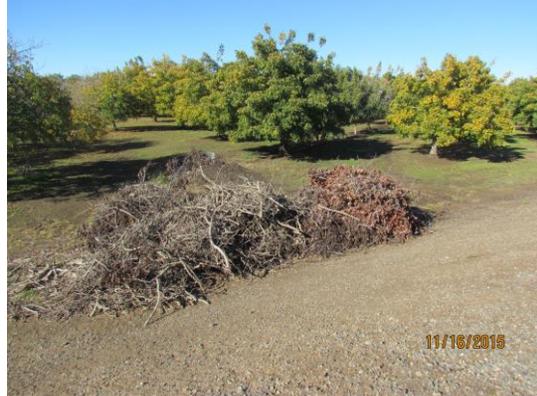
Photo 1 of 1 : FA_2015_MA0007_200_50_20151118_00018.jpg

View of the prunings along the landside toe.

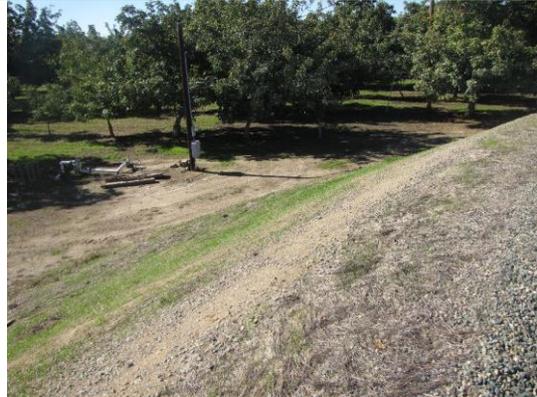
Photo 1 of 3 : UCIP_FA_2015_5755.jpg

Action/Comments
 Inspector Comments: FS_ID:46143
 DS_ID:16946
 EP_NO: N/A
 FS_HLM: 10.247
 Repair Type: Non-Urgent
 Crossing Status: Indicator Found
 UCIP Comments: 6/11/2015 Same as last inspection. unable to determine if this crossing still is in use, signs of depression on waterward shoulder, pump located on LS (GW?) valve on waterward toe. No slide gate or concrete standpipe present; structure appears to have been modified--need permit issued for modifications.5/10/2013 Same as last inspection.5/13/2013 SBFCA project recommends removal.11/7/2013 Same as last inspection.5/20/2014 Same as last inspection.12/30/2014 Same as last inspection.
 FIELD_STRUCT_DESC: 10-inch steel irrigation pipe through the levee, 14.5 feet below the crown. Slide gate in concrete standpipe and pump on the landward side.
 FS Date: 07/07/2015

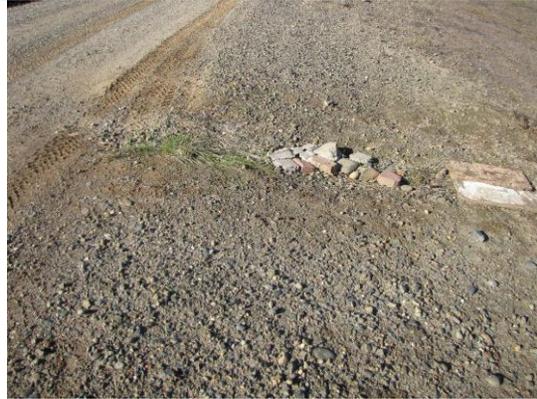
Photo 2 of 3 : UCIP_FA_2015_5756.jpg

Waterward shoulder with a low point along filled with rocks and brick pieces with what appears to be crossing alignment.

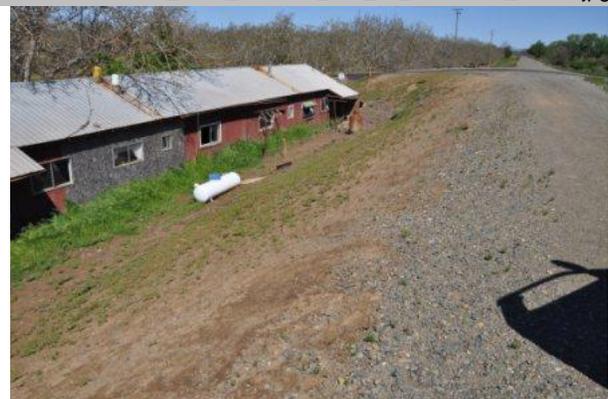
Photo 1 of 1 : FA_2015_MA0007_200_15_20151109_00002.jpg

landside levee toe- Abandoned building.

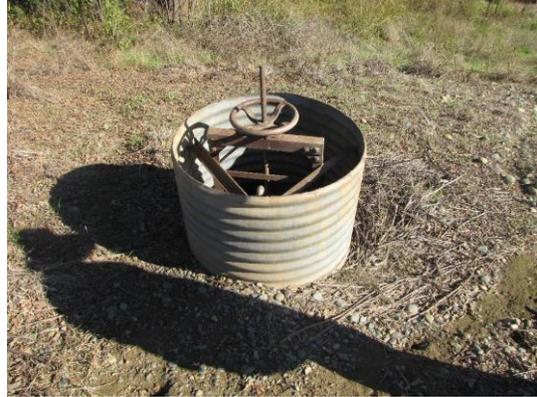
Photo 2 of 3 : UCIP_FA_2015_5376.jpg

Action/Comments					
<p>Inspector Comments: FS_ID:46153 DS_ID:16936 EP_NO: N/A FS_HLM: 11.518 Repair Type: Non-Urgent Crossing Status: Found UCIP Comments: 6/11/2015 LS inlet is still mostly buried with soil. SBFCA project recommends removal. Non-functional crossing landward inlet buried; waterward side-debris in CMP riser, riser missing lid; This crossing was listed in the USACE Periodic Inspection as ID# USACE_CESPK_MA07_2010_a_0344 for pipes filled > 50 % with soil. 5/10/2013 Same as last inspection. LS inlet excavated but more than 50% still covered by soil. 5/13/2013 SBFCA project recommends removal. 11/7/2013 Same as last inspection. 5/20/2014 Same as last inspection. 12/30/2014 Same as last inspection. FIELD_STRUCT_DESC: 24-inch CM drainpipe through the levee, 16.2 feet below the crown. Concrete headwall at both toes. Flap gate on the waterward end. This entry matches the Drainage or Irrigation Structure referenced in O&M manual (Historic Station 508+40). (USACE O&M Manual, 1957) FS Date: 07/07/2015</p>

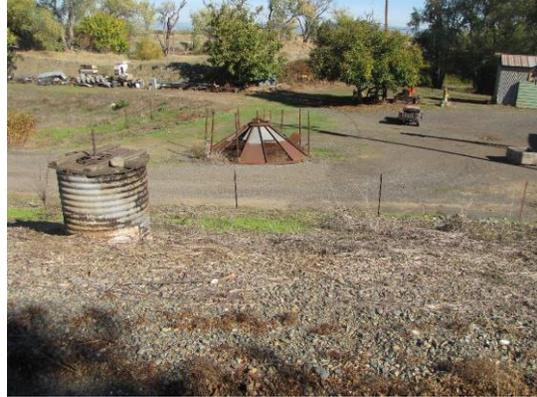
Photo 1 of 3 : UCIP_FA_2015_4930.jpg

View of waterward side with unknown structure along pipe alignment and pump located over 100 feet from waterward toe.
