**Flood Control Project Maintenance
Levee Inspections
LMA District Cover Sheet
Spring 2011 Levee Inspection Results**

Spring 2011 Levee Inspection Results

Sutter Maintenance Yard Maintenance Area 0007

Waterway		Bank	Unit Miles
Unit No. 01 Feather River		Right	12.07

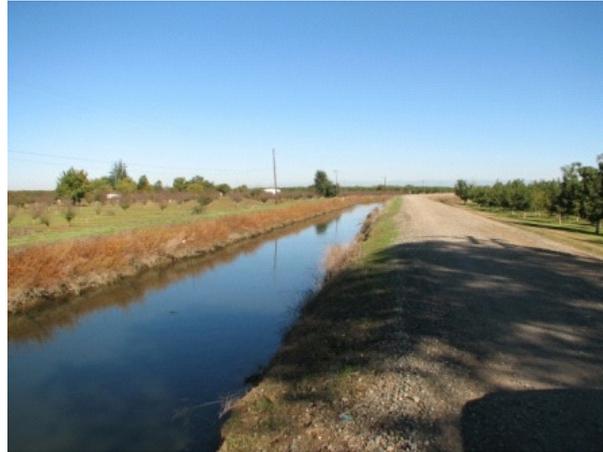
Levee Mile Report Line	1
Start Levee Mile	0.01
End Levee Mile	1.73
Location	Land Side
Category	Earthen Levee
Item	Encroachments
AG ditch landside slope and toe.	
cathom_s_20110228_043.jpg

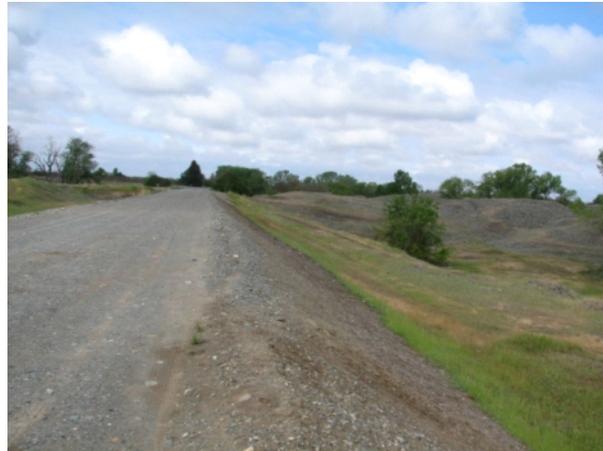
Levee Mile Report Line	2
Start Levee Mile	0.05
End Levee Mile	11.85
Location	Land Side
Category	Earthen Levee
Item	Vegetation
Levee mile 11.85, this photo is looking downstream at the vegetation on the landside slope.	
cathom_s_20110427_151.jpg

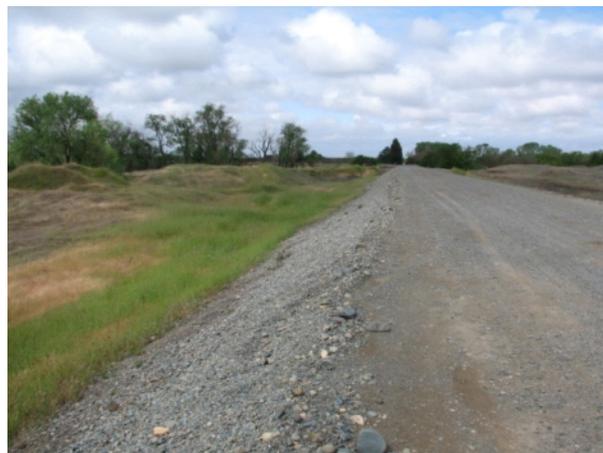
Levee Mile Report Line	3
Start Levee Mile	0.05
End Levee Mile	11.85
Location	Water Side
Category	Earthen Levee
Item	Vegetation
Levee mile 11.85, this photo is looking downstream at the vegetation on the waterside slope.	
cathom_s_20110427_150.jpg

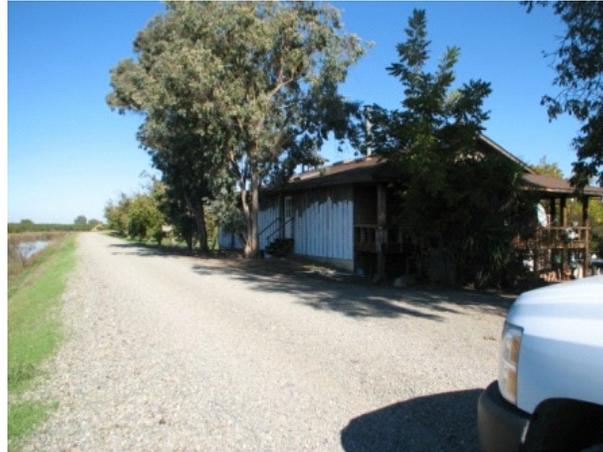
Levee Mile Report Line	4
Start Levee Mile	1.21
End Levee Mile	1.21
Location	Water Side
Category	Earthen Levee
Item	Encroachments
<p>Levee mile 1.21. This is a photo of the building on the waterside slope.</p>	
<p>cathom_s_20110228_040.jpg</p>

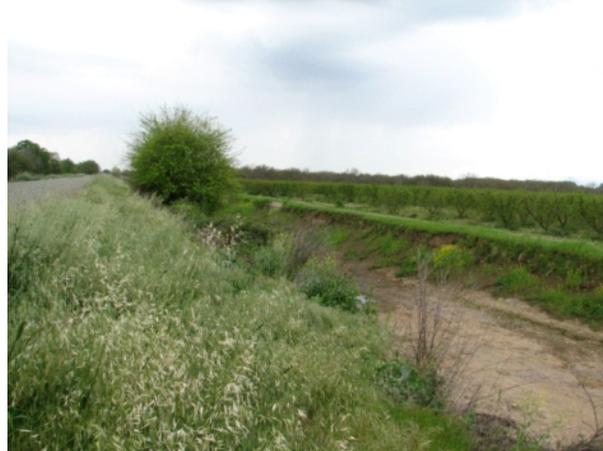
Levee Mile Report Line	6
Start Levee Mile	3.85
End Levee Mile	5.37
Location	Land Side
Category	Earthen Levee
Item	Encroachments
<p>Levee mile 5.37. This is a photo of the AG ditch on the landside slope and toe.</p>	
<p>cathom_s_20110228_041.jpg</p>

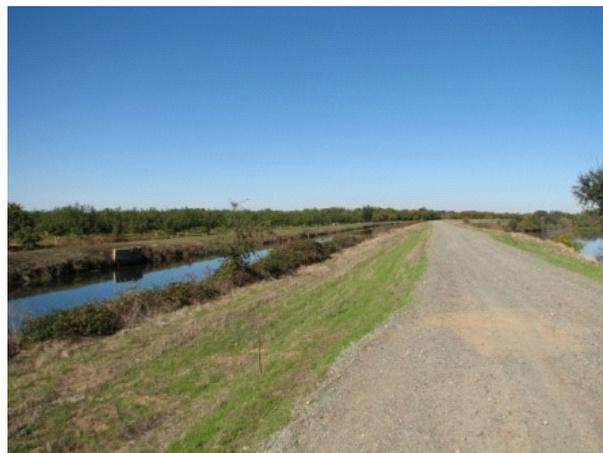
Levee Mile Report Line	6
Start Levee Mile	3.85
End Levee Mile	5.37
Location	Land Side
Category	Earthen Levee
Item	Encroachments
<p>AG ditch landside slope and toe.</p>	
<p>cathom_s_20110228_042.jpg</p>

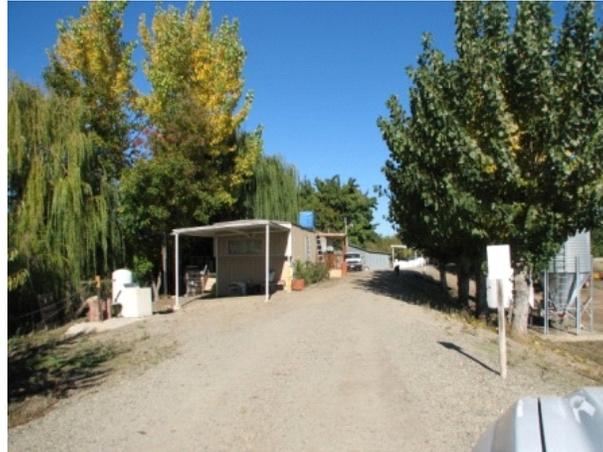
Levee Mile Report Line	9
Start Levee Mile	5.42
End Levee Mile	5.42
Location	Land Side
Category	Earthen Levee
Item	Encroachments

Levee mile 5.42. This photo shows a building on the landside crown, shoulder and slope.

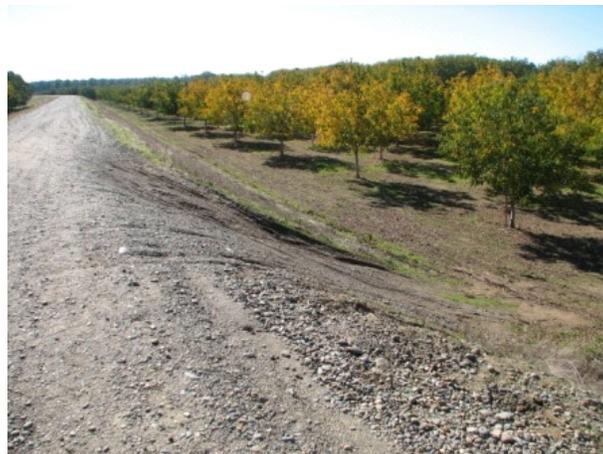
Levee Mile Report Line	13
Start Levee Mile	8.00
End Levee Mile	8.00
Location	Land Side
Category	Earthen Levee
Item	Erosion / Bank Caving

Levee mile 8.00. This photo shows the erosion on the landside slope.

13	8.00	8.00	Earthen Levee	Erosion / Bank Caving	LS	M	Schedule repair of erosion site prior to the next inspection.	39.401147 ° -121.630885 °	39.401147 ° -121.630885 °	3 Y
14	9.05	9.41	Earthen Levee	Slope Stability	LS	M	Repair slope instability.	39.409363 ° -121.634667 °	39.412797 ° -121.632463 °	7
15	9.28	9.28	Earthen Levee	Encroachments	LS	M	Prunings	39.412664 ° -121.634709 °	39.412664 ° -121.634709 °	5
16	9.79	9.79	Earthen Levee	Encroachments	LS	CO	Buildings	39.416384 ° -121.634503 °	39.416384 ° -121.634503 °	45 Y
17	11.63	11.69	Earthen Levee	Encroachments	LS	PO	Landscaping	39.437119 ° -121.645860 °	39.437949 ° -121.646280 °	43 Y

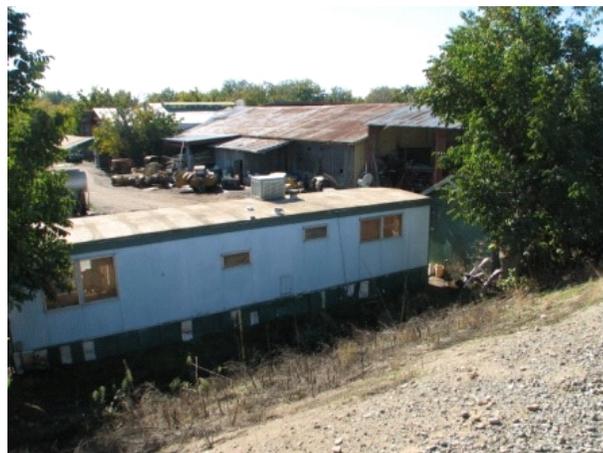
Levee Mile Report Line	16
Start Levee Mile	9.79
End Levee Mile	9.79
Location	Land Side
Category	Earthen Levee
Item	Encroachments

Levee mile 9.79. This photo shows a building at the landside toe.

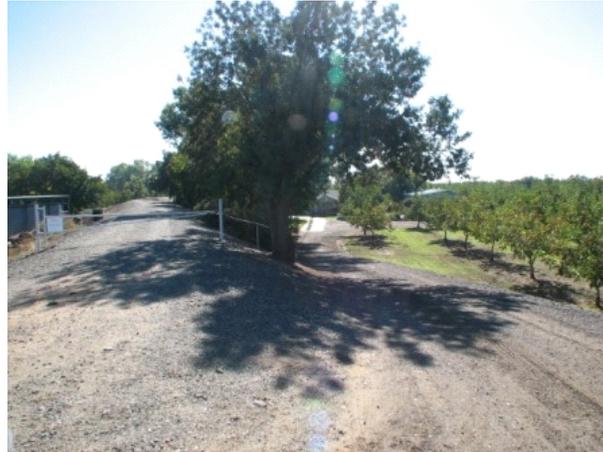
Levee Mile Report Line	17
Start Levee Mile	11.63
End Levee Mile	11.69
Location	Land Side
Category	Earthen Levee
Item	Encroachments
Landside landscaping levee mile 11.63.	
cathom_s_20110228_044.jpg
