**Flood Control Project Maintenance
Levee Inspections
LMA District Cover Sheet
Spring 2014 Levee Inspection Results**

Sutter Maintenance Yard Maintenance Area 0007

Spring 2014 Levee Inspection Results

Waterway		Bank	Unit Miles
Unit No. 01 Feather River		Right	12.07

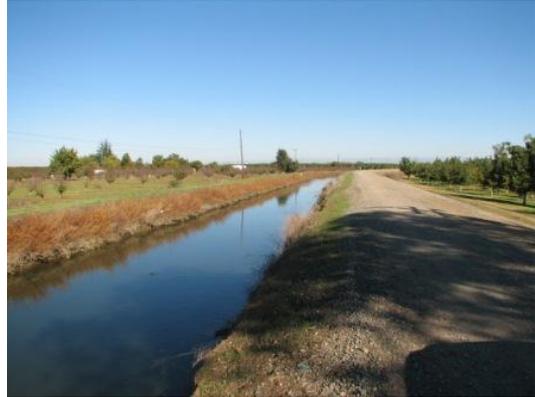
Photo 1 of 2 : mhoffman_s_20140306_047.jpg

AG ditch landside slope and toe.

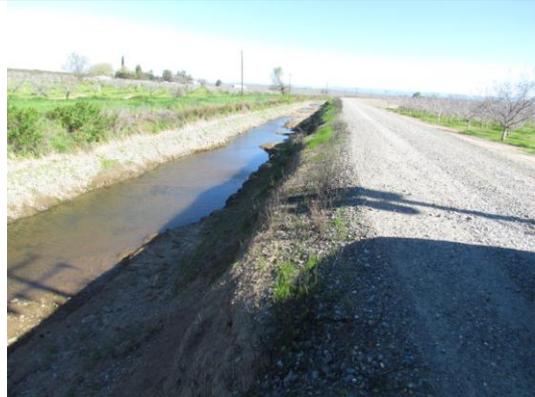
Photo 2 of 2 : mhoffman_s_20140320_269.jpg

LM Start	0.01	Rating **	M	Issue No.	42 (cont)
LM End	1.73	Issue Type +	En	Location *	LS

This photo was taken from the levee crown facing north looking at the erosion along the landward levee slope due to an agricultural ditch. Spring 2014.

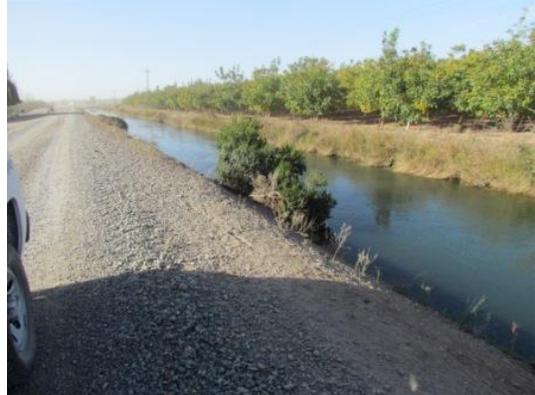
Photo 1 of 1 : mhoffman_s_20140306_050.jpg

This photo was taken from the levee crown facing south looking down the landward slope at a tree growing near the toe. Fall 2013.

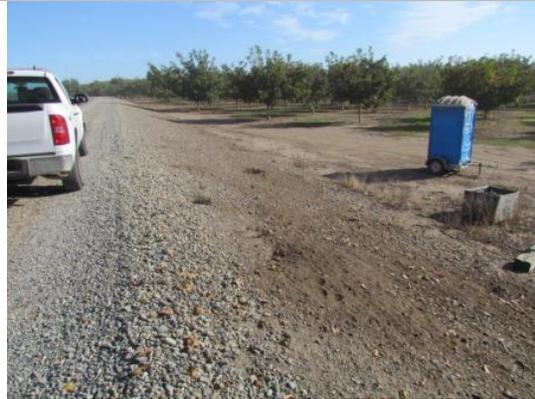
Photo 1 of 2 : mhoffman_s_20140306_051.jpg

LM Start	0.46	Rating **	M	Issue No.	217
LM End	0.46	Issue Type +	Ma	Location *	WS
Category	Earthen Levee		GPS Latitude/Longitude		
			Start	End	
Item	Animal Control		39.317050 °	39.317050 °	
			-121.633331 °	-121.633331 °	
DWR ID	DWR_MA0007_01_f_2013_217				
Action/Comments					
No rodents visible, but rodent burrows visible; need to backfill and compact or grout burrows. Inspector Comments: Rodents holes were observed but no rodents visible at time of inspection.

This photo was taken from the crown of the levee facing north looking down the slope at rodent holes. Fall 2013.

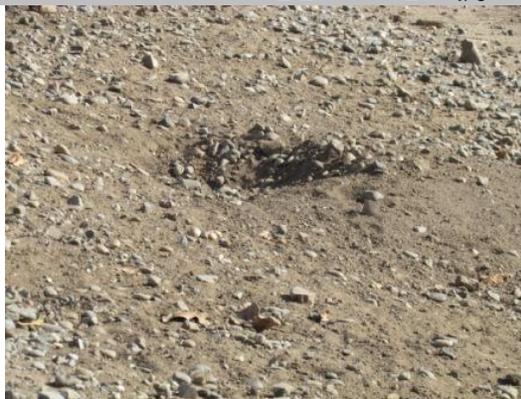
Photo 2 of 2 : mhoffman_s_20140306_052.jpg

LM Start	0.46	Rating **	M	Issue No.	217 (cont)
LM End	0.46	Issue Type +	Ma	Location *	WS
Category	Earthen Levee		GPS Latitude/Longitude		
			Start	End	
Item	Animal Control		39.317050 °	39.317050 °	
			-121.633331 °	-121.633331 °	
DWR ID	DWR_MA0007_01_f_2013_217				
Action/Comments					
No rodents visible, but rodent burrows visible; need to backfill and compact or grout burrows. Inspector Comments: Rodents holes were observed but no rodents visible at time of inspection.

Up close photo of said rodent holes. Fall 2013.

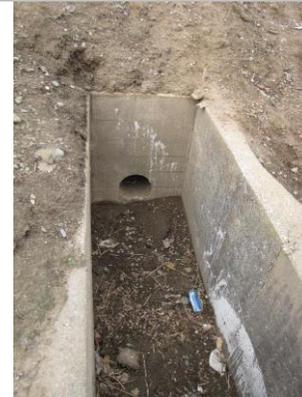
Photo 1 of 1 : UCIP_3654.jpg

LM Start	1.54	Rating **	M	Issue No.	7
LM End	1.54	Issue Type +	En	Location *	CR
Category	Supplemental			GPS Latitude/Longitude	
				Start	End
Item	DWR UCIP Field Study			39.331934 °	39.331934 °
				-121.633246 °	-121.633246 °
DWR ID	DWR_MA0007_01_s_2014_7				
Action/Comments					
Inspector Comments: FS_ID:23779 EP_NO: N/A Repair Type: Crossing Status: UCIP Comments: crossing appears abandoned, slide gate is missing on landward side; wood frame remains on LS; scour hole present on LS, 3 feet by 3 feet, near wood frame 5/10/2013 Same as last inspection. LS scour behind structure needs to be repaired 5/13/2013 SBFCA project recommends replacing in accordance with title 231/6/2013 Same as last inspection. FIELD_STRUCT_DESC: Abandoned 12-inch CM pipe through the levee, 8.2 feet below the crown. Slide gate on the landward is no longer present. Concrete "U" headwall at the waterward toe. Irrigation ditch located on landward side. FS Date: 11/8/2013 7:54:17 AM

WS view-concrete headwall located on waterward toe.

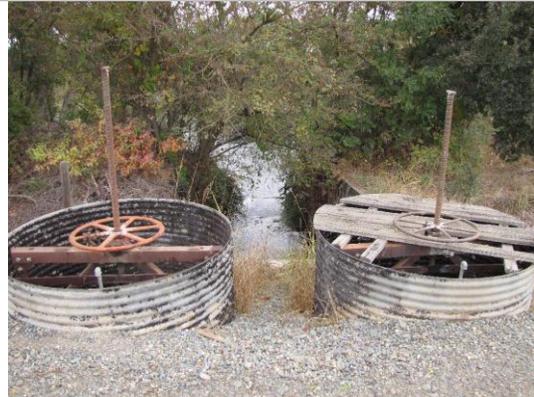
Photo 1 of 2 : UCIP_3659.jpg

LM Start	1.76	Rating **	M	Issue No.	11
LM End	1.76	Issue Type +	En	Location *	LS
Category	Supplemental			GPS Latitude/Longitude	
				Start	End
Item	DWR UCIP Field Study			39.334868 °	39.334868 °
				-121.633773 °	-121.633773 °
DWR ID	DWR_MA0007_01_s_2014_11				
Action/Comments					
Inspector Comments: FS_ID:23782 EP_NO: N/A Repair Type: Crossing Status: UCIP Comments: Debris inside riser could prevent slide gate from closing. This crossing was listed in the USACE Periodic Inspections as ID# USACE_CESPK_MA07_2010_a_0060 however, no issues noted 6/7/2013 Same debris issue as last inspection. Recommend repairing top cover to prevent falls. Wheel to open gate chained and locked so could not verify gate operation 5/13/2013 SBFCA project recommends replacing in accordance with title 231/6/2013 Same as last inspection. FIELD_STRUCT_DESC: 60-inch drain pipe through the levee, 1 of 2 pipes, two (2) 60 inch pipes, 12.5 feet below the crown. Slide gates in 78-inch CM pipe wells on the waterward slope. Concrete bulkhead on both ends. Reinforced concrete spillway on the waterward end. This entry matches the Drainage or Irrigation Structure referenced in O&M manual (Historic Station 1+90). (USACE O&M Manual, 1957) FS Date: 11/8/2013 7:56:46 AM

78-inch CMP risers located on waterward slope. Upstream riser (far left) missing riser cover. Reinforced concrete spillway also located on waterward end.

Inspector Comments: FS_ID:23782
 EP_NO: N/A
 Repair Type:
 Crossing Status:
 UCIP Comments: Debris inside riser could prevent slide gate from closing. This crossing was listed in the USACE Periodic Inspections as ID# USACE_CESPK_MA07_2010_a_0060 however, no issues noted 6/7/2013 Same debris issue as last inspection. Recommend repairing top cover to prevent falls. Wheel to open gate chained and locked so could not verify gate operation 5/13/2013 SBFCA project recommends replacing in accordance with title 231/6/2013 Same as last inspection.
 FIELD_STRUCT_DESC: 60-inch drain pipe through the levee, 1 of 2 pipes, two (2) 60 inch pipes, 12.5 feet below the crown. Slide gates in 78-inch CM pipe wells on the waterward slope. Concrete bulkhead on both ends. Reinforced concrete spillway on the waterward end. This entry matches the Drainage or Irrigation Structure referenced in O&M manual (Historic Station 1+90). (USACE O&M Manual, 1957)

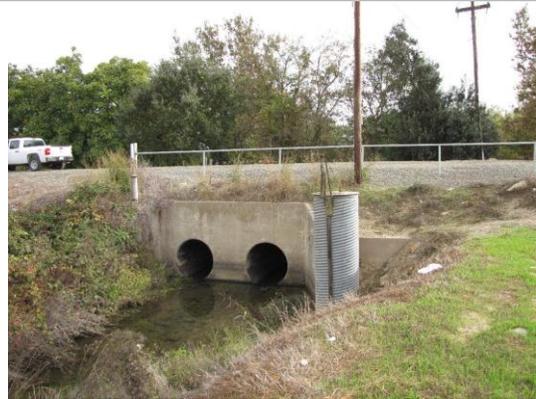
Photo 2 of 2 : UCIP_3661.jpg

Concrete headwall on landward side.

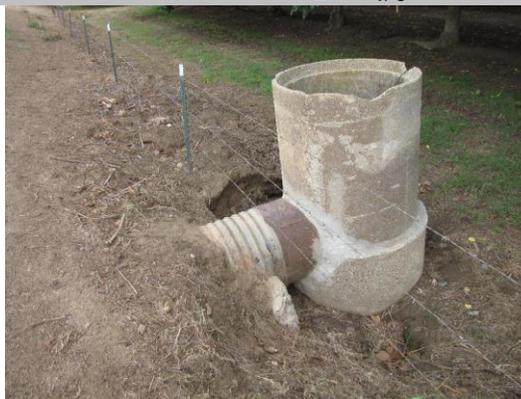
Photo 1 of 2 : UCIP_3647.jpg

Inspector Comments: FS_ID:23778
 EP_NO: N/A
 Repair Type:
 Crossing Status:
 UCIP Comments: Erosion on waterward side around concrete standpipe--might be leaking. Burrow activity present on waterward slope, unable to determine if structure is still being used. This crossing was listed in the USACE Periodic Inspections as ID# USACE_CESPK_MA07_2010_a_0075 however, no issues noted 5/7/2013 Same as last inspection. Need to investigate source of WS erosion 5/13/2013 SBFCA project recommends removal 1/6/2013 Same as last inspection.
 FIELD_STRUCT_DESC: Abandoned 24-inch CM drainpipe through the levee 12.7 feet below the crown. Flap gate on the waterward end. Concrete distribution box at the waterward toe. Second concrete distribution box located 400-500 feet from landward toe likely connected with drainage structure. This entry matches the Drainage or Irrigation Structure referenced in O&M manual (Historic Station 28+00). (USACE O&M Manual, 1957)

View of crossing and standpipe located on waterward end.

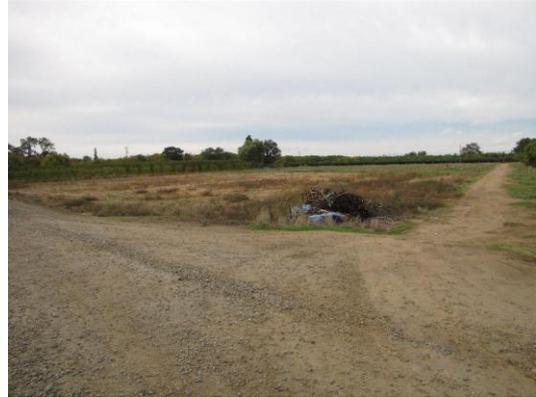
Photo 2 of 2 : UCIP_3650.jpg

Concrete distribution box located approximately 400-500 feet from landward toe.

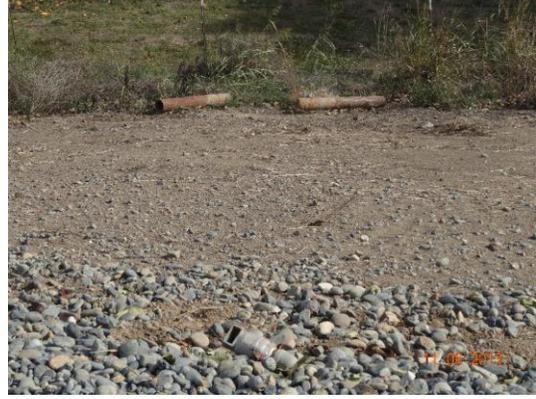
Photo 1 of 1 : UCIP_5258.jpg

LM Start	2.37	Rating **	M	Issue No.	16
LM End	2.37	Issue Type +	En	Location *	LS
Category	Supplemental			GPS Latitude/Longitude	
				Start	End
Item	DWR UCIP Field Study			39.342859 °	39.342859 °
				-121.629909 °	-121.629909 °
DWR ID	DWR_MA0007_01_s_2014_16				
Action/Comments					
Inspector Comments: FS_ID:26389 EP_NO: N/A Repair Type: Crossing Status: UCIP Comments: Need permit authorizing work 5/7/2013 Need to find owner of structure 5/13/2013 Permit number and owner in detailed report book 1/6/2013 Air vac bent over and both metal posts are laying at toe of levee. FIELD_STRUCT_DESC: Air vac on waterward shoulder protected by two metal posts. No other signs of encroachment are present. FS Date: 1/6/2014 8:41:46 AM

damaged airvent

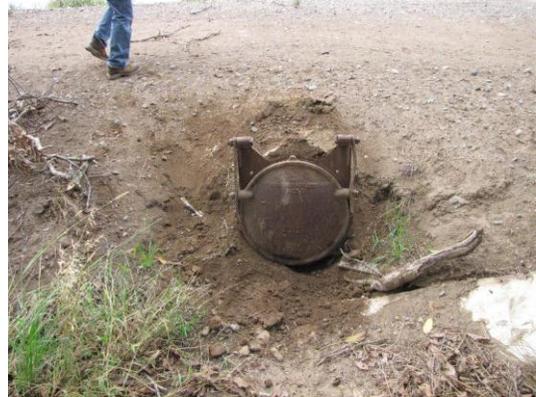
Photo 1 of 1 : UCIP_3673.jpg

LM Start	2.57	Rating **	M	Issue No.	17
LM End	2.57	Issue Type +	En	Location *	LS
Category	Supplemental			GPS Latitude/Longitude	
				Start	End
Item	DWR UCIP Field Study			39.345638 °	39.345638 °
				-121.629607 °	-121.629607 °
DWR ID	DWR_MA0007_01_s_2014_17				
Action/Comments					
Inspector Comments: FS_ID:23791 EP_NO: N/A Repair Type: Crossing Status: UCIP Comments: WS headwall may be present not visible due to soil cover. Sediment build up on landward headwall--clear. This crossing was listed in the USACE Periodic Inspections as ID# USACE_CESPK_MA07_2010_a_0083 for inoperable gate 6/7/2013 WS sediment blocking gate has been cleared so gate can operate normally. Recommend clearing sediment buildup at mouth of pipe on 11/13/2013 SBFCA project recommends replacing in accordance with title 231/6/2013 Same as last inspection. FIELD_STRUCT_DESC: 24-inch CM pipe through the levee, 6.7 feet below the crown. Flap gate on the waterward end. Concrete headwall at both toes. This entry matches the Drainage or Irrigation Structure referenced in O&M manual (Historic Station 44+50). (USACE O&M Manual, 1957) FS Date: 11/8/2013 8:10:18 AM

View of flap gate located on waterward side.

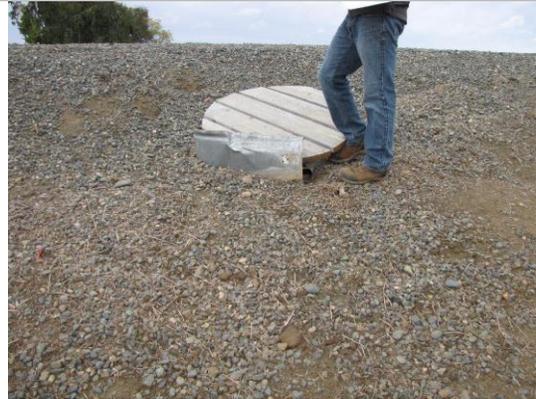
Photo 1 of 1 : UCIP_3679.jpg

LM Start	2.74	Rating **	M	Issue No.	18
LM End	2.74	Issue Type +	En	Location *	LS
Category	Supplemental			GPS Latitude/Longitude	
				Start	End
Item	DWR UCIP Field Study			39.347977 °	39.347977 °
				-121.630337 °	-121.630337 °
DWR ID	DWR_MA0007_01_s_2014_18				
Action/Comments					
Inspector Comments: FS_ID:23793 EP_NO: N/A Repair Type: Crossing Status: UCIP Comments: CMP riser damage-repair needed. Unable to locate pipe on landward side. This crossing was listed in the USACE Periodic Inspections as ID# USACE_CESPK_MA07_2010_a_0090 however, no issues noted 6/7/2013 Same as last inspection, rodent activity near crossing, need to repair rodent hole on WS/13/2013 SBFCA project recommends relacing in accordance with title 231/6/2013 Same as last inspection. FIELD_STRUCT_DESC: 24-inch CM drain pipe through the levee, 25.5 feet below the crown. Slide gate in 36-inch CM pipe riser on the waterward slope. This entry matches the Drainage or Irrigation Structure referenced in O&M manual (Historic Station 52+50). (USACE O&M Manual, 1957) FS Date: 11/8/2013 8:12:20 AM

CMP riser damaged. Part of the CMP riser wall is crushed.

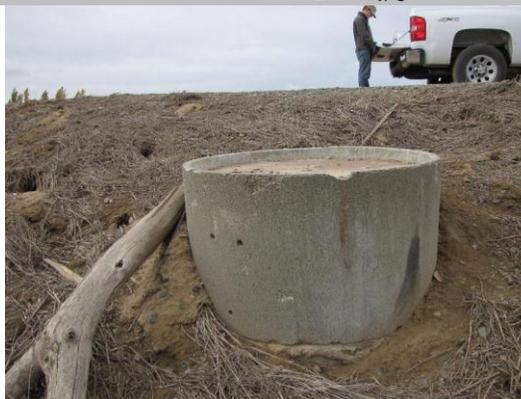
Photo 1 of 1 : UCIP_3687.jpg

LM Start	2.83	Rating **	M	Issue No.	19
LM End	2.83	Issue Type +	En	Location *	LS
Category	Supplemental		GPS Latitude/Longitude		
			Start	End	
Item	DWR UCIP Field Study		39.349158 °	39.349158 °	
			-121.630354 °	-121.630354 °	
DWR ID	DWR_MA0007_01_s_2014_19				
Action/Comments					
Inspector Comments: FS_ID:23794 EP_NO: 5722 Repair Type: Crossing Status: UCIP Comments: dense burrow activity on crown and slopes 5/7/2013 Same as last inspection. WS sediment drop above concrete stand pipe. Coordinate with owner and levee inspector to address issue 5/13/2013 SBFCA project recommends relacing in accordance with title 231/6/2013 Same as last inspection. FIELD_STRUCT_DESC: 1-12 inch cement coated and lined steel sewer pipe sleeved through the existing 24-inch CM pipe. Annular space pressure grouted. A 36 inch diameter reinforced concrete pipe riser is located on the waterward side. (Permit No. 5722-1968) The existing 24-inch CMP matches the Drainage or Irrigation structure referenced in the O&M manual (historic station 56+90, USACE O&M Manual, 1957) 24-inch CM pipe goes through levee at a depth of 21.4 feet below the crown. Slide gate in 36-inch reinforced concrete pipe riser located on the waterward slope. Crossing 2 of 2 see levee mile 3.35 entry. FS Date: 11/8/2013 8:12:54 AM

View of concrete standpipe with cover located on waterward side. Dense burrow activity near standpipe.

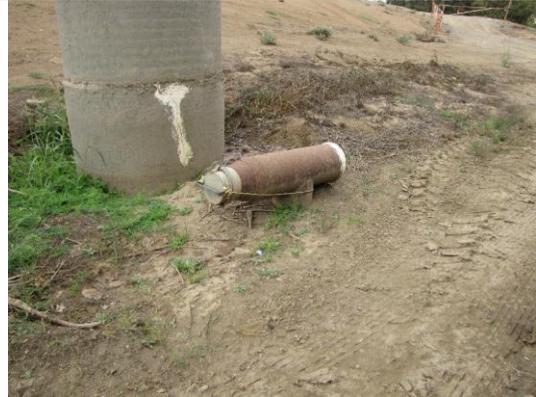
Photo 1 of 1 : UCIP_3696.jpg

View of additional appurtenances associated with crossing.

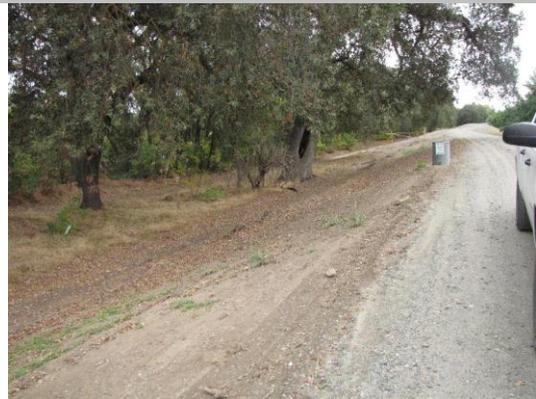
Photo 1 of 1 : UCIP_3699.jpg

LM Start	3.34	Rating **	M	Issue No.	21
LM End	3.34	Issue Type +	En	Location *	LS
Category	Supplemental			GPS Latitude/Longitude	
				Start	End
Item	DWR UCIP Field Study			39.354549 °	39.354549 °
				-121.635326 °	-121.635326 °
DWR ID	DWR_MA0007_01_s_2014_21				
Action/Comments					
Inspector Comments: FS_ID:23796 EP_NO: 5722 Repair Type: Crossing Status: UCIP Comments: shallow penetration--markers should be present at both sides of the levee to prevent damage to crossing. Marker on waterward side is damaged 5/7/2013 Contact City of Gridley to install carsonite markers on LS to mark crossings location 5/13/2013 SBFCA project recommends relacing in accordance with title 231/6/2013 Same as last inspection. FIELD_STRUCT_DESC: 18-inch cast iron sewer pipe through the levee, 2.8 feet below the crown. Concrete thrust block for cutoff walls on both shoulders. Siphon breaker in concrete pipe riser on the waterward shoulder. Pipe crosses river and discharges into sewer ponds in the left bank overflow area. (Permit No. 5722-1968) FS Date: 11/8/2013 8:14:12 AM

View of waterward side. Riser is located on waterward shoulder and marker is located approximately 15 feet from landward toe. Marker is damaged.

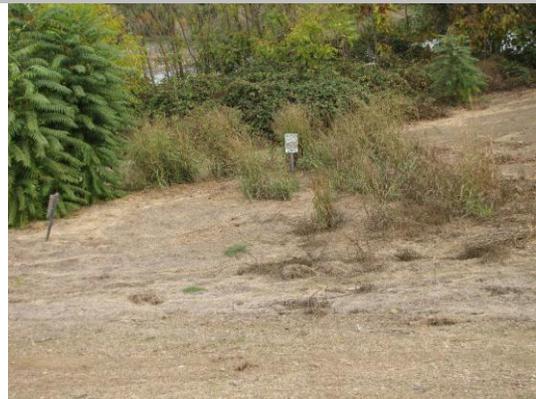
Photo 1 of 1 : UCIP_3703.jpg

LM Start	4.08	Rating **	M	Issue No.	22
LM End	4.08	Issue Type +	En	Location *	LS
Category	Supplemental		GPS Latitude/Longitude		
			Start	End	
Item	DWR UCIP Field Study		39.362706 °	39.362706 °	
			-121.643678 °	-121.643678 °	
DWR ID	DWR_MA0007_01_s_2014_22				
Action/Comments					
Inspector Comments: FS_ID:23797 EP_NO: N/A Repair Type: Crossing Status: UCIP Comments: Markers need to be replaced--marker should also be present on landward side 5/7/2013 Same as last inspection 11/6/2013 Same as last inspection. FIELD_STRUCT_DESC: 8 inch steel sewer line about 2.5 feet below crown. Air relief valve (12 inch by 24 inch) box located on landward shoulder. From waterward side, sewer line runs parallel along levee for approximately 3,952 feet downstream and ties into existing 18 inch pipeline located at LM 3.341. FS Date: 11/8/2013 8:14:44 AM

View of sewer line markers on waterward berm.

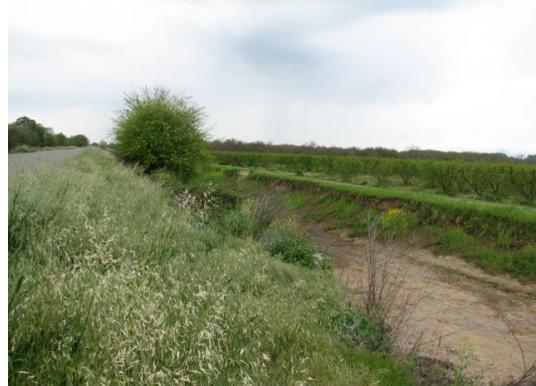
Photo 1 of 2 : mhoffman_s_20140306_045.jpg

Levee mile 5.37. This is a photo of the Ag ditch on the landside slope and toe.

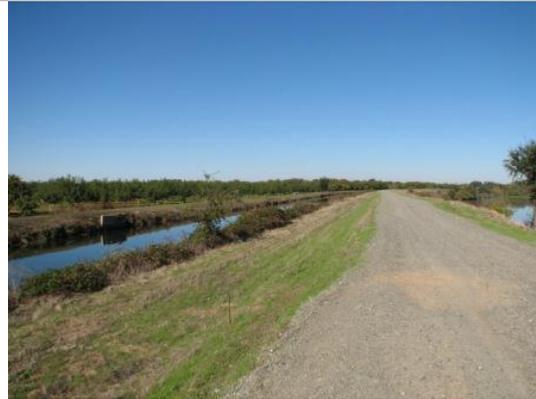
Photo 2 of 2 : mhoffman_s_20140306_046.jpg

Ag ditch landside slope and toe.

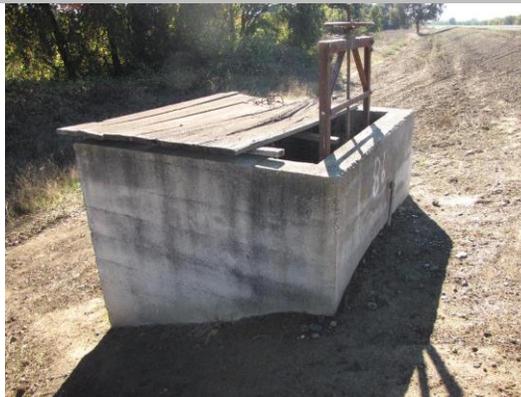
Photo 1 of 1 : UCIP_3710.jpg

LM Start	4.98	Rating **	M	Issue No.	23
LM End	4.98	Issue Type +	En	Location *	WS
Category	Supplemental		GPS Latitude/Longitude		
			Start	End	
Item	DWR UCIP Field Study		39.373851 °	39.373851 °	
			-121.650322 °	-121.650322 °	
DWR ID	DWR_MA0007_01_s_2014_23				
Action/Comments					
Inspector Comments: FS_ID:23805 EP_NO: N/A Repair Type: Crossing Status: UCIP Comments: burrow activity on waterward slope. This crossing was listed in the USACE Periodic Inspection as ID# USACE_CESPK_MA07_2010_a_0160 no issues reported 5/10/2013 Barrel down inside standpipe. Slide gate difficult to operate 5/13/2013 SBFCA project recommends relacing in accordance with title 231/7/2013 Same as last inspection. FIELD_STRUCT_DESC: 42-inch CM pipe through the levee 13.6 feet below the crown. Concrete distribution box with slide gate inside located on waterward side. 36-inch pipe goes through the waterward side berm. FS Date: 11/8/2013 8:36:13 AM

Close up view of distribution box on landward side.

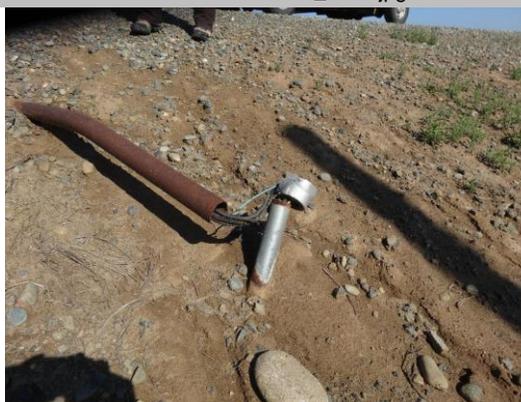
Photo 1 of 1 : UCIP_3721.jpg

LM Start	5.22	Rating **	M	Issue No.	24
LM End	5.22	Issue Type +	En	Location *	WS
Category	Supplemental		GPS Latitude/Longitude		
			Start	End	
Item	DWR UCIP Field Study		39.377343 °	39.377343 °	
			-121.650450 °	-121.650450 °	
DWR ID	DWR_MA0007_01_s_2014_24				
Action/Comments					
Inspector Comments: FS_ID:23807 EP_NO: N/A Repair Type: Crossing Status: UCIP Comments: 5/9/2013 Appeared to be damaged where it exits the WS slope, minor settling on LS toe, unable to obtain permit. SBFCA project recommends replacing in accordance with title 231/7/2013 More damage has occurred to power wires. Live wires are now exposed. Power company is aware of the problem and are going to fix it. FIELD_STRUCT_DESC: FS Date: 11/8/2013 8:51:23 AM

Conduit damage on WS slope

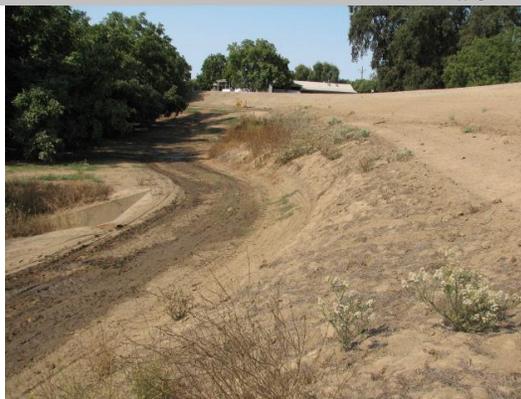
Photo 1 of 1 : mhoffman_s_20140306_036.jpg

LM Start	5.38	Rating **	M	Issue No.	5
LM End	5.98	Issue Type +	En	Location *	WS
Category	Earthen Levee		GPS Latitude/Longitude		
			Start	End	
Item	Encroachments		39.380272 °	39.380527 °	
			-121.649622 °	-121.638423 °	
DWR ID	DWR_MA0007_01_f_2012_5				
Action/Comments					
Agricultural tilling Inspector Comments: This site is property of Cilker Revocable Trust, it has an encroachment violation notice dated 7-23-2012, enforcement action : 2011-321. The stockpile has been removed, excavation at the levee toe is still present.

This photo shows vehicle traffic has cut into the toe of the levee.

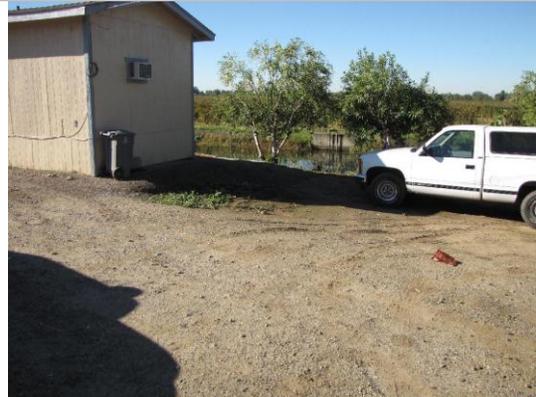
Photo 1 of 1 : UCIP_3723.jpg

LM Start	5.40	Rating **	M	Issue No.	25
LM End	5.40	Issue Type +	En	Location *	WS
Category	Supplemental		GPS Latitude/Longitude		
			Start	End	
Item	DWR UCIP Field Study		39.379838 °	39.379838 °	
			-121.650611 °	-121.650611 °	
DWR ID	DWR_MA0007_01_s_2014_25				
Action/Comments					
Inspector Comments: FS_ID:23808 EP_NO: N/A Repair Type: Crossing Status: UCIP Comments: No access to landward side--residential property; unable to determine the type of abandonment for this crossing; need to determine if there is a positive closure device on waterward side. This crossing was listed in the USACE Periodic Inspection as ID# USACE_CESPK_MA07_2010_a_0173 unknown 5/10/2013 Same as last inspection 5/13/2013 SBFCA project recommends relacing in accordance with title 231/7/2013 Same as last inspection. FIELD_STRUCT_DESC: Abandoned 24-inch CM irrigation pipe through the levee, 14.0 feet below the crown. Slide gate on the landward side. Slide gate in concrete pipe riser on the waterward berm. This entry matches the Drainage or Irrigation Structure referenced in O&M manual (Historic Station 191+13). (USACE O&M Manual, 1957) FS Date: 11/8/2013 8:51:56 AM

View of landward side--no access.

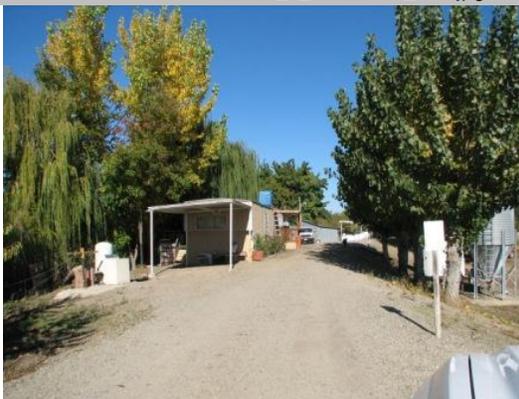
Photo 1 of 1 : mhoffman_s_20140306_043.jpg

LM Start	5.41	Rating **	M	Issue No.	9
LM End	5.41	Issue Type +	En	Location *	WS
Category	Earthen Levee		GPS Latitude/Longitude		
			Start	End	
Item	Encroachments		39.380153 °	39.380153 °	
			-121.650447 °	-121.650447 °	
DWR ID	DWR_MA0007_01_s_2012_9				
Action/Comments					
Tank

Levee mile 5.42. This photo shows a building on the landside crown, shoulder and slope.

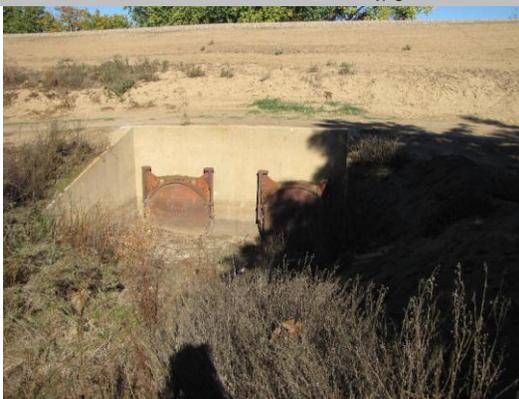
Photo 1 of 1 : UCIP_3726.jpg

LM Start	5.49	Rating **	M	Issue No.	26
LM End	5.49	Issue Type +	En	Location *	LS
Category	Supplemental		GPS Latitude/Longitude		
			Start	End	
Item	DWR UCIP Field Study		39.380377 °	39.380377 °	
			-121.649344 °	-121.649344 °	
DWR ID	DWR_MA0007_01_s_2014_26				
Action/Comments					
Inspector Comments: FS_ID:23809					
EP_NO: N/A					
Repair Type:					
Crossing Status:					
UCIP Comments: Sediment blocking flap gates on waterward side-- need to clear sediment. This crossing was listed in the USACE Periodic Inspection as ID# USACE_CESPK_MA07_2010_a_0180 no issues reported 5/10/2013 Same as last inspection 5/13/2013 SBFCA project recommends relacing in accordance with title 231.7/2013 Same as last inspection.					
FIELD_STRUCT_DESC: 1 of 2: 60 inch pipe (downstream pipe), through the levee, 23.4 feet below the crown. Flap gate on the waterward end. Concrete headwalls on both ends. Ditch at waterward outlet. This entry matches the Drainage or Irrigation Structure referenced in O&M manual (Historic Station 195+80). (USACE O&M Manual, 1957)

View of headwall structure on waterward side. Sediment built up

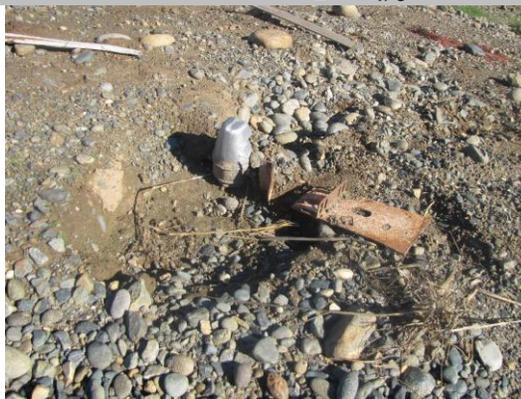
Photo 1 of 1 : UCIP_3736.jpg

LM Start	7.85	Rating **	M	Issue No.	28
LM End	7.85	Issue Type +	En	Location *	LS
Category	Supplemental		GPS Latitude/Longitude		
			Start	End	
Item	DWR UCIP Field Study		39.398336 °	39.398336 °	
			-121.630529 °	-121.630529 °	
DWR ID	DWR_MA0007_01_s_2014_28				
Action/Comments					
Inspector Comments: FS_ID:23818 EP_NO: 17895 Repair Type: Crossing Status: UCIP Comments: localized erosion at air vent located on waterward shoulder; this crossing appears to have leaking at the air vent--will need to determine reason for erosion at air vent (vehicles going over vent?); also recommend installing utility market 1/7/2013 Same as last inspection. FIELD_STRUCT_DESC: 5-inch diameter steel irrigation pipe through the right (west) bank levee and connect to existing pipe within the overflow area of the Feather River. (Permit No. 17895-2005) FS Date: 11/8/2013 9:03:15 AM

Photo 1 of 2. View of localized erosion at air vent located on waterward shoulder.

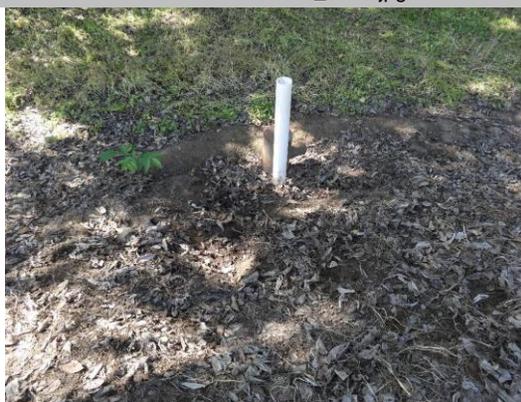
Photo 1 of 1 : UCIP_3739.jpg

LM Start	8.56	Rating **	M	Issue No.	29
LM End	8.56	Issue Type +	En	Location *	LS
Category	Supplemental		GPS Latitude/Longitude		
			Start	End	
Item	DWR UCIP Field Study		39.404475 °	39.404475 °	
			-121.636958 °	-121.636958 °	
DWR ID	DWR_MA0007_01_s_2014_29				
Action/Comments					
Inspector Comments: FS_ID:23820 EP_NO: N/A Repair Type: Crossing Status: UCIP Comments: 5/9/13 Depression along WS slope that could indicate a leak or poor compaction. Unknown permit number need to coordinate with landowner to find out more info 1/7/2013 Same as last inspection. FIELD_STRUCT_DESC: FS Date: 11/8/2013 9:04:29 AM

PVC and steel pipe on LS toe

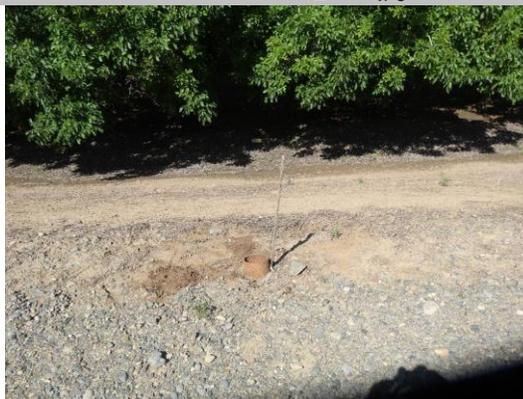
Photo 1 of 1 : UCIP_3744.jpg

LM Start	8.72	Rating **	M	Issue No.	30
LM End	8.72	Issue Type +	En	Location *	LS
Category	Supplemental		GPS Latitude/Longitude		
			Start	End	
Item	DWR UCIP Field Study		39.406614 °	39.406614 °	
			-121.637384 °	-121.637384 °	
DWR ID	DWR_MA0007_01_s_2014_30				
Action/Comments					
Inspector Comments: FS_ID:23821 EP_NO: N/A Repair Type: Crossing Status: UCIP Comments: 5/9/13 Unkown permit coordinate with landowner to find out more information 1/7/2013 Same as last inspection. FIELD_STRUCT_DESC: FS Date: 11/8/2013 9:05:15 AM

LS slope with steel standpipe

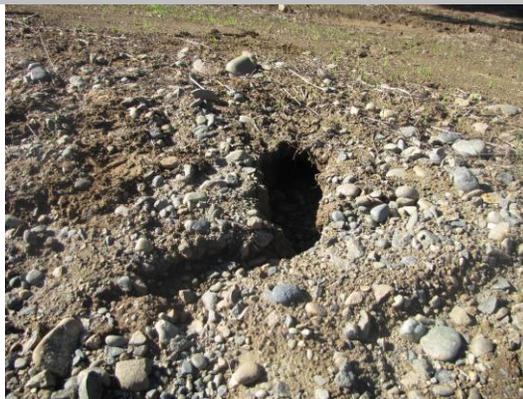
Photo 1 of 1 : UCIP_3750.jpg

LM Start	8.76	Rating **	M	Issue No.	31
LM End	8.76	Issue Type +	En	Location *	LS
Category	Supplemental		GPS Latitude/Longitude		
			Start	End	
Item	DWR UCIP Field Study		39.407159 °	39.407159 °	
			-121.637409 °	-121.637409 °	
DWR ID	DWR_MA0007_01_s_2014_31				
Action/Comments					
Inspector Comments: FS_ID:23822 EP_NO: 14200 Repair Type: Crossing Status: UCIP Comments: Landward shoulder, small hole with too much moisture; rocks look wet last rain event ocured 4 days ago 5/10/2013 Appears to just be surface erosion and not a crossing. Will keep monitoring until sur 5/13/2013 SBFCA project recommends relacing in accordance with title 231/7/2013 Same as last inspection. FIELD_STRUCT_DESC: 2-inch diameter galvanized pipe line 2 feet below crown. (Permit No. 14200-1985) FS Date: 11/8/2013 9:06:09 AM

View of cavity collapse along assumed pipe alignment located on landward shoulder.

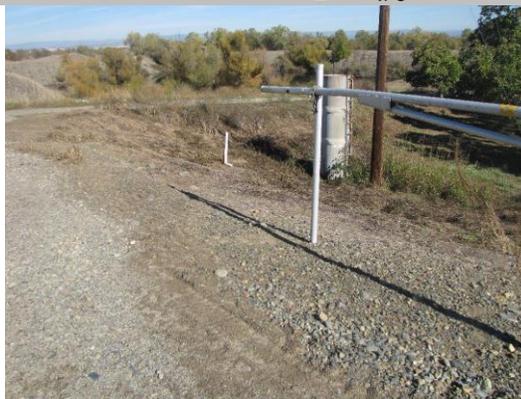
Photo 1 of 1 : UCIP_3754.jpg

View of waterward side and levee shoulder looking upstream at crossing. Crossing appurtances include concrete riser and power pole.

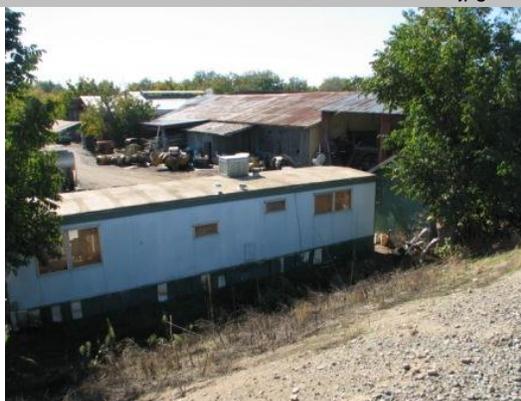
Photo 1 of 1 : mhoffman_s_20140306_049.jpg

Levee mile 9.79. This photo shows a building at the landside toe.

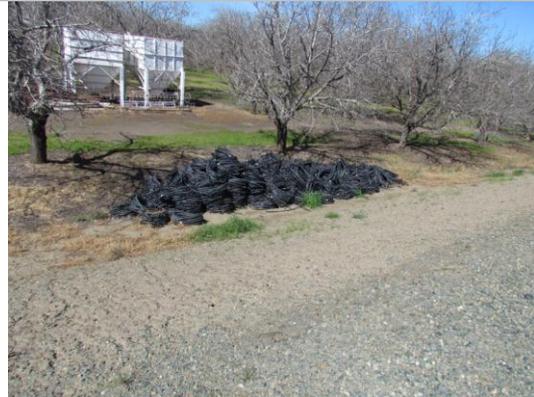
Photo 1 of 1 : mhoffman_s_20140320_270.jpg

This photo was taken from the levee crown facing north looking at irrigation pipe placed on the levee slope near the landward toe. Spring 2014.

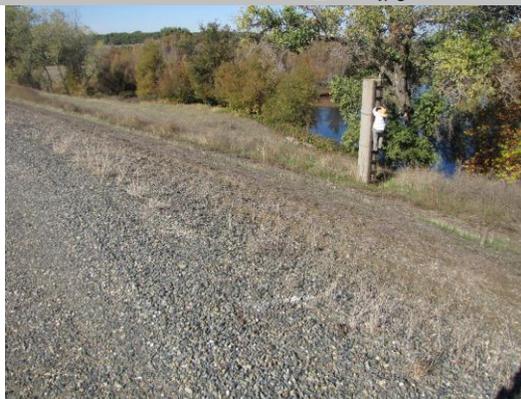
Photo 1 of 1 : UCIP_3760.jpg

View of waterward shoulder and slope looking upstream at crossing.

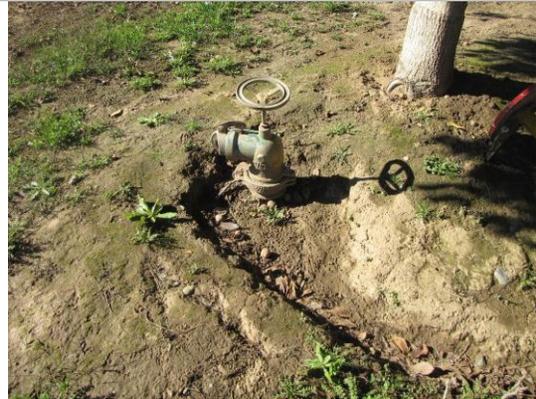
Photo 1 of 1 : UCIP_3764.jpg

Valve located on landward toe with surface erosion around valve.

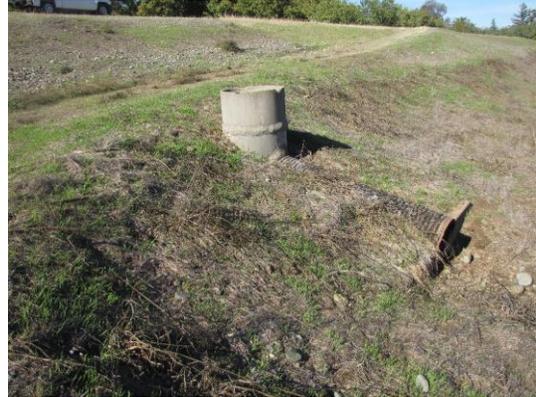
Photo 1 of 1 : UCIP_3770.jpg

View of concrete standpipe located on waterward side.

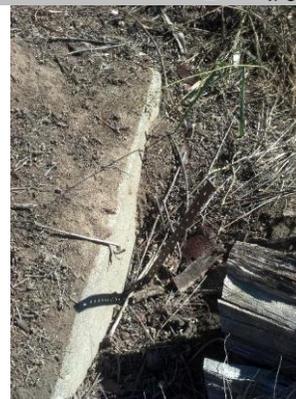
Photo 1 of 1 : UCIP_3774.jpg

Exposed concrete headwall located at the toe of the levee on the landward side.

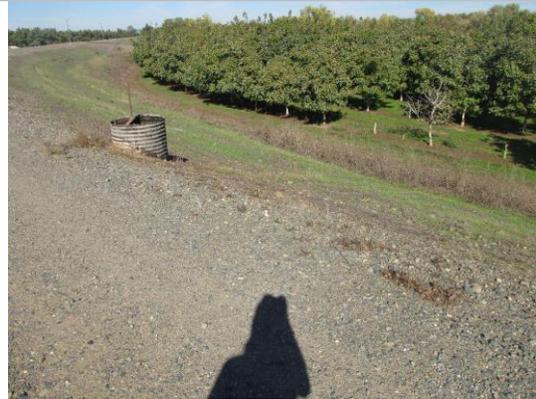
Photo 1 of 1 : UCIP_3779.jpg

View of waterward side looking upstream at crossing. CMP riser located on waterward shoulder.

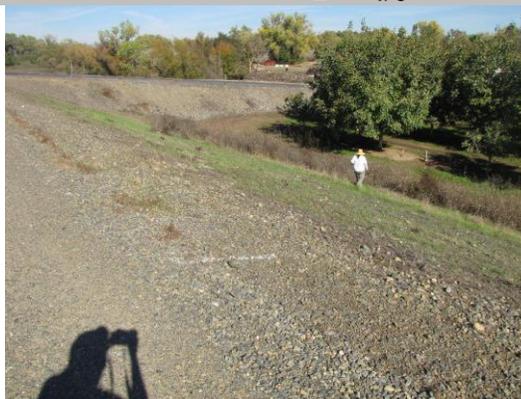
Photo 1 of 1 : UCIP_3783.jpg

View of waterward side looking upstream at crossing.

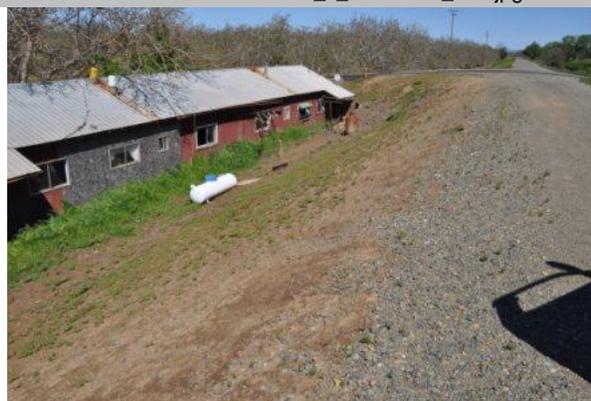
Photo 1 of 1 : mhoffman_s_20140306_042.jpg

L/S levee toe- Abandoned building.

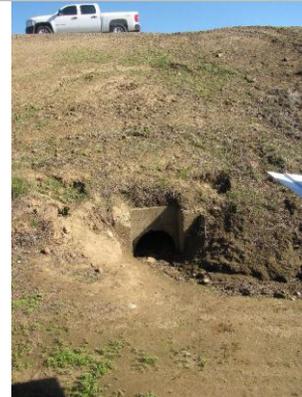
Photo 1 of 1 : UCIP_3792.jpg

View of inlet located on landward side.

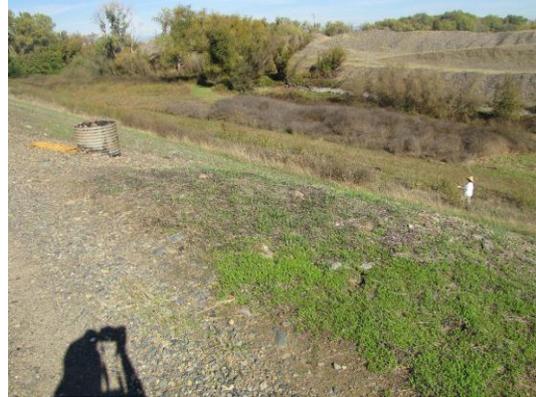
Photo 1 of 1 : UCIP_3795.jpg

View of waterward side looking upstream at crossing.

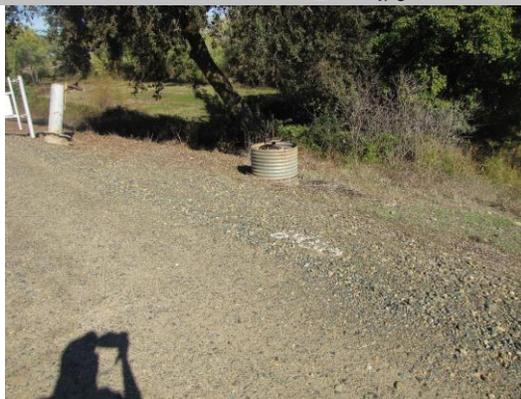
Photo 1 of 1 : UCIP_3804.jpg

View of waterward side looking upstream at crossing.

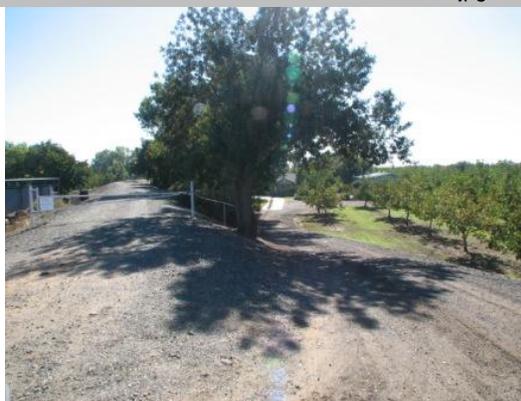
Photo 1 of 1 : mhoffman_s_20140306_048.jpg

Landside landscaping levee mile 11.63.

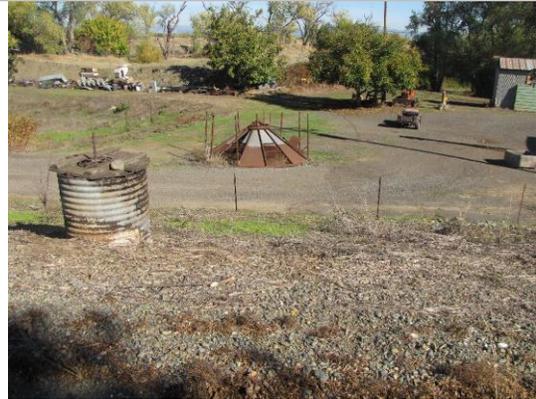
Photo 1 of 1 : UCIP_5264.jpg

View of waterward side with unknown structure along pipe alignment and pump located over 100 feet from waterward toe.
