**Flood Control Project Maintenance
Levee Inspections**
LMA District Cover Sheet
Spring 2015 Levee Inspection Results

Sutter Maintenance Yard Maintenance Area 0007

Spring 2015 Levee Inspection Results

Waterway		Bank	Unit Miles
Unit No. 01 Feather River		Right	11.90

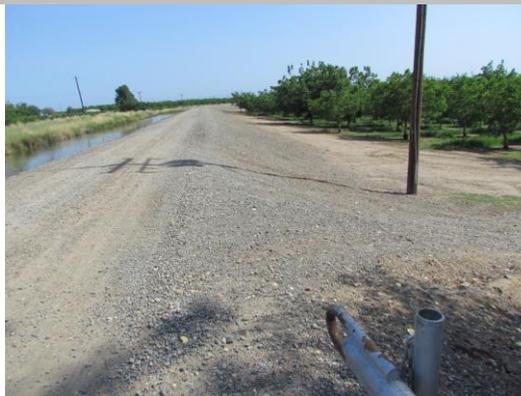
Photo 1 of 1 : SP_2015_MA0007_200_47_20150505_00017.jpg

LM Start	0.01	Rating **	A	Issue No.	47
LM End	1.77	Issue Type +	Ma	Location *	WS
Category	Earthen Levee		GPS Latitude/Longitude		
			Start	End	
Item	Vegetation		39.311097 °	39.335015 °	
			-121.637638 °	-121.633808 °	
DWR ID	DWR_MA0007_01_s_2015_47				
Action/Comments					
Control annual grass and weeds on the levee slopes and easements.

The view of the vegetation was taken on the waterside facing upstream.

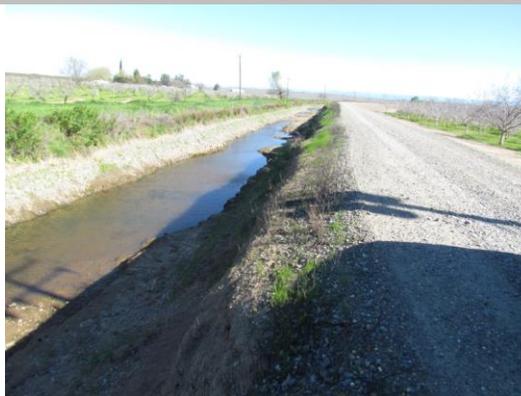
Photo 1 of 2 : SP_2015_MA0007_200_42_20150401_00007.jpg

LM Start	0.03	Rating **	M	Issue No.	42
LM End	1.72	Issue Type +	En	Location *	LS
Category	Earthen Levee		GPS Latitude/Longitude		
			Start	End	
Item	Encroachments		39.311297 °	39.334365 °	
			-121.637490 °	-121.633975 °	
DWR ID	DWR_MA0007_01_s_2012_42				
Action/Comments					
Ditch Inspector Comments: Erosion along landward levee slope due to agricultural ditch.

This photo was taken from the levee crown facing north looking at the erosion along the landward levee slope due to an agricultural ditch. Spring 2014.

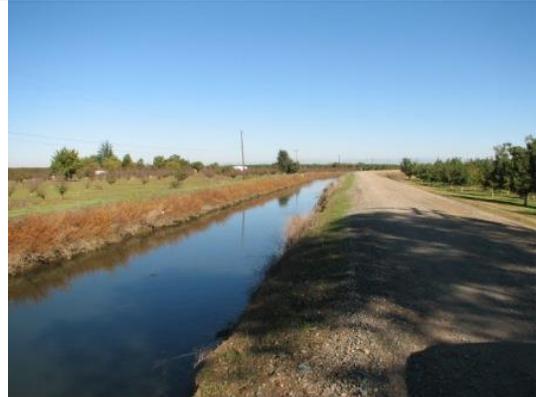
Photo 2 of 2 : SP_2015_MA0007_200_42_20150401_00008.jpg

LM Start	0.03	Rating **	M	Issue No.	42 (cont)
LM End	1.72	Issue Type +	En	Location *	LS
Category	Earthen Levee			GPS Latitude/Longitude	
				Start	End
Item	Encroachments			39.311297 °	39.334365 °
				-121.637490 °	-121.633975 °
DWR ID	DWR_MA0007_01_s_2012_42				
Action/Comments					
Ditch Inspector Comments: Erosion along landward levee slope due to agricultural ditch.

Agricultural ditch landside slope and toe.

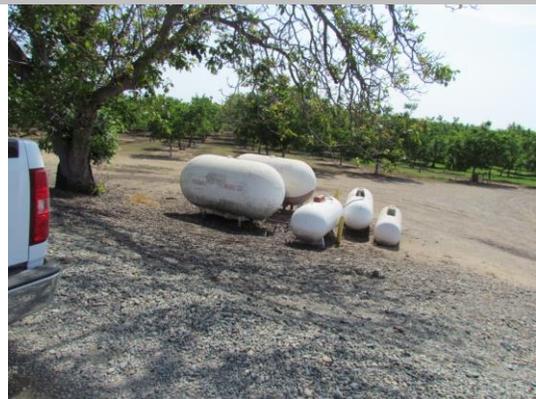
Photo 1 of 1 : SP_2015_MA0007_200_48_20150505_00016.jpg

LM Start	0.47	Rating **	M	Issue No.	48
LM End	0.47	Issue Type +	En	Location *	WS
Category	Earthen Levee			GPS Latitude/Longitude	
				Start	End
Item	Encroachments			39.316950 °	39.316950 °
				-121.633438 °	-121.633438 °
DWR ID	DWR_MA0007_01_s_2015_48				
Action/Comments					
Tank

This view of the tanks was taken looking at the waterside of the levee facing upstream.

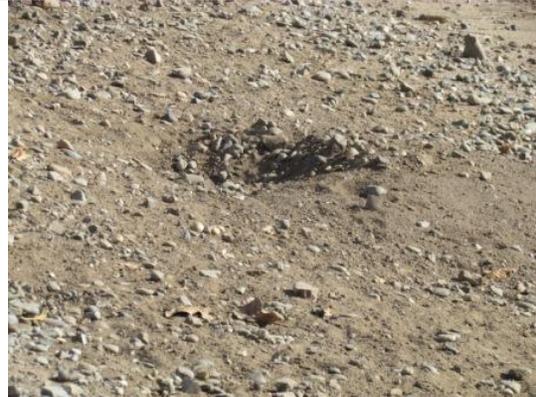
Photo 1 of 2 : SP_2015_MA0007_200_217_20150401_00014.jpg

LM Start	0.48	Rating **	M	Issue No.	217
LM End	0.48	Issue Type +	Ma	Location *	WS
Category	Earthen Levee		GPS Latitude/Longitude		
			Start	End	
Item	Animal Control		39.317050 °	39.317050 °	
			-121.633331 °	-121.633331 °	
DWR ID	DWR_MA0007_01_f_2013_217				
Action/Comments					
No rodents visible, but rodent burrows visible; need to backfill and compact or grout burrows. Inspector Comments: Rodents holes were observed but no rodents visible at time of inspection.

Up close photo of said rodent holes. Fall 2013.

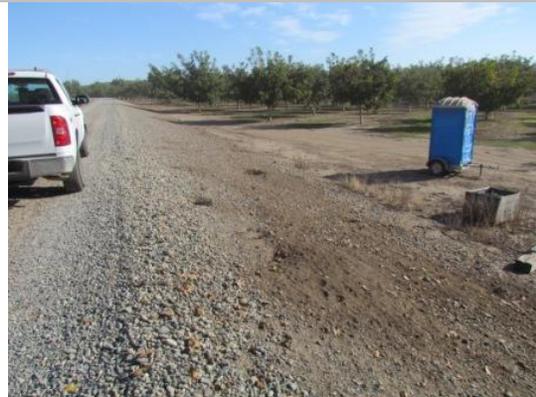
Photo 2 of 2 : SP_2015_MA0007_200_217_20150401_00015.jpg

This photo was taken from the crown of the levee facing north looking down the slope at rodent holes. Fall 2013.

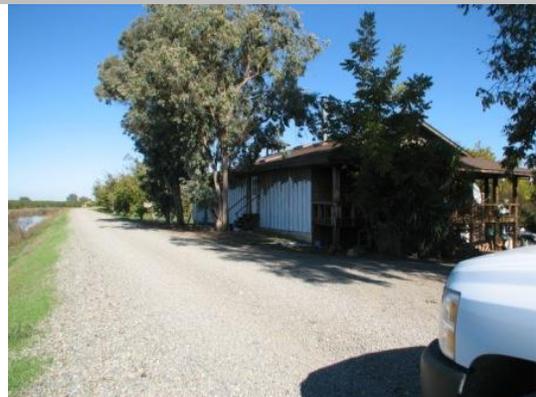
Photo 1 of 1 : SP_2015_MA0007_200_33_20150401_00004.jpg

LM Start	1.21	Rating **	U	Issue No.	33
LM End	1.21	Issue Type +	En	Location *	WS
Category	Earthen Levee		GPS Latitude/Longitude		
			Start	End	
Item	Encroachments		39.327187 °	39.327187 °	
			-121.632395 °	-121.632395 °	
DWR ID	DWR_MA0007_01_s_2012_33				
Action/Comments					
Building

Levee mile 1.21. This is a photo of the building on the waterside slope.

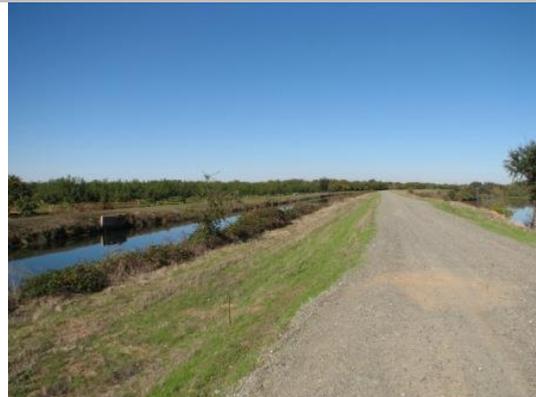
Photo 1 of 2 : SP_2015_MA0007_200_39_20150401_00005.jpg

LM Start	4.39	Rating **	M	Issue No.	39
LM End	5.34	Issue Type +	En	Location *	LS
Category	Earthen Levee			GPS Latitude/Longitude	
				Start	End
Item	Encroachments			39.366547 °	39.379961 °
				-121.647523 °	-121.650632 °
DWR ID	DWR_MA0007_01_s_2012_39				
Action/Comments					
Ditch

Ag ditch landside slope and toe.

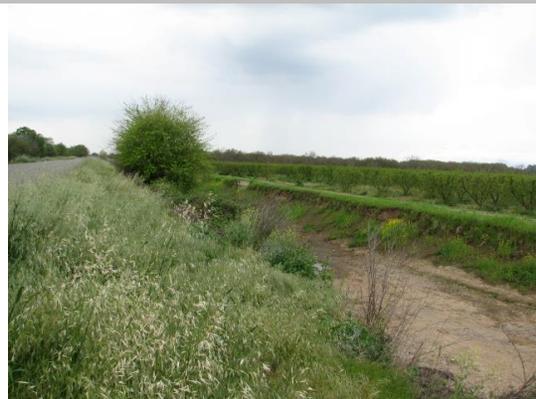
Photo 2 of 2 : SP_2015_MA0007_200_39_20150401_00006.jpg

This is a photo of the Ag ditch on the landside slope and toe.

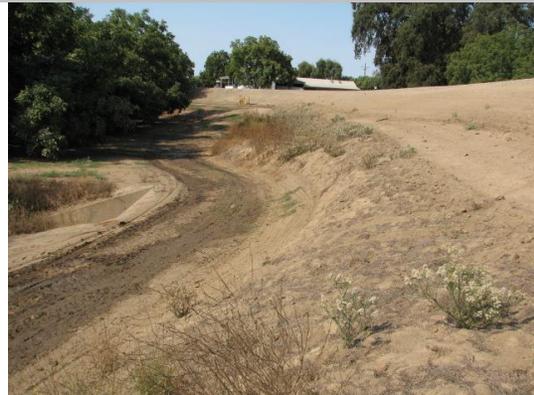
Photo 1 of 1 : SP_2015_MA0007_200_5_20150401_00001.jpg

LM Start	5.40	Rating **	M	Issue No.	5
LM End	6.00	Issue Type +	En	Location *	WS
Category	Earthen Levee			GPS Latitude/Longitude	
				Start	End
Item	Encroachments			39.380272 °	39.380527 °
				-121.649622 °	-121.638423 °
DWR ID	DWR_MA0007_01_f_2012_5				
Action/Comments					
Agricultural tilling Inspector Comments: This site is property of Cilker Revocable Trust, it has an encroachment violation notice dated 7-23-2012, enforcement action : 2011-321. The stockpile has been removed, excavation at the levee toe is still present.

This photo shows vehicle traffic has cut into the toe of the levee.

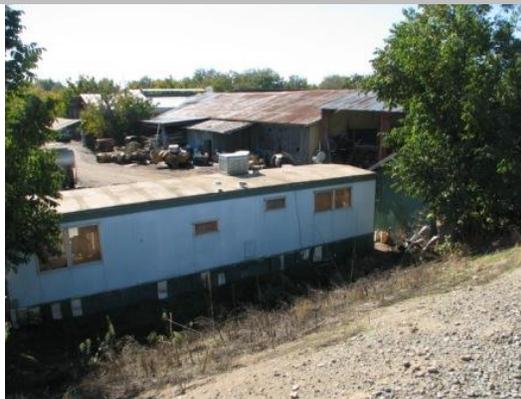
Photo 1 of 1 : SP_2015_MA0007_200_45_20150401_00010.jpg

LM Start	9.65	Rating **	U	Issue No.	45
LM End	9.65	Issue Type +	En	Location *	LS
Category	Earthen Levee			GPS Latitude/Longitude	
				Start	End
Item	Encroachments			39.416384 °	39.416384 °
				-121.634503 °	-121.634503 °
DWR ID	DWR_MA0007_01_s_2012_45				
Action/Comments					
Building

This photo shows a building at the landside toe.

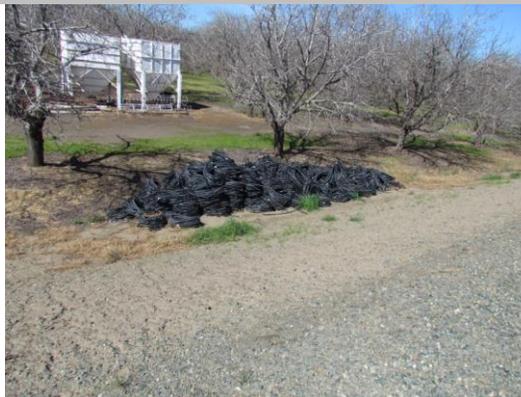
Photo 1 of 1 : SP_2015_MA0007_200_51_20150401_00012.jpg

LM Start	9.69	Rating **	M	Issue No.	51
LM End	9.69	Issue Type +	En	Location *	LS
Category	Earthen Levee		GPS Latitude/Longitude		
			Start	End	
Item	Encroachments		39.416864 °	39.416864 °	
			-121.634822 °	-121.634822 °	
DWR ID	DWR_MA0007_01_s_2014_51				
Action/Comments					
Debris Inspector Comments: Irrigation pipe on landward levee slope. Spring 2014.

This photo was taken from the levee crown facing north looking at irrigation pipe placed on the levee slope near the landward toe. Spring 2014.

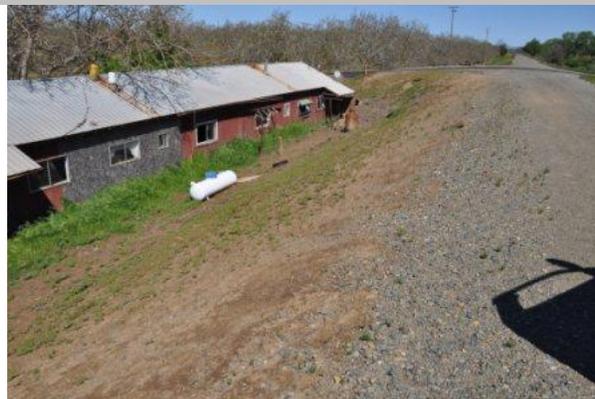
Photo 1 of 1 : SP_2015_MA0007_200_15_20150401_00002.jpg

LM Start	11.08	Rating **	M	Issue No.	15
LM End	11.08	Issue Type +	En	Location *	LS
Category	Earthen Levee			GPS Latitude/Longitude	
				Start	End
Item	Encroachments			39.431591 °	39.431591 °
				-121.645477 °	-121.645477 °
DWR ID	DWR_MA0007_01_s_2013_15				
Action/Comments					
Building Inspector Comments: Building appears to be abandoned.

L/S levee toe- Abandoned building.
