**Flood Control Project Maintenance
Levee Inspections**

Fall 2012 Levee Maintenance Deficiency Summary Report

Sutter Maintenance Yard Maintenance Area 0012

Waterway		Bank	Unit Miles
Unit No. 01 Colusa Drain		Left	11.31

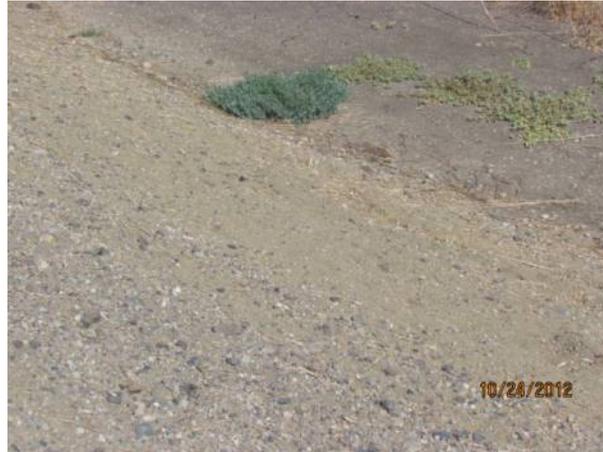
Levee Mile Report Line	7
Start Levee Mile	5.30
End Levee Mile	5.30
Location	Land Side
Category	Earthen Levee
Item	Animal Control
View of the levee slope with no rodent activity.	
rduffey_f_20121203_380.JPG

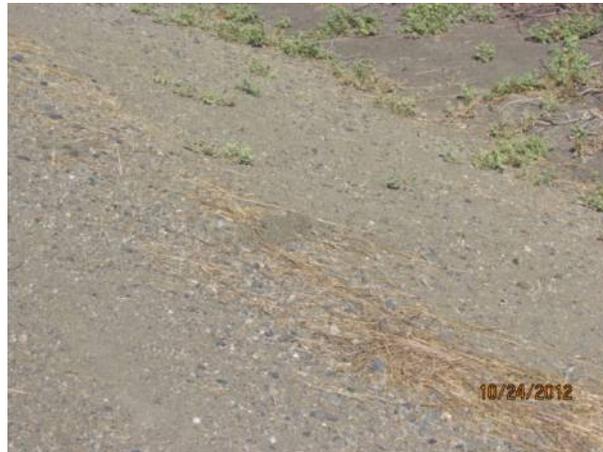
Levee Mile Report Line	8
Start Levee Mile	5.77
End Levee Mile	5.77
Location	Land Side
Category	Earthen Levee
Item	Animal Control
View of the levee slope with no rodent activity.	
rduffey_f_20121203_381.JPG

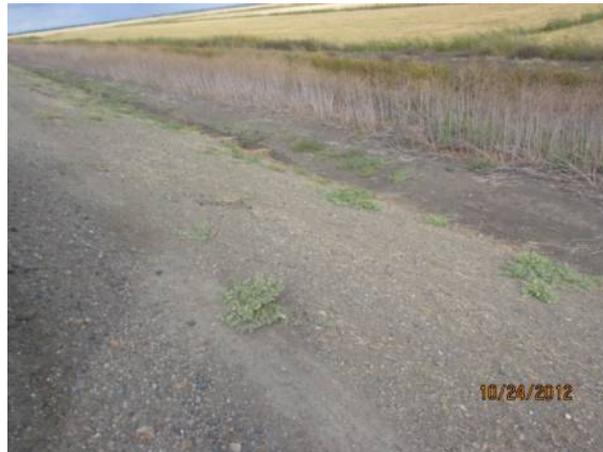
Levee Mile Report Line	9
Start Levee Mile	5.82
End Levee Mile	5.82
Location	Land Side
Category	Earthen Levee
Item	Animal Control
View of the slope levee with no rodent activity.	
rduffey_f_20121203_382.JPG

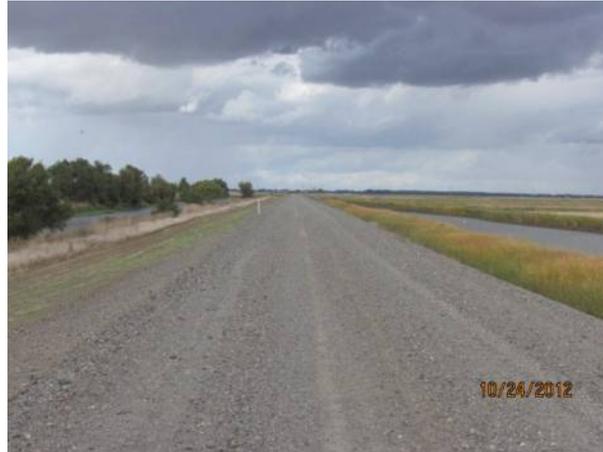
Levee Mile Report Line	10
Start Levee Mile	7.04
End Levee Mile	7.04
Location	Land Side
Category	Earthen Levee
Item	Vegetation
View of the levee slopes with no vegetation.	
rduffey_f_20121203_383.JPG

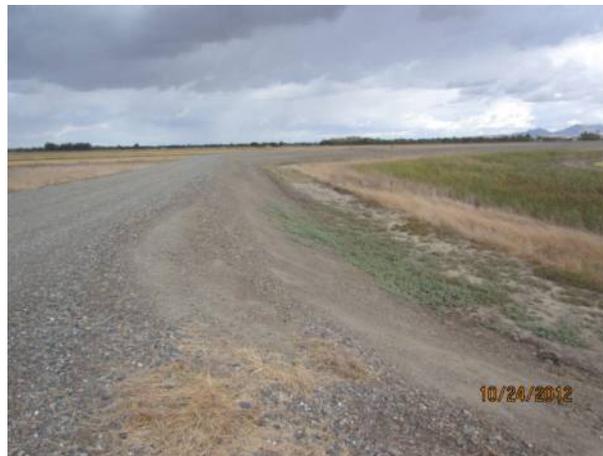
Levee Mile Report Line	12
Start Levee Mile	10.31
End Levee Mile	10.31
Location	Land Side
Category	Earthen Levee
Item	Animal Control
View of the levee slope with no rodent activity.	
rduffey_f_20121203_384.JPG
