**Flood Control Project Maintenance  
Levee Inspections**

**Fall 2014 Levee Maintenance Deficiency Summary Report**

**Sutter Maintenance Yard Maintenance Area 0012**

Waterway		Bank	Unit Miles	
Unit No. 01 Colusa Drain		Left	11.06	
	Spring (March - May)	Summer (June - August)	(September - November) Fall	Winter (December - February)
Unit Maintenance Rating (Fall Only)			<b>A</b>	
Date of Inspection	03/12/2014 - 03/12/2014		10/22/2014 - 10/22/2014	
DWR Inspector	Bob Duffey		Bob Duffey	
Accompanied By	Bryan Reniff Sutter Maintenance Yard		Bryan Reniff Sutter Maintenance Yard

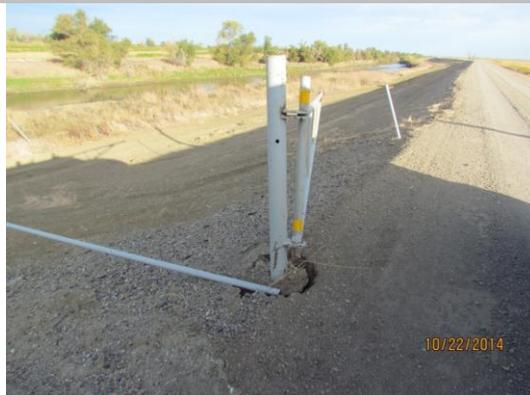
Photo 1 of 1 : FA\_2014\_MA0012\_299\_22\_20141118\_00009.jpg

LM Start	<b>4.83</b>	Rating **	M	Issue No.	<b>22</b>
LM End	<b>4.83</b>	Issue Type +	Ma	Location *	WS
Category	Earthen Levee		GPS Latitude/Longitude		
			Start	End	
Item	Repair Gates		39.096777 °	39.096777 °	
			-122.015548 °	-122.015548 °	
DWR ID	DWR_MA0012_01_f_2014_22				
Action/Comments

View of the gate that needs to be repaired.

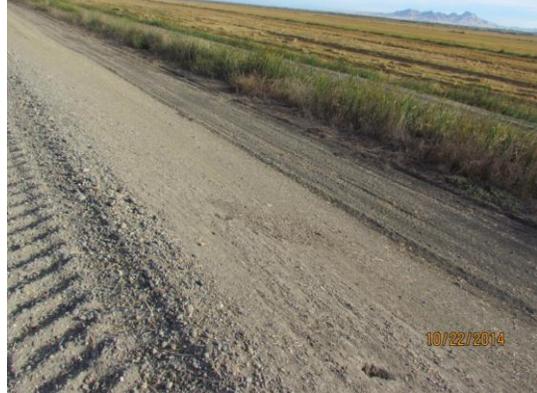
Photo 1 of 1 : FA\_2014\_MA0012\_299\_206\_20141118\_00011.jpg

View of the rodent holes on the landside slope.

LM Start	<b>5.30</b>	Rating **	A/W	Issue No.	<b>206</b>
LM End	<b>5.30</b>	Issue Type +	Ma	Location *	LS
Category	Earthen Levee			GPS Latitude/Longitude	
				Start	End
Item	Animal Control			39.103490 °	39.103490 °
				-122.016340 °	-122.016340 °
DWR ID	DWR_MA0012_01_s_2012_206				
Action/Comments					
Exterminate rodents and backfill and compact or grout burrows.

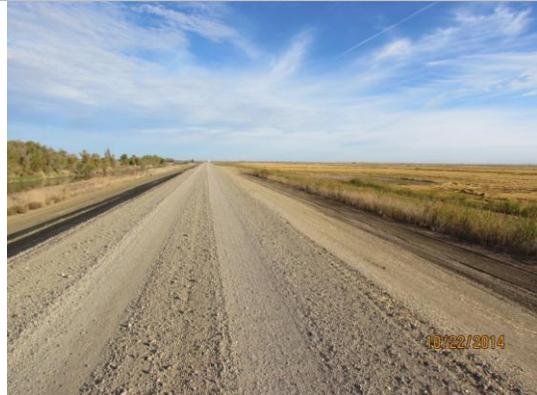
Photo 1 of 1 : FA\_2014\_MA0012\_299\_23\_20141118\_00010.jpg

View of controlled vegetation on both slopes.

LM Start	<b>5.61</b>	Rating **	A	Issue No.	<b>23</b>
LM End	<b>5.61</b>	Issue Type +	Ma	Location *	LS
Category	Earthen Levee			GPS Latitude/Longitude	
				Start	End
Item	Vegetation			39.107792 °	39.107792 °
				-122.016968 °	-122.016968 °
DWR ID	DWR_MA0012_01_f_2014_23				
Action/Comments					
Control annual grass and weeds on the levee slopes and easements.

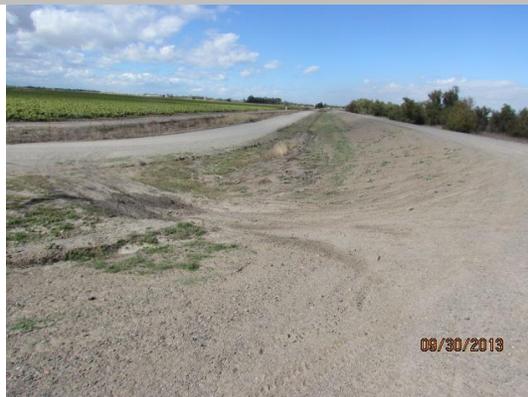
Photo 1 of 1 : FA\_2014\_MA0012\_299\_11\_20141013\_00001.jpg

View of the slope vehicle erosion.

LM Start	<b>10.72</b>	Rating **	M	Issue No.	<b>11</b>
LM End	<b>10.72</b>	Issue Type +	Ma	Location *	LS
Category	Earthen Levee		GPS Latitude/Longitude		
			Start	End	
Item	Slope Stability		39.173971 °	39.173971 °	
			-122.014362 °	-122.014362 °	
DWR ID	DWR_MA0012_01_f_2013_11				
Action/Comments					
Repair the levee slope damaged by vehicle traffic and prevent access where possible.
