**Flood Control Project Maintenance  
Levee Inspections**

**Levee Inspection Report By Mile - Spring 2010**

**Sutter Maintenance Yard Maintenance Area 0012**

Waterway						Bank	Unit Miles	Inspection Start/End	Inspector	
Unit No. 01 Colusa Drain						Left	11.31	03/22/2010 03/22/2010	Bob Duffey	
LMR No	Levee Mile		Category	Item	Location *	Rating **	Action/Comment	GPS Latitude/Longitude		Issue No. Photo
	Start	End						Start	End	
1	2.65	3.76	Earthen Levee	Encroachments	LS	PO	Agricultural Ditch	39.067343 ° -122.009611 °	39.081684 ° -122.016243 °	1
2	3.60	3.69	Earthen Levee	Erosion / Bank Caving	LS	M	Schedule repair of erosion site prior to the next inspection.	39.079396 ° -122.016328 °	39.080715 ° -122.016420 °	2 Y
3	4.16	4.31	Earthen Levee	Encroachments	LS	PO	Agricultural Ditch	39.087326 ° -122.015182 °	39.089409 ° -122.015253 °	3
4	4.83	4.88	Earthen Levee	Encroachments	LS	PO	Agricultural Ditch	39.096839 ° -122.015568 °	39.097455 ° -122.015581 °	4
5	7.68	7.70	Earthen Levee	Erosion / Bank Caving	WS	M	Schedule repair of erosion site prior to the next inspection.	39.136206 ° -122.022815 °	39.136464 ° -122.022819 °	5 Y

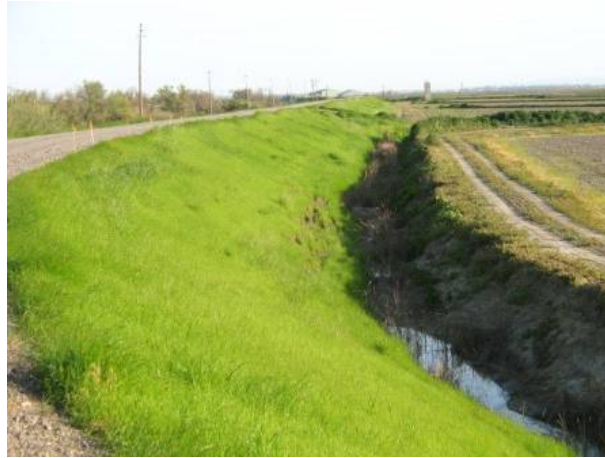
rduffey\_s\_20100607\_008.jpg

Levee Mile Report Line	2
Start Levee Mile	3.60
End Levee Mile	3.69
Location	Land Side
Category	Earthen Levee
Item	Erosion / Bank Caving

View of the erosion along the landslide toe of the levee.

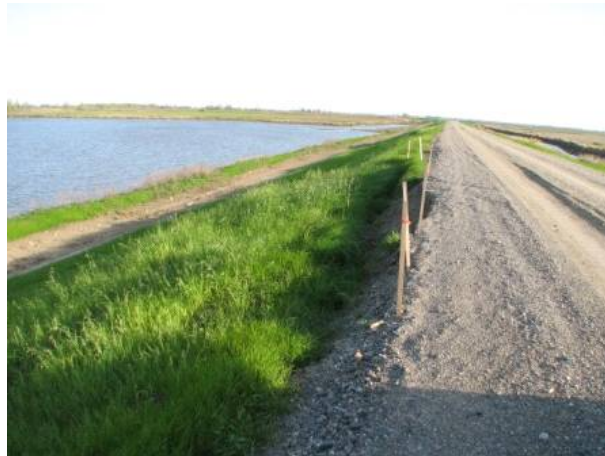
rduffey\_s\_20100607\_009.jpg

Levee Mile Report Line	5
Start Levee Mile	7.68
End Levee Mile	7.70
Location	Water Side
Category	Earthen Levee
Item	Erosion / Bank Caving

View of the erosion along the edge of the waterside crown.

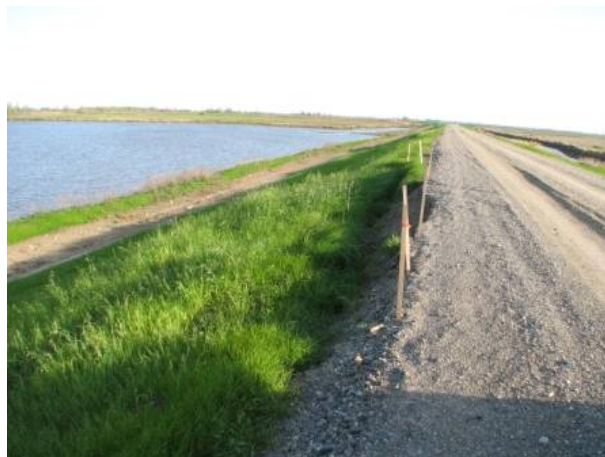
rduffey\_s\_20100607\_015.jpg

Levee Mile Report Line	6
Start Levee Mile	7.92
End Levee Mile	7.94
Location	Water Side
Category	Earthen Levee
Item	Erosion / Bank Caving

View of the erosion along the waterside crown of the levee

6	7.92	7.94	Earthen Levee	Erosion / Bank Caving	WS	M	Schedule repair of erosion site prior to the next inspection.	39.139608 ° -122.022566 °	39.139788 ° -122.022539 °	6 Y
7	10.72	10.72	Earthen Levee	Slope Stability	WS	M	Repair the levee slope damaged by vehicle traffic and prevent access where possible.	39.173931 ° -122.014372 °	39.173931 ° -122.014372 °	7
