**Flood Control Project Maintenance
Levee Inspections****LMA District Cover Sheet****Spring 2011 Levee Inspection Results****Sutter Maintenance Yard Maintenance Area 0012**

Spring 2011 Levee Inspection Results

Sutter Maintenance Yard Maintenance Area 0012

Waterway			Bank	Unit Miles
Unit No. 01 Colusa Drain			Left	11.31

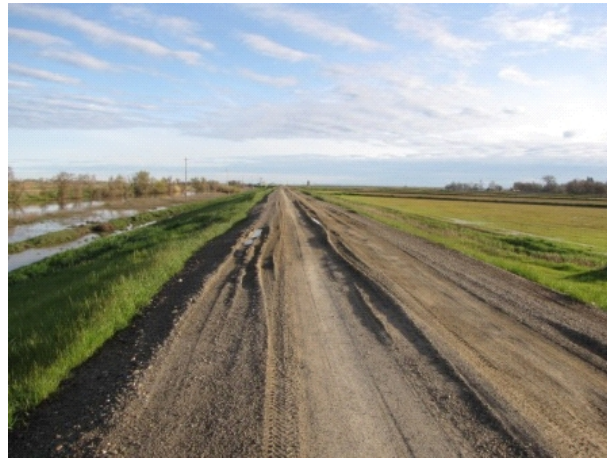
Levee Mile Report Line	2
Start Levee Mile	3.77
End Levee Mile	11.28
Location	Crown
Category	Earthen Levee
Item	Crown Surface / Depressions / Rutting
View of the crown roadway that needs gravel & Grading.	
rduffey_s_20110427_280.jpg

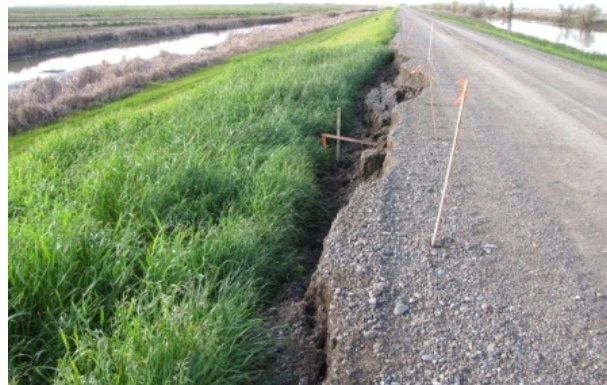
Levee Mile Report Line	5
Start Levee Mile	7.66
End Levee Mile	7.68
Location	Land Side
Category	Earthen Levee
Item	Slope Stability
View of the slope slip along the L/S crown roadway.	
rduffey_s_20110427_281.jpg

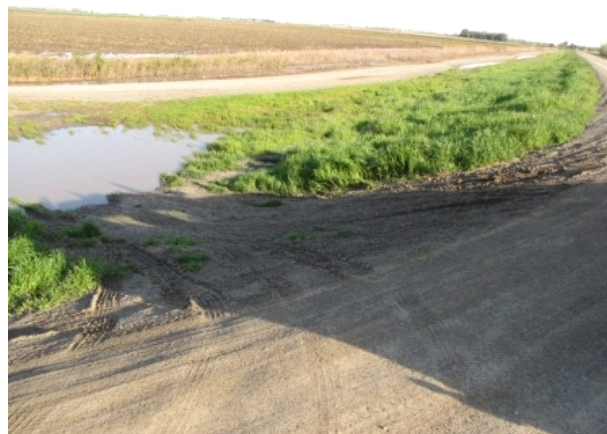
Levee Mile Report Line	6
Start Levee Mile	10.72
End Levee Mile	10.72
Location	Land Side
Category	Earthen Levee
Item	Slope Stability
View of vehicle erosion along the slope.	
rduffey_s_20110427_282.jpg
