**Flood Control Project Maintenance
Levee Inspections****LMA District Cover Sheet****Spring 2012 Levee Inspection Results****Sutter Maintenance Yard Maintenance Area 0012**

Levee Inspection Report By Mile - Spring 2012

Waterway					Bank	Unit Miles	Inspection Start/End	Inspector
Unit No. 01 Colusa Drain					Left	11.31	03/13/2012 03/13/2012	Bob Duffey

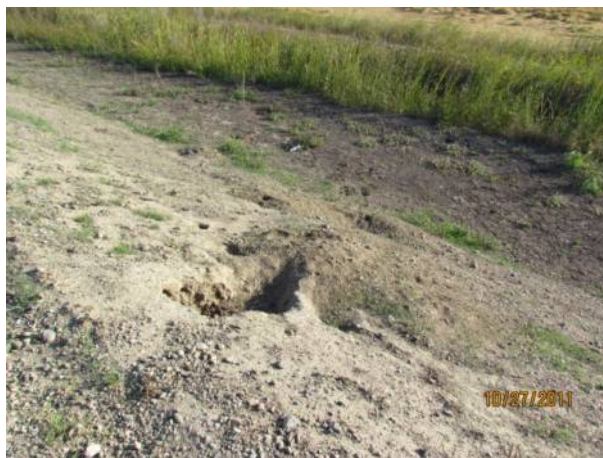
Levee Mile Report Line	7
Start Levee Mile	5.30
End Levee Mile	5.30
Location	Land Side
Category	Earthen Levee
Item	Animal Control

View of the rodent holes along the L/S slope.

7	5.30	5.30	Earthen Levee	Animal Control	LS	M Ma	A1 : Exterminate rodents and backfill and compact or grout burrows.	39.103490 ° -122.016340 °	39.103490 ° -122.016340 °	206 Y
DWR ID: DWR_MA0012_01_s_2012_206										
8	5.77	5.77	Earthen Levee	Animal Control	LS	M Ma	A3 : No rodents visible, but rodent burrows visible; need to backfill and compact or grout burrows.	39.109189 ° -122.017139 °	39.109189 ° -122.017139 °	8 Y
DWR ID: DWR_MA0012_01_s_2012_8										
9	5.82	5.82	Earthen Levee	Animal Control	LS	M Ma	A3 : No rodents visible, but rodent burrows visible; need to backfill and compact or grout burrows.	39.110742 ° -122.017342 °	39.110742 ° -122.017342 °	207 Y
DWR ID: DWR_MA0012_01_s_2012_207										
10	9.19	9.20	Supplemental	USACE Erosion Survey	WS	M Ma	Inspector Comments: 2011: Erosion occurring upstream and downstream of an irrigation diversion structure. [2011 Site ID: SYC_9-3_L]	39.158226 ° -122.021950 °	39.157957 ° -122.021950 °	7 Y

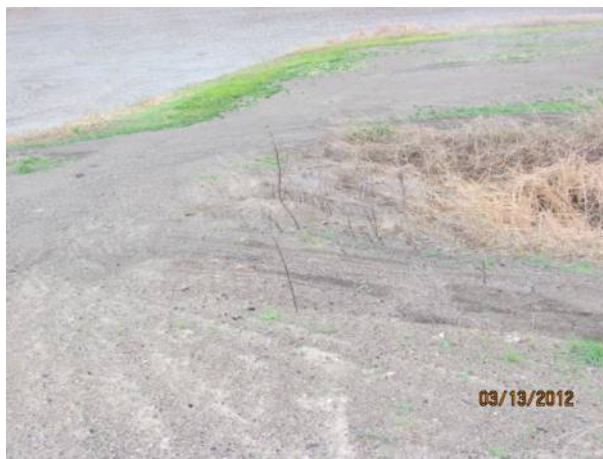
Levee Mile Report Line	8
Start Levee Mile	5.77
End Levee Mile	5.77
Location	Land Side
Category	Earthen Levee
Item	Animal Control

View of the rodent burrows along the L/S slope.

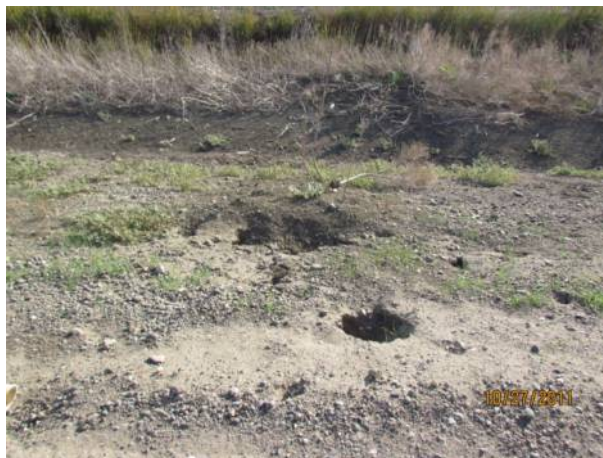
Levee Mile Report Line	9
Start Levee Mile	5.82
End Levee Mile	5.82
Location	Land Side
Category	Earthen Levee
Item	Animal Control

View of rodent holes along the L/S slope.

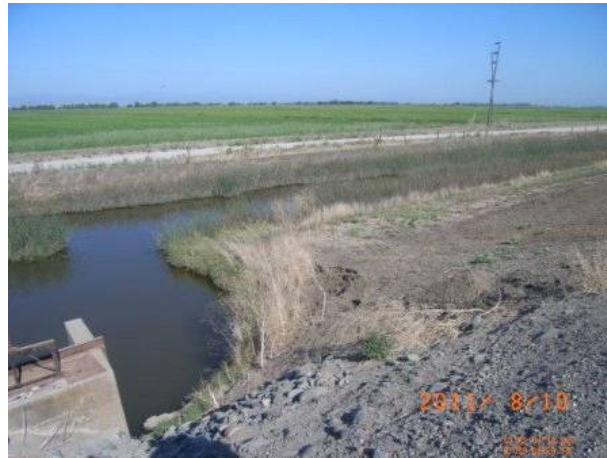
Levee Mile Report Line	10
Start Levee Mile	9.19
End Levee Mile	9.20
Location	Water Side
Category	Supplemental
Item	USACE Erosion Survey

USACE 2011 Photo #1

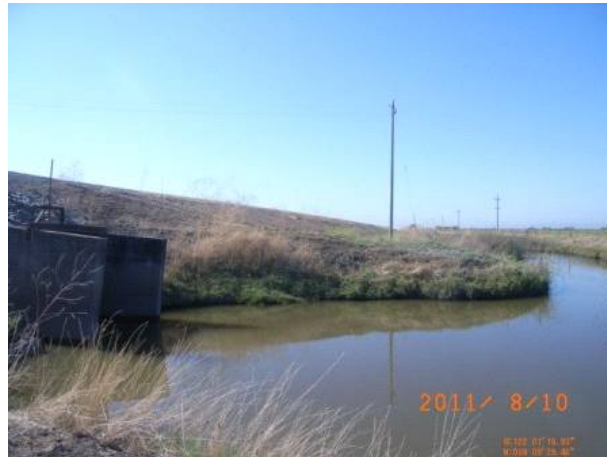
Levee Mile Report Line	10
Start Levee Mile	9.19
End Levee Mile	9.20
Location	Water Side
Category	Supplemental
Item	USACE Erosion Survey

USACE 2011 Photo #2

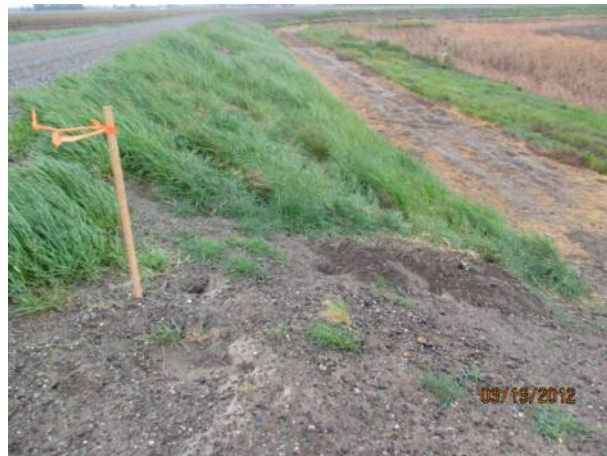
Levee Mile Report Line	11
Start Levee Mile	10.31
End Levee Mile	10.31
Location	Land Side
Category	Earthen Levee
Item	Animal Control

View of the rodent burrows along the L/S slope.

DWR ID: DWR_MA0012_01_s_2012_7										
11	10.31	10.31	Earthen Levee	Animal Control	LS	M Ma	A3 : No rodents visible, but rodent burrows visible; need to backfill and compact or grout burrows.	39.173370 ° -122.021357 °	39.173370 ° -122.021357 °	10 Y
DWR ID: DWR_MA0012_01_s_2012_10										
12	10.72	10.72	Earthen Levee	Slope Stability	LS	M Ma	S3 : Repair the levee slope damaged by vehicle traffic and prevent access where possible.	39.173970 ° -122.014335 °	39.173970 ° -122.014335 °	6 Y
DWR ID: DWR_MA0012_01_s_2012_6

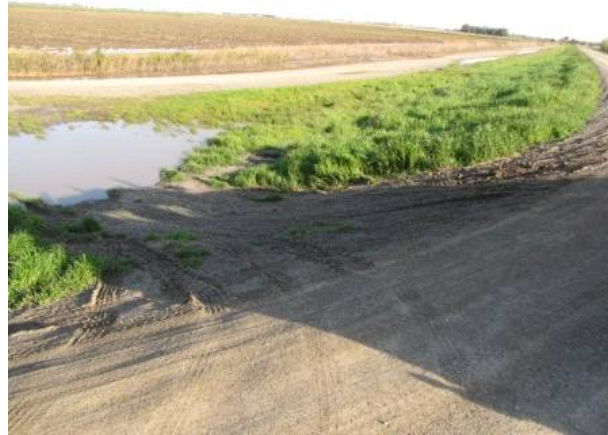
Levee Mile Report Line	12
Start Levee Mile	10.72
End Levee Mile	10.72
Location	Land Side
Category	Earthen Levee
Item	Slope Stability

View of vehicle erosion along the slope.
