**Flood Control Project Maintenance
Levee Inspections****LMA District Cover Sheet****Spring 2013 Levee Inspection Results****Sutter Maintenance Yard Maintenance Area 0012**

Spring 2013 Levee Inspection Results

Sutter Maintenance Yard Maintenance Area 0012

Waterway			Bank	Unit Miles
Unit No. 01 Colusa Drain			Left	11.31
	Spring (March - May)	Summer (June - August)	(September - November) Fall	Winter (December - February)
Unit Maintenance Rating (Fall Only)				
Date of Inspection	03/12/2013 - 03/12/2013			
DWR Inspector	Bob Duffey			
Accompanied By	Bryan Reniff Sutter Maintenance Yard

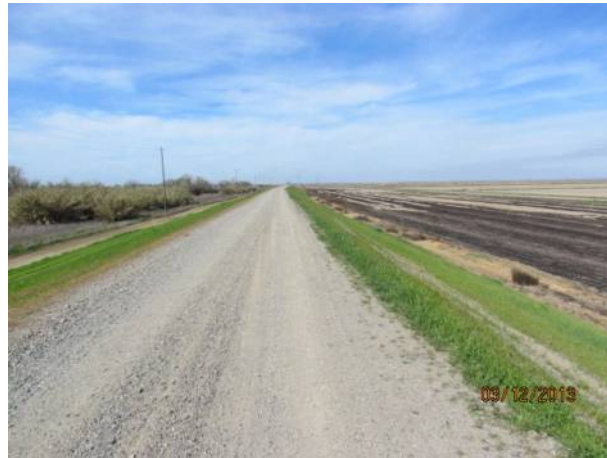
Levee Mile Report Line	5
Start Levee Mile	4.52
End Levee Mile	4.52
Location	Land Side
Category	
Item	Vegetation

View of the levee with native grasses on both slopes.

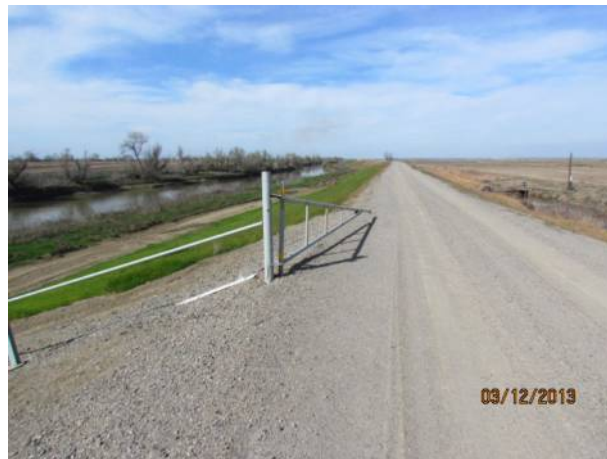
Levee Mile Report Line	6
Start Levee Mile	4.82
End Levee Mile	4.82
Location	Land Side
Category	
Item	Encroachments

View of the gate that needs repairs.

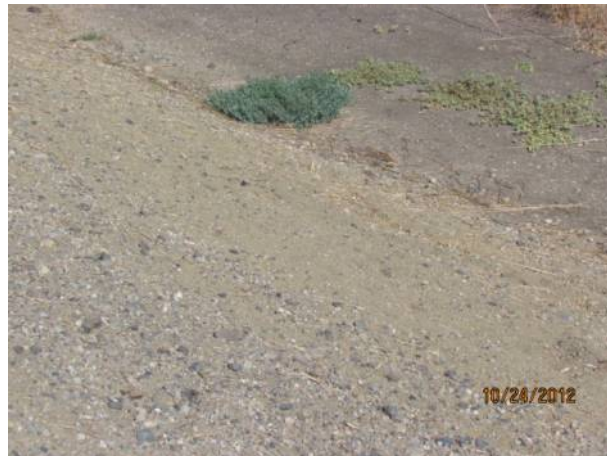
Levee Mile Report Line	8
Start Levee Mile	5.30
End Levee Mile	5.30
Location	Land Side
Category	
Item	Animal Control

View of the levee slope with no rodent activity.

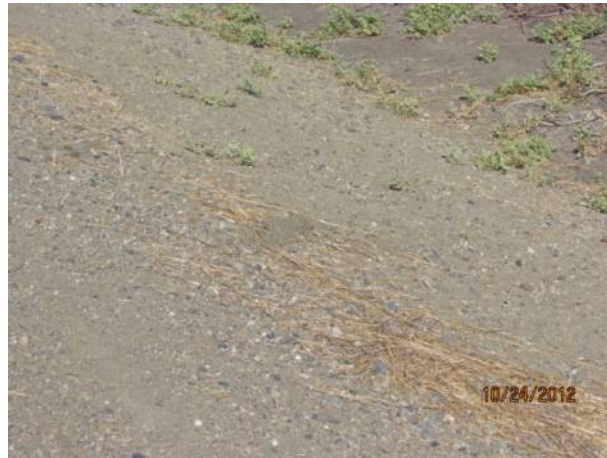
Levee Mile Report Line	9
Start Levee Mile	5.77
End Levee Mile	5.77
Location	Land Side
Category	
Item	Animal Control

View of the levee slope with no rodent activity.

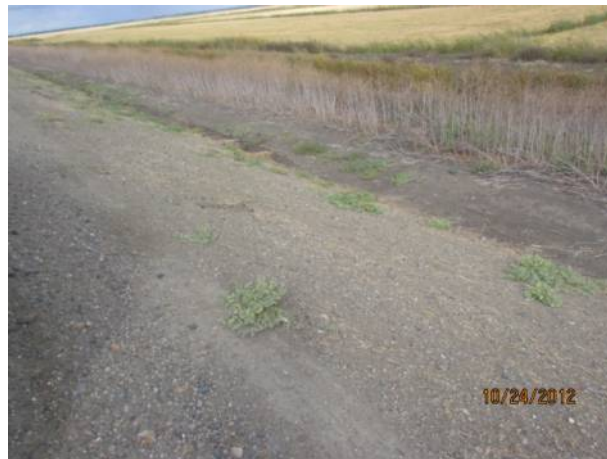
Levee Mile Report Line	10
Start Levee Mile	5.82
End Levee Mile	5.82
Location	Land Side
Category	
Item	Animal Control

View of the slope levee with no rodent activity.

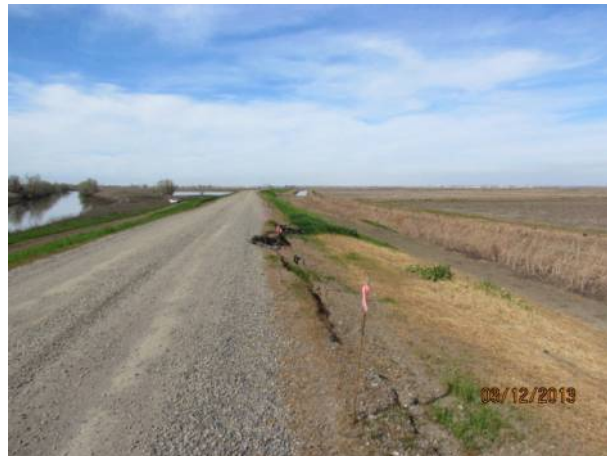
Levee Mile Report Line	11
Start Levee Mile	7.67
End Levee Mile	7.67
Location	Land Side
Category	
Item	Erosion / Bank Caving

View of the erosion along the landside slope.

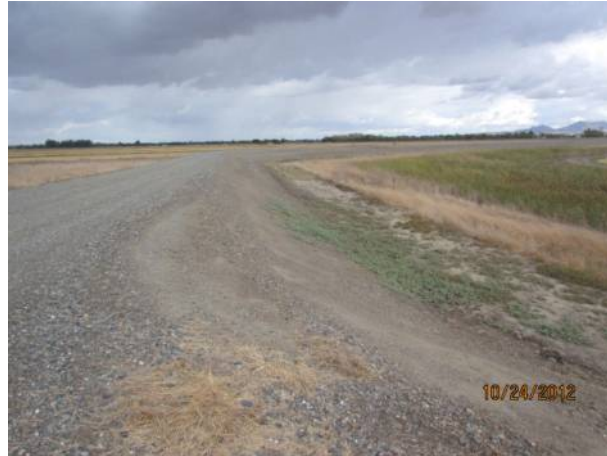
Levee Mile Report Line	13
Start Levee Mile	10.31
End Levee Mile	10.31
Location	Land Side
Category	
Item	Animal Control

View of the levee slope with no rodent activity.

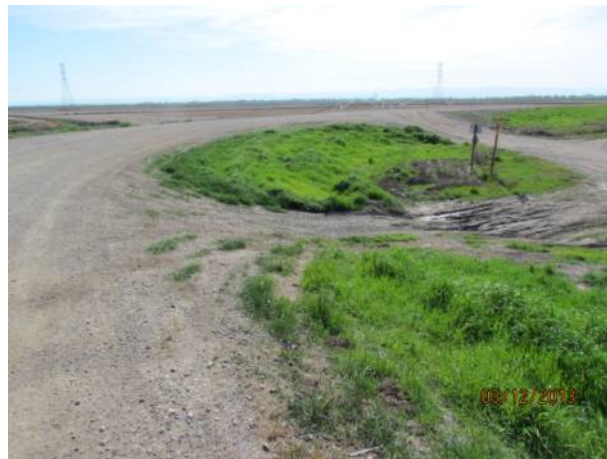
Levee Mile Report Line	14
Start Levee Mile	10.72
End Levee Mile	10.72
Location	Water Side
Category	
Item	Slope Stability

View of the vehicle erosion along the waterside slope.
