**Flood Control Project Maintenance
Levee Inspections**
LMA District Cover Sheet
Spring 2014 Levee Inspection Results

Sutter Maintenance Yard Maintenance Area 0012

Waterway	Bank	Unit Miles
Unit No. 01 Colusa Drain	Left	11.31

Levee Inspection Report By Mile - Spring 2014

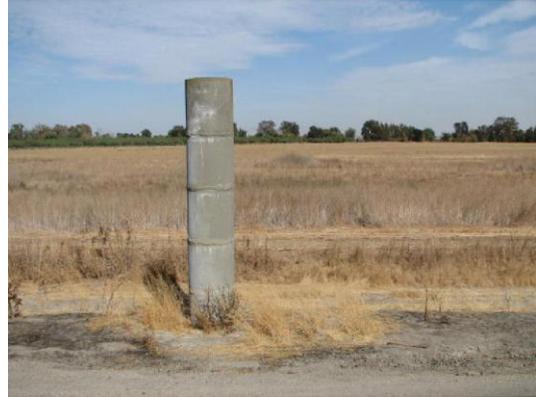
Photo 1 of 1 : UCIP_4746.jpg

LM Start	0.24	Rating **	M	Issue No.	3
LM End	0.24	Issue Type +	En	Location *	LS
Category	Supplemental			GPS Latitude/Longitude	
				Start	End
Item	DWR UCIP Field Study			39.035889 °	39.035889 °
				-121.996882 °	-121.996882 °
DWR ID	DWR_MA0012_01_s_2014_3				
Action/Comments					
Inspector Comments: FS_ID:25484 EP_NO: 9381 Repair Type: Crossing Status: UCIP Comments: Need to verify proper abandonment of pipe 12/16/2013 Same as last inspection 12/16/2013 Same as last inspection. FIELD_STRUCT_DESC: *Abandoned* 14-inch pipe through levee, 3.0 feet below crown. Open on waterward end 3-foot x 6-foot concrete well on waterward berm. Siphon breaker in 24-inch pipe riser on landward shoulder. 36-inch concrete standpipe on landward berm. (Permit No. 9381 - Tribble). Originally included in O+M Manual (1959). Asbuilt available 50-4-3081. (The only item identified is the 36-inch standpipe on the LS toe). FS Date: 12/16/2013 2:25:18 PM

36-inch concrete riser on LS toe.

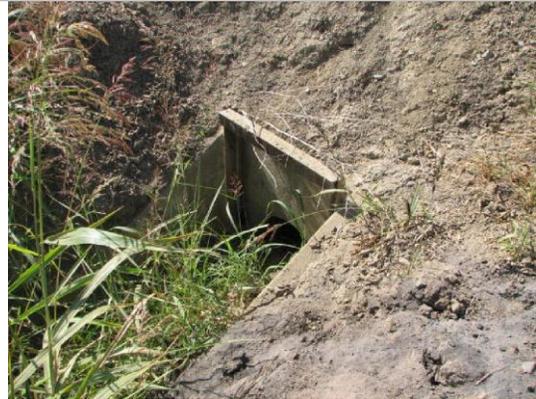
Photo 1 of 1 : UCIP_4747.jpg

LM Start	1.73	Rating **	M	Issue No.	6
LM End	1.73	Issue Type +	En	Location *	LS
Category	Supplemental			GPS Latitude/Longitude	
				Start	End
Item	DWR UCIP Field Study			39.055711 °	39.055711 °
				-122.003252 °	-122.003252 °
DWR ID	DWR_MA0012_01_s_2014_6				
Action/Comments					
Inspector Comments: FS_ID:25488 EP_NO: 9382 Repair Type: Crossing Status: UCIP Comments: Inlet on LS filled partially with soil. Outlet blocked with soil and the flap gate wont close 7/16/2013 Same as last inspection. Make sure flapgate is closed before highwater season 12/16/2013 Same as last inspection. WS flapgate still needs to be cleaned out and shut. FIELD_STRUCT_DESC: 24-inch CM drain pipe through the levee, 13.0 feet below crown. Flap gate, concrete headwall and grouted cobble spillway on waterward side. Concrete headwall on landward side. (Permit No. 9382 Baber). Originally included in O+M manual (1959). FS Date: 12/16/2013 2:28:27 PM

Concrete U shaped headwall at LS inlet.

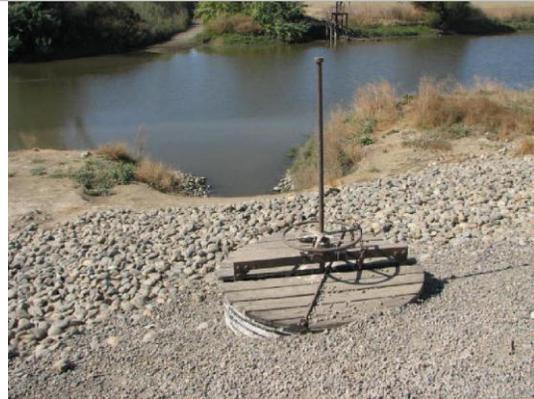
Photo 1 of 1 : UCIP_4752.jpg

LM Start	1.81	Rating **	M	Issue No.	8
LM End	1.81	Issue Type +	En	Location *	LS
Category	Supplemental			GPS Latitude/Longitude	
				Start	End
Item	DWR UCIP Field Study			39.056847 °	39.056847 °
				-122.003288 °	-122.003288 °
DWR ID	DWR_MA0012_01_s_2014_8				
Action/Comments					
Inspector Comments: FS_ID:25491 EP_NO: 9387 Repair Type: Crossing Status: UCIP Comments: No inlet could be located on LS. Flap gate partially blocked and will not close completely 7/16/2013 Same as last inspection. Was told inlet is about 1/4 mile down road way next to house. Will try to get coordinates for inlet 2/16/2013 Pipe was flowing water and flap gate was being pushed open. Cannot verify if it will close all the way. FIELD_STRUCT_DESC: 48-inch drain pipe through the levee 20.0 feet below crown. Slide gate in 60-inch pipe riser on waterward slope. Flap gate and concrete headwall on waterward side. (Permit No. 9387 - Christenson). Originally included in O+M manual (1959). FS Date: 12/16/2013 2:30:56 PM

60-inch standpipe with slide gate on WS slope with outlet in background.

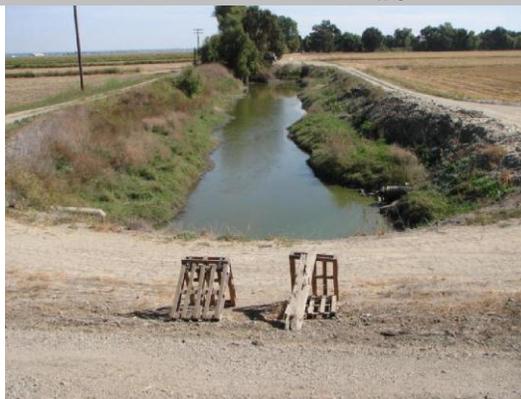
Photo 1 of 1 : UCIP_4758.jpg

LM Start	3.78	Rating **	M	Issue No.	10
LM End	3.78	Issue Type +	En	Location *	LS
Category	Supplemental			GPS Latitude/Longitude	
				Start	End
Item	DWR UCIP Field Study			39.081949 °	39.081949 °
				-122.016179 °	-122.016179 °
DWR ID	DWR_MA0012_01_s_2014_10				
Action/Comments					
Inspector Comments: FS_ID:25495 EP_NO: 9388 Repair Type: Crossing Status: UCIP Comments: Slide gate inoperable, but appears to be in closed position. Flap gate held in open position. Good candidate for video inspection when, if ever, dry/16/2013 Water flowing through pipe so screw gate definately not closed. Was told NOV's have been sent for owner to replace stem. Flap gate gets closed for flood season12/16/2013 Slide gate stem is still bent. WS flapgate was closed. FIELD_STRUCT_DESC: 48-inch CM pipe through the levee, 28.0 feet below the crown. Slide gate in 66-inch pipe riser on the waterward slope. Concrete headwall on the waterward side. Grouted cobble spillway from drain ditch to large canal on the landward side. (Permit No. 9388 Wallace) Originally included in the O+M manual (1959). FS Date: 12/16/2013 2:36:38 PM

Drainage ditch on LS toe.

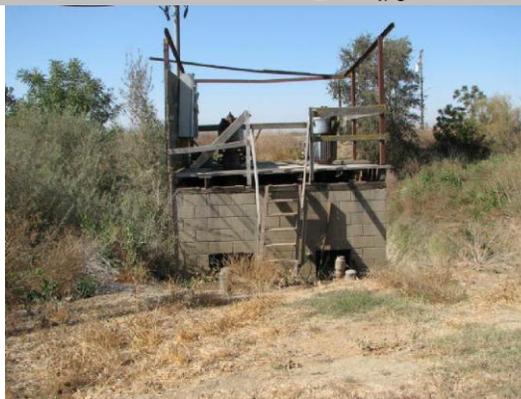
Photo 1 of 1 : UCIP_4764.jpg

LM Start	4.33	Rating **	M	Issue No.	15
LM End	4.33	Issue Type +	En	Location *	LS
Category	Supplemental		GPS Latitude/Longitude		
			Start	End	
Item	DWR UCIP Field Study		39.089666 °	39.089666 °	
			-122.015248 °	-122.015248 °	
DWR ID	DWR_MA0012_01_s_2014_15				
Action/Comments					
Inspector Comments: FS_ID:25500 EP_NO: N/A Repair Type: Crossing Status: UCIP Comments: No permit identified for this crossing 7/16/2013 Same as last inspection 12/16/2013 Pump has been removed for winter. FIELD_STRUCT_DESC: 24-inch steel pipe through levee, 4.5 feet below crown. Pump in pump house on waterward bank. Siphon breaker valve installed on LS shoulder. FS Date: 12/16/2013 2:46:18 PM

Pumping plant on WS toe.

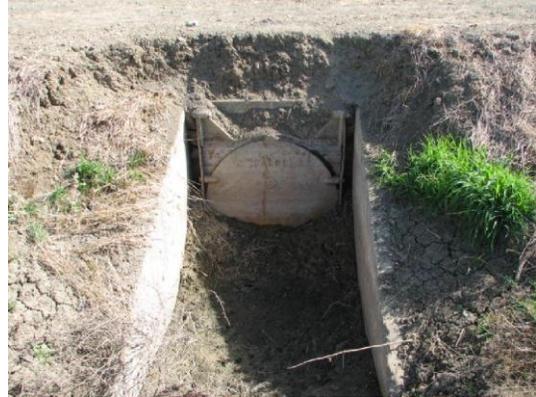
Photo 1 of 1 : UCIP_4766.jpg

LM Start	5.12	Rating **	M	Issue No.	16
LM End	5.12	Issue Type +	En	Location *	LS
Category	Supplemental		GPS Latitude/Longitude		
			Start	End	
Item	DWR UCIP Field Study		39.100898 °	39.100898 °	
			-122.016078 °	-122.016078 °	
DWR ID	DWR_MA0012_01_s_2014_16				
Action/Comments					
Inspector Comments: FS_ID:25502 EP_NO: 0 Repair Type: Crossing Status: UCIP Comments: Pipe is clogged at both the inlet and outlet. Good candidate for video inspection 7/16/2013 Same as last inspection 12/16/2013 Same as last inspection. FIELD_STRUCT_DESC: 48-inch CM pipe approximately 15 feet below the crown. Concrete headwalls on both ends with an automatic drainage gate on the WS. FS Date: 12/16/2013 2:48:49 PM

Concrete U shaped headwall and flap gate on WS toe.

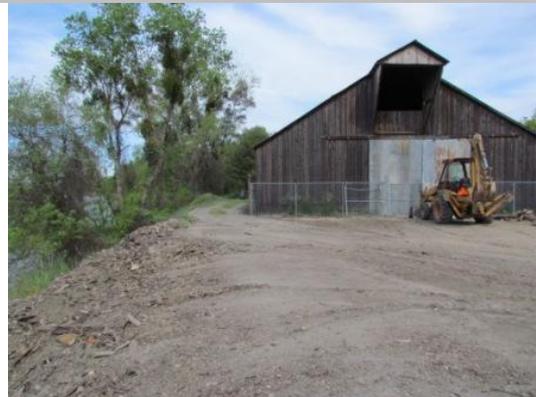
Photo 1 of 1 : rduffey_s_20140304_425.jpg

View of the levee slope with no rodent activity.

LM Start	5.30	Rating **	A/W	Issue No.	206
LM End	5.30	Issue Type +	Ma	Location *	LS
Category	Earthen Levee		GPS Latitude/Longitude		
			Start	End	
Item	Animal Control		39.103490 °	39.103490 °	
			-122.016340 °	-122.016340 °	
DWR ID	DWR_MA0012_01_s_2012_206				
Action/Comments					
Exterminate rodents and backfill and compact or grout burrows.

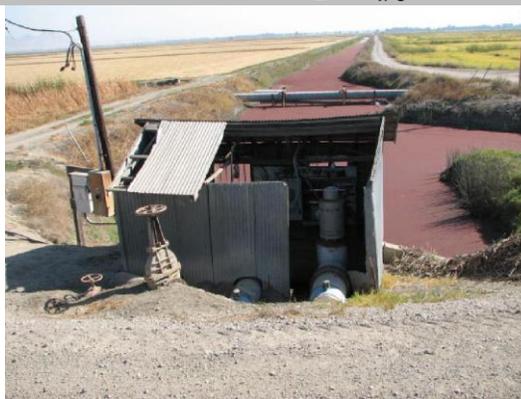
Photo 1 of 1 : UCIP_4772.jpg

LM Start	6.12	Rating **	M	Issue No.	17
LM End	6.12	Issue Type +	En	Location *	LS
Category	Supplemental		GPS Latitude/Longitude		
			Start	End	
Item	DWR UCIP Field Study		39.114949 °	39.114949 °	
			-122.017946 °	-122.017946 °	
DWR ID	DWR_MA0012_01_s_2014_17				
Action/Comments					
Inspector Comments: FS_ID:25505 EP_NO: 13699 Repair Type: Crossing Status: UCIP Comments: Oil leakage around pump 12/16/2013 Same as last inspection. FIELD_STRUCT_DESC: 1 of 2: 20-inch soilproofed steel Stormdrain pipe through levee, 4.4 feet below crown. Cobble revetted sump on waterward side. Siphon breaker in 24-inch metal pipe risers on waterward shoulder. Pump house at toe of landward slope. (Permit No. 13699, 1984). Replaced 18-inch pipe at same location. FS Date: 12/16/2013 2:52:13 PM

Pumping plant on LS slope

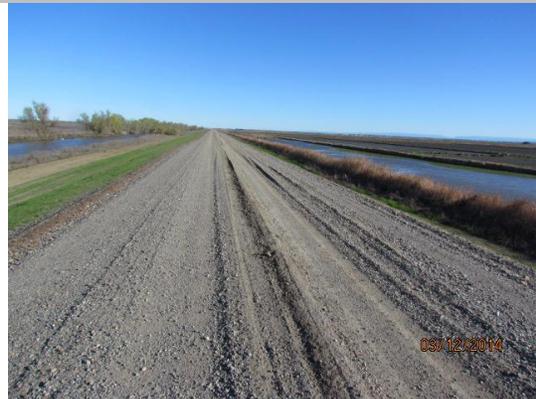
Photo 1 of 1 : rduffey_s_20140317_116.jpg

View of the rutted up crown roadway.

LM Start	6.38	Rating **	M	Issue No.	24
LM End	8.15	Issue Type +	Ma	Location *	CR
Category	Earthen Levee		GPS Latitude/Longitude		
			Start	End	
Item	Crown Surface / Depressions / Rutting		39.118211 °	39.142866 °	
			-122.019951 °	-122.022094 °	
DWR ID	DWR_MA0012_01_s_2014_24				
Action/Comments					
Repair depressions or ruts in the crown or slope.

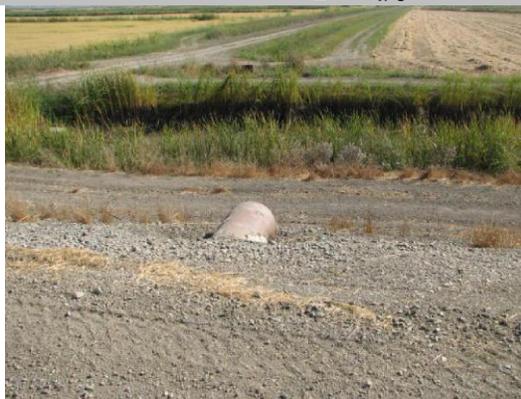
Photo 1 of 1 : UCIP_4782.jpg

LM Start	7.75	Rating **	M	Issue No.	20
LM End	7.75	Issue Type +	En	Location *	CR
Category	Supplemental		GPS Latitude/Longitude		
			Start	End	
Item	DWR UCIP Field Study		39.137187 °	39.137187 °	
			-122.022793 °	-122.022793 °	
DWR ID	DWR_MA0012_01_s_2014_20				
Action/Comments					
Inspector Comments: FS_ID:25510 EP_NO: 9390 Repair Type: Crossing Status: UCIP Comments: Rodent burrowing along sides of pipe on LS/16/2013 Same as last inspection FIELD_STRUCT_DESC: 24-inch steel pipe through levee, 3.0 feet below crown. Both ends capped, terminating on levee slopes. (Permit No. 9390 - Profpe) Originally included in O+M manual (1959). FS Date: 12/16/2013 2:57:02 PM

Pipe on LS.

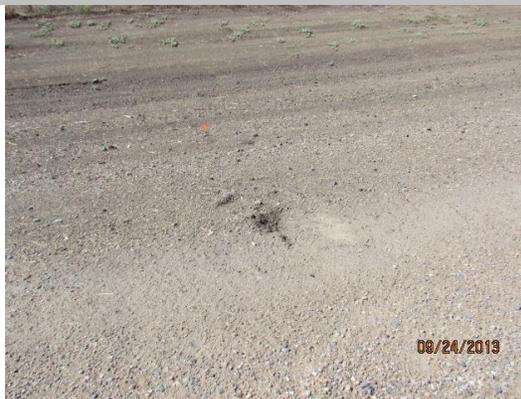
Photo 1 of 1 : ruffey_s_20140304_422.jpg

View of the rodent hole along the slope of the levee.

LM Start	8.82	Rating **	A/W	Issue No.	53
LM End	8.82	Issue Type +	Ma	Location *	WS
Category	Earthen Levee		GPS Latitude/Longitude		
			Start	End	
Item	Animal Control		39.152245 °	39.152245 °	
			-122.021782 °	-122.021782 °	
DWR ID	DWR_MA0012_01_f_2013_53				
Action/Comments					
No rodents visible, but rodent burrows visible; need to backfill and compact or grout burrows.

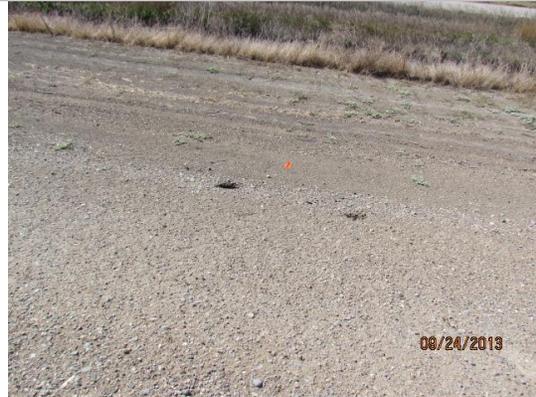
Photo 1 of 1 : rduffey_s_20140304_423.jpg

View of the rodent holes along the slope of the levee.

LM Start	8.92	Rating **	A/W	Issue No.	54
LM End	8.92	Issue Type +	Ma	Location *	WS
Category	Earthen Levee		GPS Latitude/Longitude		
			Start	End	
Item	Animal Control		39.153702 °	39.153702 °	
			-122.021773 °	-122.021773 °	
DWR ID	DWR_MA0012_01_f_2013_54				
Action/Comments					
No rodents visible, but rodent burrows visible; need to backfill and compact or grout burrows.

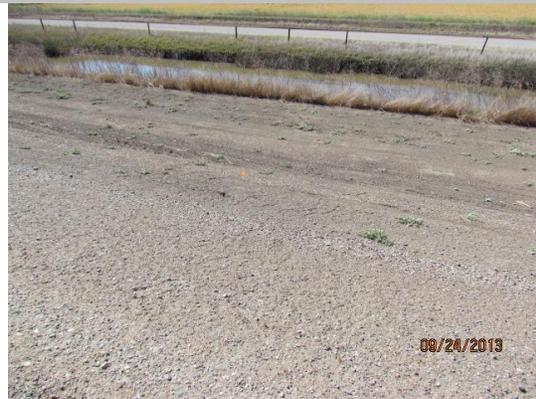
Photo 1 of 1 : rduffey_s_20140304_424.jpg

View of the rodnet hole along the toe of the levee.

LM Start	9.03	Rating **	M	Issue No.	55
LM End	9.03	Issue Type +	Ma	Location *	WS
Category	Earthen Levee		GPS Latitude/Longitude		
			Start	End	
Item	Animal Control		39.155207 °	39.155207 °	
			-122.021769 °	-122.021769 °	
DWR ID	DWR_MA0012_01_f_2013_55				
Action/Comments					
No rodents visible, but rodent burrows visible; need to backfill and compact or grout burrows.

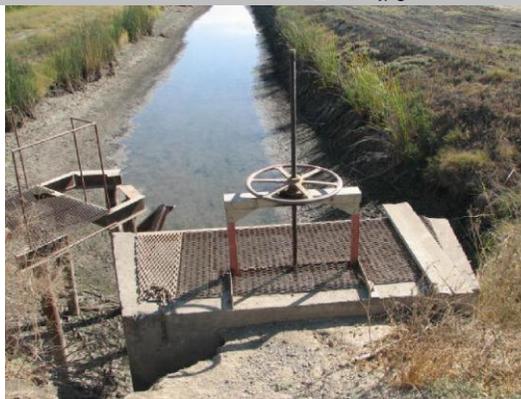
Photo 1 of 1 : UCIP_4788.jpg

LM Start	9.23	Rating **	M	Issue No.	21
LM End	9.23	Issue Type +	En	Location *	WS
Category	Supplemental			GPS Latitude/Longitude	
				Start	End
Item	DWR UCIP Field Study			39.158097 °	39.158097 °
				-122.021706 °	-122.021706 °
DWR ID	DWR_MA0012_01_s_2014_21				
Action/Comments					
Inspector Comments: FS_ID:25512 EP_NO: 9390 Repair Type: Crossing Status: UCIP Comments: Concrete Headwall tilting on WS slop#16/2013 Same as last inspection12/16/2013 Same as last inspection. FIELD_STRUCT_DESC: 36-inch CM drain pipe through the levee, 15.0 feet below crown. Concrete head wall, slide gate and grouted revetment on waterward side. Slide gate and Concrete headwall on landward side. (Permit No. 9390 - Profpe). Originally included in O+M manual (1959). FS Date: 12/16/2013 2:58:55 PM

slide gate and headwall on LS toe.

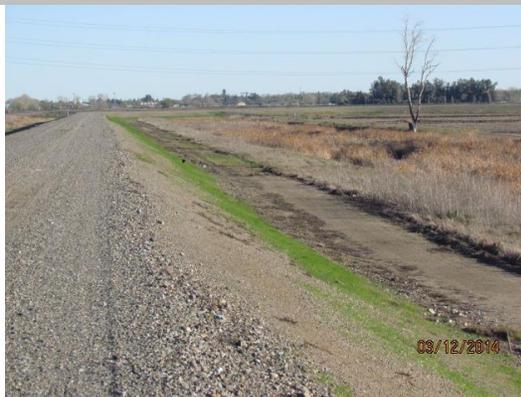
Photo 1 of 1 : rduffey_s_20140317_115.jpg

View of the native grasses starting to grow on both slope.

LM Start	9.86	Rating **	A	Issue No.	23
LM End	9.86	Issue Type +	Ma	Location *	LS
Category	Earthen Levee			GPS Latitude/Longitude	
				Start	End
Item	Vegetation			39.166996 °	39.166996 °
				-122.021857 °	-122.021857 °
DWR ID	DWR_MA0012_01_s_2014_23				
Action/Comments					
Control annual grass and weeds on the levee slopes and easements.

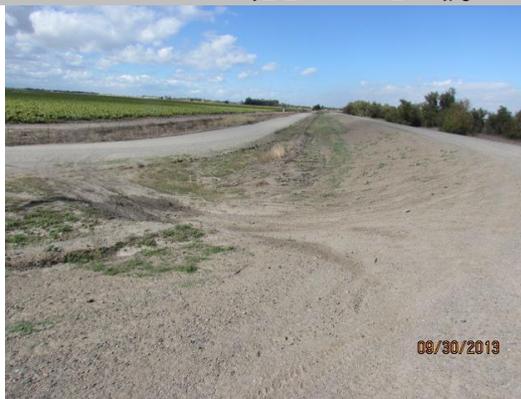
Photo 1 of 1 : rduffey_s_20140304_420.jpg

View of the slope vehicle erosion.

LM Start	10.72	Rating **	M	Issue No.	11
LM End	10.72	Issue Type +	Ma	Location *	LS
Category	Earthen Levee			GPS Latitude/Longitude	
				Start	End
Item	Slope Stability			39.173971 °	39.173971 °
				-122.014362 °	-122.014362 °
DWR ID	DWR_MA0012_01_f_2013_11				
Action/Comments					
Repair the levee slope damaged by vehicle traffic and prevent access where possible.

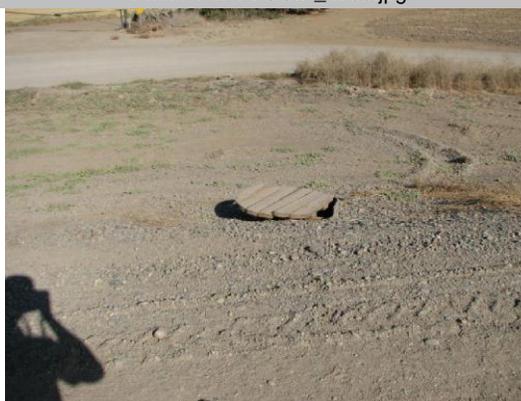
Photo 1 of 1 : UCIP_4790.jpg

LM Start	11.16	Rating **	M	Issue No.	22
LM End	11.16	Issue Type +	En	Location *	LS
Category	Supplemental			GPS Latitude/Longitude	
				Start	End
Item	DWR UCIP Field Study			39.180039 °	39.180039 °
				-122.014266 °	-122.014266 °
DWR ID	DWR_MA0012_01_s_2014_22				
Action/Comments					
Inspector Comments: FS_ID:25516 EP_NO: 9386 Repair Type: Crossing Status: UCIP Comments: Pipe plugged with soil on both ends as well as at slide gate on WS slope. Slide gate inoperable 12/16/2013 Same as last inspection 12/16/2013 Same as last inspection. FIELD_STRUCT_DESC: 24-inch Corrugated metal drainpipe through the levee, 8.0 feet below the crown. Slide gate in 36-inch pipe riser on the waterward shoulder. (Permit No. 9386 - Wescott) Levee turns eastward. FS Date: 12/16/2013 3:06:10 PM

cover on 36-inch CMP standpipe on WS slope.
