**Flood Control Project Maintenance  
Levee Inspections****LMA District Cover Sheet****Spring 2015 Levee Inspection Results****Sutter Maintenance Yard Maintenance Area 0012**

**Levee Inspection Report By Mile - Spring 2015**

Waterway	Bank	Unit Miles	Inspection Start/End	Inspector
Unit No. 01 Colusa Drain	Left	11.06	03/11/2015 03/11/2015	Bob Duffey

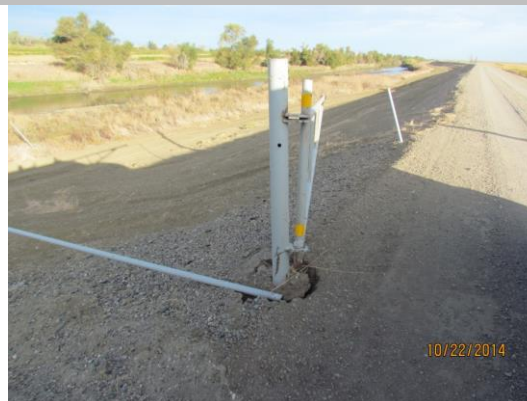
Photo 1 of 1 : SP\_2015\_MA0012\_299\_22\_20150310\_00002.jpg

LM Start	4.72	Rating **	M	Issue No.	22
LM End	4.72	Issue Type +	Ma	Location *	WS
Category	Earthen Levee			GPS Latitude/Longitude	
				Start	End
Item	Repair Gates			39.096777 °	39.096777 °
				-122.015548 °	-122.015548 °
DWR ID	DWR_MA0012_01_f_2014_22				
Action/Comments

View of the gate that needs to be repaired.

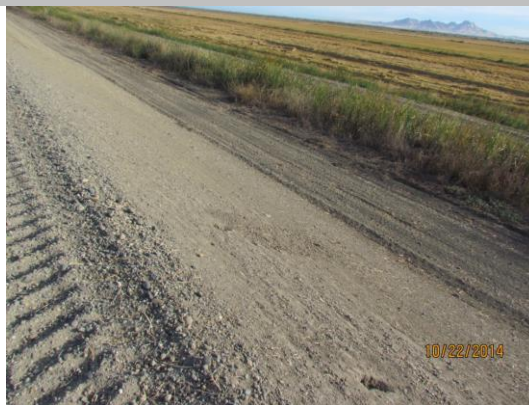
Photo 1 of 1 : SP\_2015\_MA0012\_299\_206\_20150310\_00003.jpg

LM Start	5.19	Rating **	A/W	Issue No.	206
LM End	5.19	Issue Type +	Ma	Location *	LS
Category	Earthen Levee			GPS Latitude/Longitude	
				Start	End
Item	Animal Control			39.103490 °	39.103490 °
				-122.016340 °	-122.016340 °

View of the rodent holes on the landside slope.

Action/Comments					
Exterminate rodents and backfill and compact or grout burrows.

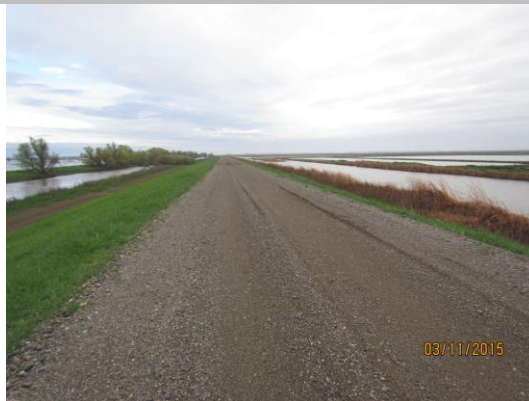
Photo 1 of 1 : SP\_2015\_MA0012\_299\_23\_20150406\_00004.jpg

LM Start	6.62	Rating **	M	Issue No.	23
LM End	7.96	Issue Type +	Ma	Location *	CR
Category	Earthen Levee			GPS Latitude/Longitude	
				Start	End
Item	Crown Surface / Depressions / Rutting			39.123283 °	39.127985 °
				-122.022738 °	-122.022767 °
DWR ID	DWR_MA0012_01_s _ 2015_23				
Action/Comments					
Repair depressions or ruts in the crown or slope.					
Inspector Comments: The crown roadway needs additional gravel.

View of the damaged crown roadway.

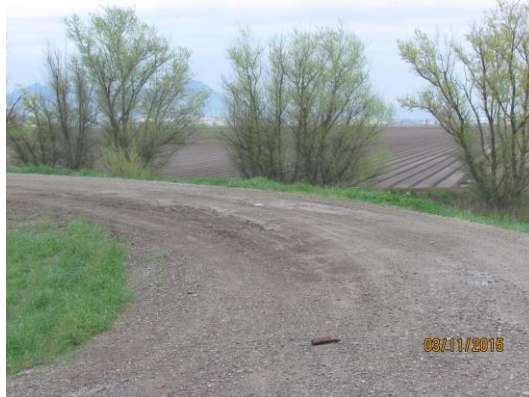
Photo 1 of 1 : SP\_2015\_MA0012\_299\_24\_20150406\_00005.jpg

LM Start	10.46	Rating **	M	Issue No.	24
LM End	10.77	Issue Type +	Ma	Location *	CR
Category	Earthen Levee			GPS Latitude/Longitude	
				Start	End
Item	Crown Surface / Depressions / Rutting			39.173743 °	39.177968 °
				-122.014800 °	-122.014315 °
DWR ID	DWR MA0012 01 s 2015 24

View of damaged crown roadway.

Action/Comments					
Repair depressions or ruts in the crown or slope. Inspector Comments: The crown roadway needs additional gravel.

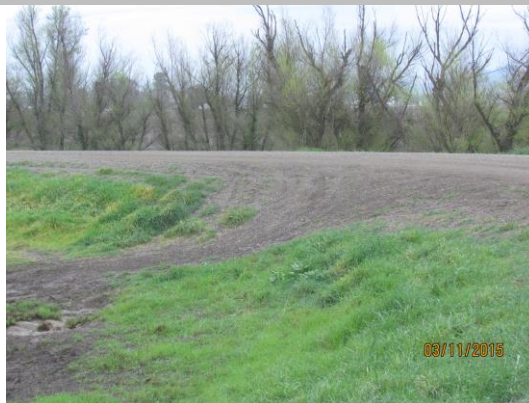
Photo 1 of 1 : SP\_2015\_MA0012\_299\_11\_20150406\_00006.jpg

LM Start	10.49	Rating **	M	Issue No.	11
LM End	10.49	Issue Type +	Ma	Location *	LS
Category	Earthen Levee			GPS Latitude/Longitude	
				Start	End
Item	Slope Stability			39.173971 °	39.173971 °
				-122.014362 °	-122.014362 °
DWR ID	DWR_MA0012_01_f_2013_11				
Action/Comments					
Repair the levee slope damaged by vehicle traffic and prevent access where possible.

View of vehicle slope erosion.
