**Flood Control Project Maintenance
Levee Inspections****LMA District Cover Sheet****Spring 2016 Levee Inspection Results****Sutter Maintenance Yard Maintenance Area 0012**

Levee Inspection Report By Mile - Spring 2016

Waterway	Bank	Unit Miles	Inspection Start/End	Inspector
Unit No. 01 Colusa Drain	Left	11.06	03/18/2016 03/18/2016	Keith Millard

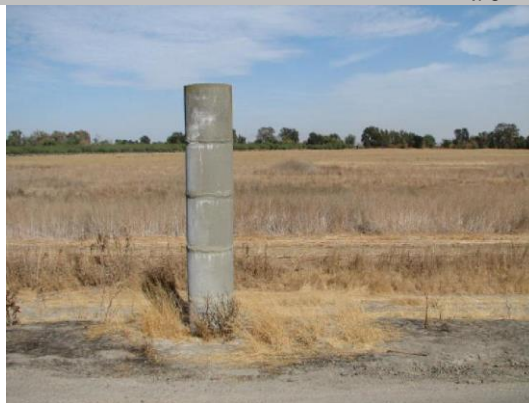
Photo 1 of 1 : UCIP_SP_2016_48467_68970.jpg

LM Start	0.24	Rating **	M	Issue No.	32
LM End	0.24	Issue Type +	En	Location *	N/A
Category	Supplemental			GPS Latitude/Longitude	
				Start	End
Item	DWR UCIP Field Study			39.035889 °	39.035889 °
				-121.996882 °	-121.996882 °
DWR ID

Comment Code					
Inspector Comment					
FS_ID:48467 DS_ID:17145 EP_NO: 9381 Repair Type: Non-Urgent Crossing Status: Indicator Found UCIP Comments: 5/4/2015 Abandoned crossing.6/17/2014 Same as last inspection.12/16/2013 Same as last inspection.7/16/2013 Same as last inspection.10/11/2012 Need to verify proper abandonment of pipe. FIELD_STRUCT_DESC: *ABANDONED* 14-inch pipe through levee, 3.0 feet below crown. Open on waterside (WS) end. 3-foot x 6-foot concrete well on WS berm. Siphon breaker in 24-inch pipe riser on landside (LS) shoulder. 36-inch concrete stand pipe on LS berm. The only item identified is the 36-inch standpipe on the LS toe (Permit No. 9381, - Tribble). [Additional Reference(s): DWR Levee Log, 2005. USACE Sacramento O&M Manual 132, October 1959 (Station #####, Drawing No. 50-4-3081)] FS Date: 5/5/2015 8:20:00 AM

36-inch concrete riser on LS toe.

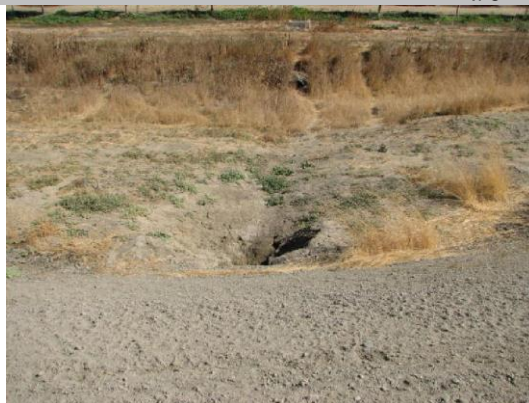
Photo 1 of 2 : UCIP_SP_2016_48468_68973.jpg

LM Start	0.49	Rating **	U	Issue No.	33
LM End	0.49	Issue Type +	En	Location *	WS
Category	Supplemental			GPS Latitude/Longitude	
				Start	End
Item	DWR UCIP Field Study			39.039413 °	39.039413 °
				-121.997766 °	-121.997766 °
DWR ID

FS_ID:48468
DS_ID:17146
EP_NO: 9382
Repair Type: Urgent
Crossing Status: Found
UCIP Comments: 5/4/2015 WS flap gate is blocked by sediment and unable to open. LS inlet is about 50% plugged with soil. Needs to be cleaned.6/17/2014 Same as last inspection.12/16/2013 Sediment against flapgate has been cleared and it can now function properly.7/16/2013 Sediment is built up against WS flapgate preventing it from opening.10/11/2012 Pipe is partially filled with soil.
FIELD_STRUCT_DESC: 24-inch corrugated metal drain pipe through levee, 13.0 feet below the crown. Flap gate, concrete headwall and grouted cobble spillway on waterside (WS). Concrete headwall on landside (LS). (Permit No. 9382, Baber). [Additional Reference(s): DWR Levee Log, 2005. USACE Sacramento O&M Manual 132, October 1959 (Station #####, Drawing No. 50-4-3081)]
FS Date: 5/5/2015 8:27:00 AM

Intake at LS toe.

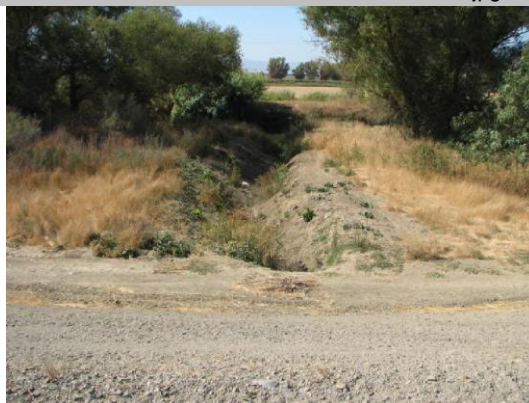
Photo 2 of 2 : UCIP_SP_2016_48468_68972.jpg

Outlet at WS toe.

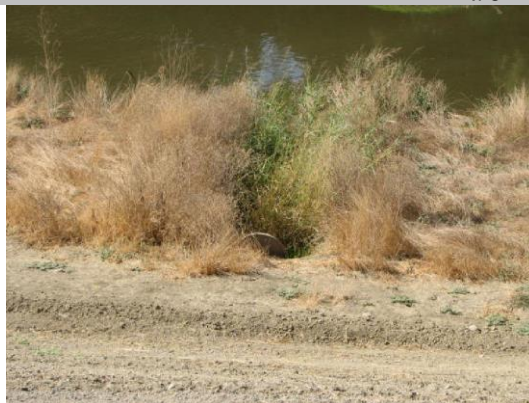
Photo 1 of 2 : UCIP_SP_2016_48471_68984.jpg

LM Start	1.69	Rating **	U	Issue No.	34
LM End	1.69	Issue Type +	En	Location *	WS
Category	Supplemental			GPS Latitude/Longitude	
				Start	End
Item	DWR UCIP Field Study			39.055711 °	39.055711 °
				-122.003252 °	-122.003252 °
DWR ID

FS_ID:48471
DS_ID:17149
EP_NO: 9382
Repair Type: Urgent
Crossing Status: Found
UCIP Comments: 5/4/2015 WS flapgate is blocked by sediment and unable to open. LS inlet is plugged by silt and wood chippings. Needs to be cleaned.6/17/2014 Flap gate was cleaned out and is fully closed. LS inlet still partially full of soil.12/16/2013 Same as last inspection. WS flapgate still needs to be cleaned out and shut.7/16/2013 Same as last inspection. Make sure flapgate is closed before highwater season.10/11/2012 Inlet on LS filled partially with soil. Outlet blocked with soil and the flap gate wont close.
FIELD_STRUCT_DESC: 24-inch corrugated metal drain pipe through the levee, 13.0 feet below crown. Flap gate, concrete headwall and grouted cobble spillway on waterside (WS). Concrete headwall on landside (LS). (Permit No. 9382, Baber). [Additional Reference(s): DWR Levee Log, 2005. USACE Sacramento O&M Manual 132, October 1959 (Station #####)]

Outlet on WS toe.

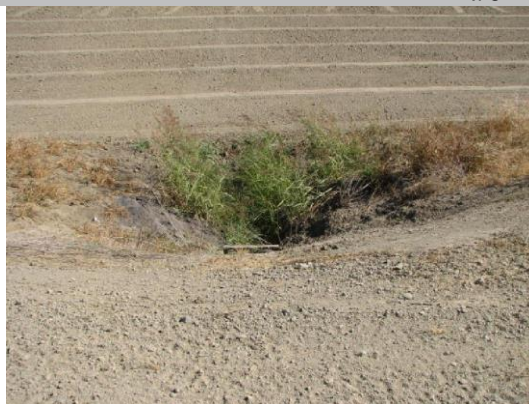
Photo 2 of 2 : UCIP_SP_2016_48471_68983.jpg

Inlet on LS toe.

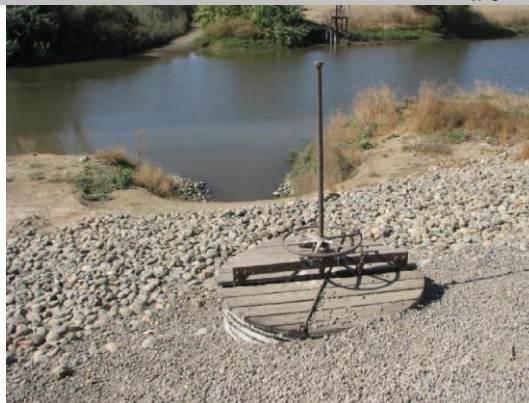
Photo 1 of 2 : UCIP_SP_2016_48474_68991.jpg

LM Start	1.77	Rating **	U	Issue No.	35
LM End	1.77	Issue Type +	En	Location *	WS
Category	Supplemental			GPS Latitude/Longitude	
				Start	End
Item	DWR UCIP Field Study			39.056847 °	39.056847 °
				-122.003288 °	-122.003288 °
DWR ID

FS_ID:48474
DS_ID:17150
EP_NO: 9387
Repair Type: Urgent
Crossing Status: Found
UCIP Comments: 5/4/2015 WS flapgate mostly underwater but could tell it was blocked open by something. LS inlet is located about 1/4 mile north along the side of the roadway.6/17/2014 Same as last inspection.12/16/2013 Pipe was flowing water and flap gate was being pushed open. Cannot verify if it will close all the way.7/16/2013 Same as last inspection. Was told inlet is about 1/4 mile down road way next to house. Will try to get coordinates for inlet.10/11/2012 No inlet could be located on LS. Flap gate partially blocked and will not close completely.
FIELD_STRUCT_DESC: 48-inch drain pipe through the levee, 20.0 feet below crown. Slide gate in 60-inch pipe riser on waterside (WS) slope. Flap gate and concrete headwall on WS. (Permit No. 9387, - Christenson). [Additional Reference(s): DWR Levee Log, 2005. USACE Sacramento O&M Manual 132, October 1959 (Station #####)]

60-inch standpipe with slide gate on WS slope with outlet in background.

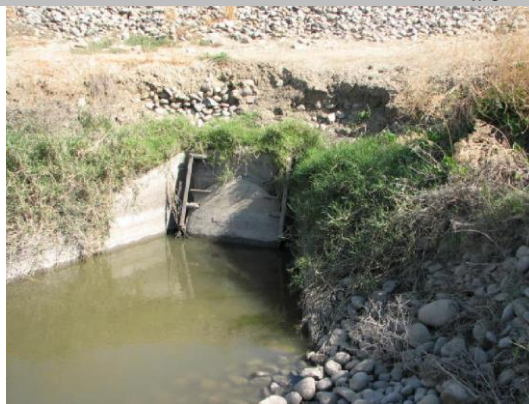
Photo 2 of 2 : UCIP_SP_2016_48474_68990.jpg

Flap gate and concrete headwall at WS toe.

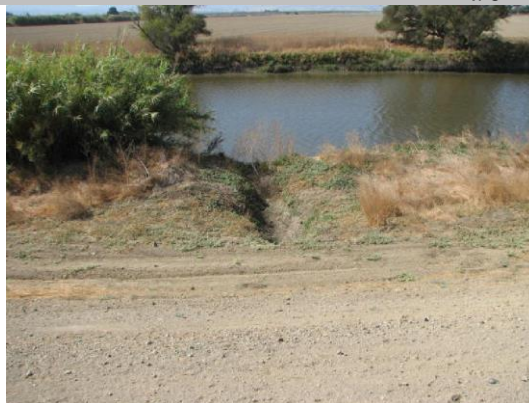
Photo 1 of 2 : UCIP_SP_2016_48475_68994.jpg

LM Start	1.98	Rating **	U	Issue No.	36
LM End	1.98	Issue Type +	En	Location *	WS
Category	Supplemental			GPS Latitude/Longitude	
				Start	End
Item	DWR UCIP Field Study			39.059773 °	39.059773 °
				-122.004391 °	-122.004391 °
DWR ID

Comment Code					
Inspector Comment					
FS_ID:48475 DS_ID:17151 EP_NO: 9391 Repair Type: Urgent Crossing Status: Found UCIP Comments: 5/4/2015 LS and WS ends are blocked with soil. Pipe is inoperable as it is.6/17/2014 Same as last inspection.12/16/2013 Same as last inspection.7/16/2013 LS inlet is completely filled with soil. Needs to be cleaned out.10/11/2012 Inlet is partially filled with soil. FIELD_STRUCT_DESC: 24-inch corrugated metal drain pipe through levee, 13.0 feet below crown. Flap gate, concrete headwall and grouted cobble spillway on the waterside (WS). Concrete headwall on landside (LS). (Permit No. 9391, Christenson). [Additional Reference(s): DWR Levee Log, 2005. USACE Sacramento O&M Manual 132, October 1959 (Station #####)] FS Date: 5/5/2015 8:58:00 AM

WS view of outlet.

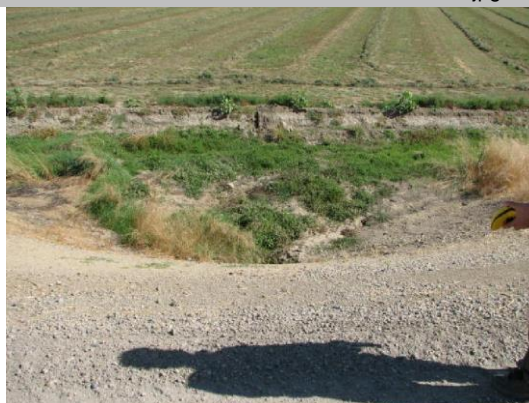
Photo 2 of 2 : UCIP_SP_2016_48475_68993.jpg

LS view of inlet.

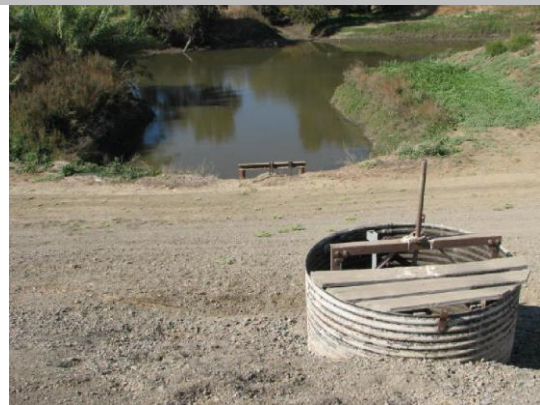
Photo 1 of 2 : UCIP_SP_2016_48478_69005.jpg

LM Start	3.69	Rating **	U	Issue No.	37
LM End	3.69	Issue Type +	En	Location *	LS
Category	Supplemental			GPS Latitude/Longitude	
				Start	End
Item	DWR UCIP Field Study			39.081949 °	39.081949 °
				-122.016179 °	-122.016179 °
DWR ID

Comment Code					
Inspector Comment					
FS_ID:48478 DS_ID:17154 EP_NO: 9388 Repair Type: Urgent Crossing Status: Found UCIP Comments: 5/4/2015 Slide gate stem is still bent. Gate looks to be unable to close all the way.6/17/2014 Same as last inspection.12/16/2013 Slide gate stem is still bent. WS flapgate was closed.7/16/2013 Water flowing through pipe so screw gate definately not closed. Was told NOV's have been sent for owner to replace stem. Flap gate gets closed for flood season.10/11/2012 Slide gate inoperable, but appears to be in closed position. Flap gate held in open position. Good candidate for video inspection when, if ever, dry. FIELD_STRUCT_DESC: 48-inch corrugated metal pipe through the levee, 28.0 feet below the crown. Slide gate in 66-inch pipe riser on the waterside (WS) slope. Concrete headwall on the WS. Grouted cobble spillway from drain ditch to large canal on the landside (LS). (Permit No. 9388, Wallace) [Additional Reference(s): DWR Levee Log, 2005. USACE Sacramento O&M Manual 132, October 1959 (Station #####)] FS Date: 5/5/2015 1:08:00 PM

Slide gate in corrugated metal riser on WS slope.

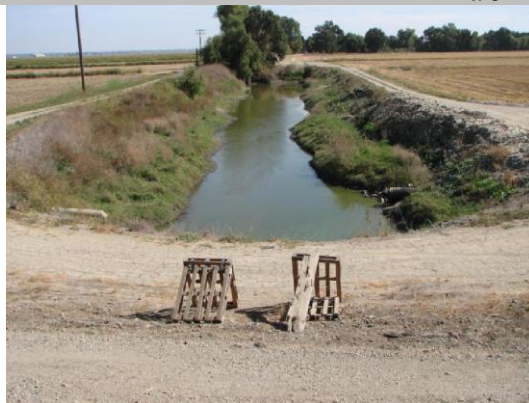
Photo 2 of 2 : UCIP_SP_2016_48478_69004.jpg

Comment Code					
Inspector Comment					
FS_ID:48478 DS_ID:17154 EP_NO: 9388 Repair Type: Urgent Crossing Status: Found UCIP Comments: 5/4/2015 Slide gate stem is still bent. Gate looks to be unable to close all the way.6/17/2014 Same as last inspection.12/16/2013 Slide gate stem is still bent. WS flapgate was closed.7/16/2013 Water flowing through pipe so screw gate definately not closed. Was told NOV's have been sent for owner to replace stem. Flap gate gets closed for flood season.10/11/2012 Slide gate inoperable, but appears to be in closed position. Flap gate held in open position. Good candidate for video inspection when, if ever, dry. FIELD_STRUCT_DESC: 48-inch corrugated metal pipe through the levee, 28.0 feet below the crown. Slide gate in 66-inch pipe riser on the waterside (WS) slope. Concrete headwall on the WS. Grouted cobble spillway from drain ditch to large canal on the landside (LS). (Permit No. 9388, Wallace) [Additional Reference(s): DWR Levee Log, 2005. USACE Sacramento O&M Manual 132, October 1959 (Station #####)] FS Date: 5/5/2015 1:08:00 PM

Drainage ditch on LS toe.

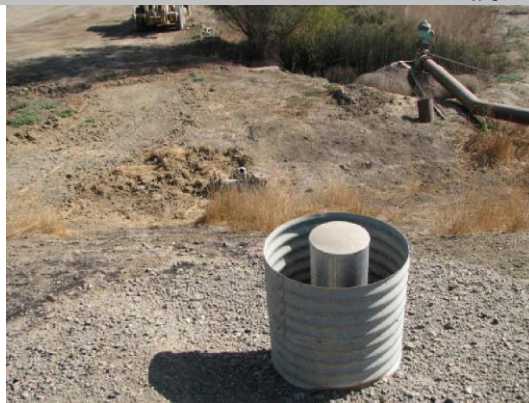
Photo 1 of 2 : UCIP_SP_2016_48484_69023.jpg

LM Start	4.23	Rating **	M	Issue No.	38
LM End	4.23	Issue Type +	En	Location *	LS
Category	Supplemental			GPS Latitude/Longitude	
				Start	End
Item	DWR UCIP Field Study			39.089666 °	39.089666 °
				-122.015248 °	-122.015248 °
DWR ID

Comment Code					
Inspector Comment					
FS_ID:48484 DS_ID:20717 EP_NO: N/A Repair Type: Non-Urgent Crossing Status: Found UCIP Comments: 5/4/2015 Corssing appears to be in good condition. No noticeable issues to report.6/17/2014 Same as last inspection. Pump reinstalled on pier.12/16/2013 Pump has been removed for winter.7/16/2013 Same as last inspection.10/11/2012 No permit identified for this crossing. FIELD_STRUCT_DESC: 24-inch steel pipe though levee, 4.5 feet below crown. Pump in pump house on waterside (WS) bank. Siphon breaker valve installed on landside (LS) shoulder. [Additional Reference(s): DWR Levee Log, 2005. USACE Sacramento O&M Manual 132, October 1959 (Station #####)] FS Date: 5/5/2015 1:23:00 PM

Possible siphon breaker for pipe on LS shoulder.

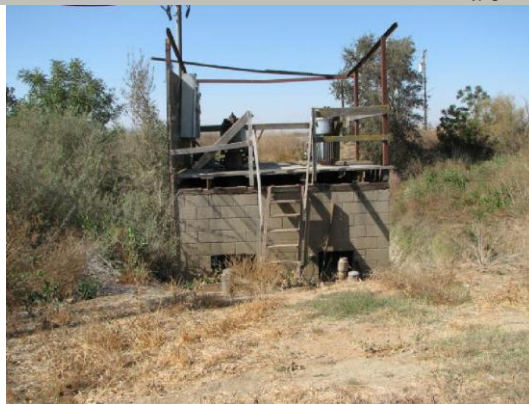
Photo 2 of 2 : UCIP_SP_2016_48484_69022.jpg

Pumping plant on WS toe.

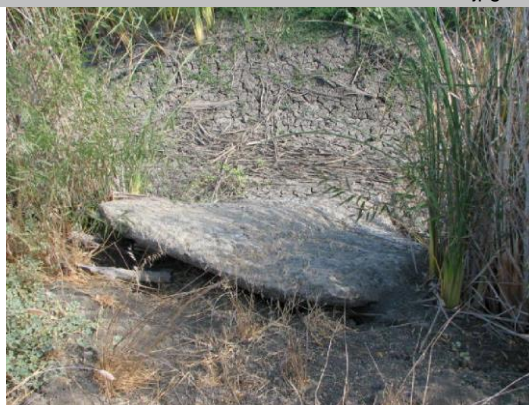
Photo 1 of 2 : UCIP_SP_2016_48486_69030.jpg

Comment Code					
Inspector Comment					
FS_ID:48486 DS_ID:17191 EP_NO: N/A Repair Type: Urgent Crossing Status: Found UCIP Comments: 5/4/2015 WS flapgate is blocked by sediment and unable to open. LS inlet is hidden by sediment and heavy vegetation and unable to be located. Needs to be cleared.6/17/2014 Same as last inspection.12/16/2013 Same as last inspection.7/16/2013 Same as last inspection.10/11/2012 Pipe is clogged at both the inlet and outlet. Good candidate for video inspection. FIELD_STRUCT_DESC: 48-inch corrugated metal pipe through the levee, approximately 15 feet below the crown. Concrete headwalls on both waterside (WS) and (LS) ends with an automatic drainage gate on the WS. [Additional Reference(s): DWR Levee Log, 2005. USACE Sacramento O&M Manual 132, October 1959 (Station #####)] FS Date: 5/5/2015 1:27:00 PM

Apparent inlet clogged with concrete or grout on LS toe in drainage swale.

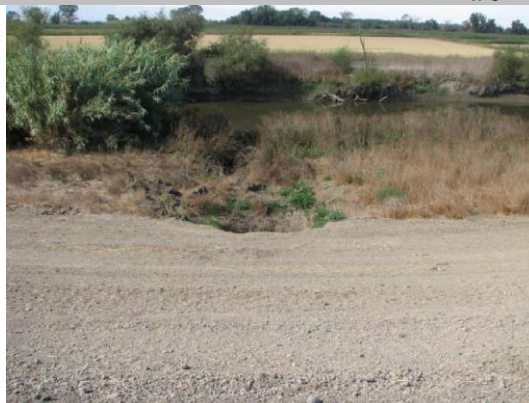
Photo 2 of 2 : UCIP_SP_2016_48486_69029.jpg

Comment Code						
Inspector Comment						
FS_ID:48486 DS_ID:17191 EP_NO: N/A Repair Type: Urgent Crossing Status: Found UCIP Comments: 5/4/2015 WS flapgate is blocked by sediment and unable to open. LS inlet is hidden by sediment and heavy vegetation and unable to be located. Needs to be cleared.6/17/2014 Same as last inspection.12/16/2013 Same as last inspection.7/16/2013 Same as last inspection.10/11/2012 Pipe is clogged at both the inlet and outlet. Good candidate for video inspection. FIELD_STRUCT_DESC: 48-inch corrugated metal pipe through the levee, approximately 15 feet below the crown. Concrete headwalls on both waterside (WS) and (LS) ends with an automatic drainage gate on the WS. [Additional Reference(s): DWR Levee Log, 2005. USACE Sacramento O&M Manual 132, October 1959 (Station #####)] FS Date: 5/5/2015 1:27:00 PM

Outlet on WS toe.

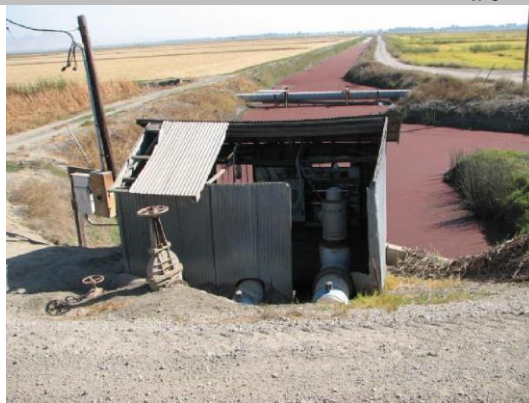
Photo 1 of 2 : UCIP_SP_2016_48489_69061.jpg

Comment Code					
Inspector Comment					
FS_ID:48489 DS_ID:20715 EP_NO: 13699 Repair Type: Non-Urgent Crossing Status: Found UCIP Comments: 5/4/2015 Corssing appears to be in good condition. No noticeable issues to report.6/17/2014 Same as last inspection.12/16/2013 Same as last inspection.7/16/2013 Same as last inspection.10/11/2012 Oil leakage around pump. FIELD_STRUCT_DESC: 1 of 2: 20-inch soilproofed steel storn drain pipe through levee, 4.4 feet below crown. Cobble revetted sump on waterside (WS). Siphon breaker in 24-inch metal pipe risers on WS shoulder. Pump house at toe of landside (LS) slope. (Permit No. 13699, 1984). Replaced 18-inch pipe at same location. FS Date: 5/5/2015 1:34:00 PM

Pumping plant on LS slope

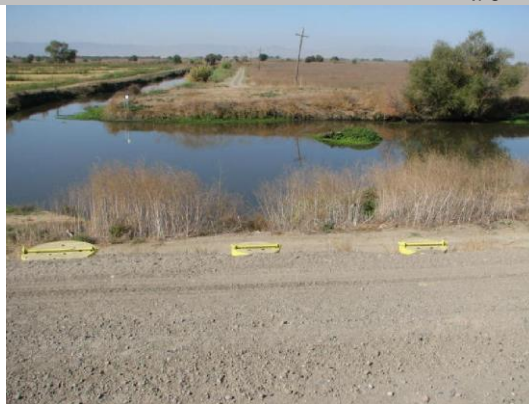
Photo 2 of 2 : UCIP_SP_2016_48489_69060.jpg

Siphon Breaker on WS shoulder.

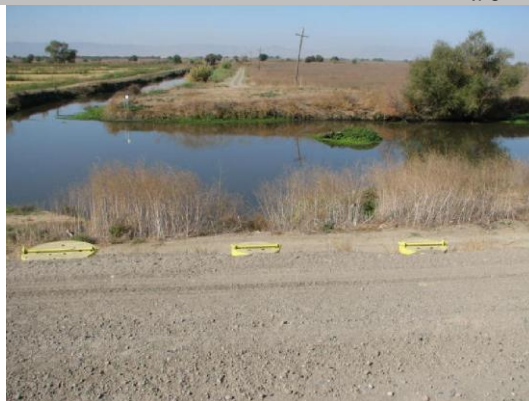
Photo 1 of 2 : UCIP_SP_2016_48492_69064.jpg

Comment Code					
Inspector Comment					
FS_ID:48492 DS_ID:20716 EP_NO: 13699 Repair Type: Non-Urgent Crossing Status: Found UCIP Comments: 5/4/2015 Corssing appears to be in good condition. No noticeable issues to report.6/17/2014 Same as last inspection.12/16/2013 Same as last inspection.7/16/2013 Same as last inspection.10/11/2012 Oil leaks at pump head. FIELD_STRUCT_DESC: 2 of 2: 20-inch soilproofed steel storm drain pipe through levee, 4.4 feet below crown. Cobble revetted sump on waterside (WS). Siphon breaker in 24-inch metal pipe risers on WS shoulder. Pump house at toe of landside (LS) slope. (Permit No. 13699, 1984). Replaced 18-inch pipe at same location. FS Date: 5/5/2015 1:36:00 PM

Siphon Breaker on WS shoulder.

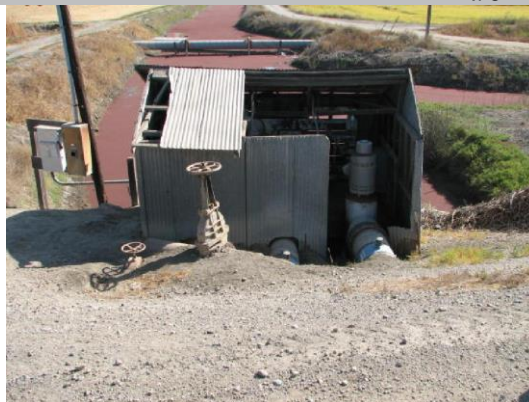
Photo 2 of 2 : UCIP_SP_2016_48492_69063.jpg

Pumphouse on LS slope.

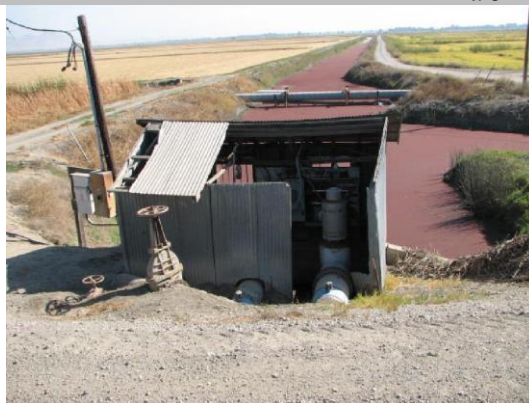
Photo 1 of 2 : UCIP_SP_2016_48458_69081.jpg

Comment Code					
Inspector Comment					
FS_ID:48458 DS_ID:17199 EP_NO: 9390 Repair Type: Non-Urgent Crossing Status: Found UCIP Comments: 5/4/2015 Corssing appears to be in good condition. No noticeable issues to report.6/17/2014 Same as last inspection.12/16/2013 Same as last inspection.7/16/2013 Same as last inspection.10/11/2012 Minor oil leak on pump. FIELD_STRUCT_DESC: 3 of 3: 18-inch pipe through levee, 4.4 feet below crown. Cobble revetted sump on waterward side. Siphon breaker in 16-inch metal pipe risers on waterward shoulder. Pump house at toe of landward slope. (Permit No. 9390 - Profpe) Originally included in O+M manual (1959). [Additional Reference(s): DWR Levee Log, 2005. USACE Sacramento O&M Manual 132, October 1959 (Station #####)] FS Date: 5/5/2015 1:39:00 PM

Pump house on LS slope.

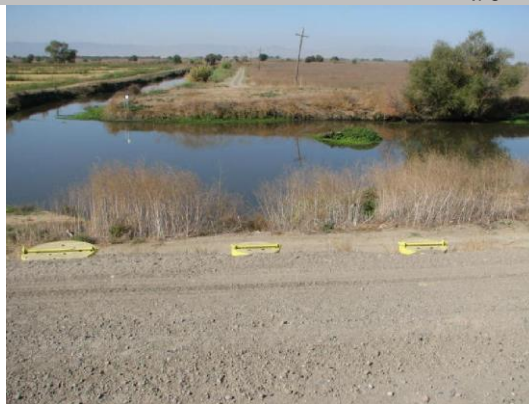
Photo 2 of 2 : UCIP_SP_2016_48458_69080.jpg

Siphon breaker on WS shoulder.

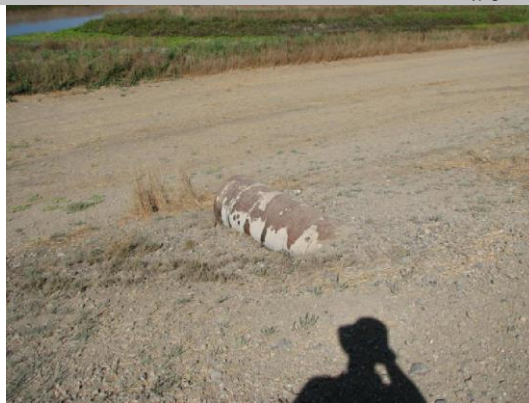
Photo 1 of 2 : UCIP_SP_2016_48459_69089.jpg

FS_ID:48459
DS_ID:17163
EP_NO: 9390
Repair Type: Non-Urgent
Crossing Status: Found
UCIP Comments: 5/4/2015 Corssing appears to be in good condition. No noticeable issues to report.6/17/2014 Same as last inspection.12/16/2013 Same as last inspection.7/16/2013 Same as last inspection.10/11/2012 Rodent burrowing along sides of pipe on LS.
FIELD_STRUCT_DESC: 24-inch steel pipe through levee, 3.0 feet below crown. Both ends capped, terminating on levee slopes. (Permit No. 9390 - Profpe) Originally included in O+M manual (1959).
[Additional Reference(s): DWR Levee Log, 2005. USACE Sacramento O&M Manual 132, October 1959 (Station #####)]
FS Date: 5/5/2015 1:39:00 PM

Pipe on WS.

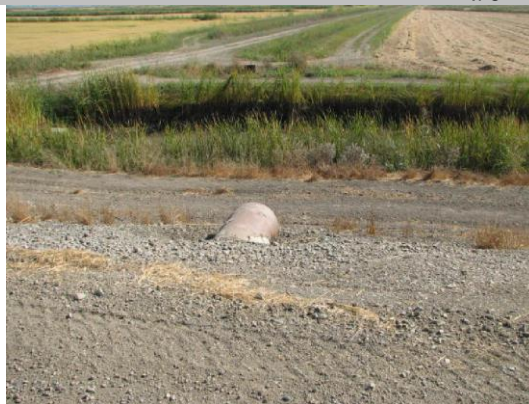
Photo 2 of 2 : UCIP_SP_2016_48459_69088.jpg

Pipe on LS.

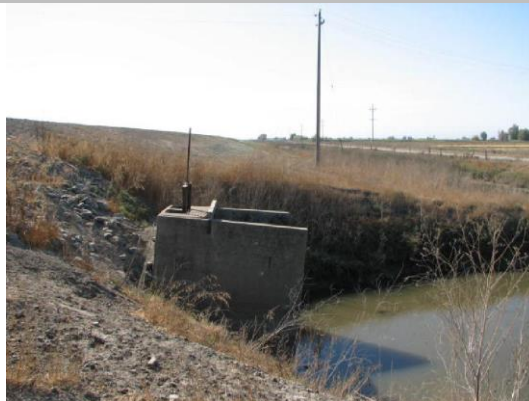
Photo 1 of 2 : UCIP_SP_2016_48461_69100.jpg

FS_ID:48461
DS_ID:17166
EP_NO: 9390
Repair Type: Urgent
Crossing Status: Found
UCIP Comments: 5/4/2015 WS concrete headwall tilting away from the levee slope.6/17/2014 Same as last inspection.12/16/2013 Same as last inspection.7/16/2013 Same as last inspection.10/11/2012 Concrete Headwall tilting on WS slope.
FIELD_STRUCT_DESC: 36-inch CM drain pipe through the levee, 15.0 feet below crown. Concrete head wall, slide gate and grouted revetment on waterward side. Slide gate and Concrete headwall on landward side. (Permit No. 9390 - Profpe). Originally included in O+M manual (1959). [Additional Reference(s): DWR Levee Log, 2005. USACE Sacramento O&M Manual 132, October 1959 (Station #####)]
FS Date: 5/5/2015 1:41:00 PM

Tilting headwall on WS toe.

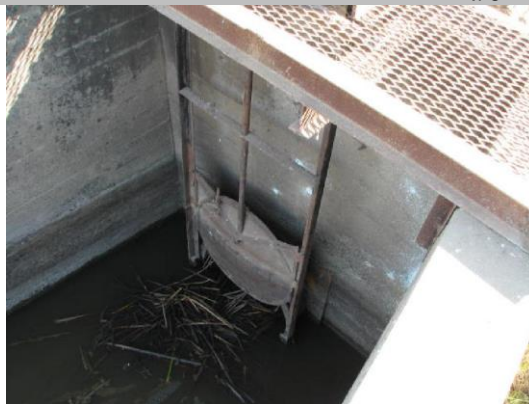
Photo 2 of 2 : UCIP_SP_2016_48461_69099.jpg

Slidegate on WS toe.

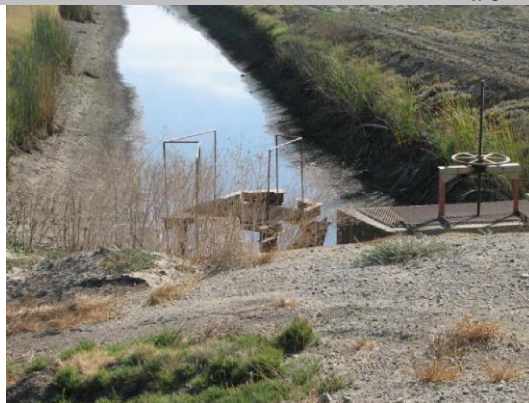
Photo 1 of 2 : UCIP_SP_2016_48462_69109.jpg

FS_ID:48462
DS_ID:17165
EP_NO: 9390
Repair Type: Non-Urgent
Crossing Status: Indicator Found
UCIP Comments: 5/4/2015 Abandoned crossing.6/17/2014 Same as last inspection.12/16/2013 Same as last inspection.7/16/2013 Same as last inspection.10/11/2012 Pipe abandoned. Steel pump platform remains on LS slope, but all appurtances have been removed.
FIELD_STRUCT_DESC: 18-inch steel pipe through levee, 3.0 feet below crown. waterward end open into concrete spill box. Pump on landward side on steel pier.. (Permit No. 9390 - Profpe) Originally included in O+M manual (1959) [Additional Reference(s): DWR Levee Log, 2005. USACE Sacramento O&M Manual 132, October 1959 (Station #####)]
FS Date: 5/5/2015 1:42:00 PM

Pump platform at center left of photo.

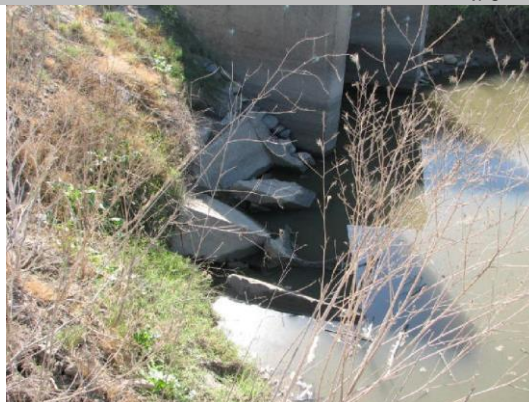
Photo 2 of 2 : UCIP_SP_2016_48462_69108.jpg

headwall debris on LS toe showing evidence of 18-inch cmp.

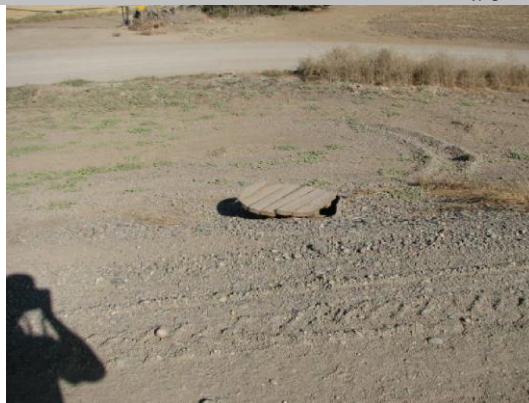
Photo 1 of 2 : UCIP_SP_2016_48465_69115.jpg

FS_ID:48465
DS_ID:17157
EP_NO: 9386
Repair Type: Urgent
Crossing Status: Found
UCIP Comments: 5/4/2015 Both pipe ends and slide gate in riser are plugged with soil. Crossing is inoperable.6/17/2014 Same as last inspection.12/16/2013 Same as last inspection.7/16/2013 Same as last inspection.10/11/2012 Pipe plugged with soil on both ends as well as at slide gate on WS slope. Slide gate inoperable.
FIELD_STRUCT_DESC: 24-inch Corrugated metal drainpipe through the levee, 8.0 feet below the crown. Slide gate in 36-inch pipe riser on the waterward shoulder. (Permit No. 9386 - Wescott) Levee turns eastward. [Additional Reference(s): DWR Levee Log, 2005. USACE Sacramento O&M Manual 132, October 1959 (Station #####)]
FS Date: 5/5/2015 1:51:00 PM

cover on 36-inch CMP standpipe on WS slope.

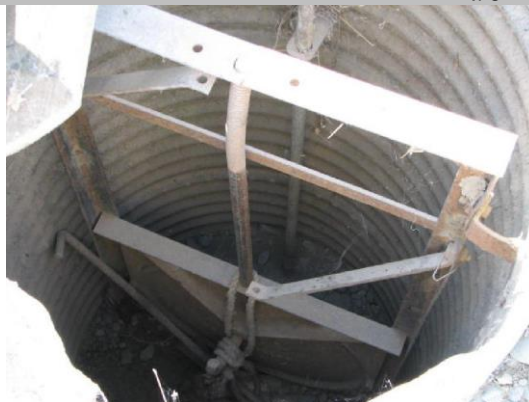
Photo 2 of 2 : UCIP_SP_2016_48465_69114.jpg

Bent and broken actuator on slide gate in 36-inch CMP. Pipe appears to be filled with soil.
