**Flood Control Project Maintenance
Levee Inspections**
LMA District Cover Sheet
Spring 2017 Levee Inspection Results

Sutter Maintenance Yard Maintenance Area 0012

Spring 2017 Levee Inspection Results

Waterway			Bank	Unit Miles
Unit No. 01 Colusa Drain			Left	11.06
	Spring (March - May)	Summer (June - August)	(September - November) Fall	Winter (December - February)
Unit Maintenance Rating (Fall Only)				
Date of Inspection	3/16/2017 - 3/16/2017			
DWR Inspector	Bob Duffey			
Accompanied By	Bryan Reniff Sutter Maintenance Yard

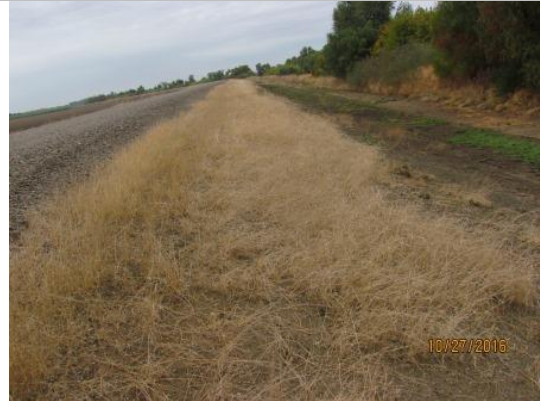
Photo 1 of 1 : SP_2017_MA0012_299_36_20170315_00010.jpg

View of the annual grass along the waterside slope.

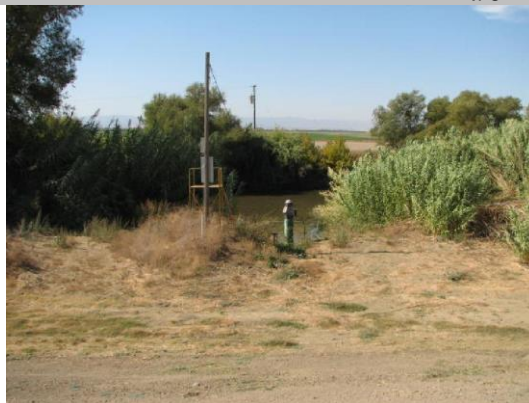
Photo 1 of 3 : UCIP_SP_2017_51781_68981.jpg

FS_ID:51781
DS_ID:17148
EP_NO: 9382
Repair Type: Non-Urgent
Crossing Status: Found
UCIP Comments: 5/2/2017 WS is being overgrown with vegetation. The rest of the crossing appears to be in good condition. (DWR Sutter Yard- A Freitag)10/17/2016 Vegetation is overgrowing the WS head wall near the pump. The rest of the crossing appears to be in good condition. (DWR Sutter Yard- A Freitag)5/31/2016 Crossing appears to be in good condition.5/4/2015 Crossing appears in good condition. No noticeable issues to report.6/17/2014 Same as last inspection.12/16/2013 Same as last inspection.7/16/2013 Same as last inspection.
FIELD_STRUCT_DESC: 18-inch steel irrigation pipe through the levee, 3 feet below the crown. Pump, butterfly valve, and concrete headwall at the edge of bank. Bank cobble re-vetted 10 feet on both waterside (WS) and landside (LS) of installation. 18-inch polyvinyl chloride (PVC) standpipe on the LS berm. Siphon breaker in 18-inch concrete riser on the LS shoulder. Service pole at the edge of the bank. (Automatic Board Order (ABO) issued as Permit No. 9382, 1974 - Baber)

Pump, pole, and meter on WS toe.

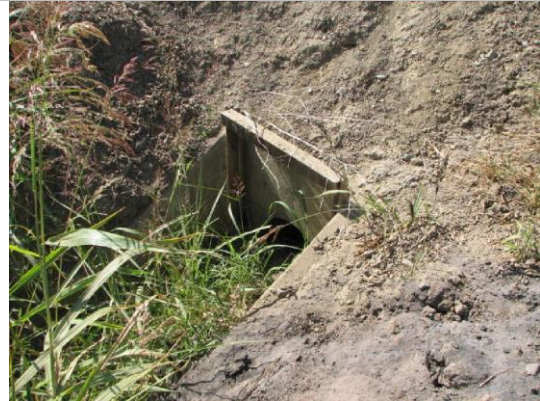
Photo 3 of 3 : UCIP_SP_2017_51782_68982.jpg

FS_ID:51782
DS_ID:17149
EP_NO: 9382
Repair Type: Non-Urgent
Crossing Status: Found
UCIP Comments: 5/2/2017 WS flapgate buried by sediment. Needs to be dug out. (DWR Sutter Yard- A Freitag)10/17/2016 Crossing appears to be in good condition. This is a gravity drain for the LS. (DWR Sutter Yard- A Freitag)5/31/2016 LS inlets was partially plugged. WS flapgate was clear of sediment and abale to operate properly.5/4/2015 WS flapgate is blocked by sediment and unable to open. LS inlet is plugged by silt and wood chippings. Needs to be cleaned.6/17/2014 Flap gate was cleaned out and is fully closed. LS inlet still partially full of soil.12/16/2013 Same as last inspection. WS flapgate still needs to be cleaned out and shut.7/16/2013 Same as last inspection. Make sure flapgate is closed before highwater season.10/11/2012 Inlet on LS filled partially with soil. Outlet blocked with soil and the flap gate wont close.

Concrete U shaped headwall at LS inlet.

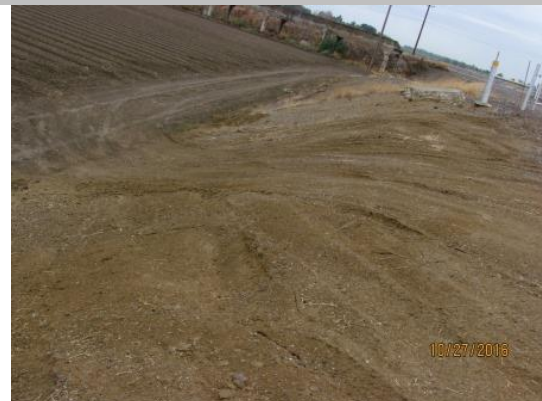
Photo 1 of 1 : SP_2017_MA0012_299_35_20170315_00009.jpg

LM Start	1.81	Rating **	M	Issue No.	35
LM End	1.81	Issue Type +	Ma	Location *	LS
Category	Earthen Levee		GPS Latitude/Longitude		
			Start	End	
Item	Slope Stability		39.057393 °	39.057393 °	
			-122.003452 °	-122.003452 °	
DWR ID	DWR_MA0012_01_f_2016_35

View of the slope instability caused by vehicles along the landside slope.

S3 : Repair the levee slope damaged by vehicle traffic and prevent access where possible.

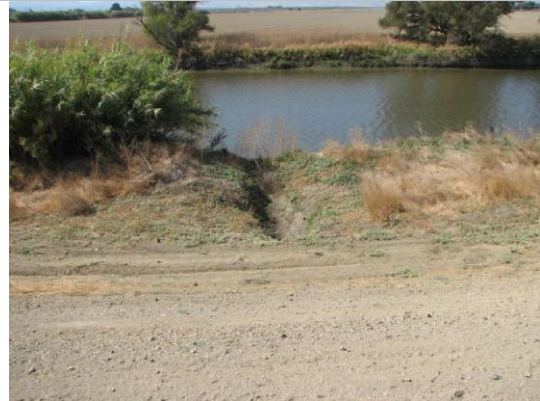
Photo 1 of 3 : UCIP_SP_2017_51786_68994.jpg

Comment Code					
Inspector Comment					
FS_ID:51786 DS_ID:17151 EP_NO: 9391 Repair Type: Non-Urgent Crossing Status: Found UCIP Comments: 5/2/2017 Both ends of pipe buried. (DWR Sutter Yard- AFreitag)10/17/2016 Appears abandoned. Both pipe ends are completely buried. (DWR Sutter Yard- AFreitag)9/29/2016 Crossing has been downgraded from Urgent to Non-Urgent both pipe ends are buried. Having both ends buried prevents water from flowing from WS to LS during flood season. Need to contact owner and have owner coordinate with CVFPB to comply with Title 23. (DWR UCIP - omagana)5/31/2016 Both pipe ends are buried. Pipe is non-operational. (DWR Sutter Yard - afreitag)5/4/2015 LS and WS ends are blocked with soil. Pipe is inoperable as it is. (DWR Sutter Yard - afreitag)6/17/2014 Same as last inspection. (DWR Sutter Yard - afreitag)12/16/2013 Same as last inspection. (DWR Sutter Yard - afreitag)7/16/2013 LS inlet is completely filled with soil. Needs to be cleaned out. (DWR Sutter Yard - afreitag)10/11/2012 Inlet is partially filled with soil. (DWR Sutter Yard - wwylie) FIELD_STRUCT_DESC: *ABANDONED* 24-inch corrugated metal drainage pipe through the levee, 13 feet below the crown. Flap gate, concrete headwall and grouted cobble spillway on the waterside (WS). Concrete headwall located on the landside (LS). (Automatic Board Order (ABO) issued as Permit No. 9391, Christenson). [Additional Reference(s): DWR Levee Log, 2005. USACE Sacramento O&M Manual 132, October 1959 (HLM 2.02)] FS Date: 5/2/2017 2:01:25 PM

WS view of outlet.

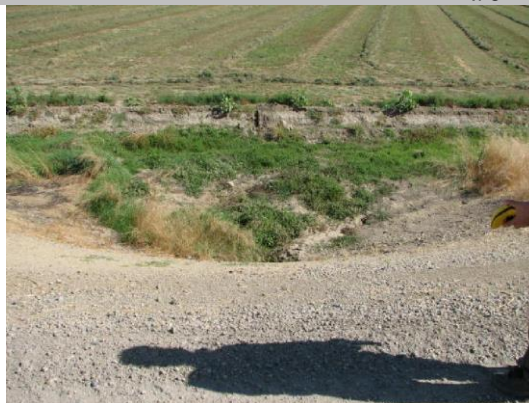
Photo 2 of 3 : UCIP_SP_2017_51786_68993.jpg

Comment Code					
Inspector Comment					
FS_ID:51786 DS_ID:17151 EP_NO: 9391 Repair Type: Non-Urgent Crossing Status: Found UCIP Comments: 5/2/2017 Both ends of pipe buried. (DWR Sutter Yard- AFreitag)10/17/2016 Appears abandoned. Both pipe ends are completely buried. (DWR Sutter Yard- AFreitag)9/29/2016 Crossing has been downgraded from Urgent to Non-Urgent both pipe ends are buried. Having both ends buried prevents water from flowing from WS to LS during flood season. Need to contact owner and have owner coordinate with CVFPB to comply with Title 23. (DWR UCIP - omagana)5/31/2016 Both pipe ends are buried. Pipe is non-operational. (DWR Sutter Yard - afreitag)5/4/2015 LS and WS ends are blocked with soil. Pipe is inoperable as it is. (DWR Sutter Yard - afreitag)6/17/2014 Same as last inspection. (DWR Sutter Yard - afreitag)12/16/2013 Same as last inspection. (DWR Sutter Yard - afreitag)7/16/2013 LS inlet is completely filled with soil. Needs to be cleaned out. (DWR Sutter Yard - afreitag)10/11/2012 Inlet is partially filled with soil. (DWR Sutter Yard - wwyilie) FIELD_STRUCT_DESC: *ABANDONED* 24-inch corrugated metal drainage pipe through the levee, 13 feet below the crown. Flap gate, concrete headwall and grouted cobble spillway on the waterside (WS). Concrete headwall located on the landside (LS). (Automatic Board Order (ABO) issued as Permit No. 9391, Christenson). [Additional Reference(s): DWR Levee Log, 2005. USACE Sacramento O&M Manual 132, October 1959 (HLM 2.02)] FS Date: 5/2/2017 2:01:25 PM

LS view of inlet.

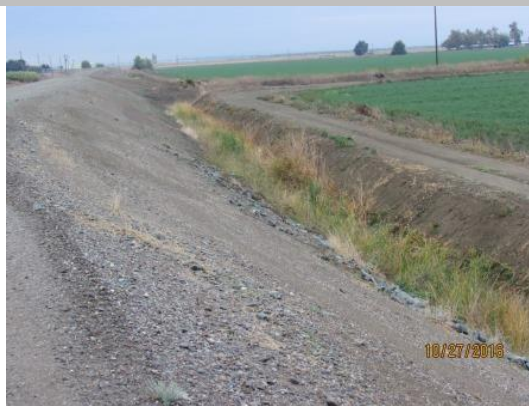
Photo 1 of 1 : SP_2017_MA0012_299_1_20170315_00001.jpg

View of a ditch along the landside toe.

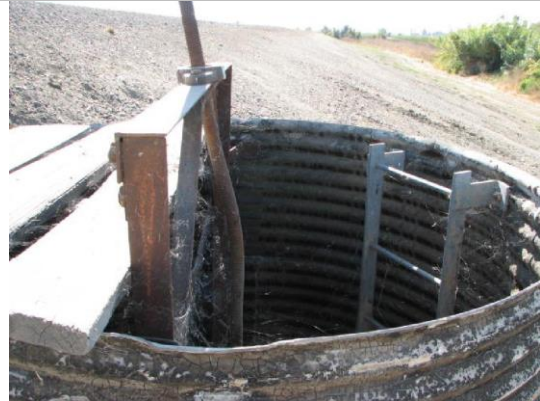
Photo 3 of 3 : UCIP_SP_2017_51789_69008.jpg

FS_ID:51789
DS_ID:17154
EP_NO: 9388
Repair Type: Urgent
Crossing Status: Found
UCIP Comments: 5/2/2017 WS slidegate stem is still bent, wheel to operate gate is missing. Needs a cover made for the standpipe to prevent falls. (DWR Sutter Yard- A Freitag)10/17/2016 Slide gate stem is still bent and the gate appears to be inoperable. (DWR Sutter Yard- A Freitag)5/31/2016 Slide gate stem is still bent. WS flap gate is chained open. (DWR Sutter Yard - A Freitag)5/4/2015 Slide gate stem is still bent. Gate looks to be unable to close all the way. (DWR Sutter Yard - A Freitag)6/17/2014 Same as last inspection. (DWR Sutter Yard - A Freitag)12/16/2013 Slide gate stem is still bent. WS flapgate was closed. (DWR Sutter Yard - A Freitag)7/16/2013 Water flowing through pipe so screw gate definitely not closed. Was told NOV's have been sent for owner to replace stem. Flap gate gets closed for flood season. (DWR Sutter Yard - A Freitag)10/11/2012 Slide gate inoperable, but appears to be in closed position. Flap gate held in open position. Good candidate for video inspection when, if ever, dry. (DWR UCIP - Wylie)

Bent screw for slide gate at WS shoulder.

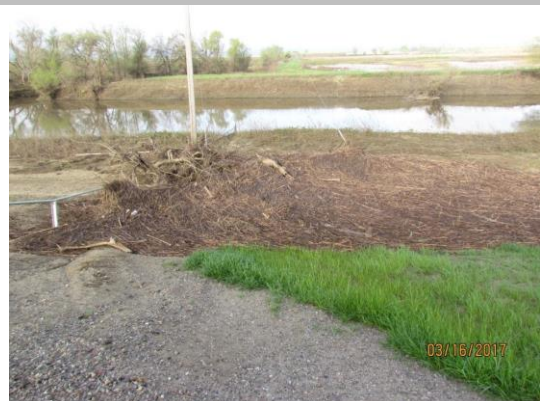
Photo 1 of 1 : SP_2017_MA0012_299_49_20170328_00086.jpg

View of the debris at the waterside toe.

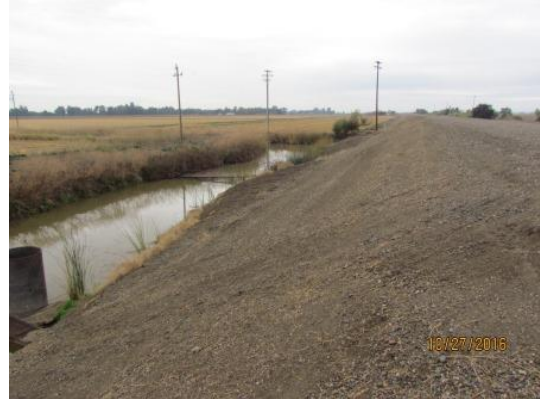
Photo 1 of 1 : SP_2017_MA0012_299_4_20170315_00002.jpg

View of a ditch along the landside toe.

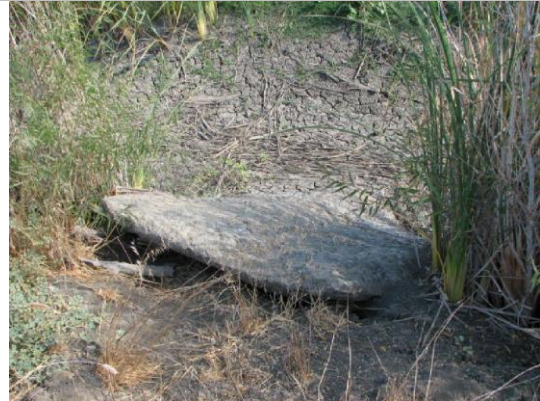
Photo 1 of 3 : UCIP_SP_2017_51796_69030.jpg

Apparent inlet clogged with concrete or grout on LS toe in drainage swale.

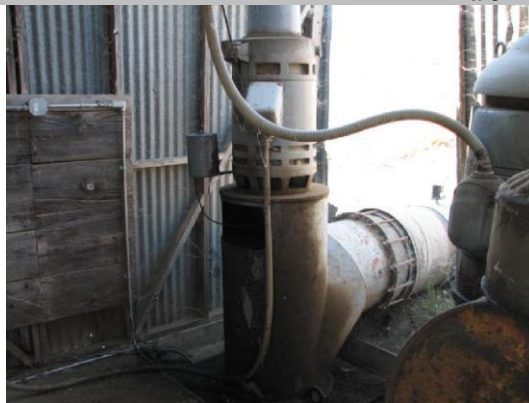
Photo 3 of 3 : UCIP_SP_2017_51800_69059.jpg

Pump with oil leakage shown on side of pipe.

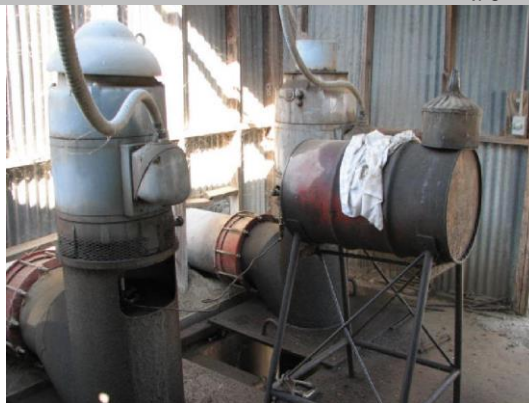
Photo 3 of 3 : UCIP_SP_2017_51802_69074.jpg

Pump for 20-inch pipe at left. See oil bouser and leakage around pumps.

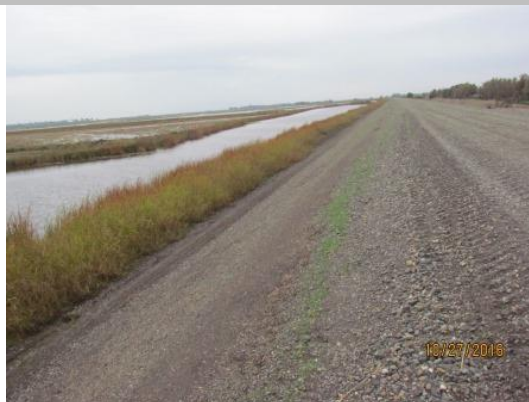
Photo 1 of 1 : SP_2017_MA0012_299_37_20170315_00011.jpg

View of a ditch along the landside toe.

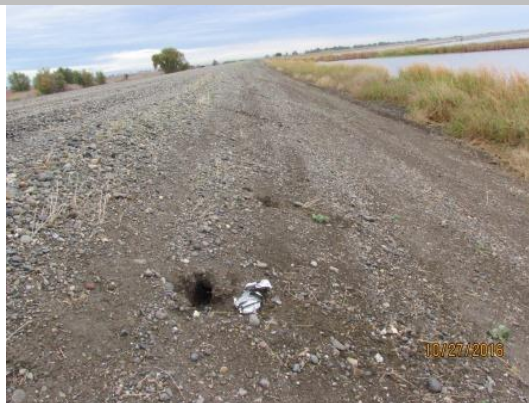
Photo 1 of 1 : SP_2017_MA0012_299_32_20170315_00006.jpg

View of the rodent holes along the landside slope.

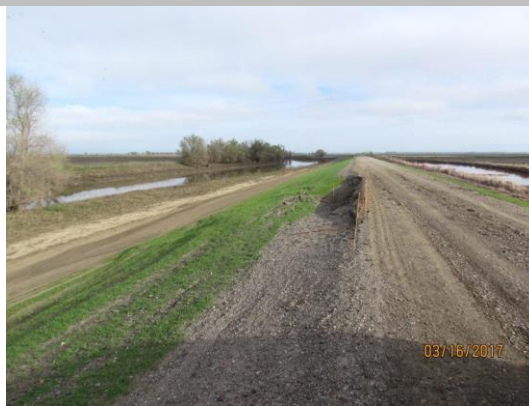
Photo 1 of 1 : SP_2017_MA0012_299_50_20170328_00087.jpg

View of the slough on the waterside slope.

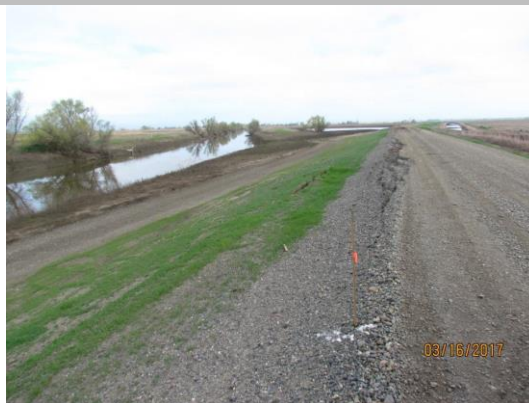
Photo 1 of 1 : SP_2017_MA0012_299_51_20170328_00088.jpg

View of the slough on the waterside slope.

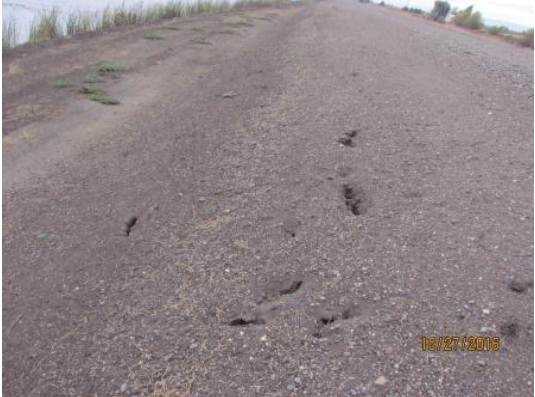
Photo 1 of 1 : SP_2017_MA0012_299_28_20170315_00005.jpg

View of the longitudinal cracks along the landside slope.

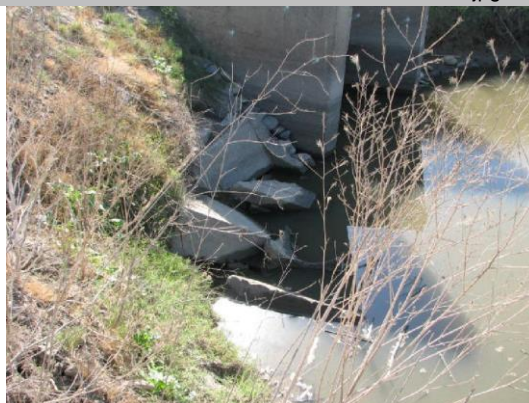
Photo 2 of 3 : UCIP_SP_2017_51807_69108.jpg

headwall debris on LS toe showing evidence of 18-inch cmp.

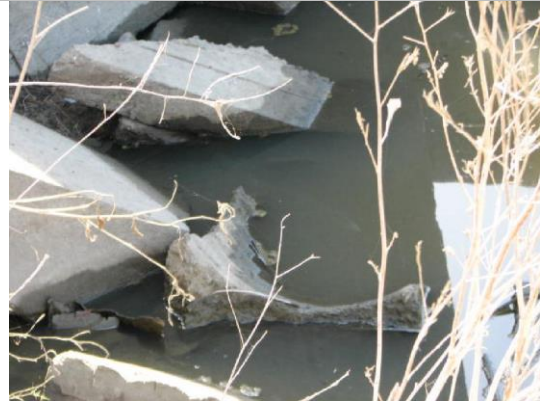
Photo 3 of 3 : UCIP_SP_2017_51807_69107.jpg

headwall debris on LS toe showing evidence of 18-inch cmp.

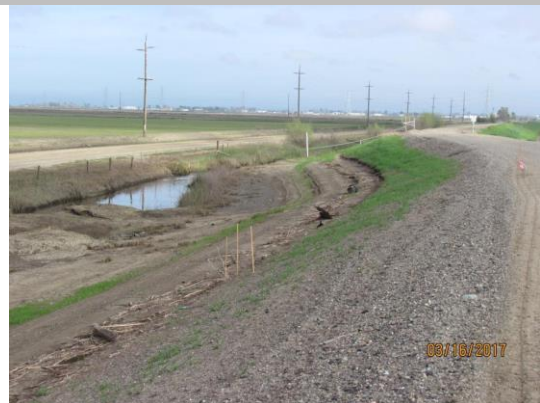
Photo 1 of 1 : SP_2017_MA0012_299_52_20170328_00089.jpg

View of the erosion along the waterside slope.

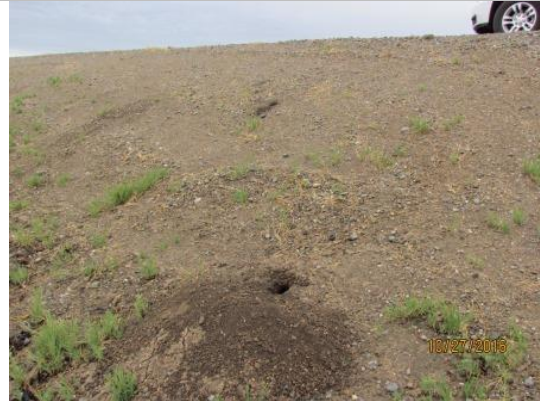
Photo 1 of 1 : SP_2017_MA0012_299_24_20170315_00004.jpg

View of the rodent holes along the landside slope.

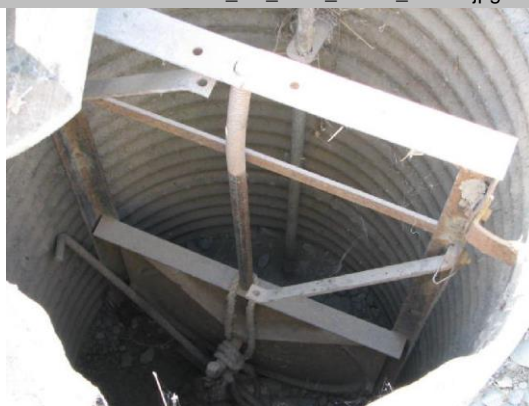
Photo 2 of 2 : UCIP_SP_2017_51810_69114.jpg

Bent and broken actuator on slide gate in 36-inch CMP. Pipe appears to be filled with soil.
