**Flood Control Project Maintenance
Levee Inspections**
LMA District Cover Sheet
Spring 2018 Levee Inspection Results

Sutter Maintenance Yard Maintenance Area 0012

Spring 2018 Levee Inspection Results

Waterway			Bank	Unit Miles
Unit No. 01 Colusa Drain			Left	11.06
	Spring (March - May)	Summer (June - August)	(September - November) Fall	Winter (December - February)
Unit Maintenance Rating (Fall Only)				
Date of Inspection	4/18/2018 - 4/18/2018			
DWR Inspector	Bob Duffey			
Accompanied By	Bryan Reniff Sutter Maintenance Yard

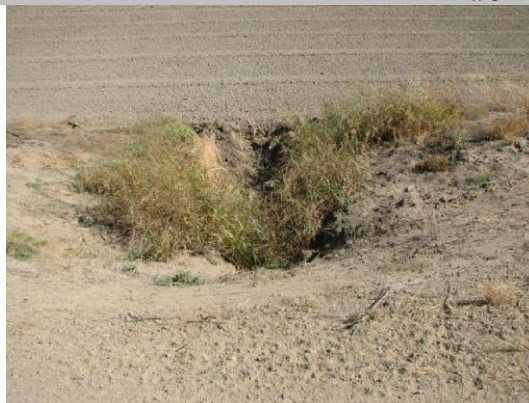
Photo 1 of 3 : UCIP_SP_2018_51780_68977.jpg

Comment Code					
Inspector Comment					
FS_ID:51780 DS_ID:17147 EP_NO: 9382 Repair Type: No Action Needed Crossing Status: Found UCIP Comments: 5/2/2017 Crossing appears to be in good condition. (DWR Sutter Yard- AFreitag)10/17/2016 Crossing appears to be in good condition. This is a gravity for the LS.(DWR Sutter Yard- AFreitag)5/31/2016 Crossing appears to be in good condition.5/4/2015 Crossing is in good condition. No issues.6/17/2014 Same as last inspection.12/16/2013 Same as last inspection.7/16/2013 Same as last inspection. FIELD_STRUCT_DESC: 24-inch corrugated metal drainage pipe through the levee, 13 feet below the crown. Flap gate, concrete headwall, and grouted cobble spillway on the waterside (WS). Concrete headwall on the landside (LS). (24-inch pipe [HLM 1.40] authorized under Automatic Board Order (ABO) issued as Permit No. 9382, 1974 - Olen C. Bober). [Additional Reference(s): DWR Levee Log, 2005. USACE Sacramento O&M Manual 132, October 1959, (HLM 1.4)]. FS Date: 5/2/2017 1:40:20 PM

Intake on LS toe.

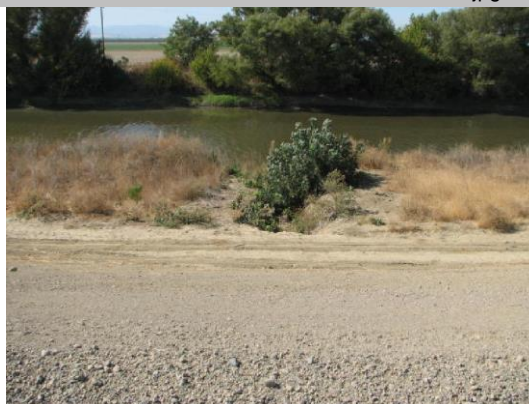
Photo 2 of 3 : UCIP_SP_2018_51780_68976.jpg

Outlet at WS toe.

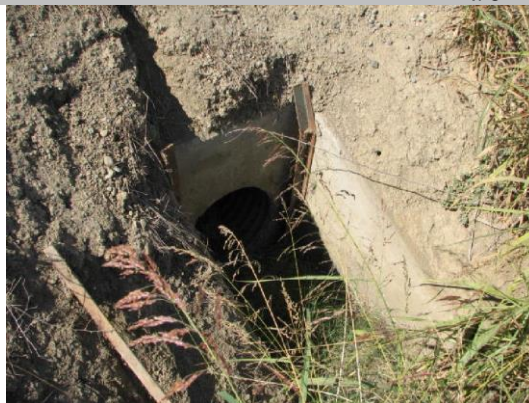
Photo 3 of 3 : UCIP_SP_2018_51780_68975.jpg

Comment Code						
Inspector Comment						
FS_ID:51780 DS_ID:17147 EP_NO: 9382 Repair Type: No Action Needed Crossing Status: Found UCIP Comments: 5/2/2017 Crossing appears to be in good condition. (DWR Sutter Yard- AFreitag)10/17/2016 Crossing appears to be in good condition. This is a gravity for the LS.(DWR Sutter Yard- AFreitag)5/31/2016 Crossing appears to be in good condition.5/4/2015 Crossing is in good condition. No issues.6/17/2014 Same as last inspection.12/16/2013 Same as last inspection.7/16/2013 Same as last inspection. FIELD_STRUCT_DESC: 24-inch corrugated metal drainage pipe through the levee, 13 feet below the crown. Flap gate, concrete headwall, and grouted cobble spillway on the waterside (WS). Concrete headwall on the landside (LS). (24-inch pipe [HLM 1.40] authorized under Automatic Board Order (ABO) issued as Permit No. 9382, 1974 - Olen C. Bober). [Additional Reference(s): DWR Levee Log, 2005. USACE Sacramento O&M Manual 132, October 1959, (HLM 1.4)]. FS Date: 5/2/2017 1:40:20 PM

Concrete U shaped headwall on LS toe.

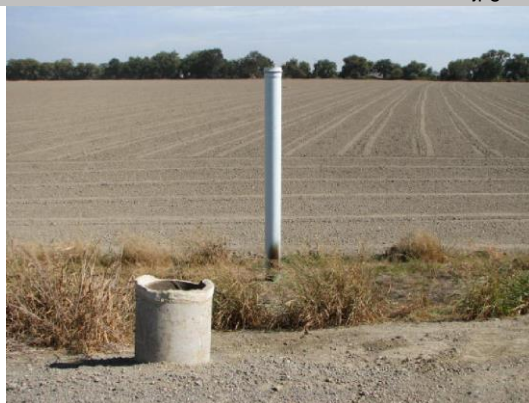
Photo 2 of 3 : UCIP_SP_2018_51781_68980.jpg

Concrete and PVC risers on LS.

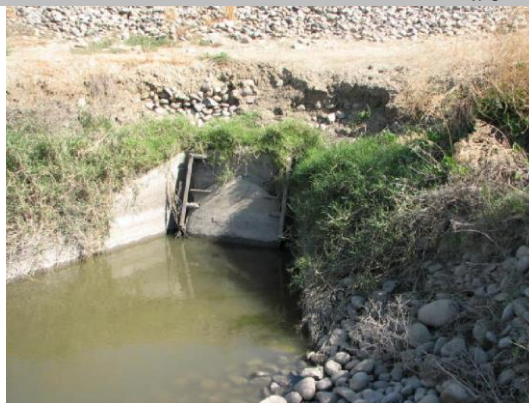
Photo 2 of 3 : UCIP_SP_2018_51785_68990.jpg

Flap gate and concrete headwall at WS toe.

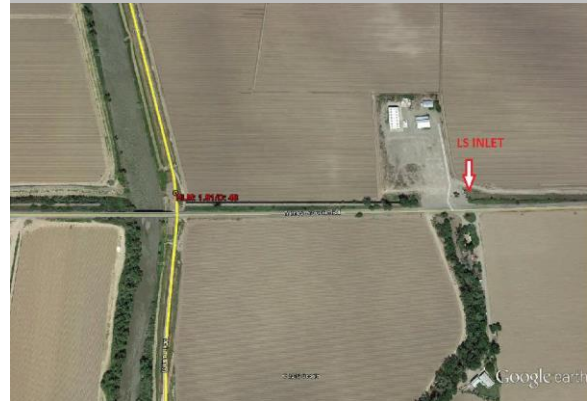
Photo 3 of 3 : UCIP_SP_2018_51785_75168.jpg

Comment Code						
Inspector Comment						
FS_ID:51785 DS_ID:17150 EP_NO: 9387 Repair Type: No Action Needed Crossing Status: Found UCIP Comments: 5/2/2017 Crossing appears to be in good condition. (DWR Sutter Yard- AFreitag)10/17/2016 Crossing appears to be in good condition. (DWR Sutter Yard- AFreitag)5/31/2016 Crossing appears to be in good condition. Attached photo showing location of LS inlet.5/4/2015 WS flapgate mostly underwater but could tell it was blocked open by something. LS inlet is located about 1/4 mile north along the side of the roadway.6/17/2014 Same as last inspection.12/16/2013 Pipe was flowing water and flap gate was bing pushed open. Cannot verify if it will close all the way.7/16/2013 Same as last inspection. Was told inlet is about 1/4 mile down road way next to house. Will try to get coordinates for inlet.10/11/2012 No inlet could be located on LS. Flap gate partially blocked and will not close completely. FIELD_STRUCT_DESC: 48-inch corrugated metal drainage pipe through the levee, 20 feet below the crown. Slide gate in 60-inch riser on the waterside (WS) slope. Flap gate and concrete headwall on the WS. (48-inch pipe authorized under Automatic Board Order (ABO) issued as Permit No. 9387, 1974 - Lauretta S. Christenson). [Additional Reference(s): DWR Levee Log, 2005. USACE Sacramento O&M Manual 132, October 1959, (HLM 1.8)]. FS Date: 5/2/2017 1:56:07 PM

Arrow showing location of LS inlet

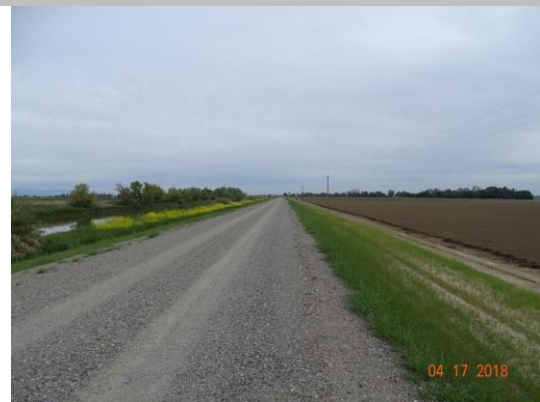
Photo 1 of 1 : SP_2018_MA0012_299_36_20180430_00083.jpg

LM Start	1.87	Rating **	A	Issue No.	36
LM End	1.87	Issue Type +	Ma	Location *	LS
Category	Earthen Levee			GPS Latitude/Longitude	
				Start	End
Item	Vegetation			39.058257 °	39.058257 °
				-122.003802 °	-122.003802 °
DWR ID	DWR_MA0012_01_s_2018_36				
Comment Code					
V1 : Control annual grass and weeds on the levee slopes and easements.					
Inspector Comment					
Native grasses are well maintained on both slopes.

View of native grasses on both slopes.

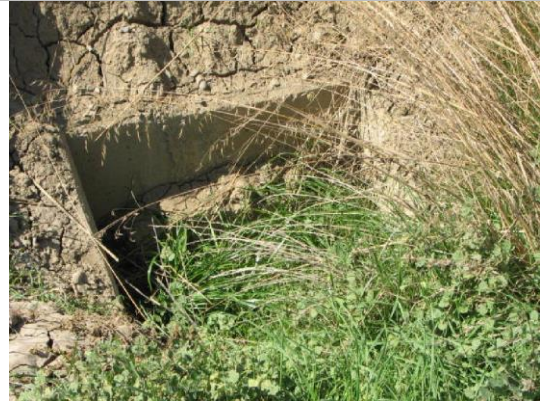
Photo 3 of 3 : UCIP_SP_2018_51786_68992.jpg

FS_ID:51786
DS_ID:17151
EP_NO: 9391
Repair Type: Non-Urgent
Crossing Status: Found
UCIP Comments: 5/2/2017 Both ends of pipe buried. (DWR Sutter Yard- AFreitag)10/17/2016 Appears abandoned. Both pipe ends are completely buried. (DWR Sutter Yard- AFreitag)9/29/2016 Crossing has been downgraded from Urgent to Non-Urgent both pipe ends are buried. Having both ends buried prevents water from flowing from WS to LS during flood season. Need to contact owner and have owner coordinate with CVFPB to comply with Title 23. (DWR UCIP - omagana)5/31/2016 Both pipe ends are buried. Pipe is non-operational. (DWR Sutter Yard - afreitag)5/4/2015 LS and WS ends are blocked with soil. Pipe is inoperable as it is. (DWR Sutter Yard - afreitag)6/17/2014 Same as last inspection. (DWR Sutter Yard - afreitag)12/16/2013 Same as last inspection. (DWR Sutter Yard - afreitag)7/16/2013 LS inlet is completely filled with soil. Needs to be cleaned out. (DWR Sutter Yard - afreitag)10/11/2012 Inlet is partially filled with soil. (DWR Sutter Yard - wylie)

Concrete U shaped headwall at LS toe.

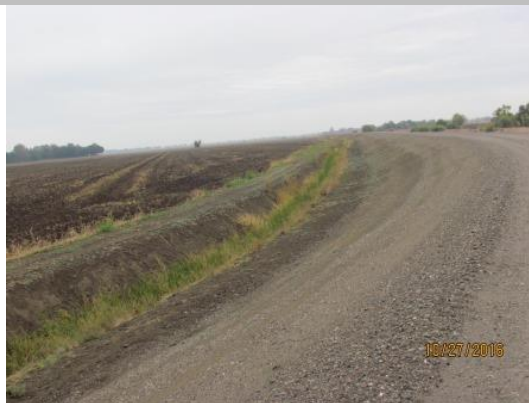
Photo 1 of 1 : SP_2018_MA0012_299_34_20180305_00003.jpg

View of a ditch along the landside toe.

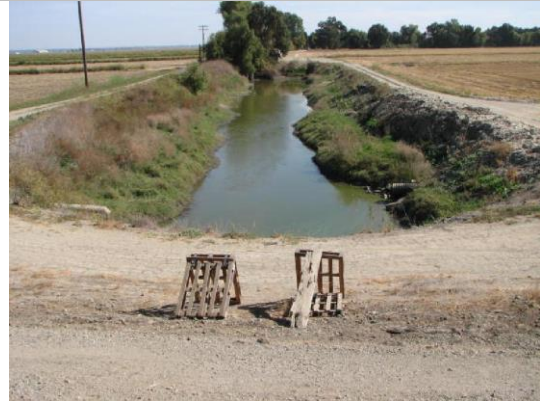
Photo 2 of 3 : UCIP_SP_2018_51789_69004.jpg

Comment Code						
Inspector Comment						
FS_ID:51789 DS_ID:17154 EP_NO: 9388 Repair Type: Urgent Crossing Status: Found UCIP Comments: 5/2/2017 WS slidegate stem is still bent, wheel tto operate gate is missing. Needs a cover made for the standpipe to prevent falls. (DWR Sutter Yard- AFreitag)10/17/2016 Slide gate stem is still and and the gate appears to be inoperable. (DWR Sutter Yard- AFreitag)5/31/2016 SLide gate stem is still bent. WS flap gate is chained open. (DWR Sutter Yard - afreitag)5/4/2015 Slide gate stem is still bent. Gate looks to be unable to close all the way. (DWR Sutter Yard - afreitag)6/17/2014 Same as last inspection. (DWR Sutter Yard - afreitag)12/16/2013 Slide gate stem is still bent. WS flapgate was closed. (DWR Sutter Yard - afreitag)7/16/2013 Water flowing through pipe so screw gate definately not closed. Was told NOV's have been sent for owner to replace stem. Flap gate gets closed for flood season. (DWR Sutter Yard - afreitag)10/11/2012 Slide gate inoperable, but appears to be in closed position. Flap gate held in open position. Good candidate for video inspection when, if ever, dry. (DWR UCIP - wwylie) FIELD_STRUCT_DESC: 48-inch corrugated metal drainage pipe through the levee, 28 feet below the crown. Slide gate in a 66-inch riser on the waterside (WS) slope. Concrete headwall on the WS. Grouted cobble spillway from drainage ditch to large canal on the landside (LS). (48-inch pipe [HLM 3.78] authorized under Automatic Board Order (ABO) issued as Permit No. 9388, 1974 - Pauline A. Wallace). [Additional Reference(s): DWR Levee Log, 2005. USACE Sacramento O&M Manual 132, October 1959, (HLM 3.78)]. FS Date: 5/2/2017 2:05:16 PM

Drainage ditch on LS toe.

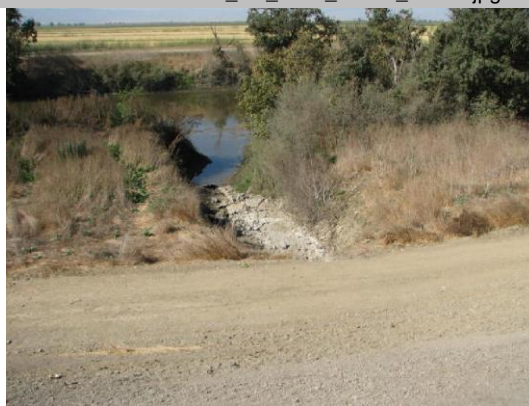
Photo 1 of 3 : UCIP_SP_2018_51791_69014.jpg

FS_ID:51791
DS_ID:17168
EP_NO: 9388
Repair Type: No Action Needed
Crossing Status: Found
UCIP Comments: 5/2/2017 Crossing appears to be in good condition.
(DWR Sutter Yard- AFreitag)10/17/2016 Crossing appears to be in good condition. (DWR Sutter Yard- AFreitag)5/31/2016 Crossing appears to be in good condition.5/4/2015 Corssing appears to be in good condition. No noticeable issues to report.6/17/2014 Same as last inspection.12/16/2013 Same as last inspection.7/16/2013 Same as last inspection.
FIELD_STRUCT_DESC: 36-inch corrugated metal drainage pipe through the levee, 27.5 feet below the crown. Flap gate, concrete headwall, and grouted cobble spillway located on the waterside (WS). Concrete headwall located on the landside (LS). (24-inch pipe [HLM 4.25] authorized under Automatic Board Order (ABO) issued as Permit No. 9388, 1974 - Pauline A. Wallace). [Additional Reference(s): DWR Levee Log, 2005. USACE Sacramento O&M Manual 132, October 1959, (HLM 4.25)].

Outlet at WS toe.

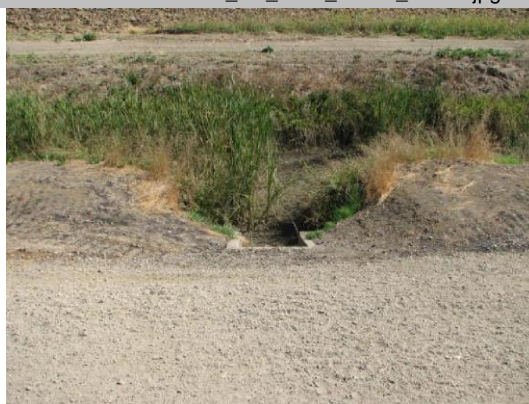
Photo 2 of 3 : UCIP_SP_2018_51791_69013.jpg

Concrete U shaped headwall on LS toe.

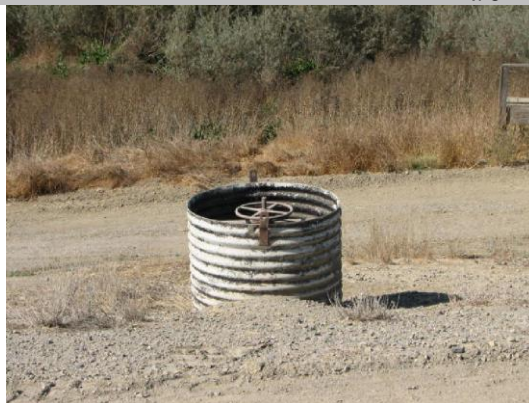
Photo 3 of 3 : UCIP_SP_2018_51792_69015.jpg

Comment Code					
Inspector Comment					
FS_ID:51792 DS_ID:17156 EP_NO: 9388 Repair Type: No Action Needed Crossing Status: Found UCIP Comments: 5/2/2017 Crossing appears to be in good condition. (DWR Sutter Yard- AFreitag)10/17/2016 Crossing appears to be in good condition. (DWR Sutter Yard- AFreitag)5/31/2016 Crossing appears to be in good condition.5/4/2015 Corssing appears to be in good condition. No noticeable issues to report.6/17/2014 Same as last inspection.12/16/2013 Same as last inspection.7/16/2013 Same as last inspection. FIELD_STRUCT_DESC: 24-inch corrugated metal drainage pipe through the levee, 9.2 feet below the crown. Slide gate in a 36-inch corrugated metal pipe (CMP) riser on the waterside (WS) slope. Pump on a 60-inch concrete standpipe at the landside (LS) toe. (24-inch pipe [HLM 4.32] authorized under Automatic Board Order (ABO) issued as Permit No. 9388, 1974 - Pauline A. Wallace). [Additional Reference(s): DWR Levee Log, 2005. USACE Sacramento O&M Manual 132, October 1959, (HLM 4.32)]. FS Date: 5/2/2017 2:20:21 PM

36-inch CMP riser with Slide gate on WS shoulder.

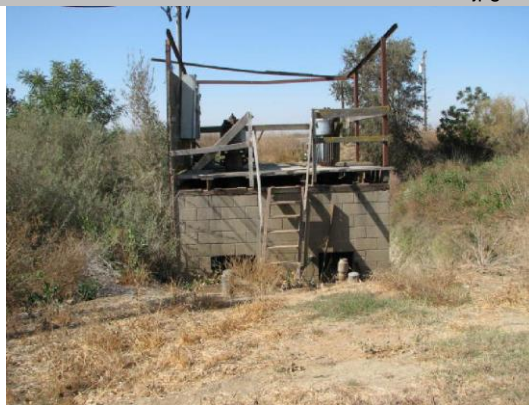
Photo 2 of 3 : UCIP_SP_2018_51794_69022.jpg

Pumping plant on WS toe.

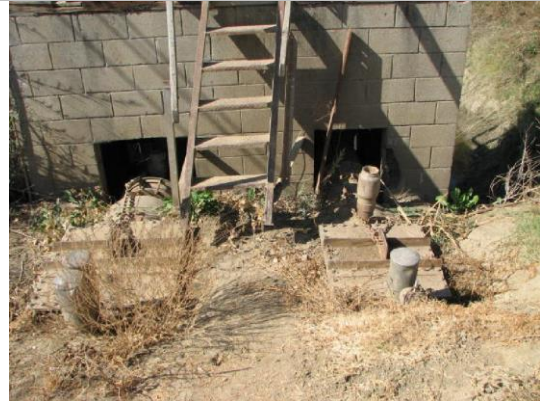
Photo 3 of 3 : UCIP_SP_2018_51794_69021.jpg

Comment Code						
Inspector Comment						
FS_ID:51794 DS_ID:20717 EP_NO: N/A Repair Type: Non-Urgent Crossing Status: Found UCIP Comments: 5/2/2017 Crossing appears to be in good condition. (DWR Sutter Yard- AFreitag)10/17/2016 Crossing appears to be in good condition. (DWR Sutter Yard- AFreitag)5/31/2016 Crossing appears to be in good condition.5/4/2015 Corssing appears to be in good condition. No noticeable issues to report.6/17/2014 Same as last inspection. Pump reinstalled on pier.12/16/2013 Pump has been removed for winter.7/16/2013 Same as last inspection.10/11/2012 No permit identified for this crossing. FIELD_STRUCT_DESC: 24-inch asphalt coated steel irrigation pipe though the levee, 4.5 feet below the crown. Pump in pump house located on the waterside (WS) bank. Siphon breaker valve installed on the landside (LS) shoulder. No permit has been identified since crossing was field discovered in 2012. FS Date: 5/2/2017 2:29:42 PM

Pipe on seft side of photo.

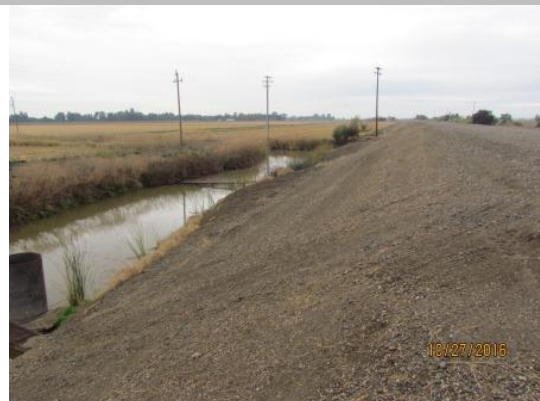
Photo 1 of 1 : SP_2018_MA0012_299_4_20180305_00002.jpg

View of a ditch along the landside toe.

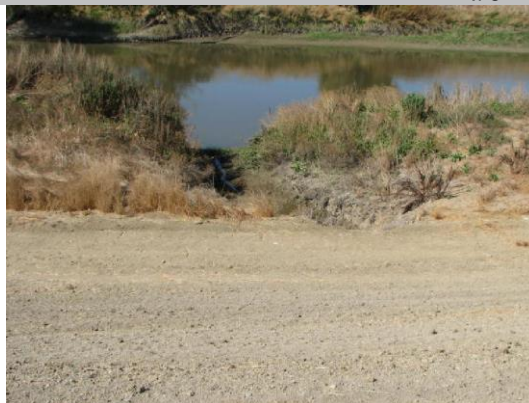
Photo 1 of 3 : UCIP_SP_2018_51795_69026.jpg

Comment Code					
Inspector Comment					
FS_ID:51795 DS_ID:17158 EP_NO: 9390 Repair Type: No Action Needed Crossing Status: Found UCIP Comments: 5/2/2017 Crossing appears to be in good condition. There is minor sediment build up in front of the WS flap gate/ (DWR Sutter Yard- A Freitag)10/17/2016 Crossing appears to be in good condition. (DWR Sutter Yard- A Freitag)5/31/2016 Crossing appears to be in good condition.5/4/2015 Corssing appears to be in good condition. No noticeable issues to report.6/17/2014 Same as last inspection.12/16/2013 Same as last inspection.7/16/2013 New flapgate installed on WS pipe end.10/11/2012 Flap gate broken on WS, Pipe shows significant rust at outlet. This is a good candidate for video inspection. FIELD_STRUCT_DESC: 36-inch corrugated metal drainage pipe though the levee, 20 feet below the crown. Pump on metal pier in landside (LS) channel. 40-inch steel standpipe at the LS toe. Flap gate and concrete headwall on the waterside (WS). Concrete headwall on the LS. (36-inch pipe authorized under Automatic Board Order (ABO) issued as Permit No. 9390, 1974 - Annie D. Propfe). [Additional Reference(s): DWR Levee Log, 2005. USACE Sacramento O&M Manual 132, October 1959, (HLM 4.87)]. FS Date: 5/2/2017 2:30:31 PM

Outlet channel on WS toe.

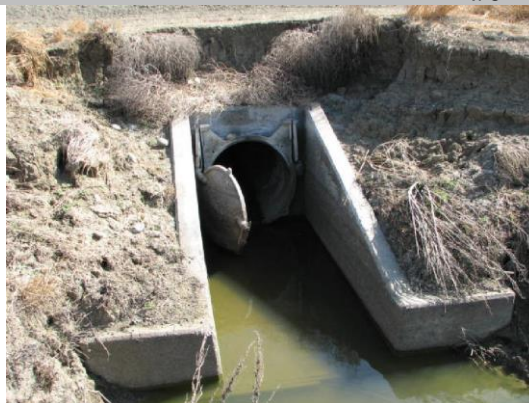
Photo 3 of 3 : UCIP_SP_2018_51795_69024.jpg

Comment Code						
Inspector Comment						
FS_ID:51795 DS_ID:17158 EP_NO: 9390 Repair Type: No Action Needed Crossing Status: Found UCIP Comments: 5/2/2017 Crossing appears to be in good condition. There is minor sediment build up in front of the WS flap gate/ (DWR Sutter Yard- A Freitag)10/17/2016 Crossing appears to be in good condition. (DWR Sutter Yard- A Freitag)5/31/2016 Crossing appears to be in good condition.5/4/2015 Corssing appears to be in good condition. No noticeable issues to report.6/17/2014 Same as last inspection.12/16/2013 Same as last inspection.7/16/2013 New flapgate installed on WS pipe end.10/11/2012 Flap gate broken on WS, Pipe shows significant rust at outlet. This is a good candidate for video inspection. FIELD_STRUCT_DESC: 36-inch corrugated metal drainage pipe though the levee, 20 feet below the crown. Pump on metal pier in landside (LS) channel. 40-inch steel standpipe at the LS toe. Flap gate and concrete headwall on the waterside (WS). Concrete headwall on the LS. (36-inch pipe authorized under Automatic Board Order (ABO) issued as Permit No. 9390, 1974 - Annie D. Propfe). [Additional Reference(s): DWR Levee Log, 2005. USACE Sacramento O&M Manual 132, October 1959, (HLM 4.87)]. FS Date: 5/2/2017 2:30:31 PM

Flap gate in concrete U-shaped headwall on WS toe.

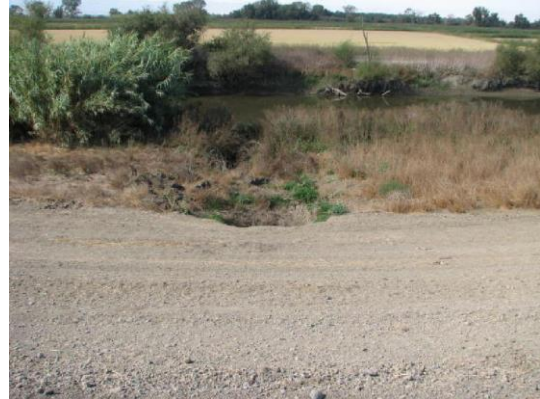
Photo 2 of 3 : UCIP_SP_2018_51796_69029.jpg

Outlet on WS toe.

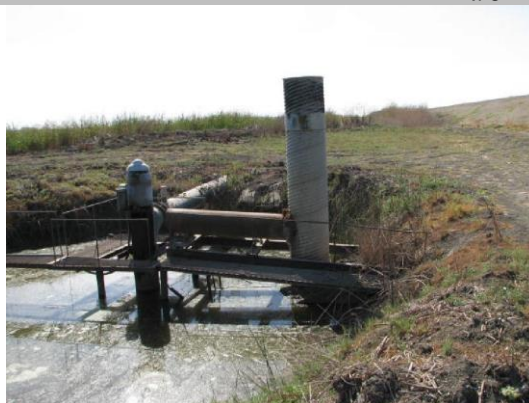
Photo 1 of 3 : UCIP_SP_2018_51797_69034.jpg

36-inch CM standpipe with steel pipe extension for weir on LS toe.
pump not associated with storm drain crossing.

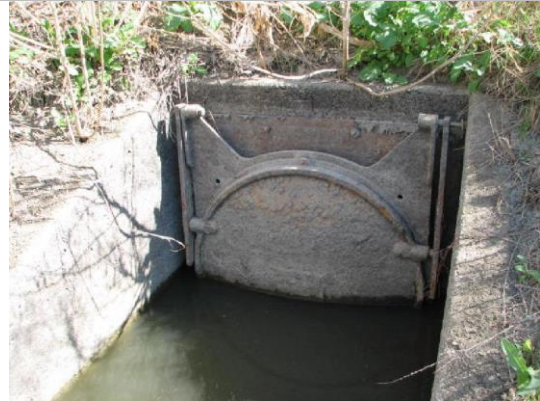
Photo 3 of 3 : UCIP_SP_2018_51797_69032.jpg

Flap gate in concrete U-shaped headwall at WS toe.

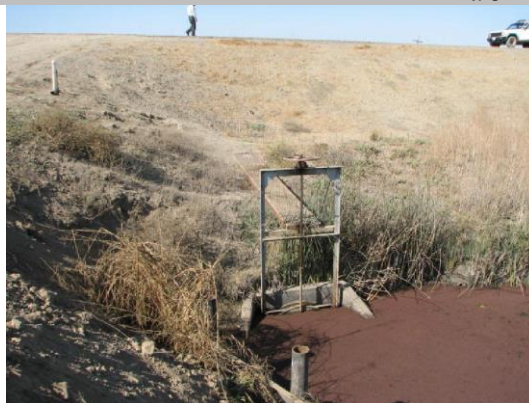
Photo 3 of 3 : UCIP_SP_2018_51798_69040.jpg

Concrete headwall with slide gate at LS toe.

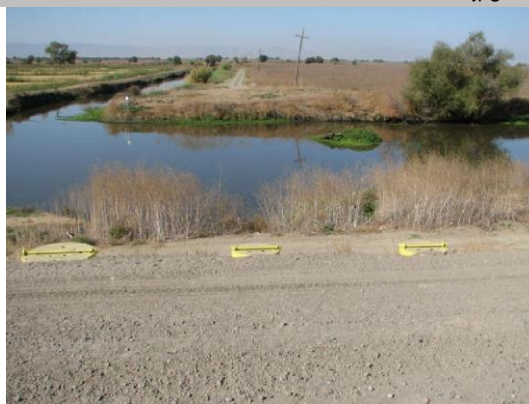
Photo 2 of 3 : UCIP_SP_2018_51800_69060.jpg

Siphon Breaker on WS shoulder.

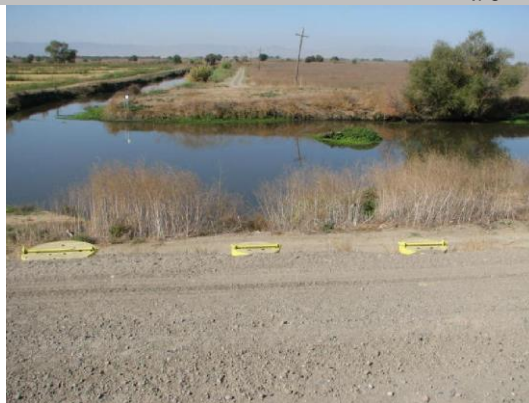
Photo 1 of 3 : UCIP_SP_2018_51799_69068.jpg

Siphon Breakers in risers on WS slope.

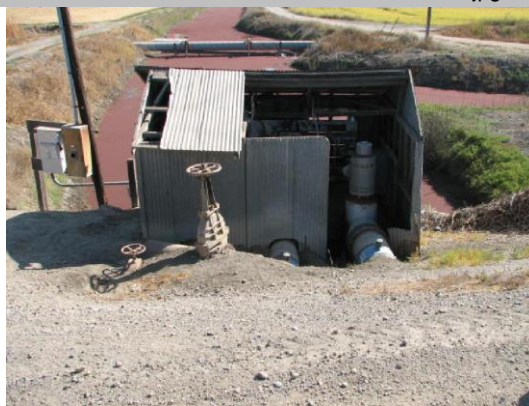
Photo 2 of 3 : UCIP_SP_2018_51799_69067.jpg

Pumphouse on LS slope.

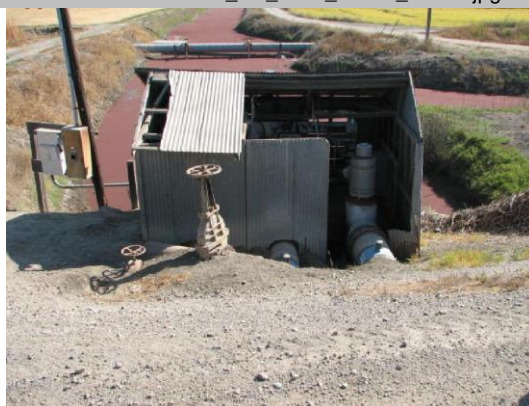
Photo 1 of 3 : UCIP_SP_2018_51802_69076.jpg

Pump house on LS slope

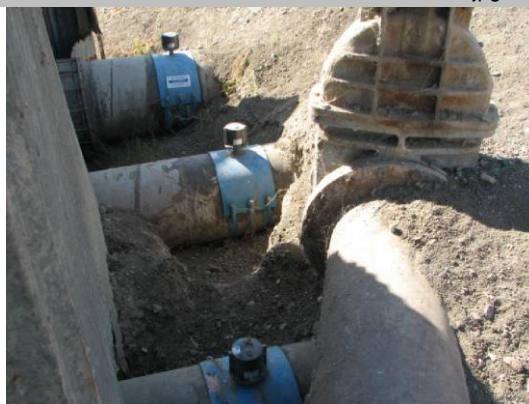
Photo 2 of 3 : UCIP_SP_2018_51802_69075.jpg

20-inch pipe at center of photo.

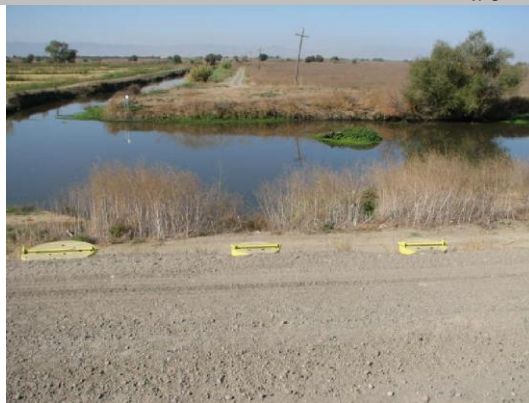
Photo 1 of 3 : UCIP_SP_2018_51801_69064.jpg

Siphon Breaker on WS shoulder.

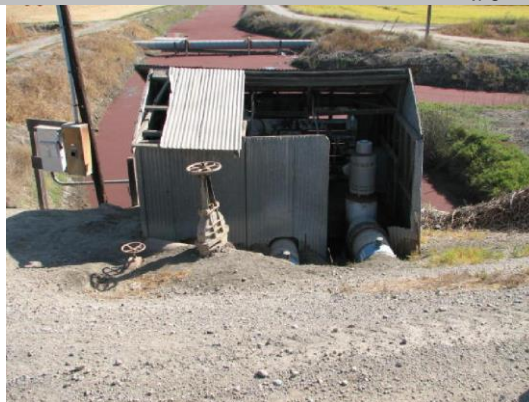
Photo 2 of 3 : UCIP_SP_2018_51801_69063.jpg

Pumphouse on LS slope.

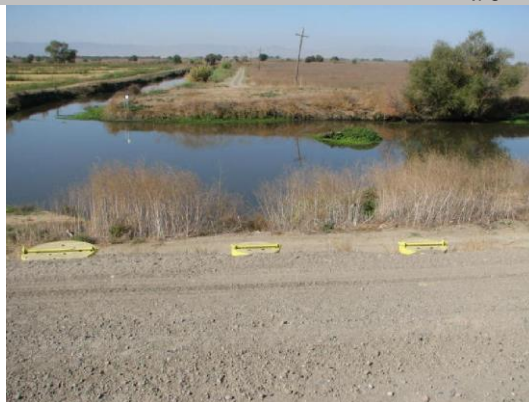
Photo 2 of 3 : UCIP_SP_2018_51803_69080.jpg

Siphon breaker on WS shoulder.

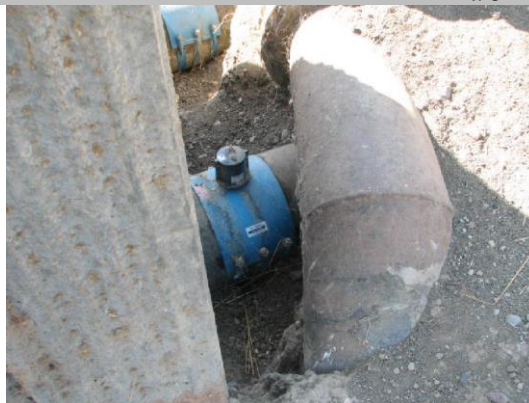
Photo 3 of 3 : UCIP_SP_2018_51803_69079.jpg

Pipe at exit from pumphouse.

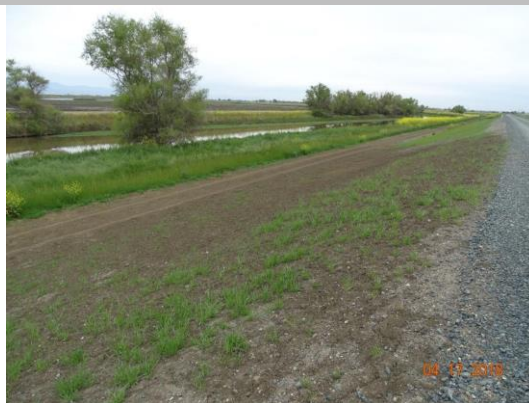
Photo 1 of 4 : SP_2018_MA0012_299_41_20180430_00084.jpg

LM Start	7.36	Rating **	A/W	Issue No.	41
LM End	7.52	Issue Type +	Ma	Location *	
Category	Supplemental			GPS Latitude/Longitude	
				Start	End
Item	2017 Storm Damage			39.133920 °	39.136240 °
				-122.022770 °	-122.022760 °
DWR ID	DWR_MA0012_01_f_2017_41

View of the repaired erosion along the waterside slope. The erosion was repaired by Sutter Maintenance Yard.

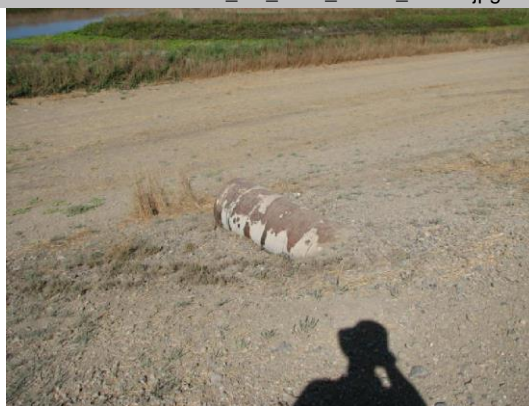
Photo 1 of 3 : UCIP_SP_2018_51804_69089.jpg

Pipe on WS.

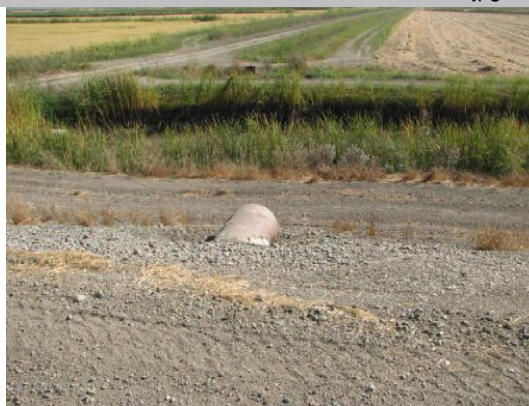
Photo 2 of 3 : UCIP_SP_2018_51804_69088.jpg

Pipe on LS.

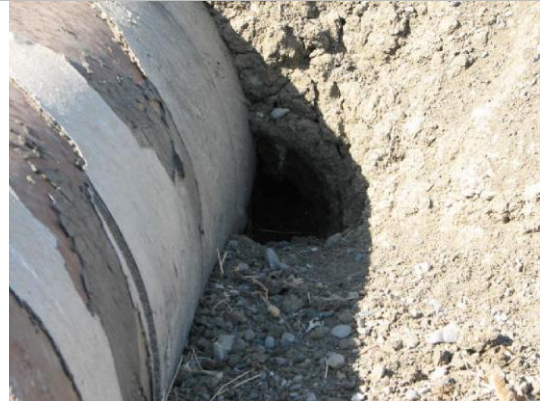
Photo 3 of 3 : UCIP_SP_2018_51804_69087.jpg

Animal burrows along side of pipe LS.

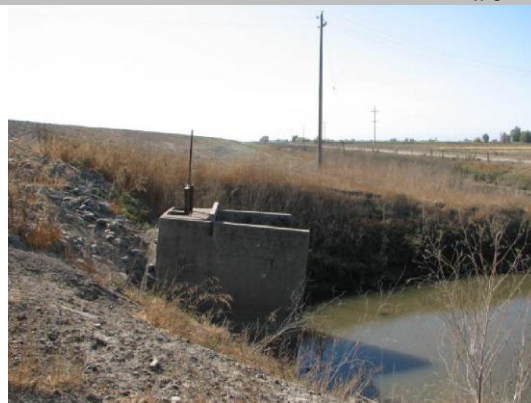
Photo 1 of 3 : UCIP_SP_2018_51806_69100.jpg

Tilting headwall on WS toe.

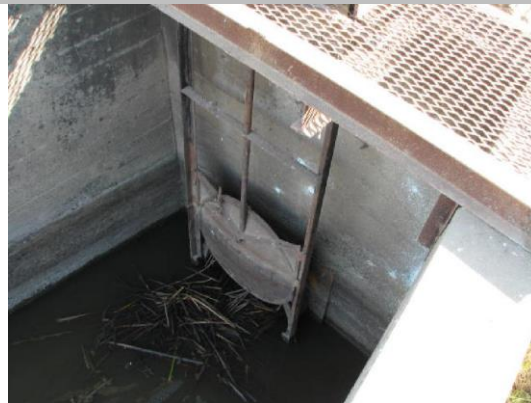
Photo 2 of 3 : UCIP_SP_2018_51806_69099.jpg

Slidegate on WS toe.

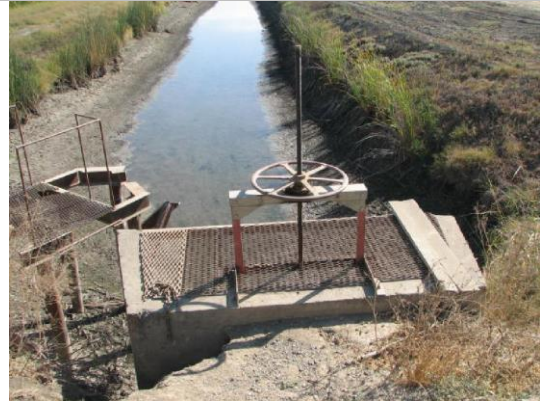
Photo 3 of 3 : UCIP_SP_2018_51806_69102.jpg

slide gate and headwall on LS toe.

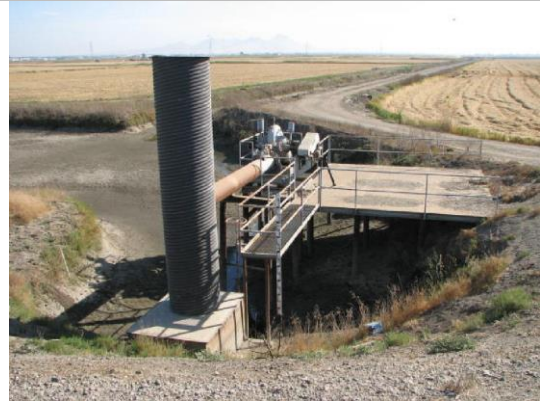
Photo 1 of 3 : UCIP_SP_2018_51809_69112.jpg

Pumping plant on LS toe.

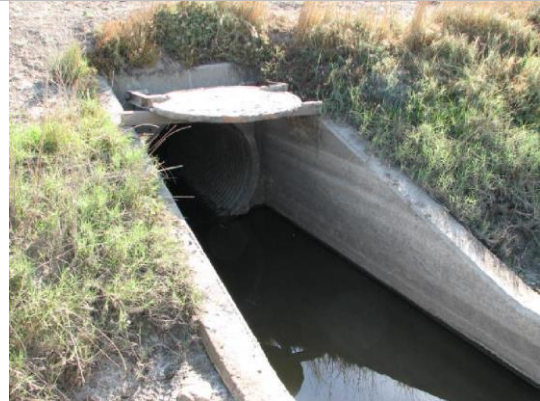
Photo 2 of 3 : UCIP_SP_2018_51809_69111.jpg

Flap gate and headwall on WS toe.

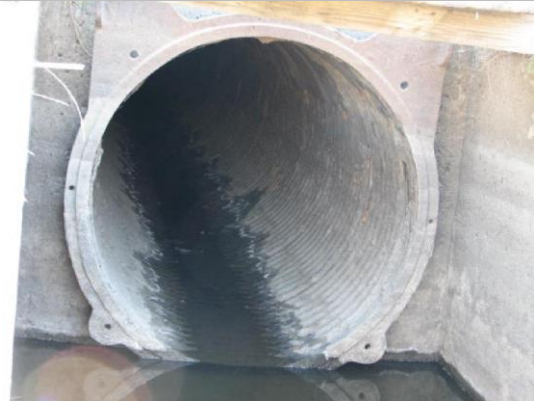
Photo 3 of 3 : UCIP_SP_2018_51809_69110.jpg

Corrugated metal pipe at outlet.

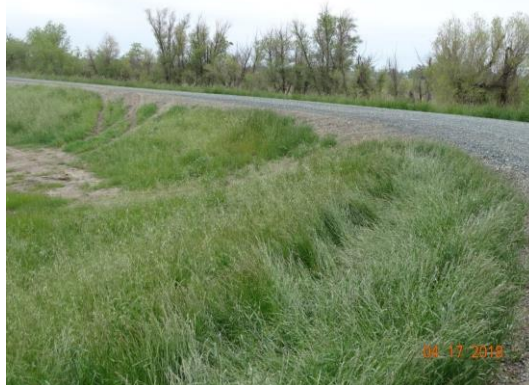
Photo 1 of 1 : SP_2018_MA0012_299_38_20180430_00085.jpg

View of the vehicle erosion along the landside slope.

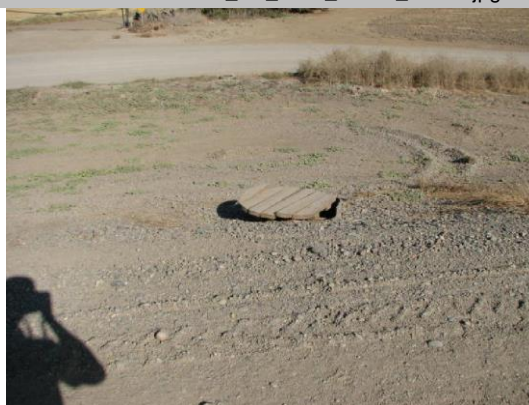
Photo 1 of 2 : UCIP_SP_2018_51810_69115.jpg

cover on 36-inch CMP standpipe on WS slope.

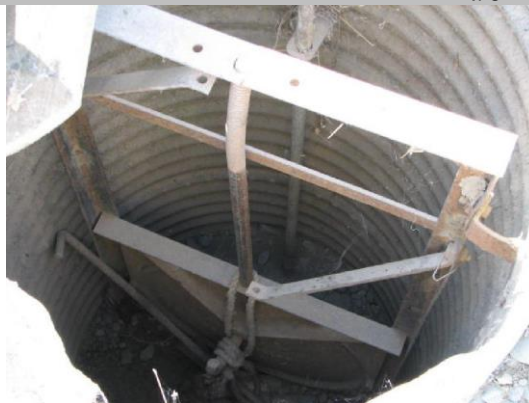
Photo 2 of 2 : UCIP_SP_2018_51810_69114.jpg

Bent and broken actuator on slide gate in 36-inch CMP. Pipe appears to be filled with soil.
