**Flood Control Project Maintenance
Levee Inspections**
LMA District Cover Sheet
Spring 2019 Levee Inspection Results

Sutter Maintenance Yard Maintenance Area 0012

Spring 2019 Levee Inspection Results

Waterway			Bank	Unit Miles
Unit No. 01 Colusa Drain			Left	11.06
	Spring (March - May)	Summer (June - August)	(September - November) Fall	Winter (December - February)
Unit Maintenance Rating (Fall Only)				
Date of Inspection	4/8/2019 - 4/8/2019			
DWR Inspector	Zach Jojola			
Accompanied By

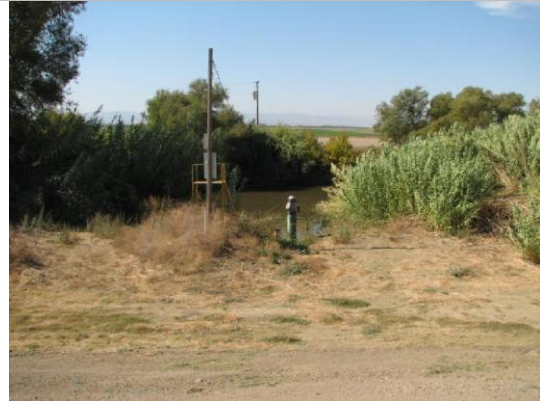
Photo 1 of 3 : UCIP_SP_2019_51781_68981.jpg

Comment Code						
Inspector Comment						
FS_ID:51781 DS_ID:17148 EP_NO: 9382 Repair Type: Non-Urgent Crossing Status: Found UCIP Comments: 5/2/2017 WS is being overgrown with vegetation. The rest of the crossing appears to be in good condition. (DWR Sutter Yard- A Freitag)10/17/2016 Vegetation is overgrowing the WS head wall near the pump. The rest of the crossing appears to be in good condition. (DWR Sutter Yard- A Freitag)5/31/2016 Crossing appears to be in good condition.5/4/2015 Crossing appears in good condition. No noticeable issues to report.6/17/2014 Same as last inspection.12/16/2013 Same as last inspection.7/16/2013 Same as last inspection. FIELD_STRUCT_DESC: 18-inch steel irrigation pipe through the levee, 3 feet below the crown. Pump, butterfly valve, and concrete headwall at the edge of the bank. Bank cobble revetted 10 feet on both the waterside (WS) and the landside (LS) of installation. 18-inch polyvinyl chloride (PVC) standpipe on the LS berm. Siphon breaker in 18-inch concrete riser on the LS shoulder. Service pole at the edge of the bank. (24-inch [HLM 1.53] authorized under Automatic Board Order (ABO) issued as Permit No. 9382, 1974 - Olen C. Bober) [Additional Reference(s): DWR Levee Log, 2005. USACE Sacramento O&M Manual 132, October 1959, (HLM 1.53)]. FS Date: 5/2/2017 1:47:19 PM

Pump, pole, and meter on WS toe.

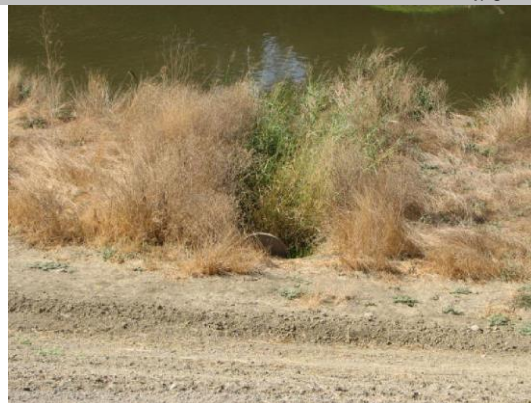
Photo 1 of 3 : UCIP_SP_2019_51782_68984.jpg

FS_ID:51782
DS_ID:17149
EP_NO: 9382
Repair Type: Non-Urgent
Crossing Status: Found
UCIP Comments: 5/2/2017 WS flapgate buried by sediment. Needs to be dug out. (DWR Sutter Yard- A Freitag)10/17/2016 Crossing appears to be in good condition. This is a gravity drain for the LS. (DWR Sutter Yard- A Freitag)5/31/2016 LS inlets was partially plugged. WS flapgate was clear of sediment and abale to operate properly.5/4/2015 WS flapgate is blocked by sediment and unable to open. LS inlet is plugged by silt and wood chippings. Needs to be cleaned.6/17/2014 Flap gate was cleaned out and is fully closed. LS inlet still partially full of soil.12/16/2013 Same as last inspection. WS flapgate still needs to be cleaned out and shut.7/16/2013 Same as last inspection. Make sure flapgate is closed before highwater season.10/11/2012 Inlet on LS filled partially with soil. Outlet blocked with soil and the flap gate wont close.

Outlet on WS toe.

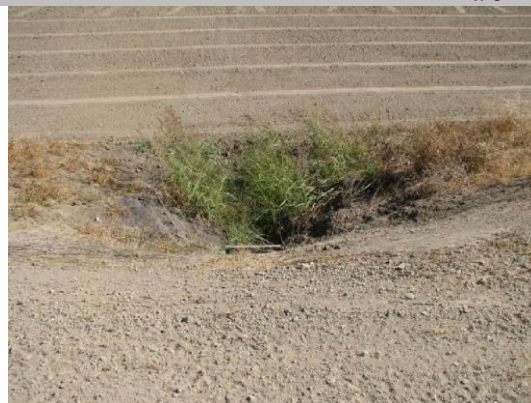
Photo 2 of 3 : UCIP_SP_2019_51782_68983.jpg

Inlet on LS toe.

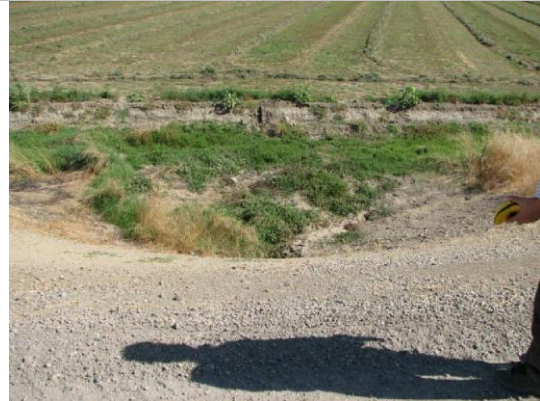
Photo 2 of 3 : UCIP_SP_2019_51786_68993.jpg

LS view of inlet.

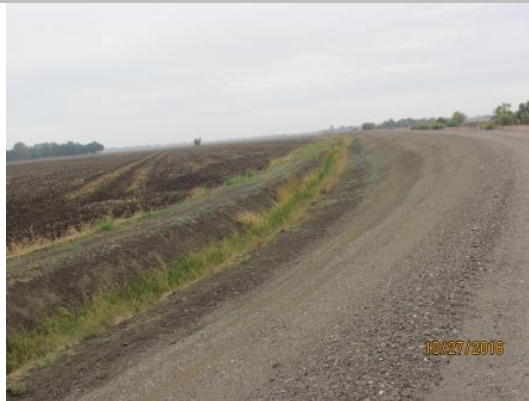
Photo 1 of 1 : SP_2019_MA0012_299_34_20190304_00003.jpg

View of a ditch along the landside toe.

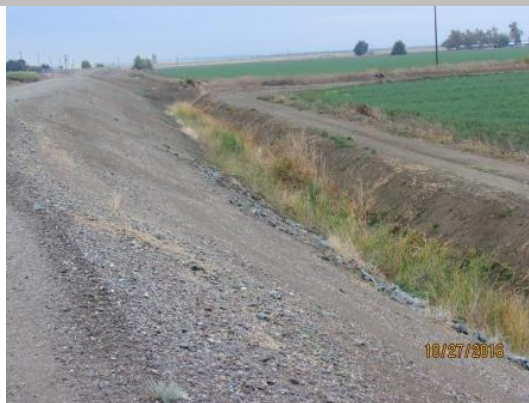
Photo 1 of 1 : SP_2019_MA0012_299_1_20190304_00001.jpg

LM Start	3.01	Rating **	U	Issue No.	1
LM End	3.68	Issue Type +	En	Location *	LS
Category	Earthen Levee			GPS Latitude/Longitude	
				Start	End
Item	Encroachments			39.072267 °	39.081684 °
				-122.014453 °	-122.016243 °
DWR ID	DWR_MA0012_01_s_2019_1				
Comment Code					
DT : Ditch					
Inspector Comment

View of a ditch along the landside toe.

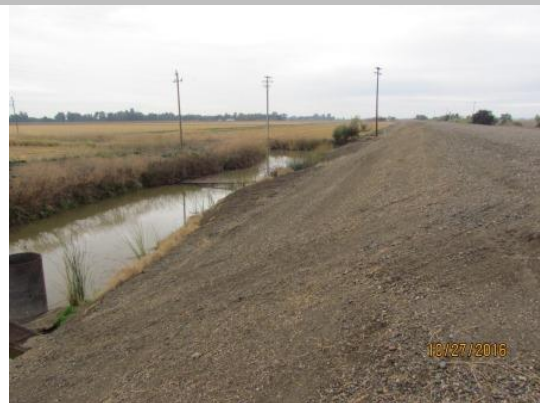
Photo 1 of 1 : SP_2019_MA0012_299_4_20190304_00002.jpg

View of a ditch along the landside toe.

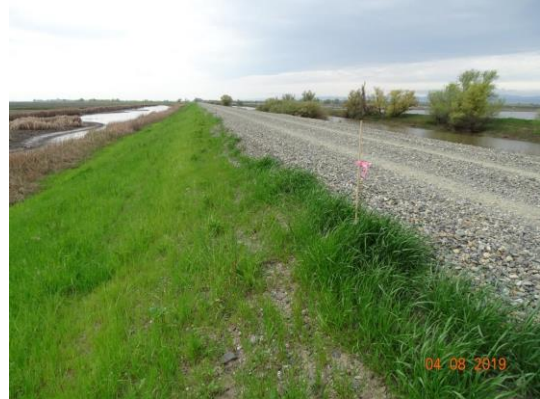
Photo 1 of 1 : SP_2019_MA0012_299_2_20190415_00077.jpg

View of the sloughing on the landside slope. Spring 2019.

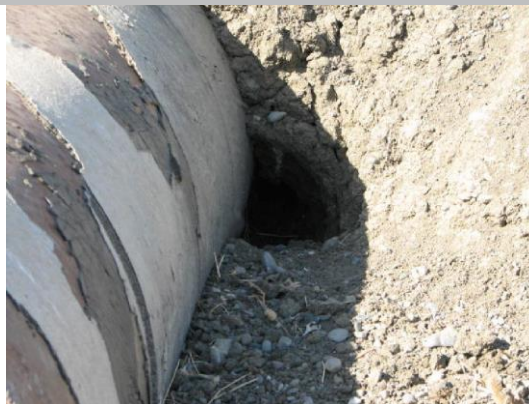
Photo 3 of 3 : UCIP_SP_2019_51804_69087.jpg

Animal burrows along side of pipe LS.

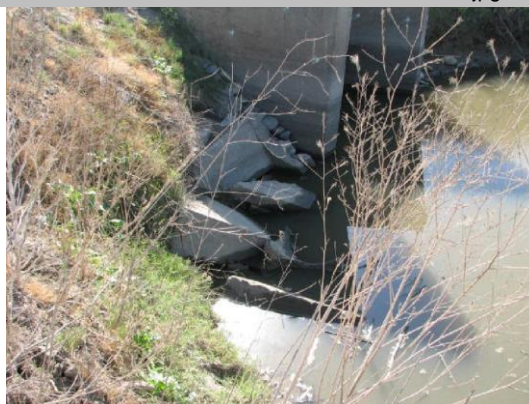
Photo 2 of 3 : UCIP_SP_2019_51807_69108.jpg

headwall debris on LS toe showing evidence of 18-inch cmp.
