**Flood Control Project Maintenance
Levee Inspections**
LMA District Cover Sheet
Spring 2020 Levee Inspection Results

Sutter Maintenance Yard Maintenance Area 0012

Spring 2020 Levee Inspection Results

Waterway			Bank	Unit Miles
Unit No. 01 Colusa Drain			Left	11.06
	Spring (March - May)	Summer (June - August)	(September - November) Fall	Winter (December - February)
Unit Maintenance Rating (Fall Only)				
Date of Inspection	4/1/2020 - 4/1/2020			
DWR Inspector	Zach Jojola			
Accompanied By

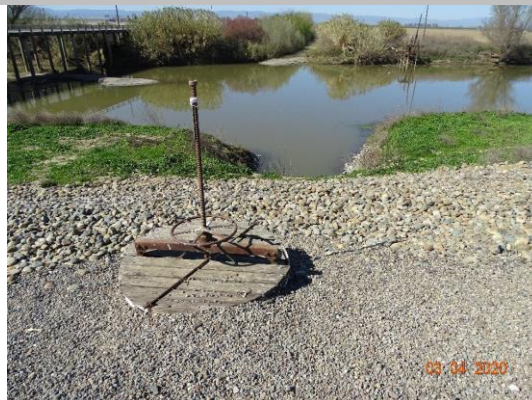
Photo 2 of 3 : UCIP_SP_2020_56171_83486.jpg

60-inch standpipe with slide gate on WS slope with outlet in background.

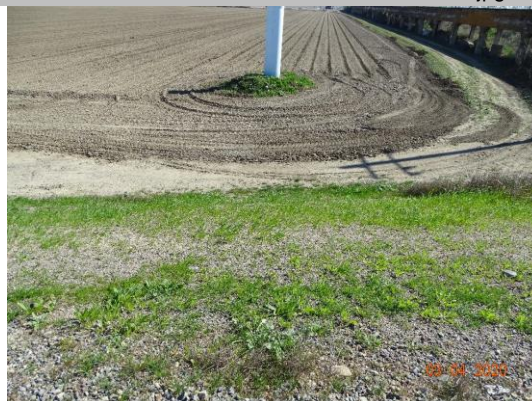
Photo 3 of 3 : UCIP_SP_2020_56171_83487.jpg

View of LS slope looking from levee crown. PVC pipe in the field doesn't belong to this crossing

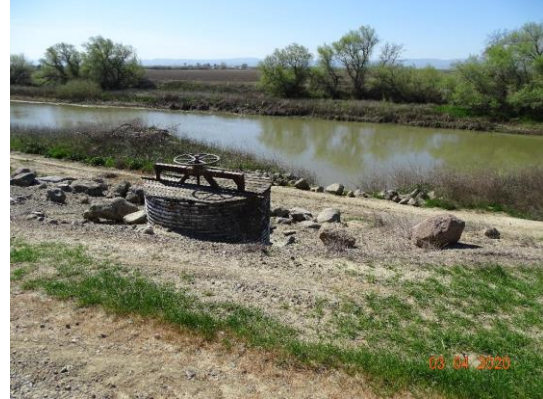
Photo 2 of 3 : UCIP_SP_2020_56173_83506.jpg

84-inch CMP riser with slide gate on WS shoulder

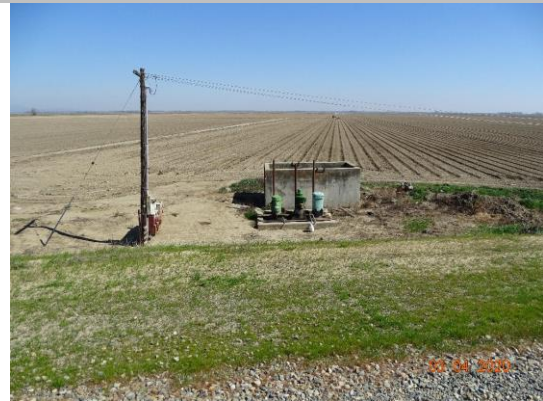
Photo 3 of 3 : UCIP_SP_2020_56173_83507.jpg

3 pumps, concrete distributionbox, power pole with electrical panel on LS

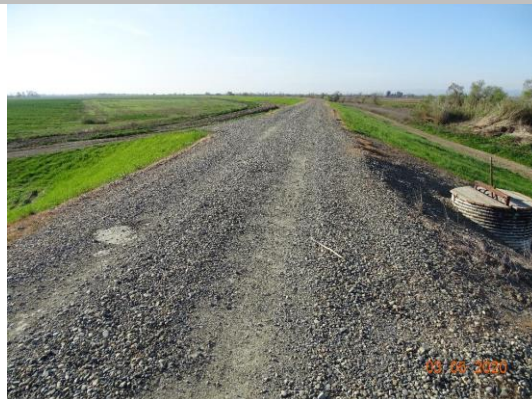
Photo 1 of 3 : UCIP_SP_2020_56176_83526.jpg

DS_ID:17154
FS_ID:56176
EP_NO: 9388
Repair Type: Non-Urgent
Crossing Status: Found
UCIP Comments: 03/05/2020 Record remains Non-Urgent. New cover on CMP riser has been installed. Piping around slide gate at LS toe was modified, new 14-inch pipes installed. Unable to locate a permit for system modification. New steel walkway to slide gate on LS. Need to coordinate with LMA for find a permit authorizing modification. Need to have CVFPB review ABO and determine current owner. (O.Yakimov - DWR UCIP)
10/05/2018 Fall hazard: missing cover on CMP riser. Closure devices are present on both ends of crossing and seem to be in operable condition. Downgraded to non-urgent. Recommend owner add cover to CMP riser. (O.Yakimov - DWR UCIP)
05/02/2017 WS slide gate stem is still bent, wheel to operate gate is missing. Needs a cover made for the standpipe to prevent falls. (DWR Sutter Yard- A.Freitag)
10/17/2016 Slide gate stem is still and the gate appears to be inoperable. (DWR Sutter Yard- A.Freitag)

View of levee crown at the crossing looking downstream

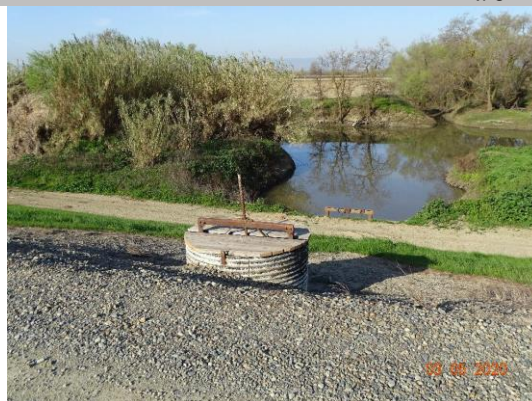
Photo 3 of 3 : UCIP_SP_2020_56176_83528.jpg

View of WS looking from levee crown. CMP riser with slide gate on WS shoulder

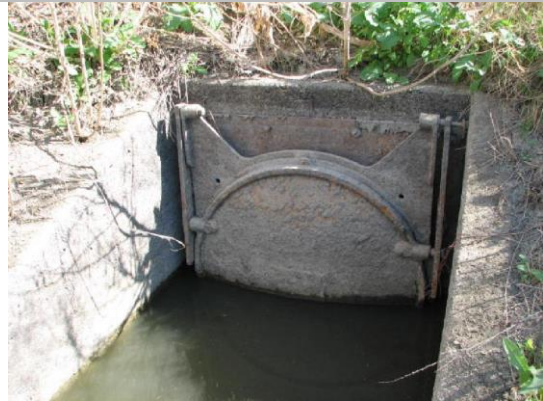
Photo 2 of 3 : UCIP_SP_2020_56182_69032.jpg

Flap gate in concrete U-shaped headwall at WS toe.

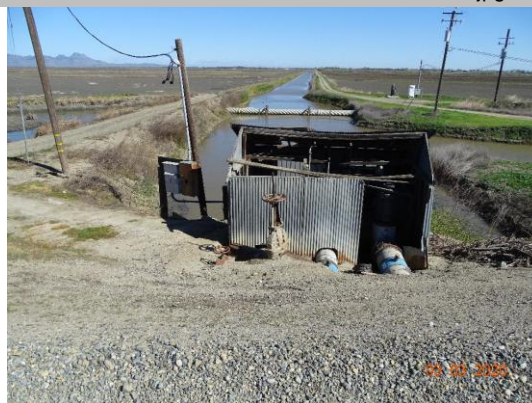
Photo 3 of 3 : UCIP_SP_2020_56186_83596.jpg

View of LS looking from levee crown. Pumphouse with 3 pumps at LS toe

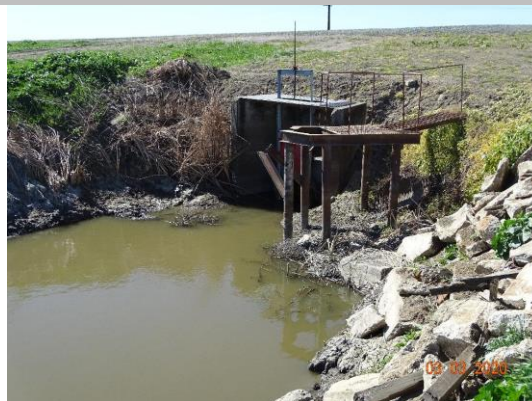
Photo 3 of 3 : UCIP_SP_2020_56190_83620.jpg

Abandoned pumping platform in irrigation canal on LS

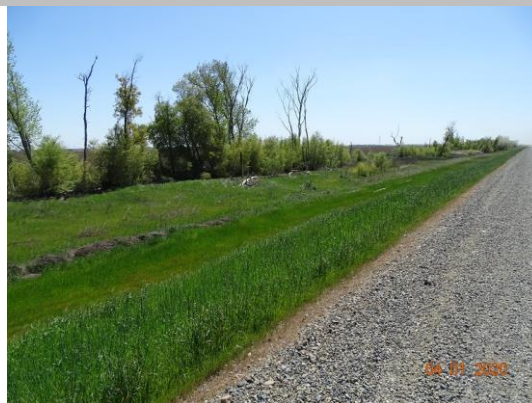
Photo 1 of 1 : SP_2020_MA0012_299_30_20200401_00074.jpg

View of vegetation on the landside slope. Spring 2020.
