**Flood Control Project Maintenance
Levee Inspections
Unit Cover Sheet**

Sutter Maintenance Yard Maintenance Area 0012

| Waterway | | | Bank | Unit Miles |
|--|---|---|---|---|
| Unit No. 01 Colusa Drain | | | Left | 11.06 |

Levee Inspection Report By Mile - Spring 2021

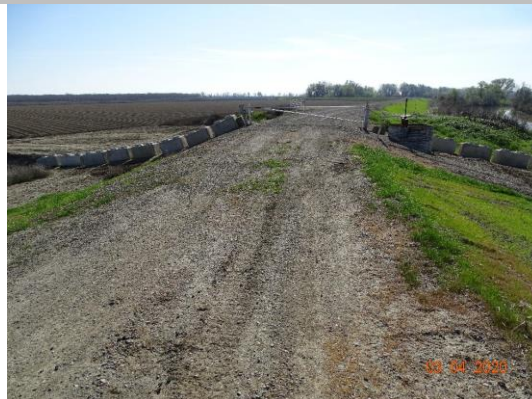
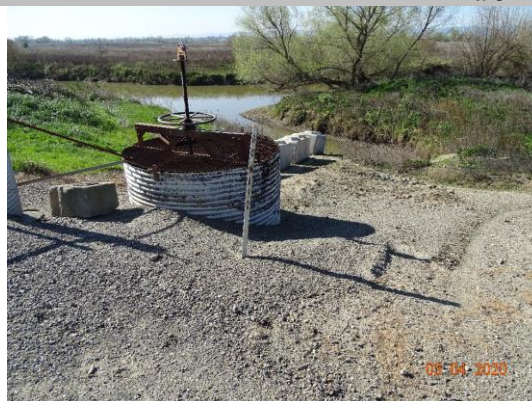
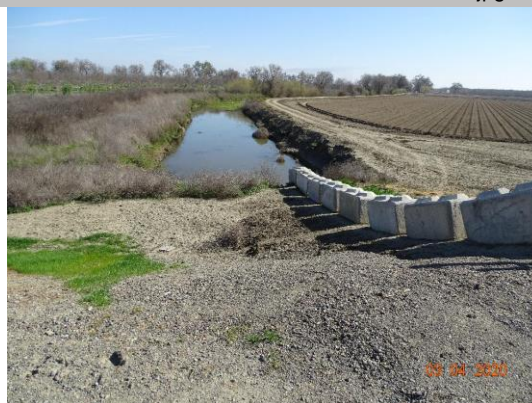
Photo 1 of 3 : UCIP_SP_2021_57220_83424.jpg

FS_ID:57220
DS_ID:17155
EP_NO: 9381
Repair Type: Non-Urgent
Crossing Status: Found
UCIP Comments: 03/04/2020 Record updated from No Action Needed to Non-Urgent. Need to have CVFPB review ABO and determine current owner. Recommend internal video inspection. (O.Yakimov - DWR UCIP)
05/02/2017 Crossing appears to be in good condition. (A.Freitag - DWR Sutter Yard)
10/17/2016 Crossing appears to be in good condition. Pipe material is CMP and the flow is from the LS to the WS. (A.Freitag - DWR Sutter Yard)
05/31/2016 Crossing appears to be in good condition. (A.Freitag - DWR Sutter Yard)
05/04/2015 Crossing in good condition. No issues. (A.Freitag - DWR Sutter Yard)
06/17/2014 Same as last inspection. (A.Freitag - DWR Sutter Yard)
07/16/2013 Same as last inspection. (A.Freitag - DWR Sutter Yard)
12/16/2013 Same as last inspection. (A.Freitag - DWR Sutter Yard)
FIELD_STRUCT_DESC: 60-inch drainage pipe through the levee, 22.1 feet below the crown. Concrete headwalls located on both the WS and landside (LS) toes. Slide gate and flap gate in 84-inch pipe riser located on the waterside (WS) slope. (60-inch pipe [HLM 0.00] authorized under Automatic Board Order (ABO) issued as Permit No. 9381, 1974 - Tribble; 60-inch pipe [HLM 0.00] was also authorized under Automatic Board Order (ABO) issued as Permit No. 8225, 1972 - Harold Baldson). [Additional Reference(s): DWR Levee Log, 2005 (HLM 0.00). USACE Sacramento O&M Manual, Unit 132, October 1959, Revised 14 January 2019, (HLM 20.49 - RD 108), listed as 60-inch pipe. USACE As-Built Drawing No. 50-4-3081, Sheets 3 and 15, Station 1326+00, 4 April 1957].

View of levee crown at the crossing looking downstream

84-inch CMP riser with slide gate on WS shoulder

Drainage ditch on LS toe. Looking from levee crown

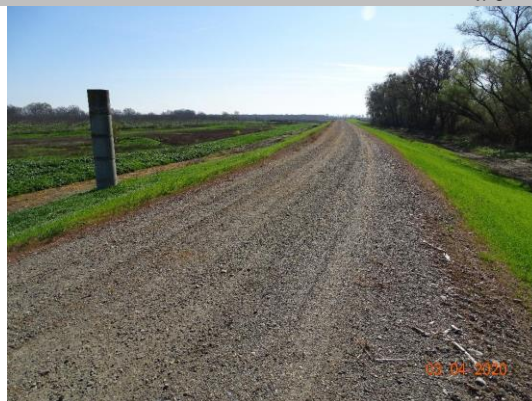
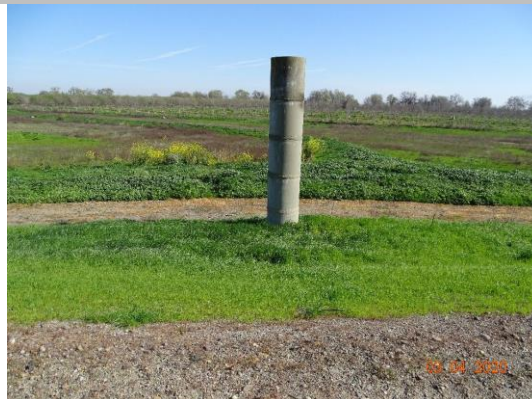
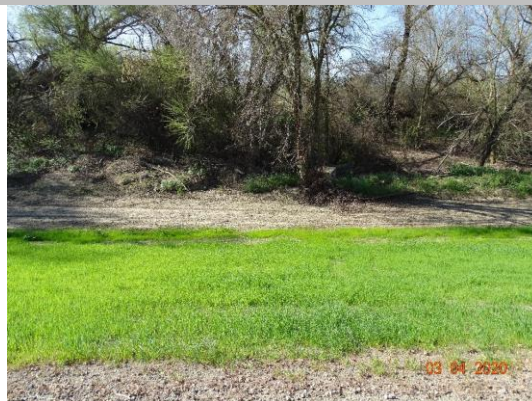
Photo 1 of 3 : UCIP_SP_2021_57221_83444.jpg

FS_ID:57221
DS_ID:17145
EP_NO: 9381
Repair Type: Non-Urgent
Crossing Status: Indicator Found
UCIP Comments: 03/04/2020 Record remains Non-Urgent. Crossing appears abandoned. Unable to locate pipe appurtenances on waterside due to dense vegetation. Recommend geophysical study of this site. Need to have CVFPB review ABO and determine current owner. (O.Yakimov - DWR UCIP)05/02/2017 Abandoned- needs to be done so properly. Only the LS standpipe was found. (A.Freitag - DWR Sutter Yard)10/17/2016 Abandoned (A.Freitag - DWR Sutter Yard)05/31/2016 Abandoned- only the LS concrete standpipe was found. (A.Freitag - DWR Sutter Yard)05/04/2015 Abandoned crossing. (A.Freitag - DWR Sutter Yard)06/17/2014 Same as last inspection.(A.Freitag - DWR Sutter Yard)12/16/2013 Same as last inspection.(A.Freitag - DWR Sutter Yard)07/16/2013 Same as last inspection. (A.Freitag - DWR Sutter Yard)10/11/2012 Need to verify proper abandonment of pipe. (W.Wylie - DWR)

Levee crown at the crossing looking downstream

View of LS looking from levee crown

View of WS looking from levee crown

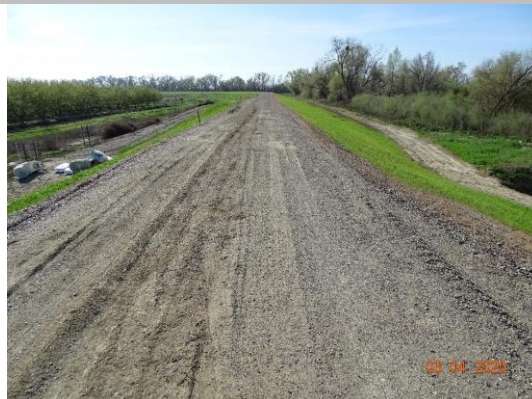
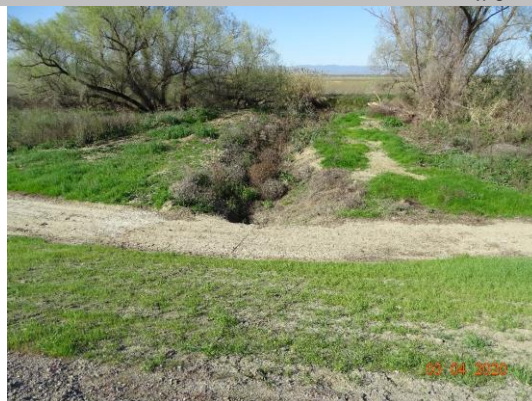
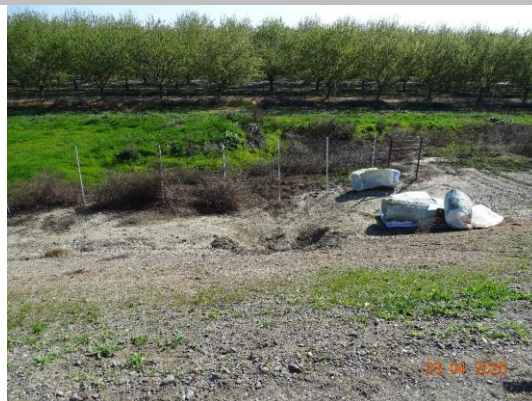
Photo 1 of 3 : UCIP_SP_2021_57222_83449.jpg

FS_ID:57222
DS_ID:17146
EP_NO: 9385
Repair Type: Urgent
Crossing Status: Found
UCIP Comments: 03/04/2020 Record updated from Non-Urgent to Urgent. Pipe has been CIPP-lined under the DWR DMP Phase 2 Project. Flap gate not closing properly posing flood risk to the landside during flood season. LMA needs to repair or replace flap gate. Need to have CVFPB review ABO and determine current owner. (O.Yakimov - DWR UCIP)
05/02/2017 WS is in good condition. LS inlet is more than 50% full of sediment. Pipe needs to be cleaned internally. (A.Freitag - DWR Sutter Yard)
10/17/2016 Minor sediment blocking the WS flap gate from opening. LS inlet still mostly full of sediment. (A.Freitag - DWR Sutter Yard)09/29/2016 Crossing has been downgraded from Urgent to Non-Urgent WS flap gate is closed for flood season. Need to coordinate with owner to remove sediment blocking WS flap gate. (O.Magana - DWR UCIP)
05/31/2016 WS flap gate is blocked from opening by sediment. LS inlet is over 50% full of sediment. (A.Freitag - DWR Sutter Yard)05/04/2015 WS flap gate is blocked by sediment and unable to open. LS inlet is about 50% plugged with soil. Needs to be cleaned. (A.Freitag - DWR Sutter Yard)

Levee crown at the crossing

View of WS looking from levee crown

View of LS looking from levee crown

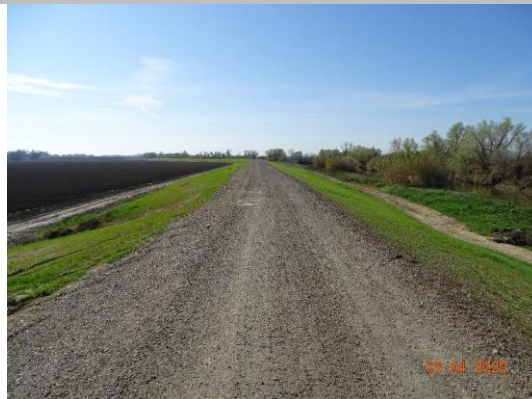
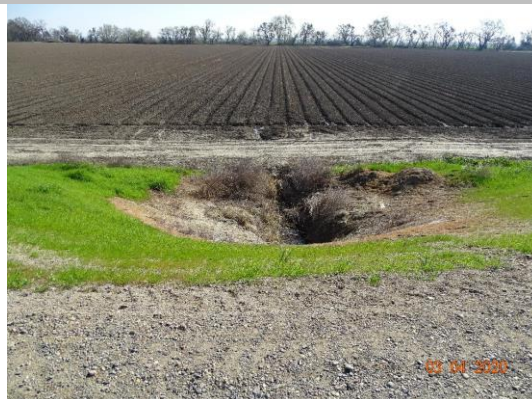
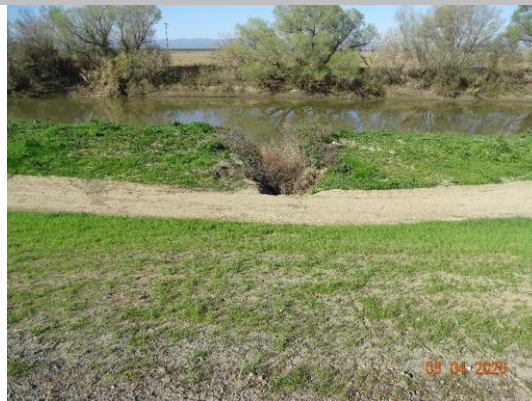
Photo 1 of 3 : UCIP_SP_2021_57190_83458.jpg

FS_ID:57190
DS_ID:17147
EP_NO: 9382
Repair Type: Non-Urgent
Crossing Status: Found
UCIP Comments: 03/04/2020 Record updated from No Action Needed to Non-Urgent. Pipe has been CIPP-lined under the DWR DMP Phase 2 Project. Need to have CVFPB review ABO and determine current owner. (O.Yakimov - DWR UCIP) 05/02/2017 Crossing appears to be in good condition. (A.Freitag - DWR Sutter Yard)10/17/2016 Crossing appears to be in good condition. This is a gravity for the LS. (A.Freitag - DWR Sutter Yard)05/31/2016 Crossing appears to be in good condition. (A.Freitag - DWR Sutter Yard)05/04/2015 Crossing is in good condition. No issues. (A.Freitag - DWR Sutter Yard)06/17/2014 Same as last inspection. (A.Freitag - DWR Sutter Yard)12/16/2013 Same as last inspection. (A.Freitag - DWR Sutter Yard)07/16/2013 Same as last inspection. (A.Freitag - DWR Sutter Yard)
FIELD_STRUCT_DESC: 24-inch corrugated metal CIPP-lined drainage pipe through the levee, 13 feet below the crown. Flap gate, concrete headwall, and grouted cobble spillway on the waterside (WS). Concrete headwall on the landside (LS). (24-inch pipe [HLM 1.40] authorized under Automatic Board Order (ABO) issued as Permit No. 9382, 1974 - Olen C. Bober; 24-inch pipe [HLM 1.40] was also authorized under Automatic Board Order (ABO) issued as Permit No. 8228, 1972 - Olin C. Baber). [Additional Reference(s): DWR Levee Log, 2005 (HLM 1.40). USACE Sacramento O&M Manual, Unit 132, October 1959, Revised 14 January 2019, (HLM 1.40), listed as 24-inch pipe. USACE As-Built Drawing No. 50-4-3081, Sheet 4 and 15, Station 1402+63, 4 April 1957].

Levee crown at the crossing

View of LS looking from levee crown

View of WS looking from levee crown

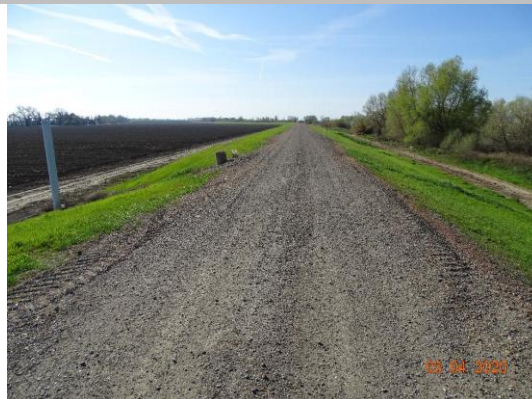
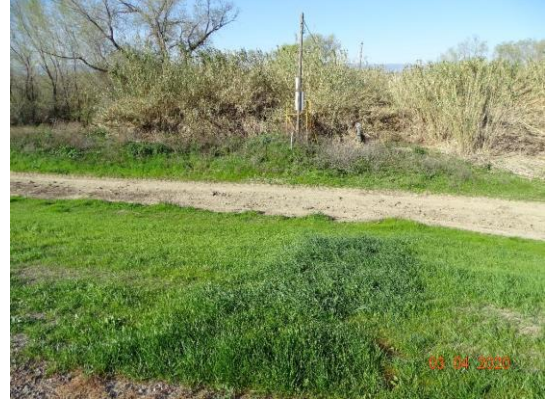
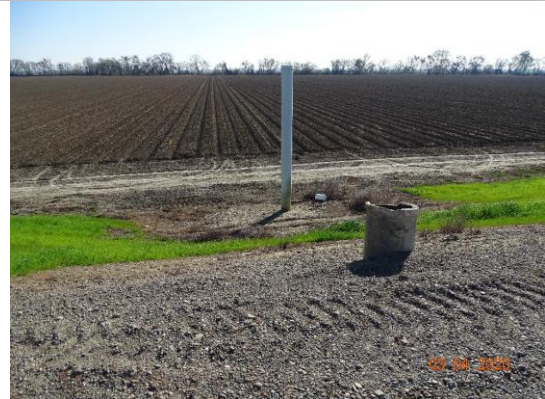
Photo 1 of 3 : UCIP_SP_2021_57223_83466.jpg

FS_ID:57223
DS_ID:17148
EP_NO: 9382
Repair Type: Non-Urgent
Crossing Status: Found
UCIP Comments: 03/04/2020 Record remains Non-Urgent. Need to have CVFPB review ABO and determine current owner. Taller grass observed along pipe alignment on WS slope. Pressure test or video inspection of crossing is recommended. (O.Yakimov - DWR UCIP)05/02/2017 WS is being overgrown with vegetation. The rest of the crossing appears to be in good condition. (A.Freitag - DWR Sutter Yard)10/17/2016 Vegetation is overgrowing the WS head wall near the pump. The rest of the crossing appears to be in good condition. (A.Freitag - DWR Sutter Yard)05/31/2016 Crossing appears to be in good condition. (A.Freitag - DWR Sutter Yard)05/04/2015 Crossing appears in good condition. No noticeable issues to report. (A.Freitag - DWR Sutter Yard)06/17/2014 Same as last inspection. (A.Freitag - DWR Sutter Yard)12/16/2013 Same as last inspection. (A.Freitag - DWR Sutter Yard)07/16/2013 Same as last inspection. (A.Freitag - DWR Sutter Yard)

View of levee crown at the crossing looking downstream

View of WS looking from crown

View of LS looking from crown

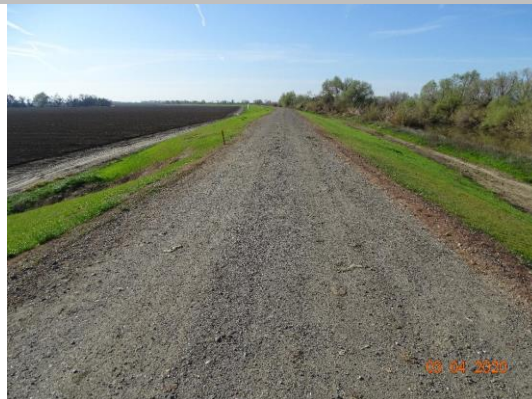
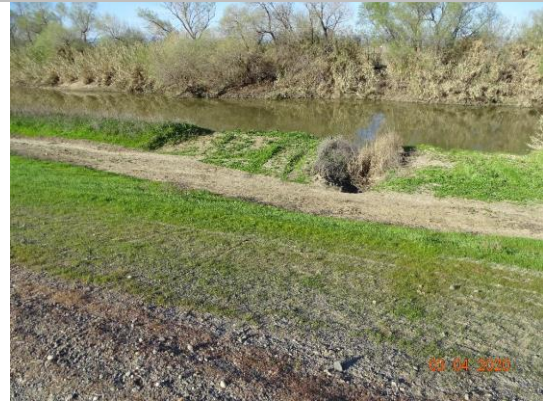
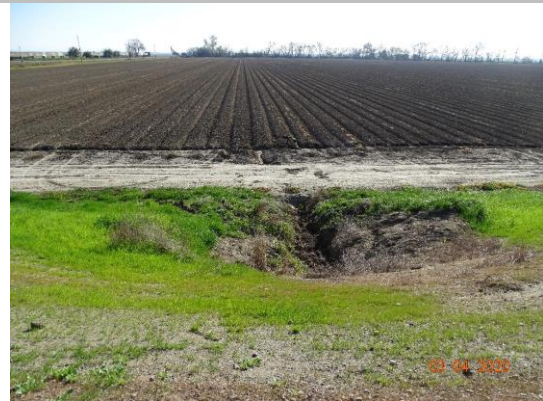
Photo 1 of 3 : UCIP_SP_2021_57224_83473.jpg

FS_ID:57224
DS_ID:17149
EP_NO: 9382
Repair Type: Non-Urgent
Crossing Status: Found
UCIP Comments: 03/04/2020 Record remains Non-Urgent. Pipe has been CIPP-lined and new flap gate installed under the DWR DMP Phase 2 Project. Vegetation around flap gate was cleared. Need to have CVFPB review ABO and determine current owner. (O.Yakimov - DWR UCIP) 05/02/2017 WS flapgate buried by sediment. Needs to be dug out. (A.Freitag - DWR Sutter Yard)10/17/2016 Crossing appears to be in good condition. This is a gravity drain for the LS. (A.Freitag - DWR Sutter Yard)05/31/2016 LS inlets was partially plugged. WS flapgate was clear of sediment and able to operate properly. (A.Freitag - DWR Sutter Yard)05/04/2015 WS flapgate is blocked by sediment and unable to open. LS inlet is plugged by silt and wood chippings. Needs to be cleaned. (A.Freitag - DWR Sutter Yard)06/17/2014 Flap gate was cleaned out and is fully closed. LS inlet still partially full of soil. (A.Freitag - DWR Sutter Yard)12/16/2013 Same as last inspection. WS flapgate still needs to be cleaned out and shut. (A.Freitag - DWR Sutter Yard)07/16/2013 Same as last inspection. Make sure flapgate is closed before highwater season. (A.Freitag - DWR Sutter Yard)10/11/2012 Inlet on LS filled partially with soil. Outlet blocked with soil and the flap gate won't close. (W.Wylie - DWR UCIP)

View of levee crown at the crossing looking downstream

View of WS looking from levee crown

View of LS looking from levee crown

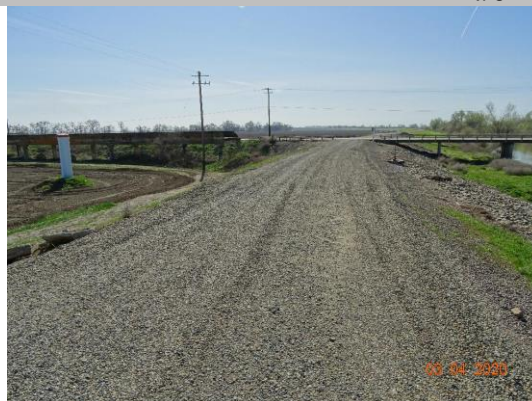
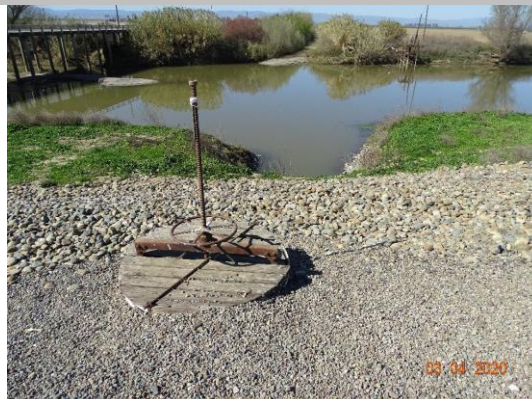
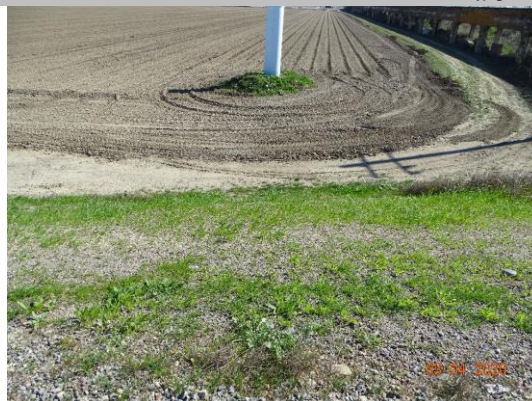
Photo 1 of 3 : UCIP_SP_2021_57227_83485.jpg

FS_ID:57227
DS_ID:17150
EP_NO: 9387
Repair Type: Urgent
Crossing Status: Found
UCIP Comments: 03/04/2020 Record updated from No Action Needed to Urgent. Flap gate at WS levee toe not closing tightly leaving a gap for water to enter a part of crossing up to slide gate. Since slide gate on WS shoulder is in open position, this can pose flood risk to the landside during high water events. Recommend LMA to repair flap gate before next flood season. Pipe inlet near LS levee toe not found. Crossing appears abandoned. Concrete standpipe observed on landside 1,400 feet east of levee that seem to belong to the drainage system. Abandoned pump in irrigation/drainage canal 1,750 feet east of levee found. Recommend geophysical study to determine alignment of pipe through the levee. Need to have CVFPB review ABO and determine current owner. Need to contact owner to determine status of crossing. (O.Yakimov - DWR UCIP)05/02/2017 Crossing appears to be in good condition. (A.Freitag - DWR Sutter Yard)10/17/2016 Crossing appears to be in good condition. (A.Freitag - DWR Sutter Yard)05/31/2016 Crossing appears to be in good condition. Attached photo showing location of LS inlet. (A.Freitag - DWR Sutter Yard)05/04/2015 WS flapgate mostly underwater but could tell it was blocked open by something. LS inlet is located about 1/4 mile north along the side of the roadway. (A.Freitag - DWR Sutter Yard)06/17/2014 Same as last inspection. (A.Freitag - DWR Sutter Yard)12/16/2013 Pipe was flowing water and flap gate was being pushed open. Cannot verify if it will close all the way. (A.Freitag - DWR Sutter Yard)07/16/2013 Same as last inspection. Was told inlet is about 1/4 mile down road way next to house. Will try to get coordinates for inlet. (A.Freitag - DWR Sutter Yard)10/11/2012 No inlet could be located on LS. Flap gate partially blocked and will not close completely. (W.Wylie - DWR UCIP)

View of levee crown at crossing looking downstream

60-inch standpipe with slide gate on WS slope with outlet in background.

View of LS slope looking from levee crown. PVC pipe in the field doesn't belong to this crossing

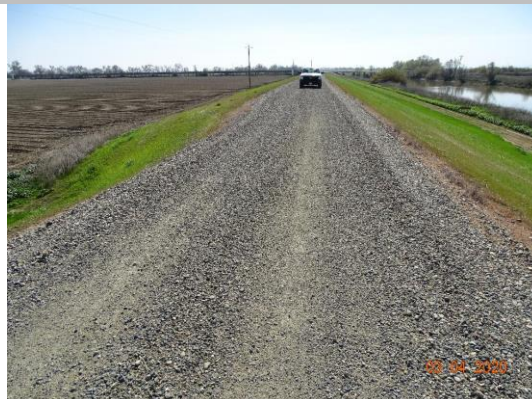
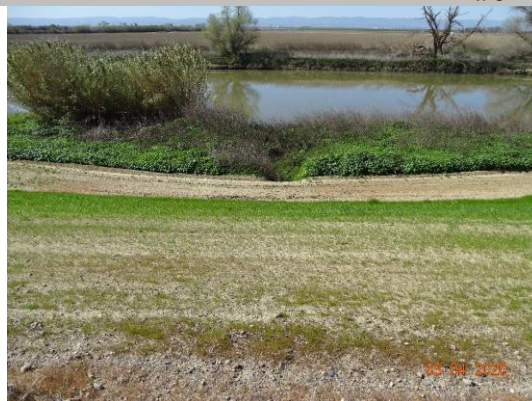
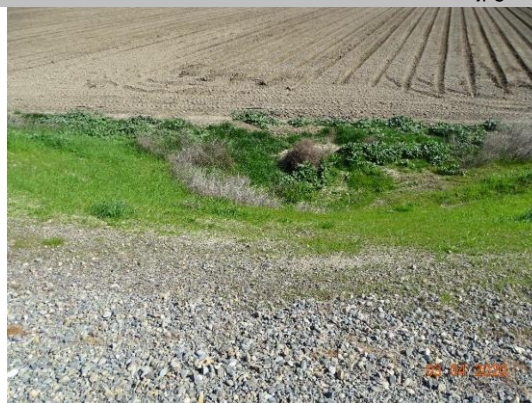
Photo 1 of 3 : UCIP_SP_2021_57228_83501.jpg

UCIP Comments: 03/04/2020 Record remains Non-Urgent. Need to have CVFPB review ABO and determine current owner. Crossing appears abandoned. Both end of crossing are buried. Recommend performing maintenance of the crossing. (O.Yakimov - DWR UCIP)

View of levee crown at the crossing looking downstream

View of WS looking from levee crown

View of LS looking from levee crown

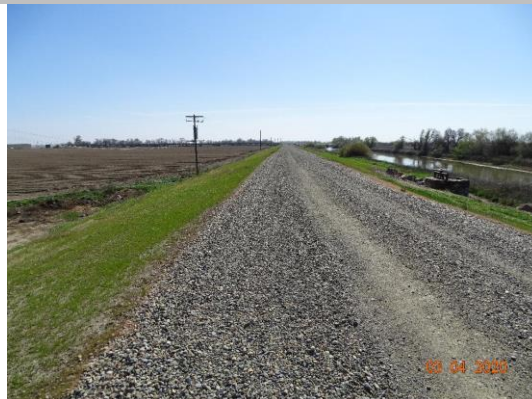
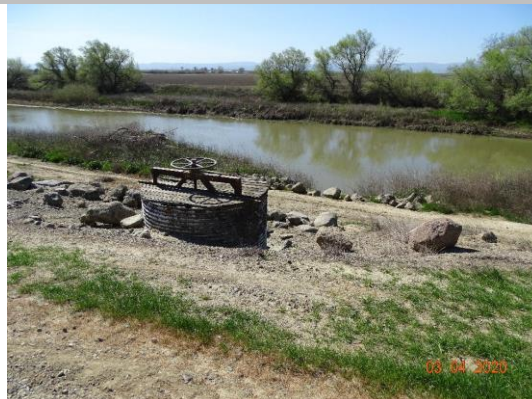
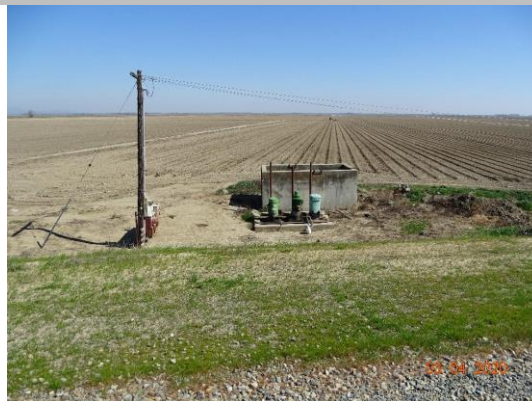
Photo 1 of 3 : UCIP_SP_2021_57194_83505.jpg

FS_ID:57194
DS_ID:17152
EP_NO: 9319
Repair Type: Non-Urgent
Crossing Status: Found
UCIP Comments: 03/04/2020 Record updated from No Action Needed to Non-Urgent. Metal debris observed at LS levee toe considered trip and fall safety hazard. Need to have CVFPB review ABO and determine current owner. (O.Yakimov - DWR UCIP)05/02/2017 Crossing appears to be in good condition. (A.Freitag - DWR Sutter Yard)10/17/2016 Crossing appears to be in good condition. (A.Freitag - DWR Sutter Yard)05/31/2016 Crossing appears to be in good condition. (A.Freitag - DWR Sutter Yard)05/04/2015 Crossing appears in good condition. No noticeable issues. (A.Freitag - DWR Sutter Yard)06/17/2014 Same as last inspection. (A.Freitag - DWR Sutter Yard)12/16/2013 Same as last inspection. (A.Freitag - DWR Sutter Yard)07/16/2013 Same as last inspection. (A.Freitag - DWR Sutter Yard)
FIELD_STRUCT_DESC: 60-inch corrugated metal irrigation pipe through the levee, 22.7 feet below the crown. Slide gate in a 84-inch corrugated metal riser on the waterside (WS) slope. Three pumps over a sump, and distribution box on the landside (LS). Concrete headwall on the WS. (60-inch pipe [HLM 2.19] authorized under Automatic Board Order (ABO) issued as Permit No. 9319, 1974 - Frederick J. Strain; 60-inch pipe [HLM 2.19] was also authorized under Automatic Board Order (ABO) issued as Permit No. 8230, 1972 - Jack Baber). [Additional Reference(s): DWR Levee Log, 2005 (HLM 2.19). USACE Sacramento O&M Manual, Unit 132, October 1959, Revised 14 January 2019, (HLM 2.19), listed as 60-inch pipe. USACE As-Built Drawing No. 50-4-3081, Sheet 4 and 15, Station 1443+00, 4 April 1957].

View of levee crown at the crossing

84-inch CMP riser with slide gate on WS shoulder

3 pumps, concrete distributionbox, power pole with electrical panel on LS

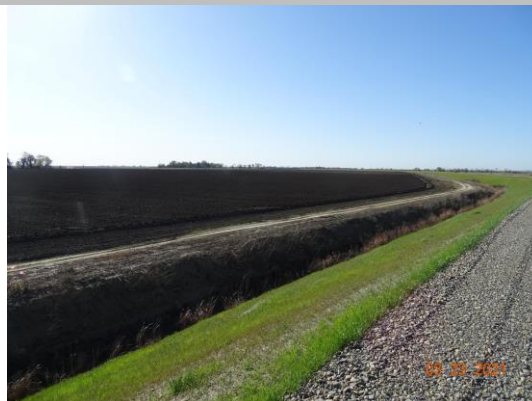
Photo 1 of 1 : SP_2021_MA0012_299_1_20210323_00085.jpg

View of irrigation ditch at the landside toe. Spring 2021.

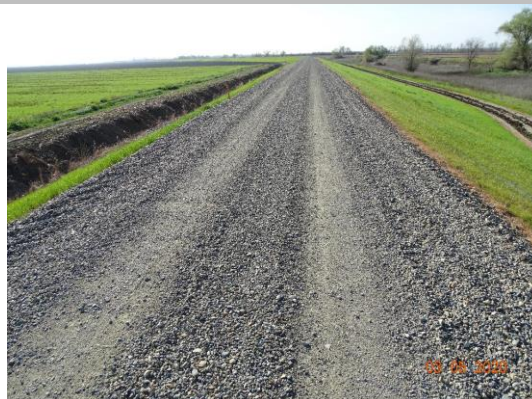
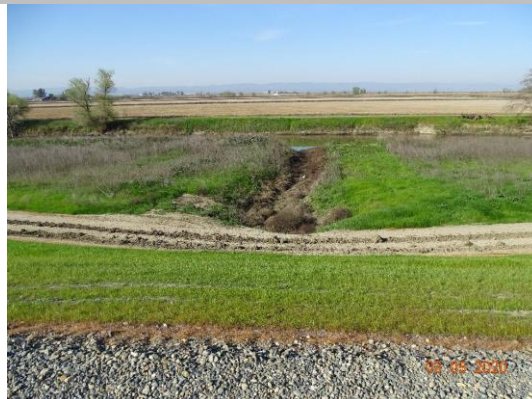
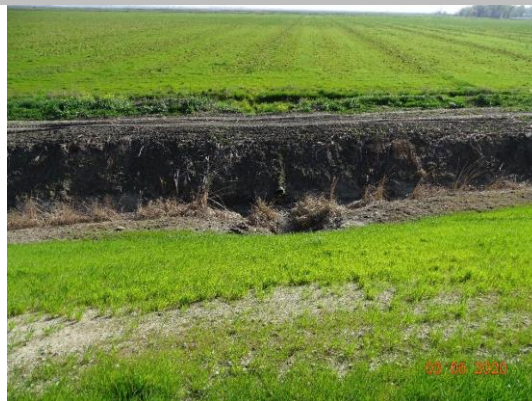
Photo 1 of 3 : UCIP_SP_2021_57195_83514.jpg

FS_ID:57195
DS_ID:17153
EP_NO: 9384
Repair Type: Non-Urgent
Crossing Status: Found
UCIP Comments: 03/05/2020 Record updated from No Action Needed to Non-Urgent. Sediment at LS headwall, vegetation at WS headwall need to be cleared. Need to have CVFPB review ABO and determine current owner. (O.Yakimov - DWR UCIP)05/02/2017 Crossing appears to be in good condition. (A.Freitag - DWR Sutter Yard)10/17/2016 Crossing appears to be in good condition. (A.Freitag - DWR Sutter Yard)05/31/2016 Crossing appears to be in good condition. (A.Freitag - DWR Sutter Yard)05/04/2015 Crossing appears in good condition. No noticeable issues. (A.Freitag - DWR Sutter Yard)06/17/2014 Same as last inspection. (A.Freitag - DWR Sutter Yard)12/16/2013 Same as last inspection. (A.Freitag - DWR Sutter Yard)07/16/2013 Same as last inspection. (A.Freitag - DWR Sutter Yard)
FIELD_STRUCT_DESC: 24-inch corrugated metal drainage pipe through the levee, 16 feet below the crown. Flap gate, concrete headwall, and grouted cobble spillway on the waterside (WS). Concrete headwall on the landside (LS). (24-inch pipe [HLM 3.22] authorized under Automatic Board Order (ABO) issued as Permit No. 9384, 1974 - William D. Struckmeyer; 24-inch pipe [HLM 3.22] was also authorized under Automatic Board Order (ABO) issued as Permit No. 8231, 1972 - Roy E. Kitts). [Additional Reference(s): DWR Levee Log, 2005 (HLM 3.22). USACE Sacramento O&M Manual, Unit 132, October 1959, Revised 14 January 2019, (HLM 3.22), listed as 24-inch pipe. USACE As-Built Drawing No. 50-4-3081, Sheet 5 and 15, Station 1495+75, 4 April 1957].

View of levee crown at the crossing

View of WS looking from levee crown

View of LS looking from levee crown

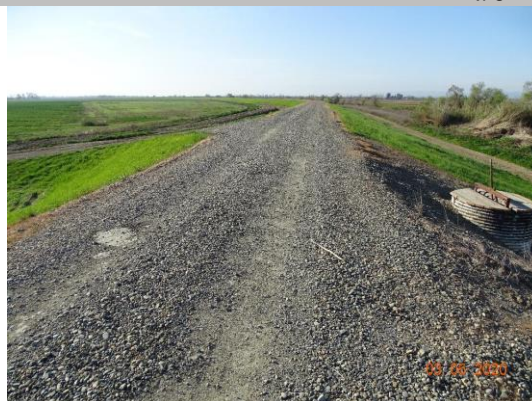
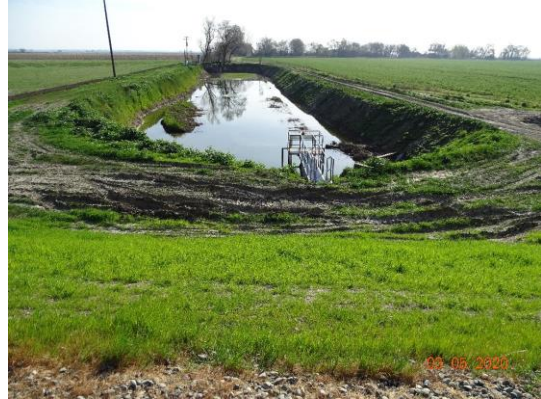
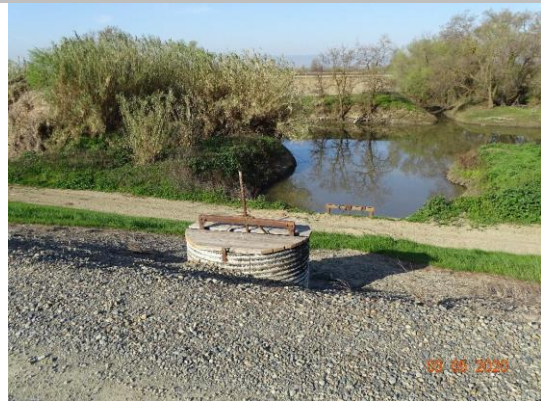
Photo 1 of 3 : UCIP_SP_2021_57196_83526.jpg

FS_ID:57196
DS_ID:17154
EP_NO: 9388
Repair Type: Non-Urgent
Crossing Status: Found
UCIP Comments: 03/05/2020 Record remains Non-Urgent. New cover on CMP riser has been installed. Piping around slide gate at LS toe was modified, new 14-inch pipes installed. Unable to locate a permit for system modification. New steel walkway to slide gate on LS. Need to coordinate with LMA for find a permit authorizing modification. Need to have CVFPB review ABO and determine current owner. (O.Yakimov - DWR UCIP)
10/05/2018 Fall hazard: missing cover on CMP riser. Closure devices are present on both ends of crossing and seem to be in operable condition. Downgraded to non-urgent. Recommend owner add cover to CMP riser. (O.Yakimov - DWR UCIP)
05/02/2017 WS slide gate stem is still bent, wheel to operate gate is missing. Needs a cover made for the standpipe to prevent falls. (A.Freitag - DWR Sutter Yard)10/17/2016 Slide gate stem is still and the gate appears to be inoperable. (A.Freitag - DWR Sutter Yard)05/31/2016 Slide gate stem is still bent. WS flap gate is chained open. (A.Freitag - DWR Sutter Yard)

05/04/2015 Slide gate stem is still bent. Gate looks to be unable to close all the way. (A.Freitag - DWR Sutter Yard)06/17/2014 Same as last inspection. (A.Freitag - DWR Sutter Yard)12/16/2013 Slide gate stem is still bent. WS flapgate was closed. (A.Freitag - DWR Sutter Yard)
07/16/2013 Water flowing through pipe so screw gate definitely not closed. Was told NOV's have been sent for owner to replace stem. Flap gate gets closed for flood season. (A.Freitag - DWR Sutter Yard)
10/11/2012 Slide gate inoperable, but appears to be in closed position. Flap gate held in open position. Good candidate for video inspection when, if ever, dry. (W.Wylie - DWR UCIP)
FIELD_STRUCT_DESC: 48-inch corrugated metal drainage pipe through the levee, 28 feet below the crown. Slide gate in a 66-inch riser on the waterside (WS) slope. Concrete headwall on the WS. Grouted cobble spillway from drainage ditch to large canal on the landside (LS). (48-inch pipe [HLM 3.78] authorized under Automatic Board Order (ABO) issued as Permit No. 9388, 1974 - Pauline A. Wallace; 48-inch pipe [HLM 3.78] was also authorized under Automatic Board Order (ABO) issued as Permit No. 8231, 1972 - Roy E. Kitts). [Additional Reference(s): DWR Levee Log, 2005 (HLM 3.78). USACE Sacramento O&M Manual, Unit 132, October 1959, Revised 14 January 2019, (HLM 3.78), listed as 48-inch pipe. USACE As-Built Drawing No. 50-4-3081, Sheet 5 and 15, Station 1524+75, 4 April 1957].

View of levee crown at the crossing looking downstream

View of LS looking from levee crown

View of WS looking from levee crown. CMP riser with slide gate on WS shoulder

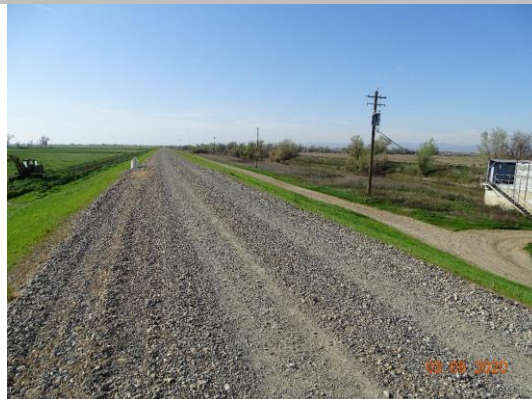
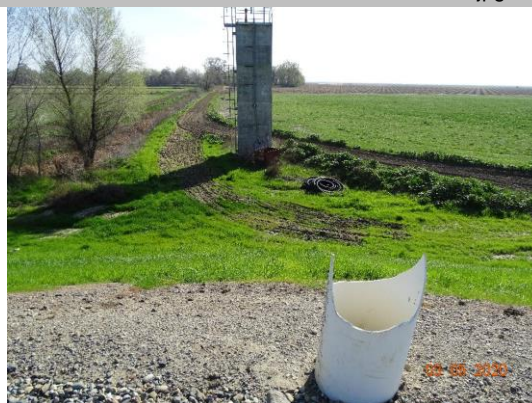
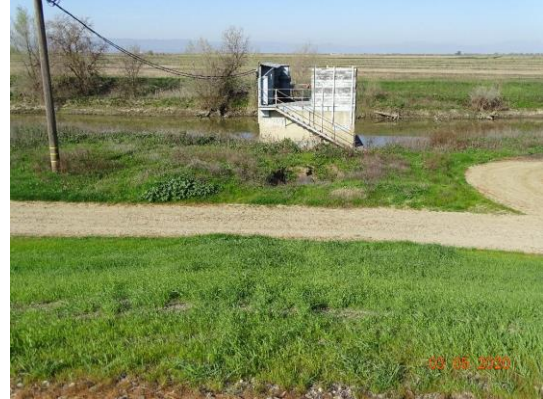
Photo 1 of 3 : UCIP_SP_2021_57197_83433.jpg

FS_ID:57197
DS_ID:17186
EP_NO: 16874
Repair Type: Urgent
Crossing Status: Found
UCIP Comments: 03/05/2020 Record updated from No Action Needed to Urgent. Pipe exposed due to unauthorized excavation on WS berm 25 feet from WS toe. Excavation measures 12' x 15' x 4.5' deep. Broken PVC riser on LS shoulder and leaking siphon breaker inside of PVC riser. (O.Yakimov - DWR UCIP) 05/02/2017 Crossing appears to be in good condition. (A. Freitag - DWR Sutter Yard) 10/17/2016 Crossing appears to be in good condition. (A. Freitag - DWR Sutter Yard) 05/31/2016 Crossing appears to be in good condition. (A. Freitag - DWR Sutter Yard) 05/04/2015 Crossing appears to be in good condition. No noticeable issues to report. (A. Freitag - DWR Sutter Yard) 06/17/2014 Same as last inspection. (A. Freitag - DWR Sutter Yard) 12/16/2013 Same as last inspection. (A. Freitag - DWR Sutter Yard) 07/16/2013 Same as last inspection. (A. Freitag - DWR Sutter Yard)

View of levee crown at the crossing looking downstream

View of LS looking from levee crown

View of WS looking from levee crown

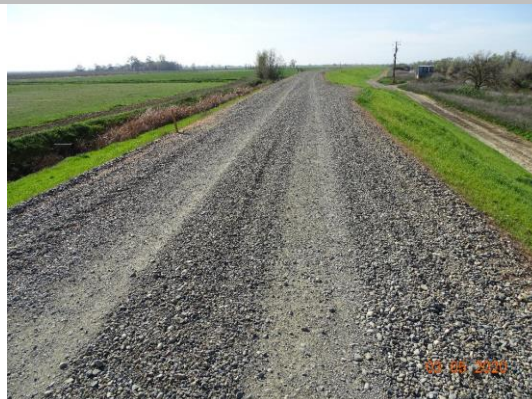
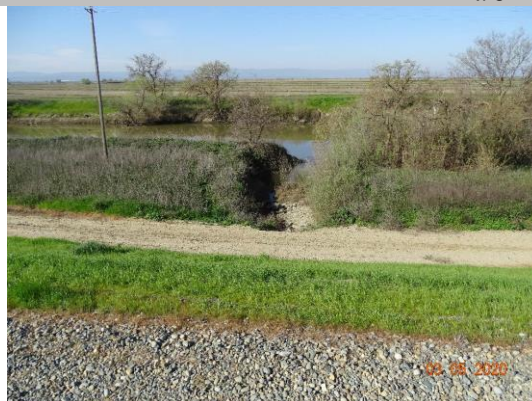
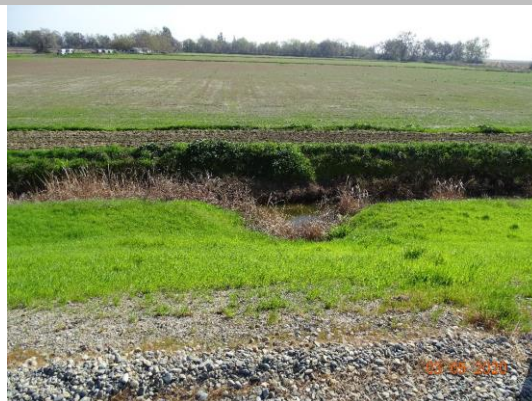
Photo 1 of 3 : UCIP_SP_2021_57229_83531.jpg

FS_ID:57229
DS_ID:17168
EP_NO: 9388
Repair Type: Non-Urgent
Crossing Status: Found
UCIP Comments: 03/05/2020 Record updated from No Action Needed to Non-Urgent. Need to have CVFPB review ABO and determine current owner. (O.Yakimov - DWR UCIP)05/02/2017 Crossing appears to be in good condition. (A.Freitag - DWR Sutter Yard)

10/17/2016 Crossing appears to be in good condition. (A.Freitag - DWR Sutter Yard)05/31/2016 Crossing appears to be in good condition. (A.Freitag - DWR Sutter Yard)05/04/2015 Crossing appears to be in good condition. No noticeable issues to report. (A.Freitag - DWR Sutter Yard)06/17/2014 Same as last inspection. (A.Freitag - DWR Sutter Yard)12/16/2013 Same as last inspection. (A.Freitag - DWR Sutter Yard)07/16/2013 Same as last inspection. (A.Freitag - DWR Sutter Yard)

View of levee crown at the crossing looking downstream

View of WS looking from levee crown

View of LS looking from levee crown

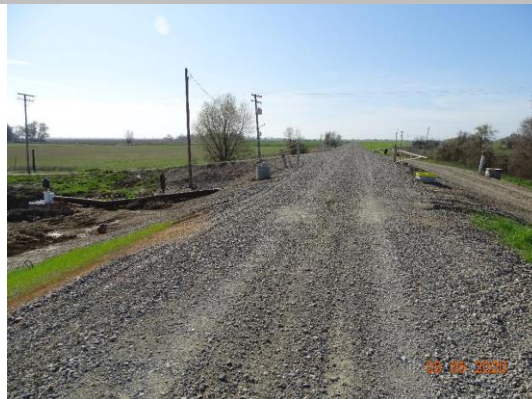
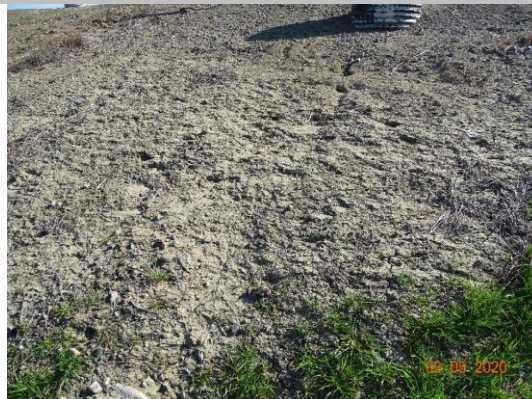
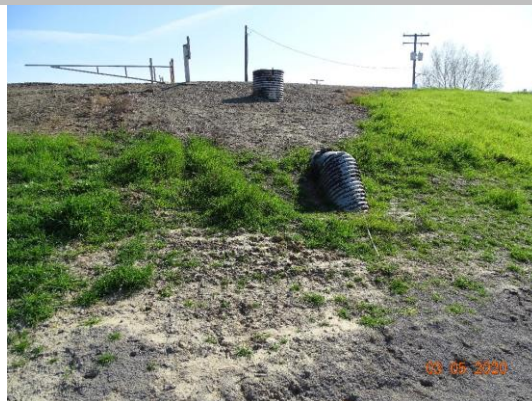
Photo 1 of 3 : UCIP_SP_2021_57199_83540.jpg

FS_ID:57199
DS_ID:17156
EP_NO: 9388
Repair Type: Non-Urgent
Crossing Status: Found
UCIP Comments: 03/05/2020 Record updated from No Action Needed to Non-Urgent. Modifications to the system done: 24-inch steel pipe connected to a CMP pipe at LS toe, pump in irrigation canal on LS. Unable to find pump system in O&M drawings. Steel pipe is currently disconnected from the pump in irrigation canal. Unable to locate a permit authorizing modifications. Need to have CVFPB review ABO and determine current owner. Pipe outlet on WS not found due to dense vegetation. (O.Yakimov - DWR UCIP)05/02/2017 Crossing appears to be in good condition. (A.Freitag - DWR Sutter Yard)10/17/2016 Crossing appears to be in good condition. (A.Freitag - DWR Sutter Yard)05/31/2016 Crossing appears to be in good condition. (A.Freitag - DWR Sutter Yard)05/04/2015 Crossing appears to be in good condition. No noticeable issues to report. (A.Freitag - DWR Sutter Yard)06/17/2014 Same as last inspection. (A. Freitag - DWR Sutter Yard)12/16/2013 Same as last inspection. (A. Freitag - DWR Sutter Yard)07/16/2013 Same as last inspection. (A. Freitag - DWR Sutter Yard)

View of levee crown at the crossing looking downstream

View of WS slope looking from levee toe

CMP pipe daylights on WS slope

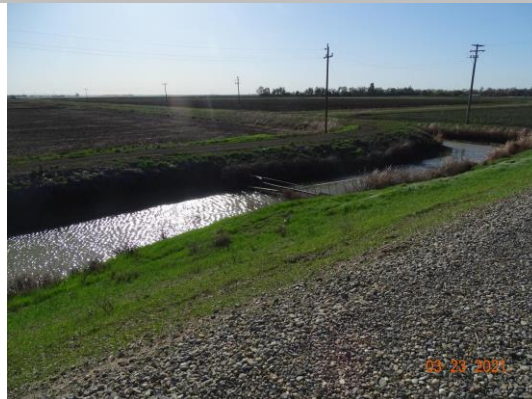
Photo 1 of 1 : SP_2021_MA0012_299_4_20210323_00084.jpg

View of ditch at the landside toe. Spring 2021.

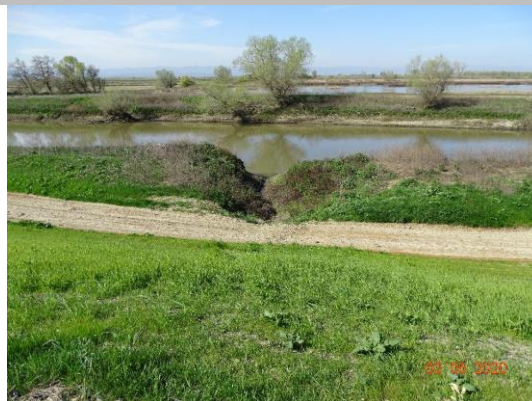
Photo 3 of 3 : UCIP_SP_2021_57231_83549.jpg

FS_ID:57231
DS_ID:17158
EP_NO: 9390
Repair Type: Non-Urgent
Crossing Status: Found
UCIP Comments: 03/05/2020 Record updated from No Action Needed to Non-Urgent. Pump in drainage ditch and standpipe are not designed per O&M As-Built drawing. Unable to locate a permit for modifications. Need to have CVFPB review ABO and determine current owner.
(O.Yakimov - DWR UCIP)05/02/2017 Crossing appears to be in good condition. There is minor sediment build up in front of the WS flap gate.
(A.Freitag - DWR Sutter Yard)10/17/2016 Crossing appears to be in good condition. (A.Freitag - DWR Sutter Yard)05/31/2016 Crossing appears to be in good condition. (A.Freitag - DWR Sutter Yard)05/04/2015 Crossing appears to be in good condition. No noticeable issues to report. (A.Freitag - DWR Sutter Yard)06/17/2014 Same as last inspection. (A.Freitag - DWR Sutter Yard)12/16/2013 Same as last inspection. (A.Freitag - DWR Sutter Yard)07/16/2013 New flapgate installed on WS pipe end. (A.Freitag - DWR Sutter Yard)10/11/2012 Flap gate broken on WS. Pipe shows significant rust at outlet. This is a good candidate for video inspection. (W.Wylie - DWR UCIP)

View of WS looking from levee crown

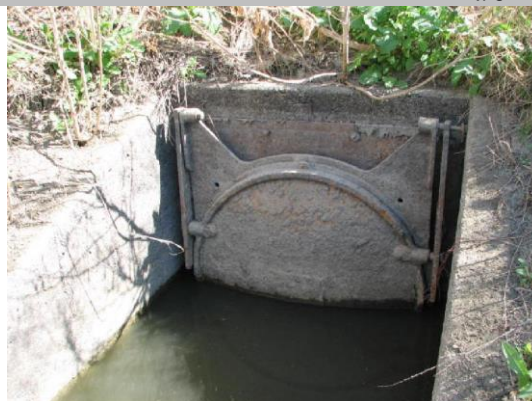
Photo 2 of 3 : UCIP_SP_2021_57234_69032.jpg

Flap gate in concrete U-shaped headwall at WS toe.

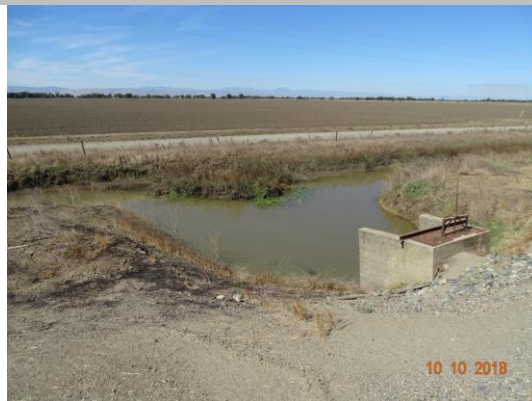
Photo 1 of 2 : SP_2021_MA0012_299_35_20210308_00004.jpg

View of diversion structure. Fall 2018.

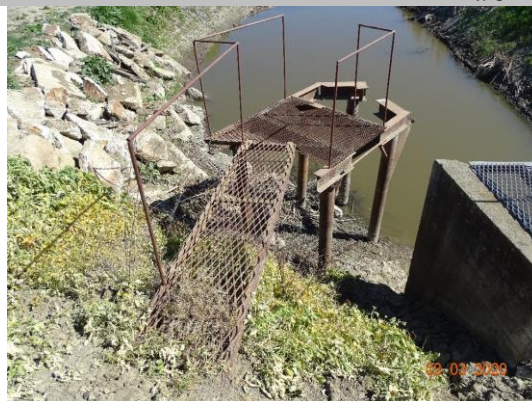
Photo 2 of 3 : UCIP_SP_2021_57243_83621.jpg

Steel walkway to former pumping platform in irrigation canal on LS

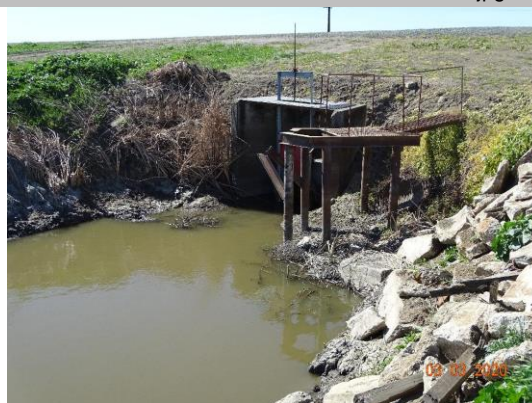
Photo 3 of 3 : UCIP_SP_2021_57243_83620.jpg

Abandoned pumping platform in irrigation canal on LS

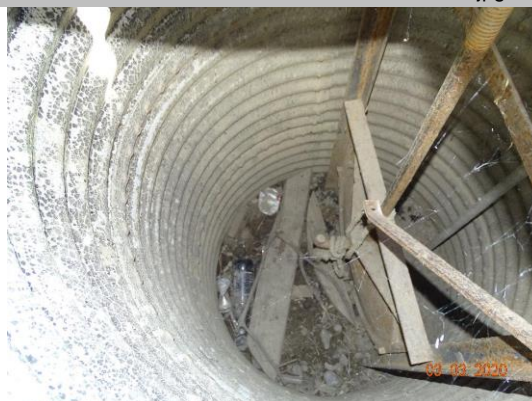
Photo 3 of 3 : UCIP_SP_2021_57245_83422.jpg

View inside of CMP riser on WS shoulder
