**Flood Control Project Maintenance  
Levee Inspections  
LMA District Cover Sheet**

**Sutter Maintenance Yard Maintenance Area 0012**

Waterway			Bank	Unit Miles
Unit No. 01 Colusa Drain			Left	11.06
	Spring (March - May)	Summer (June - August)	(September - November) Fall	Winter (December - February)
Unit Maintenance Rating (Fall Only)				
Date of Inspection	3/30/2022 - 3/30/2022			
DWR Inspector	Zach Jojola			
Accompanied By

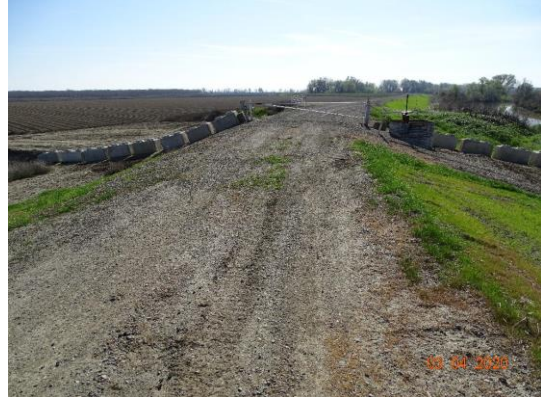
Photo 1 of 3 : UCIP\_SP\_2022\_57220\_83424.jpg

FS\_ID:57220  
DS\_ID:17155  
EP\_NO: 9381  
Repair Type: Non-Urgent  
Crossing Status: Found  
UCIP Comments: 03/04/2020 Record updated from No Action Needed to Non-Urgent. Need to have CVFPB review ABO and determine current owner. Recommend internal video inspection. (O.Yakimov - DWR UCIP)  
05/02/2017 Crossing appears to be in good condition. (A.Freitag - DWR Sutter Yard)  
10/17/2016 Crossing appears to be in good condition. Pipe material is CMP and the flow is from the LS to the WS. (A.Freitag - DWR Sutter Yard)  
05/31/2016 Crossing appears to be in good condition. (A.Freitag - DWR Sutter Yard)  
05/04/2015 Crossing in good condition. No issues. (A.Freitag - DWR Sutter Yard)  
06/17/2014 Same as last inspection. (A.Freitag - DWR Sutter Yard)  
07/16/2013 Same as last inspection. (A.Freitag - DWR Sutter Yard)  
12/16/2013 Same as last inspection. (A.Freitag - DWR Sutter Yard)  
FIELD\_STRUCT\_DESC: 60-inch drainage pipe through the levee, 22.1 feet below the crown. Concrete headwalls located on both the WS and landside (LS) toes. Slide gate and flap gate in 84-inch pipe riser located on the waterside (WS) slope. (60-inch pipe [HLM 0.00] authorized under Automatic Board Order (ABO) issued as Permit No. 9381, 1974 - Tribble; 60-inch pipe [HLM 0.00] was also authorized under Automatic Board Order (ABO) issued as Permit No. 8225, 1972 - Harold Baldson). [Additional Reference(s): DWR Levee Log, 2005 (HLM 0.00). USACE Sacramento O&M Manual, Unit 132, October 1959, Revised 14 January 2019, (HLM 20.49 - RD 108), listed as 60-inch pipe. USACE As-Built Drawing No. 50-4-3081, Sheets 3 and 15, Station 1326+00, 4 April 1957].

View of levee crown at the crossing looking downstream

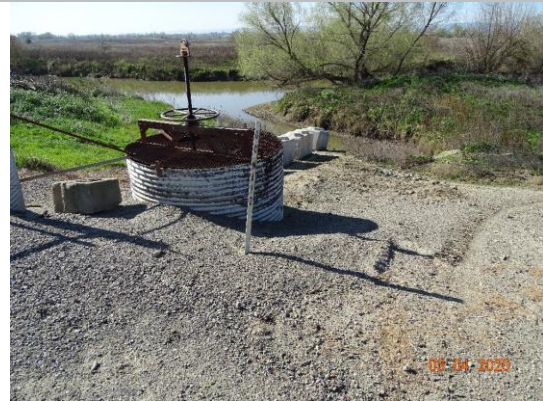
Photo 2 of 3 : UCIP\_SP\_2022\_57220\_83425.jpg

84-inch CMP riser with slide gate on WS shoulder

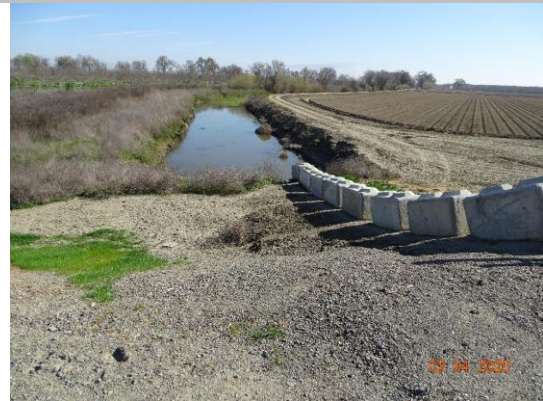
Photo 3 of 3 : UCIP\_SP\_2022\_57220\_83426.jpg

Drainage ditch on LS toe. Looking from levee crown

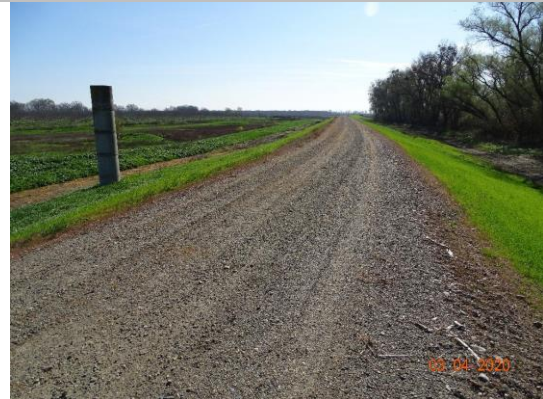
Photo 1 of 3 : UCIP\_SP\_2022\_57221\_83444.jpg

Comment Code						
Inspector Comment						
FS_ID:57221 DS_ID:17145 EP_NO: 9381 Repair Type: Non-Urgent Crossing Status: Indicator Found UCIP Comments: 03/04/2020 Record remains Non-Urgent. Crossing appears abandoned. Unable to locate pipe appurtenances on waterside due to dense vegetation. Recommend geophysical study of this site. Need to have CVFPB review ABO and determine current owner. (O.Yakimov - DWR UCIP)05/02/2017 Abandoned- needs to be done so properly. Only the LS standpipe was found. (A.Freitag - DWR Sutter Yard)10/17/2016 Abandoned (A.Freitag - DWR Sutter Yard)05/31/2016 Abandoned- only the LS concrete standpipe was found. (A.Freitag - DWR Sutter Yard)05/04/2015 Abandoned crossing. (A.Freitag - DWR Sutter Yard)06/17/2014 Same as last inspection.(A.Freitag - DWR Sutter Yard)12/16/2013 Same as last inspection.(A.Freitag - DWR Sutter Yard)07/16/2013 Same as last inspection. (A.Freitag - DWR Sutter Yard)10/11/2012 Need to verify proper abandonment of pipe. (W.Wylie - DWR) FIELD_STRUCT_DESC: 14-inch steel irrigation pipe through the levee, 3 feet below the crown. Open on the waterside (WS) end. 3-foot by 6-foot concrete well on the WS berm. Siphon breaker in 24-inch riser located on the landside (LS) shoulder. 36-inch concrete standpipe on the LS toe. The only item identified is the 36-inch standpipe on the LS toe (2012). (14-inch pipe [HLM 0.22] authorized under Automatic Board Order (ABO) issued as Permit No. 9381, 1974 - F. L. Tribble; 14-inch pipe [HLM 0.22] was also authorized under Automatic Board Order (ABO) issued as Permit No. 8226, 1972 - Jackson S. King). [Additional Reference(s): DWR Levee Log, 2005 (HLM 0.22). USACE Sacramento O&M Manual, Unit 132, October 1959, Revised 14 January 2019, (HLM 0.22), listed 14-inch pipe. USACE As-Built Drawing No. 50-4-3081, Sheet 3 and 15, Station 1338+00, 4 April 1957]. FS Date: 3/4/2020 3:32:00 PM

Levee crown at the crossing looking downstream

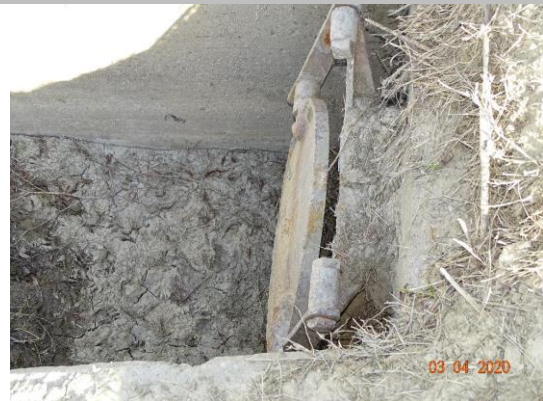
Photo 3 of 3 : UCIP\_SP\_2022\_57222\_83455.jpg

Flap gate should be closing properly

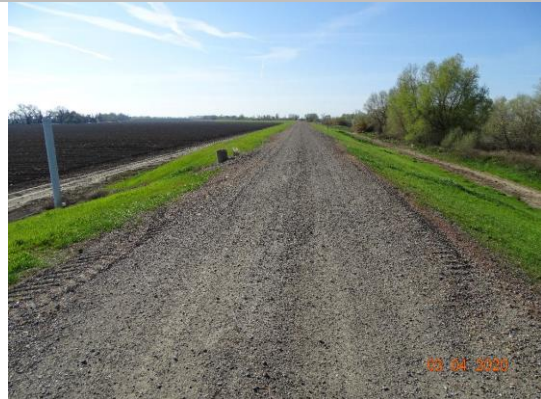
Photo 1 of 3 : UCIP\_SP\_2022\_57223\_83466.jpg

Comment Code						
Inspector Comment						
FS_ID:57223 DS_ID:17148 EP_NO: 9382 Repair Type: Non-Urgent Crossing Status: Found UCIP Comments: 03/04/2020 Record remains Non-Urgent. Need to have CVFPB review ABO and determine current owner. Taller grass observed along pipe alignment on WS slope. Pressure test or video inspection of crossing is recommended. (O.Yakimov - DWR UCIP)05/02/2017 WS is being overgrown with vegetation. The rest of the crossing appears to be in good condition. (A.Freitag - DWR Sutter Yard)10/17/2016 Vegetation is overgrowing the WS head wall near the pump. The rest of the crossing appears to be in good condition. (A.Freitag - DWR Sutter Yard)05/31/2016 Crossing appears to be in good condition. (A.Freitag - DWR Sutter Yard)05/04/2015 Crossing appears in good condition. No noticeable issues to report. (A.Freitag - DWR Sutter Yard)06/17/2014 Same as last inspection. (A.Freitag - DWR Sutter Yard)12/16/2013 Same as last inspection. (A.Freitag - DWR Sutter Yard)07/16/2013 Same as last inspection. (A.Freitag - DWR Sutter Yard) FIELD_STRUCT_DESC: 18-inch steel irrigation pipe through the levee, 3 feet below the crown. Pump, butterfly valve, and concrete headwall at the edge of the bank. Bank cobble revetted 10 feet on both the waterside (WS) and the landside (LS) of installation. 18-inch polyvinyl chloride (PVC) standpipe on the LS berm. Siphon breaker in 18-inch concrete riser on the LS shoulder. Service pole at the edge of the bank. (18-inch pipe [HLM 1.53] authorized under Automatic Board Order (ABO) issued as Permit No. 9382, 1974 - Olen C. Baber; 18-inch pipe [HLM 1.53] was also authorized under Automatic Board Order (ABO) issued as Permit No. 8228, 1972 - Olin C. Baber). [Additional Reference(s): DWR Levee Log, 2005 (HLM 1.53), listed as 18-inch pipe. USACE Sacramento O&M Manual, Unit 132, October 1959, Revised 14 January 2019, (HLM 1.53). USACE As-Built Drawing No. 50-4-3081, Sheet 4 and 15, Station 1409+25, 4 April 1957]. FS Date: 3/4/2020 10:15:00 AM

View of levee crown at the crossing looking downstream

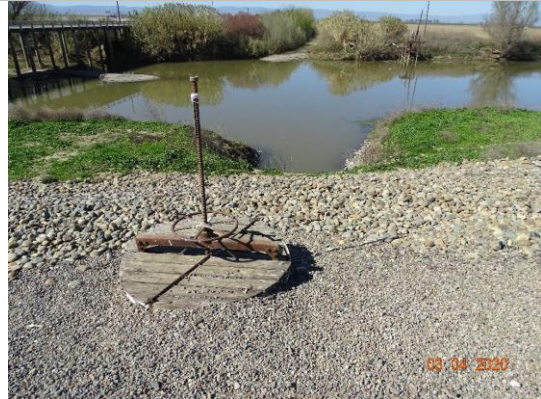
Photo 2 of 3 : UCIP\_SP\_2022\_57227\_83486.jpg

60-inch standpipe with slide gate on WS slope with outlet in background.

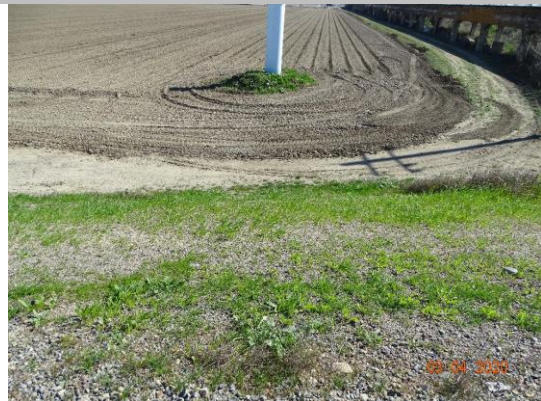
Photo 3 of 3 : UCIP\_SP\_2022\_57227\_83487.jpg

View of LS slope looking from levee crown. PVC pipe in the field doesn't belong to this crossing

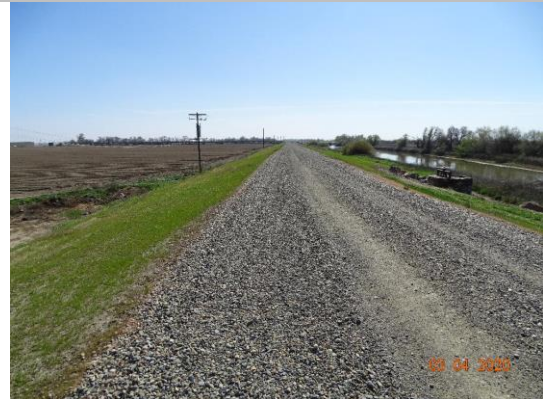
Photo 1 of 3 : UCIP\_SP\_2022\_57194\_83505.jpg

Comment Code					
Inspector Comment					
FS_ID:57194 DS_ID:17152 EP_NO: 9319 Repair Type: Non-Urgent Crossing Status: Found UCIP Comments: 03/04/2020 Record updated from No Action Needed to Non-Urgent. Metal debris observed at LS levee toe considered trip and fall safety hazard. Need to have CVFPB review ABO and determine current owner. (O.Yakimov - DWR UCIP)05/02/2017 Crossing appears to be in good condition. (A.Freitag - DWR Sutter Yard)10/17/2016 Crossing appears to be in good condition. (A.Freitag - DWR Sutter Yard)05/31/2016 Crossing appears to be in good condition. (A.Freitag - DWR Sutter Yard)05/04/2015 Crossing appears in good condition. No noticeable issues. (A.Freitag - DWR Sutter Yard)06/17/2014 Same as last inspection. (A.Freitag - DWR Sutter Yard)12/16/2013 Same as last inspection. (A.Freitag - DWR Sutter Yard)07/16/2013 Same as last inspection. (A.Freitag - DWR Sutter Yard) FIELD_STRUCT_DESC: 60-inch corrugated metal irrigation pipe through the levee, 22.7 feet below the crown. Slide gate in a 84-inch corrugated metal riser on the waterside (WS) slope. Three pumps over a sump, and distribution box on the landside (LS). Concrete headwall on the WS. (60-inch pipe [HLM 2.19] authorized under Automatic Board Order (ABO)issued as Permit No. 9319, 1974 - Frederick J. Strain; 60-inch pipe [HLM 2.19] was also authorized under Automatic Board Order (ABO) issued as Permit No. 8230, 1972 - Jack Baber). [Additional Reference(s): DWR Levee Log, 2005 (HLM 2.19). USACE Sacramento O&M Manual, Unit 132, October 1959, Revised 14 January 2019, (HLM 2.19), listed as 60-inch pipe. USACE As-Built Drawing No. 50-4-3081, Sheet 4 and 15, Station 1443+00, 4 April 1957]. FS Date: 3/4/2020 1:48:00 PM

View of levee crown at the crossing

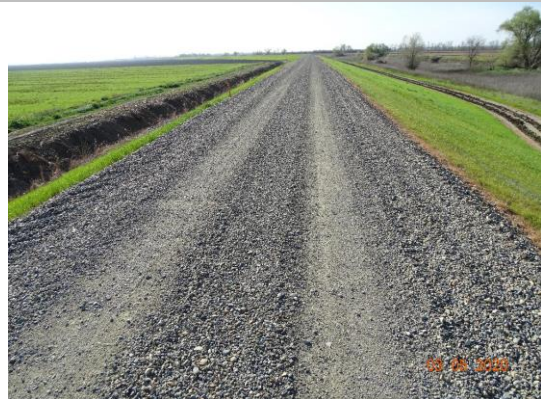
Photo 1 of 3 : UCIP\_SP\_2022\_57195\_83514.jpg

Comment Code					
Inspector Comment					
FS_ID:57195 DS_ID:17153 EP_NO: 9384 Repair Type: Non-Urgent Crossing Status: Found UCIP Comments: 03/05/2020 Record updated from No Action Needed to Non-Urgent. Sediment at LS headwall, vegetation at WS headwall need to be cleared. Need to have CVFPB review ABO and determine current owner. (O.Yakimov - DWR UCIP)05/02/2017 Crossing appears to be in good condition. (A.Freitag - DWR Sutter Yard)10/17/2016 Crossing appears to be in good condition. (A.Freitag - DWR Sutter Yard)05/31/2016 Crossing appears to be in good condition. (A.Freitag - DWR Sutter Yard)05/04/2015 Crossing appears in good condition. No noticeable issues. (A.Freitag - DWR Sutter Yard)06/17/2014 Same as last inspection. (A.Freitag - DWR Sutter Yard)12/16/2013 Same as last inspection. (A.Freitag - DWR Sutter Yard)07/16/2013 Same as last inspection. (A.Freitag - DWR Sutter Yard) FIELD_STRUCT_DESC: 24-inch corrugated metal drainage pipe through the levee, 16 feet below the crown. Flap gate, concrete headwall, and grouted cobble spillway on the waterside (WS). Concrete headwall on the landside (LS). (24-inch pipe [HLM 3.22] authorized under Automatic Board Order (ABO) issued as Permit No. 9384, 1974 - William D. Struckmeyer; 24-inch pipe [HLM 3.22] was also authorized under Automatic Board Order (ABO) issued as Permit No. 8231, 1972 - Roy E. Kitts). [Additional Reference(s): DWR Levee Log, 2005 (HLM 3.22). USACE Sacramento O&M Manual, Unit 132, October 1959, Revised 14 January 2019, (HLM 3.22), listed as 24-inch pipe. USACE As-Built Drawing No. 50-4-3081, Sheet 5 and 15, Station 1495+75, 4 April 1957]. FS Date: 3/5/2020 3:09:00 PM

View of levee crown at the crossing

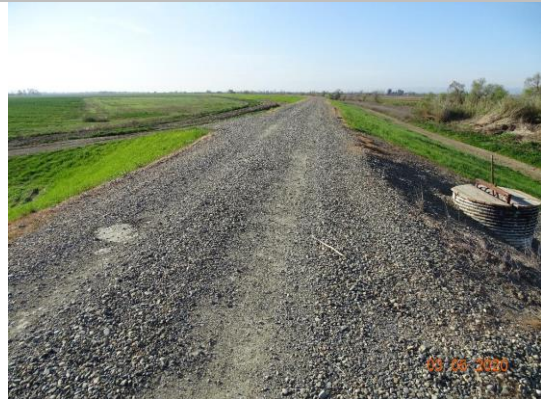
Photo 1 of 3 : UCIP\_SP\_2022\_57196\_83526.jpg

FS\_ID:57196  
DS\_ID:17154  
EP\_NO: 9388  
Repair Type: Urgent  
Crossing Status: Found  
UCIP Comments: 03/05/2020 Record remains Non-Urgent. New cover on CMP riser has been installed. Piping around slide gate at LS toe was modified, new 14-inch pipes installed. Unable to locate a permit for system modification. New steel walkway to slide gate on LS. Need to coordinate with LMA for find a permit authorizing modification. Need to have CVFPB review ABO and determine current owner. (O.Yakimov - DWR UCIP)  
10/05/2018 Fall hazard: missing cover on CMP riser. Closure devices are present on both ends of crossing and seem to be in operable condition. Downgraded to non-urgent. Recommend owner add cover to CMP riser. (O.Yakimov - DWR UCIP)  
05/02/2017 WS slide gate stem is still bent, wheel to operate gate is missing. Needs a cover made for the standpipe to prevent falls. (A.Freitag - DWR Sutter Yard)10/17/2016 Slide gate stem is still and the gate appears to be inoperable. (A.Freitag - DWR Sutter Yard)05/31/2016 Slide gate stem is still bent. WS flap gate is chained open. (A.Freitag - DWR Sutter Yard)

05/04/2015 Slide gate stem is still bent. Gate looks to be unable to close all the way. (A.Freitag - DWR Sutter Yard)06/17/2014 Same as last inspection. (A.Freitag - DWR Sutter Yard)12/16/2013 Slide gate stem is still bent. WS flapgate was closed. (A.Freitag - DWR Sutter Yard)  
07/16/2013 Water flowing through pipe so screw gate definitely not closed. Was told NOV's have been sent for owner to replace stem. Flap gate gets closed for flood season. (A.Freitag - DWR Sutter Yard)  
10/11/2012 Slide gate inoperable, but appears to be in closed position. Flap gate held in open position. Good candidate for video inspection when, if ever, dry. (W.Wylie - DWR UCIP)  
FIELD\_STRUCT\_DESC: 48-inch corrugated metal drainage pipe through the levee, 28 feet below the crown. Slide gate in a 66-inch riser on the waterside (WS) slope. Concrete headwall on the WS. Grouted cobble spillway from drainage ditch to large canal on the landside (LS). (48-inch pipe [HLM 3.78] authorized under Automatic Board Order (ABO) issued as Permit No. 9388, 1974 - Pauline A. Wallace; 48-inch pipe [HLM 3.78] was also authorized under Automatic Board Order (ABO) issued as Permit No. 8231, 1972 - Roy E. Kitts). [Additional Reference(s): DWR Levee Log, 2005 (HLM 3.78). USACE Sacramento O&M Manual, Unit 132, October 1959, Revised 14 January 2019, (HLM 3.78), listed as 48-inch pipe. USACE As-Built Drawing No. 50-4-3081, Sheet 5 and 15, Station 1524+75, 4 April 1957].

View of levee crown at the crossing looking downstream

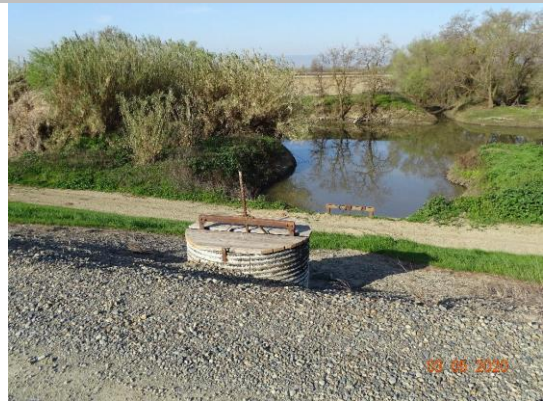
Photo 3 of 3 : UCIP\_SP\_2022\_57196\_83528.jpg

View of WS looking from levee crown. CMP riser with slide gate on WS shoulder

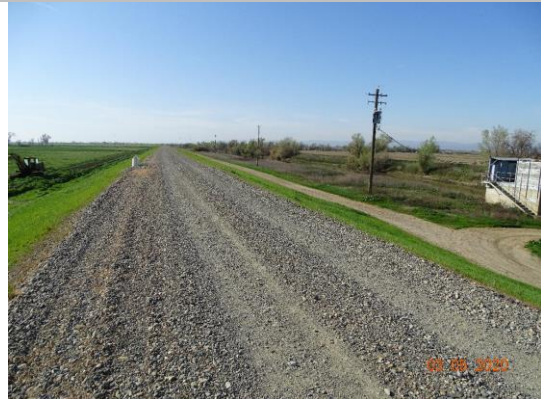
Photo 1 of 3 : UCIP\_SP\_2022\_57197\_83433.jpg

FS\_ID:57197  
DS\_ID:17186  
EP\_NO: 16874  
Repair Type: Urgent  
Crossing Status: Found  
UCIP Comments: 03/05/2020 Record updated from No Action Needed to Urgent. Pipe exposed due to unauthorized excavation on WS berm 25 feet from WS toe. Excavation measures 12' x 15' x 4.5' deep. Broken PVC riser on LS shoulder and leaking siphon breaker inside of PVC riser. (O.Yakimov - DWR UCIP) 05/02/2017 Crossing appears to be in good condition. (A. Freitag - DWR Sutter Yard) 10/17/2016 Crossing appears to be in good condition. (A. Freitag - DWR Sutter Yard) 05/31/2016 Crossing appears to be in good condition. (A. Freitag - DWR Sutter Yard) 05/04/2015 Crossing appears to be in good condition. No noticeable issues to report. (A. Freitag - DWR Sutter Yard) 06/17/2014 Same as last inspection. (A. Freitag - DWR Sutter Yard) 12/16/2013 Same as last inspection. (A. Freitag - DWR Sutter Yard) 07/16/2013 Same as last inspection. (A. Freitag - DWR Sutter Yard)

View of levee crown at the crossing looking downstream

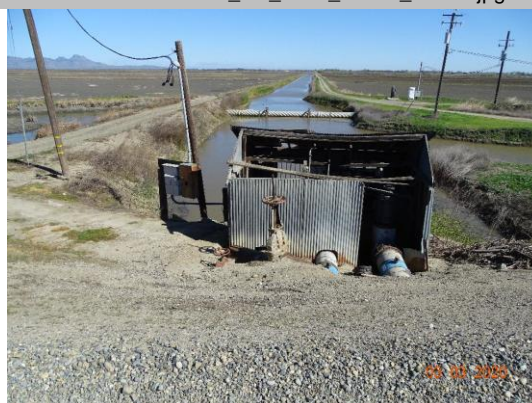
Photo 3 of 3 : UCIP\_SP\_2022\_57238\_83596.jpg

View of LS looking from levee crown. Pumphouse with 3 pumps at LS toe

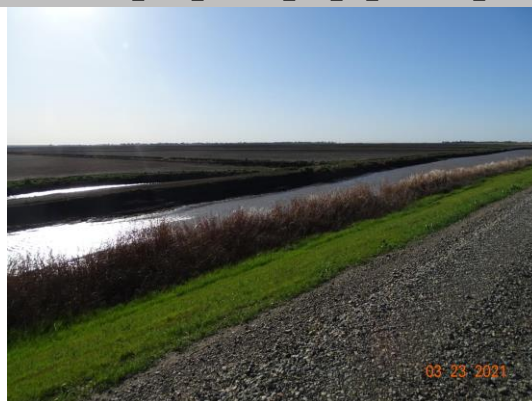
Photo 1 of 1 : SP\_2022\_MA0012\_299\_37\_20220308\_00003.jpg

View of the irrigation ditch at the landside toe. Spring 2021.

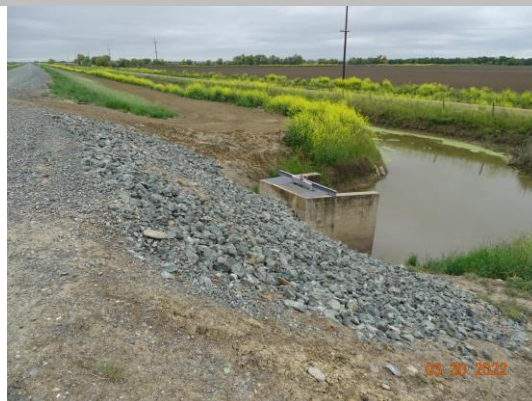
Photo 1 of 1 : SP\_2022\_MA0012\_299\_31\_20220404\_00079.jpg

View of repaired waterside slope. Spring 2022.

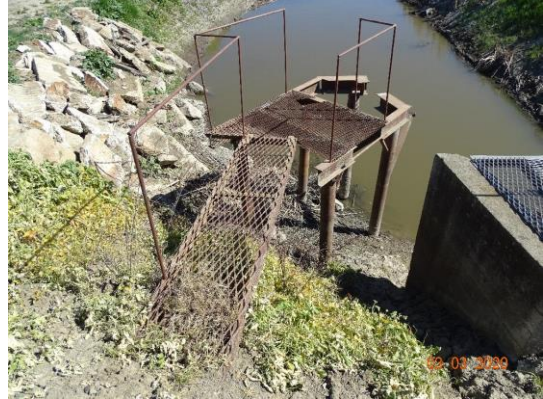
Photo 2 of 3 : UCIP\_SP\_2022\_57243\_83621.jpg

Steel walkway to former pumping platform in irrigation canal on LS

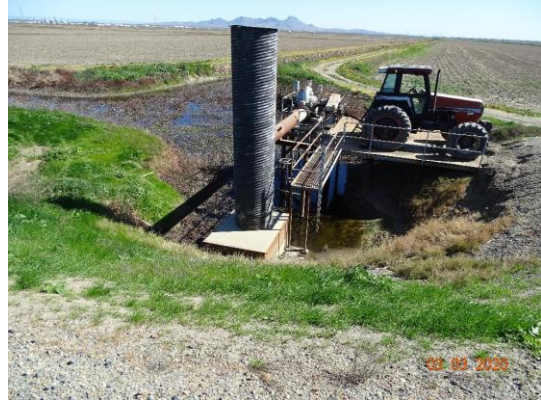
Photo 2 of 3 : UCIP\_SP\_2022\_57219\_83634.jpg

Stanspipe, pump in drainage ditch, and tractor used as a pump motor on LS

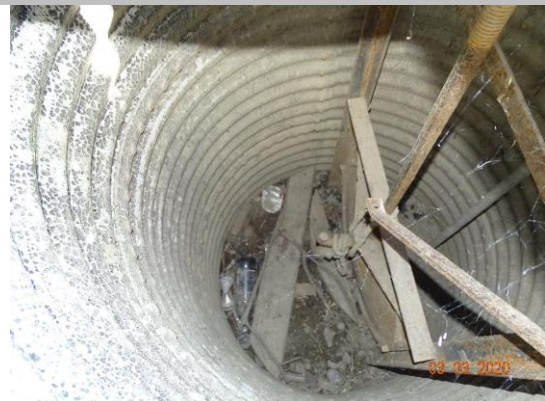
Photo 3 of 3 : UCIP\_SP\_2022\_57245\_83422.jpg

View inside of CMP riser on WS shoulder
