**Flood Control Project Maintenance
Levee Inspections
LMA District Cover Sheet**

Sutter Maintenance Yard Maintenance Area 0012

Waterway			Bank	Unit Miles
Unit No. 01 Colusa Drain			Left	11.06
	Spring (March - May)	Summer (June - August)	(September - November) Fall	Winter (December - February)
Unit Maintenance Rating (Fall Only)				
Date of Inspection	4/4/2023 - 4/4/2023			
DWR Inspector	Zach Jojola			
Accompanied By

Levee Inspection Report By Mile - Spring 2023

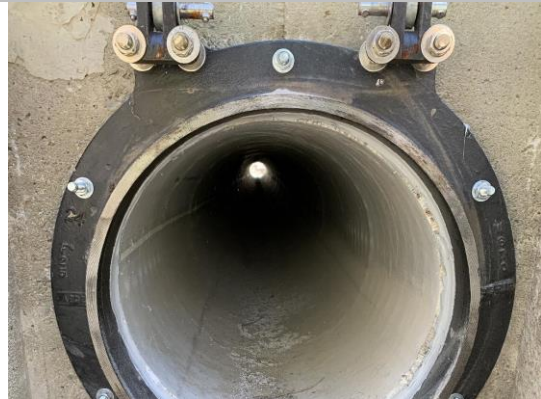
Photo 1 of 3 : UCIP_SP_2023_57222_103216.jpg

DS_ID:17146
FS_ID:57222
EP_NO: 9385
Repair Type: Non-Urgent
EVAL Issue:
Crossing Status: Found
UCIP Comments: 08/04/2021 Record updated from Urgent to Non-Urgent. Flap gate was replaced, LMA provided updated photos. (O.Yakimov - DWR UCIP)
03/04/2020 Record updated from Non-Urgent to Urgent. Pipe has been CIPP-lined under the DWR DMP Phase 2 Project. Flap gate not closing properly posing flood risk to the landside during flood season. LMA needs to repair or replace flap gate. No permit has been identified authorizing pipe. Need to have CVFPB review ABO and determine current owner. (O.Yakimov - DWR UCIP)
05/02/2017 WS is in good condition. LS inlet is more than 50% full of sediment. Pipe needs to be cleaned internally. (A.Freitag - DWR Sutter Yard)
10/17/2016 Minor sediment blocking the WS flap gate from opening. LS inlet still mostly full of sediment. (A.Freitag - DWR Sutter Yard)09/29/2016 Crossing has been downgraded from Urgent to Non-Urgent WS flap gate is closed for flood season. Need to coordinate with owner to remove sediment blocking WS flap gate. (O.Magana - DWR UCIP)

Water-Side: View inside of pipe with flap gate open

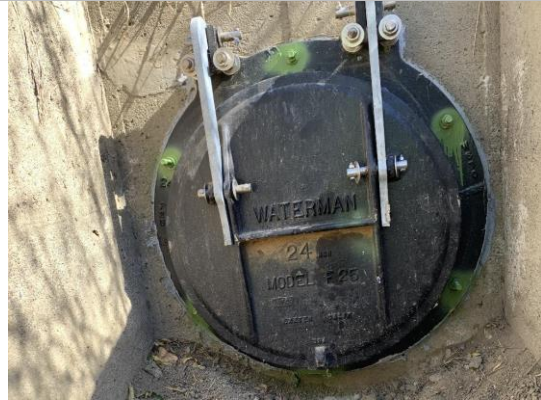
Photo 2 of 3 : UCIP_SP_2023_57222_103215.jpg

Water-Side: New flap gate installed

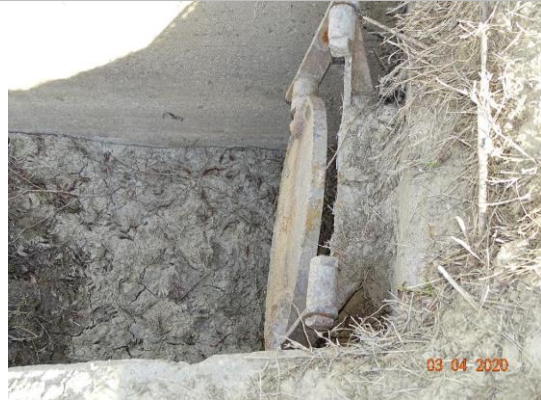
Photo 3 of 3 : UCIP_SP_2023_57222_83455.jpg

Flap gate should be closing properly

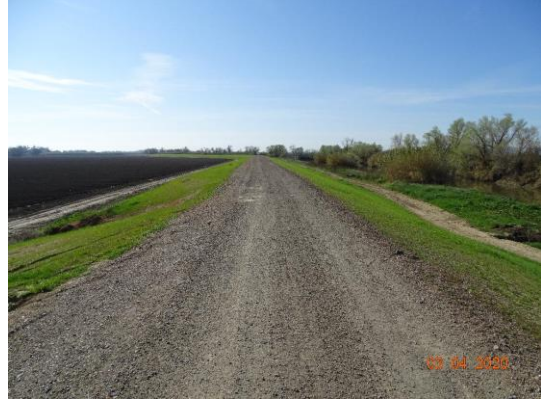
Photo 1 of 3 : UCIP_SP_2023_57190_83458.jpg

Comment Code					
Inspector Comment					
DS_ID:17147 FS_ID:57190 EP_NO: 9382 Repair Type: Non-Urgent EVAL Issue: Crossing Status: Found UCIP Comments: 03/04/2020 Record updated from No Action Needed to Non-Urgent. Pipe has been CIPP-lined under the DWR DMP Phase 2 Project. Need to have CVFPB review ABO and determine current owner. (O.Yakimov - DWR UCIP) 05/02/2017 Crossing appears to be in good condition. (A.Freitag - DWR Sutter Yard)10/17/2016 Crossing appears to be in good condition. This is a gravity for the LS. (A.Freitag - DWR Sutter Yard)05/31/2016 Crossing appears to be in good condition. (A.Freitag - DWR Sutter Yard)05/04/2015 Crossing is in good condition. No issues. (A.Freitag - DWR Sutter Yard)06/17/2014 Same as last inspection. (A.Freitag - DWR Sutter Yard)12/16/2013 Same as last inspection. (A.Freitag - DWR Sutter Yard)07/16/2013 Same as last inspection. (A.Freitag - DWR Sutter Yard) FIELD_STRUCT_DESC: 24-inch corrugated metal CIPP-lined drainage pipe through the levee, 13 feet below the crown. Flap gate, concrete headwall, and grouted cobble spillway on the waterside (WS). Concrete headwall on the landside (LS). (24-inch pipe [HLM 1.40] authorized under Automatic Board Order (ABO) issued as Permit No. 9382, 1974 - Olen C. Bober; 24-inch pipe [HLM 1.40] was also authorized under Automatic Board Order (ABO) issued as Permit No. 8228, 1972 - Olin C. Baber). [Additional Reference(s): DWR Levee Log, 2005 (HLM 1.40). USACE Sacramento O&M Manual, Unit 132, October 1959, Revised 14 January 2019, (HLM 1.40), listed as 24-inch pipe. USACE As-Built Drawing No. 50-4-3081, Sheet 4 and 15, Station 1402+63, 4 April 1957]. FS Date: 3/4/2020 9:53:00 AM

Levee crown at the crossing

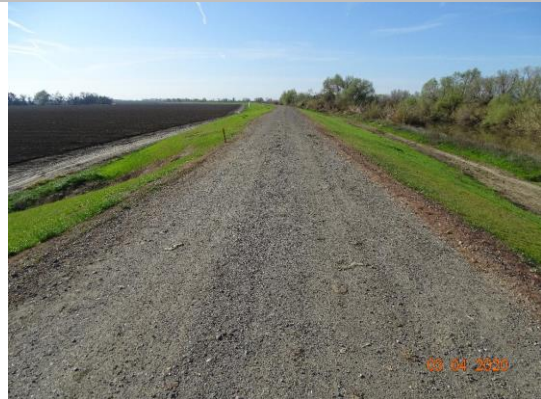
Photo 1 of 3 : UCIP_SP_2023_57224_83473.jpg

DS_ID:17149
FS_ID:57224
EP_NO: 9382
Repair Type: Non-Urgent
EVAL Issue:
Crossing Status: Found
UCIP Comments: 03/04/2020 Record remains Non-Urgent. Pipe has been CIPP-lined and new flap gate installed under the DWR DMP Phase 2 Project. Vegetation around flap gate was cleared. Need to have CVFPB review ABO and determine current owner. (O.Yakimov - DWR UCIP) 05/02/2017 WS flapgate buried by sediment. Needs to be dug out. (A.Freitag - DWR Sutter Yard)10/17/2016 Crossing appears to be in good condition. This is a gravity drain for the LS. (A.Freitag - DWR Sutter Yard)05/31/2016 LS inlets was partially plugged. WS flapgate was clear of sediment and able to operate properly. (A.Freitag - DWR Sutter Yard)05/04/2015 WS flapgate is blocked by sediment and unable to open. LS inlet is plugged by silt and wood chippings. Needs to be cleaned. (A.Freitag - DWR Sutter Yard)06/17/2014 Flap gate was cleaned out and is fully closed. LS inlet still partially full of soil. (A.Freitag - DWR Sutter Yard)12/16/2013 Same as last inspection. WS flapgate still needs to be cleaned out and shut. (A.Freitag - DWR Sutter Yard)07/16/2013 Same as last inspection. Make sure flapgate is closed before highwater season. (A.Freitag - DWR Sutter Yard)10/11/2012 Inlet on LS filled partially with soil. Outlet blocked with soil and the flap gate won't close. (W.Wylie - DWR UCIP)

View of levee crown at the crossing looking downstream

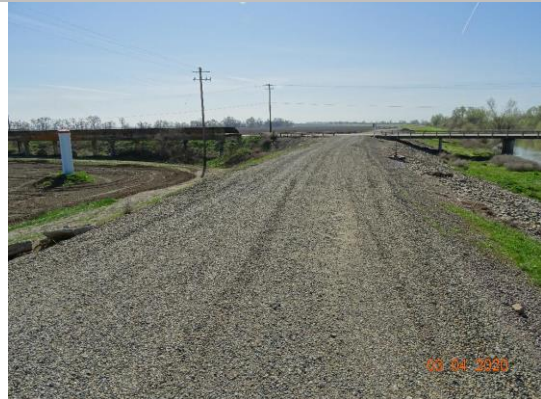
Photo 1 of 3 : UCIP_SP_2023_57227_83485.jpg

DS_ID:17150
FS_ID:57227
EP_NO: 9387
Repair Type: Urgent
EVAL Issue: 3a, Flood Risk
Crossing Status: Found
UCIP Comments: 03/04/2020 Record updated from No Action Needed to Urgent. Flap gate at WS levee toe not closing tightly leaving a gap for water to enter a part of crossing up to slide gate. Since slide gate on WS shoulder is in open position, this can pose flood risk to the landside during high water events. Recommend LMA to repair flap gate before next flood season. Pipe inlet near LS levee toe not found. Crossing appears abandoned. Concrete standpipe observed on landside 1,400 feet east of levee that seem to belong to the drainage system. Abandoned pump in irrigation/drainage canal 1,750 feet east of levee found. Recommend geophysical study to determine alignment of pipe through the levee. Need to have CVFPB review ABO and determine current owner. Need to contact owner to determine status of crossing. (O.Yakimov - DWR UCIP)05/02/2017 Crossing appears to be in good condition. (A.Freitag - DWR Sutter Yard)10/17/2016 Crossing appears to be in good condition. (A.Freitag - DWR Sutter Yard)05/31/2016 Crossing appears to be in good condition. Attached photo showing location of LS inlet. (A.Freitag - DWR Sutter Yard)05/04/2015 WS flapgate mostly underwater but could tell it was blocked open by something. LS inlet is located about 1/4 mile north along the side of the roadway. (A.Freitag - DWR Sutter Yard)06/17/2014 Same as last inspection. (A.Freitag - DWR Sutter Yard)12/16/2013 Pipe was flowing water and flap gate was being pushed open. Cannot verify if it will close all the way. (A.Freitag - DWR Sutter Yard)07/16/2013 Same as last inspection. Was told inlet is about 1/4 mile down road way next to house. Will try to get coordinates for inlet. (A.Freitag - DWR Sutter Yard)10/11/2012 No inlet could be located on LS. Flap gate partially blocked and will not close completely. (W.Wylie - DWR UCIP)

View of levee crown at crossing looking downstream

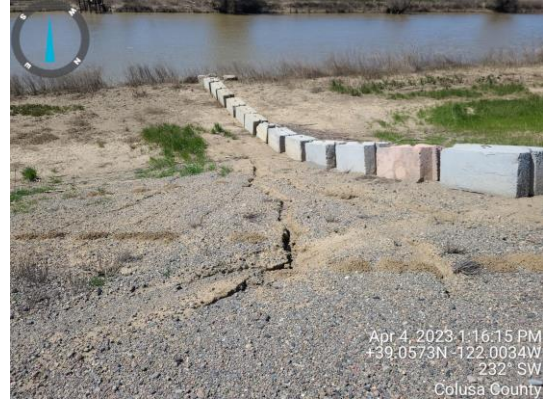
Photo 1 of 1 : SP_2023_MA0012_299_26_20230404_00065.jpg

LM Start	1.80	Rating **	M	Issue No.	26
LM End	1.80	Issue Type +	Ma	Location *	WS
Category	Earthen Levee			GPS Latitude/Longitude	
				Start	End
Item	Erosion / Rills			39.057257°	39.057365°
				-122.003428°	-122.003464°
DWR ID	DWR_MA0012_01_s_2023_26				
Comment Code					
E5 : Schedule repair of rills prior to the next inspection.					
Inspector Comment					
Rills on waterside slope.

View of rill on the waterside slope. Spring 2023.

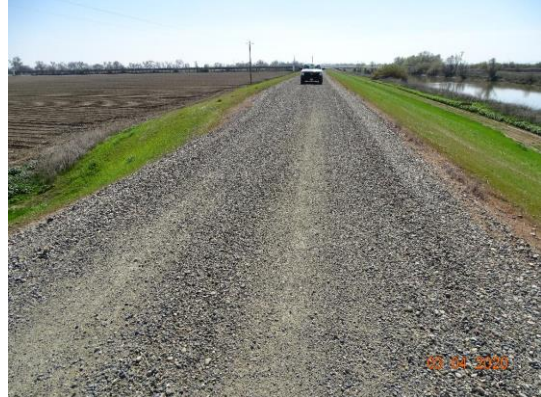
Photo 1 of 3 : UCIP_SP_2023_57228_83501.jpg

DS_ID:17151
FS_ID:57228
EP_NO: 9387
Repair Type: Non-Urgent
EVAL Issue:
Crossing Status: Found
UCIP Comments: 03/04/2020 Record remains Non-Urgent. Need to have CVFPB review ABO and determine current owner. Crossing appears abandoned. Both end of crossing are buried. Recommend performing maintenance of the crossing. (O.Yakimov - DWR UCIP)

View of levee crown at the crossing looking downstream

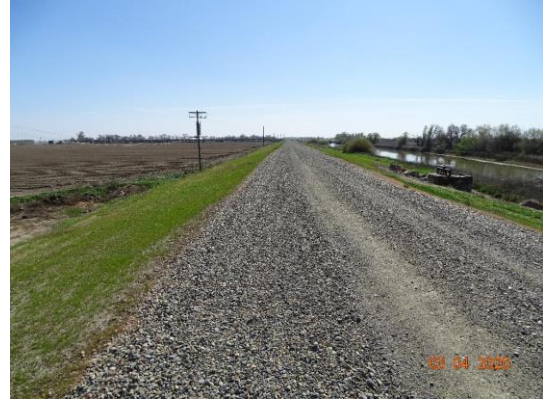
Photo 1 of 3 : UCIP_SP_2023_57194_83505.jpg

DS_ID:17152
FS_ID:57194
EP_NO: 9319
Repair Type: Non-Urgent
EVAL Issue: 4b, Safety Issue
Crossing Status: Found
UCIP Comments: 03/04/2020 Record updated from No Action Needed to Non-Urgent. Metal debris observed at LS levee toe considered trip and fall safety hazard. Need to have CVFPB review ABO and determine current owner. (O.Yakimov - DWR UCIP)05/02/2017 Crossing appears to be in good condition. (A.Freitag - DWR Sutter Yard)10/17/2016 Crossing appears to be in good condition. (A.Freitag - DWR Sutter Yard)05/31/2016 Crossing appears to be in good condition. (A.Freitag - DWR Sutter Yard)05/04/2015 Crossing appears in good condition. No noticeable issues. (A.Freitag - DWR Sutter Yard)06/17/2014 Same as last inspection. (A.Freitag - DWR Sutter Yard)12/16/2013 Same as last inspection. (A.Freitag - DWR Sutter Yard)07/16/2013 Same as last inspection. (A.Freitag - DWR Sutter Yard)
FIELD_STRUCT_DESC: 60-inch corrugated metal irrigation pipe through the levee, 22.7 feet below the crown. Slide gate in a 84-inch corrugated metal riser on the waterside (WS) slope. Three pumps over a sump, and distribution box on the landside (LS). Concrete headwall on the WS. (60-inch pipe [HLM 2.19] authorized under Automatic Board Order (ABO) issued as Permit No. 9319, 1974 - Frederick J. Strain; 60-inch pipe [HLM 2.19] was also authorized under Automatic Board Order (ABO) issued as Permit No. 8230, 1972 - Jack Baber. [Additional Reference(s): DWR Levee Log, 2005 (HLM 2.19). USACE Sacramento O&M Manual, Unit 132, October 1959, Revised 14 January 2019, (HLM 2.19), listed as 60-inch pipe. USACE As-Built Drawing No. 50-4-3081, Sheet 4 and 15, Station 1443+00, 4 April 1957].

View of levee crown at the crossing

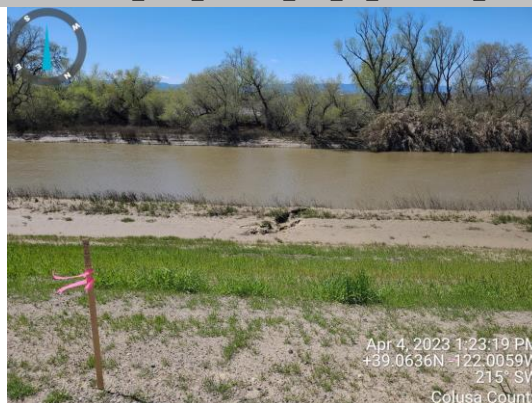
Photo 1 of 1 : SP_2023_MA0012_299_27_20230404_00066.jpg

LM Start	2.25	Rating **	M	Issue No.	27
LM End	2.25	Issue Type +	Ma	Location *	WS
Category	Earthen Levee			GPS Latitude/Longitude	
				Start	End
Item	Erosion / Bank Caving			39.063466°	39.063466°
				-122.005938°	-122.005938°
DWR ID	DWR_MA0012_01_s_2023_27				
Comment Code					
E2 : Schedule repair of erosion site prior to the next inspection.					
Inspector Comment					
Sink hole on waterside toe road.

View of sinkhole on the waterside toe road. Spring 2023.

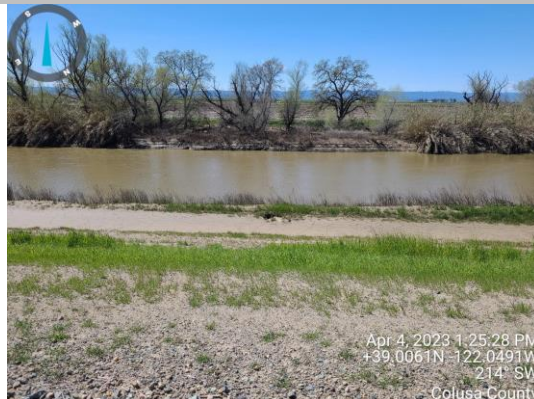
Photo 1 of 1 : SP_2023_MA0012_299_28_20230404_00067.jpg

LM Start	2.28	Rating **	M	Issue No.	28
LM End	2.28	Issue Type +	Ma	Location *	WS
Category	Earthen Levee			GPS Latitude/Longitude	
				Start	End
Item	Erosion / Bank Caving			39.063985°	39.063985°
				-122.006149°	-122.006149°
DWR ID	DWR_MA0012_01_s_2023_28				
Comment Code					
E2 : Schedule repair of erosion site prior to the next inspection.					
Inspector Comment					
Sinkhole on waterside toe road.

View of sinkhole on waterside toe road. Spring 2023.

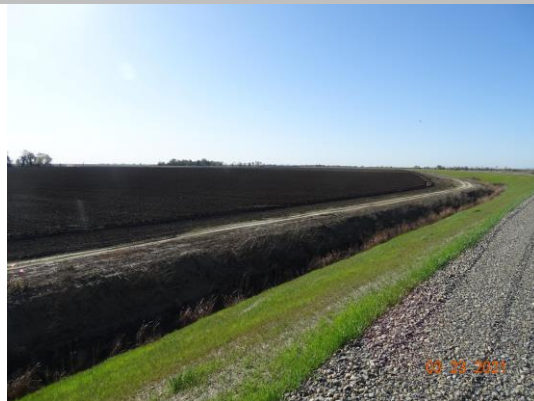
Photo 1 of 1 : SP_2023_MA0012_299_1_20230403_00001.jpg

View of irrigation ditch at the landside toe. Spring 2021.

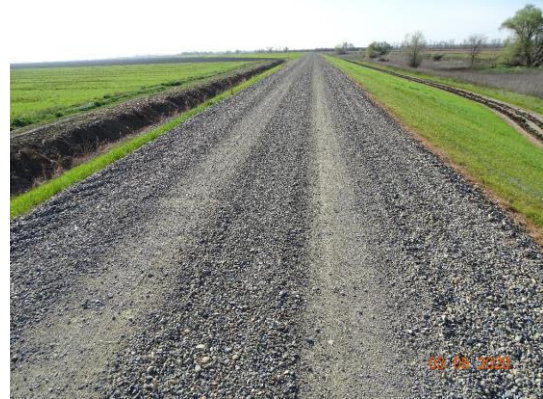
Photo 1 of 3 : UCIP_SP_2023_57195_83514.jpg

DS_ID:17153
FS_ID:57195
EP_NO: 9384
Repair Type: Non-Urgent
EVAL Issue: 11, Maintenance Compliance Issue
Crossing Status: Found
UCIP Comments: 03/05/2020 Record updated from No Action Needed to Non-Urgent. Sediment at LS headwall, vegetation at WS headwall need to be cleared. Need to have CVFPB review ABO and determine current owner. (O.Yakimov - DWR UCIP)05/02/2017 Crossing appears to be in good condition. (A.Freitag - DWR Sutter Yard)10/17/2016 Crossing appears to be in good condition. (A.Freitag - DWR Sutter Yard)05/31/2016 Crossing appears to be in good condition. (A.Freitag - DWR Sutter Yard)05/04/2015 Crossing appears in good condition. No noticeable issues. (A.Freitag - DWR Sutter Yard)06/17/2014 Same as last inspection. (A.Freitag - DWR Sutter Yard)12/16/2013 Same as last inspection. (A.Freitag - DWR Sutter Yard)07/16/2013 Same as last inspection. (A.Freitag - DWR Sutter Yard)
FIELD_STRUCT_DESC: 24-inch corrugated metal drainage pipe through the levee, 16 feet below the crown. Flap gate, concrete headwall, and grouted cobble spillway on the waterside (WS). Concrete headwall on the landside (LS). (24-inch pipe [HLM 3.22] authorized under Automatic Board Order (ABO) issued as Permit No. 9384, 1974 - William D. Struckmeyer; 24-inch pipe [HLM 3.22] was also authorized under Automatic Board Order (ABO) issued as Permit No. 8231, 1972 - Roy E. Kitts). [Additional Reference(s): DWR Levee Log, 2005 (HLM 3.22). USACE Sacramento O&M Manual, Unit 132, October 1959, Revised 14 January 2019, (HLM 3.22), listed as 24-inch pipe. USACE As-Built Drawing No. 50-4-3081, Sheet 5 and 15, Station 1495+75, 4 April 1957].

View of levee crown at the crossing

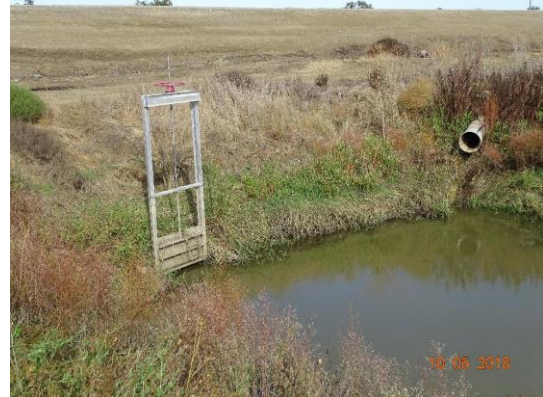
Photo 1 of 3 : UCIP_SP_2023_57196_78205.jpg

DS_ID:17154
FS_ID:57196
EP_NO: 9388
Repair Type: Urgent
EVAL Issue: 1, Pipe Integrity
Crossing Status: Found
UCIP Comments: 03/05/2020 Record remains Non-Urgent. New cover on CMP riser has been installed. Piping around slide gate at LS toe was modified, new 14-inch pipes installed. Unable to locate a permit for system modification. New steel walkway to slide gate on LS. Need to coordinate with LMA for find a permit authorizing modification. Need to have CVFPB review ABO and determine current owner. (O.Yakimov - DWR UCIP)
10/05/2018 Fall hazard: missing cover on CMP riser. Closure devices are present on both ends of crossing and seem to be in operable condition. Downgraded to non-urgent. Recommend owner add cover to CMP riser. (O.Yakimov - DWR UCIP)
05/02/2017 WS slide gate stem is still bent, wheel to operate gate is missing. Needs a cover made for the standpipe to prevent falls. (A.Freitag - DWR Sutter Yard)10/17/2016 Slide gate stem is still and the gate appears to be inoperable. (A.Freitag - DWR Sutter Yard)05/31/2016 Slide gate stem is still bent. WS flap gate is chained open. (A.Freitag - DWR Sutter Yard)

05/04/2015 Slide gate stem is still bent. Gate looks to be unable to close all the way. (A.Freitag - DWR Sutter Yard)06/17/2014 Same as last inspection. (A.Freitag - DWR Sutter Yard)12/16/2013 Slide gate stem is still bent. WS flapgate was closed. (A.Freitag - DWR Sutter Yard)
07/16/2013 Water flowing through pipe so screw gate definitely not closed. Was told NOV's have been sent for owner to replace stem. Flap gate gets closed for flood season. (A.Freitag - DWR Sutter Yard)
10/11/2012 Slide gate inoperable, but appears to be in closed position. Flap gate held in open position. Good candidate for video inspection when, if ever, dry. (W.Wylie - DWR UCIP)
FIELD_STRUCT_DESC: 48-inch corrugated metal drainage pipe through the levee, 28 feet below the crown. Slide gate in a 66-inch riser on the waterside (WS) slope. Concrete headwall on the WS. Grouted cobble spillway from drainage ditch to large canal on the landside (LS). (48-inch pipe [HLM 3.78] authorized under Automatic Board Order (ABO) issued as Permit No. 9388, 1974 - Pauline A. Wallace; 48-inch pipe [HLM 3.78] was also authorized under Automatic Board Order (ABO) issued as Permit No. 8231, 1972 - Roy E. Kitts). [Additional Reference(s): DWR Levee Log, 2005 (HLM 3.78). USACE Sacramento O&M Manual, Unit 132, October 1959, Revised 14 January 2019, (HLM 3.78), listed as 48-inch pipe. USACE As-Built Drawing No. 50-4-3081, Sheet 5 and 15, Station 1524+75, 4 April 1957].

Headwall with slide gate at LS toe.

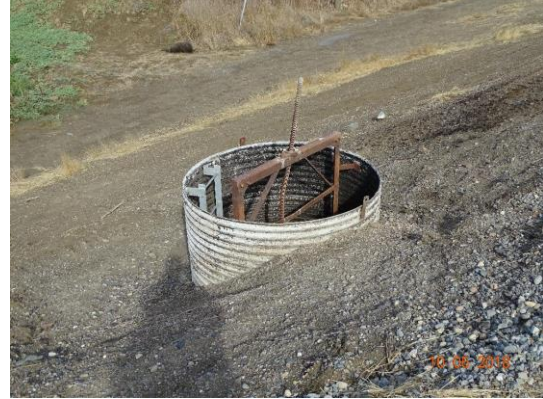
Photo 2 of 3 : UCIP_SP_2023_57196_78199.jpg

CMP riser with slide gate on WS shoulder.

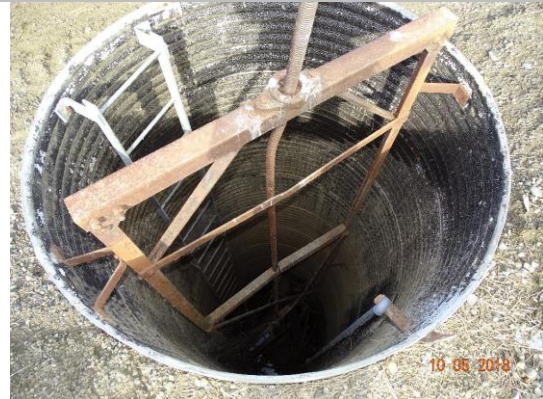
Photo 3 of 3 : UCIP_SP_2023_57196_78200.jpg

Inside view of CMP riser. Slide gate stem is bent.

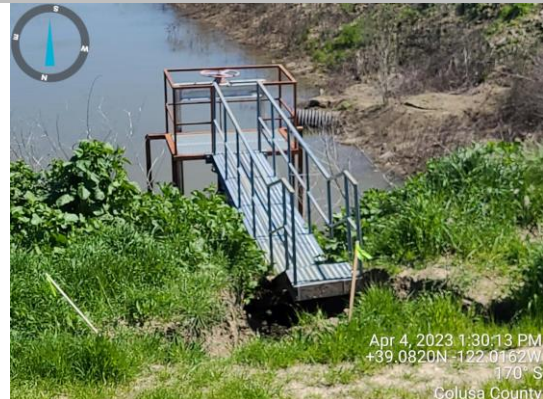
Photo 1 of 1 : SP_2023_MA0012_299_29_20230404_00068.jpg

LM Start	3.69	Rating **	M	Issue No.	29
LM End	3.69	Issue Type +	Ma	Location *	LS
Category	Earthen Levee			GPS Latitude/Longitude	
				Start	End
Item	Erosion / Bank Caving			39.081958°	39.081958°
				-122.016207°	-122.016207°
DWR ID	DWR_MA0012_01_s_2023_29				
Comment Code					
E2 : Schedule repair of erosion site prior to the next inspection.					
Inspector Comment					
Erosion around screw gate walkway.

View of erosion around walkway. Spring 2023.

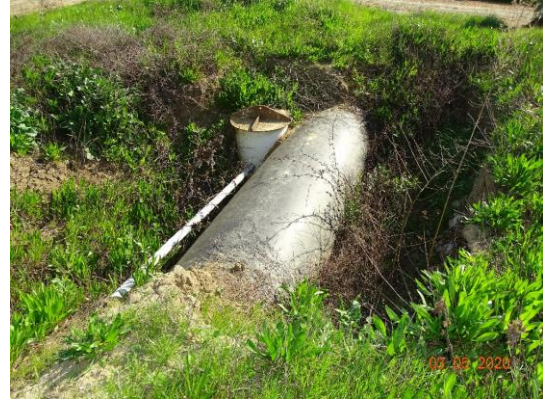
Photo 3 of 3 : UCIP_SP_2023_57197_83439.jpg

Unauthorized excavation on WS berm

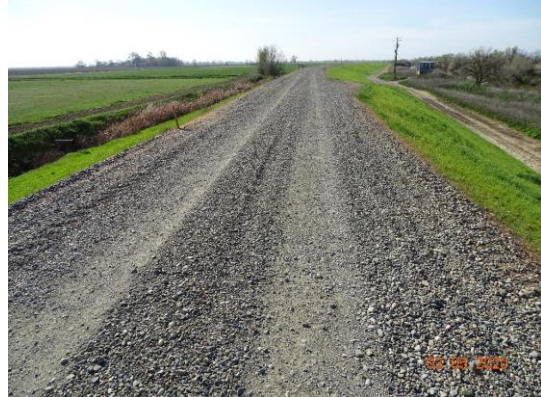
Photo 1 of 3 : UCIP_SP_2023_57229_83531.jpg

Comment Code						
Inspector Comment						
DS_ID:17168 FS_ID:57229 EP_NO: 9388 Repair Type: Non-Urgent EVAL Issue: Crossing Status: Found UCIP Comments: 03/05/2020 Record updated from No Action Needed to Non-Urgent. Need to have CVFPB review ABO and determine current owner. (O.Yakimov - DWR UCIP)05/02/2017 Crossing appears to be in good condition. (A.Freitag - DWR Sutter Yard) 10/17/2016 Crossing appears to be in good condition. (A.Freitag - DWR Sutter Yard)05/31/2016 Crossing appears to be in good condition. (A.Freitag - DWR Sutter Yard)05/04/2015 Crossing appears to be in good condition. No noticeable issues to report. (A.Freitag - DWR Sutter Yard)06/17/2014 Same as last inspection. (A.Freitag - DWR Sutter Yard)12/16/2013 Same as last inspection. (A.Freitag - DWR Sutter Yard)07/16/2013 Same as last inspection. (A.Freitag - DWR Sutter Yard) FIELD_STRUCT_DESC: 36-inch corrugated metal drainage pipe through the levee, 27.5 feet below the crown. Flap gate, concrete headwall, and grouted cobble spillway located on the waterside (WS). Concrete headwall located on the landside (LS). (24-inch pipe [HLM 4.25] authorized under Automatic Board Order (ABO) issued as Permit No. 9388, 1974 - Pauline A. Wallace; 24-inch pipe [HLM 4.25] was also authorized under Automatic Board Order (ABO) issued as Permit No. 8232, 1972 - Pauline Wallace Estates). [Additional Reference(s): DWR Levee Log, 2005 (HLM 4.25). USACE Sacramento O&M Manual, Unit 132, October 1959, Revised 14 January 2019, (HLM 4.25), listed as 36-inch pipe. USACE As-Built Drawing No. 50-4-3081, Sheet 6 and 16, Station 1548+95, 4 April 1957]. FS Date: 3/5/2020 7:28:00 AM

View of levee crown at the crossing looking downstream

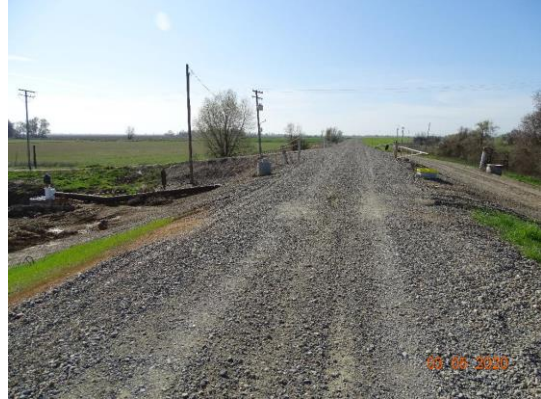
Photo 1 of 3 : UCIP_SP_2023_57199_83540.jpg

Comment Code					
Inspector Comment					
DS_ID:17156 FS_ID:57199 EP_NO: 9388 Repair Type: Non-Urgent EVAL Issue: 10, Unauthorized Modification or Non-Compliant Permit Crossing Status: Found UCIP Comments: 03/05/2020 Record updated from No Action Needed to Non-Urgent. Modifications to the system done: 24-inch steel pipe connected to a CMP pipe at LS toe, pump in irrigation canal on LS. Unable to find pump system in O&M drawings. Steel pipe is currently disconnected from the pump in irrigation canal. Unable to locate a permit authorizing modifications. Need to have CVFPB review ABO and determine current owner. Pipe outlet on WS not found due to dense vegetation. (O.Yakimov - DWR UCIP)05/02/2017 Crossing appears to be in good condition. (A.Freitag - DWR Sutter Yard)10/17/2016 Crossing appears to be in good condition. (A.Freitag - DWR Sutter Yard)05/31/2016 Crossing appears to be in good condition. (A.Freitag - DWR Sutter Yard)05/04/2015 Crossing appears to be in good condition. No noticeable issues to report. (A.Freitag - DWR Sutter Yard)06/17/2014 Same as last inspection. (A. Freitag - DWR Sutter Yard)12/16/2013 Same as last inspection. (A. Freitag - DWR Sutter Yard)07/16/2013 Same as last inspection. (A. Freitag - DWR Sutter Yard) FIELD_STRUCT_DESC: 24-inch corrugated metal drainage pipe through the levee, 9.2 feet below the crown. Slide gate in a 36-inch corrugated metal pipe (CMP) riser on the waterside (WS) slope. Pump on a 60-inch concrete standpipe at the landside (LS) toe. (24-inch pipe [HLM 4.32] authorized under Automatic Board Order (ABO) issued as Permit No. 9388, 1974 - Pauline A. Wallace). [Additional Reference(s): DWR Levee Log, 2005 (HLM 4.32). USACE Sacramento O&M Manual, Unit 132, October 1959, Revised 14 January 2019, (HLM 4.32), listed as 24-inch pipe. USACE As-Built Drawing No. 50-4-3081, Sheet 6 and 19, Station 1552+62, 4 April 1957]. FS Date: 3/5/2020 7:33:00 AM

View of levee crown at the crossing looking downstream

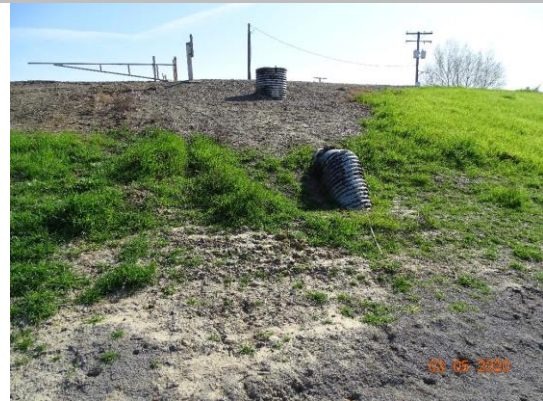
Photo 3 of 3 : UCIP_SP_2023_57199_83544.jpg

CMP pipe daylights on WS slope

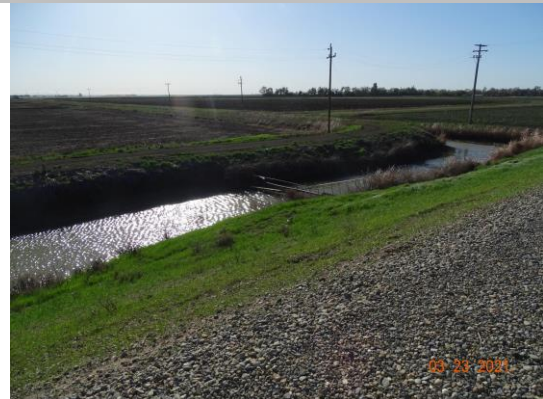
Photo 1 of 1 : SP_2023_MA0012_299_4_20230403_00002.jpg

View of ditch at the landside toe. Spring 2021.

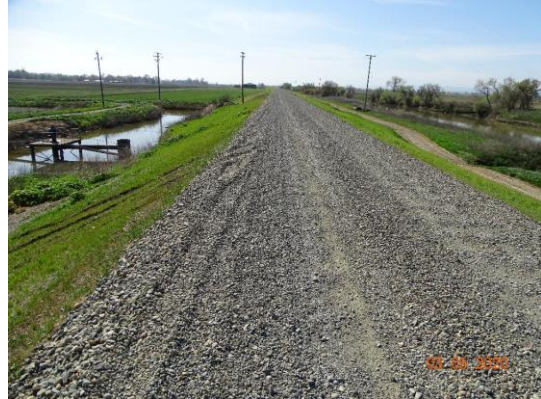
Photo 1 of 3 : UCIP_SP_2023_57231_83547.jpg

DS_ID:17158
FS_ID:57231
EP_NO: 9390
Repair Type: Non-Urgent
EVAL Issue: 10, Unauthorized Modification or Non-Compliant Permit
Crossing Status: Found
UCIP Comments: 03/05/2020 Record updated from No Action Needed to Non-Urgent. Pump in drainage ditch and standpipe are not designed per O&M As-Built drawing. Unable to locate a permit for modifications. Need to have CVFPB review ABO and determine current owner. (O.Yakimov - DWR UCIP)05/02/2017 Crossing appears to be in good condition. There is minor sediment build up in front of the WS flap gate. (A.Freitag - DWR Sutter Yard)10/17/2016 Crossing appears to be in good condition. (A.Freitag - DWR Sutter Yard)05/31/2016 Crossing appears to be in good condition. (A.Freitag - DWR Sutter Yard)05/04/2015 Crossing appears to be in good condition. No noticeable issues to report. (A.Freitag - DWR Sutter Yard)06/17/2014 Same as last inspection. (A.Freitag - DWR Sutter Yard)12/16/2013 Same as last inspection. (A.Freitag - DWR Sutter Yard)07/16/2013 New flapgate installed on WS pipe end. (A.Freitag - DWR Sutter Yard)10/11/2012 Flap gate broken on WS. Pipe shows significant rust at outlet. This is a good candidate for video inspection. (W.Wylie - DWR UCIP)

View of levee crown at the crossing looking downstream

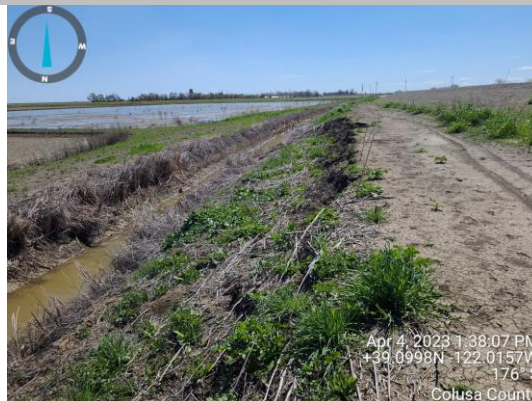
Photo 1 of 1 : SP_2023_MA0012_299_30_20230404_00069.jpg

View of sloughing on landside toe road. Spring 2023.

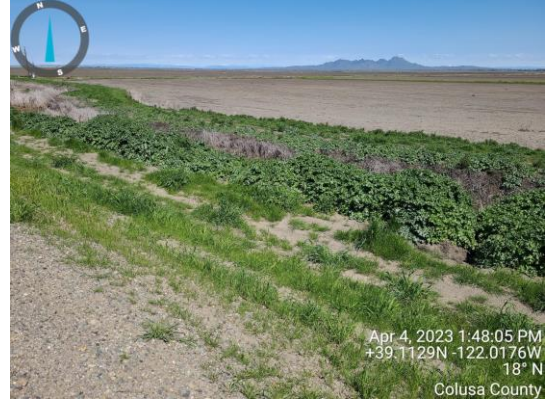
Photo 1 of 1 : SP_2023_MA0012_299_31_20230404_00070.jpg

View of sloughing on landside toe road. Spring 2023.

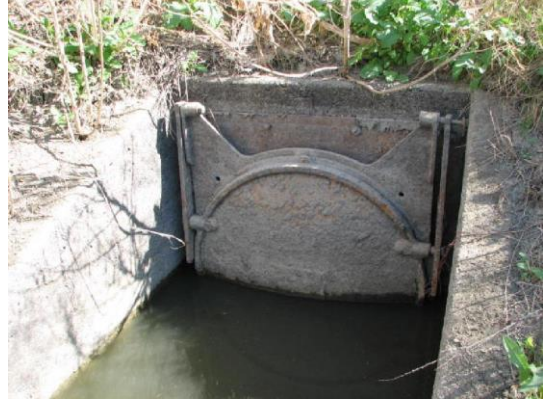
Photo 2 of 3 : UCIP_SP_2023_57234_69032.jpg

Flap gate in concrete U-shaped headwall at WS toe.

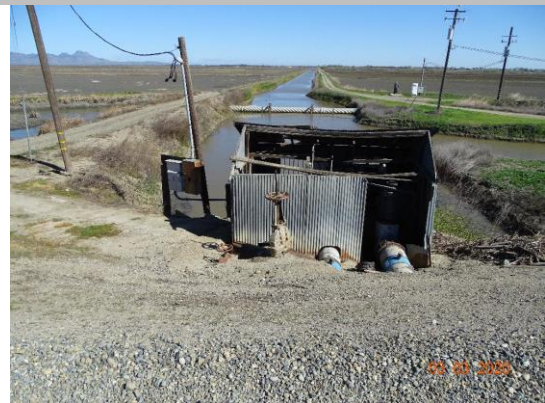
Photo 3 of 3 : UCIP_SP_2023_57238_83596.jpg

View of LS looking from levee crown. Pumphouse with 3 pumps at LS toe

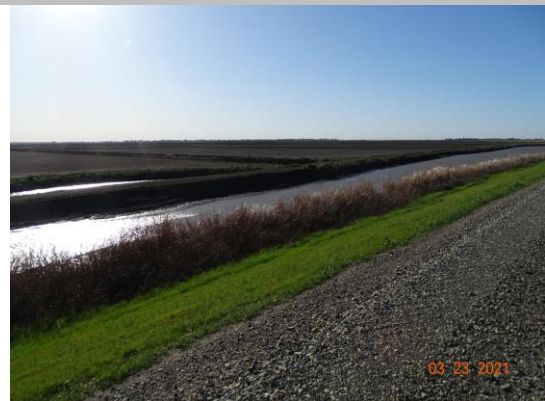
Photo 1 of 1 : SP_2023_MA0012_299_37_20230403_00005.jpg

View of the irrigation ditch at the landside toe. Spring 2021.

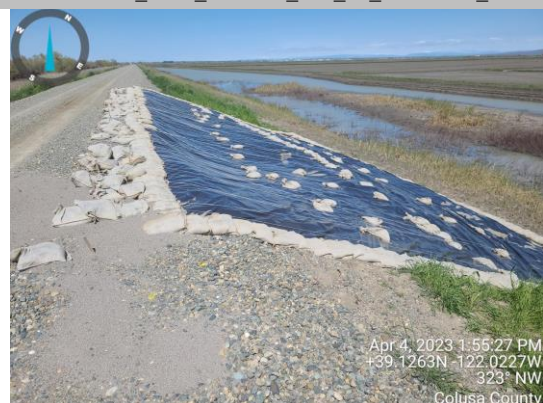
Photo 1 of 1 : SP_2023_MA0012_299_36_20230404_00071.jpg

View of sloughing and raincoat on landside slope. Spring 2023.

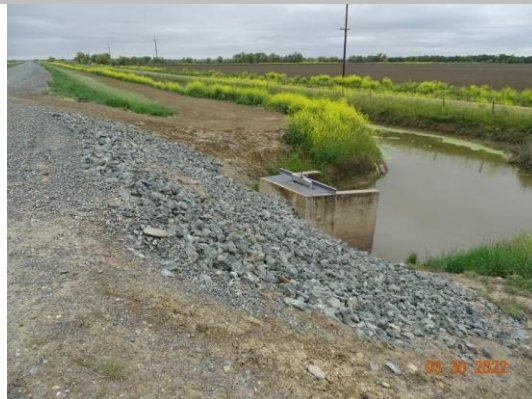
Photo 1 of 1 : SP_2023_MA0012_299_35_20230403_00004.jpg

View of repaired waterside slope. Spring 2022.

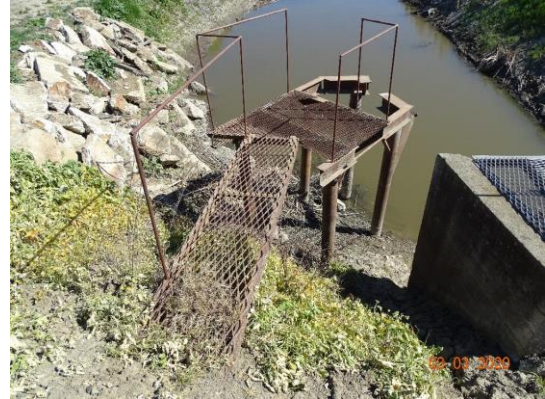
Photo 2 of 3 : UCIP_SP_2023_57243_83621.jpg

Steel walkway to former pumping platform in irrigation canal on LS

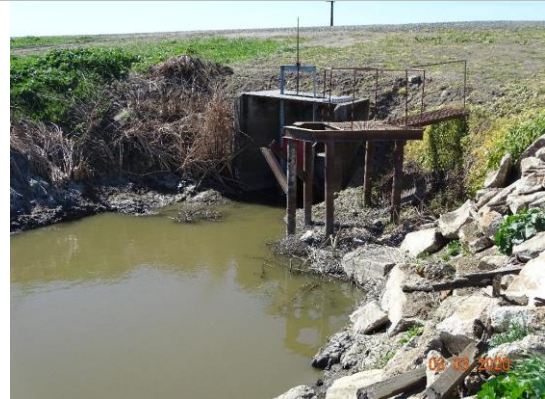
Photo 3 of 3 : UCIP_SP_2023_57243_83620.jpg

Abandoned pumping platform in irrigation canal on LS

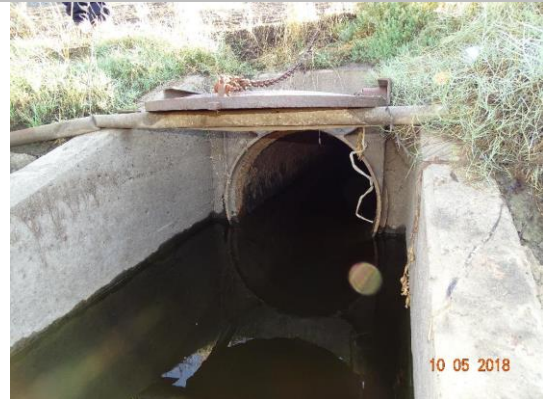
Photo 1 of 2 : UCIP_SP_2023_57219_78160.jpg

View of outfall structure on WS

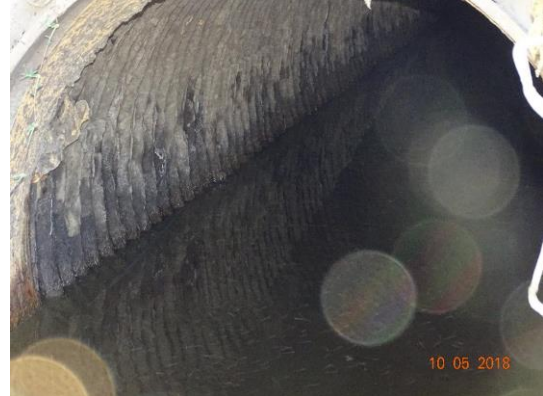
Photo 2 of 2 : UCIP_SP_2023_57219_78161.jpg

Pipe is corroded inside

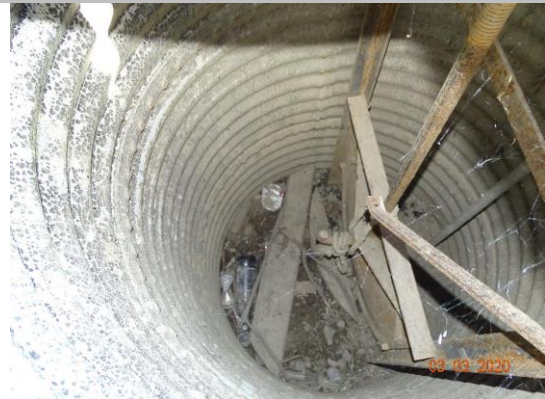
Photo 3 of 3 : UCIP_SP_2023_57245_83422.jpg

View inside of CMP riser on WS shoulder
