Flood Control Project Maintenance
Levee Inspections
LMA District Cover Sheet

Sutter Maintenance Yard Maintenance Area 0012

Waterway			Bank	Unit Miles
Unit No. 01 Colusa Drain			Left	11.06
	Spring (March - May)	Summer (June - August)	(September - November) Fall	Winter (December - February)
Unit Maintenance Rating (Fall Only)				
Date of Inspection	3/6/2024 - 3/6/2024			
DWR Inspector	Zach Jojola			
Accompanied By	Gregg Ahlers DWR

Levee Inspection Report By Mile - Spring 2024

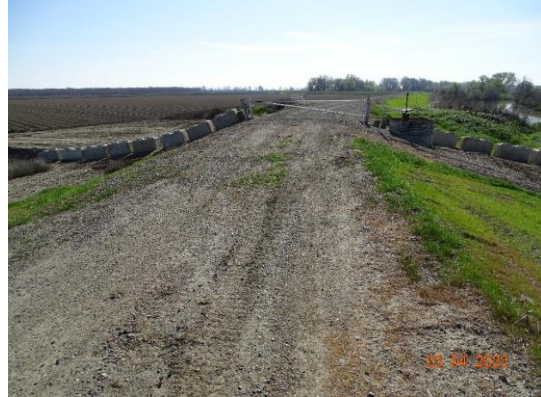
Photo 1 of 3 : UCIP_SP_2024_57220_83424.jpg

Comment Code						
Inspector Comment						
DS_ID:17155 FS_ID:57220 EP_NO: 9381 Repair Type: Non-Urgent EVAL Issue: 5, Pipe Damage Crossing Status: Found UCIP Comments: 03/04/2020 Record updated from No Action Needed to Non-Urgent. Need to have CVFPB review ABO and determine current owner. Recommend internal video inspection. (O.Yakimov - DWR UCIP) 05/02/2017 Crossing appears to be in good condition. (A.Freitag - DWR Sutter Yard) 10/17/2016 Crossing appears to be in good condition. Pipe material is CMP and the flow is from the LS to the WS. (A.Freitag - DWR Sutter Yard) 05/31/2016 Crossing appears to be in good condition. (A.Freitag - DWR Sutter Yard) 05/04/2015 Crossing in good condition. No issues. (A.Freitag - DWR Sutter Yard) 06/17/2014 Same as last inspection. (A.Freitag - DWR Sutter Yard) 07/16/2013 Same as last inspection. (A.Freitag - DWR Sutter Yard) 12/16/2013 Same as last inspection. (A.Freitag - DWR Sutter Yard) FIELD_STRUCT_DESC: 60-inch drainage pipe through the levee, 22.1 feet below the crown. Concrete headwalls located on both the WS and landside (LS) toes. Slide gate and flap gate in 84-inch pipe riser located on the waterside (WS) slope. (60-inch pipe [HLM 0.00] authorized under Automatic Board Order (ABO) issued as Permit No. 9381, 1974 - Tribble; 60-inch pipe [HLM 0.00] was also authorized under Automatic Board Order (ABO) issued as Permit No. 8225, 1972 - Harold Baldson). [Additional Reference(s): DWR Levee Log, 2005 (HLM 0.00). USACE Sacramento O&M Manual, Unit 132, October 1959, Revised 14 January 2019, (HLM 20.49 - RD 108), listed as 60-inch pipe. USACE As-Built Drawing No. 50-4-3081, Sheets 3 and 15, Station 1326+00, 4 April 1957]. FS Date: 3/4/2020 2:54:00 PM

View of levee crown at the crossing looking downstream

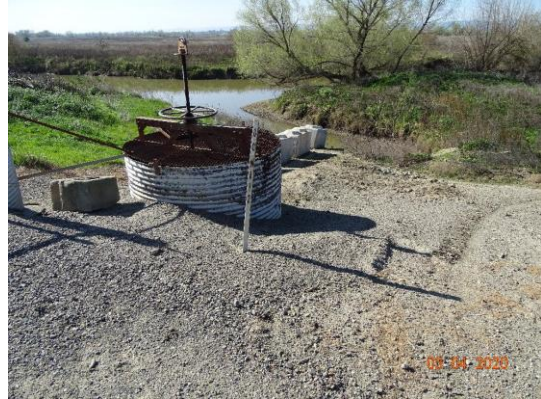
Photo 2 of 3 : UCIP_SP_2024_57220_83425.jpg

84-inch CMP riser with slide gate on WS shoulder

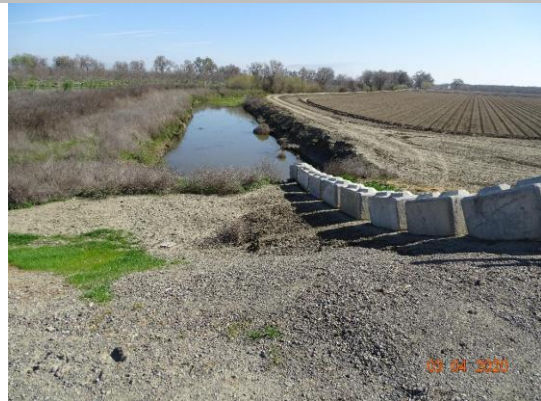
Photo 3 of 3 : UCIP_SP_2024_57220_83426.jpg

Drainage ditch on LS toe. Looking from levee crown

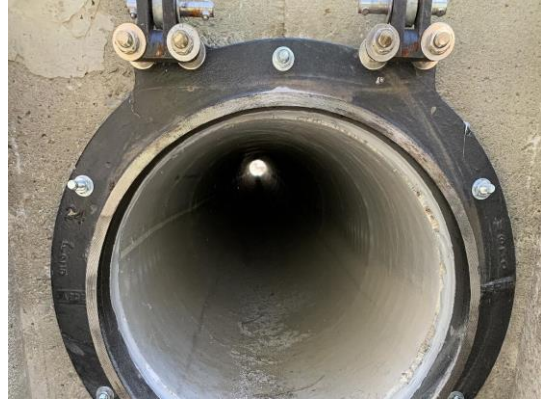
Photo 1 of 3 : UCIP_SP_2024_81149_103216.jpg

DS_ID:17146
FS_ID:81149
EP_NO: 9385
Repair Type: Non-Urgent
EVAL Issue:
Crossing Status: Found
UCIP Comments: 09/25/2023 DMP internal video inspection has found none or minor pipe defects. Recommend next video inspection in 5 years. (J. Taylor - DWR UCIP)08/04/2021 Record updated from Urgent to Non-Urgent. Flap gate was replaced, LMA provided updated photos. (O.Yakimov - DWR UCIP) 03/04/2020 Record updated from Non-Urgent to Urgent. Pipe has been CIPP-lined under the DWR DMP Phase 2 Project. Flap gate not closing properly posing flood risk to the landside during flood season. LMA needs to repair or replace flap gate. No permit has been identified authorizing pipe. Need to have CVFPB review ABO and determine current owner. (O.Yakimov - DWR UCIP)05/02/2017 WS is in good condition. LS inlet is more than 50% full of sediment. Pipe needs to be cleaned internally. (A.Freitag - DWR Sutter Yard)10/17/2016 Minor sediment blocking the WS flap gate from opening. LS inlet still mostly full of sediment. (A.Freitag - DWR Sutter Yard)09/29/2016 Crossing has been downgraded from Urgent to Non-Urgent WS flap gate is closed for flood season. Need to coordinate with owner to remove sediment blocking WS flap gate. (O.Magana - DWR UCIP)05/31/2016 WS flap gate is blocked from opening by sediment. LS inlet is over 50% full of sediment. (A.Freitag - DWR Sutter Yard)05/04/2015 WS flap gate is blocked by sediment and unable to open. LS inlet is about 50% plugged with soil. Needs to be cleaned. (A.Freitag - DWR Sutter Yard)06/17/2014 Same as last inspection. (A.Freitag - DWR Sutter Yard)12/16/2013 Sediment against flapgate has been cleared and it can now function properly. (A.Freitag - DWR Sutter Yard)07/16/2013 Sediment is built up against WS flapgate preventing it from opening. (A.Freitag - DWR Sutter Yard)10/11/2012 Pipe is partially filled with soil. (W.Wylie - DWR UCIP)

Water-Side: View inside of pipe with flap gate open

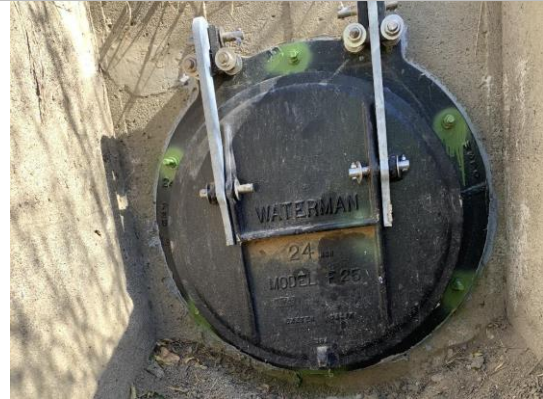
Photo 2 of 3 : UCIP_SP_2024_81149_103215.jpg

Water-Side: New flap gate installed

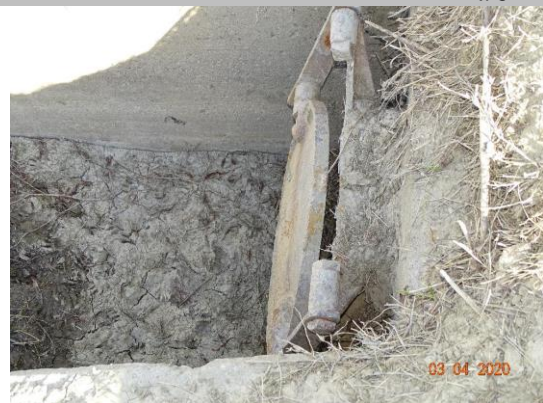
Photo 3 of 3 : UCIP_SP_2024_81149_83455.jpg

Flap gate should be closing properly

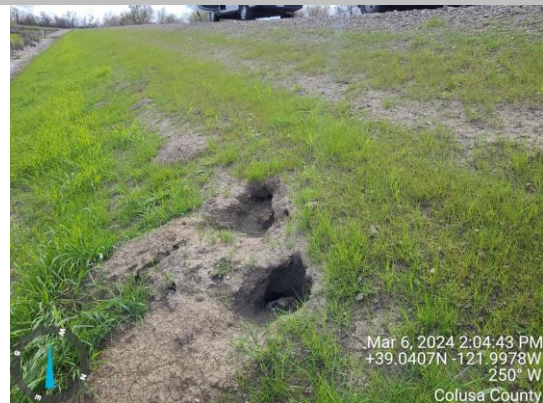
Photo 1 of 1 : SP_2024_MA0012_299_42_20240307_00079.jpg

LM Start	0.56	Rating **	U	Issue No.	42
LM End	0.56	Issue Type +	Ma	Location *	LS
Category	Earthen Levee			GPS Latitude/Longitude	
				Start	End
Item	Animal Control			39.040474°	39.040474°
				-121.997854°	-121.997854°
DWR ID	DWR_MA0012_01_s_2024_42				
Comment Code					
A3 : No rodents visible, but rodent burrows visible; need to backfill and compact or grout burrows.					
Inspector Comment					
There are rodent holes on the landside slope.

View of holes on the landside slope. Spring 2024.

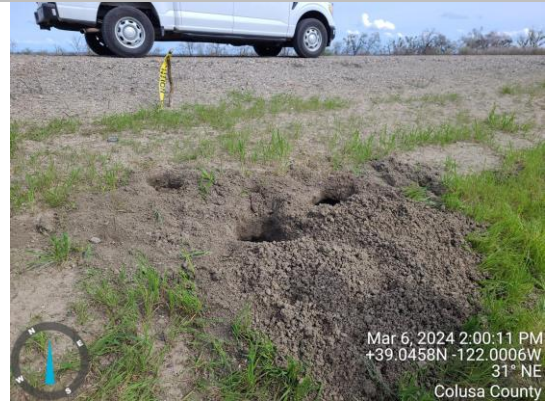
Photo 1 of 1 : SP_2024_MA0012_299_41_20240307_00078.jpg

View of fox den on the waterside slope. Spring 2024.

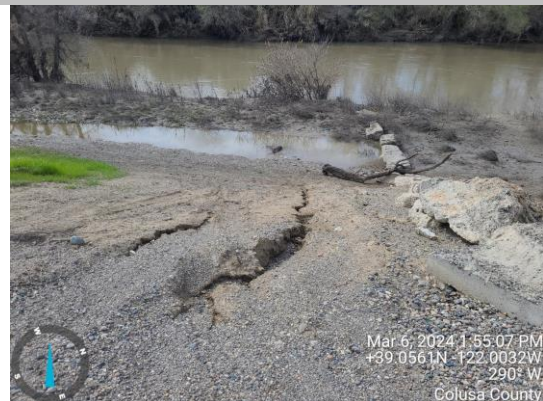
Photo 1 of 1 : SP_2024_MA0012_299_40_20240307_00077.jpg

LM Start	1.71	Rating **	M	Issue No.	40
LM End	1.71	Issue Type +	Ma	Location *	WS
Category	Earthen Levee			GPS Latitude/Longitude	
				Start	End
Item	Erosion / Rills			39.055979 °	39.055979 °
				-122.003264 °	-122.003264 °
DWR ID	DWR_MA0012_01_s_2024_40				
Comment Code					
E5 : Schedule repair of rills prior to the next inspection.					
Inspector Comment					
Rills are on the waterside slope.

View of rill on the waterside slope. Spring 2024.

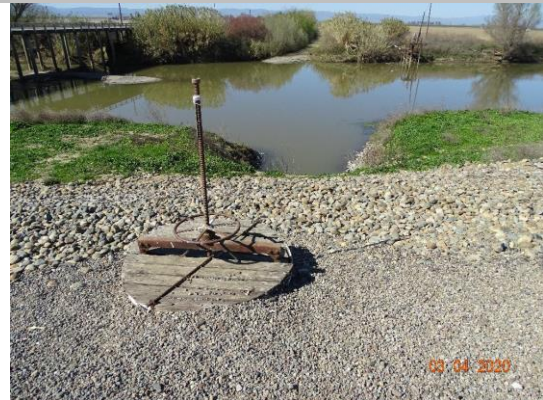
Photo 2 of 3 : UCIP_SP_2024_57227_83486.jpg

DS_ID:17150
FS_ID:57227
EP_NO: 9387
Repair Type: Urgent
EVAL Issue: 3a, Flood Risk
Crossing Status: Found
UCIP Comments: 03/04/2020 Record updated from No Action Needed to Urgent. Flap gate at WS levee toe not closing tightly leaving a gap for water to enter a part of crossing up to slide gate. Since slide gate on WS shoulder is in open position, this can pose flood risk to the landside during high water events. Recommend LMA to repair flap gate before next flood season. Pipe inlet near LS levee toe not found. Crossing appears abandoned. Concrete standpipe observed on landside 1,400 feet east of levee that seem to belong to the drainage system. Abandoned pump in irrigation/drainage canal 1,750 feet east of levee found. Recommend geophysical study to determine alignment of pipe through the levee. Need to have CVFPB review ABO and determine current owner. Need to contact owner to determine status of crossing. (O.Yakimov - DWR UCIP)05/02/2017 Crossing appears to be in good condition. (A.Freitag - DWR Sutter Yard)10/17/2016 Crossing appears to be in good condition. (A.Freitag - DWR Sutter Yard)05/31/2016 Crossing appears to be in good condition. Attached photo showing location of LS inlet. (A.Freitag - DWR Sutter Yard)05/04/2015 WS flapgate mostly underwater but could tell it was blocked open by something. LS inlet is located about 1/4 mile north along the side of the roadway. (A.Freitag - DWR Sutter Yard)06/17/2014 Same as last inspection. (A.Freitag - DWR Sutter Yard)12/16/2013 Pipe was flowing water and flap gate was being pushed open. Cannot verify if it will close all the way. (A.Freitag - DWR Sutter Yard)07/16/2013 Same as last inspection. Was told inlet is about 1/4 mile down road way next to house. Will try to get coordinates for inlet. (A.Freitag - DWR Sutter Yard)10/11/2012 No inlet could be located on LS. Flap gate partially blocked and will not close completely. (W.Wylie - DWR UCIP)

60-inch standpipe with slide gate on WS slope with outlet in background.

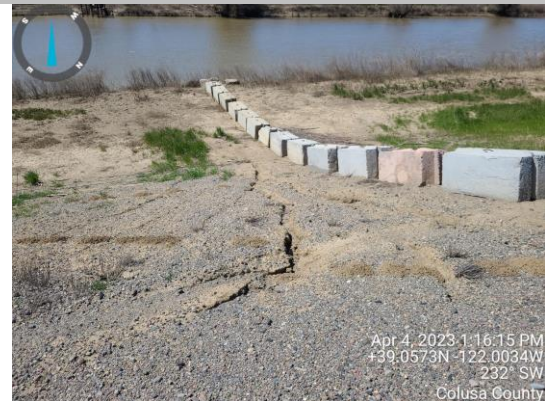
Photo 1 of 1 : SP_2024_MA0012_299_26_20240306_00003.jpg

LM Start	1.80	Rating **	M	Issue No.	26
LM End	1.81	Issue Type +	Ma	Location *	WS
Category	Earthen Levee			GPS Latitude/Longitude	
				Start	End
Item	Erosion / Rills			39.057257°	39.057431°
				-122.003428°	-122.003479°
DWR ID	DWR_MA0012_01_s_2023_26				
Comment Code					
E5 : Schedule repair of rills prior to the next inspection.					
Inspector Comment					
Rills are on the waterside slope.

View of rill on the waterside slope. Spring 2023.

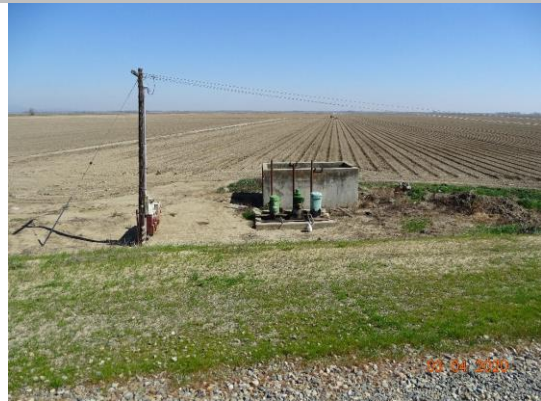
Photo 3 of 3 : UCIP_SP_2024_57194_83507.jpg

DS_ID:17152
FS_ID:57194
EP_NO: 9319
Repair Type: Non-Urgent
EVAL Issue: 4b, Safety Issue
Crossing Status: Found
UCIP Comments: 03/04/2020 Record updated from No Action Needed to Non-Urgent. Metal debris observed at LS levee toe considered trip and fall safety hazard. Need to have CVFPB review ABO and determine current owner. (O.Yakimov - DWR UCIP)05/02/2017 Crossing appears to be in good condition. (A.Freitag - DWR Sutter Yard)10/17/2016 Crossing appears to be in good condition. (A.Freitag - DWR Sutter Yard)05/31/2016 Crossing appears to be in good condition. (A.Freitag - DWR Sutter Yard)05/04/2015 Crossing appears in good condition. No noticeable issues. (A.Freitag - DWR Sutter Yard)06/17/2014 Same as last inspection. (A.Freitag - DWR Sutter Yard)12/16/2013 Same as last inspection. (A.Freitag - DWR Sutter Yard)07/16/2013 Same as last inspection. (A.Freitag - DWR Sutter Yard)
FIELD_STRUCT_DESC: 60-inch corrugated metal irrigation pipe through the levee, 22.7 feet below the crown. Slide gate in a 84-inch corrugated metal riser on the waterside (WS) slope. Three pumps over a sump, and distribution box on the landside (LS). Concrete headwall on the WS. (60-inch pipe [HLM 2.19] authorized under Automatic Board Order (ABO) issued as Permit No. 9319, 1974 - Frederick J. Strain; 60-inch pipe [HLM 2.19] was also authorized under Automatic Board Order (ABO) issued as Permit No. 8230, 1972 - Jack Baber. [Additional Reference(s): DWR Levee Log, 2005 (HLM 2.19). USACE Sacramento O&M Manual, Unit 132, October 1959, Revised 14 January 2019, (HLM 2.19), listed as 60-inch pipe. USACE As-Built Drawing No. 50-4-3081, Sheet 4 and 15, Station 1443+00, 4 April 1957].

3 pumps, concrete distributionbox, power pole with electrical panel on LS

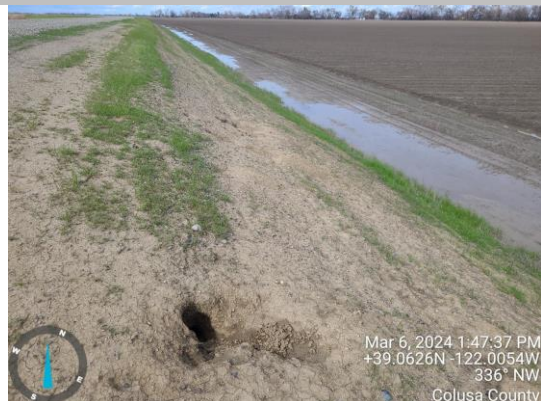
Photo 1 of 1 : SP_2024_MA0012_299_38_20240307_00076.jpg

View of rodent holes on the landside slope. Spring 2024.

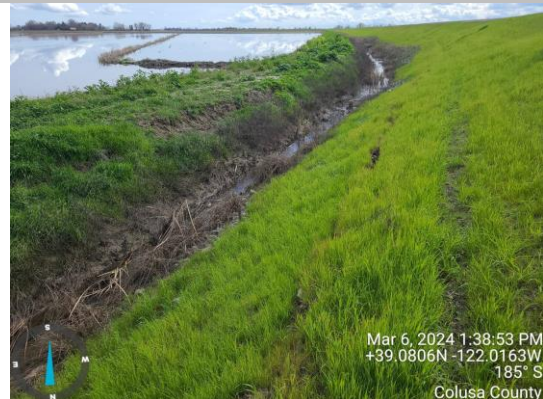
Photo 1 of 1 : SP_2024_MA0012_299_34_20240307_00075.jpg

LM Start	3.58	Rating **	M	Issue No.	34
LM End	3.61	Issue Type +	Ma	Location *	LS
Category	Earthen Levee			GPS Latitude/Longitude	
				Start	End
Item	Slope Stability			39.080371°	39.080712°
				-122.016476°	-122.016431°
DWR ID	DWR_MA0012_01_s_2024_34				
Comment Code					
S1 : Repair slope instability.					
Inspector Comment					
Approximately a 150' slough is located near the landside toe.

View of slip near the landside toe. Spring, 2024.

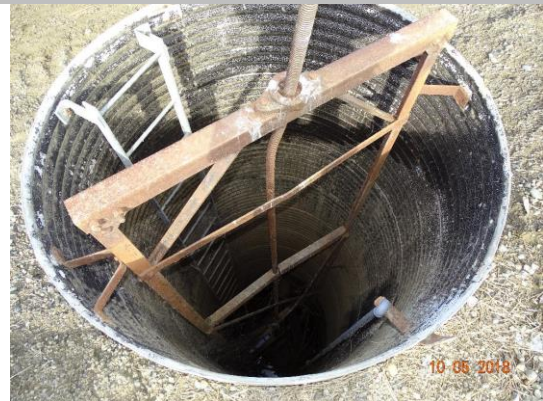
Photo 3 of 3 : UCIP_SP_2024_57196_78200.jpg

DS_ID:17154
FS_ID:57196
EP_NO: 9388
Repair Type: Urgent
EVAL Issue: 1, Pipe Integrity
Crossing Status: Found
UCIP Comments: 03/05/2020 Record remains Non-Urgent. New cover on CMP riser has been installed. Piping around slide gate at LS toe was modified, new 14-inch pipes installed. Unable to locate a permit for system modification. New steel walkway to slide gate on LS. Need to coordinate with LMA for find a permit authorizing modification. Need to have CVFPB review ABO and determine current owner. (O.Yakimov - DWR UCIP)
10/05/2018 Fall hazard: missing cover on CMP riser. Closure devices are present on both ends of crossing and seem to be in operable condition. Downgraded to non-urgent. Recommend owner add cover to CMP riser. (O.Yakimov - DWR UCIP)
05/02/2017 WS slide gate stem is still bent, wheel to operate gate is missing. Needs a cover made for the standpipe to prevent falls. (A.Freitag - DWR Sutter Yard)10/17/2016 Slide gate stem is still and the gate appears to be inoperable. (A.Freitag - DWR Sutter Yard)05/31/2016 Slide gate stem is still bent. WS flap gate is chained open. (A.Freitag - DWR Sutter Yard)

05/04/2015 Slide gate stem is still bent. Gate looks to be unable to close all the way. (A.Freitag - DWR Sutter Yard)06/17/2014 Same as last inspection. (A.Freitag - DWR Sutter Yard)12/16/2013 Slide gate stem is still bent. WS flapgate was closed. (A.Freitag - DWR Sutter Yard)
07/16/2013 Water flowing through pipe so screw gate definitely not closed. Was told NOV's have been sent for owner to replace stem. Flap gate gets closed for flood season. (A.Freitag - DWR Sutter Yard)
10/11/2012 Slide gate inoperable, but appears to be in closed position. Flap gate held in open position. Good candidate for video inspection when, if ever, dry. (W.Wylie - DWR UCIP)
FIELD_STRUCT_DESC: 48-inch corrugated metal drainage pipe through the levee, 28 feet below the crown. Slide gate in a 66-inch riser on the waterside (WS) slope. Concrete headwall on the WS. Grouted cobble spillway from drainage ditch to large canal on the landside (LS). (48-inch pipe [HLM 3.78] authorized under Automatic Board Order (ABO) issued as Permit No. 9388, 1974 - Pauline A. Wallace; 48-inch pipe [HLM 3.78] was also authorized under Automatic Board Order (ABO) issued as Permit No. 8231, 1972 - Roy E. Kitts). [Additional Reference(s): DWR Levee Log, 2005 (HLM 3.78). USACE Sacramento O&M Manual, Unit 132, October 1959, Revised 14 January 2019, (HLM 3.78), listed as 48-inch pipe. USACE As-Built Drawing No. 50-4-3081, Sheet 5 and 15, Station 1524+75, 4 April 1957].

Inside view of CMP riser. Slide gate stem is bent.

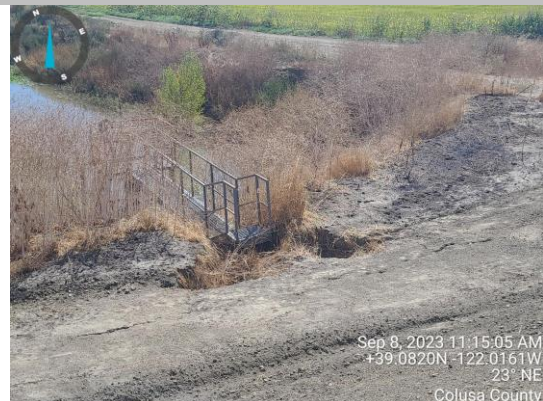
Photo 1 of 1 : SP_2024_MA0012_299_29_20240306_00004.jpg

LM Start	3.69	Rating **	M	Issue No.	29
LM End	3.69	Issue Type +	Ma	Location *	LS
Category	Earthen Levee			GPS Latitude/Longitude	
				Start	End
Item	Erosion / Bank Caving			39.081958°	39.081958°
				-122.016207°	-122.016207°
DWR ID	DWR_MA0012_01_s_2023_29				
Comment Code					
E2 : Schedule repair of erosion site prior to the next inspection.					
Inspector Comment					
There is erosion around the screw gate walkway.

View of erosion around walkway. Fall 2023.

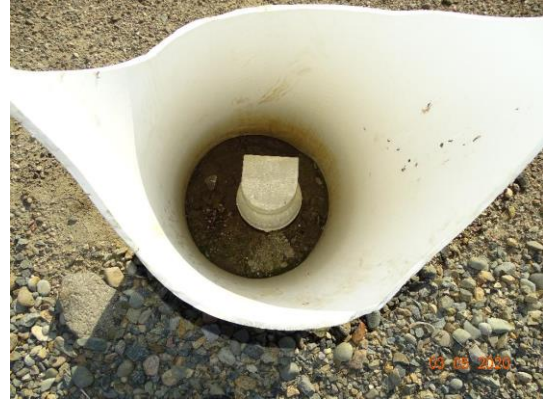
Photo 1 of 3 : UCIP_SP_2024_57197_83435.jpg

Comment Code					
Inspector Comment					
DS_ID:17186 FS_ID:57197 EP_NO: 16874 Repair Type: Urgent EVAL Issue: 2a, Levee Integrity Crossing Status: Found UCIP Comments: 03/05/2020 Record updated from No Action Needed to Urgent. Pipe exposed due to unauthorized excavation on WS berm 25 feet from WS toe. Excavation measures 12' x 15' x 4.5' deep. Broken PVC riser on LS shoulder and leaking siphon breaker inside of PVC riser. (O.Yakimov - DWR UCIP) 05/02/2017 Crossing appears to be in good condition. (A. Freitag - DWR Sutter Yard)10/17/2016 Crossing appears to be in good condition. (A.Freitag - DWR Sutter Yard)05/31/2016 Crossing appears to be in good condition. (A.Freitag - DWR Sutter Yard)05/04/2015 Corssing appears to be in good condition. No noticeable issues to report. (A.Freitag - DWR Sutter Yard)06/17/2014 Same as last inspection. (A.Freitag - DWR Sutter Yard)12/16/2013 Same as last inspection. (A.Freitag - DWR Sutter Yard)07/16/2013 Same as last inspection. (A.Freitag - DWR Sutter Yard) FIELD_STRUCT_DESC: 36-inch asphalt coated steel irrigation pipe through the levee, 2.0 feet below the crown. Pump facility located on the waterside (WS). Siphon breaker in an 18-inch polyvinyl chloride (PVC) riser located on the landside (LS) shoulder. 40-foot tall, 8-foot by 8-foot concrete tower, 50 feet from the LS toe. (36-inch pipeline authorized under Permit No. 16874, 1998 - Wallace Brothers). FS Date: 3/5/2020 11:42:00 AM

Broken PVC riser and leaking siphon breaker

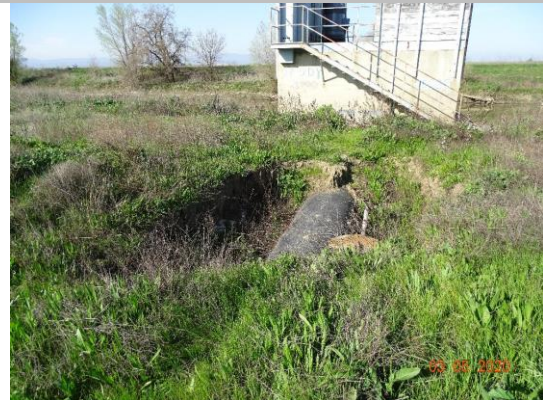
Photo 2 of 3 : UCIP_SP_2024_57197_83438.jpg

Pumping station in riverbank. Unauthorized excavation on WS berm

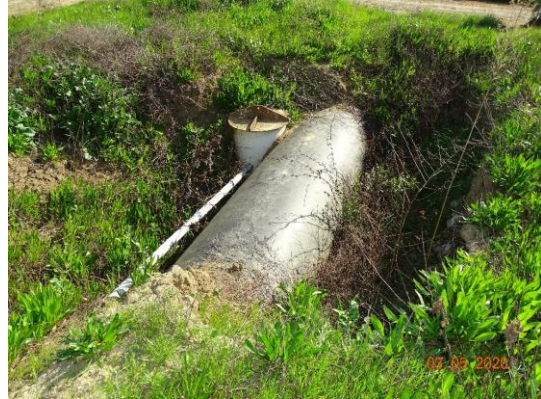
Photo 3 of 3 : UCIP_SP_2024_57197_83439.jpg

Unauthorized excavation on WS berm

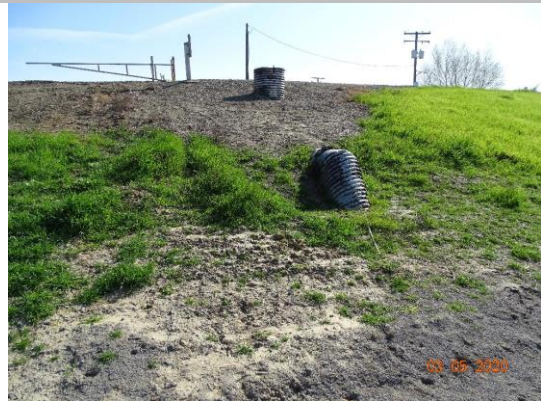
Photo 3 of 3 : UCIP_SP_2024_57199_83544.jpg

CMP pipe daylights on WS slope

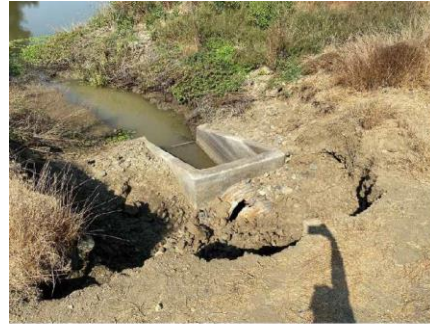
Photo 1 of 3 : UCIP_SP_2024_81287_117160.jpg

Water-Side: Damaged pipe and erosion around headwall. Photo courtesy by CVFPB

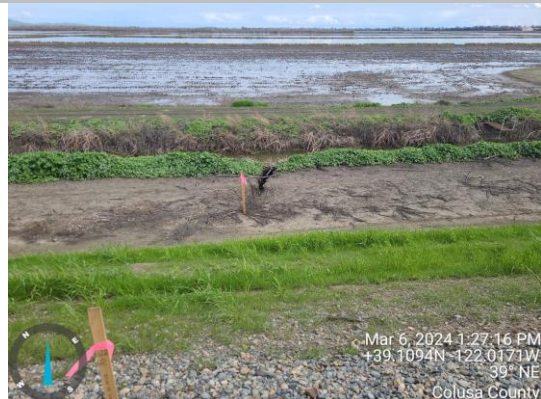
Photo 1 of 1 : SP_2024_MA0012_299_31_20240307_00074.jpg

View of erosion on the landside toe road. Spring 2024.

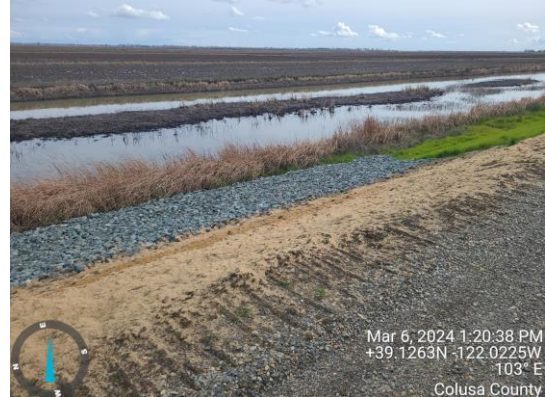
Photo 1 of 1 : SP_2024_MA0012_299_36_20240307_00073.jpg

View of temporary repair on the landside slope. Spring 2024.

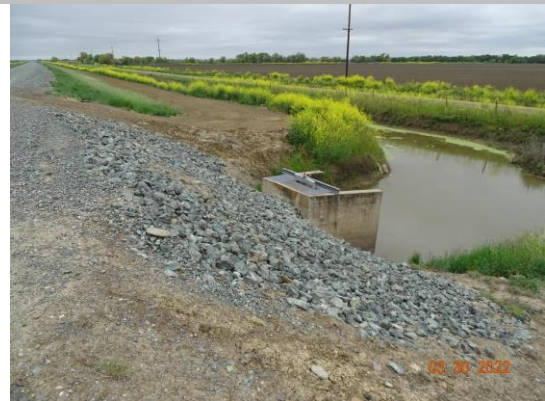
Photo 1 of 1 : SP_2024_MA0012_299_35_20240306_00007.jpg

View of repaired waterside slope. Spring 2022.

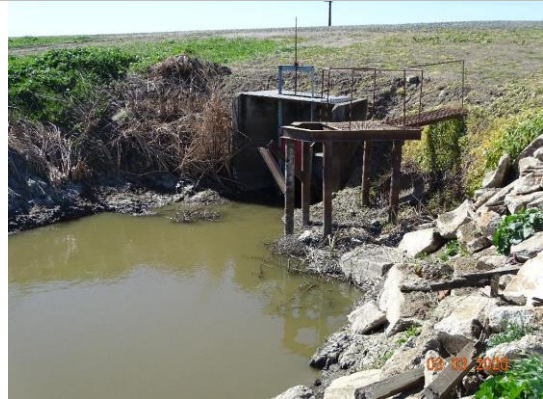
Photo 3 of 3 : UCIP_SP_2024_57243_83620.jpg

Abandoned pumping platform in irrigation canal on LS

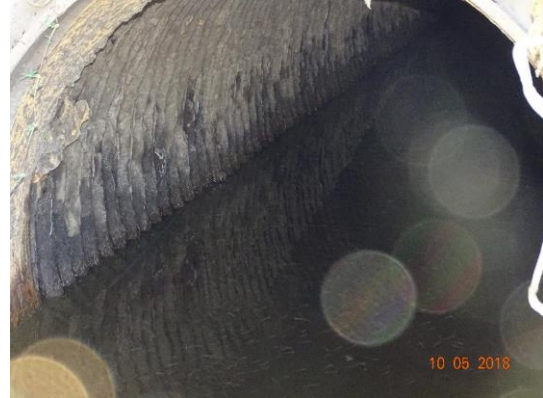
Photo 2 of 2 : UCIP_SP_2024_57219_78161.jpg

Pipe is corroded inside
