**Flood Control Project Maintenance
Levee Inspections**

Maintenance Issue Types Only, Levee Inspection Report By Mile - Fall 2014

Sutter Maintenance Yard Maintenance Area 0012

Waterway	Bank	Unit Miles	Inspection Start/End	Inspector
Unit No. 01 Colusa Drain	Left	11.06	10/22/2014 10/22/2014	Bob Duffey

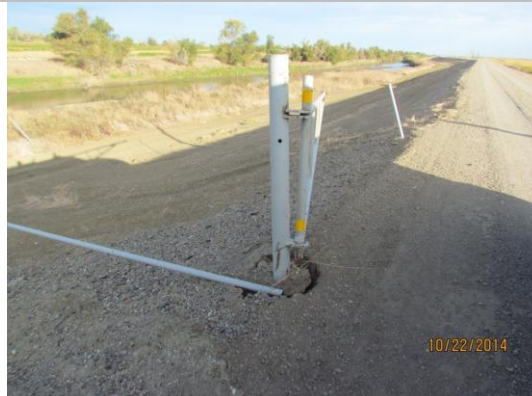
Photo 1 of 1 : FA_2014_MA0012_299_22_20141118_00009.jpg

LM Start	4.83	Rating **	M	Issue No.	22
LM End	4.83	Issue Type +	Ma	Location *	WS
Category	Earthen Levee			GPS Latitude/Longitude	
				Start	End
Item	Repair Gates			39.096777 °	39.096777 °
				-122.015548 °	-122.015548 °
DWR ID	DWR_MA0012_01_f_2014_22				
Action/Comments

View of the gate that needs to be repaired.

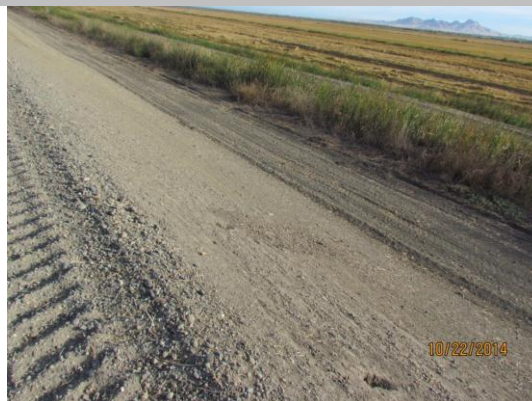
Photo 1 of 1 : FA_2014_MA0012_299_206_20141118_00011.jpg

View of the rodent holes on the landside slope.

LM Start	5.30	Rating **	A/W	Issue No.	206
LM End	5.30	Issue Type +	Ma	Location *	LS
Category	Earthen Levee			GPS Latitude/Longitude	
				Start	End
Item	Animal Control			39.103490 °	39.103490 °
				-122.016340 °	-122.016340 °
DWR ID	DWR_MA0012_01_s_2012_206				
Action/Comments					
Exterminate rodents and backfill and compact or grout burrows.

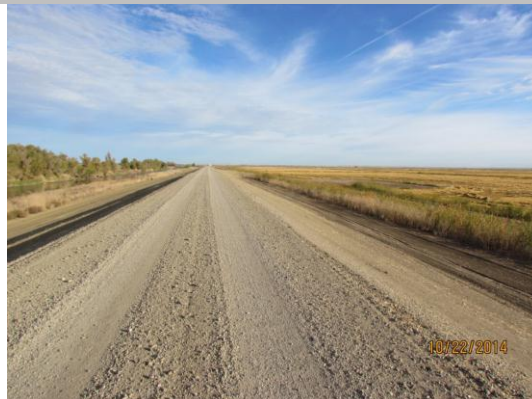
Photo 1 of 1 : FA_2014_MA0012_299_23_20141118_00010.jpg

View of controlled vegetation on both slopes.

LM Start	5.61	Rating **	A	Issue No.	23
LM End	5.61	Issue Type +	Ma	Location *	LS
Category	Earthen Levee			GPS Latitude/Longitude	
				Start	End
Item	Vegetation			39.107792 °	39.107792 °
				-122.016968 °	-122.016968 °
DWR ID	DWR_MA0012_01_f_2014_23				
Action/Comments					
Control annual grass and weeds on the levee slopes and easements.

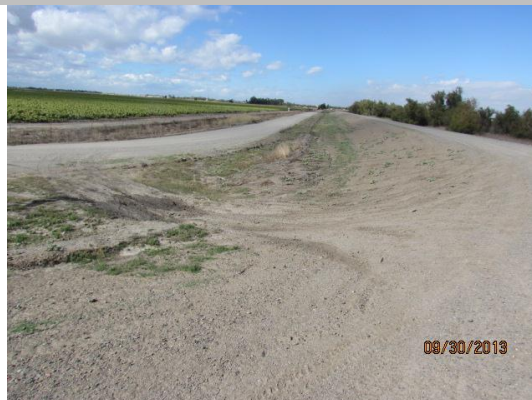
Photo 1 of 1 : FA_2014_MA0012_299_11_20141013_00001.jpg

View of the slope vehicle erosion.

LM Start	10.72	Rating **	M	Issue No.	11
LM End	10.72	Issue Type +	Ma	Location *	LS
Category	Earthen Levee			GPS Latitude/Longitude	
				Start	End
Item	Slope Stability			39.173971 °	39.173971 °
				-122.014362 °	-122.014362 °
DWR ID	DWR_MA0012_01_f_2013_11				
Action/Comments					
Repair the levee slope damaged by vehicle traffic and prevent access where possible.
