**Flood Control Project Maintenance
Levee Inspections**

Maintenance Issue Types Only, Levee Inspection Report By Mile - Fall 2015

Sutter Maintenance Yard Maintenance Area 0012

Waterway	Bank	Unit Miles	Inspection Start/End	Inspector
Unit No. 01 Colusa Drain	Left	11.06	09/15/2015 09/15/2015	Bob Duffey

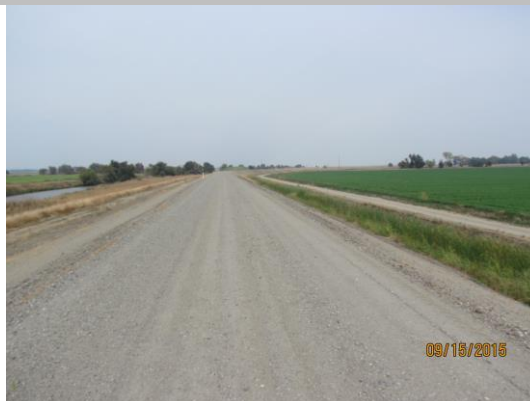
Photo 1 of 1 : FA_2015_MA0012_299_25_20151013_00006.jpg

LM Start	3.43	Rating **	A	Issue No.	25
LM End	3.43	Issue Type +	Ma	Location *	LS
Category	Earthen Levee			GPS Latitude/Longitude	
				Start	End
Item	Vegetation			39.078165 °	39.078165 °
				-122.016040 °	-122.016040 °
DWR ID	DWR_MA0012_01_f _ 2015_25				
Action/Comments					
Control annual grass and weeds on the levee slopes and easements. Inspector Comments: Sutter Yard burned and dragged both slopes.

View of the levee with no vegetation on both slopes.
