**Flood Control Project Maintenance
Levee Inspections**

Maintenance Issue Types Only, Levee Inspection Report By Mile - Fall 2016

Sutter Maintenance Yard Maintenance Area 0012

Waterway	Bank	Unit Miles	Inspection Start/End	Inspector
Unit No. 01 Colusa Drain	Left	11.06	10/27/2016 10/27/2016	Tariq Chechi

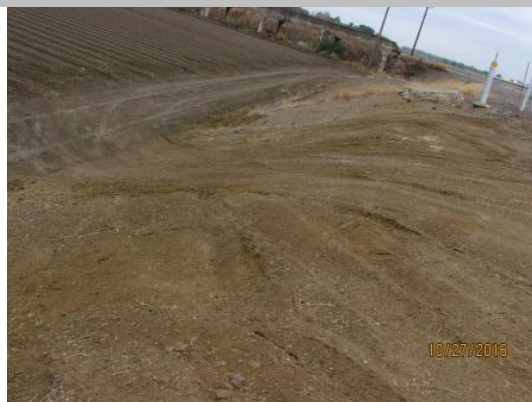
Photo 1 of 1 : FA_2016_MA0012_299_35_20161107_00041.jpg

LM Start	1.81	Rating **	M	Issue No.	35
LM End	1.81	Issue Type +	Ma	Location *	LS
Category	Earthen Levee			GPS Latitude/Longitude	
				Start	End
Item	Slope Stability			39.057393 °	39.057393 °
				-122.003452 °	-122.003452 °
DWR ID	DWR_MA0012_01_f_2016_35				
Comment Code					
S3 : Repair the levee slope damaged by vehicle traffic and prevent access where possible.					
Inspector Comment

View of the slope instability caused by vehicles along the landside slope.

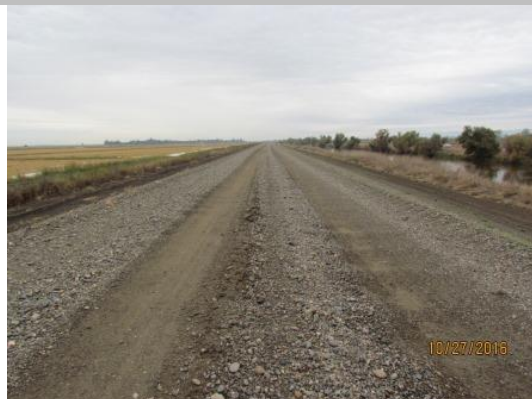
Photo 1 of 1 : FA_2016_MA0012_299_33_20161107_00045.jpg

LM Start	5.16	Rating **	M	Issue No.	33
LM End	5.81	Issue Type +	Ma	Location *	CR
Category	Earthen Levee			GPS Latitude/Longitude	
				Start	End
Item	Crown Surface / Depressions / Rutting			39.103082 °	39.112440 °
				-122.016377 °	-122.017598 °
DWR ID	DWR_MA0012_01_f_2016_33				
Comment Code					
C3 : Add appropriate gravel or road base. Grade and compact.					
Inspector Comment

View of minor ruts on the levee crown

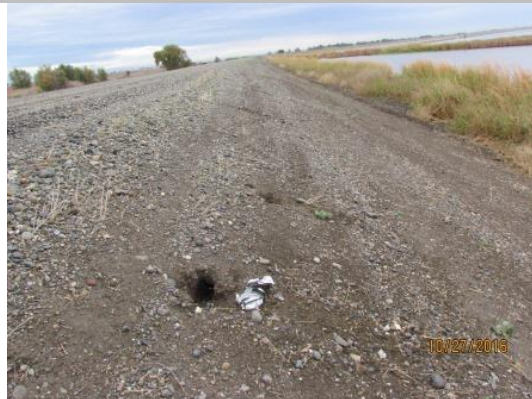
Photo 1 of 1 : FA_2016_MA0012_299_32_20161107_00047.jpg

LM Start	6.05	Rating **	M	Issue No.	32
LM End	6.05	Issue Type +	Ma	Location *	LS
Category	Earthen Levee			GPS Latitude/Longitude	
				Start	End
Item	Animal Control			39.115903 °	39.115903 °
				-122.018190 °	-122.018190 °
DWR ID	DWR_MA0012_01_f_2016_32				
Comment Code					
A3 : No rodents visible, but rodent burrows visible; need to backfill and compact or grout burrows.					
Inspector Comment

View of the rodent holes along the landside slope.

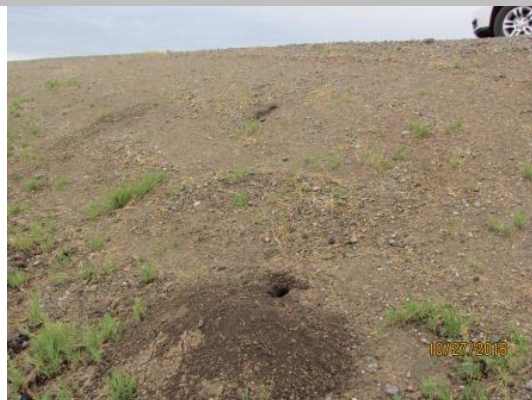
Photo 1 of 1 : FA_2016_MA0012_299_24_20161107_00048.jpg

LM Start	10.45	Rating **	M	Issue No.	24
LM End	10.45	Issue Type +	Ma	Location *	LS
Category	Earthen Levee			GPS Latitude/Longitude	
				Start	End
Item	Animal Control			39.173798 °	39.173798 °
				-122.015097 °	-122.015097 °
DWR ID	DWR_MA0012_01_f_2016_24				
Comment Code					
A3 : No rodents visible, but rodent burrows visible; need to backfill and compact or grout burrows.					
Inspector Comment

View of the rodent holes along the landside slope.

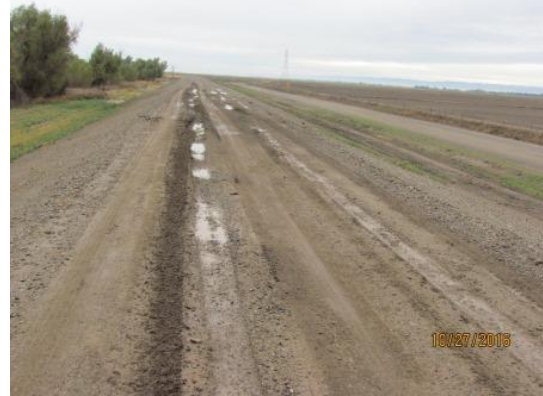
Photo 1 of 1 : FA_2016_MA0012_299_23_20161107_00050.jpg

LM Start	10.69	Rating **	U	Issue No.	23
LM End	10.73	Issue Type +	Ma	Location *	CR
Category	Earthen Levee			GPS Latitude/Longitude	
				Start	End
Item	Crown Surface / Depressions / Rutting			39.176778 °	39.177313 °
				-122.014340 °	-122.014380 °
DWR ID	DWR_MA0012_01_s_2016_23				
Comment Code					
C2 : Repair depressions or ruts in the crown or slope.					
Inspector Comment					
Ruts are 6" deep at places.

View of the ruts on the levee crown.
