**Flood Control Project Maintenance
Levee Inspections**

Maintenance Issue Types Only, Levee Inspection Report By Mile - Fall 2017

Sutter Maintenance Yard Maintenance Area 0012

Waterway	Bank	Unit Miles	Inspection Start/End	Inspector
Unit No. 01 Colusa Drain	Left	11.06	09/13/2017 09/13/2017	Bob Duffey

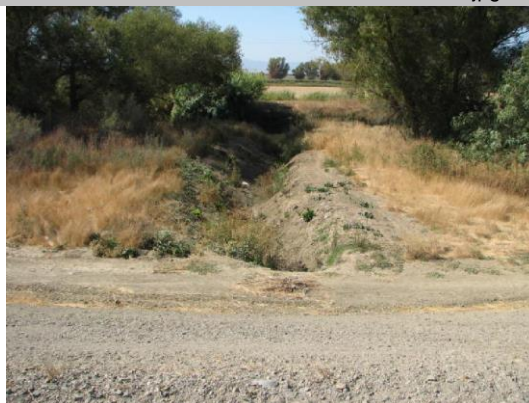
Photo 2 of 3 : UCIP_FA_2017_51779_68972.jpg

FS_ID:51779
DS_ID:17146
EP_NO: 9382
Repair Type: Non-Urgent
Crossing Status: Found
UCIP Comments: 5/2/2017 WS is in good condition. LS inlet is more than 50% full of sediment. Pipe needs to be cleaned internally. (DWR Sutter Yard- AFreitag)10/17/2016 Minor sediment blocking the WS flap gate from opening. LS inlet still mostly full of sediment.(DWR Sutter Yard- AFreitag)9/29/2016 Crossing has been downgraded from Urgent to Non-Urgent WS flap gate is closed for flood season. Need to coordinate with owner to remove sediment blocking WS flap gate. (DWR UCIP - omagana)5/31/2016 WS flap gate is blocked from opening by sediment. LS inlet is over 50% full of sediment. (DWR Sutter Yard - afreitag)5/4/2015 WS flap gate is blocked by sediment and unable to open. LS inlet is about 50% plugged with soil. Needs to be cleaned. (DWR Sutter Yard - afreitag)6/17/2014 Same as last inspection. (DWR Sutter Yard - afreitag)12/16/2013 Sediment against flapgate has been cleared and it can now function properly. (DWR Sutter Yard - afreitag)7/16/2013 Sediment is built up against WS flapgate preventing it from opening. (DWR Sutter Yard - afreitag)10/11/2012 Pipe is partially filled with soil. (DWR UCIP - wwylie)

Outlet at WS toe.

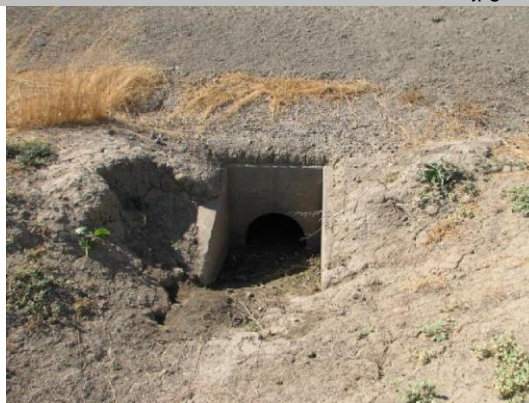
Photo 3 of 3 : UCIP_FA_2017_51779_68971.jpg

FS_ID:51779
DS_ID:17146
EP_NO: 9382
Repair Type: Non-Urgent
Crossing Status: Found
UCIP Comments: 5/2/2017 WS is in good condition. LS inlet is more than 50% full of sediment. Pipe needs to be cleaned internally. (DWR Sutter Yard- AFreitag)10/17/2016 Minor sediment blocking the WS flap gate from opening. LS inlet still mostly full of sediment.(DWR Sutter Yard- AFreitag)9/29/2016 Crossing has been downgraded from Urgent to Non-Urgent WS flap gate is closed for flood season. Need to coordinate with owner to remove sediment blocking WS flap gate. (DWR UCIP - omagana)5/31/2016 WS flap gate is blocked from opening by sediment. LS inlet is over 50% full of sediment. (DWR Sutter Yard - afreitag)5/4/2015 WS flap gate is blocked by sediment and unable to open. LS inlet is about 50% plugged with soil. Needs to be cleaned. (DWR Sutter Yard - afreitag)6/17/2014 Same as last inspection. (DWR Sutter Yard - afreitag)12/16/2013 Sediment against flapgate has been cleared and it can now function properly. (DWR Sutter Yard - afreitag)7/16/2013 Sediment is built up against WS flapgate preventing it from opening. (DWR Sutter Yard - afreitag)10/11/2012 Pipe is partially filled with soil. (DWR UCIP - wwylie)

Inlet and concrete headwall on LS toe.

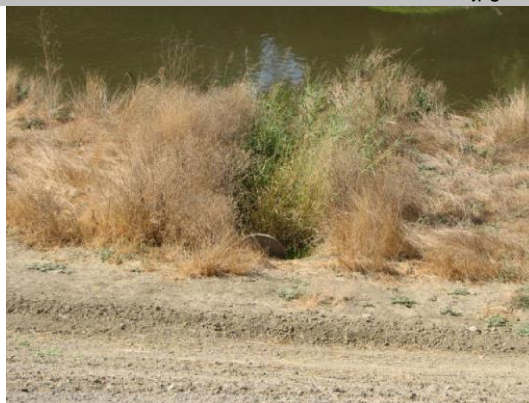
Photo 1 of 3 : UCIP_FA_2017_51782_68984.jpg

FS_ID:51782
DS_ID:17149
EP_NO: 9382
Repair Type: Non-Urgent
Crossing Status: Found
UCIP Comments: 5/2/2017 WS flapgate buried by sediment. Needs to be dug out. (DWR Sutter Yard- A Freitag)10/17/2016 Crossing appears to be in good condition. This is a gravity drain for the LS. (DWR Sutter Yard- A Freitag)5/31/2016 LS inlets was partially plugged. WS flapgate was clear of sediment and able to operate properly.5/4/2015 WS flapgate is blocked by sediment and unable to open. LS inlet is plugged by silt and wood chippings. Needs to be cleaned.6/17/2014 Flap gate was cleaned out and is fully closed. LS inlet still partially full of soil.12/16/2013 Same as last inspection. WS flapgate still needs to be cleaned out and shut.7/16/2013 Same as last inspection. Make sure flapgate is closed before highwater season.10/11/2012 Inlet on LS filled partially with soil. Outlet blocked with soil and the flap gate wont close.

Outlet on WS toe.

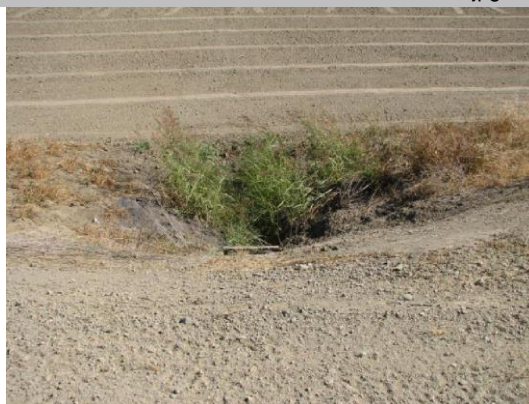
Photo 2 of 3 : UCIP_FA_2017_51782_68983.jpg

Inlet on LS toe.

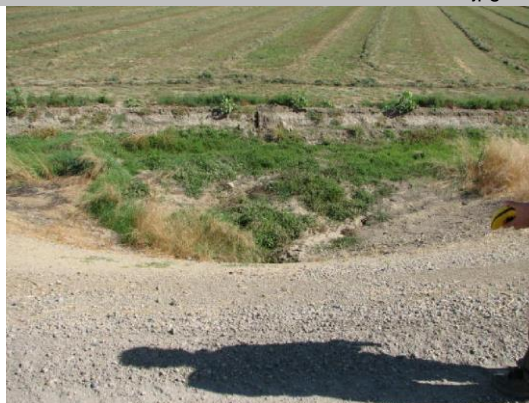
Photo 2 of 3 : UCIP_FA_2017_51786_68993.jpg

FS_ID:51786
DS_ID:17151
EP_NO: 9391
Repair Type: Non-Urgent
Crossing Status: Found
UCIP Comments: 5/2/2017 Both ends of pipe buried. (DWR Sutter Yard- AFreitag)10/17/2016 Appears abandoned. Both pipe ends are completely buried. (DWR Sutter Yard- AFreitag)9/29/2016 Crossing has been downgraded from Urgent to Non-Urgent both pipe ends are buried. Having both ends buried prevents water from flowing from WS to LS during flood season. Need to contact owner and have owner coordinate with CVFPB to comply with Title 23. (DWR UCIP - omagana)5/31/2016 Both pipe ends are buried. Pipe is non-operational. (DWR Sutter Yard - afreitag)5/4/2015 LS and WS ends are blocked with soil. Pipe is inoperable as it is. (DWR Sutter Yard - afreitag)6/17/2014 Same as last inspection. (DWR Sutter Yard - afreitag)12/16/2013 Same as last inspection. (DWR Sutter Yard - afreitag)7/16/2013 LS inlet is completely filled with soil. Needs to be cleaned out. (DWR Sutter Yard - afreitag)10/11/2012 Inlet is partially filled with soil. (DWR Sutter Yard - wwylie)

LS view of inlet.

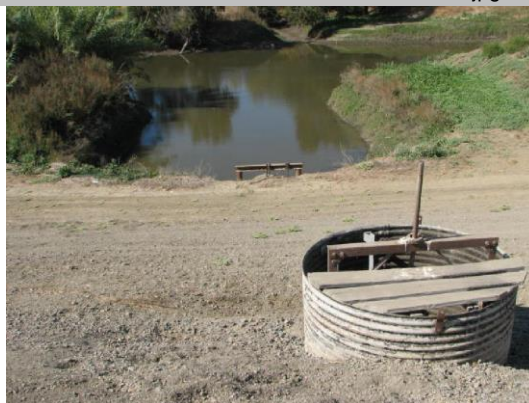
Photo 1 of 3 : UCIP_FA_2017_51789_69005.jpg

FS_ID:51789
DS_ID:17154
EP_NO: 9388
Repair Type: Urgent
Crossing Status: Found
UCIP Comments: 5/2/2017 WS slidegate stem is still bent, wheel to operate gate is missing. Needs a cover made for the standpipe to prevent falls. (DWR Sutter Yard- A Freitag)10/17/2016 Slide gate stem is still bent and the gate appears to be inoperable. (DWR Sutter Yard- A Freitag)5/31/2016 Slide gate stem is still bent. WS flap gate is chained open. (DWR Sutter Yard - A Freitag)5/4/2015 Slide gate stem is still bent. Gate looks to be unable to close all the way. (DWR Sutter Yard - A Freitag)6/17/2014 Same as last inspection. (DWR Sutter Yard - A Freitag)12/16/2013 Slide gate stem is still bent. WS flapgate was closed. (DWR Sutter Yard - A Freitag)7/16/2013 Water flowing through pipe so screw gate definitely not closed. Was told NOV's have been sent for owner to replace stem. Flap gate gets closed for flood season. (DWR Sutter Yard - A Freitag)10/11/2012 Slide gate inoperable, but appears to be in closed position. Flap gate held in open position. Good candidate for video inspection when, if ever, dry. (DWR UCIP - Wwyllie)

Slide gate in corrugated metal riser on WS slope.

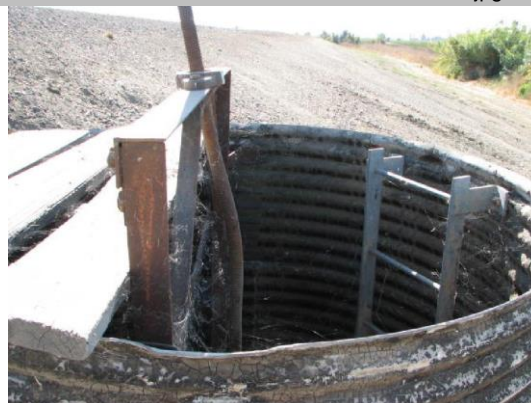
Photo 3 of 3 : UCIP_FA_2017_51789_69008.jpg

FS_ID:51789
DS_ID:17154
EP_NO: 9388
Repair Type: Urgent
Crossing Status: Found
UCIP Comments: 5/2/2017 WS slidegate stem is still bent, wheel to operate gate is missing. Needs a cover made for the standpipe to prevent falls. (DWR Sutter Yard- A Freitag)10/17/2016 Slide gate stem is still and the gate appears to be inoperable. (DWR Sutter Yard- A Freitag)5/31/2016 Slide gate stem is still bent. WS flap gate is chained open. (DWR Sutter Yard - a Freitag)5/4/2015 Slide gate stem is still bent. Gate looks to be unable to close all the way. (DWR Sutter Yard - a Freitag)6/17/2014 Same as last inspection. (DWR Sutter Yard - a Freitag)12/16/2013 Slide gate stem is still bent. WS flapgate was closed. (DWR Sutter Yard - a Freitag)7/16/2013 Water flowing through pipe so screw gate definitely not closed. Was told NOV's have been sent for owner to replace stem. Flap gate gets closed for flood season. (DWR Sutter Yard - a Freitag)10/11/2012 Slide gate inoperable, but appears to be in closed position. Flap gate held in open position. Good candidate for video inspection when, if ever, dry. (DWR UCIP - wwyllie)

Bent screw for slide gate at WS shoulder.

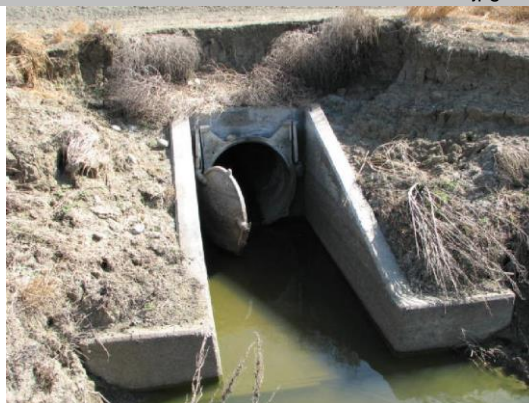
Photo 3 of 3 : UCIP_FA_2017_51795_69024.jpg

FS_ID:51795
DS_ID:17158
EP_NO: 9390
Repair Type: No Action Needed
Crossing Status: Found
UCIP Comments: 5/2/2017 Crossing appears to be in good condition. There is minor sediment build up in front of the WS flap gate/ (DWR Sutter Yard- A Freitag)10/17/2016 Crossing appears to be in good condition. (DWR Sutter Yard- A Freitag)5/31/2016 Crossing appears to be in good condition.5/4/2015 Corssing appears to be in good condition. No noticeable issues to report.6/17/2014 Same as last inspection.12/16/2013 Same as last inspection.7/16/2013 New flapgate installed on WS pipe end.10/11/2012 Flap gate broken on WS, Pipe shows significant rust at outlet. This is a good candidate for video inspection.
FIELD_STRUCT_DESC: 36-inch corrugated metal drainage pipe though the levee, 20 feet below the crown. Pump on metal pier in landside (LS) channel. 40-inch steel standpipe at the LS toe. Flap gate and concrete headwall on the waterside (WS). Concrete headwall on the LS. (36-inch pipe authorized under Automatic Board Order (ABO) issued as Permit No. 9390, 1974 - Annie D. Propfe). [Additional Reference(s): DWR Levee Log, 2005. USACE Sacramento O&M Manual 132, October 1959, (HLM 4.87)].

Flap gate in concrete U-shaped headwall on WS toe.

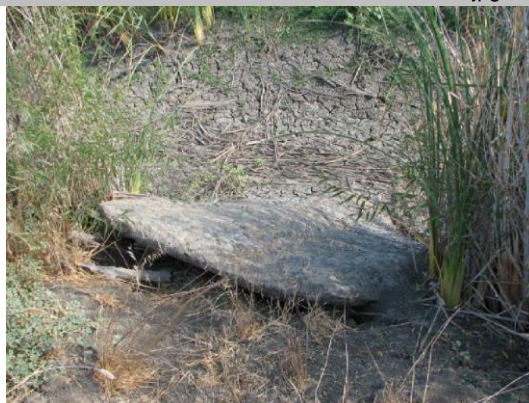
Photo 1 of 3 : UCIP_FA_2017_51796_69030.jpg

FS_ID:51796
DS_ID:17191
EP_NO: N/A
Repair Type: Non-Urgent
Crossing Status: Found
UCIP Comments: 5/2/2017 WS headwall and flapgate almost completely buried with only a small portion of the head wall visible. LS end is buried and unable to be located. (DWR Sutter Yard-AFreitag)10/17/2016 WS flap gate is still silted over and LS inlet is heavily vegetated and unable to be inspected. (DWR Sutter Yard-AFreitag)9/29/2016 Crosssing has been downgraded from Urgent to Non-Urgent WS flap gate is closed shut due to sediment build up. For flood season flap gate is required to be closed. Need to coordinate with owner to remove sediment from WS to have WS flap gate be operable after flood season. (DWR UCIP - omagana)5/31/2016 WS pipe end was mostly underwater but it appears to still be silted over. (DWR Sutter Yard - afreitag)5/4/2015 WS flapgate is blocked by sediment and unable to open. LS inlet is hidden by sediment and heavy vegetation and unable to be located. Needs to be cleared. (DWR Sutter Yard - afreitag)6/17/2014 Same as last inspection. (DWR Sutter Yard - afreitag)12/16/2013 Same as last inspection. (DWR Sutter Yard - afreitag)7/16/2013 Same as last inspection. (DWR Sutter Yard - afreitag)10/11/2012 Pipe is clogged at both the inlet and outlet. Good candidate for video inspection. (DWR UCIP - wwylie)

Apparent inlet clogged with concrete or grout on LS toe in drainage swale.

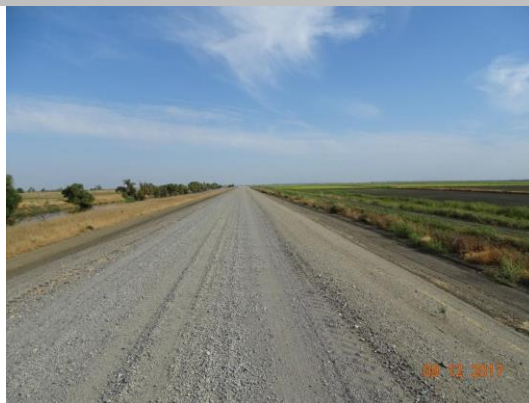
Photo 1 of 1 : FA_2017_MA0012_299_42_20171010_00150.jpg

View of no vegetation on both slopes.

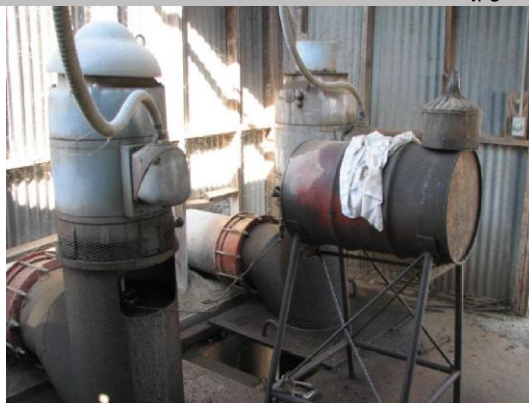
Photo 3 of 3 : UCIP_FA_2017_51802_69074.jpg

Pump for 20-inch pipe at left. See oil bouser and leakage around pumps.

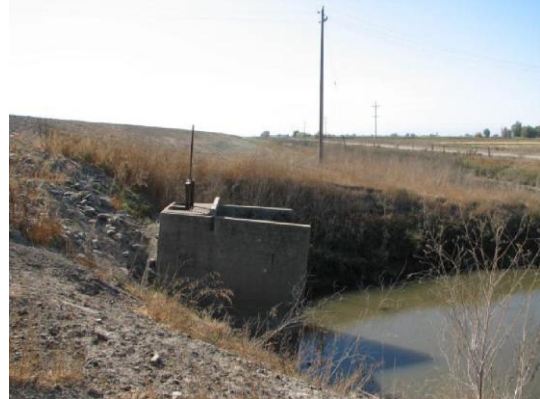
Photo 1 of 3 : UCIP_FA_2017_51806_69100.jpg

Tilting headwall on WS toe.

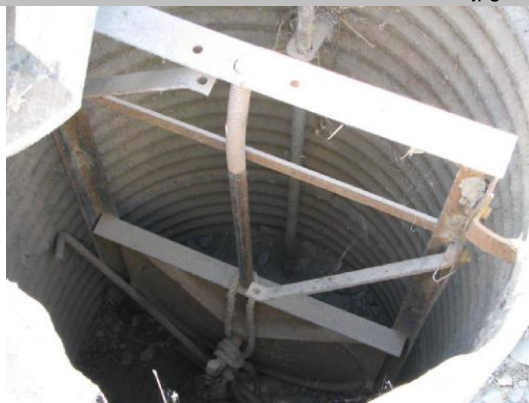
Photo 2 of 2 : UCIP_FA_2017_51810_69114.jpg

Bent and broken actuator on slide gate in 36-inch CMP. Pipe appears to be filled with soil.
