**Flood Control Project Maintenance
Levee Inspections**

Maintenance Issue Types Only, Levee Inspection Report By Mile - Fall 2018

Sutter Maintenance Yard Maintenance Area 0012

Waterway	Bank	Unit Miles	Inspection Start/End	Inspector
Unit No. 01 Colusa Drain	Left	11.06	10/09/2018 10/09/2018	Zach Jojola

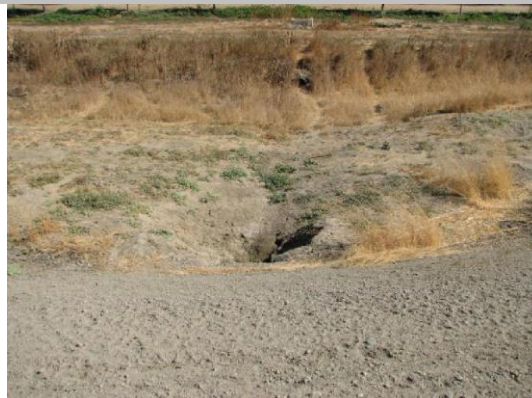
Photo 1 of 3 : UCIP_FA_2018_51779_68973.jpg

FS_ID:51779
DS_ID:17146
EP_NO: 9382
Repair Type: Non-Urgent
Crossing Status: Found
UCIP Comments: 5/2/2017 WS is in good condition. LS inlet is more than 50% full of sediment. Pipe needs to be cleaned internally. (DWR Sutter Yard- AFreitag)10/17/2016 MInor sediment blocking the WS flap gate from opening. LS inlet still mostly full of sediment.(DWR Sutter Yard- AFreitag)9/29/2016 Crossing has been downgraded from Urgent to Non-Urgent WS flap gate is closed for flood season. Need to coordinate with owner to remove sediment blocking WS flap gate. (DWR UCIP - omagana)5/31/2016 WS flap gate is blocked from opening by sediment. LS inlet is over 50% full of sediment. (DWR Sutter Yard - afreitag)5/4/2015 WS flap gate is blocked by sediment and unable to open. LS inlet is about 50% plugged with soil. Needs to be cleaned. (DWR Sutter Yard - afreitag)6/17/2014 Same as last inspection. (DWR Sutter Yard - afreitag)12/16/2013 Sediment against flapgate has been cleared and it can now function properly. (DWR Sutter Yard - afreitag)7/16/2013 Sediment is built up against WS flapgate preventing it from opening. (DWR Sutter Yard - afreitag)10/11/2012 Pipe is partially filled with soil. (DWR UCIP - wwylie)

Intake at LS toe.

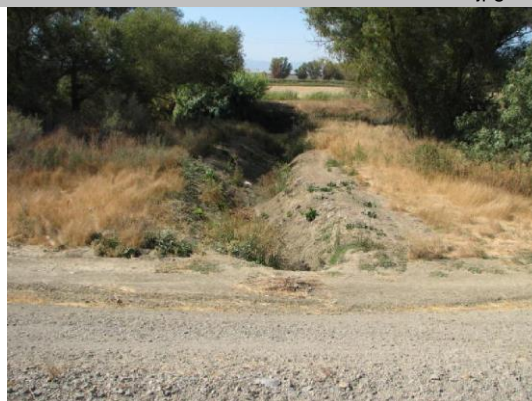
Photo 2 of 3 : UCIP_FA_2018_51779_68972.jpg

Comment Code						
Inspector Comment						
FS_ID:51779 DS_ID:17146 EP_NO: 9382 Repair Type: Non-Urgent Crossing Status: Found UCIP Comments: 5/2/2017 WS is in good condition. LS inlet is more than 50% full of sediment. Pipe needs to be cleaned internally. (DWR Sutter Yard- A Freitag)10/17/2016 MInor sediment blocking the WS flap gate from opening. LS inlet still mostly full of sediment.(DWR Sutter Yard- A Freitag)9/29/2016 Crossing has been downgraded from Urgent to Non-Urgent WS flap gate is closed for flood season. Need to coordinate with owner to remove sediment blocking WS flap gate. (DWR UCIP - omagana)5/31/2016 WS flap gate is blocked from opening by sediment. LS inlet is over 50% full of sediment. (DWR Sutter Yard - a Freitag)5/4/2015 WS flap gate is blocked by sediment and unable to open. LS inlet is about 50% plugged with soil. Needs to be cleaned. (DWR Sutter Yard - a Freitag)6/17/2014 Same as last inspection. (DWR Sutter Yard - a Freitag)12/16/2013 Sediment against flapgate has been cleared and it can now function properly. (DWR Sutter Yard - a Freitag)7/16/2013 Sediment is built up against WS flapgate preventing it from opening. (DWR Sutter Yard - a Freitag)10/11/2012 Pipe is partially filled with soil. (DWR UCIP - wwylye) FIELD_STRUCT_DESC: 24-inch corrugated metal drainage pipe through the levee, 13 feet below the crown. Flap gate, concrete headwall, and grouted cobble spillway on the waterside (WS). Concrete headwall on the landside (LS). (24-inch pipe authorized under Automatic Board Order (ABO) issued as Permit No. 9385, 1974 - Jackson S. King). [Additional Reference(s): DWR Levee Log references ABO 9382, 2005. USACE Sacramento O&M Manual 132, October 1959, (HLM 0.49, Drawing No. 50-4-3081)]. FS Date: 5/2/2017 1:38:42 PM

Outlet at WS toe.

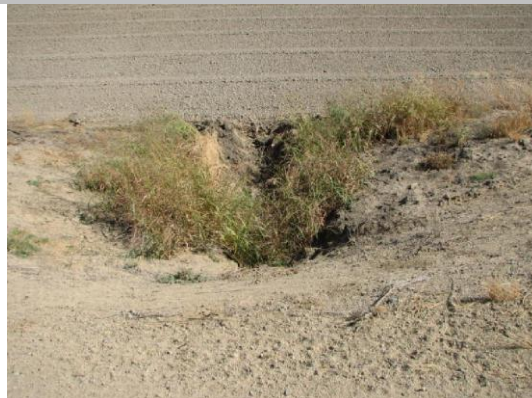
Photo 1 of 3 : UCIP_FA_2018_51780_68977.jpg

Comment Code					
Inspector Comment					
FS_ID:51780 DS_ID:17147 EP_NO: 9382 Repair Type: No Action Needed Crossing Status: Found UCIP Comments: 5/2/2017 Crossing appears to be in good condition. (DWR Sutter Yard- AFreitag)10/17/2016 Crossing appears to be in good condition. This is a gravity for the LS.(DWR Sutter Yard- AFreitag)5/31/2016 Crossing appears to be in good condition.5/4/2015 Crossing is in good condition. No issues.6/17/2014 Same as last inspection.12/16/2013 Same as last inspection.7/16/2013 Same as last inspection. FIELD_STRUCT_DESC: 24-inch corrugated metal drainage pipe through the levee, 13 feet below the crown. Flap gate, concrete headwall, and grouted cobble spillway on the waterside (WS). Concrete headwall on the landside (LS). (24-inch pipe [HLM 1.40] authorized under Automatic Board Order (ABO) issued as Permit No. 9382, 1974 - Olen C. Bober). [Additional Reference(s): DWR Levee Log, 2005. USACE Sacramento O&M Manual 132, October 1959, (HLM 1.4)]. FS Date: 5/2/2017 1:40:20 PM

Intake on LS toe.

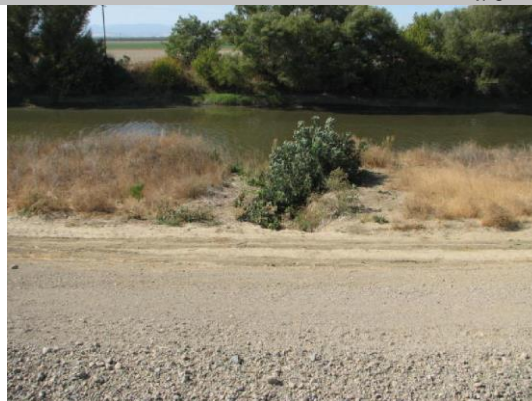
Photo 2 of 3 : UCIP_FA_2018_51780_68976.jpg

Outlet at WS toe.

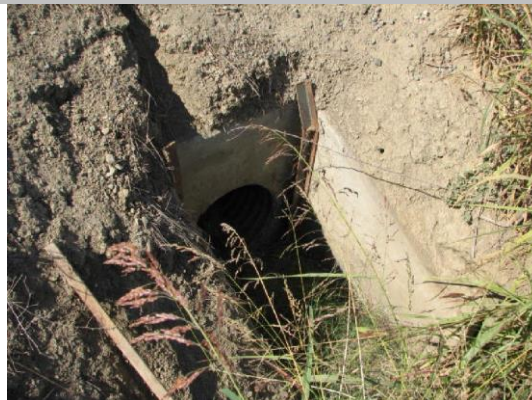
Photo 3 of 3 : UCIP_FA_2018_51780_68975.jpg

Comment Code						
Inspector Comment						
FS_ID:51780						
DS_ID:17147						
EP_NO: 9382						
Repair Type: No Action Needed						
Crossing Status: Found						
UCIP Comments: 5/2/2017 Crossing appears to be in good condition.						
(DWR Sutter Yard- AFreitag)10/17/2016 Crossing appears to be in						
good condition. This is a gravity for the LS.(DWR Sutter Yard-						
AFreitag)5/31/2016 Crossing appears to be in good						
condition.5/4/2015 Crossing is in good condition. No						
issues.6/17/2014 Same as last inspection.12/16/2013 Same as						
last inspection.7/16/2013 Same as last inspection.						
FIELD_STRUCT_DESC: 24-inch corrugated metal drainage pipe						
through the levee, 13 feet below the crown. Flap gate, concrete						
headwall, and grouted cobble spillway on the waterside (WS). Concrete						
headwall on the landside (LS). (24-inch pipe [HLM 1.40] authorized						
under Automatic Board Order (ABO) issued as Permit No. 9382, 1974 -

Concrete U shaped headwall on LS toe.

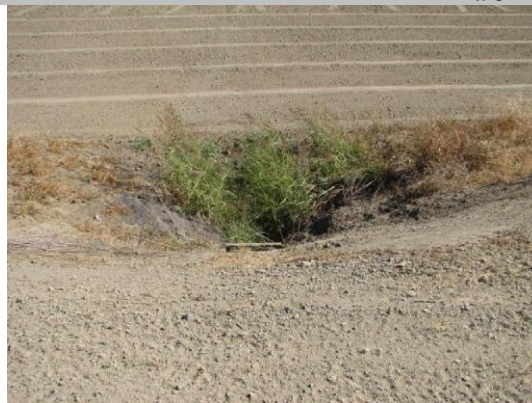
Photo 2 of 3 : UCIP_FA_2018_51782_68983.jpg

Inlet on LS toe.

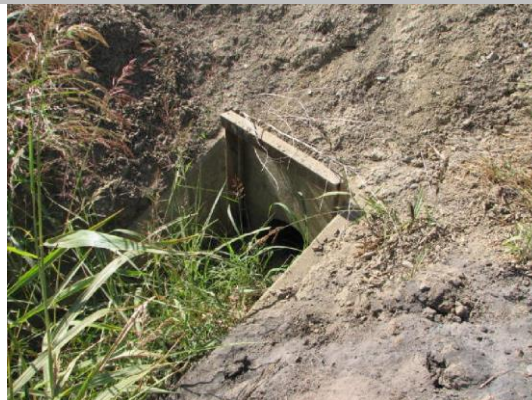
Photo 3 of 3 : UCIP_FA_2018_51782_68982.jpg

Comment Code						
Inspector Comment						
FS_ID:51782 DS_ID:17149 EP_NO: 9382 Repair Type: Non-Urgent Crossing Status: Found UCIP Comments: 5/2/2017 WS flapgate buried by sediment. Needs to be dug out. (DWR Sutter Yard- AFreitag)10/17/2016 Crossing appears to be in good condition. This is a gravity drain for the LS. (DWR Sutter Yard- AFreitag)5/31/2016 LS inlets was partially plugged. WS flapgate was clear of sediment and abale to operate properly.5/4/2015 WS flapgate is blocked by sediment and unable to open. LS inlet is plugged by silt and wood chippings. Needs to be cleaned.6/17/2014 Flap gate was cleaned out and is fully closed. LS inlet still partially full of soil.12/16/2013 Same as last inspection. WS flapgate still needs to be cleaned out and shut.7/16/2013 Same as last inspection. Make sure flapgate is closed before highwater season.10/11/2012 Inlet on LS filled partially with soil. Outlet blocked with soil and the flap gate wont close. FIELD_STRUCT_DESC: 24-inch corrugated metal drainage pipe through the levee, 13 feet below the crown. Flap gate, concrete headwall, and grouted cobble spillway on the waterside (WS). Concrete headwall on the landside (LS). (24-inch pipe [HLM 1.72] authorized under Automatic Board Order (ABO) issued as Permit No. 9382, 1974 - Olen C. Bober). [Additional Reference(s): DWR Levee Log, 2005. USACE Sacramento O&M Manual 132, October 1959, (HLM 1.72)]. FS Date: 5/2/2017 1:50:52 PM

Concrete U shaped headwall at LS inlet.

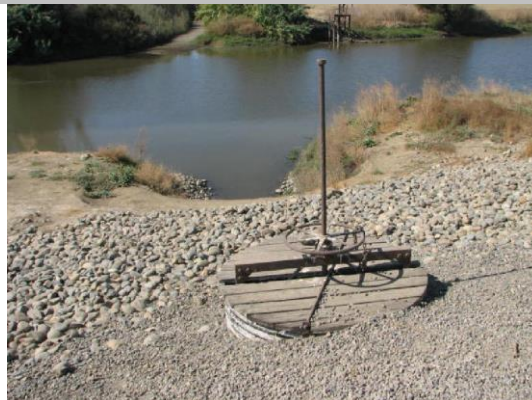
Photo 1 of 3 : UCIP_FA_2018_51785_68991.jpg

FS_ID:51785
DS_ID:17150
EP_NO: 9387
Repair Type: No Action Needed
Crossing Status: Found
UCIP Comments: 5/2/2017 Crossing appears to be in good condition. (DWR Sutter Yard- AFreitag)10/17/2016 Crossing appears to be in good condition. (DWR Sutter Yard- AFreitag)5/31/2016 Crossing appears to be in good condition. Attached photo showing location of LS inlet.5/4/2015 WS flapgate mostly underwater but could tell it was blocked open by something. LS inlet is located about 1/4 mile north along the side of the roadway.6/17/2014 Same as last inspection.12/16/2013 Pipe was flowing water and flap gate was being pushed open. Cannot verify if it will close all the way.7/16/2013 Same as last inspection. Was told inlet is about 1/4 mile down road way next to house. Will try to get coordinates for inlet.10/11/2012 No inlet could be located on LS. Flap gate partially blocked and will not close completely.
FIELD_STRUCT_DESC: 48-inch corrugated metal drainage pipe through the levee, 20 feet below the crown. Slide gate in 60-inch riser on the waterside (WS) slope. Flap gate and concrete headwall on the WS. (48-inch pipe authorized under Automatic Board Order (ABO) issued as Permit No. 9387, 1974 - Lauretta S. Christenson). [Additional Reference(s): DWR Levee Log, 2005. USACE Sacramento O&M Manual 132, October 1959, (HLM 1.8)].

60-inch standpipe with slide gate on WS slope with outlet in background.

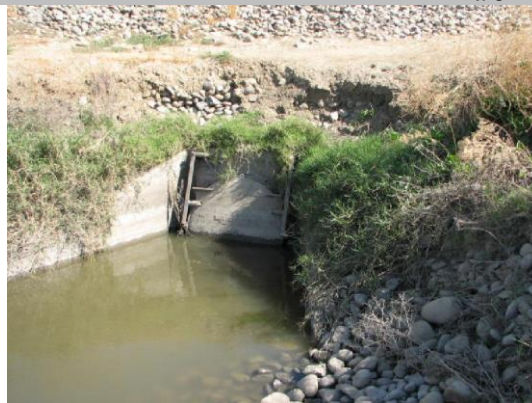
Photo 2 of 3 : UCIP_FA_2018_51785_68990.jpg

Flap gate and concrete headwall at WS toe.

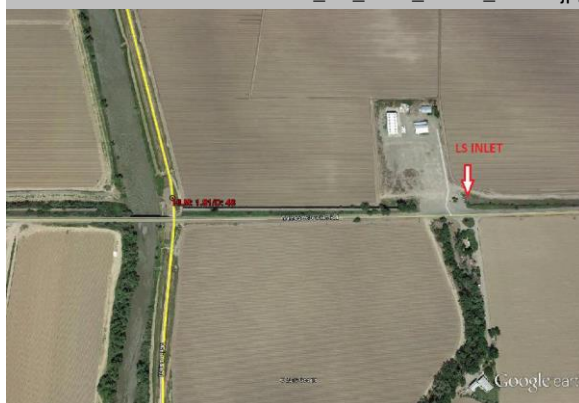
Photo 3 of 3 : UCIP_FA_2018_51785_75168.jpg

FS_ID:51785
DS_ID:17150
EP_NO: 9387
Repair Type: No Action Needed
Crossing Status: Found
UCIP Comments: 5/2/2017 Crossing appears to be in good condition. (DWR Sutter Yard- AFreitag)10/17/2016 Crossing appears to be in good condition. (DWR Sutter Yard- AFreitag)5/31/2016 Crossing appears to be in good condition. Attached photo showing location of LS inlet.5/4/2015 WS flapgate mostly underwater but could tell it was blocked open by something. LS inlet is located about 1/4 mile north along the side of the roadway.6/17/2014 Same as last inspection.12/16/2013 Pipe was flowing water and flap gate was being pushed open. Cannot verify if it will close all the way.7/16/2013 Same as last inspection. Was told inlet is about 1/4 mile down road way next to house. Will try to get coordinates for inlet.10/11/2012 No inlet could be located on LS. Flap gate partially blocked and will not close completely.
FIELD_STRUCT_DESC: 48-inch corrugated metal drainage pipe through the levee, 20 feet below the crown. Slide gate in 60-inch riser on the waterside (WS) slope. Flap gate and concrete headwall on the WS. (48-inch pipe authorized under Automatic Board Order (ABO) issued as Permit No. 9387, 1974 - Lauretta S. Christenson). [Additional Reference(s): DWR Levee Log, 2005. USACE Sacramento O&M Manual 132, October 1959, (HLM 1.8)].

Arrow showing location of LS inlet

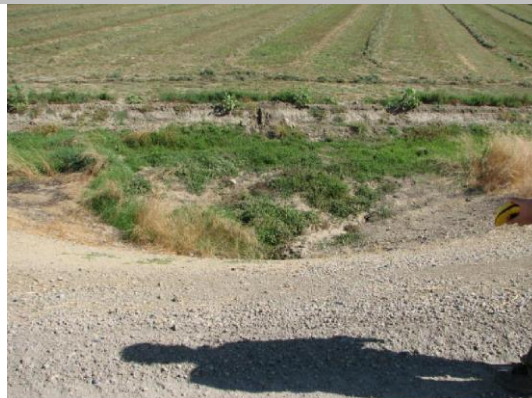
Photo 2 of 3 : UCIP_FA_2018_51786_68993.jpg

Comment Code						
Inspector Comment						
FS_ID:51786 DS_ID:17151 EP_NO: 9391 Repair Type: Non-Urgent Crossing Status: Found UCIP Comments: 5/2/2017 Both ends of pipe buried. (DWR Sutter Yard- AFreitag)10/17/2016 Appears abandoned. Both pipe ends are completely buried. (DWR Sutter Yard- AFreitag)9/29/2016 Crossing has been downgraded from Urgent to Non-Urgent both pipe ends are buried. Having both ends buried prevents water from flowing from WS to LS during flood season. Need to contact owner and have owner coordinate with CVFPB to comply with Title 23. (DWR UCIP - omagana)5/31/2016 Both pipe ends are buried. Pipe is non-operational. (DWR Sutter Yard - afreitag)5/4/2015 LS and WS ends are blocked with soil. Pipe is inoperable as it is. (DWR Sutter Yard - afreitag)6/17/2014 Same as last inspection. (DWR Sutter Yard - afreitag)12/16/2013 Same as last inspection. (DWR Sutter Yard - afreitag)7/16/2013 LS inlet is completely filled with soil. Needs to be cleaned out. (DWR Sutter Yard - afreitag)10/11/2012 Inlet is partially filled with soil. (DWR Sutter Yard - wwylie) FIELD_STRUCT_DESC: *ABANDONED* 24-inch corrugated metal drainage pipe through the levee, 13 feet below the crown. Flap gate, concrete headwall, and grouted cobble spillway on the waterside (WS). Concrete headwall on the landside (LS). (24-inch pipe authorized under Automatic Board Order (ABO) issued as Permit No. 9391, 1974 - Department of Water Resources, Northern District). [Additional Reference(s): DWR Levee Log, 2005. USACE Sacramento O&M Manual 132, October 1959, (HLM 2.02)]. FS Date: 5/2/2017 2:01:25 PM

LS view of inlet.

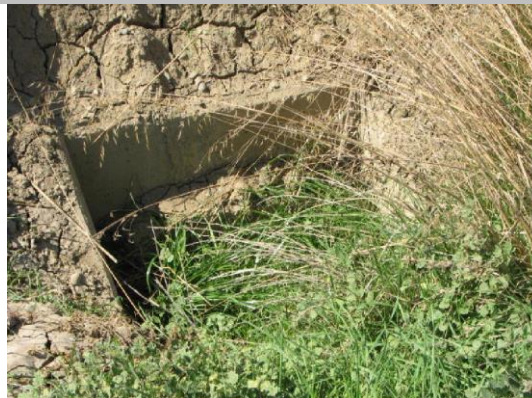
Photo 3 of 3 : UCIP_FA_2018_51786_68992.jpg

Comment Code						
Inspector Comment						
FS_ID:51786 DS_ID:17151 EP_NO: 9391 Repair Type: Non-Urgent Crossing Status: Found UCIP Comments: 5/2/2017 Both ends of pipe buried. (DWR Sutter Yard- AFreitag)10/17/2016 Appears abandoned. Both pipe ends are completely buried. (DWR Sutter Yard- AFreitag)9/29/2016 Crossing has been downgraded from Urgent to Non-Urgent both pipe ends are buried. Having both ends buried prevents water from flowing from WS to LS during flood season. Need to contact owner and have owner coordinate with CVFPB to comply with Title 23. (DWR UCIP - omagana)5/31/2016 Both pipe ends are buried. Pipe is non-operational. (DWR Sutter Yard - afreitag)5/4/2015 LS and WS ends are blocked with soil. Pipe is inoperable as it is. (DWR Sutter Yard - afreitag)6/17/2014 Same as last inspection. (DWR Sutter Yard - afreitag)12/16/2013 Same as last inspection. (DWR Sutter Yard - afreitag)7/16/2013 LS inlet is completely filled with soil. Needs to be cleaned out. (DWR Sutter Yard - afreitag)10/11/2012 Inlet is partially filled with soil. (DWR Sutter Yard - wwylie) FIELD_STRUCT_DESC: *ABANDONED* 24-inch corrugated metal drainage pipe through the levee, 13 feet below the crown. Flap gate, concrete headwall, and grouted cobble spillway on the waterside (WS). Concrete headwall on the landside (LS). (24-inch pipe authorized under Automatic Board Order (ABO) issued as Permit No. 9391, 1974 - Department of Water Resources, Northern District). [Additional Reference(s): DWR Levee Log, 2005. USACE Sacramento O&M Manual 132, October 1959, (HLM 2.02)]. FS Date: 5/2/2017 2:01:25 PM

Concrete U shaped headwall at LS toe.

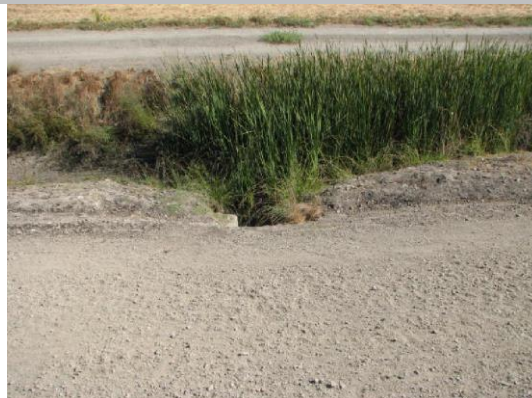
Photo 1 of 3 : UCIP_FA_2018_51788_69002.jpg

Comment Code					
Inspector Comment					
FS_ID:51788 DS_ID:17153 EP_NO: 9384 Repair Type: No Action Needed Crossing Status: Found UCIP Comments: 5/2/2017 Crossing appears to be in good condition. (DWR Sutter Yard- AFreitag)10/17/2016 Crossing appears to be in good condition. (DWR Sutter Yard- AFreitag)5/31/2016 Crossing appears to be in good condition.5/4/2015 Crossing appears in good condition. No noticeable issues.6/17/2014 Same as last inspection.12/16/2013 Same as last inspection.7/16/2013 Same as last inspection. FIELD_STRUCT_DESC: 24-inch corrugated metal drainage pipe through the levee, 16 feet below the crown. Flap gate, concrete headwall, and grouted cobble spillway on the waterside (WS). Concrete headwall on the landside (LS). (24-inch pipe [HLM 3.22] authorized under Automatic Board Order (ABO) issued as Permit No. 9384, 1974 - William D. Struckmeyer) [Additional Reference(s): DWR Levee Log, 2005. USACE Sacramento O&M Manual 132, October 1959, (HLM 3.22)]. FS Date: 5/2/2017 2:04:40 PM

Concrete headwall at LS toe.

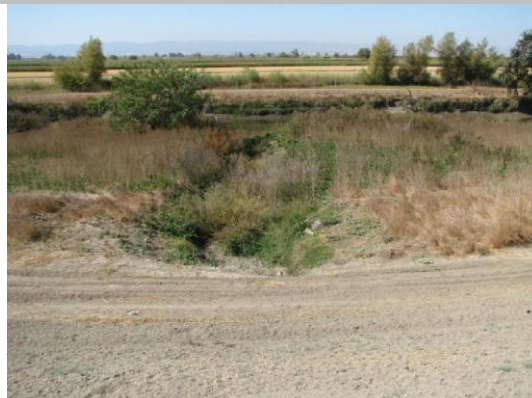
Photo 2 of 3 : UCIP_FA_2018_51788_69001.jpg

Drainage Swale on WS toe.

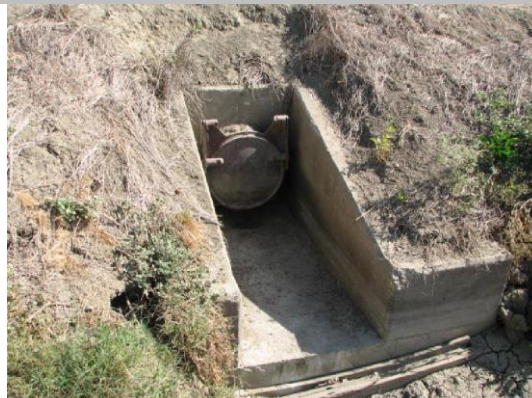
Photo 3 of 3 : UCIP_FA_2018_51788_69000.jpg

Comment Code						
Inspector Comment						
FS_ID:51788 DS_ID:17153 EP_NO: 9384 Repair Type: No Action Needed Crossing Status: Found UCIP Comments: 5/2/2017 Crossing appears to be in good condition. (DWR Sutter Yard- AFreitag)10/17/2016 Crossing appears to be in good condition. (DWR Sutter Yard- AFreitag)5/31/2016 Crossing appears to be in good condition.5/4/2015 Crossing appears in good condition. No noticeable issues.6/17/2014 Same as last inspection.12/16/2013 Same as last inspection.7/16/2013 Same as last inspection. FIELD_STRUCT_DESC: 24-inch corrugated metal drainage pipe through the levee, 16 feet below the crown. Flap gate, concrete headwall, and grouted cobble spillway on the waterside (WS). Concrete headwall on the landside (LS). (24-inch pipe [HLM 3.22] authorized under Automatic Board Order (ABO) issued as Permit No. 9384, 1974 - William D. Struckmeyer) [Additional Reference(s): DWR Levee Log, 2005. USACE Sacramento O&M Manual 132, October 1959, (HLM 3.22)]. FS Date: 5/2/2017 2:04:40 PM

Concrete headwall and flap gate at WS toe.

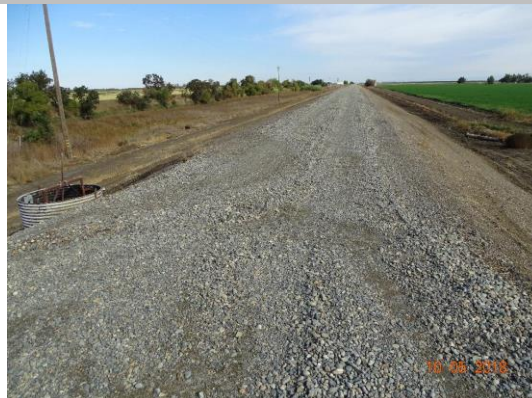
Photo 1 of 3 : UCIP_FA_2018_53011_78198.jpg

FS_ID:53011
DS_ID:17154
EP_NO: 9388
Repair Type: Non-Urgent
Crossing Status: Found
UCIP Comments: 10/5/2018 Fall hazard: missing cover on CMP riser. Closure devices are present on both ends of crossing and seem to be in operable condition. Downgraded to non-urgent. Recommend owner add cover to CMP riser. (O.Yakimov - DWR)5/2/2017 WS slidegate stem is still bent, wheel to operate gate is missing. Needs a cover made for the standpipe to prevent falls. (DWR Sutter Yard- AFreitag)10/17/2016 Slide gate stem is still and the gate appears to be inoperable. (DWR Sutter Yard- AFreitag)5/31/2016 Slide gate stem is still bent. WS flap gate is chained open. (DWR Sutter Yard - afreitag)5/4/2015 Slide gate stem is still bent. Gate looks to be unable to close all the way. (DWR Sutter Yard - afreitag)6/17/2014 Same as last inspection. (DWR Sutter Yard - afreitag)12/16/2013 Slide gate stem is still bent. WS flapgate was closed. (DWR Sutter Yard - afreitag)7/16/2013 Water flowing through pipe so screw gate definitely not closed. Was told NOV's have been sent for owner to replace stem. Flap gate gets closed for flood season. (DWR Sutter Yard - afreitag)10/11/2012 Slide gate inoperable, but appears to be in closed position. Flap gate held in open position. Good candidate for video inspection when, if ever, dry. (DWR UCIP - wwyllie)

View of levee crown at crossing.

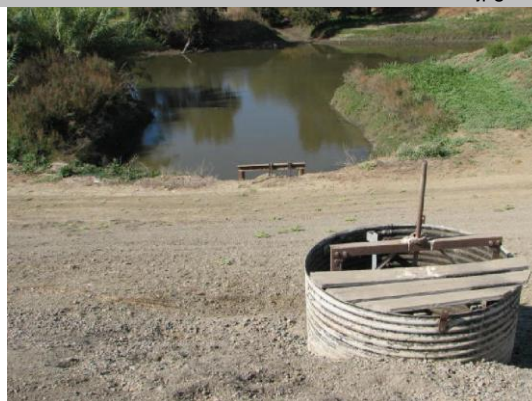
Photo 2 of 3 : UCIP_FA_2018_53011_69005.jpg

FS_ID:53011
DS_ID:17154
EP_NO: 9388
Repair Type: Non-Urgent
Crossing Status: Found
UCIP Comments: 10/5/2018 Fall hazard: missing cover on CMP riser. Closure devices are present on both ends of crossing and seem to be in operable condition. Downgraded to non-urgent. Recommend owner add cover to CMP riser. (O.Yakimov - DWR)5/2/2017 WS slidegate stem is still bent, wheel to operate gate is missing. Needs a cover made for the standpipe to prevent falls. (DWR Sutter Yard- AFreitag)10/17/2016 Slide gate stem is still and the gate appears to be inoperable. (DWR Sutter Yard- AFreitag)5/31/2016 Slide gate stem is still bent. WS flap gate is chained open. (DWR Sutter Yard - afreitag)5/4/2015 Slide gate stem is still bent. Gate looks to be unable to close all the way. (DWR Sutter Yard - afreitag)6/17/2014 Same as last inspection. (DWR Sutter Yard - afreitag)12/16/2013 Slide gate stem is still bent. WS flapgate was closed. (DWR Sutter Yard - afreitag)7/16/2013 Water flowing through pipe so screw gate definitely not closed. Was told NOV's have been sent for owner to replace stem. Flap gate gets closed for flood season. (DWR Sutter Yard - afreitag)10/11/2012 Slide gate inoperable, but appears to be in closed position. Flap gate held in open position. Good candidate for video inspection when, if ever, dry. (DWR UCIP - wwyllie)

Slide gate in corrugated metal riser on WS slope.

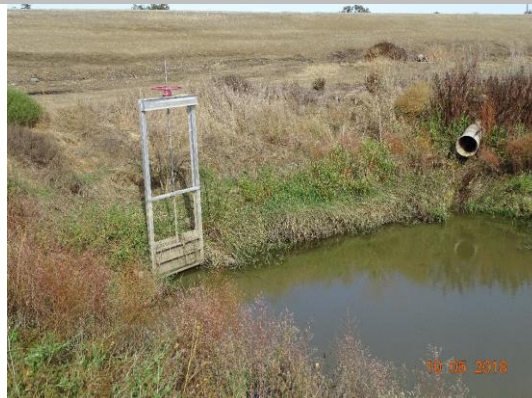
Photo 3 of 3 : UCIP_FA_2018_53011_78205.jpg

FS_ID:53011
DS_ID:17154
EP_NO: 9388
Repair Type: Non-Urgent
Crossing Status: Found
UCIP Comments: 10/5/2018 Fall hazard: missing cover on CMP riser. Closure devices are present on both ends of crossing and seem to be in operable condition. Downgraded to non-urgent. Recommend owner add cover to CMP riser. (O.Yakimov - DWR)5/2/2017 WS slidegate stem is still bent, wheel to operate gate is missing. Needs a cover made for the standpipe to prevent falls. (DWR Sutter Yard- AFreitag)10/17/2016 Slide gate stem is still and the gate appears to be inoperable. (DWR Sutter Yard- AFreitag)5/31/2016 Slide gate stem is still bent. WS flap gate is chained open. (DWR Sutter Yard - afreitag)5/4/2015 Slide gate stem is still bent. Gate looks to be unable to close all the way. (DWR Sutter Yard - afreitag)6/17/2014 Same as last inspection. (DWR Sutter Yard - afreitag)12/16/2013 Slide gate stem is still bent. WS flapgate was closed. (DWR Sutter Yard - afreitag)7/16/2013 Water flowing through pipe so screw gate definitely not closed. Was told NOV's have been sent for owner to replace stem. Flap gate gets closed for flood season. (DWR Sutter Yard - afreitag)10/11/2012 Slide gate inoperable, but appears to be in closed position. Flap gate held in open position. Good candidate for video inspection when, if ever, dry. (DWR UCIP - wwylie)

Headwall with slide gate at LS toe.

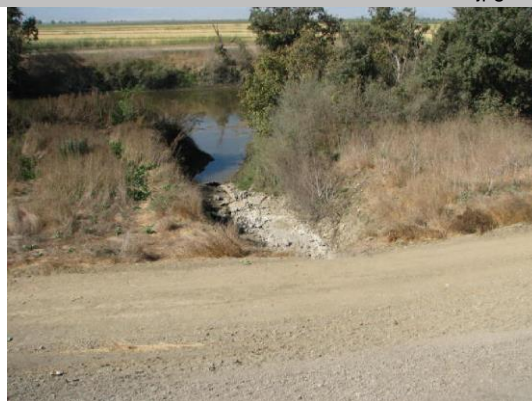
Photo 1 of 3 : UCIP_FA_2018_51791_69014.jpg

Comment Code					
Inspector Comment					
FS_ID:51791 DS_ID:17168 EP_NO: 9388 Repair Type: No Action Needed Crossing Status: Found UCIP Comments: 5/2/2017 Crossing appears to be in good condition. (DWR Sutter Yard- AFreitag)10/17/2016 Crossing appears to be in good condition. (DWR Sutter Yard- AFreitag)5/31/2016 Crossing appears to be in good condition.5/4/2015 Corssing appears to be in good condition. No noticeable issues to report.6/17/2014 Same as last inspection.12/16/2013 Same as last inspection.7/16/2013 Same as last inspection. FIELD_STRUCT_DESC: 36-inch corrugated metal drainage pipe through the levee, 27.5 feet below the crown. Flap gate, concrete headwall, and grouted cobble spillway located on the waterside (WS). Concrete headwall located on the landside (LS). (24-inch pipe [HLM 4.25] authorized under Automatic Board Order (ABO) issued as Permit No. 9388, 1974 - Pauline A. Wallace). [Additional Reference(s): DWR Levee Log, 2005. USACE Sacramento O&M Manual 132, October 1959, (HLM 4.25)]. FS Date: 5/2/2017 2:08:40 PM

Outlet at WS toe.

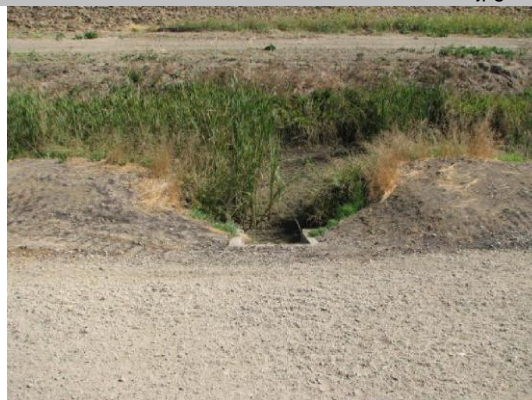
Photo 2 of 3 : UCIP_FA_2018_51791_69013.jpg

Concrete U shaped headwall on LS toe.

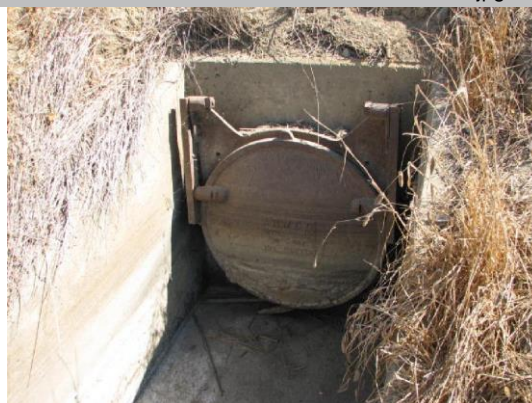
Photo 3 of 3 : UCIP_FA_2018_51791_69012.jpg

Comment Code						
Inspector Comment						
FS_ID:51791						
DS_ID:17168						
EP_NO: 9388						
Repair Type: No Action Needed						
Crossing Status: Found						
UCIP Comments: 5/2/2017 Crossing appears to be in good condition.						
(DWR Sutter Yard- A Freitag)10/17/2016 Crossing appears to be in						
good condition. (DWR Sutter Yard- A Freitag)5/31/2016 Crossing						
appears to be in good condition.5/4/2015 Corssing appears to be in						
good condition. No noticeable issues to report.6/17/2014 Same as						
last inspection.12/16/2013 Same as last inspection.7/16/2013						
Same as last inspection.						
FIELD_STRUCT_DESC: 36-inch corrugated metal drainage pipe						
through the levee, 27.5 feet below the crown. Flap gate, concrete						
headwall, and grouted cobble spillway located on the waterside (WS).						
Concrete headwall located on the landside (LS). (24-inch pipe [HLM

Concrete U shaped headwall and flap gate on WS toe.

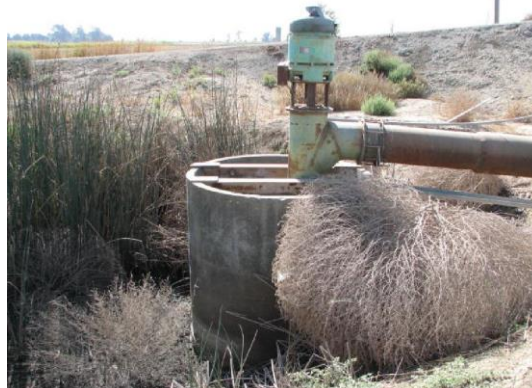
Photo 1 of 3 : UCIP_FA_2018_51792_69017.jpg

Comment Code					
Inspector Comment					
FS_ID:51792 DS_ID:17156 EP_NO: 9388 Repair Type: No Action Needed Crossing Status: Found UCIP Comments: 5/2/2017 Crossing appears to be in good condition. (DWR Sutter Yard- AFreitag)10/17/2016 Crossing appears to be in good condition. (DWR Sutter Yard- AFreitag)5/31/2016 Crossing appears to be in good condition.5/4/2015 Corssing appears to be in good condition. No noticeable issues to report.6/17/2014 Same as last inspection.12/16/2013 Same as last inspection.7/16/2013 Same as last inspection. FIELD_STRUCT_DESC: 24-inch corrugated metal drainage pipe through the levee, 9.2 feet below the crown. Slide gate in a 36-inch corrugated metal pipe (CMP) riser on the waterside (WS) slope. Pump on a 60-inch concrete standpipe at the landside (LS) toe. (24-inch pipe [HLM 4.32] authorized under Automatic Board Order (ABO) issued as Permit No. 9388, 1974 - Pauline A. Wallace). [Additional Reference(s): DWR Levee Log, 2005. USACE Sacramento O&M Manual 132, October 1959, (HLM 4.32)]. FS Date: 5/2/2017 2:20:21 PM

Pump on Concrete riser at LS toe.

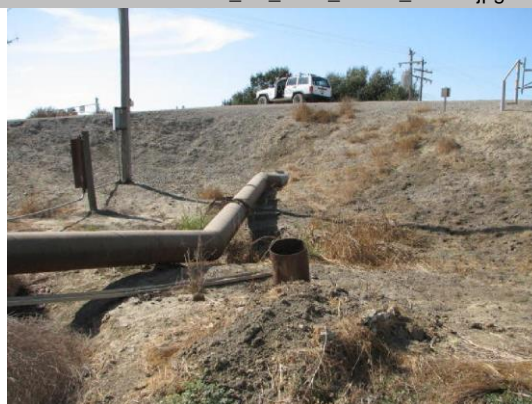
Photo 2 of 3 : UCIP_FA_2018_51792_69016.jpg

Pipe through levee at LS slope.

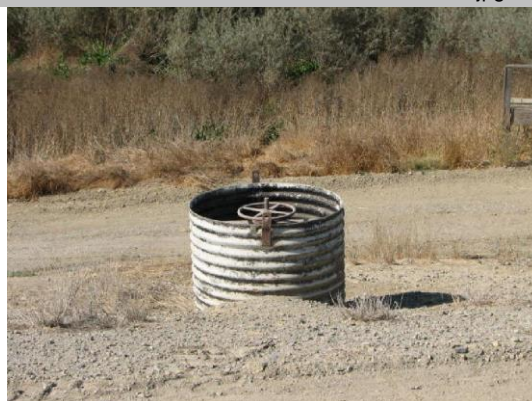
Photo 3 of 3 : UCIP_FA_2018_51792_69015.jpg

Comment Code					
Inspector Comment					
FS_ID:51792 DS_ID:17156 EP_NO: 9388 Repair Type: No Action Needed Crossing Status: Found UCIP Comments: 5/2/2017 Crossing appears to be in good condition. (DWR Sutter Yard- AFreitag)10/17/2016 Crossing appears to be in good condition. (DWR Sutter Yard- AFreitag)5/31/2016 Crossing appears to be in good condition.5/4/2015 Corssing appears to be in good condition. No noticeable issues to report.6/17/2014 Same as last inspection.12/16/2013 Same as last inspection.7/16/2013 Same as last inspection. FIELD_STRUCT_DESC: 24-inch corrugated metal drainage pipe through the levee, 9.2 feet below the crown. Slide gate in a 36-inch corrugated metal pipe (CMP) riser on the waterside (WS) slope. Pump on a 60-inch concrete standpipe at the landside (LS) toe. (24-inch pipe [HLM 4.32] authorized under Automatic Board Order (ABO) issued as Permit No. 9388, 1974 - Pauline A. Wallace). [Additional Reference(s): DWR Levee Log, 2005. USACE Sacramento O&M Manual 132, October 1959, (HLM 4.32)]. FS Date: 5/2/2017 2:20:21 PM

36-inch CMP riser with Slide gate on WS shoulder.

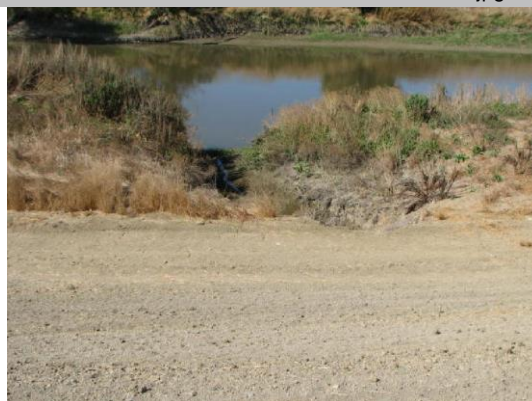
Photo 1 of 3 : UCIP_FA_2018_51795_69026.jpg

FS_ID:51795
DS_ID:17158
EP_NO: 9390
Repair Type: No Action Needed
Crossing Status: Found
UCIP Comments: 5/2/2017 Crossing appears to be in good condition. There is minor sediment build up in front of the WS flap gate/ (DWR Sutter Yard- A/Freitag)10/17/2016 Crossing appears to be in good condition. (DWR Sutter Yard- A/Freitag)5/31/2016 Crossing appears to be in good condition.5/4/2015 Corssing appears to be in good condition. No noticeable issues to report.6/17/2014 Same as last inspection.12/16/2013 Same as last inspection.7/16/2013 New flapgate installed on WS pipe end.10/11/2012 Flap gate broken on WS, Pipe shows significant rust at outlet. This is a good candidate for video inspection.
FIELD_STRUCT_DESC: 36-inch corrugated metal drainage pipe though the levee, 20 feet below the crown. Pump on metal pier in landside (LS) channel. 40-inch steel standpipe at the LS toe. Flap gate and concrete headwall on the waterside (WS). Concrete headwall on the LS. (36-inch pipe authorized under Automatic Board Order (ABO) issued as Permit No. 9390, 1974 - Annie D. Propfe). [Additional Reference(s): DWR Levee Log, 2005. USACE Sacramento O&M Manual 132, October 1959, (HLM 4.87)].

Outlet channel on WS toe.

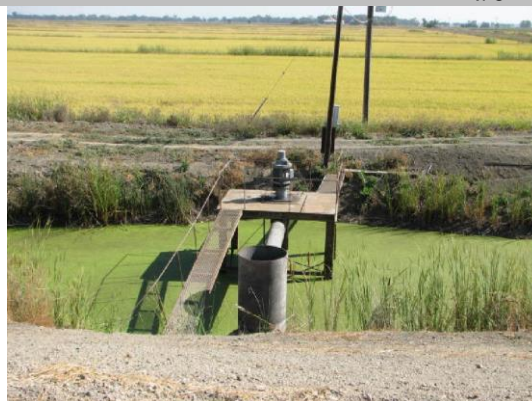
Photo 2 of 3 : UCIP_FA_2018_51795_69025.jpg

Pump, walkway, and standpipe on LS toe.

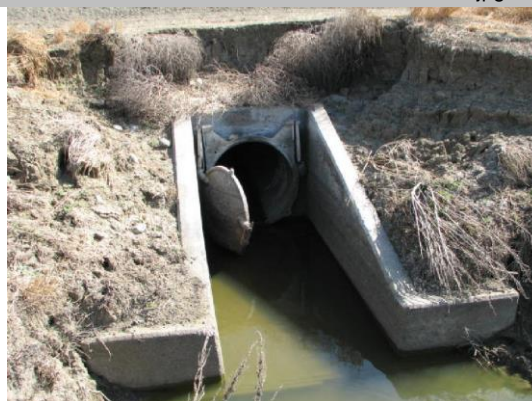
Photo 3 of 3 : UCIP_FA_2018_51795_69024.jpg

Comment Code						
Inspector Comment						
FS_ID:51795 DS_ID:17158 EP_NO: 9390 Repair Type: No Action Needed Crossing Status: Found UCIP Comments: 5/2/2017 Crossing appears to be in good condition. There is minor sediment build up in front of the WS flap gate/ (DWR Sutter Yard- A Freitag)10/17/2016 Crossing appears to be in good condition. (DWR Sutter Yard- A Freitag)5/31/2016 Crossing appears to be in good condition.5/4/2015 Corssing appears to be in good condition. No noticeeable issues to report.6/17/2014 Same as last inspection.12/16/2013 Same as last inspection.7/16/2013 New flapgate installed on WS pipe end.10/11/2012 Flap gate broken on WS, Pipe shows significant rust at outlet. This is a good candidate for video inspection. FIELD_STRUCT_DESC: 36-inch corrugated metal drainage pipe though the levee, 20 feet below the crown. Pump on metal pier in landside (LS) channel. 40-inch steel standpipe at the LS toe. Flap gate and concrete headwall on the waterside (WS). Concrete headwall on the LS. (36-inch pipe authorized under Automatic Board Order (ABO) issued as Permit No. 9390, 1974 - Annie D. Propfe). [Additional Reference(s): DWR Levee Log, 2005. USACE Sacramento O&M Manual 132, October 1959, (HLM 4.87)]. FS Date: 5/2/2017 2:30:31 PM

Flap gate in concrete U-shaped headwall on WS toe.

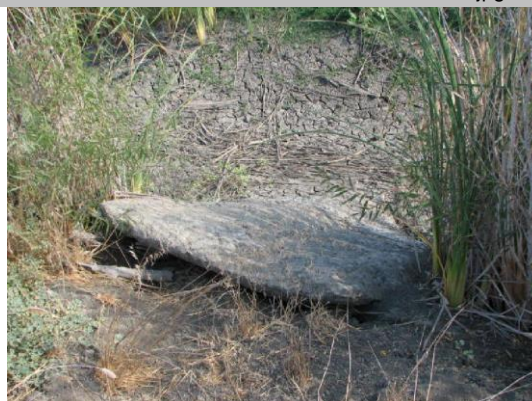
Photo 1 of 3 : UCIP_FA_2018_51796_69030.jpg

Comment Code						
Inspector Comment						
FS_ID:51796 DS_ID:17191 EP_NO: N/A Repair Type: Non-Urgent Crossing Status: Found UCIP Comments: 5/2/2017 WS headwall and flapgate almost completely buried with only a small portion of the head wall visible. LS end is buried and unable to be located. (DWR Sutter Yard-AFreitag)10/17/2016 WS flap gate is still silted over and LS inlet is heavily vegetated and unable to be inspected. (DWR Sutter Yard-AFreitag)9/29/2016 Crosssing has been downgraded from Urgent to Non-Urgent WS flap gate is closed shut due to sediment build up. For flood season flap gate is required to be closed. Need to coordinate with owner to remove sediment from WS to have WS flap gate be operable after flood season. (DWR UCIP - omagana)5/31/2016 WS pipe end was mostly underwater but it appears to still be silted over. (DWR Sutter Yard - afreitag)5/4/2015 WS flapgate is blocked by sediment and unable to open. LS inlet is hidden by sediment and heavy vegetation and unable to be located. Needs to be cleared. (DWR Sutter Yard - afreitag)6/17/2014 Same as last inspection. (DWR Sutter Yard - afreitag)12/16/2013 Same as last inspection. (DWR Sutter Yard - afreitag)7/16/2013 Same as last inspection. (DWR Sutter Yard - afreitag)10/11/2012 Pipe is clogged at both the inlet and outlet. Good candidate for video inspection. (DWR UCIP - wwylie) FIELD_STRUCT_DESC: 48-inch corrugated metal drainage pipe through the levee, approximately 15 feet below the crown. Concrete headwalls on both the waterside (WS) and the landside (LS) ends with an automatic drainage gate on the WS. [Additional Reference(s): USACE Sacramento O&M Manual 132, October 1959, (HLM 5.12)]. FS Date: 5/2/2017 2:31:39 PM

Apparent inlet clogged with concrete or grout on LS toe in drainage swale.

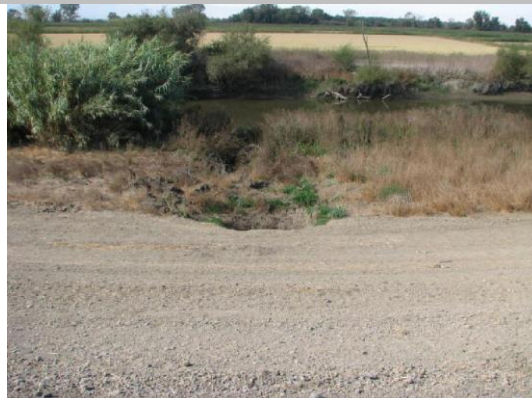
Photo 2 of 3 : UCIP_FA_2018_51796_69029.jpg

Comment Code						
Inspector Comment						
FS_ID:51796 DS_ID:17191 EP_NO: N/A Repair Type: Non-Urgent Crossing Status: Found UCIP Comments: 5/2/2017 WS headwall and flapgate almost completely buried with only a small portion of the head wall visible. LS end is buried and unable to be located. (DWR Sutter Yard-AFreitag)10/17/2016 WS flap gate is still silted over and LS inlet is heavily vegetated and unable to be inspected. (DWR Sutter Yard-AFreitag)9/29/2016 Crosssing has been downgraded from Urgent to Non-Urgent WS flap gate is closed shut due to sediment build up. For flood season flap gate is required to be closed. Need to coordinate with owner to remove sediment from WS to have WS flap gate be operable after flood season. (DWR UCIP - omagana)5/31/2016 WS pipe end was mostly underwater but it appears to still be silted over. (DWR Sutter Yard - afreitag)5/4/2015 WS flapgate is blocked by sediment and unable to open. LS inlet is hidden by sediment and heavy vegetation and unable to be located. Needs to be cleared. (DWR Sutter Yard - afreitag)6/17/2014 Same as last inspection. (DWR Sutter Yard - afreitag)12/16/2013 Same as last inspection. (DWR Sutter Yard - afreitag)7/16/2013 Same as last inspection. (DWR Sutter Yard - afreitag)10/11/2012 Pipe is clogged at both the inlet and outlet. Good candidate for video inspection. (DWR UCIP - wwylie) FIELD_STRUCT_DESC: 48-inch corrugated metal drainage pipe through the levee, approximately 15 feet below the crown. Concrete headwalls on both the waterside (WS) and the landside (LS) ends with an automatic drainage gate on the WS. [Additional Reference(s): USACE Sacramento O&M Manual 132, October 1959, (HLM 5.12)]. FS Date: 5/2/2017 2:31:39 PM

Outlet on WS toe.

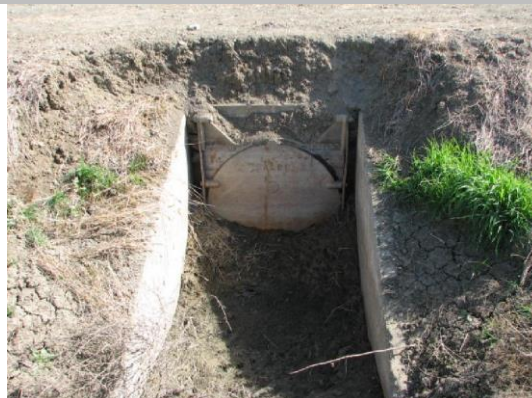
Photo 3 of 3 : UCIP_FA_2018_51796_69028.jpg

Comment Code						
Inspector Comment						
FS_ID:51796 DS_ID:17191 EP_NO: N/A Repair Type: Non-Urgent Crossing Status: Found UCIP Comments: 5/2/2017 WS headwall and flapgate almost completely buried with only a small portion of the head wall visible. LS end is buried and unable to be located. (DWR Sutter Yard-AFreitag)10/17/2016 WS flap gate is still silted over and LS inlet is heavily vegetated and unable to be inspected. (DWR Sutter Yard-AFreitag)9/29/2016 Crosssing has been downgraded from Urgent to Non-Urgent WS flap gate is closed shut due to sediment build up. For flood season flap gate is required to be closed. Need to coordinate with owner to remove sediment from WS to have WS flap gate be operable after flood season. (DWR UCIP - omagana)5/31/2016 WS pipe end was mostly underwater but it appears to still be silted over. (DWR Sutter Yard - afreitag)5/4/2015 WS flapgate is blocked by sediment and unable to open. LS inlet is hidden by sediment and heavy vegetation and unable to be located. Needs to be cleared. (DWR Sutter Yard - afreitag)6/17/2014 Same as last inspection. (DWR Sutter Yard - afreitag)12/16/2013 Same as last inspection. (DWR Sutter Yard - afreitag)7/16/2013 Same as last inspection. (DWR Sutter Yard - afreitag)10/11/2012 Pipe is clogged at both the inlet and outlet. Good candidate for video inspection. (DWR UCIP - wwylie) FIELD_STRUCT_DESC: 48-inch corrugated metal drainage pipe through the levee, approximately 15 feet below the crown. Concrete headwalls on both the waterside (WS) and the landside (LS) ends with an automatic drainage gate on the WS. [Additional Reference(s): USACE Sacramento O&M Manual 132, October 1959, (HLM 5.12)]. FS Date: 5/2/2017 2:31:39 PM

Concrete U shaped headwall and flap gate on WS toe.

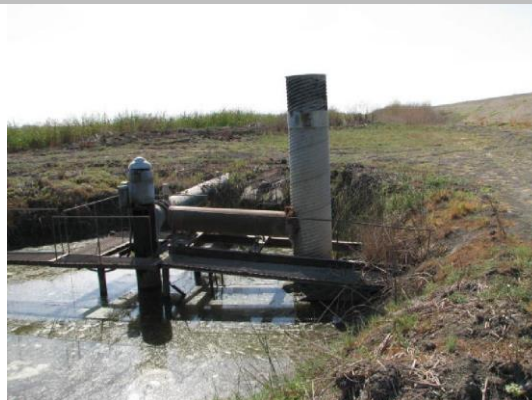
Photo 1 of 3 : UCIP_FA_2018_51797_69034.jpg

FS_ID:51797
DS_ID:17190
EP_NO: N/A
Repair Type: No Action Needed
Crossing Status: Found
UCIP Comments: 5/2/2017 Crossing appears to be in good condition. (DWR Sutter Yard- AFreitag)10/17/2016 Crossing appears to be in good condition. Pipe was field verified to be 48inch cmp. (DWR Sutter Yard- AFreitag)5/31/2016 Crossing appears to be in good condition.5/4/2015 Corssing appears to be in good condition. No noticeable issues to report.6/17/2014 Same as last inspection.12/16/2013 Same as last inspection.7/16/2013 Same as last inspection.
FIELD_STRUCT_DESC: 48-inch corrugated metal drainage pipe through the levee, approximately 22 feet below the crown. Concrete headwalls at both the waterside (WS) and the landside (LS) ends with flap gate on the WS. 36-inch corrugated metal pipe (CMP) riser on the LS toe with steel pipe extension for overflow weir of LS ditch. Walkway and pump not associated with this crossing. (Automatic board order (ABO) issued as Permit No. 8234, 1972 - Glenn Irrigation District, for 36-inch, not 48-inch). [Additional Reference(s): USACE Sacramento O&M Manual 132, October 1959, (HLM 6.04, Drawing No. 50-4-3081, Sheet 16)].

36-inch CM standpipe with steel pipe extension for weir on LS toe. pump not associated with storm drain crossing.

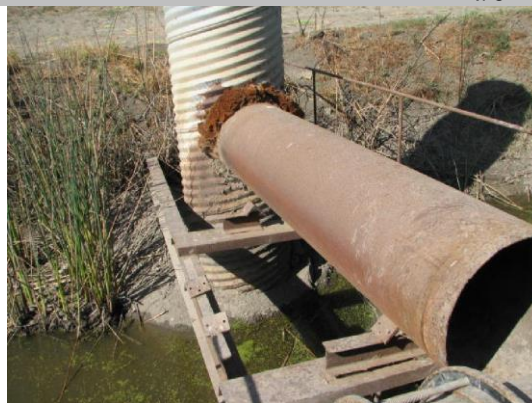
Photo 2 of 3 : UCIP_FA_2018_51797_69033.jpg

36-inch CM standpipe with steel pipe extension for weir on LS toe.

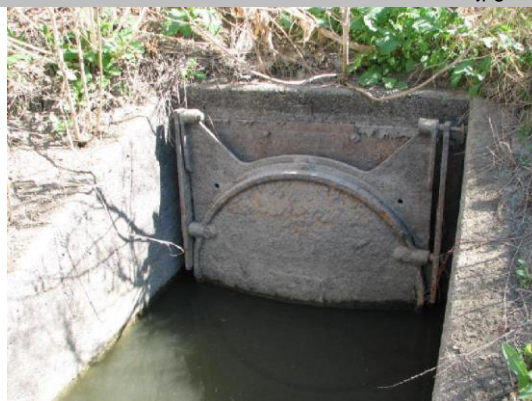
Photo 3 of 3 : UCIP_FA_2018_51797_69032.jpg

Flap gate in concrete U-shaped headwall at WS toe.

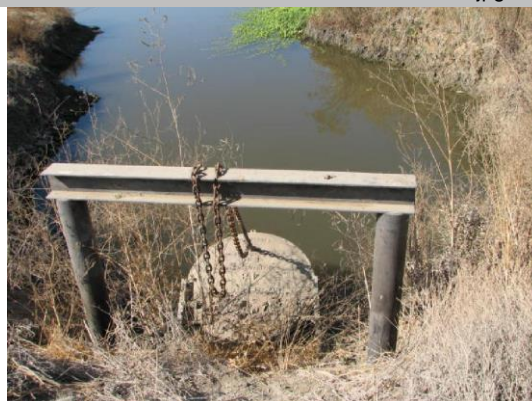
Photo 1 of 3 : UCIP_FA_2018_51798_69042.jpg

48-inch flap gate on WS toe.

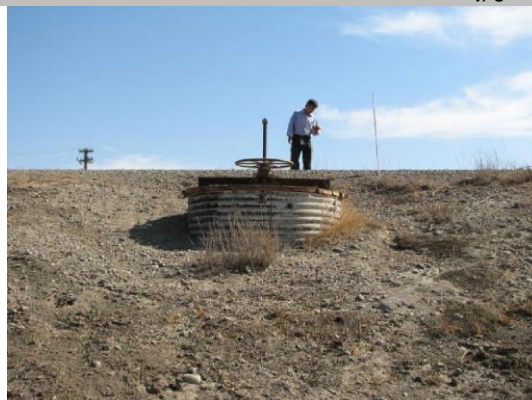
Photo 2 of 3 : UCIP_FA_2018_51798_69041.jpg

60-inch CMP riser with slide gate on WS slope.

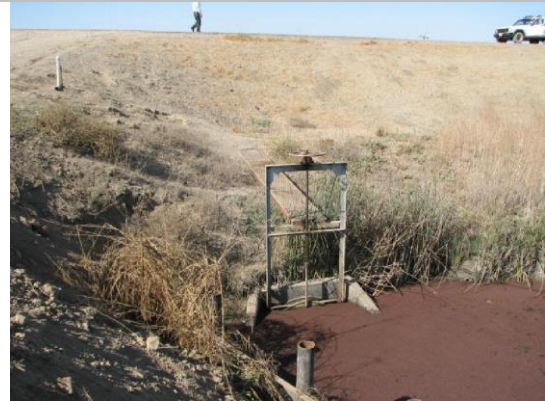
Photo 3 of 3 : UCIP_FA_2018_51798_69040.jpg

Concrete headwall with slide gate at LS toe.

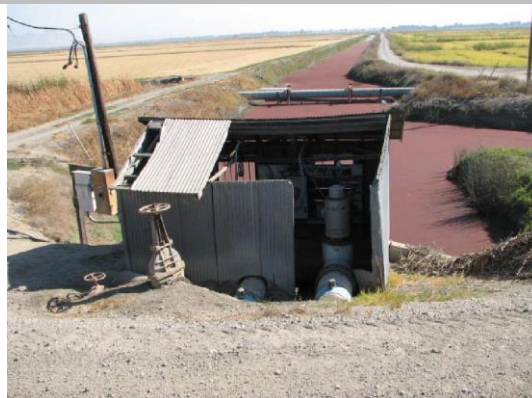
Photo 1 of 3 : UCIP_FA_2018_51803_69081.jpg

Pump house on LS slope.

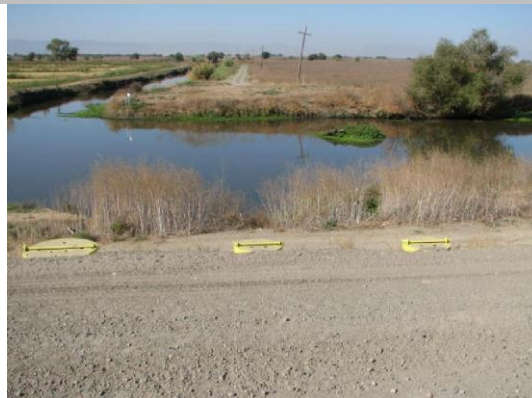
Photo 2 of 3 : UCIP_FA_2018_51803_69080.jpg

Siphon breaker on WS shoulder.

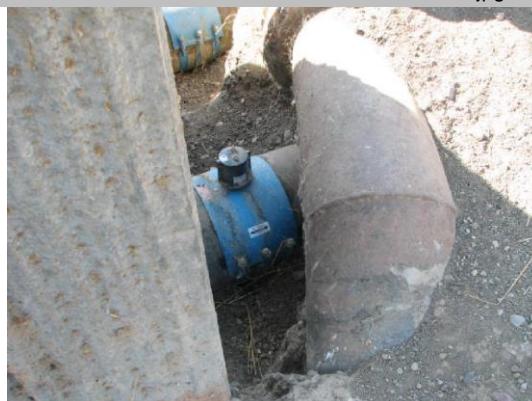
Photo 3 of 3 : UCIP_FA_2018_51803_69079.jpg

Pipe at exit from pumphouse.

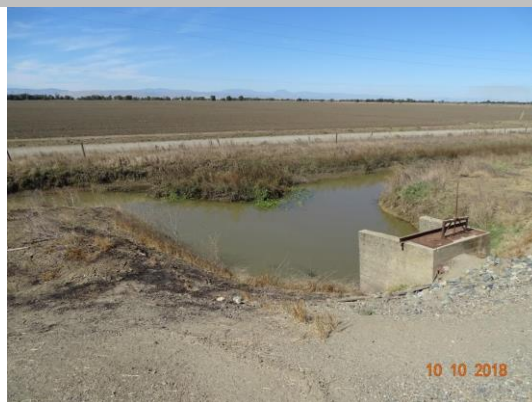
Photo 1 of 2 : FA_2018_MA0012_299_35_20181011_00086.jpg

View of diversion structure. Fall 2018.

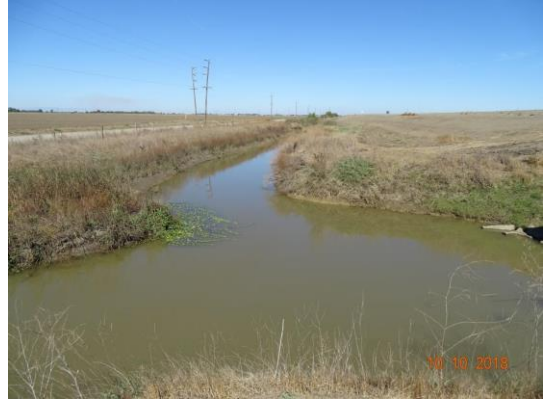
Photo 2 of 2 : FA_2018_MA0012_299_35_20181011_00088.jpg

Upstream view of Colusa Basin from the diversion structure. Fall 2018.

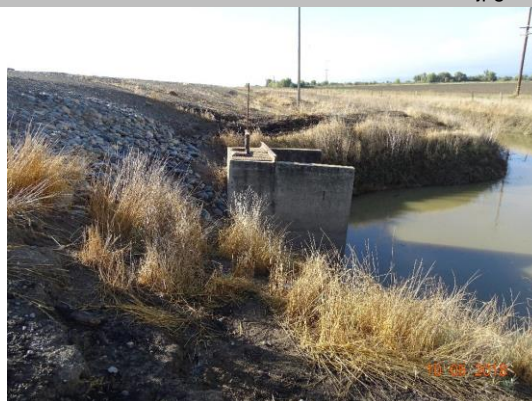
Photo 1 of 3 : UCIP_FA_2018_53012_78206.jpg

Headwall at WS toe.

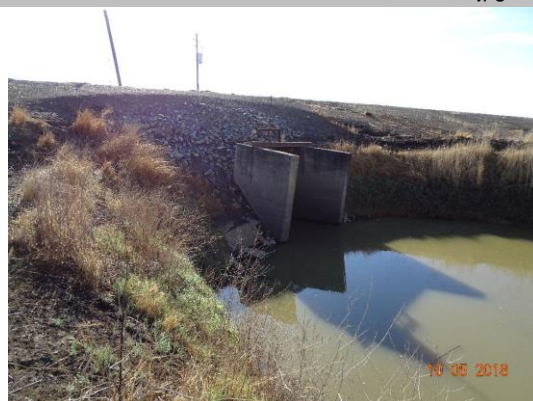
Photo 2 of 3 : UCIP_FA_2018_53012_78208.jpg

Overview of headwall at WS toe.

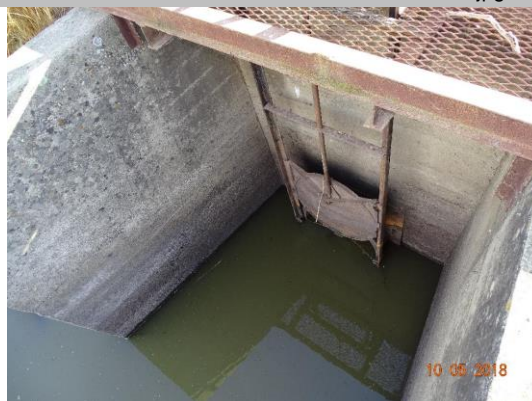
Photo 3 of 3 : UCIP_FA_2018_53012_78209.jpg

Inside view of concrete headwall and slidegate at WS toe.

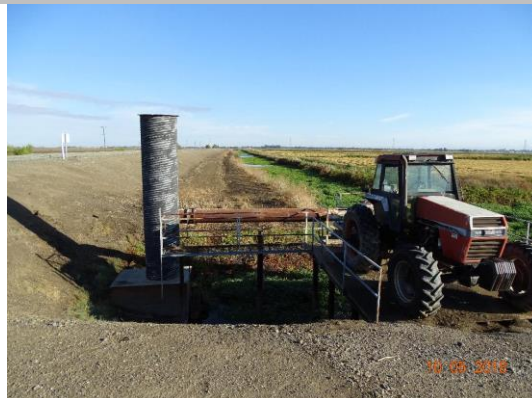
Photo 1 of 3 : UCIP_FA_2018_53013_78165.jpg

Repair Type: Urgent

Pumping plant at LS toe.

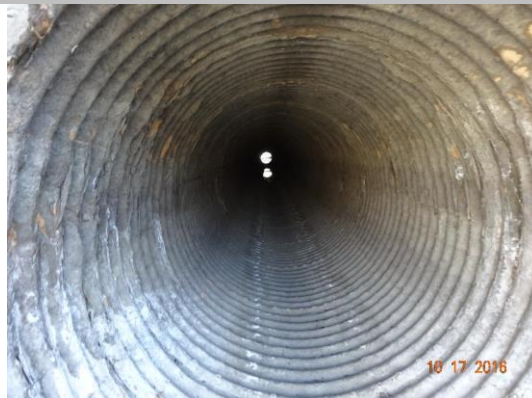
Photo 2 of 3 : UCIP_FA_2018_53013_76060.jpg

Repair Type: Urgent

View inside of pipe from the WS

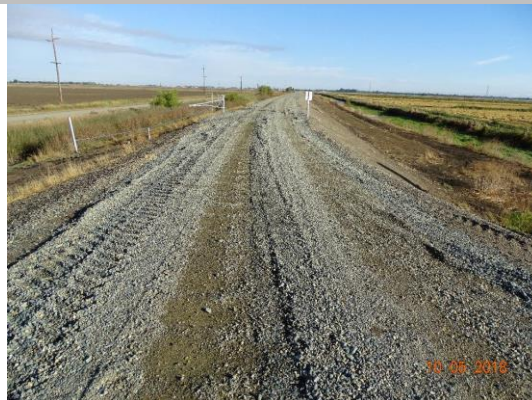
Photo 3 of 3 : UCIP_FA_2018_53013_78159.jpg

View of levee crown at crossing.

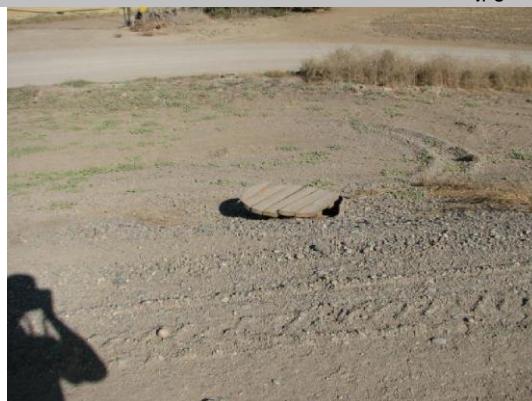
Photo 1 of 2 : UCIP_FA_2018_51810_69115.jpg

cover on 36-inch CMP standpipe on WS slope.

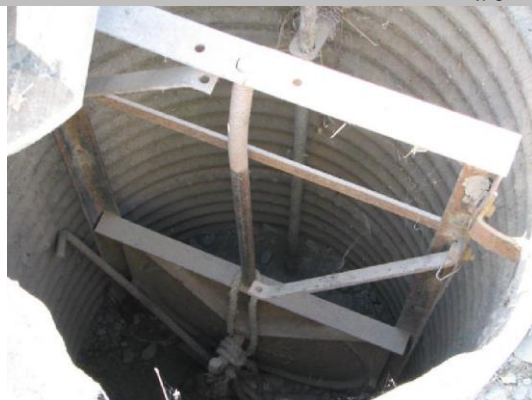
Photo 2 of 2 : UCIP_FA_2018_51810_69114.jpg

Bent and broken actuator on slide gate in 36-inch CMP. Pipe appears to be filled with soil.
