**Flood Control Project Maintenance
Levee Inspections**

Maintenance Issue Types Only, Levee Inspection Report By Mile - Fall 2019

Sutter Maintenance Yard Maintenance Area 0012

Waterway	Bank	Unit Miles	Inspection Start/End	Inspector
Unit No. 01 Colusa Drain	Left	11.06	10/09/2019 10/09/2019	Zach Jojola

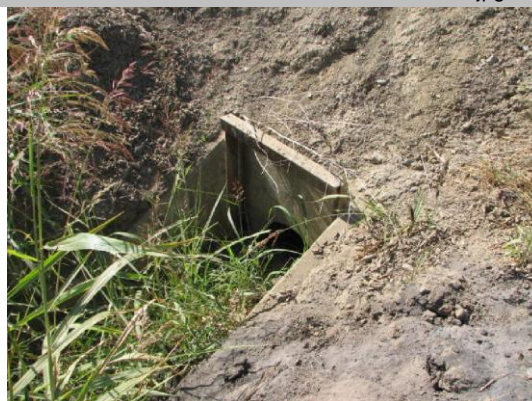
Photo 3 of 3 : UCIP_FA_2019_51782_68982.jpg

Concrete U shaped headwall at LS inlet.

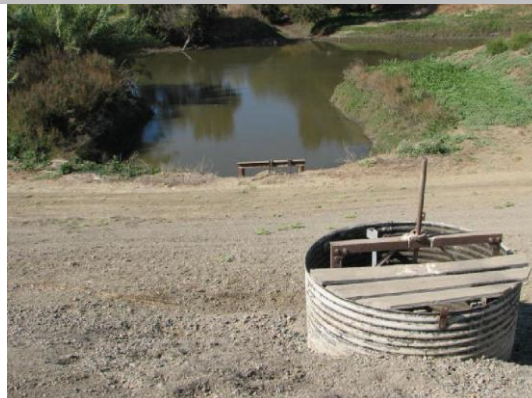
Photo 2 of 3 : UCIP_FA_2019_54536_69005.jpg

DS_ID:17154
FS_ID:54536
EP_NO: 9388
Repair Type: Non-Urgent
Crossing Status: Found
UCIP Comments: 10/5/2018 Fall hazard: missing cover on CMP riser. Closure devices are present on both ends of crossing and seem to be in operable condition. Downgraded to non-urgent. Recommend owner add cover to CMP riser. (O.Yakimov - DWR UCIP)5/2/2017 WS slidegate stem is still bent, wheel to operate gate is missing. Needs a cover made for the standpipe to prevent falls. (DWR Sutter Yard- AFreitag)10/17/2016 Slide gate stem is still and the gate appears to be inoperable. (DWR Sutter Yard- AFreitag)5/31/2016 Slide gate stem is still bent. WS flap gate is chained open. (DWR Sutter Yard - afreitag)5/4/2015 Slide gate stem is still bent. Gate looks to be unable to close all the way. (DWR Sutter Yard - afreitag)6/17/2014 Same as last inspection. (DWR Sutter Yard - afreitag)12/16/2013 Slide gate stem is still bent. WS flapgate was closed. (DWR Sutter Yard - afreitag)7/16/2013 Water flowing through pipe so screw gate definitely not closed. Was told NOV's have been sent for owner to replace stem. Flap gate gets closed for flood season. (DWR Sutter Yard - afreitag)10/11/2012 Slide gate inoperable, but appears to be in closed position. Flap gate held in open position. Good candidate for video inspection when, if ever, dry. (DWR UCIP - wwyllie)

Slide gate in corrugated metal riser on WS slope.

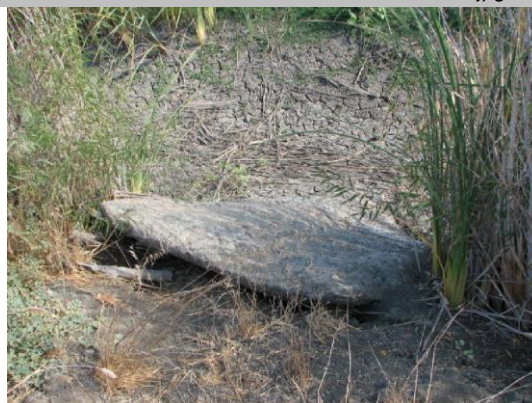
Photo 1 of 3 : UCIP_FA_2019_51796_69030.jpg

DS_ID:17191
FS_ID:51796
EP_NO: N/A
Repair Type: Non-Urgent
Crossing Status: Found
UCIP Comments: 5/2/2017 WS headwall and flapgate almost completely buried with only a small portion of the head wall visible. LS end is buried and unable to be located. (DWR Sutter Yard-AFreitag)10/17/2016 WS flap gate is still silted over and LS inlet is heavily vegetated and unable to be inspected. (DWR Sutter Yard-AFreitag)9/29/2016 Crosssing has been downgraded from Urgent to Non-Urgent WS flap gate is closed shut due to sediment build up. For flood season flap gate is required to be closed. Need to coordinate with owner to remove sediment from WS to have WS flap gate be operable after flood season. (DWR UCIP - omagana)5/31/2016 WS pipe end was mostly underwater but it appears to still be silted over. (DWR Sutter Yard - afreitag)5/4/2015 WS flapgate is blocked by sediment and unable to open. LS inlet is hidden by sediment and heavy vegetation and unable to be located. Needs to be cleared. (DWR Sutter Yard - afreitag)6/17/2014 Same as last inspection. (DWR Sutter Yard - afreitag)12/16/2013 Same as last inspection. (DWR Sutter Yard - afreitag)7/16/2013 Same as last inspection. (DWR Sutter Yard - afreitag)10/11/2012 Pipe is clogged at both the inlet and outlet. Good candidate for video inspection. (DWR UCIP - wwylie)

Apparent inlet clogged with concrete or grout on LS toe in drainage swale.

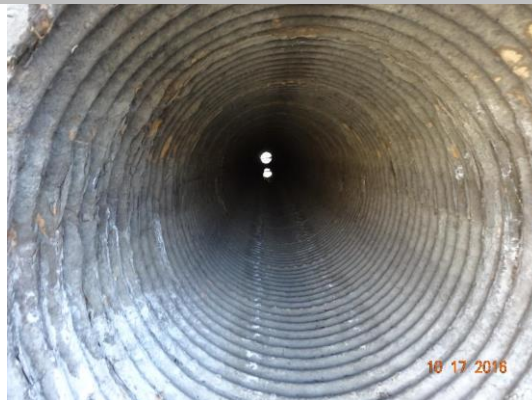
Photo 2 of 3 : UCIP_FA_2019_53013_76060.jpg

View inside of pipe from the WS

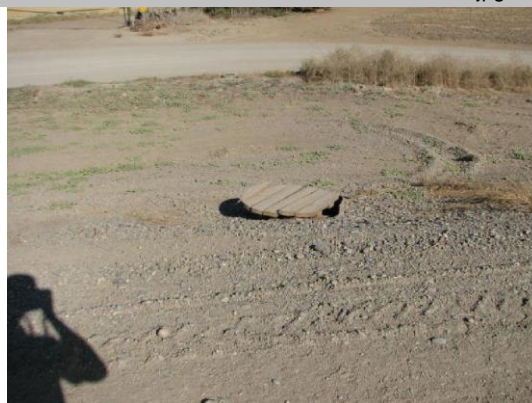
Photo 1 of 2 : UCIP_FA_2019_51810_69115.jpg

cover on 36-inch CMP standpipe on WS slope.

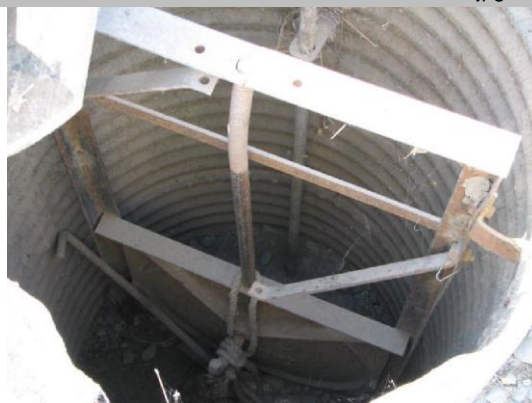
Photo 2 of 2 : UCIP_FA_2019_51810_69114.jpg

Bent and broken actuator on slide gate in 36-inch CMP. Pipe appears to be filled with soil.
