**Flood Control Project Maintenance  
Levee Inspections**

**Maintenance Issue Types Only, Levee Inspection Report By Mile - Fall 2020**

**Sutter Maintenance Yard Maintenance Area 0012**

Waterway	Bank	Unit Miles	Inspection Start/End	Inspector
Unit No. 01 Colusa Drain	Left	11.06	09/23/2020 09/23/2020	Zach Jojola

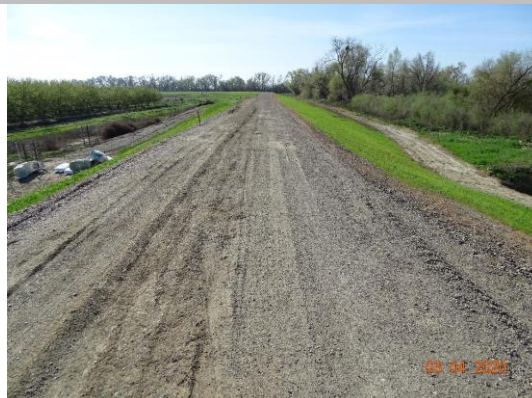
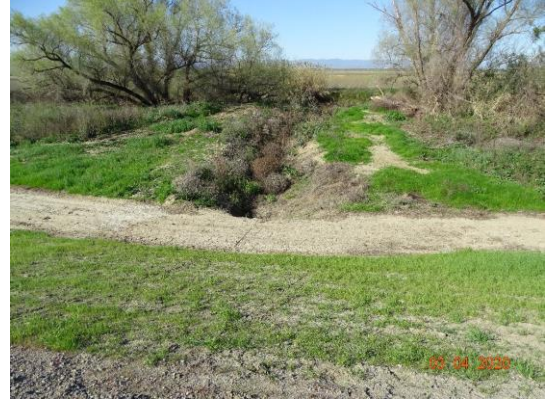
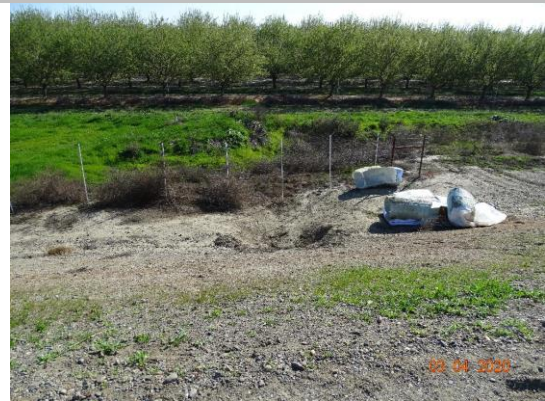
Photo 1 of 3 : UCIP\_FA\_2020\_57222\_83449.jpg

DS\_ID:17146  
FS\_ID:57222  
EP\_NO: 9385  
Repair Type: Urgent  
EVAL Issue: Flood Risk  
Crossing Status: Found  
UCIP Comments: 03/04/2020 Record updated from Non-Urgent to Urgent. Pipe has been CIPP-lined under the DWR DMP Phase 2 Project. Flap gate not closing properly posing flood risk to the landside during flood season. LMA needs to repair or replace flap gate. Need to have CVFPB review ABO and determine current owner. (O.Yakimov - DWR UCIP)  
05/02/2017 WS is in good condition. LS inlet is more than 50% full of sediment. Pipe needs to be cleaned internally. (A.Freitag - DWR Sutter Yard)  
10/17/2016 Minor sediment blocking the WS flap gate from opening. LS inlet still mostly full of sediment. (A.Freitag - DWR Sutter Yard)09/29/2016 Crossing has been downgraded from Urgent to Non-Urgent WS flap gate is closed for flood season. Need to coordinate with owner to remove sediment blocking WS flap gate. (O.Magana - DWR UCIP)

Levee crown at the crossing

View of WS looking from levee crown

View of LS looking from levee crown

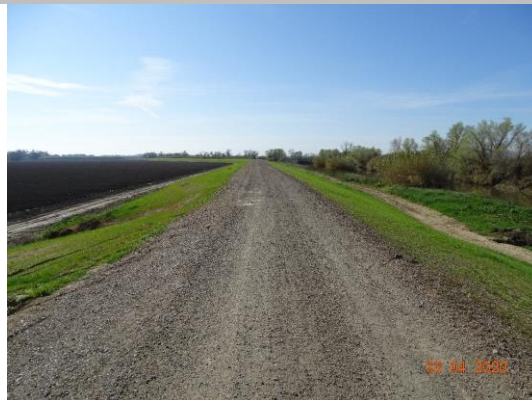
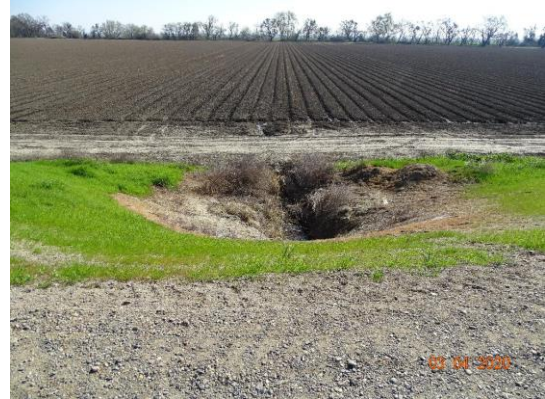
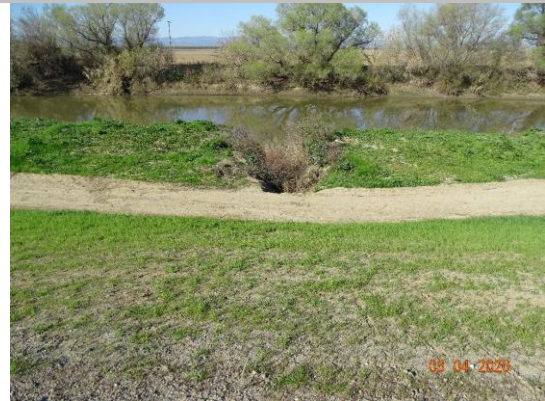
Photo 1 of 3 : UCIP\_FA\_2020\_57190\_83458.jpg

DS\_ID:17147  
FS\_ID:57190  
EP\_NO: 9382  
Repair Type: Non-Urgent  
EVAL Issue: Unauthorized Encroachment, installed decades prior  
Crossing Status: Found  
UCIP Comments: 03/04/2020 Record updated from No Action Needed to Non-Urgent. Pipe has been CIPP-lined under the DWR DMP Phase 2 Project. Need to have CVFPB review ABO and determine current owner. (O.Yakimov - DWR UCIP) 05/02/2017 Crossing appears to be in good condition. (A.Freitag - DWR Sutter Yard)10/17/2016 Crossing appears to be in good condition. This is a gravity for the LS. (A.Freitag - DWR Sutter Yard)05/31/2016 Crossing appears to be in good condition. (A.Freitag - DWR Sutter Yard)05/04/2015 Crossing is in good condition. No issues. (A.Freitag - DWR Sutter Yard)06/17/2014 Same as last inspection. (A.Freitag - DWR Sutter Yard)12/16/2013 Same as last inspection. (A.Freitag - DWR Sutter Yard)07/16/2013 Same as last inspection. (A.Freitag - DWR Sutter Yard)

Levee crown at the crossing

View of LS looking from levee crown

View of WS looking from levee crown

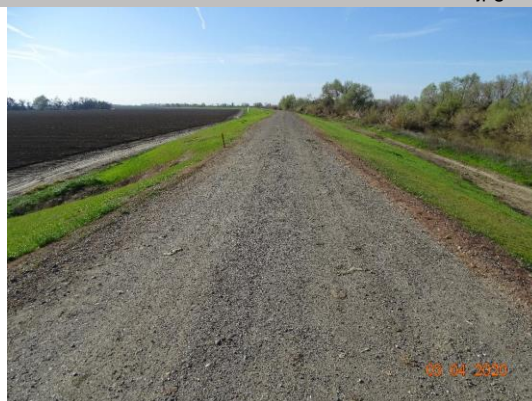
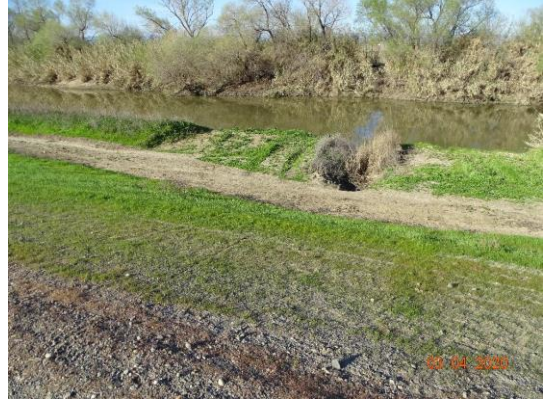
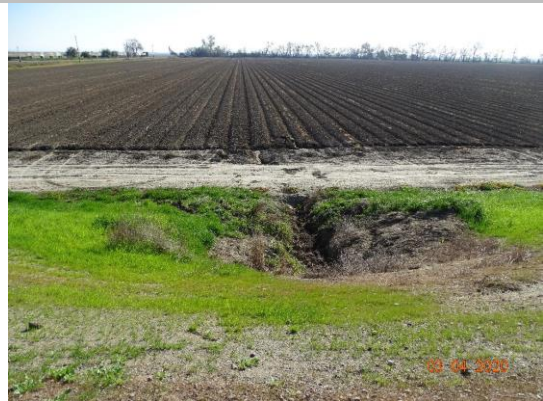
Photo 1 of 3 : UCIP\_FA\_2020\_57224\_83473.jpg

DS\_ID:17149  
FS\_ID:57224  
EP\_NO: 9382  
Repair Type: Non-Urgent  
EVAL Issue: Unauthorized Encroachment, installed decades prior  
Crossing Status: Found  
UCIP Comments: 03/04/2020 Record remains Non-Urgent. Pipe has been CIPP-lined and new flap gate installed under the DWR DMP Phase 2 Project. Vegetation around flap gate was cleared. Need to have CVFPB review ABO and determine current owner. (O.Yakimov - DWR UCIP) 05/02/2017 WS flapgate buried by sediment. Needs to be dug out. (A.Freitag - DWR Sutter Yard)10/17/2016 Crossing appears to be in good condition. This is a gravity drain for the LS. (A.Freitag - DWR Sutter Yard)05/31/2016 LS inlets was partially plugged. WS flapgate was clear of sediment and able to operate properly. (A.Freitag - DWR Sutter Yard)05/04/2015 WS flapgate is blocked by sediment and unable to open. LS inlet is plugged by silt and wood chippings. Needs to be cleaned. (A.Freitag - DWR Sutter Yard)06/17/2014 Flap gate was cleaned out and is fully closed. LS inlet still partially full of soil. (A.Freitag - DWR Sutter Yard)12/16/2013 Same as last inspection. WS flapgate still needs to be cleaned out and shut. (A.Freitag - DWR Sutter Yard)07/16/2013 Same as last inspection. Make sure flapgate is closed before highwater season. (A.Freitag - DWR Sutter Yard)10/11/2012 Inlet on LS filled partially with soil. Outlet blocked with soil and the flap gate won't close. (W.Wylie - DWR UCIP)

View of levee crown at the crossing looking downstream

View of WS looking from levee crown

View of LS looking from levee crown

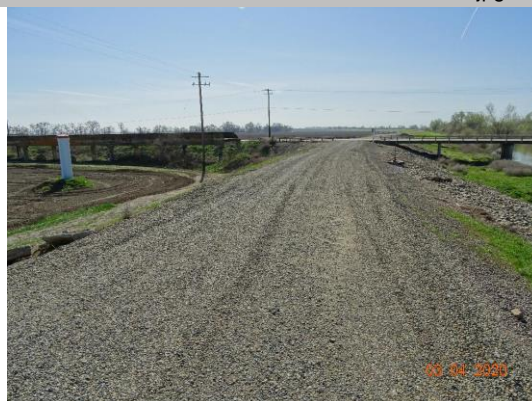
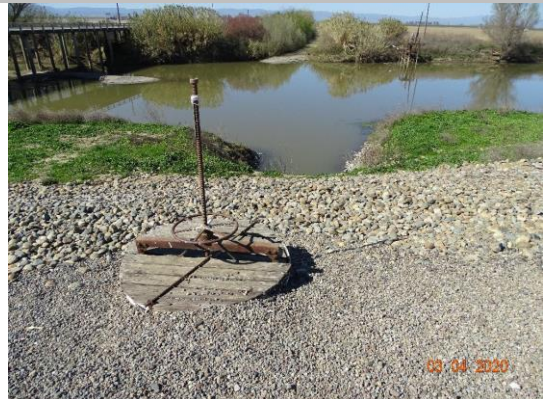
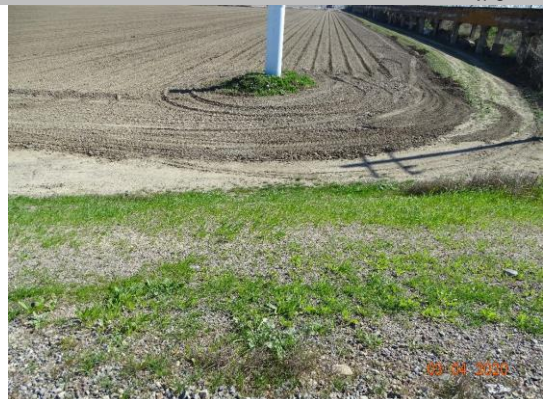
Photo 1 of 3 : UCIP\_FA\_2020\_57227\_83485.jpg

DS\_ID:17150  
FS\_ID:57227  
EP\_NO: 9387  
Repair Type: Urgent  
EVAL Issue: Flood Risk  
Crossing Status: Found  
UCIP Comments: 03/04/2020 Record updated from No Action Needed to Urgent. Flap gate at WS levee toe not closing tightly leaving a gap for water to enter a part of crossing up to slide gate. Since slide gate on WS shoulder is in open position, this can pose flood risk to the landside during high water events. Recommend LMA to repair flap gate before next flood season. Pipe inlet near LS levee toe not found. Crossing appears abandoned. Concrete standpipe observed on landside 1,400 feet east of levee that seem to belong to the drainage system. Abandoned pump in irrigation/drainage canal 1,750 feet east of levee found. Recommend geophysical study to determine alignment of pipe through the levee. Need to have CVFPB review ABO and determine current owner. Need to contact owner to determine status of crossing. (O.Yakimov - DWR UCIP)05/02/2017 Crossing appears to be in good condition. (A.Freitag - DWR Sutter Yard)10/17/2016 Crossing appears to be in good condition. (A.Freitag - DWR Sutter Yard)05/31/2016 Crossing appears to be in good condition. Attached photo showing location of LS inlet. (A.Freitag - DWR Sutter Yard)05/04/2015 WS flapgate mostly underwater but could tell it was blocked open by something. LS inlet is located about 1/4 mile north along the side of the roadway. (A.Freitag - DWR Sutter Yard)06/17/2014 Same as last inspection. (A.Freitag - DWR Sutter Yard)12/16/2013 Pipe was flowing water and flap gate was being pushed open. Cannot verify if it will close all the way. (A.Freitag - DWR Sutter Yard)07/16/2013 Same as last inspection. Was told inlet is about 1/4 mile down road way next to house. Will try to get coordinates for inlet. (A.Freitag - DWR Sutter Yard)10/11/2012 No inlet could be located on LS. Flap gate partially blocked and will not close completely. (W.Wylie - DWR UCIP)

View of levee crown at crossing looking downstream

60-inch standpipe with slide gate on WS slope with outlet in background.

View of LS slope looking from levee crown. PVC pipe in the field doesn't belong to this crossing

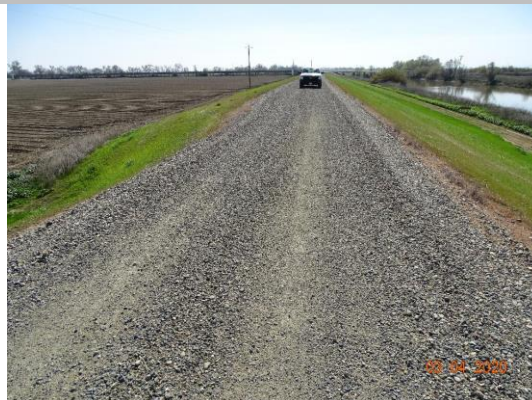
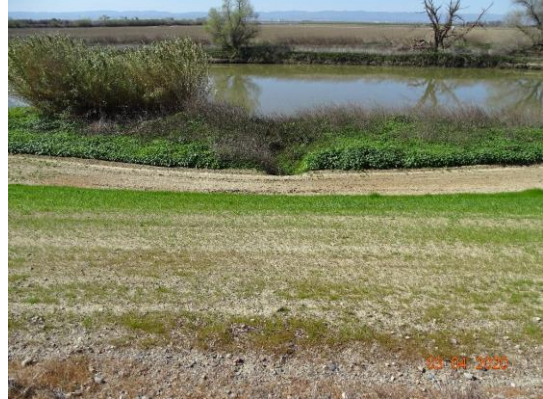
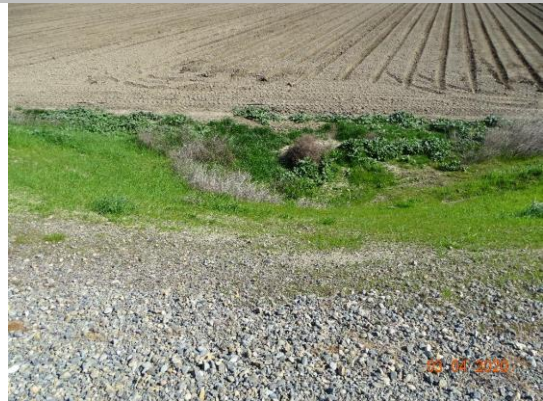
Photo 1 of 3 : UCIP\_FA\_2020\_57228\_83501.jpg

UCIP Comments: 03/04/2020 Record remains Non-Urgent. Need to have CVFPB review ABO and determine current owner. Crossing appears abandoned. Both end of crossing are buried. Recommend performing maintenance of the crossing. (O.Yakimov - DWR UCIP)

View of levee crown at the crossing looking downstream

View of WS looking from levee crown

View of LS looking from levee crown

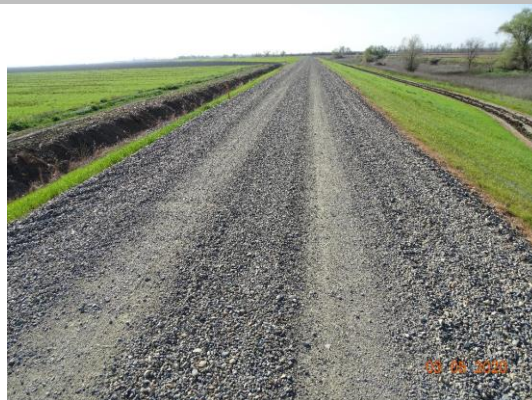
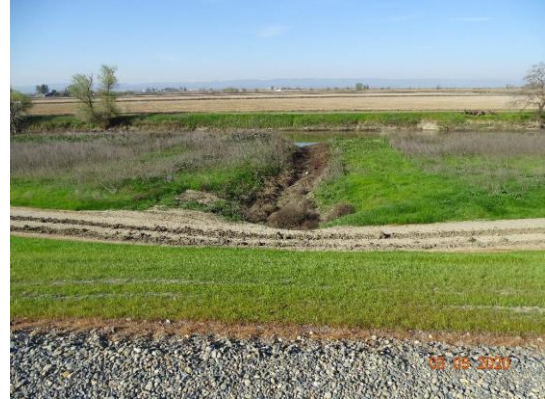
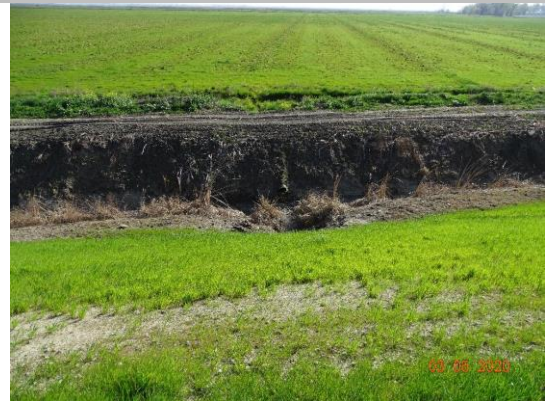
Photo 1 of 3 : UCIP\_FA\_2020\_57195\_83514.jpg

DS\_ID:17153  
FS\_ID:57195  
EP\_NO: 9384  
Repair Type: Non-Urgent  
EVAL Issue: Maintenance Compliance Issue  
Crossing Status: Found  
UCIP Comments: 03/05/2020 Record updated from No Action Needed to Non-Urgent. Sediment at LS headwall, vegetation at WS headwall need to be cleared. Need to have CVFPB review ABO and determine current owner. (O.Yakimov - DWR UCIP)05/02/2017 Crossing appears to be in good condition. (A.Freitag - DWR Sutter Yard)10/17/2016 Crossing appears to be in good condition. (A.Freitag - DWR Sutter Yard)05/31/2016 Crossing appears to be in good condition. (A.Freitag - DWR Sutter Yard)05/04/2015 Crossing appears in good condition. No noticeable issues. (A.Freitag - DWR Sutter Yard)06/17/2014 Same as last inspection. (A.Freitag - DWR Sutter Yard)12/16/2013 Same as last inspection. (A.Freitag - DWR Sutter Yard)07/16/2013 Same as last inspection. (A.Freitag - DWR Sutter Yard)

View of levee crown at the crossing

View of WS looking from levee crown

View of LS looking from levee crown

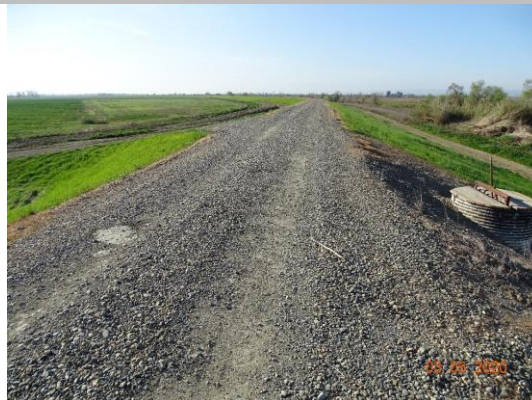
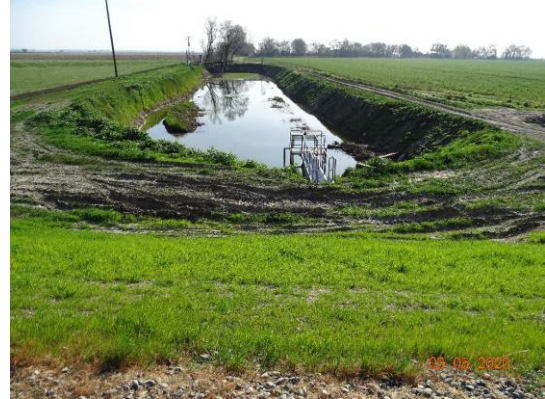
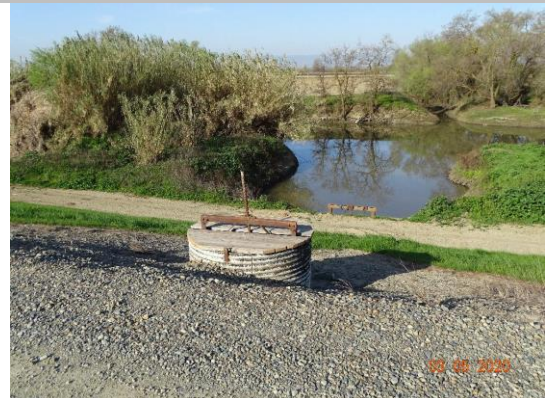
Photo 1 of 3 : UCIP\_FA\_2020\_57196\_83526.jpg

DS\_ID:17154  
FS\_ID:57196  
EP\_NO: 9388  
Repair Type: Non-Urgent  
EVAL Issue: Unauthorized Modification or Non-Compliant Permit  
Crossing Status: Found  
UCIP Comments: 03/05/2020 Record remains Non-Urgent. New cover on CMP riser has been installed. Piping around slide gate at LS toe was modified, new 14-inch pipes installed. Unable to locate a permit for system modification. New steel walkway to slide gate on LS. Need to coordinate with LMA for find a permit authorizing modification. Need to have CVFPB review ABO and determine current owner. (O.Yakimov - DWR UCIP)  
10/05/2018 Fall hazard: missing cover on CMP riser. Closure devices are present on both ends of crossing and seem to be in operable condition. Downgraded to non-urgent. Recommend owner add cover to CMP riser. (O.Yakimov - DWR UCIP)  
05/02/2017 WS slide gate stem is still bent, wheel to operate gate is missing. Needs a cover made for the standpipe to prevent falls. (A.Freitag - DWR Sutter Yard)10/17/2016 Slide gate stem is still and the gate appears to be inoperable. (A.Freitag - DWR Sutter Yard)05/31/2016 Slide gate stem is still bent. WS flap gate is chained open. (A.Freitag - DWR Sutter Yard)

05/04/2015 Slide gate stem is still bent. Gate looks to be unable to close all the way. (A.Freitag - DWR Sutter Yard)06/17/2014 Same as last inspection. (A.Freitag - DWR Sutter Yard)12/16/2013 Slide gate stem is still bent. WS flapgate was closed. (A.Freitag - DWR Sutter Yard)  
07/16/2013 Water flowing through pipe so screw gate definitely not closed. Was told NOV's have been sent for owner to replace stem. Flap gate gets closed for flood season. (A.Freitag - DWR Sutter Yard) 10/11/2012 Slide gate inoperable, but appears to be in closed position. Flap gate held in open position. Good candidate for video inspection when, if ever, dry. (W.Wylie - DWR UCIP)  
FIELD\_STRUCT\_DESC: 48-inch corrugated metal drainage pipe through the levee, 28 feet below the crown. Slide gate in a 66-inch riser on the waterside (WS) slope. Concrete headwall on the WS. Grouted cobble spillway from drainage ditch to large canal on the landside (LS). (48-inch pipe [HLM 3.78] authorized under Automatic Board Order (ABO) issued as Permit No. 9388, 1974 - Pauline A. Wallace; 48-inch pipe [HLM 3.78] was also authorized under Automatic Board Order (ABO) issued as Permit No. 8231, 1972 - Roy E. Kitts). [Additional Reference(s): DWR Levee Log, 2005 (HLM 3.78). USACE Sacramento O&M Manual, Unit 132, October 1959, Revised 14 January 2019, (HLM 3.78), listed as 48-inch pipe. USACE As-Built Drawing No. 50-4-3081, Sheet 5 and 15, Station 1524+75, 4 April 1957].

View of levee crown at the crossing looking downstream

View of LS looking from levee crown

View of WS looking from levee crown. CMP riser with slide gate on WS shoulder

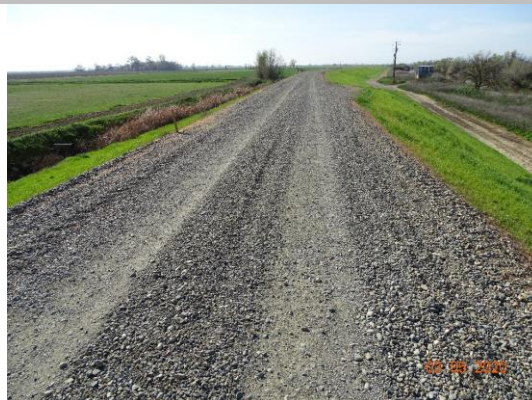
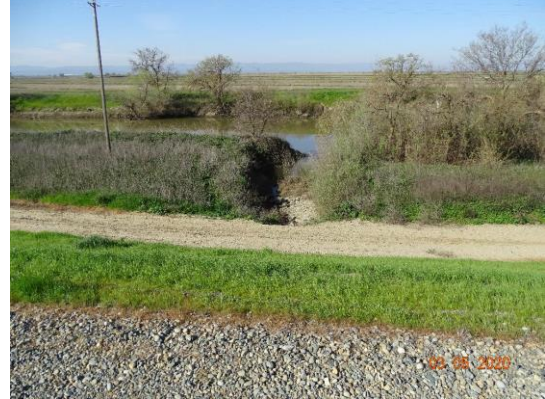
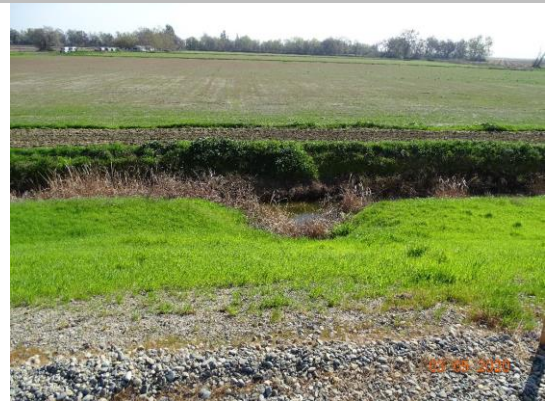
Photo 1 of 3 : UCIP\_FA\_2020\_57229\_83531.jpg

DS\_ID:17168  
FS\_ID:57229  
EP\_NO: 9388  
Repair Type: Non-Urgent  
EVAL Issue: Unauthorized Encroachment, installed decades prior  
Crossing Status: Found  
UCIP Comments: 03/05/2020 Record updated from No Action Needed to Non-Urgent. Need to have CVFPB review ABO and determine current owner. (O.Yakimov - DWR UCIP)05/02/2017 Crossing appears to be in good condition. (A.Freitag - DWR Sutter Yard)

10/17/2016 Crossing appears to be in good condition. (A.Freitag - DWR Sutter Yard)05/31/2016 Crossing appears to be in good condition. (A.Freitag - DWR Sutter Yard)05/04/2015 Crossing appears to be in good condition. No noticeable issues to report. (A.Freitag - DWR Sutter Yard)06/17/2014 Same as last inspection. (A.Freitag - DWR Sutter Yard)12/16/2013 Same as last inspection. (A.Freitag - DWR Sutter Yard)07/16/2013 Same as last inspection. (A.Freitag - DWR Sutter Yard)  
FIELD\_STRUCT\_DESC: 36-inch corrugated metal drainage pipe through the levee, 27.5 feet below the crown. Flap gate, concrete headwall, and grouted cobble spillway located on the waterside (WS). Concrete headwall located on the landside (LS). (24-inch pipe [HLM 4.25] authorized under Automatic Board Order (ABO) issued as Permit No. 9388, 1974 - Pauline A. Wallace; 24-inch pipe [HLM 4.25] was also authorized under Automatic Board Order (ABO) issued as Permit No. 8232, 1972 - Pauline Wallace Estates). [Additional Reference(s): DWR Levee Log, 2005 (HLM 4.25). USACE Sacramento O&M Manual, Unit 132, October 1959, Revised 14 January 2019, (HLM 4.25), listed as 36-inch pipe. USACE As-Built Drawing No. 50-4-3081, Sheet 6 and 16, Station 1548+95, 4 April 1957].

View of levee crown at the crossing looking downstream

View of WS looking from levee crown

View of LS looking from levee crown

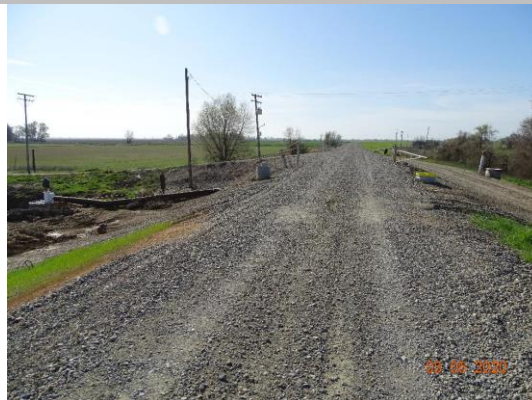
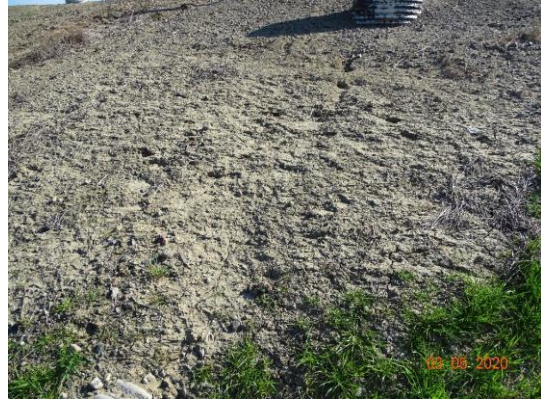
Photo 1 of 3 : UCIP\_FA\_2020\_57199\_83540.jpg

DS\_ID:17156  
FS\_ID:57199  
EP\_NO: 9388  
Repair Type: Non-Urgent  
EVAL Issue: Unauthorized Modification or Non-Compliant Permit  
Crossing Status: Found  
UCIP Comments: 03/05/2020 Record updated from No Action Needed to Non-Urgent. Modifications to the system done: 24-inch steel pipe connected to a CMP pipe at LS toe, pump in irrigation canal on LS. Unable to find pump system in O&M drawings. Steel pipe is currently disconnected from the pump in irrigation canal. Unable to locate a permit authorizing modifications. Need to have CVFPB review ABO and determine current owner. Pipe outlet on WS not found due to dense vegetation. (O.Yakimov - DWR UCIP)05/02/2017 Crossing appears to be in good condition. (A.Freitag - DWR Sutter Yard)10/17/2016 Crossing appears to be in good condition. (A.Freitag - DWR Sutter Yard)05/31/2016 Crossing appears to be in good condition. (A.Freitag - DWR Sutter Yard)05/04/2015 Crossing appears to be in good condition. No noticeable issues to report. (A.Freitag - DWR Sutter Yard)06/17/2014 Same as last inspection. (A. Freitag - DWR Sutter Yard)12/16/2013 Same as last inspection. (A. Freitag - DWR Sutter Yard)07/16/2013 Same as last inspection. (A. Freitag - DWR Sutter Yard)

View of levee crown at the crossing looking downstream

View of WS slope looking from levee toe

CMP pipe daylights on WS slope

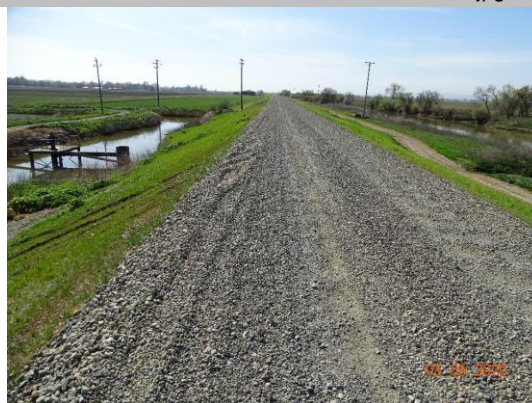
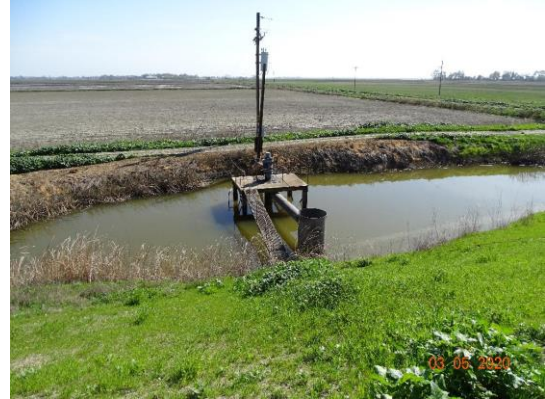
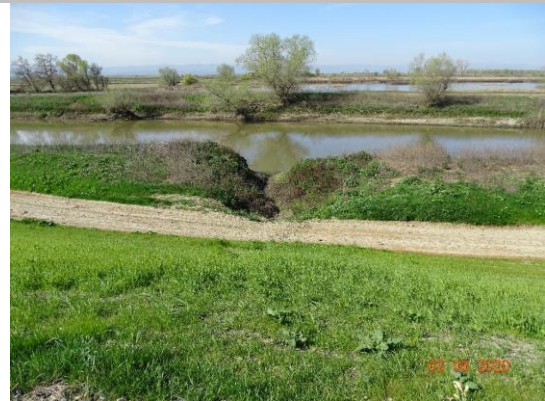
Photo 1 of 3 : UCIP\_FA\_2020\_57231\_83547.jpg

DS\_ID:17158  
FS\_ID:57231  
EP\_NO: 9390  
Repair Type: Non-Urgent  
EVAL Issue: Unauthorized Modification or Non-Compliant Permit  
Crossing Status: Found  
UCIP Comments: 03/05/2020 Record updated from No Action Needed to Non-Urgent. Pump in drainage ditch and standpipe are not designed per O&M As-Built drawing. Unable to locate a permit for modifications. Need to have CVFPB review ABO and determine current owner.  
(O.Yakimov - DWR UCIP)05/02/2017 Crossing appears to be in good condition. There is minor sediment build up in front of the WS flap gate.  
(A.Freitag - DWR Sutter Yard)10/17/2016 Crossing appears to be in good condition. (A.Freitag - DWR Sutter Yard)05/31/2016 Crossing appears to be in good condition. (A.Freitag - DWR Sutter Yard)05/04/2015 Crossing appears to be in good condition. No noticeable issues to report. (A.Freitag - DWR Sutter Yard)06/17/2014 Same as last inspection. (A.Freitag - DWR Sutter Yard)12/16/2013 Same as last inspection. (A.Freitag - DWR Sutter Yard)07/16/2013 New flapgate installed on WS pipe end. (A.Freitag - DWR Sutter Yard)10/11/2012 Flap gate broken on WS. Pipe shows significant rust at outlet. This is a good candidate for video inspection. (W.Wylie - DWR UCIP)

View of levee crown at the crossing looking downstream

View of LS looking from levee crown

View of WS looking from levee crown

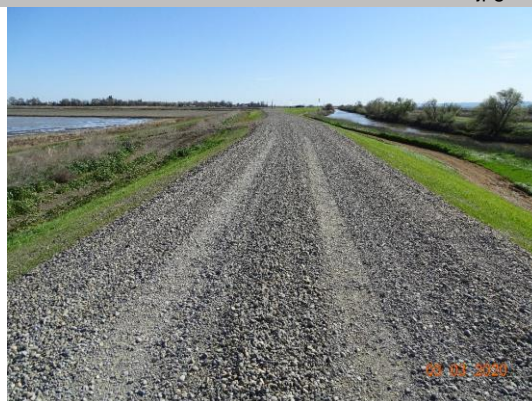
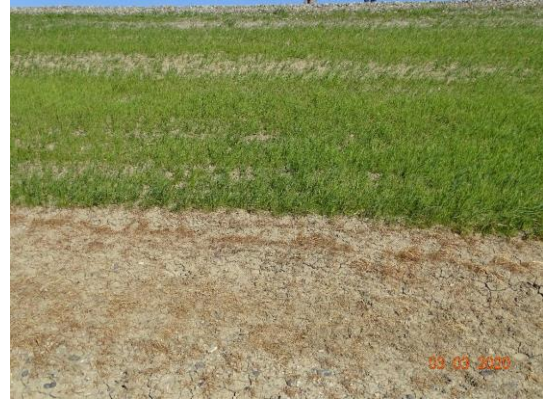
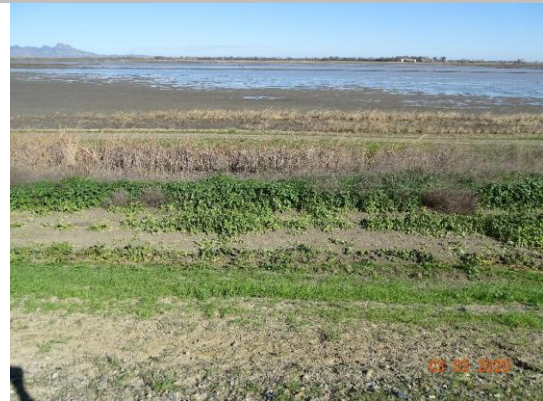
Photo 1 of 3 : UCIP\_FA\_2020\_57232\_83554.jpg

DS\_ID:17191  
FS\_ID:57232  
EP\_NO: 9390  
Repair Type: Non-Urgent  
EVAL Issue: Maintenance Compliance Issue  
Crossing Status: Found  
UCIP Comments: 03/03/2020 Record remains Non-Urgent. Pipe inlet in drainage ditch on LS is buried. Flap gate on WS is under water, unable to see if sediment was cleared. Recommend internal video inspection of the pipe. Need to have CVFPB review ABO and determine current owner. (O.Yakimov - DWR UCIP)  
05/02/2017 WS headwall and flapgate almost completely buried with only a small portion of the head wall visible. LS end is buried and unable to be located. (A.Freitag - DWR Sutter Yard)  
10/17/2016 WS flap gate is still silted over and LS inlet is heavily vegetated and unable to be inspected. (A.Freitag - DWR Sutter Yard)  
09/29/2016 Crossing has been downgraded from Urgent to Non-Urgent WS flap gate is closed shut due to sediment build up. For flood season flap gate is required to be closed. Need to coordinate with owner to remove sediment from WS to have WS flap gate be operable after flood season. (O.Magana - DWR UCIP)

View of levee crown at the crossing looking downstream

View of WS slope looking from levee toe

View of LS looking from levee crown

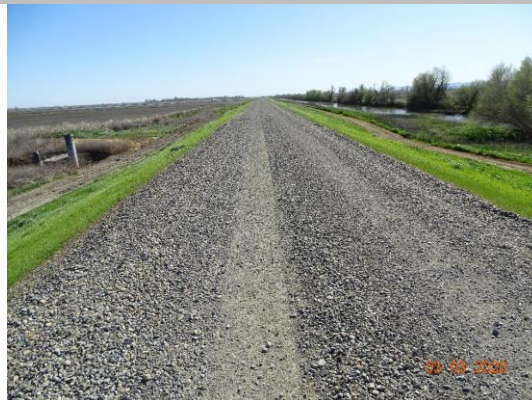
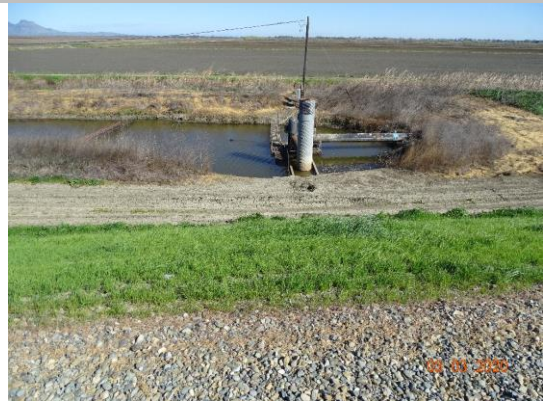
Photo 1 of 3 : UCIP\_FA\_2020\_57234\_83561.jpg

DS\_ID:17190  
FS\_ID:57234  
EP\_NO: 8234  
Repair Type: Non-Urgent  
EVAL Issue: Unauthorized Modification or Non-Compliant Permit  
Crossing Status: Found  
UCIP Comments: 03/03/2020 Record updated from No Action Needed to Non-Urgent. Modifications to the crossings: pump and a standpipe connected to the crossing located in drainage ditch that were not included in original O&M design. Supply pipe is currently disconnected from the pump. Unable to locate a permit authorizing modifications. Recommend internal inspection of crossing. Two soil depression spots apparently from a truck crane found on LS slope and LS berm. Need to have CVFPB review ABO and determine current owner. (O.Yakimov - DWR UCIP)05/02/2017 Crossing appears to be in good condition. (A.Freitag - DWR Sutter Yard)10/17/2016 Crossing appears to be in good condition. Pipe was field verified to be 48-inch CMP. (A.Freitag - DWR Sutter Yard)05/31/2016 Crossing appears to be in good condition. (A.Freitag - DWR Sutter Yard)05/04/2015 Crossing appears to be in good condition. No noticeable issues to report. (A.Freitag - DWR Sutter Yard)06/17/2014 Same as last inspection. (A.Freitag - DWR Sutter Yard)12/16/2013 Same as last inspection. (A.Freitag - DWR Sutter Yard)07/16/2013 Same as last inspection. (A.Freitag - DWR Sutter Yard)

View of levee crown at the crossing looking downstreams

Flap gate in concrete U-shaped headwall at WS toe.

View of LS looking from levee crown

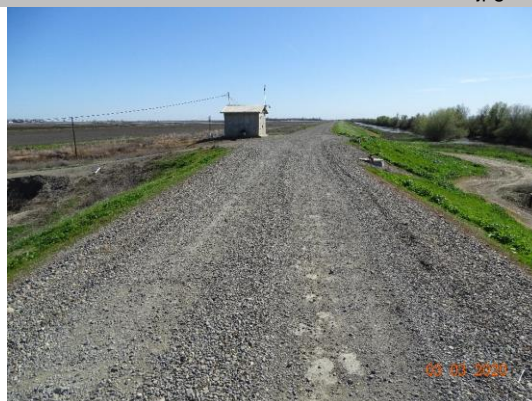
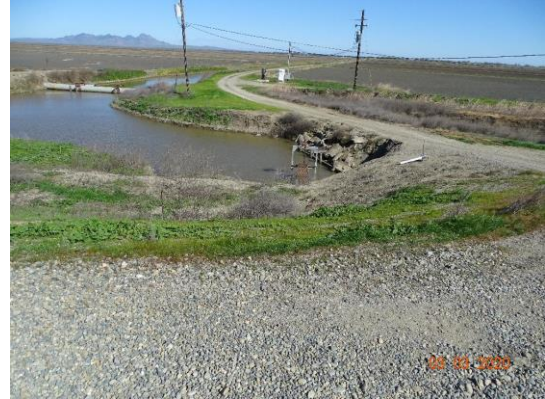
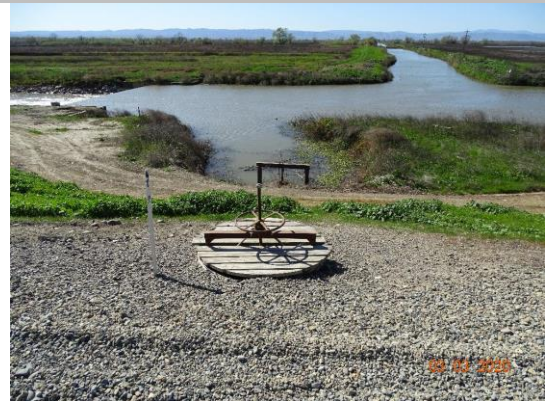
Photo 1 of 3 : UCIP\_FA\_2020\_57280\_83569.jpg

Comment Code					
Inspector Comment					
DS_ID:17161 FS_ID:57280 EP_NO: 9390 Repair Type: Non-Urgent EVAL Issue: Unauthorized Encroachment, installed decades prior Crossing Status: Found UCIP Comments: 03/03/2020 Record updated from No Action Needed to Non-Urgent. Need to have CVFPB review ABO and determine current owner. (O.Yakimov - DWR UCIP) 05/02/2017 Crossing appears to be in good condition. (A.Freitag - DWR Sutter Yard) 10/17/2016 Crossing appears to be in good condition. (A.Freitag - DWR Sutter Yard) 05/31/2016 Crossing appears to be in good condition. (A.Freitag - DWR Sutter Yard) 05/04/2015 Crossing appears to be in good condition. No noticeable issues to report. (A.Freitag - DWR Sutter Yard) 06/17/2014 Same as last inspection. (A.Freitag - DWR Sutter Yard) 12/16/2013 Same as last inspection. (A.Freitag - DWR Sutter Yard) 07/16/2013 Same as last inspection. (A.Freitag - DWR Sutter Yard) FIELD_STRUCT_DESC: 48-inch corrugated metal drainage pipe through the levee, 20.3 feet below the crown. Concrete headwall and cobble revetted spillway on the waterside (WS). Slide gate in a 60-inch corrugated metal pipe (CMP) riser on the WS slope. Concrete headwall located on the landside (LS). (48-inch pipe [HLM 6.10] authorized under Automatic Board Order (ABO) issued as Permit No. 9390, 1974 - Annie D. Propfe; 58-inch pipe [HLM 6.10] authorized under Automatic Board Order (ABO) issued as Permit No. 8234, 1972 - Glenn Irrigation District). [Additional Reference(s): DWR Levee Log, 2005 (HLM 6.10). USACE Sacramento O&M Manual, Unit 132, October 1959, Revised 14 January 2019, (HLM 6.10), listed as 48-inch pipe. USACE As-Built Drawing No. 50-4-3081, Sheet 7 and 16, Station 1648+88.2, 4 April 1957]. FS Date: 3/3/2020 1:07:00 PM

View of levee crown at the crossing looking downstream

View of LS looking from levee crown

View of WS looking from levee crown

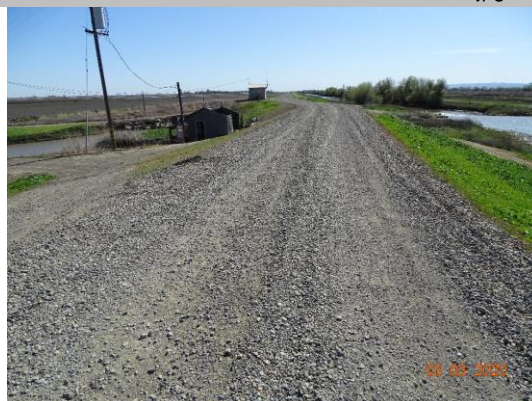
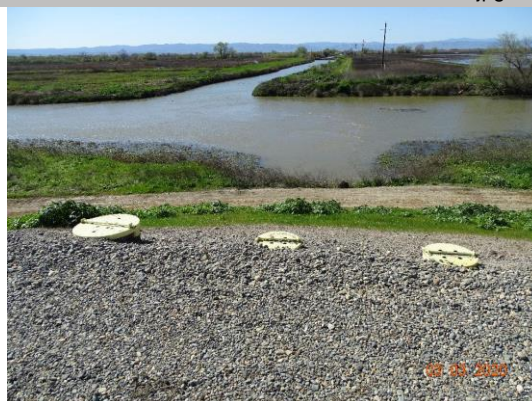
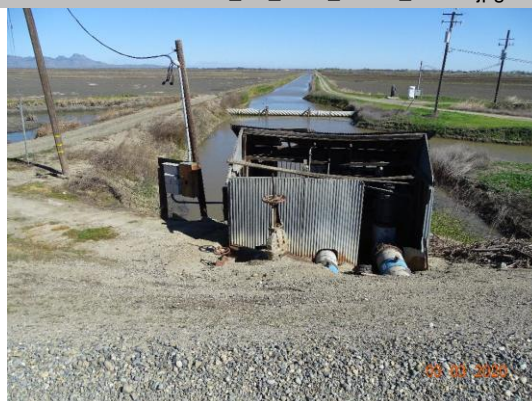
Photo 1 of 3 : UCIP\_FA\_2020\_57238\_83594.jpg

Comment Code					
Inspector Comment					
DS_ID:17199 FS_ID:57238 EP_NO: 9390 Repair Type: Non-Urgent EVAL Issue: Unauthorized Encroachment, installed decades prior Crossing Status: Found UCIP Comments: 03/03/2020 Record remains Non-Urgent. Need to have CVFPB review ABO and determine current owner. (O.Yakimov - DWR UCIP) 05/02/2017 Pipe appears to be in good condition. Minor erosion above the LS pump house. (A.Freitag - DWR Sutter Yard)10/17/2016 Crossing appears to be in good condition. (A.Freitag - DWR Sutter Yard)05/31/2016 Crossing appears to be in good condition. (A.Freitag - DWR Sutter Yard)05/04/2015 Crossing appears to be in good condition. No noticeable issues to report. (A.Freitag - DWR Sutter Yard)06/17/2014 Same as last inspection. (A.Freitag - DWR Sutter Yard)12/16/2013 Same as last inspection. (A.Freitag - DWR Sutter Yard)07/16/2013 Same as last inspection. (W.Wylie - DWR UCIP) FIELD_STRUCT_DESC: 3 of 3: 18-inch steel drainage pipe through the levee, 4.4 feet below the crown. Cobble revetted sump located on the waterside (WS). Siphon breaker in a 16-inch metal riser on the WS shoulder. Pump house at the landside (LS) toe. (18-inch pipe [HLM 6.13] authorized under Automatic Board Order (ABO) issued as Permit No. 9390, 1974 - Annie D. Propfe). [Additional Reference(s): DWR Levee Log, 2005 (HLM 6.13). USACE Sacramento O&M Manual, Unit 132, October 1959, Revised 14 January 2019, (HLM 6.13), listed as 3-18" pipes. Pipe not included to original USACE As-Built Drawing No. 50-4-3081. FS Date: 3/3/2020 3:08:00 PM

View of levee crown at the crossing looking downstream

View of WS looking from levee crown

View of LS looking from levee crown. Pumphouse with 3 pumps at LS toe

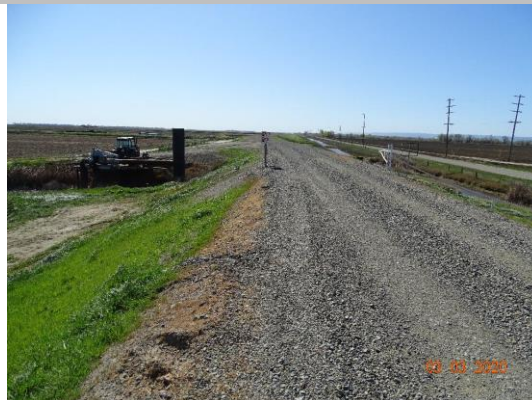
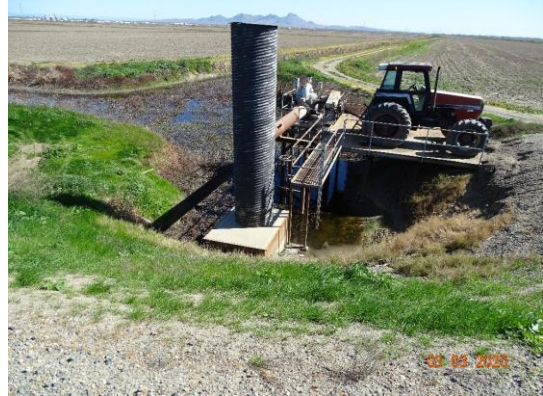
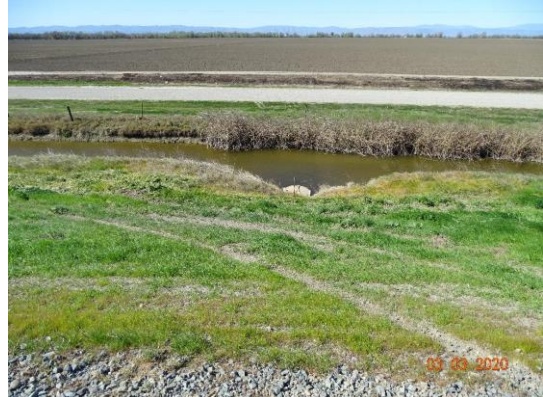
Photo 1 of 3 : UCIP\_FA\_2020\_57219\_83633.jpg

DS\_ID:17167  
FS\_ID:57219  
EP\_NO: 9389  
Repair Type: Urgent  
EVAL Issue: Pipe Integrity  
Crossing Status: Found  
UCIP Comments: 03/03/2020 Record remains Urgent. Pipe is excessively corroded inside at WS end. Recommend internal video inspection of crossing. Need to have CVFPB review ABO and determine current owner. (O.Yakimov - DWR UCIP)  
10/05/2018 Flap gate was installed at WS end of the pipe. Pipe is excessively corroded looking inside from WS end. Video inspection is recommended. Cracks more than 1-inch wide were observed on WS slope around pipe alignment that may be a sign of slope instability. (O.Yakimov - DWR UCIP)  
05/02/2017 No repairs have been made to this crossing yet. WS flap gate is still disconnected from end of pipe and pipe is showing heavy signs of rust and deterioration as far in as i can see from the WS end. Pipe should be internally camera inspected and repaired/replaced. (A.Freitag - DWR Sutter Yard)

01/31/2017 Informal Notice of Violation (NOV) was sent out January 31, 2017 by DWR Flood Maintenance Office--owner needs to re-attach flap gate to drainage pipe and coordinate with CVFPB to address additional issue(s) identified in NOV. Owner has until Monday February 27th, 2017 to respond to DWR contact: Bryan Reniff. (refer to Official Notice for details). (O.Magana - DWR UCIP)  
10/17/2016 WS flapgate has separated from the pipe end. WS pipe end is showing signs of rust and deterioration. Needs a new flapgate or other means of closing off the pipe before flood season. (A.Freitag - DWR Sutter Yard)  
05/31/2016 Crossing appears to be in good condition. (A.Freitag - DWR Sutter Yard)05/04/2015 Crossing appears to be in good condition. No noticeable issues to report. (A.Freitag - DWR Sutter Yard)  
06/17/2014 Same as last inspection. (A.Freitag - DWR Sutter Yard)12/16/2013 Same as last inspection. (A.Freitag - DWR Sutter Yard)

View of levee crown at the crossing  
looking downstream

Stanspipe, pump in drainage ditch, and tractor used as a pump motor on LS

View of WS looking from levee crown

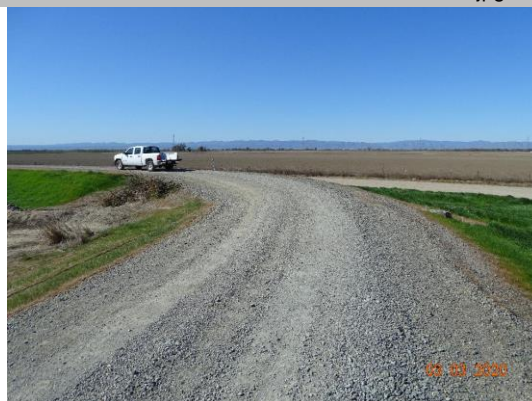
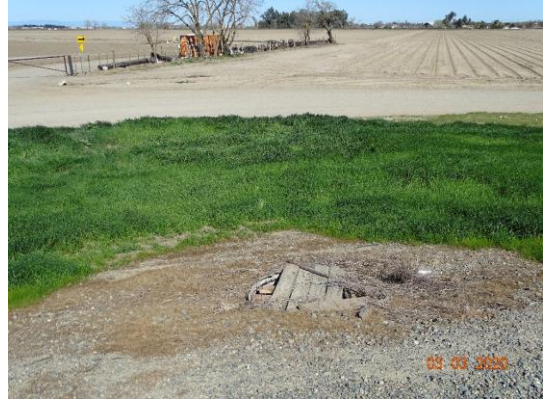
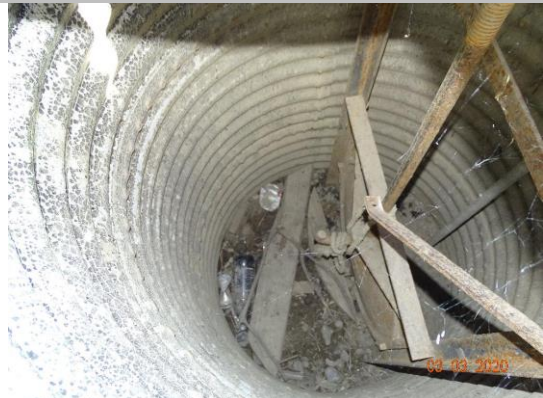
Photo 1 of 3 : UCIP\_FA\_2020\_57245\_83418.jpg

View of levee crown at crossing looking downstream

Water-Side looking from the crown

View inside of CMP riser on WS shoulder
