**Flood Control Project Maintenance  
Levee Inspections**

**Maintenance Issue Types Only, Levee Inspection Report By Mile - Fall 2021**

**Sutter Maintenance Yard Maintenance Area 0012**

Waterway	Bank	Unit Miles	Inspection Start/End	Inspector
Unit No. 01 Colusa Drain	Left	11.06	09/16/2021 09/16/2021	Zach Jojola

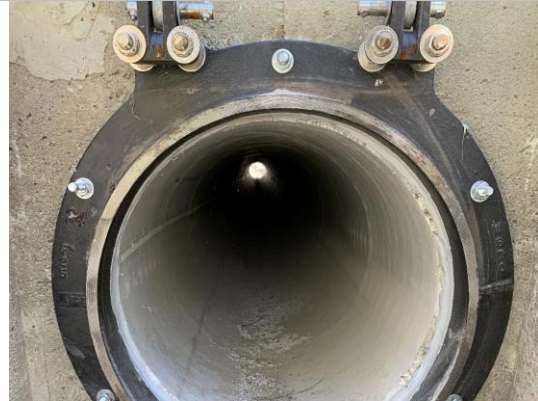
Photo 1 of 3 : UCIP\_FA\_2021\_57222\_103216.jpg

DS\_ID:17146  
FS\_ID:57222  
EP\_NO: 9385  
Repair Type: Non-Urgent  
EVAL Issue: Unauthorized Encroachment, installed decades prior  
Crossing Status: Found  
UCIP Comments: 08/04/2021 Record updated from Urgent to Non-Urgent. Flap gate was replaced, LMA provided updated photos. (O.Yakimov - DWR UCIP)  
03/04/2020 Record updated from Non-Urgent to Urgent. Pipe has been CIPP-lined under the DWR DMP Phase 2 Project. Flap gate not closing properly posing flood risk to the landside during flood season. LMA needs to repair or replace flap gate. No permit has been identified authorizing pipe. Need to have CVFPB review ABO and determine current owner. (O.Yakimov - DWR UCIP)  
05/02/2017 WS is in good condition. LS inlet is more than 50% full of sediment. Pipe needs to be cleaned internally. (A.Freitag - DWR Sutter Yard)  
10/17/2016 Minor sediment blocking the WS flap gate from opening. LS inlet still mostly full of sediment. (A.Freitag - DWR Sutter Yard)09/29/2016 Crossing has been downgraded from Urgent to Non-Urgent WS flap gate is closed for flood season. Need to coordinate with owner to remove sediment blocking WS flap gate. (O.Magana - DWR UCIP)

05/31/2016 WS flap gate is blocked from opening by sediment. LS inlet is over 50% full of sediment. (A.Freitag - DWR Sutter Yard)05/04/2015 WS flap gate is blocked by sediment and unable to open. LS inlet is about 50% plugged with soil. Needs to be cleaned. (A.Freitag - DWR Sutter Yard)  
06/17/2014 Same as last inspection. (A.Freitag - DWR Sutter Yard)  
12/16/2013 Sediment against flapgate has been cleared and it can now function properly. (A.Freitag - DWR Sutter Yard)07/16/2013 Sediment is built up against WS flapgate preventing it from opening. (A.Freitag - DWR Sutter Yard)  
10/11/2012 Pipe is partially filled with soil. (W.Wylie - DWR UCIP)  
FIELD\_STRUCT\_DESC: 24-inch corrugated metal CIPP-lined drainage pipe through the levee, 13 feet below the crown. Flap gate, concrete headwall, and grouted cobble spillway on the waterside (WS). Concrete headwall on the landside (LS). (24-inch pipe [HLM 0.49] authorized under Automatic Board Order (ABO) issued as Permit No. 9385, 1974 - Jackson S. King; 24-inch pipe [HLM 0.49] was also authorized under Automatic Board Order (ABO) issued as Permit No. 8226, 1972 - Jackson S. King). [Additional Reference(s): DWR Levee Log, 2005 (HLM 0.49). USACE Sacramento O&M Manual, Unit 132, October 1959, Revised 14 January 2019, (HLM 0.49), listed as 24-inch pipe. USACE As-Built Drawing No. 50-4-3081, Sheet 3 and 15, Station 1355+75, 4 April 1957].

Water-Side: View inside of pipe with flap gate open

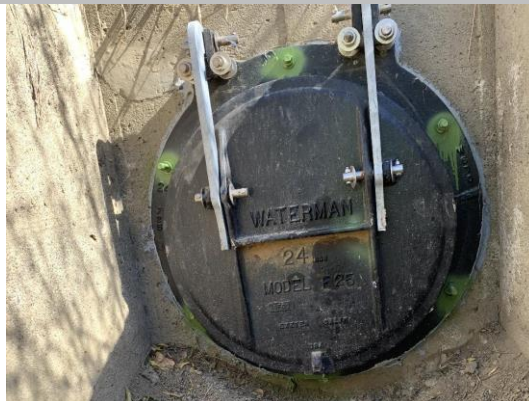
Photo 2 of 3 : UCIP\_FA\_2021\_57222\_103215.jpg

Water-Side: New flap gate installed

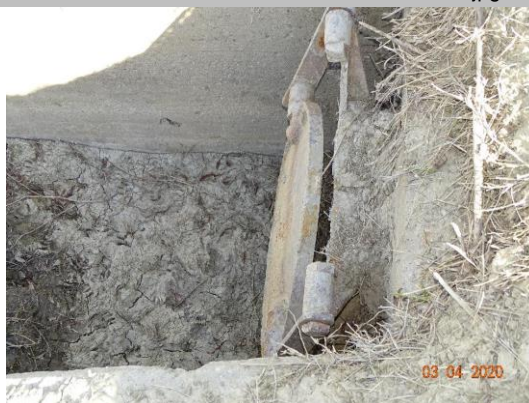
Photo 3 of 3 : UCIP\_FA\_2021\_57222\_83455.jpg

Flap gate should be closing properly

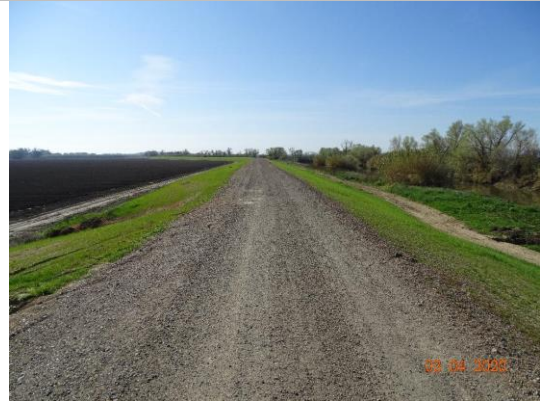
Photo 1 of 3 : UCIP\_FA\_2021\_57190\_83458.jpg

Comment Code						
Inspector Comment						
DS_ID:17147 FS_ID:57190 EP_NO: 9382 Repair Type: Non-Urgent EVAL Issue: Unauthorized Encroachment, installed decades prior Crossing Status: Found UCIP Comments: 03/04/2020 Record updated from No Action Needed to Non-Urgent. Pipe has been CIPP-lined under the DWR DMP Phase 2 Project. Need to have CVFPB review ABO and determine current owner. (O.Yakimov - DWR UCIP) 05/02/2017 Crossing appears to be in good condition. (A.Freitag - DWR Sutter Yard)10/17/2016 Crossing appears to be in good condition. This is a gravity for the LS. (A.Freitag - DWR Sutter Yard)05/31/2016 Crossing appears to be in good condition. (A.Freitag - DWR Sutter Yard)05/04/2015 Crossing is in good condition. No issues. (A.Freitag - DWR Sutter Yard)06/17/2014 Same as last inspection. (A.Freitag - DWR Sutter Yard)12/16/2013 Same as last inspection. (A.Freitag - DWR Sutter Yard)07/16/2013 Same as last inspection. (A.Freitag - DWR Sutter Yard) FIELD_STRUCT_DESC: 24-inch corrugated metal CIPP-lined drainage pipe through the levee, 13 feet below the crown. Flap gate, concrete headwall, and grouted cobble spillway on the waterside (WS). Concrete headwall on the landside (LS). (24-inch pipe [HLM 1.40] authorized under Automatic Board Order (ABO) issued as Permit No. 9382, 1974 - Olen C. Bober; 24-inch pipe [HLM 1.40] was also authorized under Automatic Board Order (ABO) issued as Permit No. 8228, 1972 - Olin C. Baber). [Additional Reference(s): DWR Levee Log, 2005 (HLM 1.40). USACE Sacramento O&M Manual, Unit 132, October 1959, Revised 14 January 2019, (HLM 1.40), listed as 24-inch pipe. USACE As-Built Drawing No. 50-4-3081, Sheet 4 and 15, Station 1402+63, 4 April 1957]. FS Date: 3/4/2020 9:53:00 AM

Levee crown at the crossing

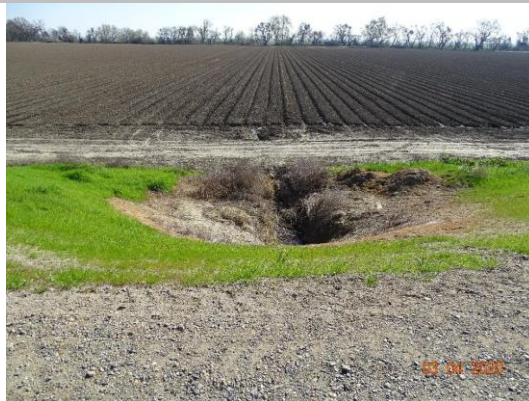
Photo 2 of 3 : UCIP\_FA\_2021\_57190\_83459.jpg

View of LS looking from levee crown

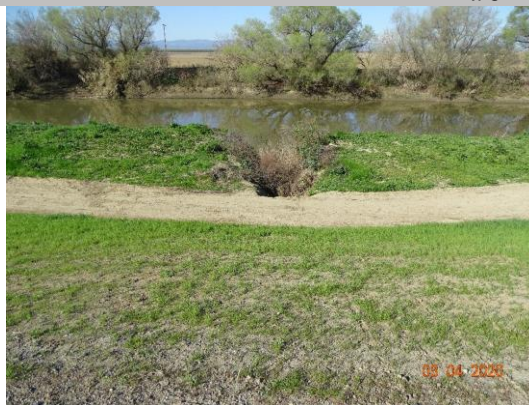
Photo 3 of 3 : UCIP\_FA\_2021\_57190\_83460.jpg

View of WS looking from levee crown

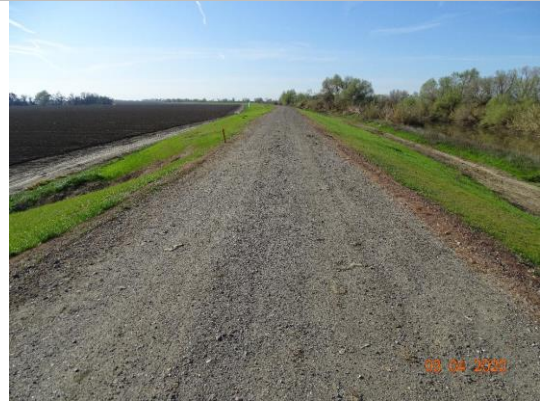
Photo 1 of 3 : UCIP\_FA\_2021\_57224\_83473.jpg

Comment Code						
Inspector Comment						
DS_ID:17149 FS_ID:57224 EP_NO: 9382 Repair Type: Non-Urgent EVAL Issue: Unauthorized Encroachment, installed decades prior Crossing Status: Found UCIP Comments: 03/04/2020 Record remains Non-Urgent. Pipe has been CIPP-lined and new flap gate installed under the DWR DMP Phase 2 Project. Vegetation around flap gate was cleared. Need to have CVFPB review ABO and determine current owner. (O.Yakimov - DWR UCIP) 05/02/2017 WS flapgate buried by sediment. Needs to be dug out. (A.Freitag - DWR Sutter Yard)10/17/2016 Crossing appears to be in good condition. This is a gravity drain for the LS. (A.Freitag - DWR Sutter Yard)05/31/2016 LS inlets was partially plugged. WS flapgate was clear of sediment and able to operate properly. (A.Freitag - DWR Sutter Yard)05/04/2015 WS flapgate is blocked by sediment and unable to open. LS inlet is plugged by silt and wood chippings. Needs to be cleaned. (A.Freitag - DWR Sutter Yard)06/17/2014 Flap gate was cleaned out and is fully closed. LS inlet still partially full of soil. (A.Freitag - DWR Sutter Yard)12/16/2013 Same as last inspection. WS flapgate still needs to be cleaned out and shut. (A.Freitag - DWR Sutter Yard)07/16/2013 Same as last inspection. Make sure flapgate is closed before highwater season. (A.Freitag - DWR Sutter Yard)10/11/2012 Inlet on LS filled partially with soil. Outlet blocked with soil and the flap gate won't close. (W.Wylie - DWR UCIP) FIELD_STRUCT_DESC: 24-inch corrugated metal CIPP-lined drainage pipe through the levee, 13 feet below the crown. Flap gate, concrete headwall, and grouted cobble spillway on the waterside (WS). Concrete headwall on the landside (LS). (24-inch pipe [HLM 1.72] authorized under Automatic Board Order (ABO) issued as Permit No. 9382, 1974 - Olen C. Bober; 24-inch pipe [HLM 1.72] was also authorized under Automatic Board Order (ABO) issued as Permit No. 8228, 1972 - Olin C. Baber). [Additional Reference(s): DWR Levee Log, 2005 (HLM 1.72). USACE Sacramento O&M Manual, Unit 132, October 1959, Revised 14 January 2019, (HLM 1.72), listed as 24-inch pipe. USACE As-Built Drawing No. 50-4-3081, Sheet 4, Station 1419+25 (construction detail same as 1434+10), 4 April 1957]. FS Date: 3/4/2020 10:42:00 AM

View of levee crown at the crossing looking downstream

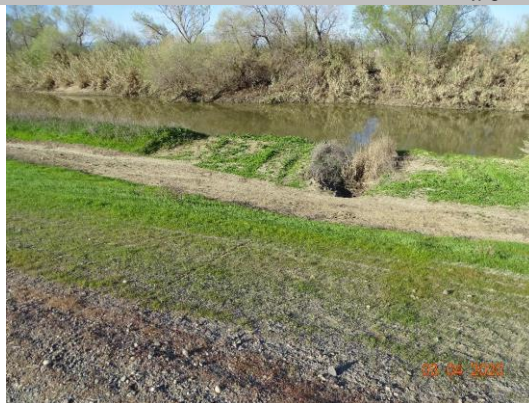
Photo 2 of 3 : UCIP\_FA\_2021\_57224\_83474.jpg

View of WS looking from levee crown

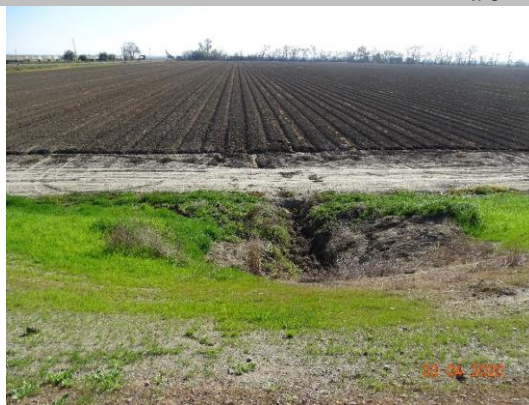
Photo 3 of 3 : UCIP\_FA\_2021\_57224\_83475.jpg

View of LS looking from levee crown

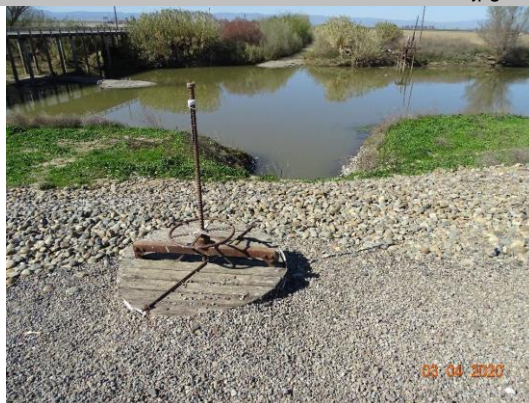
Photo 2 of 3 : UCIP\_FA\_2021\_57227\_83486.jpg

60-inch standpipe with slide gate on WS slope with outlet in background.

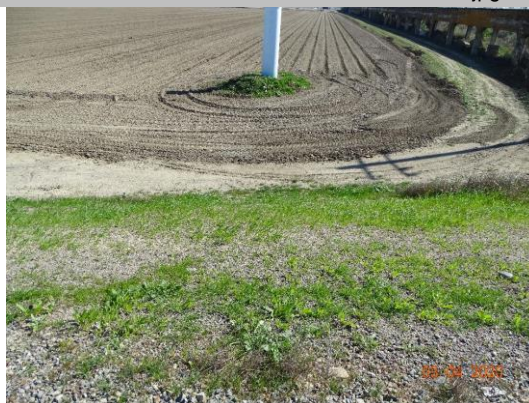
Photo 3 of 3 : UCIP\_FA\_2021\_57227\_83487.jpg

View of LS slope looking from levee crown. PVC pipe in the field doesn't belong to this crossing

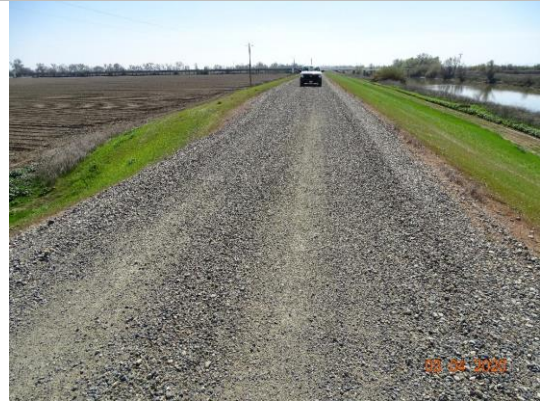
Photo 1 of 3 : UCIP\_FA\_2021\_57228\_83501.jpg

DS\_ID:17151  
FS\_ID:57228  
EP\_NO: 9387  
Repair Type: Non-Urgent  
EVAL Issue: Unauthorized Encroachment, installed decades prior  
Crossing Status: Found  
UCIP Comments: 03/04/2020 Record remains Non-Urgent. Need to have CVFPB review ABO and determine current owner. Crossing appears abandoned. Both end of crossing are buried. Recommend performing maintenance of the crossing. (O.Yakimov - DWR UCIP)

View of levee crown at the crossing looking downstream

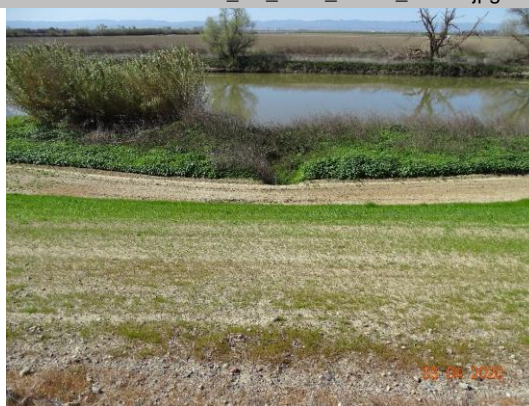
Photo 2 of 3 : UCIP\_FA\_2021\_57228\_83500.jpg

View of WS looking from levee crown

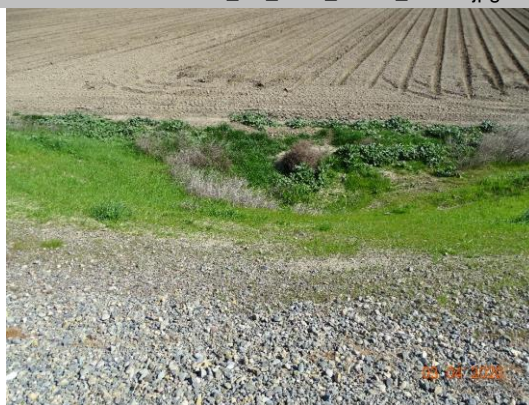
Photo 3 of 3 : UCIP\_FA\_2021\_57228\_83499.jpg

View of LS looking from levee crown

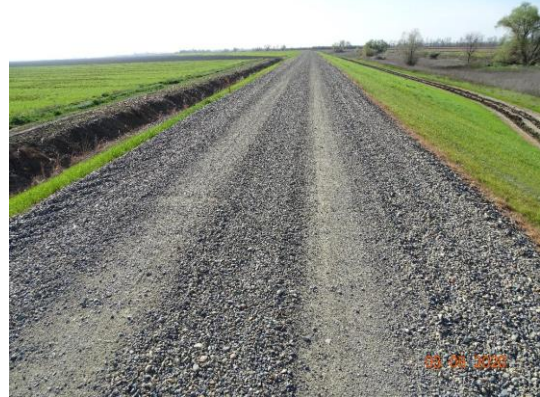
Photo 1 of 3 : UCIP\_FA\_2021\_57195\_83514.jpg

DS\_ID:17153  
FS\_ID:57195  
EP\_NO: 9384  
Repair Type: Non-Urgent  
EVAL Issue: Maintenance Compliance Issue  
Crossing Status: Found  
UCIP Comments: 03/05/2020 Record updated from No Action Needed to Non-Urgent. Sediment at LS headwall, vegetation at WS headwall need to be cleared. Need to have CVFPB review ABO and determine current owner. (O.Yakimov - DWR UCIP)05/02/2017 Crossing appears to be in good condition. (A.Freitag - DWR Sutter Yard)10/17/2016 Crossing appears to be in good condition. (A.Freitag - DWR Sutter Yard)05/31/2016 Crossing appears to be in good condition. (A.Freitag - DWR Sutter Yard)05/04/2015 Crossing appears in good condition. No noticeable issues. (A.Freitag - DWR Sutter Yard)06/17/2014 Same as last inspection. (A.Freitag - DWR Sutter Yard)12/16/2013 Same as last inspection. (A.Freitag - DWR Sutter Yard)07/16/2013 Same as last inspection. (A.Freitag - DWR Sutter Yard)

View of levee crown at the crossing

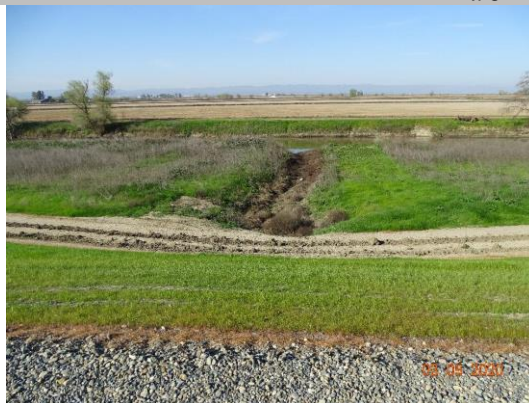
Photo 2 of 3 : UCIP\_FA\_2021\_57195\_83515.jpg

View of WS looking from levee crown

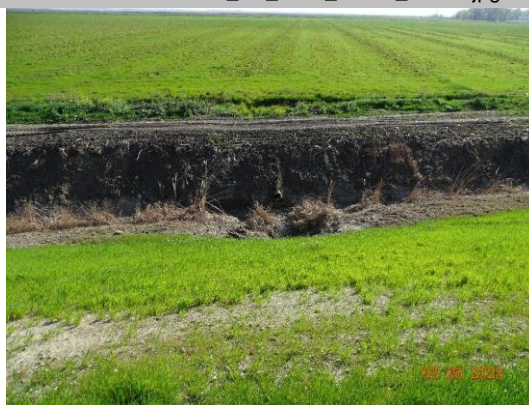
Photo 3 of 3 : UCIP\_FA\_2021\_57195\_83516.jpg

View of LS looking from levee crown

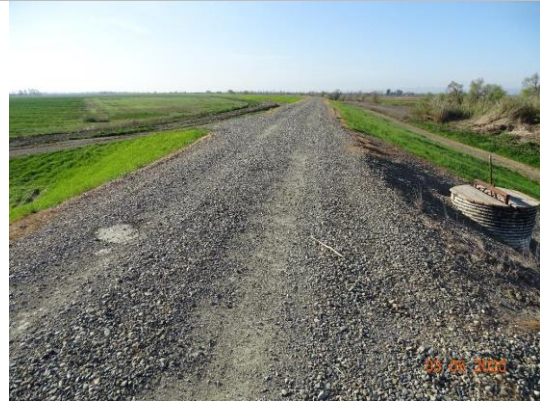
Photo 1 of 3 : UCIP\_FA\_2021\_57196\_83526.jpg

DS\_ID:17154  
FS\_ID:57196  
EP\_NO: 9388  
Repair Type: Non-Urgent  
EVAL Issue: Unauthorized Modification or Non-Compliant Permit  
Crossing Status: Found  
UCIP Comments: 03/05/2020 Record remains Non-Urgent. New cover on CMP riser has been installed. Piping around slide gate at LS toe was modified, new 14-inch pipes installed. Unable to locate a permit for system modification. New steel walkway to slide gate on LS. Need to coordinate with LMA for find a permit authorizing modification. Need to have CVFPB review ABO and determine current owner. (O.Yakimov - DWR UCIP)  
10/05/2018 Fall hazard: missing cover on CMP riser. Closure devices are present on both ends of crossing and seem to be in operable condition. Downgraded to non-urgent. Recommend owner add cover to CMP riser. (O.Yakimov - DWR UCIP)  
05/02/2017 WS slide gate stem is still bent, wheel to operate gate is missing. Needs a cover made for the standpipe to prevent falls. (A.Freitag - DWR Sutter Yard)10/17/2016 Slide gate stem is still and the gate appears to be inoperable. (A.Freitag - DWR Sutter Yard)05/31/2016 Slide gate stem is still bent. WS flap gate is chained open. (A.Freitag - DWR Sutter Yard)

05/04/2015 Slide gate stem is still bent. Gate looks to be unable to close all the way. (A.Freitag - DWR Sutter Yard)06/17/2014 Same as last inspection. (A.Freitag - DWR Sutter Yard)12/16/2013 Slide gate stem is still bent. WS flapgate was closed. (A.Freitag - DWR Sutter Yard)  
07/16/2013 Water flowing through pipe so screw gate definitely not closed. Was told NOV's have been sent for owner to replace stem. Flap gate gets closed for flood season. (A.Freitag - DWR Sutter Yard)  
10/11/2012 Slide gate inoperable, but appears to be in closed position. Flap gate held in open position. Good candidate for video inspection when, if ever, dry. (W.Wylie - DWR UCIP)  
FIELD\_STRUCT\_DESC: 48-inch corrugated metal drainage pipe through the levee, 28 feet below the crown. Slide gate in a 66-inch riser on the waterside (WS) slope. Concrete headwall on the WS. Grouted cobble spillway from drainage ditch to large canal on the landside (LS). (48-inch pipe [HLM 3.78] authorized under Automatic Board Order (ABO) issued as Permit No. 9388, 1974 - Pauline A. Wallace; 48-inch pipe [HLM 3.78] was also authorized under Automatic Board Order (ABO) issued as Permit No. 8231, 1972 - Roy E. Kitts). [Additional Reference(s): DWR Levee Log, 2005 (HLM 3.78). USACE Sacramento O&M Manual, Unit 132, October 1959, Revised 14 January 2019, (HLM 3.78), listed as 48-inch pipe. USACE As-Built Drawing No. 50-4-3081, Sheet 5 and 15, Station 1524+75, 4 April 1957].

View of levee crown at the crossing looking downstream

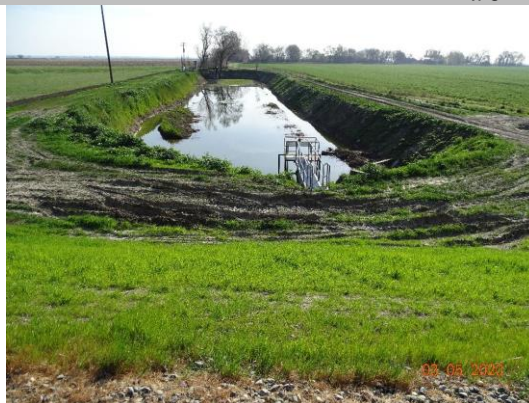
Photo 2 of 3 : UCIP\_FA\_2021\_57196\_83527.jpg

View of LS looking from levee crown

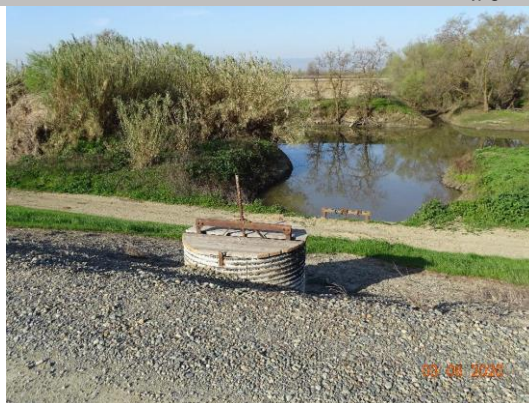
Photo 3 of 3 : UCIP\_FA\_2021\_57196\_83528.jpg

View of WS looking from levee crown. CMP riser with slide gate on WS shoulder

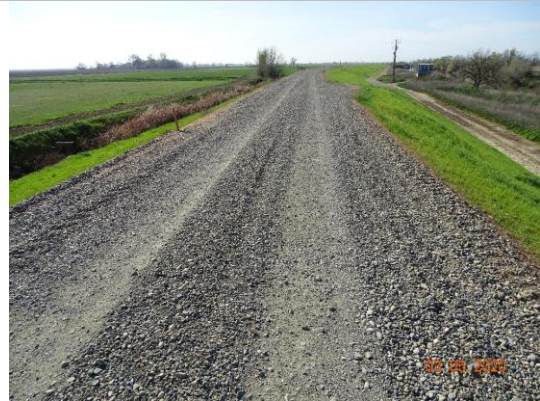
Photo 1 of 3 : UCIP\_FA\_2021\_57229\_83531.jpg

Comment Code						
Inspector Comment						
DS_ID:17168 FS_ID:57229 EP_NO: 9388 Repair Type: Non-Urgent EVAL Issue: Unauthorized Encroachment, installed decades prior Crossing Status: Found UCIP Comments: 03/05/2020 Record updated from No Action Needed to Non-Urgent. Need to have CVFPB review ABO and determine current owner. (O.Yakimov - DWR UCIP)05/02/2017 Crossing appears to be in good condition. (A.Freitag - DWR Sutter Yard)  10/17/2016 Crossing appears to be in good condition. (A.Freitag - DWR Sutter Yard)05/31/2016 Crossing appears to be in good condition. (A.Freitag - DWR Sutter Yard)05/04/2015 Crossing appears to be in good condition. No noticeable issues to report. (A.Freitag - DWR Sutter Yard)06/17/2014 Same as last inspection. (A.Freitag - DWR Sutter Yard)12/16/2013 Same as last inspection. (A.Freitag - DWR Sutter Yard)07/16/2013 Same as last inspection. (A.Freitag - DWR Sutter Yard) FIELD_STRUCT_DESC: 36-inch corrugated metal drainage pipe through the levee, 27.5 feet below the crown. Flap gate, concrete headwall, and grouted cobble spillway located on the waterside (WS). Concrete headwall located on the landside (LS). (24-inch pipe [HLM 4.25] authorized under Automatic Board Order (ABO) issued as Permit No. 9388, 1974 - Pauline A. Wallace; 24-inch pipe [HLM 4.25] was also authorized under Automatic Board Order (ABO) issued as Permit No. 8232, 1972 - Pauline Wallace Estates). [Additional Reference(s): DWR Levee Log, 2005 (HLM 4.25). USACE Sacramento O&M Manual, Unit 132, October 1959, Revised 14 January 2019, (HLM 4.25), listed as 36-inch pipe. USACE As-Built Drawing No. 50-4-3081, Sheet 6 and 16, Station 1548+95, 4 April 1957]. FS Date: 3/5/2020 7:28:00 AM

View of levee crown at the crossing looking downstream

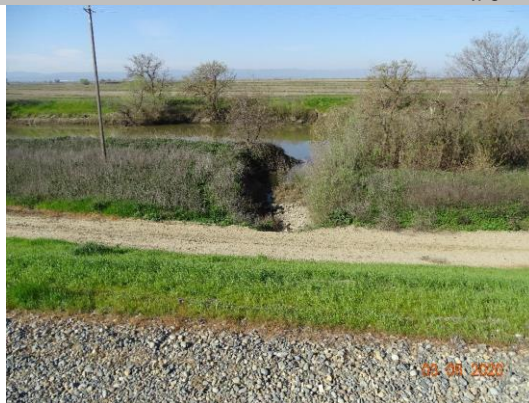
Photo 2 of 3 : UCIP\_FA\_2021\_57229\_83532.jpg

View of WS looking from levee crown

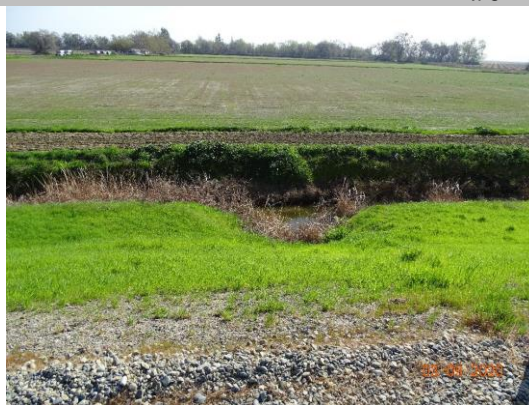
Photo 3 of 3 : UCIP\_FA\_2021\_57229\_83533.jpg

View of LS looking from levee crown

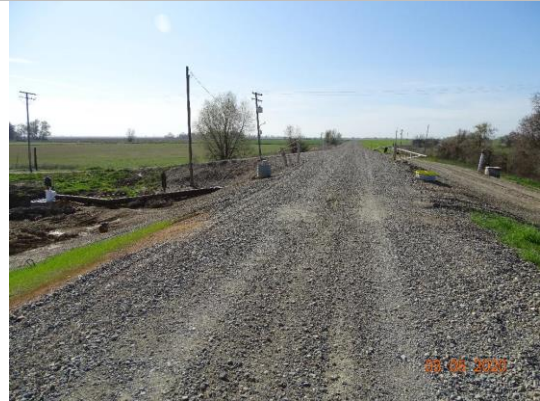
Photo 1 of 3 : UCIP\_FA\_2021\_57199\_83540.jpg

DS\_ID:17156  
FS\_ID:57199  
EP\_NO: 9388  
Repair Type: Non-Urgent  
EVAL Issue: Unauthorized Modification or Non-Compliant Permit  
Crossing Status: Found  
UCIP Comments: 03/05/2020 Record updated from No Action Needed to Non-Urgent. Modifications to the system done: 24-inch steel pipe connected to a CMP pipe at LS toe, pump in irrigation canal on LS. Unable to find pump system in O&M drawings. Steel pipe is currently disconnected from the pump in irrigation canal. Unable to locate a permit authorizing modifications. Need to have CVFPB review ABO and determine current owner. Pipe outlet on WS not found due to dense vegetation. (O.Yakimov - DWR UCIP)05/02/2017 Crossing appears to be in good condition. (A.Freitag - DWR Sutter Yard)10/17/2016 Crossing appears to be in good condition. (A.Freitag - DWR Sutter Yard)05/31/2016 Crossing appears to be in good condition. (A.Freitag - DWR Sutter Yard)05/04/2015 Crossing appears to be in good condition. No noticeable issues to report. (A.Freitag - DWR Sutter Yard)06/17/2014 Same as last inspection. (A. Freitag - DWR Sutter Yard)12/16/2013 Same as last inspection. (A. Freitag - DWR Sutter Yard)07/16/2013 Same as last inspection. (A. Freitag - DWR Sutter Yard)

View of levee crown at the crossing looking downstream

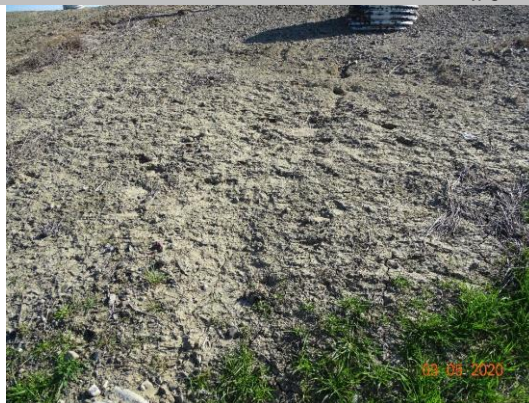
Photo 2 of 3 : UCIP\_FA\_2021\_57199\_83545.jpg

View of WS slope looking from levee toe

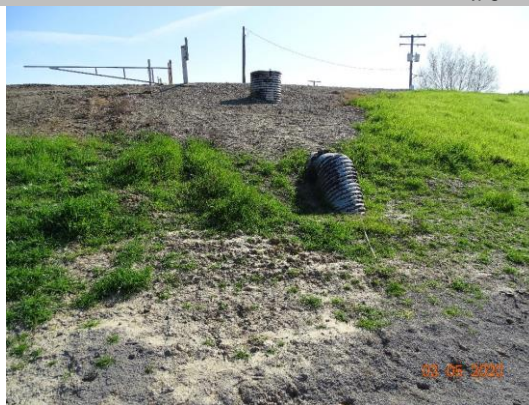
Photo 3 of 3 : UCIP\_FA\_2021\_57199\_83544.jpg

CMP pipe daylights on WS slope

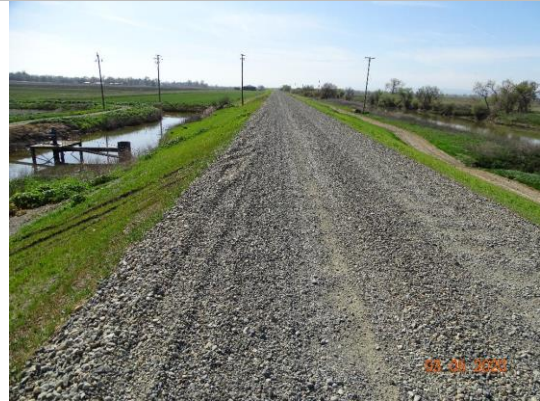
Photo 1 of 3 : UCIP\_FA\_2021\_57231\_83547.jpg

DS\_ID:17158  
FS\_ID:57231  
EP\_NO: 9390  
Repair Type: Non-Urgent  
EVAL Issue: Unauthorized Modification or Non-Compliant Permit  
Crossing Status: Found  
UCIP Comments: 03/05/2020 Record updated from No Action Needed to Non-Urgent. Pump in drainage ditch and standpipe are not designed per O&M As-Built drawing. Unable to locate a permit for modifications. Need to have CVFPB review ABO and determine current owner. (O.Yakimov - DWR UCIP)05/02/2017 Crossing appears to be in good condition. There is minor sediment build up in front of the WS flap gate. (A.Freitag - DWR Sutter Yard)10/17/2016 Crossing appears to be in good condition. (A.Freitag - DWR Sutter Yard)05/31/2016 Crossing appears to be in good condition. (A.Freitag - DWR Sutter Yard)05/04/2015 Crossing appears to be in good condition. No noticeable issues to report. (A.Freitag - DWR Sutter Yard)06/17/2014 Same as last inspection. (A.Freitag - DWR Sutter Yard)12/16/2013 Same as last inspection. (A.Freitag - DWR Sutter Yard)07/16/2013 New flapgate installed on WS pipe end. (A.Freitag - DWR Sutter Yard)10/11/2012 Flap gate broken on WS. Pipe shows significant rust at outlet. This is a good candidate for video inspection. (W.Wylie - DWR UCIP)

View of levee crown at the crossing looking downstream

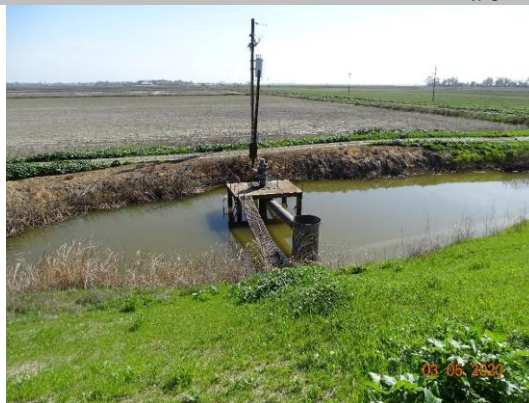
Photo 2 of 3 : UCIP\_FA\_2021\_57231\_83548.jpg

View of LS looking from levee crown

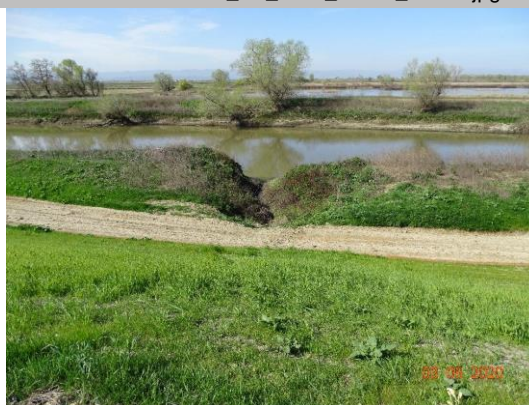
Photo 3 of 3 : UCIP\_FA\_2021\_57231\_83549.jpg

View of WS looking from levee crown

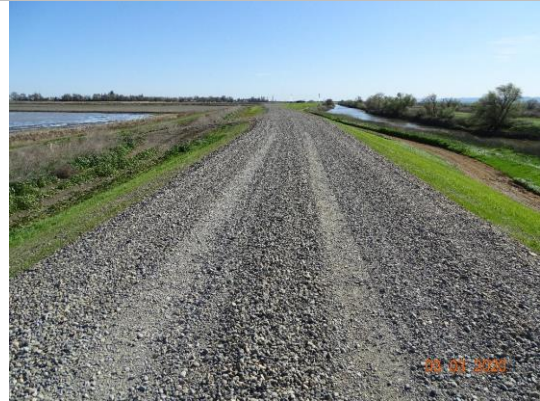
Photo 1 of 3 : UCIP\_FA\_2021\_57232\_83554.jpg

DS\_ID:17191  
FS\_ID:57232  
EP\_NO: 9390  
Repair Type: Non-Urgent  
EVAL Issue: Maintenance Compliance Issue  
Crossing Status: Found  
UCIP Comments: 03/03/2020 Record remains Non-Urgent. Pipe inlet in drainage ditch on LS is buried. Flap gate on WS is under water, unable to see if sediment was cleared. Recommend internal video inspection of the pipe. Need to have CVFPB review ABO and determine current owner. (O.Yakimov - DWR UCIP)  
05/02/2017 WS headwall and flapgate almost completely buried with only a small portion of the head wall visible. LS end is buried and unable to be located. (A.Freitag - DWR Sutter Yard)  
10/17/2016 WS flap gate is still silted over and LS inlet is heavily vegetated and unable to be inspected. (A.Freitag - DWR Sutter Yard)  
09/29/2016 Crossing has been downgraded from Urgent to Non-Urgent WS flap gate is closed shut due to sediment build up. For flood season flap gate is required to be closed. Need to coordinate with owner to remove sediment from WS to have WS flap gate be operable after flood season. (O.Magana - DWR UCIP)

View of levee crown at the crossing looking downstream

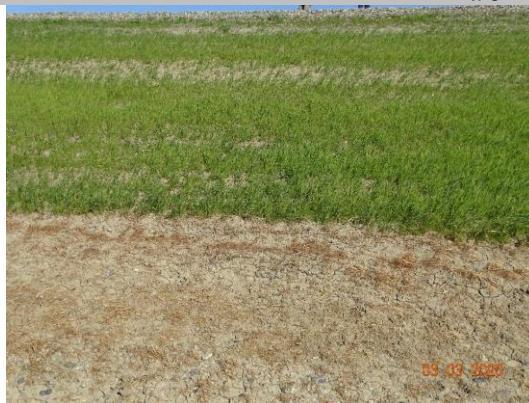
Photo 2 of 3 : UCIP\_FA\_2021\_57232\_83558.jpg

View of WS slope looking from levee toe

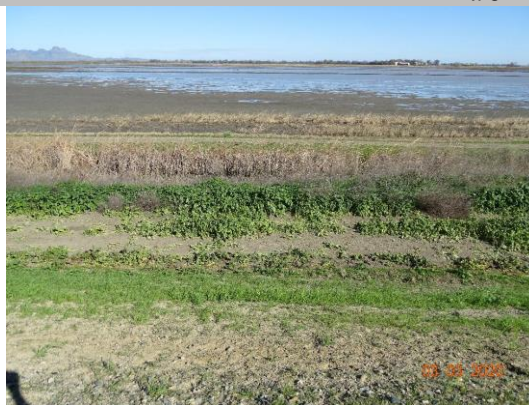
Photo 3 of 3 : UCIP\_FA\_2021\_57232\_83556.jpg

View of LS looking from levee crown

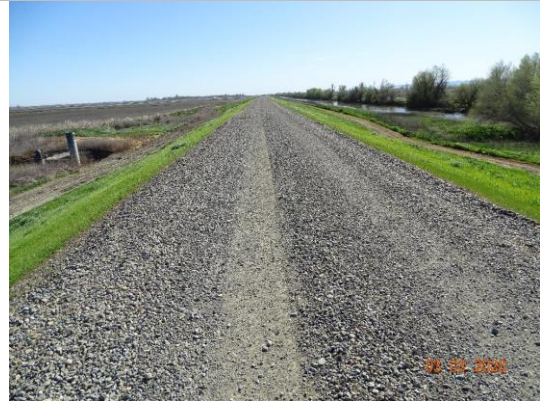
Photo 1 of 3 : UCIP\_FA\_2021\_57234\_83561.jpg

DS\_ID:17190  
FS\_ID:57234  
EP\_NO: 8234  
Repair Type: Non-Urgent  
EVAL Issue: Unauthorized Modification or Non-Compliant Permit  
Crossing Status: Found  
UCIP Comments: 03/03/2020 Record updated from No Action Needed to Non-Urgent. Modifications to the crossings: pump and a standpipe connected to the crossing located in drainage ditch that were not included in original O&M design. Supply pipe is currently disconnected from the pump. Unable to locate a permit authorizing modifications. Recommend internal inspection of crossing. Two soil depression spots apparently from a truck crane found on LS slope and LS berm. Need to have CVFPB review ABO and determine current owner. (O.Yakimov - DWR UCIP)05/02/2017 Crossing appears to be in good condition. (A.Freitag - DWR Sutter Yard)10/17/2016 Crossing appears to be in good condition. Pipe was field verified to be 48-inch CMP. (A.Freitag - DWR Sutter Yard)05/31/2016 Crossing appears to be in good condition. (A.Freitag - DWR Sutter Yard)05/04/2015 Crossing appears to be in good condition. No noticeable issues to report. (A.Freitag - DWR Sutter Yard)06/17/2014 Same as last inspection. (A.Freitag - DWR Sutter Yard)12/16/2013 Same as last inspection. (A.Freitag - DWR Sutter Yard)07/16/2013 Same as last inspection. (A.Freitag - DWR Sutter Yard)

View of levee crown at the crossing looking downstreams

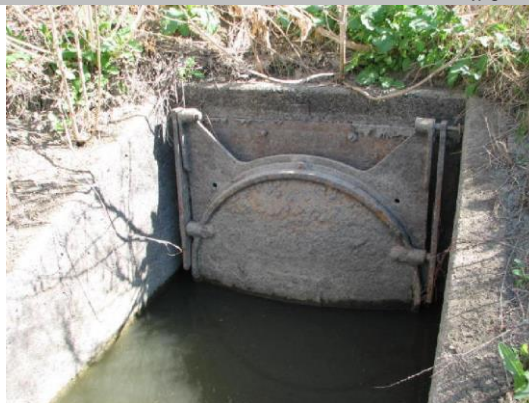
Photo 2 of 3 : UCIP\_FA\_2021\_57234\_69032.jpg

Flap gate in concrete U-shaped headwall at WS toe.

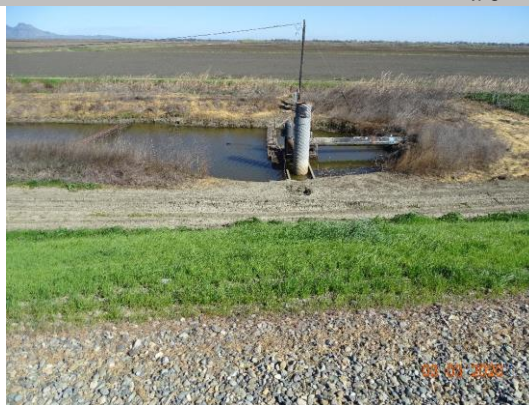
Photo 3 of 3 : UCIP\_FA\_2021\_57234\_83562.jpg

View of LS looking from levee crown

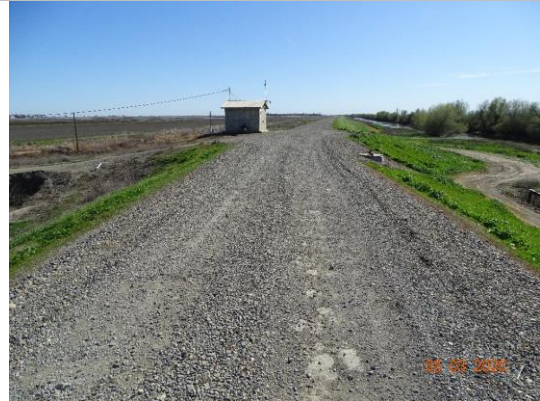
Photo 1 of 3 : UCIP\_FA\_2021\_57280\_83569.jpg

Comment Code						
Inspector Comment						
DS_ID:17161 FS_ID:57280 EP_NO: 9390 Repair Type: Non-Urgent EVAL Issue: Unauthorized Encroachment, installed decades prior Crossing Status: Found UCIP Comments: 03/03/2020 Record updated from No Action Needed to Non-Urgent. Need to have CVFPB review ABO and determine current owner. (O.Yakimov - DWR UCIP) 05/02/2017 Crossing appears to be in good condition. (A.Freitag - DWR Sutter Yard) 10/17/2016 Crossing appears to be in good condition. (A.Freitag - DWR Sutter Yard) 05/31/2016 Crossing appears to be in good condition. (A.Freitag - DWR Sutter Yard) 05/04/2015 Crossing appears to be in good condition. No noticeable issues to report. (A.Freitag - DWR Sutter Yard) 06/17/2014 Same as last inspection. (A.Freitag - DWR Sutter Yard) 12/16/2013 Same as last inspection. (A.Freitag - DWR Sutter Yard) 07/16/2013 Same as last inspection. (A.Freitag - DWR Sutter Yard) FIELD_STRUCT_DESC: 48-inch corrugated metal drainage pipe through the levee, 20.3 feet below the crown. Concrete headwall and cobble revetted spillway on the waterside (WS). Slide gate in a 60-inch corrugated metal pipe (CMP) riser on the WS slope. Concrete headwall located on the landside (LS). (48-inch pipe [HLM 6.10] authorized under Automatic Board Order (ABO) issued as Permit No. 9390, 1974 - Annie D. Propfe; 58-inch pipe [HLM 6.10] authorized under Automatic Board Order (ABO) issued as Permit No. 8234, 1972 - Glenn Irrigation District). [Additional Reference(s): DWR Levee Log, 2005 (HLM 6.10). USACE Sacramento O&M Manual, Unit 132, October 1959, Revised 14 January 2019, (HLM 6.10), listed as 48-inch pipe. USACE As-Built Drawing No. 50-4-3081, Sheet 7 and 16, Station 1648+88.2, 4 April 1957]. FS Date: 3/3/2020 1:07:00 PM

View of levee crown at the crossing looking downstream

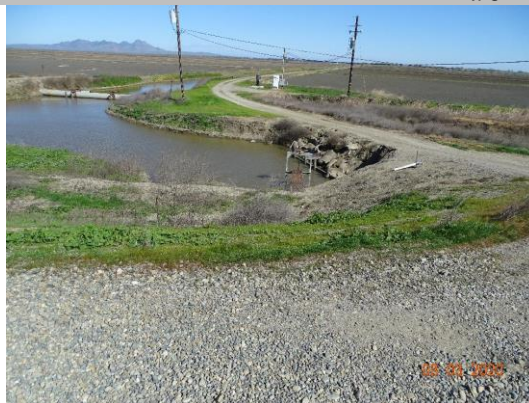
Photo 2 of 3 : UCIP\_FA\_2021\_57280\_83570.jpg

View of LS looking from levee crown

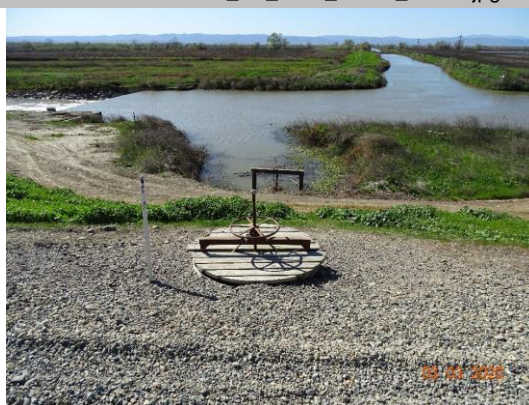
Photo 3 of 3 : UCIP\_FA\_2021\_57280\_83571.jpg

View of WS looking from levee crown

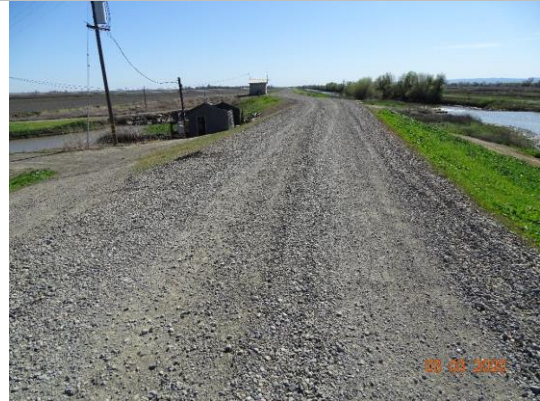
Photo 1 of 3 : UCIP\_FA\_2021\_57238\_83594.jpg

DS\_ID:17199  
FS\_ID:57238  
EP\_NO: 9390  
Repair Type: Non-Urgent  
EVAL Issue: Unauthorized Encroachment, installed decades prior  
Crossing Status: Found  
UCIP Comments: 03/03/2020 Record remains Non-Urgent. Need to have CVFPB review ABO and determine current owner. (O.Yakimov - DWR UCIP)  
05/02/2017 Pipe appears to be in good condition. Minor erosion above the LS pump house. (A.Freitag - DWR Sutter Yard)10/17/2016 Crossing appears to be in good condition. (A.Freitag - DWR Sutter Yard)05/31/2016 Crossing appears to be in good condition. (A.Freitag - DWR Sutter Yard)05/04/2015 Crossing appears to be in good condition. No noticeable issues to report. (A.Freitag - DWR Sutter Yard)06/17/2014 Same as last inspection. (A.Freitag - DWR Sutter Yard)12/16/2013 Same as last inspection. (A.Freitag - DWR Sutter Yard)07/16/2013 Same as last inspection. (W.Wylie - DWR UCIP)  
FIELD\_STRUCT\_DESC: 3 of 3: 18-inch steel drainage pipe through the levee, 4.4 feet below the crown. Cobble revetted sump located on the waterside (WS). Siphon breaker in a 16-inch metal riser on the WS shoulder. Pump house at the landside (LS) toe. (18-inch pipe [HLM 6.13] authorized under Automatic Board Order (ABO) issued as Permit No. 9390, 1974 - Annie D. Propfe). [Additional Reference(s): DWR Levee Log, 2005 (HLM 6.13). USACE Sacramento O&M Manual, Unit 132, October 1959, Revised 14 January 2019, (HLM 6.13), listed as 3-18" pipes. Pipe not included to original USACE As-Built Drawing No. 50-4-3081.

View of levee crown at the crossing looking downstream

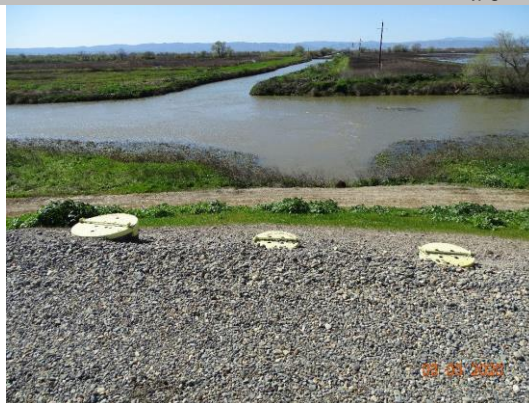
Photo 2 of 3 : UCIP\_FA\_2021\_57238\_83595.jpg

View of WS looking from levee crown

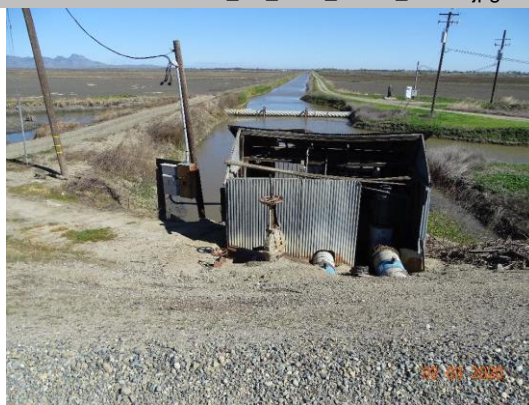
Photo 3 of 3 : UCIP\_FA\_2021\_57238\_83596.jpg

View of LS looking from levee crown. Pumphouse with 3 pumps at LS toe

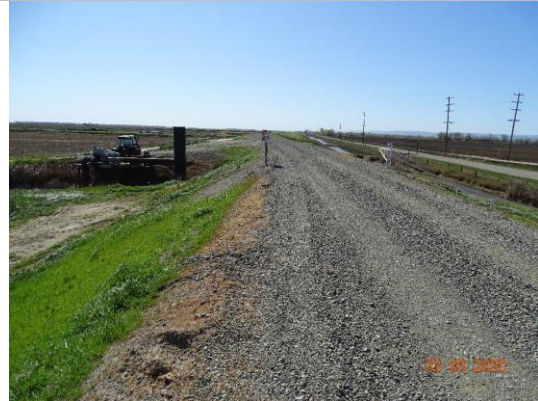
Photo 1 of 3 : UCIP\_FA\_2021\_57219\_83633.jpg

DS\_ID:17167  
FS\_ID:57219  
EP\_NO: 9389  
Repair Type: Urgent  
EVAL Issue: Pipe Integrity  
Crossing Status: Found  
UCIP Comments: 03/03/2020 Record remains Urgent. Pipe is excessively corroded inside at WS end. Recommend internal video inspection of crossing. Need to have CVFPB review ABO and determine current owner. (O.Yakimov - DWR UCIP)  
10/05/2018 Flap gate was installed at WS end of the pipe. Pipe is excessively corroded looking inside from WS end. Video inspection is recommended. Cracks more than 1-inch wide were observed on WS slope around pipe alignment that may be a sign of slope instability. (O.Yakimov - DWR UCIP)  
05/02/2017 No repairs have been made to this crossing yet. WS flap gate is still disconnected from end of pipe and pipe is showing heavy signs of rust and deterioration as far in as i can see from the WS end. Pipe should be internally camera inspected and repaired/replaced. (A.Freitag - DWR Sutter Yard)

01/31/2017 Informal Notice of Violation (NOV) was sent out January 31, 2017 by DWR Flood Maintenance Office--owner needs to re-attach flap gate to drainage pipe and coordinate with CVFPB to address additional issue(s) identified in NOV. Owner has until Monday February 27th, 2017 to respond to DWR contact: Bryan Reniff. (refer to Official Notice for details). (O.Magana - DWR UCIP)  
10/17/2016 WS flapgate has separated from the pipe end. WS pipe end is showing signs of rust and deterioration. Needs a new flapgate or other means of closing off the pipe before flood season. (A.Freitag - DWR Sutter Yard)  
05/31/2016 Crossing appears to be in good condition. (A.Freitag - DWR Sutter Yard)05/04/2015 Crossing appears to be in good condition. No noticeable issues to report. (A.Freitag - DWR Sutter Yard)  
06/17/2014 Same as last inspection. (A.Freitag - DWR Sutter Yard)12/16/2013 Same as last inspection. (A.Freitag - DWR Sutter Yard)

View of levee crown at the crossing looking downstream

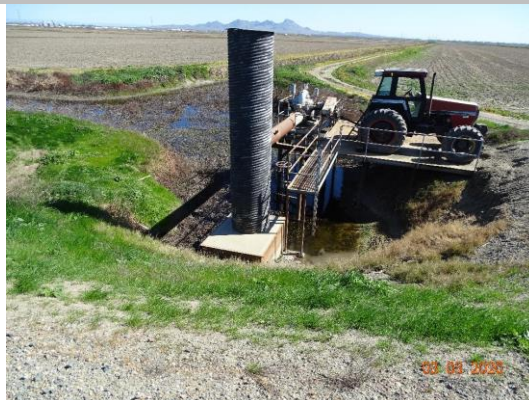
Photo 2 of 3 : UCIP\_FA\_2021\_57219\_83634.jpg

Stanspipe, pump in drainage ditch, and tractor used as a pump motor on LS

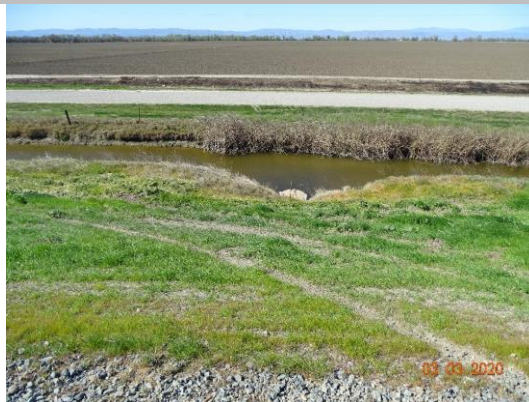
Photo 3 of 3 : UCIP\_FA\_2021\_57219\_83638.jpg

View of WS looking from levee crown

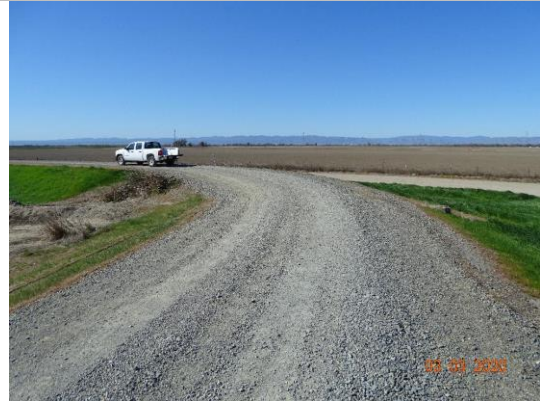
Photo 1 of 3 : UCIP\_FA\_2021\_57245\_83418.jpg

View of levee crown at crossing looking downstream

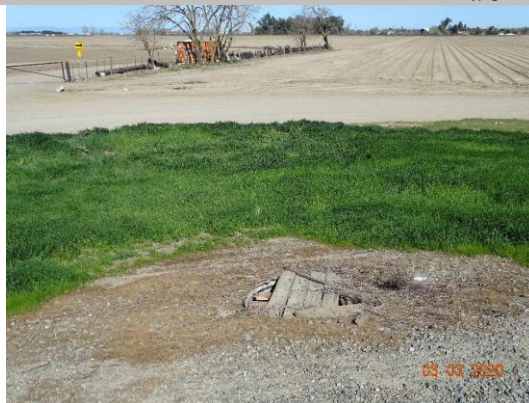
Photo 2 of 3 : UCIP\_FA\_2021\_57245\_83421.jpg

Water-Side looking from the crown

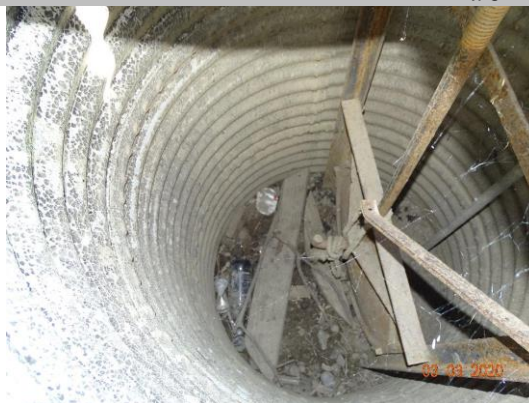
Photo 3 of 3 : UCIP\_FA\_2021\_57245\_83422.jpg

View inside of CMP riser on WS shoulder
