**Flood Control Project Maintenance
Levee Inspections**

Maintenance Issue Types Only, Levee Inspection Report By Mile - Fall 2022

Sutter Maintenance Yard Maintenance Area 0012

Waterway	Bank	Unit Miles	Inspection Start/End	Inspector
Unit No. 01 Colusa Drain	Left	11.06	09/08/2022 09/08/2022	Zach Jojola

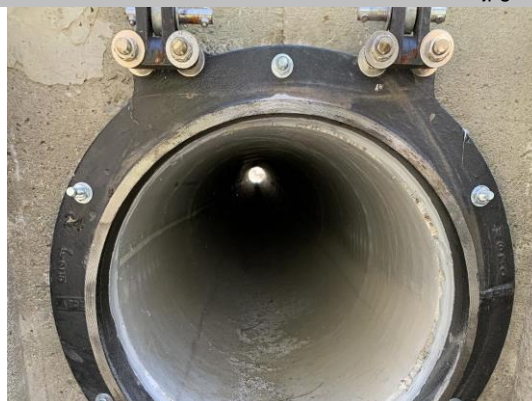
Photo 1 of 3 : UCIP_FA_2022_57222_103216.jpg

DS_ID:17146
FS_ID:57222
EP_NO: 9385
Repair Type: Non-Urgent
EVAL Issue:
Crossing Status: Found
UCIP Comments: 08/04/2021 Record updated from Urgent to Non-Urgent. Flap gate was replaced, LMA provided updated photos. (O.Yakimov - DWR UCIP)
03/04/2020 Record updated from Non-Urgent to Urgent. Pipe has been CIPP-lined under the DWR DMP Phase 2 Project. Flap gate not closing properly posing flood risk to the landside during flood season. LMA needs to repair or replace flap gate. No permit has been identified authorizing pipe. Need to have CVFPB review ABO and determine current owner. (O.Yakimov - DWR UCIP)
05/02/2017 WS is in good condition. LS inlet is more than 50% full of sediment. Pipe needs to be cleaned internally. (A.Freitag - DWR Sutter Yard)
10/17/2016 Minor sediment blocking the WS flap gate from opening. LS inlet still mostly full of sediment. (A.Freitag - DWR Sutter Yard)09/29/2016 Crossing has been downgraded from Urgent to Non-Urgent WS flap gate is closed for flood season. Need to coordinate with owner to remove sediment blocking WS flap gate. (O.Magana - DWR UCIP)

Water-Side: View inside of pipe with flap gate open

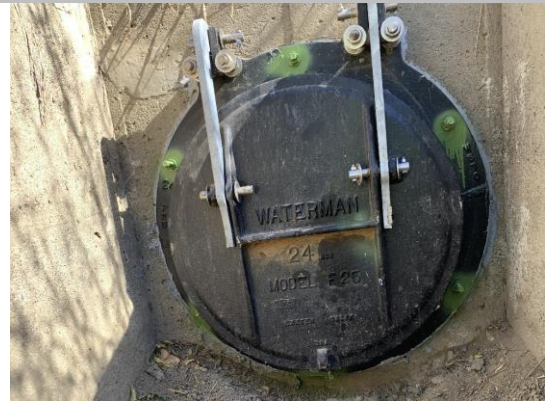
Photo 2 of 3 : UCIP_FA_2022_57222_103215.jpg

Water-Side: New flap gate installed

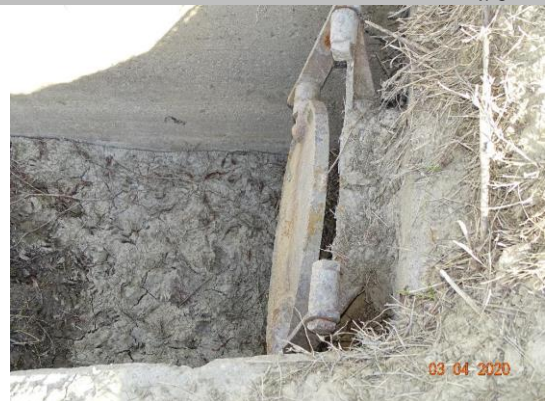
Photo 3 of 3 : UCIP_FA_2022_57222_83455.jpg

Flap gate should be closing properly

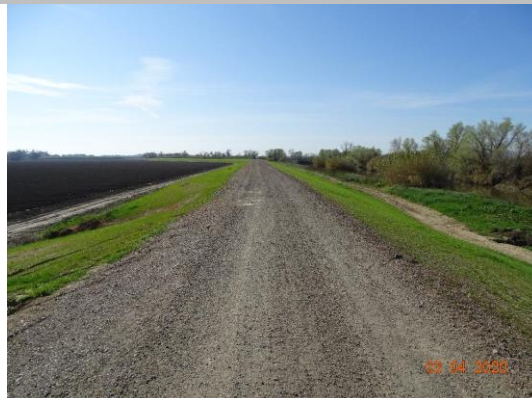
Photo 1 of 3 : UCIP_FA_2022_57190_83458.jpg

Comment Code						
Inspector Comment						
DS_ID:17147 FS_ID:57190 EP_NO: 9382 Repair Type: Non-Urgent EVAL Issue: Crossing Status: Found UCIP Comments: 03/04/2020 Record updated from No Action Needed to Non-Urgent. Pipe has been CIPP-lined under the DWR DMP Phase 2 Project. Need to have CVFPB review ABO and determine current owner. (O.Yakimov - DWR UCIP) 05/02/2017 Crossing appears to be in good condition. (A.Freitag - DWR Sutter Yard)10/17/2016 Crossing appears to be in good condition. This is a gravity for the LS. (A.Freitag - DWR Sutter Yard)05/31/2016 Crossing appears to be in good condition. (A.Freitag - DWR Sutter Yard)05/04/2015 Crossing is in good condition. No issues. (A.Freitag - DWR Sutter Yard)06/17/2014 Same as last inspection. (A.Freitag - DWR Sutter Yard)12/16/2013 Same as last inspection. (A.Freitag - DWR Sutter Yard)07/16/2013 Same as last inspection. (A.Freitag - DWR Sutter Yard) FIELD_STRUCT_DESC: 24-inch corrugated metal CIPP-lined drainage pipe through the levee, 13 feet below the crown. Flap gate, concrete headwall, and grouted cobble spillway on the waterside (WS). Concrete headwall on the landside (LS). (24-inch pipe [HLM 1.40] authorized under Automatic Board Order (ABO) issued as Permit No. 9382, 1974 - Olen C. Bober; 24-inch pipe [HLM 1.40] was also authorized under Automatic Board Order (ABO) issued as Permit No. 8228, 1972 - Olin C. Baber). [Additional Reference(s): DWR Levee Log, 2005 (HLM 1.40). USACE Sacramento O&M Manual, Unit 132, October 1959, Revised 14 January 2019, (HLM 1.40), listed as 24-inch pipe. USACE As-Built Drawing No. 50-4-3081, Sheet 4 and 15, Station 1402+63, 4 April 1957]. FS Date: 3/4/2020 9:53:00 AM

Levee crown at the crossing

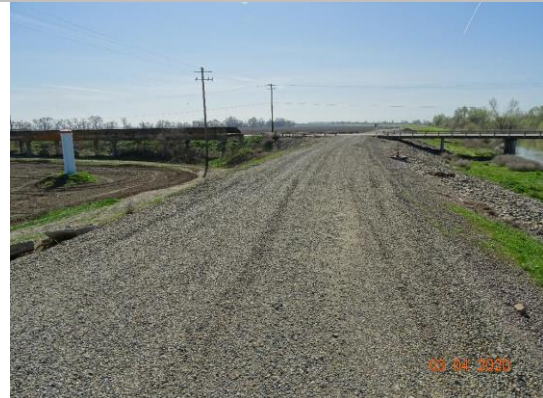
Photo 1 of 3 : UCIP_FA_2022_57227_83485.jpg

DS_ID:17150
FS_ID:57227
EP_NO: 9387
Repair Type: Urgent
EVAL Issue: 3a, Flood Risk
Crossing Status: Found
UCIP Comments: 03/04/2020 Record updated from No Action Needed to Urgent. Flap gate at WS levee toe not closing tightly leaving a gap for water to enter a part of crossing up to slide gate. Since slide gate on WS shoulder is in open position, this can pose flood risk to the landside during high water events. Recommend LMA to repair flap gate before next flood season. Pipe inlet near LS levee toe not found. Crossing appears abandoned. Concrete standpipe observed on landside 1,400 feet east of levee that seem to belong to the drainage system. Abandoned pump in irrigation/drainage canal 1,750 feet east of levee found. Recommend geophysical study to determine alignment of pipe through the levee. Need to have CVFPB review ABO and determine current owner. Need to contact owner to determine status of crossing. (O.Yakimov - DWR UCIP)05/02/2017 Crossing appears to be in good condition. (A.Freitag - DWR Sutter Yard)10/17/2016 Crossing appears to be in good condition. (A.Freitag - DWR Sutter Yard)05/31/2016 Crossing appears to be in good condition. Attached photo showing location of LS inlet. (A.Freitag - DWR Sutter Yard)05/04/2015 WS flapgate mostly underwater but could tell it was blocked open by something. LS inlet is located about 1/4 mile north along the side of the roadway. (A.Freitag - DWR Sutter Yard)06/17/2014 Same as last inspection. (A.Freitag - DWR Sutter Yard)12/16/2013 Pipe was flowing water and flap gate was being pushed open. Cannot verify if it will close all the way. (A.Freitag - DWR Sutter Yard)07/16/2013 Same as last inspection. Was told inlet is about 1/4 mile down road way next to house. Will try to get coordinates for inlet. (A.Freitag - DWR Sutter Yard)10/11/2012 No inlet could be located on LS. Flap gate partially blocked and will not close completely. (W.Wylie - DWR UCIP)

View of levee crown at crossing looking downstream

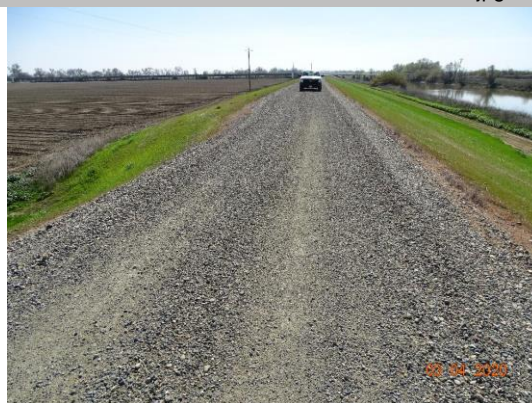
Photo 1 of 3 : UCIP_FA_2022_57228_83501.jpg

UCIP Comments: 03/04/2020 Record remains Non-Urgent. Need to have CVFPB review ABO and determine current owner. Crossing appears abandoned. Both end of crossing are buried. Recommend performing maintenance of the crossing. (O.Yakimov - DWR UCIP)

View of levee crown at the crossing looking downstream

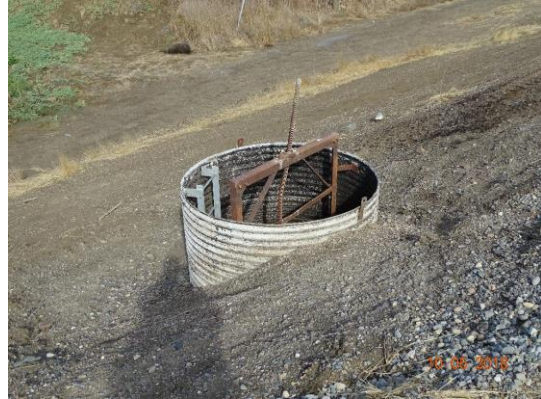
Photo 2 of 3 : UCIP_FA_2022_57196_78199.jpg

CMP riser with slide gate on WS shoulder.

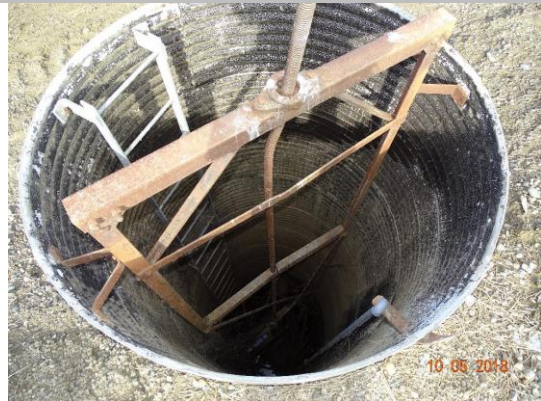
Photo 3 of 3 : UCIP_FA_2022_57196_78200.jpg

Inside view of CMP riser. Slide gate stem is bent.

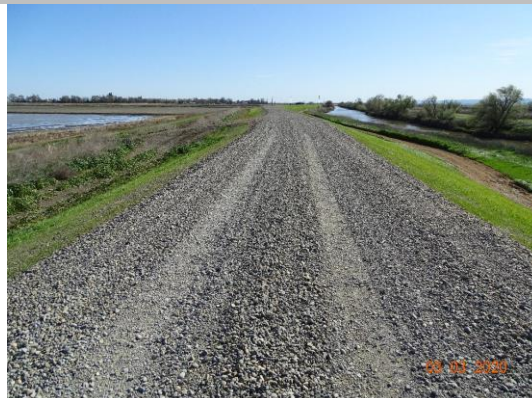
Photo 1 of 3 : UCIP_FA_2022_57232_83554.jpg

DS_ID:17191
FS_ID:57232
EP_NO: 9390
Repair Type: Urgent
EVAL Issue: 1, Pipe Integrity
Crossing Status: Found
UCIP Comments: 03/03/2020 Record remains Non-Urgent. Pipe inlet in drainage ditch on LS is buried. Flap gate on WS is under water, unable to see if sediment was cleared. Recommend internal video inspection of the pipe. Need to have CVFPB review ABO and determine current owner. (O.Yakimov - DWR UCIP)
05/02/2017 WS headwall and flapgate almost completely buried with only a small portion of the head wall visible. LS end is buried and unable to be located. (A.Freitag - DWR Sutter Yard)
10/17/2016 WS flap gate is still silted over and LS inlet is heavily vegetated and unable to be inspected. (A.Freitag - DWR Sutter Yard)
09/29/2016 Crossing has been downgraded from Urgent to Non-Urgent WS flap gate is closed shut due to sediment build up. For flood season flap gate is required to be closed. Need to coordinate with owner to remove sediment from WS to have WS flap gate be operable after flood season. (O.Magana - DWR UCIP)

View of levee crown at the crossing looking downstream

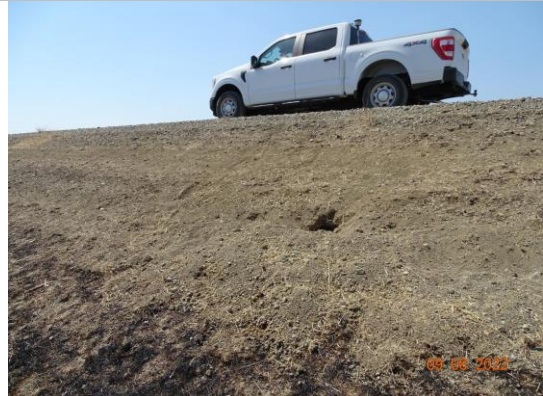
Photo 1 of 1 : FA_2022_MA0012_299_32_20220919_00082.jpg

View of rodent hole on the landside slope. Fall 2022.

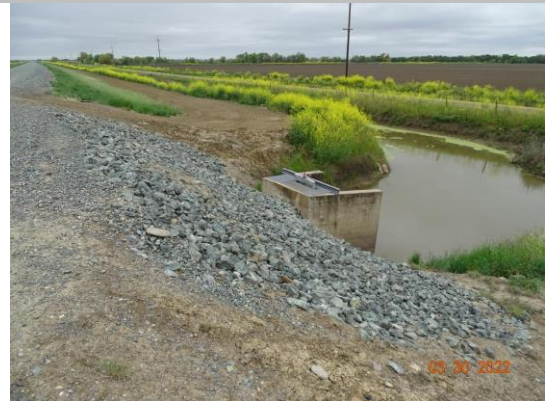
Photo 1 of 1 : FA_2022_MA0012_299_35_20220921_00083.jpg

View of repaired waterside slope. Spring 2022.

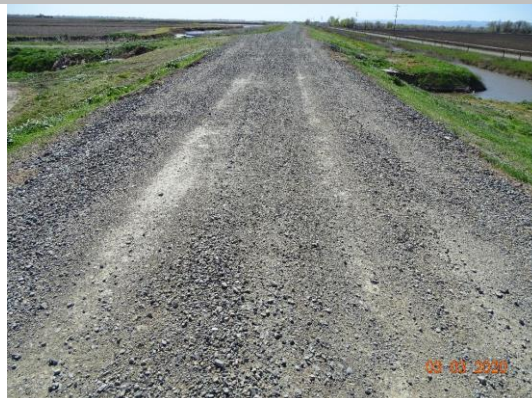
Photo 1 of 3 : UCIP_FA_2022_57244_83623.jpg

Comment Code					
Inspector Comment					
DS_ID:17189 FS_ID:57244 EP_NO: N/A Repair Type: Non-Urgent EVAL Issue: Crossing Status: Not Found UCIP Comments: 03/03/2020 Record updated from No Action Needed to Non-Urgent. Crossing not found. Geophysical results did not confirm presence of pipe through levee. Record will remain in UCIP's inspection records until future Levee Improvement Project can confirm no crossing was found through the levee. Suspect that this pipe is the same record as DSID 17164. (O.Yakimov - DWR UCIP) 05/02/2017 Unable to locate. (A.Freitag - DWR Sutter Yard) 10/17/2016 Unable to locate. (A.Freitag - DWR Sutter Yard) 05/31/2016 Unable to locate. (A.Freitag - DWR Sutter Yard) 05/04/2015 Unable to locate. (A.Freitag - DWR Sutter Yard) 06/17/2014 Unable to locate. (A.Freitag - DWR Sutter Yard) 12/16/2013 Unable to locate. (A.Freitag - DWR Sutter Yard) 07/16/2013 Same as last inspection. Unable to locate. (A.Freitag - DWR Sutter Yard) FIELD_STRUCT_DESC: 24-inch steel drainage pipe through the levee, at an unknown depth. Corrugated metal cutoff wall at center of levee. 1/4-inch cover plates continuously welded over both the waterside (WS) and the landside (LS) ends. [Additional Reference(s): USACE Sacramento O&M Manual, Unit 132, October 1959, Revised 14 January 2019, (HLM 9.25), listed 24-inch pipe. USACE As-Built Drawing No. 50-4-3081, Sheet 9 and 16, Station 1811+05, 4 April 1957]. FS Date: 3/3/2020 3:43:00 PM

View of levee crown at potential crossing looking downstream

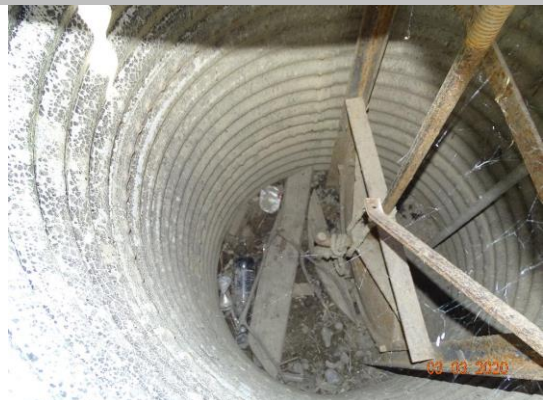
Photo 3 of 3 : UCIP_FA_2022_57245_83422.jpg

View inside of CMP riser on WS shoulder
