**Flood Control Project Maintenance
Levee Inspections**

Maintenance Issue Types Only, Levee Inspection Report By Mile - Fall 2023

Sutter Maintenance Yard Maintenance Area 0012

Waterway	Bank	Unit Miles	Inspection Start/End	Inspector
Unit No. 01 Colusa Drain	Left	11.06	09/08/2023 09/08/2023	Zach Jojola

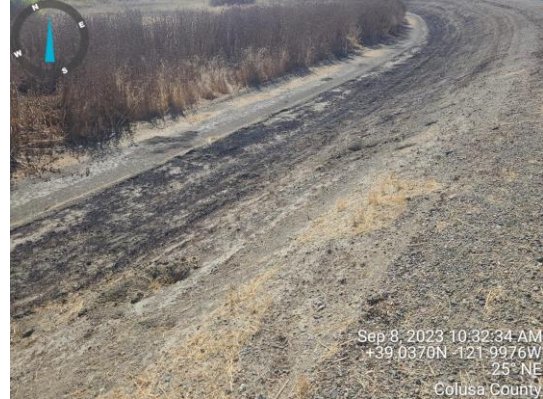
Photo 1 of 1 : FA_2023_MA0012_299_32_20230911_00071.jpg

LM Start	0.22	Rating **	M	Issue No.	32
LM End	0.22	Issue Type +	Ma	Location *	LS
Category	Earthen Levee			GPS Latitude/Longitude	
				Start	End
Item	Animal Control			39.035723°	39.035723°
				-121.996591°	-121.996591°
DWR ID	DWR_MA0012_01_f_2023_32				
Comment Code					
A3 : No rodents visible, but rodent burrows visible; need to backfill and compact or grout burrows.					
Inspector Comment					
There are multiple rodent holes on the landside slope.

View of rodent holes on the landside slope. Fall 2023.

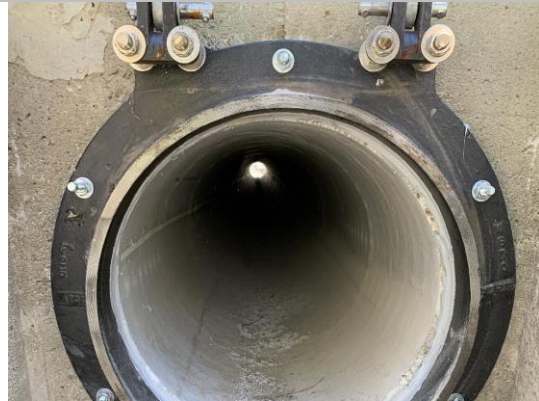
Photo 1 of 3 : UCIP_FA_2023_81149_103216.jpg

DS_ID:17146
FS_ID:81149
EP_NO: 9385
Repair Type: Non-Urgent
EVAL Issue:
Crossing Status: Found
UCIP Comments: 09/25/2023 DMP internal video inspection has found none or minor pipe defects. Recommend next video inspection in 5 years. (J. Taylor - DWR UCIP)08/04/2021 Record updated from Urgent to Non-Urgent. Flap gate was replaced, LMA provided updated photos. (O.Yakimov - DWR UCIP) 03/04/2020 Record updated from Non-Urgent to Urgent. Pipe has been CIPP-lined under the DWR DMP Phase 2 Project. Flap gate not closing properly posing flood risk to the landside during flood season. LMA needs to repair or replace flap gate. No permit has been identified authorizing pipe. Need to have CVFPB review ABO and determine current owner. (O.Yakimov - DWR UCIP)05/02/2017 WS is in good condition. LS inlet is more than 50% full of sediment. Pipe needs to be cleaned internally. (A.Freitag - DWR Sutter Yard)10/17/2016 Minor sediment blocking the WS flap gate from opening. LS inlet still mostly full of sediment. (A.Freitag - DWR Sutter Yard)09/29/2016 Crossing has been downgraded from Urgent to Non-Urgent WS flap gate is closed for flood season. Need to coordinate with owner to remove sediment blocking WS flap gate. (O.Magana - DWR UCIP)05/31/2016 WS flap gate is blocked from opening by sediment. LS inlet is over 50% full of sediment. (A.Freitag - DWR Sutter Yard)05/04/2015 WS flap gate is blocked by sediment and unable to open. LS inlet is about 50% plugged with soil. Needs to be cleaned. (A.Freitag - DWR Sutter Yard)06/17/2014 Same as last inspection. (A.Freitag - DWR Sutter Yard)12/16/2013 Sediment against flapgate has been cleared and it can now function properly. (A.Freitag - DWR Sutter Yard)07/16/2013 Sediment is built up against WS flapgate preventing it from opening. (A.Freitag - DWR Sutter Yard)10/11/2012 Pipe is partially filled with soil. (W.Wylie - DWR UCIP)

Water-Side: View inside of pipe with flap gate open

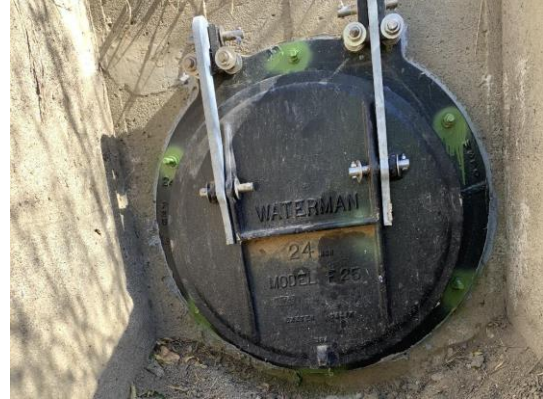
Photo 2 of 3 : UCIP_FA_2023_81149_103215.jpg

Water-Side: New flap gate installed

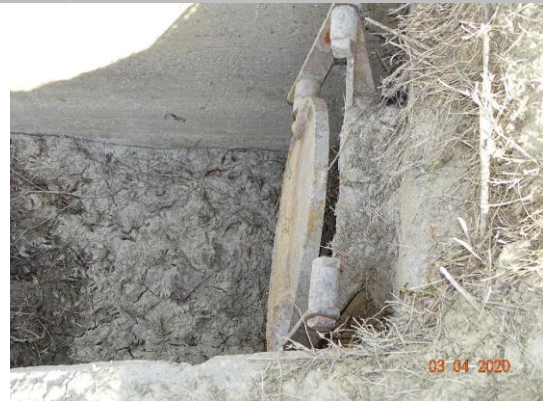
Photo 3 of 3 : UCIP_FA_2023_81149_83455.jpg

Flap gate should be closing properly

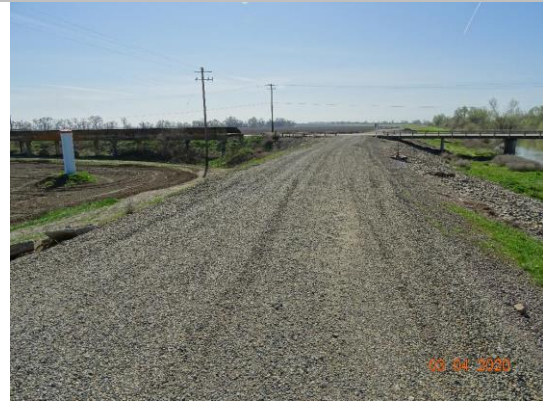
Photo 1 of 3 : UCIP_FA_2023_57227_83485.jpg

DS_ID:17150
FS_ID:57227
EP_NO: 9387
Repair Type: Urgent
EVAL Issue: 3a, Flood Risk
Crossing Status: Found
UCIP Comments: 03/04/2020 Record updated from No Action Needed to Urgent. Flap gate at WS levee toe not closing tightly leaving a gap for water to enter a part of crossing up to slide gate. Since slide gate on WS shoulder is in open position, this can pose flood risk to the landside during high water events. Recommend LMA to repair flap gate before next flood season. Pipe inlet near LS levee toe not found. Crossing appears abandoned. Concrete standpipe observed on landside 1,400 feet east of levee that seem to belong to the drainage system. Abandoned pump in irrigation/drainage canal 1,750 feet east of levee found. Recommend geophysical study to determine alignment of pipe through the levee. Need to have CVFPB review ABO and determine current owner. Need to contact owner to determine status of crossing. (O.Yakimov - DWR UCIP)05/02/2017 Crossing appears to be in good condition. (A.Freitag - DWR Sutter Yard)10/17/2016 Crossing appears to be in good condition. (A.Freitag - DWR Sutter Yard)05/31/2016 Crossing appears to be in good condition. Attached photo showing location of LS inlet. (A.Freitag - DWR Sutter Yard)05/04/2015 WS flapgate mostly underwater but could tell it was blocked open by something. LS inlet is located about 1/4 mile north along the side of the roadway. (A.Freitag - DWR Sutter Yard)06/17/2014 Same as last inspection. (A.Freitag - DWR Sutter Yard)12/16/2013 Pipe was flowing water and flap gate was being pushed open. Cannot verify if it will close all the way. (A.Freitag - DWR Sutter Yard)07/16/2013 Same as last inspection. Was told inlet is about 1/4 mile down road way next to house. Will try to get coordinates for inlet. (A.Freitag - DWR Sutter Yard)10/11/2012 No inlet could be located on LS. Flap gate partially blocked and will not close completely. (W.Wylie - DWR UCIP)

View of levee crown at crossing looking downstream

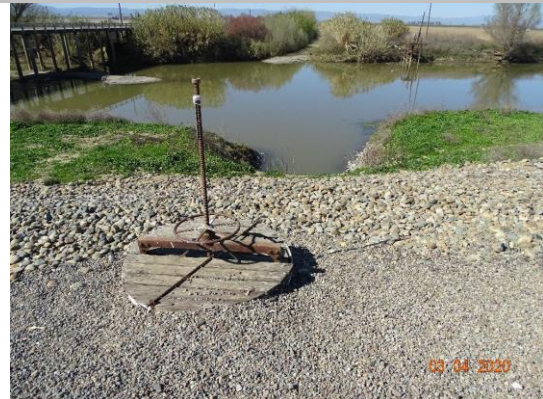
Photo 2 of 3 : UCIP_FA_2023_57227_83486.jpg

60-inch standpipe with slide gate on WS slope with outlet in background.

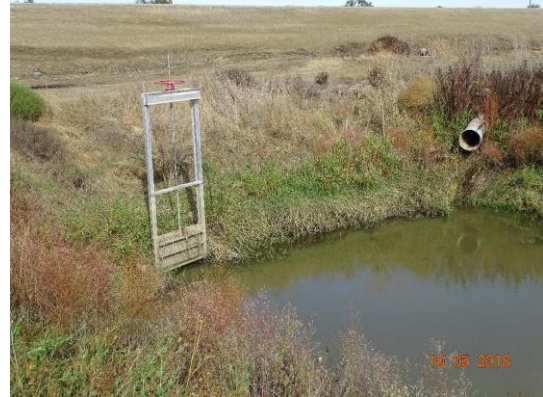
Photo 1 of 3 : UCIP_FA_2023_57196_78205.jpg

DS_ID:17154
FS_ID:57196
EP_NO: 9388
Repair Type: Urgent
EVAL Issue: 1, Pipe Integrity
Crossing Status: Found
UCIP Comments: 03/05/2020 Record remains Non-Urgent. New cover on CMP riser has been installed. Piping around slide gate at LS toe was modified, new 14-inch pipes installed. Unable to locate a permit for system modification. New steel walkway to slide gate on LS. Need to coordinate with LMA for find a permit authorizing modification. Need to have CVFPB review ABO and determine current owner. (O.Yakimov - DWR UCIP)
10/05/2018 Fall hazard: missing cover on CMP riser. Closure devices are present on both ends of crossing and seem to be in operable condition. Downgraded to non-urgent. Recommend owner add cover to CMP riser. (O.Yakimov - DWR UCIP)
05/02/2017 WS slide gate stem is still bent, wheel to operate gate is missing. Needs a cover made for the standpipe to prevent falls. (A.Freitag - DWR Sutter Yard)10/17/2016 Slide gate stem is still and the gate appears to be inoperable. (A.Freitag - DWR Sutter Yard)05/31/2016 Slide gate stem is still bent. WS flap gate is chained open. (A.Freitag - DWR Sutter Yard)

05/04/2015 Slide gate stem is still bent. Gate looks to be unable to close all the way. (A.Freitag - DWR Sutter Yard)06/17/2014 Same as last inspection. (A.Freitag - DWR Sutter Yard)12/16/2013 Slide gate stem is still bent. WS flapgate was closed. (A.Freitag - DWR Sutter Yard)
07/16/2013 Water flowing through pipe so screw gate definitely not closed. Was told NOV's have been sent for owner to replace stem. Flap gate gets closed for flood season. (A.Freitag - DWR Sutter Yard)
10/11/2012 Slide gate inoperable, but appears to be in closed position. Flap gate held in open position. Good candidate for video inspection when, if ever, dry. (W.Wylie - DWR UCIP)
FIELD_STRUCT_DESC: 48-inch corrugated metal drainage pipe through the levee, 28 feet below the crown. Slide gate in a 66-inch riser on the waterside (WS) slope. Concrete headwall on the WS. Grouted cobble spillway from drainage ditch to large canal on the landside (LS). (48-inch pipe [HLM 3.78] authorized under Automatic Board Order (ABO) issued as Permit No. 9388, 1974 - Pauline A. Wallace; 48-inch pipe [HLM 3.78] was also authorized under Automatic Board Order (ABO) issued as Permit No. 8231, 1972 - Roy E. Kitts. [Additional Reference(s): DWR Levee Log, 2005 (HLM 3.78). USACE Sacramento O&M Manual, Unit 132, October 1959, Revised 14 January 2019, (HLM 3.78), listed as 48-inch pipe. USACE As-Built Drawing No. 50-4-3081, Sheet 5 and 15, Station 1524+75, 4 April 1957].

Headwall with slide gate at LS toe.

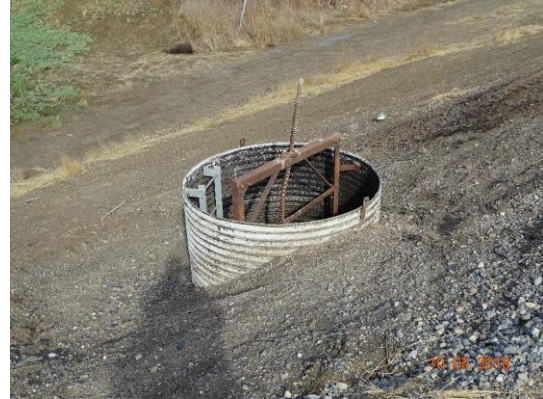
Photo 2 of 3 : UCIP_FA_2023_57196_78199.jpg

CMP riser with slide gate on WS shoulder.

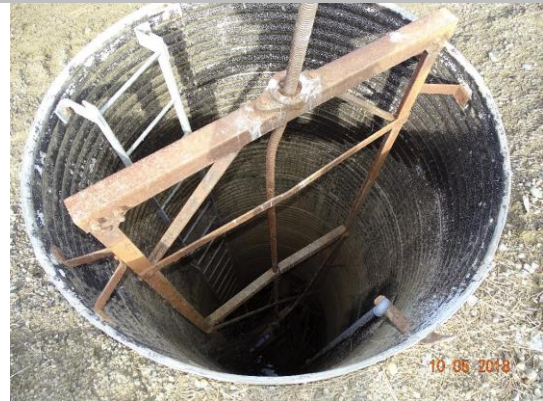
Photo 3 of 3 : UCIP_FA_2023_57196_78200.jpg

Inside view of CMP riser. Slide gate stem is bent.

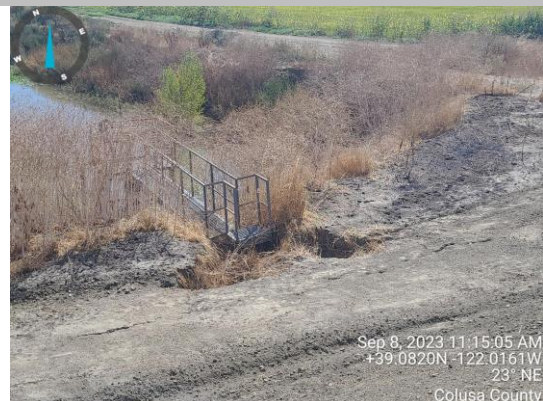
Photo 1 of 1 : FA_2023_MA0012_299_29_20230918_00072.jpg

LM Start	3.69	Rating **	M	Issue No.	29
LM End	3.69	Issue Type +	Ma	Location *	LS
Category	Earthen Levee			GPS Latitude/Longitude	
				Start	End
Item	Erosion / Bank Caving			39.081958°	39.081958°
				-122.016207°	-122.016207°
DWR ID	DWR_MA0012_01_s_2023_29				
Comment Code					
E2 : Schedule repair of erosion site prior to the next inspection.					
Inspector Comment					
There is erosion around the screw gate walkway.

View of erosion around walkway. Fall 2023.

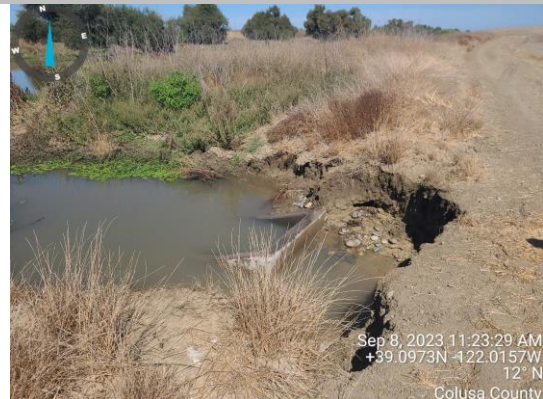
Photo 1 of 1 : FA_2023_MA0012_299_33_20230918_00073.jpg

LM Start	4.75	Rating **	M	Issue No.	33
LM End	4.75	Issue Type +	Ma	Location *	WS
Category	Earthen Levee			GPS Latitude/Longitude	
				Start	End
Item	Erosion / Bank Caving			39.097220°	39.097220°
				-122.015520°	-122.015520°
DWR ID	DWR_MA0012_01_f _ 2023_33				
Comment Code					
E2 : Schedule repair of erosion site prior to the next inspection.					
Inspector Comment

View of erosion behind concrete headwall. Fall 2023.

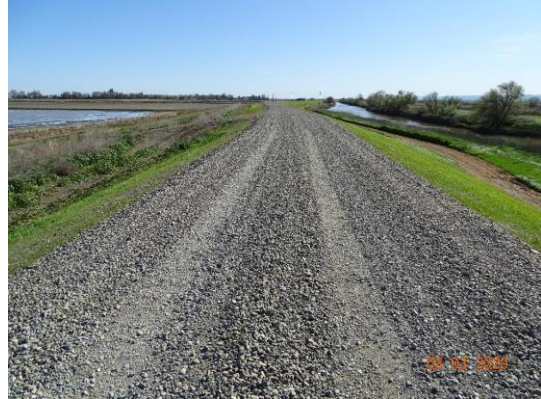
Photo 1 of 3 : UCIP_FA_2023_57232_83554.jpg

DS_ID:17191
FS_ID:57232
EP_NO: 9390
Repair Type: Urgent
EVAL Issue: 1, Pipe Integrity
Crossing Status: Found
UCIP Comments: 03/03/2020 Record remains Non-Urgent. Pipe inlet in drainage ditch on LS is buried. Flap gate on WS is under water, unable to see if sediment was cleared. Recommend internal video inspection of the pipe. Need to have CVFPB review ABO and determine current owner. (O.Yakimov - DWR UCIP)
05/02/2017 WS headwall and flapgate almost completely buried with only a small portion of the head wall visible. LS end is buried and unable to be located. (A.Freitag - DWR Sutter Yard)
10/17/2016 WS flap gate is still silted over and LS inlet is heavily vegetated and unable to be inspected. (A.Freitag - DWR Sutter Yard)
09/29/2016 Crossing has been downgraded from Urgent to Non-Urgent WS flap gate is closed shut due to sediment build up. For flood season flap gate is required to be closed. Need to coordinate with owner to remove sediment from WS to have WS flap gate be operable after flood season. (O.Magana - DWR UCIP)

View of levee crown at the crossing looking downstream

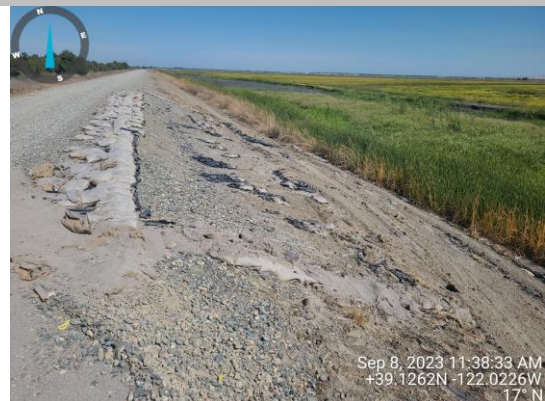
Photo 1 of 1 : FA_2023_MA0012_299_36_20230918_00074.jpg

View of sloughing on the landside slope. Fall 2023.

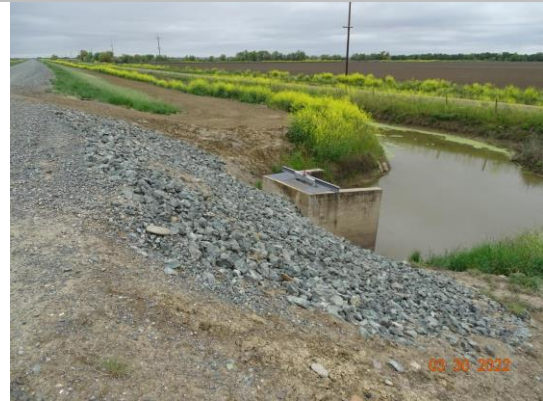
Photo 1 of 1 : FA_2023_MA0012_299_35_20230907_00009.jpg

View of repaired waterside slope. Spring 2022.

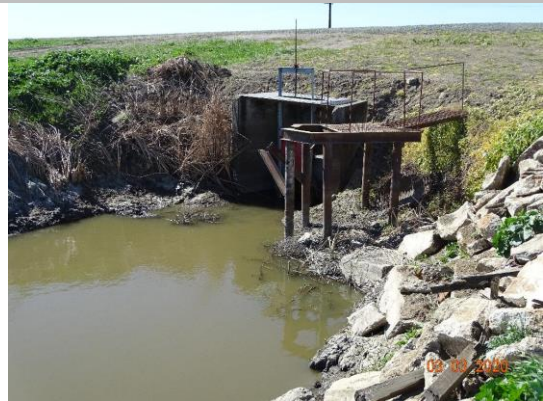
Photo 3 of 3 : UCIP_FA_2023_57243_83620.jpg

Abandoned pumping platform in irrigation canal on LS
