**Flood Control Project Maintenance
Levee Inspections**

Maintenance Issue Types Only, Levee Inspection Report By Mile - Fall 2024

Sutter Maintenance Yard Maintenance Area 0012

Waterway	Bank	Unit Miles	Inspection Start/End	Inspector
Unit No. 01 Colusa Drain	Left	11.06	09/18/2024 09/18/2024	Zach Jojoia

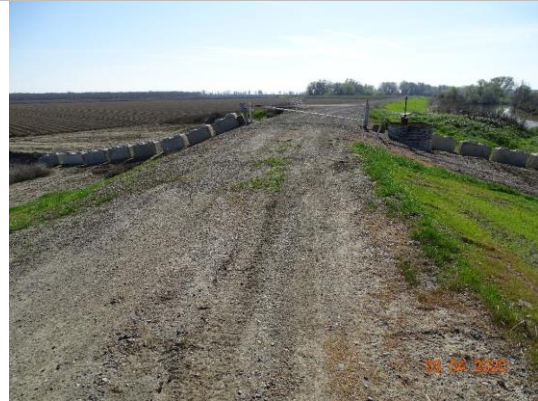
Photo 1 of 3 : UCIP_FA_2024_57220_83424.jpg

Comment Code						
Inspector Comment						
DS_ID:17155 FS_ID:57220 EP_NO: 9381 Repair Type: Non-Urgent EVAL Issue: 5, Pipe Damage Crossing Status: Found UCIP Comments: 03/04/2020 Record updated from No Action Needed to Non-Urgent. Need to have CVFPB review ABO and determine current owner. Recommend internal video inspection. (O.Yakimov - DWR UCIP) 05/02/2017 Crossing appears to be in good condition. (A.Freitag - DWR Sutter Yard) 10/17/2016 Crossing appears to be in good condition. Pipe material is CMP and the flow is from the LS to the WS. (A.Freitag - DWR Sutter Yard) 05/31/2016 Crossing appears to be in good condition. (A.Freitag - DWR Sutter Yard) 05/04/2015 Crossing in good condition. No issues. (A.Freitag - DWR Sutter Yard) 06/17/2014 Same as last inspection. (A.Freitag - DWR Sutter Yard) 07/16/2013 Same as last inspection. (A.Freitag - DWR Sutter Yard) 12/16/2013 Same as last inspection. (A.Freitag - DWR Sutter Yard) FIELD_STRUCT_DESC: 60-inch drainage pipe through the levee, 22.1 feet below the crown. Concrete headwalls located on both the WS and landside (LS) toes. Slide gate and flap gate in 84-inch pipe riser located on the waterside (WS) slope. (60-inch pipe [HLM 0.00] authorized under Automatic Board Order (ABO) issued as Permit No. 9381, 1974 - Tribble; 60-inch pipe [HLM 0.00] was also authorized under Automatic Board Order (ABO) issued as Permit No. 8225, 1972 - Harold Baldson). [Additional Reference(s): DWR Levee Log, 2005 (HLM 0.00). USACE Sacramento O&M Manual, Unit 132, October 1959, Revised 14 January 2019, (HLM 20.49 - RD 108), listed as 60-inch pipe. USACE As-Built Drawing No. 50-4-3081, Sheets 3 and 15, Station 1326+00, 4 April 1957]. FS Date: 3/4/2020 2:54:00 PM

View of levee crown at the crossing looking downstream

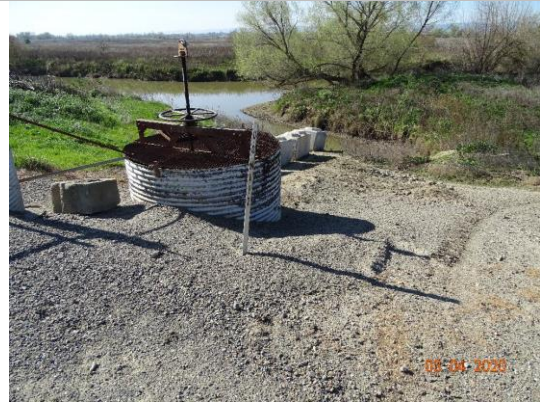
Photo 2 of 3 : UCIP_FA_2024_57220_83425.jpg

84-inch CMP riser with slide gate on WS shoulder

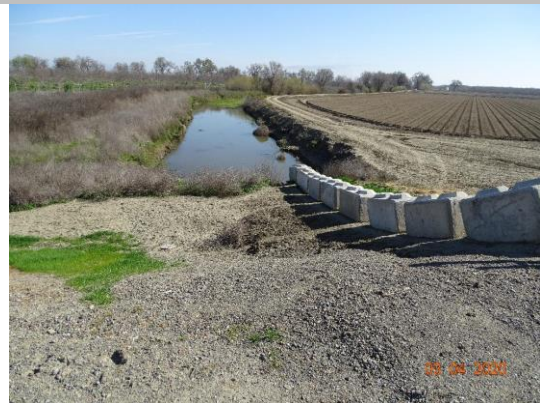
Photo 3 of 3 : UCIP_FA_2024_57220_83426.jpg

Drainage ditch on LS toe. Looking from levee crown

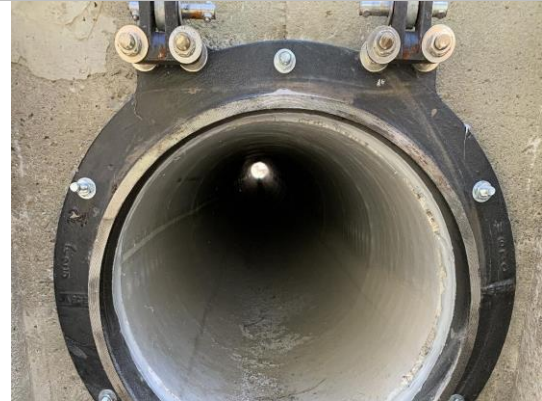
Photo 1 of 3 : UCIP_FA_2024_81149_103216.jpg

DS_ID:17146
FS_ID:81149
EP_NO: 9385
Repair Type: Non-Urgent
EVAL Issue:
Crossing Status: Found
UCIP Comments: 09/25/2023 DMP internal video inspection has found none or minor pipe defects. Recommend next video inspection in 5 years. (J. Taylor - DWR UCIP)08/04/2021 Record updated from Urgent to Non-Urgent. Flap gate was replaced, LMA provided updated photos. (O.Yakimov - DWR UCIP) 03/04/2020 Record updated from Non-Urgent to Urgent. Pipe has been CIPP-lined under the DWR DMP Phase 2 Project. Flap gate not closing properly posing flood risk to the landside during flood season. LMA needs to repair or replace flap gate. No permit has been identified authorizing pipe. Need to have CVFPB review ABO and determine current owner. (O.Yakimov - DWR UCIP)05/02/2017 WS is in good condition. LS inlet is more than 50% full of sediment. Pipe needs to be cleaned internally. (A.Freitag - DWR Sutter Yard)10/17/2016 Minor sediment blocking the WS flap gate from opening. LS inlet still mostly full of sediment. (A.Freitag - DWR Sutter Yard)09/29/2016 Crossing has been downgraded from Urgent to Non-Urgent WS flap gate is closed for flood season. Need to coordinate with owner to remove sediment blocking WS flap gate. (O.Magana - DWR UCIP)05/31/2016 WS flap gate is blocked from opening by sediment. LS inlet is over 50% full of sediment. (A.Freitag - DWR Sutter Yard)05/04/2015 WS flap gate is blocked by sediment and unable to open. LS inlet is about 50% plugged with soil. Needs to be cleaned. (A.Freitag - DWR Sutter Yard)06/17/2014 Same as last inspection. (A.Freitag - DWR Sutter Yard)12/16/2013 Sediment against flapgate has been cleared and it can now function properly. (A.Freitag - DWR Sutter Yard)07/16/2013 Sediment is built up against WS flapgate preventing it from opening. (A.Freitag - DWR Sutter Yard)10/11/2012 Pipe is partially filled with soil. (W.Wylie - DWR UCIP)

Water-Side: View inside of pipe with flap gate open

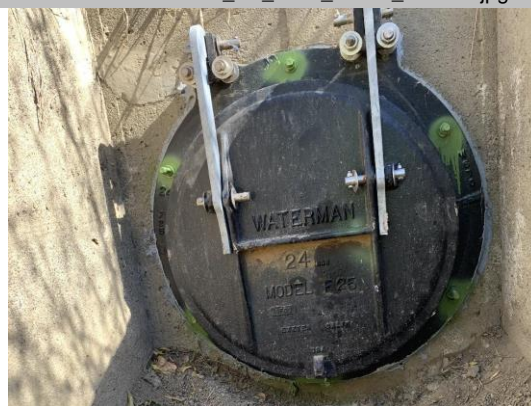
Photo 2 of 3 : UCIP_FA_2024_81149_103215.jpg

Water-Side: New flap gate installed

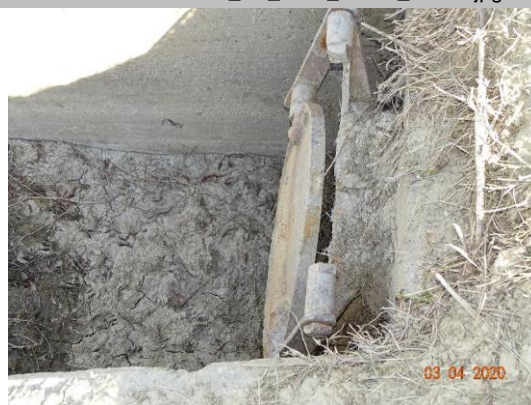
Photo 3 of 3 : UCIP_FA_2024_81149_83455.jpg

Flap gate should be closing properly

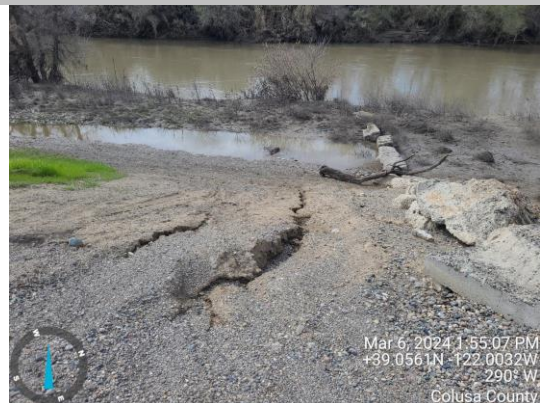
Photo 1 of 1 : FA_2024_MA0012_299_40_20240909_00011.jpg

LM Start	1.71	Rating **	M	Issue No.	40
LM End	1.71	Issue Type +	Ma	Location *	WS
Category	Earthen Levee			GPS Latitude/Longitude	
				Start	End
Item	Erosion / Rills			39.055979°	39.055979°
				-122.003264°	-122.003264°
DWR ID	DWR_MA0012_01_s_2024_40				
Comment Code					
E5 : Schedule repair of rills prior to the next inspection.					
Inspector Comment					
Rills are on the waterside slope.

View of rill on the waterside slope. Spring 2024.

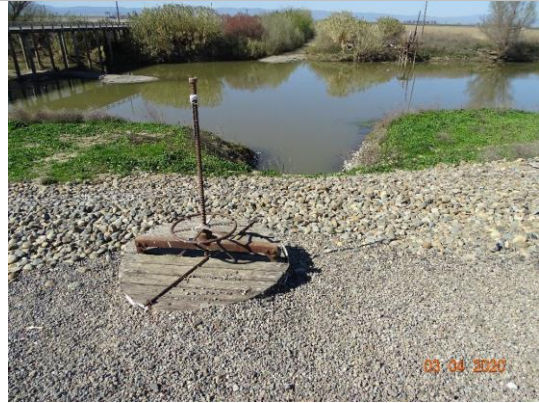
Photo 2 of 3 : UCIP_FA_2024_57227_83486.jpg

60-inch standpipe with slide gate on WS slope with outlet in background.

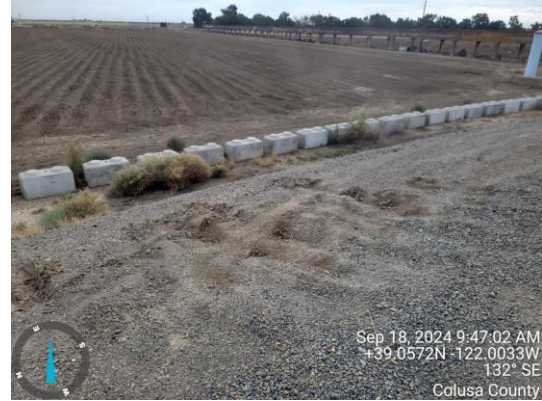
Photo 1 of 1 : FA_2024_MA0012_299_39_20240919_00076.jpg

LM Start	1.79	Rating **	M	Issue No.	39
LM End	1.79	Issue Type +	Ma	Location *	LS
Category	Earthen Levee			GPS Latitude/Longitude	
				Start	End
Item	Erosion / Vehicle Traffic			39.057208°	39.057208°
				-122.003397°	-122.003397°
DWR ID	DWR_MA0012_01_s_2024_39				
Comment Code					
E6 : Repair the levee slope damaged by vehicle traffic and prevent access where possible.					
Inspector Comment					
Tire ruts are on the landside slope.

View of ruts on the landside slope. Fall 2024.

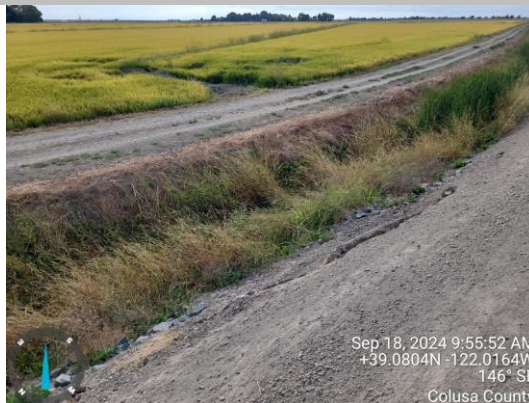
Photo 1 of 1 : FA_2024_MA0012_299_34_20240919_00078.jpg

LM Start	3.58	Rating **	M	Issue No.	34
LM End	3.61	Issue Type +	Ma	Location *	LS
Category	Earthen Levee			GPS Latitude/Longitude	
				Start	End
Item	Slope Stability			39.080371°	39.080712°
				-122.016476°	-122.016431°
DWR ID	DWR_MA0012_01_s_2024_34				
Comment Code					
S1 : Repair slope instability.					
Inspector Comment					
Approximately a 150' slough is located near the landside toe.

View of slip near the landside toe, facing downstream. Fall 2024.

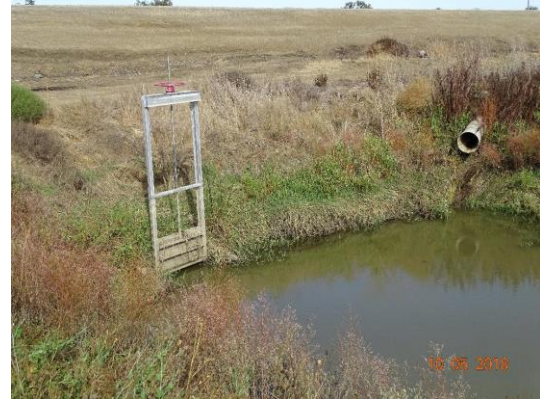
Photo 1 of 3 : UCIP_FA_2024_57196_78205.jpg

DS_ID:17154
FS_ID:57196
EP_NO: 9388
Repair Type: Urgent
EVAL Issue: 1, Pipe Integrity
Crossing Status: Found
UCIP Comments: 03/05/2020 Record remains Non-Urgent. New cover on CMP riser has been installed. Piping around slide gate at LS toe was modified, new 14-inch pipes installed. Unable to locate a permit for system modification. New steel walkway to slide gate on LS. Need to coordinate with LMA for find a permit authorizing modification. Need to have CVFPB review ABO and determine current owner. (O.Yakimov - DWR UCIP)
10/05/2018 Fall hazard: missing cover on CMP riser. Closure devices are present on both ends of crossing and seem to be in operable condition. Downgraded to non-urgent. Recommend owner add cover to CMP riser. (O.Yakimov - DWR UCIP)
05/02/2017 WS slide gate stem is still bent, wheel to operate gate is missing. Needs a cover made for the standpipe to prevent falls. (A.Freitag - DWR Sutter Yard)10/17/2016 Slide gate stem is still and the gate appears to be inoperable. (A.Freitag - DWR Sutter Yard)05/31/2016 Slide gate stem is still bent. WS flap gate is chained open. (A.Freitag - DWR Sutter Yard)

05/04/2015 Slide gate stem is still bent. Gate looks to be unable to close all the way. (A.Freitag - DWR Sutter Yard)06/17/2014 Same as last inspection. (A.Freitag - DWR Sutter Yard)12/16/2013 Slide gate stem is still bent. WS flapgate was closed. (A.Freitag - DWR Sutter Yard)
07/16/2013 Water flowing through pipe so screw gate definitely not closed. Was told NOV's have been sent for owner to replace stem. Flap gate gets closed for flood season. (A.Freitag - DWR Sutter Yard)
10/11/2012 Slide gate inoperable, but appears to be in closed position. Flap gate held in open position. Good candidate for video inspection when, if ever, dry. (W.Wylie - DWR UCIP)
FIELD_STRUCT_DESC: 48-inch corrugated metal drainage pipe through the levee, 28 feet below the crown. Slide gate in a 66-inch riser on the waterside (WS) slope. Concrete headwall on the WS. Grouted cobble spillway from drainage ditch to large canal on the landside (LS). (48-inch pipe [HLM 3.78] authorized under Automatic Board Order (ABO) issued as Permit No. 9388, 1974 - Pauline A. Wallace; 48-inch pipe [HLM 3.78] was also authorized under Automatic Board Order (ABO) issued as Permit No. 8231, 1972 - Roy E. Kitts). [Additional Reference(s): DWR Levee Log, 2005 (HLM 3.78). USACE Sacramento O&M Manual, Unit 132, October 1959, Revised 14 January 2019, (HLM 3.78), listed as 48-inch pipe. USACE As-Built Drawing No. 50-4-3081, Sheet 5 and 15, Station 1524+75, 4 April 1957].

Headwall with slide gate at LS toe.

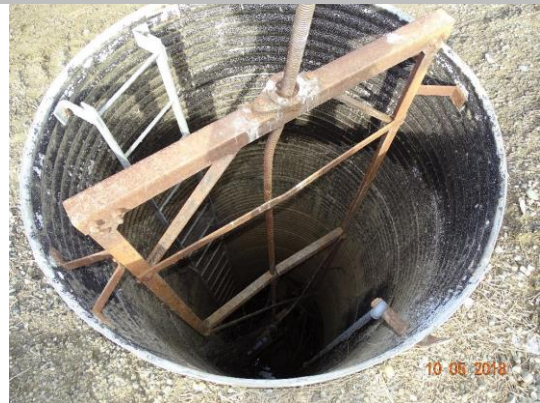
Photo 3 of 3 : UCIP_FA_2024_57196_78200.jpg

Inside view of CMP riser. Slide gate stem is bent.

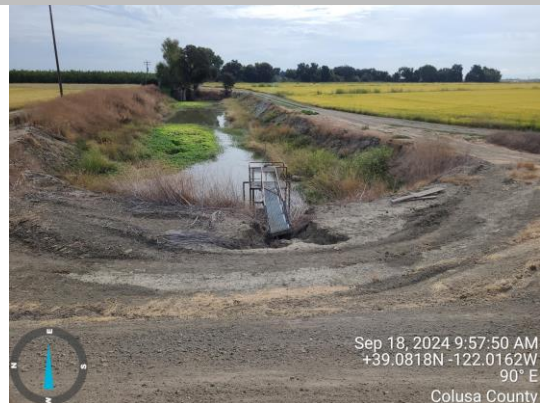
Photo 1 of 1 : FA_2024_MA0012_299_29_20240919_00079.jpg

LM Start	3.69	Rating **	M	Issue No.	29
LM End	3.69	Issue Type +	Ma	Location *	LS
Category	Earthen Levee			GPS Latitude/Longitude	
				Start	End
Item	Erosion / Bank Caving			39.081958°	39.081958°
				-122.016207°	-122.016207°
DWR ID	DWR_MA0012_01_s_2023_29				
Comment Code					
E2 : Schedule repair of erosion site prior to the next inspection.					
Inspector Comment					
There is erosion around the screw gate walkway.

View of erosion around walkway. Fall 2024.

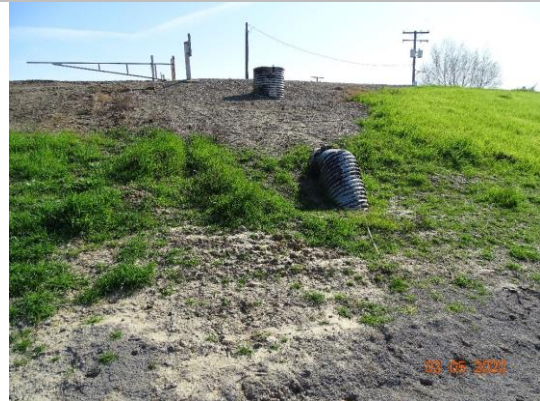
Photo 3 of 3 : UCIP_FA_2024_57199_83544.jpg

Comment Code						
Inspector Comment						
DS_ID:17156 FS_ID:57199 EP_NO: 9388 Repair Type: Non-Urgent EVAL Issue: 10, Unauthorized Modification or Non-Compliant Permit Crossing Status: Found UCIP Comments: 03/05/2020 Record updated from No Action Needed to Non-Urgent. Modifications to the system done: 24-inch steel pipe connected to a CMP pipe at LS toe, pump in irrigation canal on LS. Unable to find pump system in O&M drawings. Steel pipe is currently disconnected from the pump in irrigation canal. Unable to locate a permit authorizing modifications. Need to have CVFPB review ABO and determine current owner. Pipe outlet on WS not found due to dense vegetation. (O.Yakimov - DWR UCIP)05/02/2017 Crossing appears to be in good condition. (A.Freitag - DWR Sutter Yard)10/17/2016 Crossing appears to be in good condition. (A.Freitag - DWR Sutter Yard)05/31/2016 Crossing appears to be in good condition. (A.Freitag - DWR Sutter Yard)05/04/2015 Crossing appears to be in good condition. No noticeable issues to report. (A.Freitag - DWR Sutter Yard)06/17/2014 Same as last inspection. (A. Freitag - DWR Sutter Yard)12/16/2013 Same as last inspection. (A. Freitag - DWR Sutter Yard)07/16/2013 Same as last inspection. (A. Freitag - DWR Sutter Yard) FIELD_STRUCT_DESC: 24-inch corrugated metal drainage pipe through the levee, 9.2 feet below the crown. Slide gate in a 36-inch corrugated metal pipe (CMP) riser on the waterside (WS) slope. Pump on a 60-inch concrete standpipe at the landside (LS) toe. (24-inch pipe [HLM 4.32] authorized under Automatic Board Order (ABO) issued as Permit No. 9388, 1974 - Pauline A. Wallace). [Additional Reference(s): DWR Levee Log, 2005 (HLM 4.32). USACE Sacramento O&M Manual, Unit 132, October 1959, Revised 14 January 2019, (HLM 4.32), listed as 24-inch pipe. USACE As-Built Drawing No. 50-4-3081, Sheet 6 and 19, Station 1552+62, 4 April 1957]. FS Date: 3/5/2020 7:33:00 AM

CMP pipe daylights on WS slope

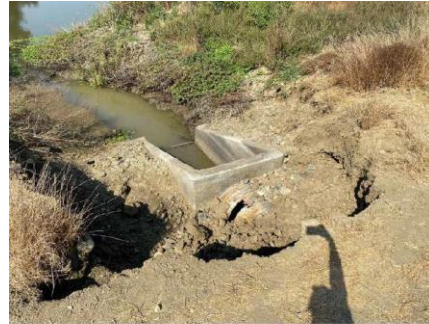
Photo 1 of 3 : UCIP_FA_2024_81287_117160.jpg

DS_ID:17158
FS_ID:81287
EP_NO: 9390
Repair Type: Urgent
EVAL Issue: 1, Pipe Integrity
Crossing Status: Found
UCIP Comments: 10/12/2023 Record updated from Non-Urgent to Urgent. Enforcement case 2023-15660 issued to this crossing. Missing wall was observed on the pipe near headwall on waterside causing erosion around headwall. (O. Yakimov - DWR UCIP)
03/05/2020 Record updated from No Action Needed to Non-Urgent. Pump in drainage ditch and standpipe are not designed per O&M As-Built drawing. Unable to locate a permit for modifications. Need to have CVFPB review ABO and determine current owner. (O.Yakimov - DWR UCIP)05/02/2017 Crossing appears to be in good condition. There is minor sediment build up in front of the WS flap gate. (A.Freitag - DWR Sutter Yard)10/17/2016 Crossing appears to be in good condition. (A.Freitag - DWR Sutter Yard)05/31/2016 Crossing appears to be in good condition. (A.Freitag - DWR Sutter Yard)05/04/2015 Crossing appears to be in good condition. No noticeable issues to report. (A.Freitag - DWR Sutter Yard)06/17/2014 Same as last inspection. (A.Freitag - DWR Sutter Yard)12/16/2013 Same as last inspection. (A.Freitag - DWR Sutter Yard)07/16/2013 New flapgate installed on WS pipe end. (A.Freitag - DWR Sutter Yard)10/11/2012 Flap gate broken on WS. Pipe shows significant rust at outlet. This is a good candidate for video inspection. (W.Wylie - DWR UCIP)

Water-Side: Damaged pipe and erosion around headwall. Photo courtesy by CVFPB

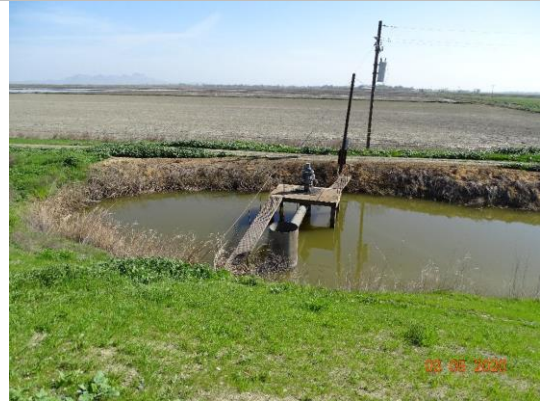
Photo 2 of 3 : UCIP_FA_2024_81287_83550.jpg

Modifications to original O&M construction: Pump in drainage ditch, standpipe connected to CMP pipe through the levee

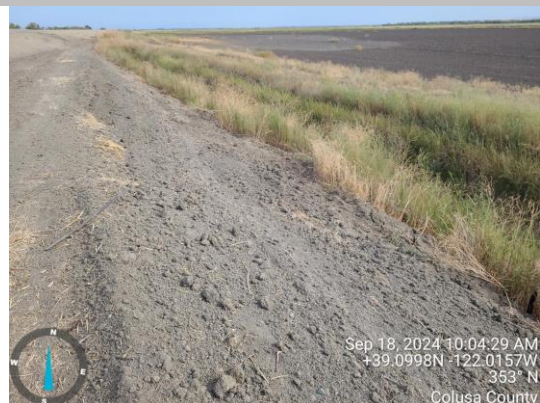
Photo 1 of 1 : FA_2024_MA0012_299_32_20240919_00080.jpg

LM Start	4.94	Rating **	A/W	Issue No.	32
LM End	4.94	Issue Type +	Ma	Location *	LS
Category	Earthen Levee			GPS Latitude/Longitude	
				Start	End
Item	Slope Stability			39.099907°	39.099907°
				-122.015861°	-122.015861°
DWR ID	DWR_MA0012_01_f_2024_32				
Comment Code					
S1 : Repair slope instability.					
Inspector Comment					
Slip location from 2024. The yard drug over the location and it appears to be stable, but there are multiple cracks still visible. Recommend monitoring.

View of minor slip on the landside slope. Fall 2024.

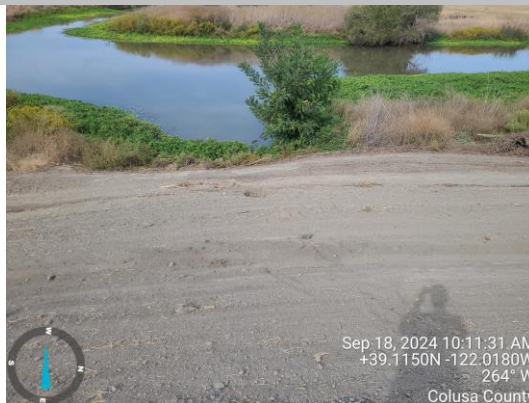
Photo 1 of 1 : FA_2024_MA0012_299_33_20240919_00081.jpg

View of sinkhole on the waterside slope. Fall 2024.

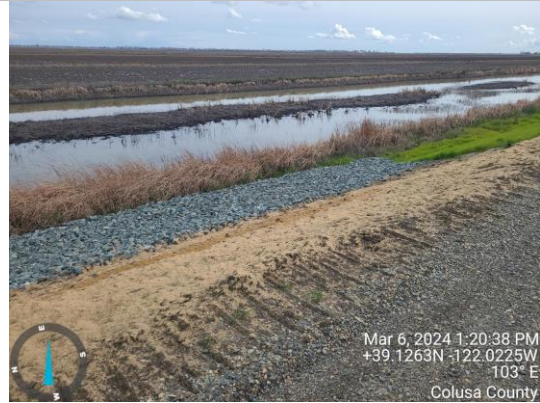
Photo 1 of 1 : FA_2024_MA0012_299_36_20240909_00008.jpg

View of temporary repair on the landside slope. Spring 2024.

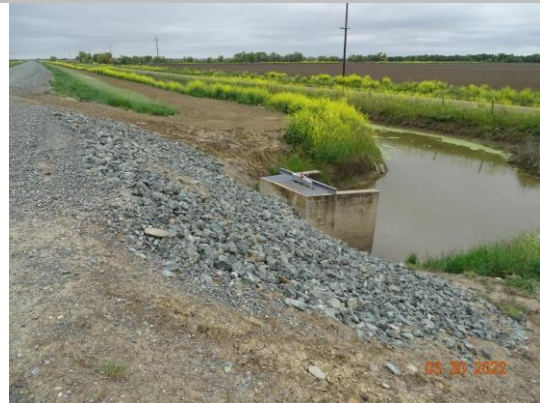
Photo 1 of 1 : FA_2024_MA0012_299_35_20240909_00007.jpg

View of repaired waterside slope. Spring 2022.

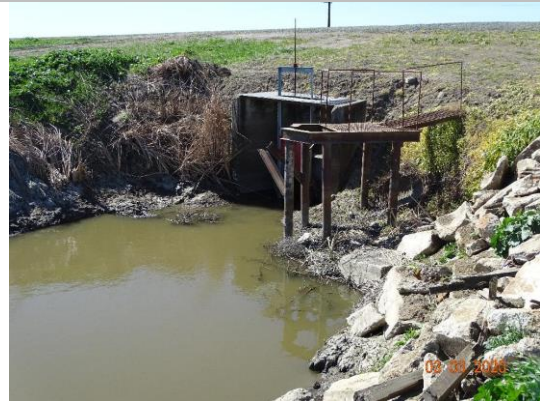
Photo 3 of 3 : UCIP_FA_2024_57243_83620.jpg

Abandoned pumping platform in irrigation canal on LS

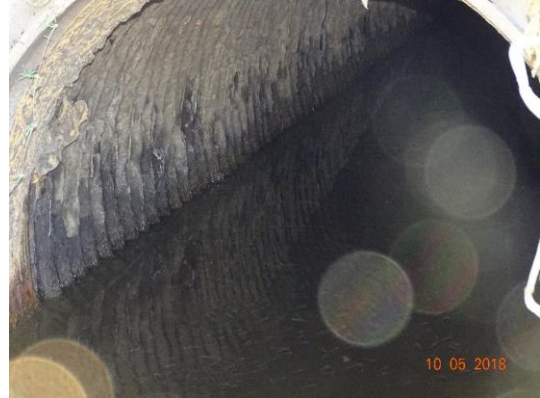
Photo 2 of 2 : UCIP_FA_2024_57219_78161.jpg

Pipe is corroded inside
