**Flood Control Project Maintenance
Levee Inspections**

Fall 2010 Levee Maintenance Deficiency Summary Report

Sacramento River Basin

MA0013 Sutter Maintenance Yard Maintenance Area 0013	Overall LMA Rating	Total LMA Miles	* Overall LMA Threshold Percent is less than 10.00%; however, U Rated Miles are present, so the Overall LMA Rating is M instead of A.			
	M *	41.97				
Rated Item	M Miles	U Miles	M + 4U Miles	Threshold %	Encroachments PO Miles CO Miles	
Trim / Thin Trees	0.03		0.03	0.07%		
Encroachments	0.16		0.16	0.38%	0.01	
Animal Control	0.01		0.01	0.02%		
Erosion / Bank Caving	0.37	0.06	0.61	1.45%		
USACE Erosion Survey	0.39		0.39	0.93%		
<i>LMA Totals:</i>	0.96	0.06	1.20	2.86% *	0.01	0.00

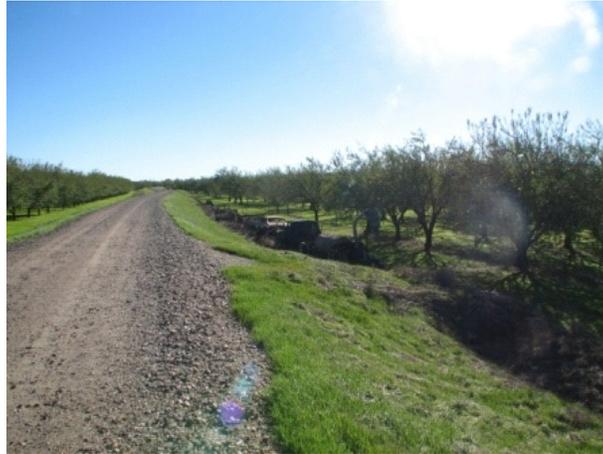
Levee Mile Report Line	1
Start Levee Mile	0.76
End Levee Mile	0.78
Location	Land Side
Category	Earthen Levee
Item	Encroachments

View of the equipment along the landside toe of the levee.

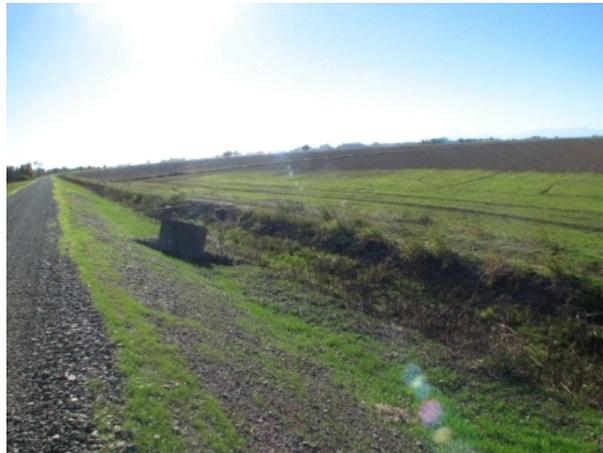
Levee Mile Report Line	3
Start Levee Mile	6.63
End Levee Mile	6.63
Location	Land Side
Category	Earthen Levee
Item	Encroachments

View of a concrete block along the toe.

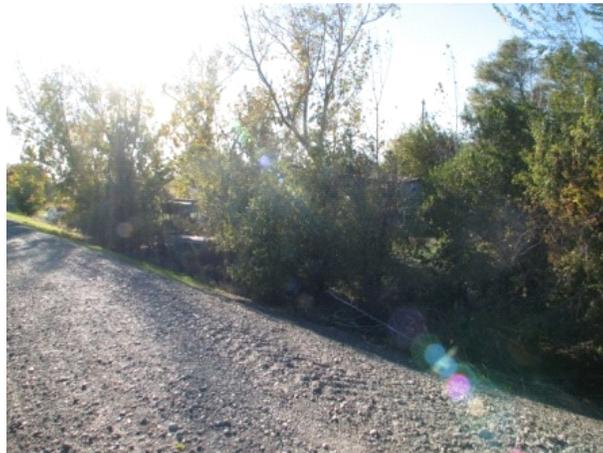
Levee Mile Report Line	4
Start Levee Mile	9.84
End Levee Mile	9.87
Location	Land Side
Category	Earthen Levee
Item	Trim / Thin Trees

View of trees that need to be trimmed along the toe.

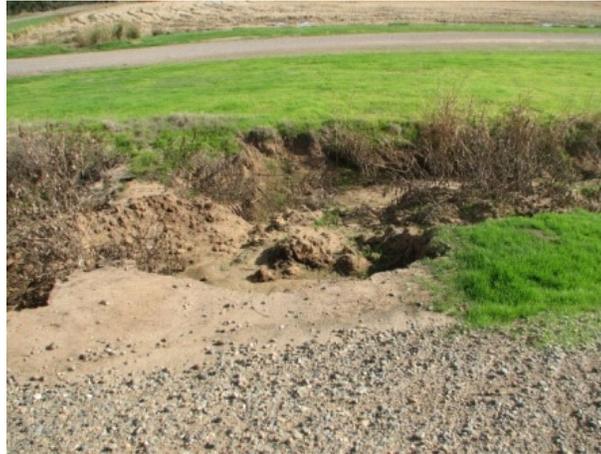
Levee Mile Report Line	2
Start Levee Mile	0.58
End Levee Mile	0.58
Location	Land Side
Category	Earthen Levee
Item	Erosion / Bank Caving

View of erosion along the levee toe.

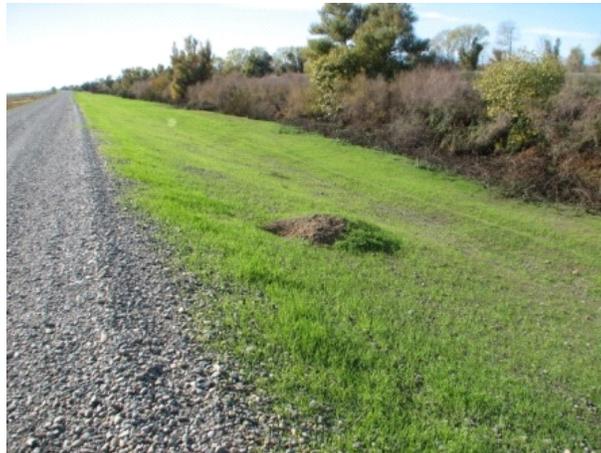
Levee Mile Report Line	10
Start Levee Mile	15.28
End Levee Mile	15.28
Location	Water Side
Category	Earthen Levee
Item	Animal Control

View of a squirrel hole along the slope.

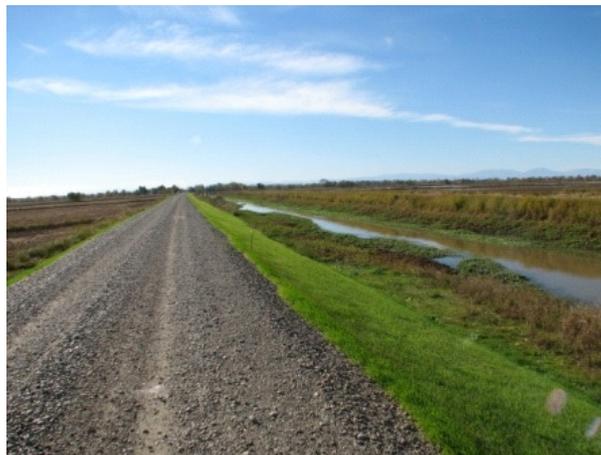
Levee Mile Report Line	12
Start Levee Mile	21.72
End Levee Mile	22.08
Location	Water Side
Category	Earthen Levee
Item	Erosion / Bank Caving

View of erosion along the toe.

12	21.72	22.08	Earthen Levee	Erosion / Bank Caving	WS	M	Schedule repair of erosion site prior to the next inspection.	39.365167 ° -121.861810 °	39.362378 ° -121.867338 °	17 Y
13	22.38	22.38	Earthen Levee	Encroachments	LS	PO	Landscaping	39.359982 ° -121.871958 °	39.359982 ° -121.871958 °	4 Y
14	22.69	22.69	Earthen Levee	Erosion / Bank Caving	LS	U	Schedule repair of erosion site prior to the next inspection.	39.357348 ° -121.876848 °	39.357348 ° -121.876848 °	3 Y
15	22.75	22.79	Earthen Levee	Erosion / Bank Caving	LS	U	Schedule repair of erosion site prior to the next inspection.	39.357180 ° -121.877755 °	39.356848 ° -121.878467 °	6 Y
16	22.83	22.83	Earthen Levee	Erosion / Bank Caving	LS	U	Schedule repair of erosion site prior to the next inspection.	39.356457 ° -121.879178 °	39.356457 ° -121.879178 °	2 Y

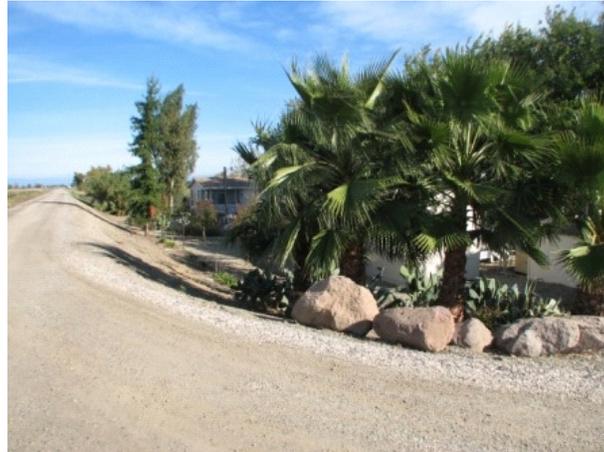
Levee Mile Report Line	13
Start Levee Mile	22.38
End Levee Mile	22.38
Location	Land Side
Category	Earthen Levee
Item	Encroachments
View of landscape along the toe.	
rduffey_f_20101123_321.jpg

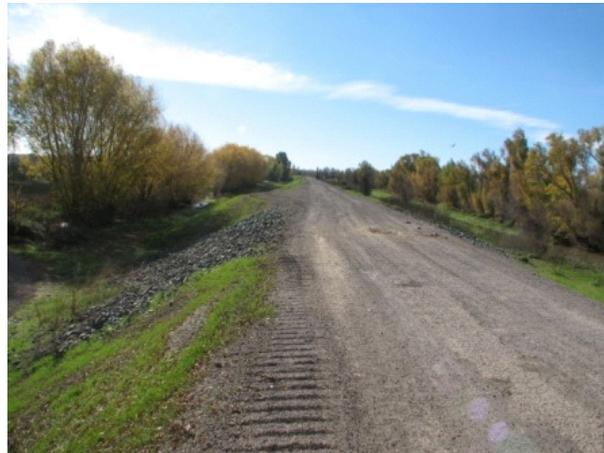
Levee Mile Report Line	14
Start Levee Mile	22.69
End Levee Mile	22.69
Location	Land Side
Category	Earthen Levee
Item	Erosion / Bank Caving
View of the erosion along the landside slope.	
rduffey_f_20101123_322.jpg

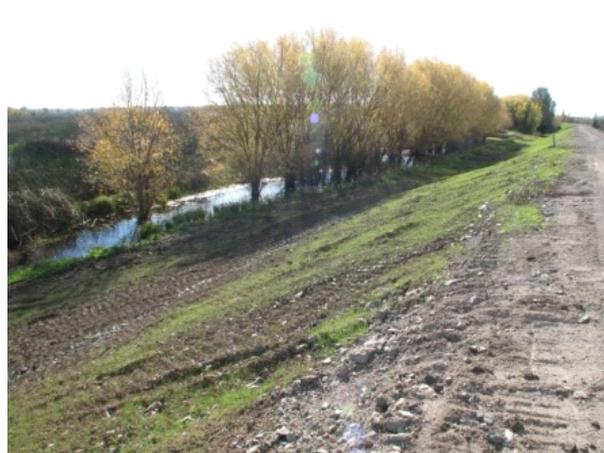
Levee Mile Report Line	15
Start Levee Mile	22.75
End Levee Mile	22.79
Location	Land Side
Category	Earthen Levee
Item	Erosion / Bank Caving
View of the erosion along the landside slope cause by a telephone company underground line.	
rduffey_f_20101123_323.jpg

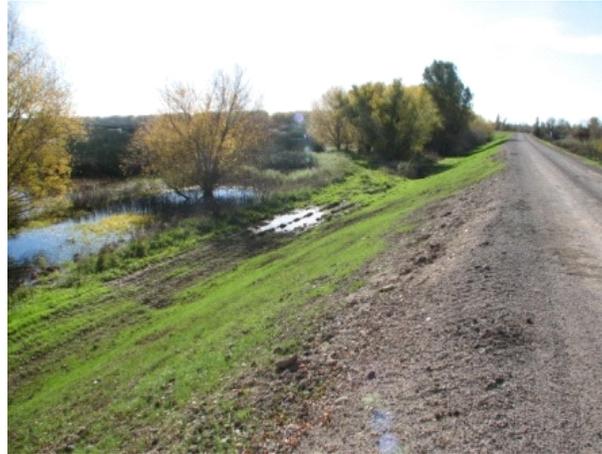
Levee Mile Report Line	16
Start Levee Mile	22.83
End Levee Mile	22.83
Location	Land Side
Category	Earthen Levee
Item	Erosion / Bank Caving

View of the erosion on the landside slope of the levee.
