**Flood Control Project Maintenance
Levee Inspections
LMA District Cover Sheet
Spring 2010 Levee Inspection Results**

Sutter Maintenance Yard Maintenance Area 0013

Levee Inspection Report By Mile - Spring 2010

Waterway							Bank	Unit Miles	Inspection Start/End	Inspector
Unit No. 01 Cherokee Canal							Right	18.87	05/25/2010 05/25/2010	Bob Duffey

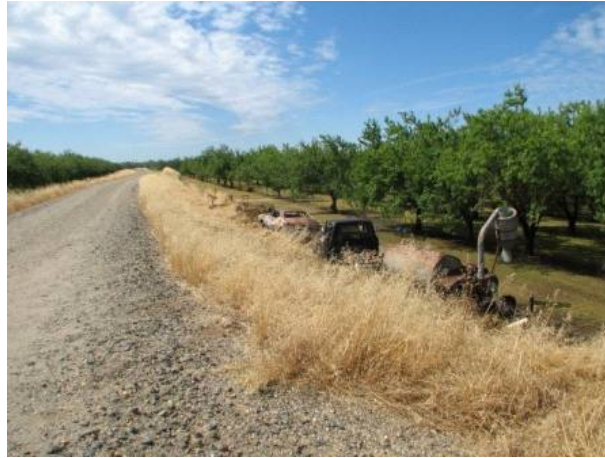
Levee Mile Report Line	3
Start Levee Mile	0.76
End Levee Mile	0.78
Location	Land Side
Category	Earthen Levee
Item	Encroachments

View of the equipment along the landside toe of the levee.

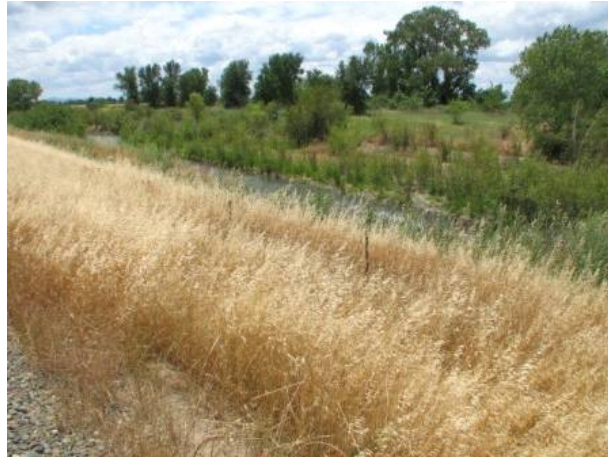
Levee Mile Report Line	2
Start Levee Mile	1.83
End Levee Mile	1.83
Location	Water Side
Category	Earthen Levee
Item	Erosion / Bank Caving

View of the erosion at the waterside toe of the levee.

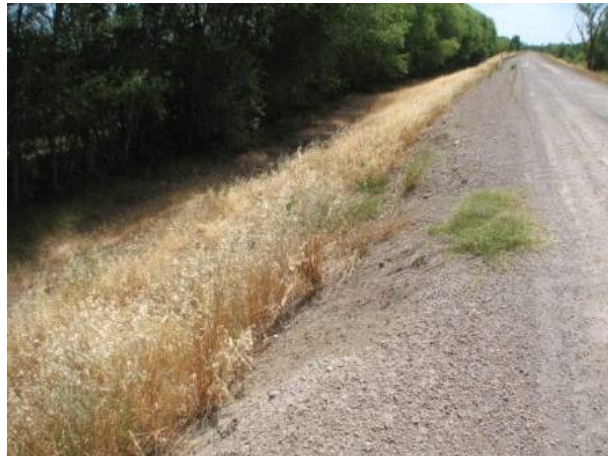
Levee Mile Report Line	11
Start Levee Mile	22.69
End Levee Mile	22.69
Location	Land Side
Category	Earthen Levee
Item	Erosion / Bank Caving

View of the erosion along the landside slope.

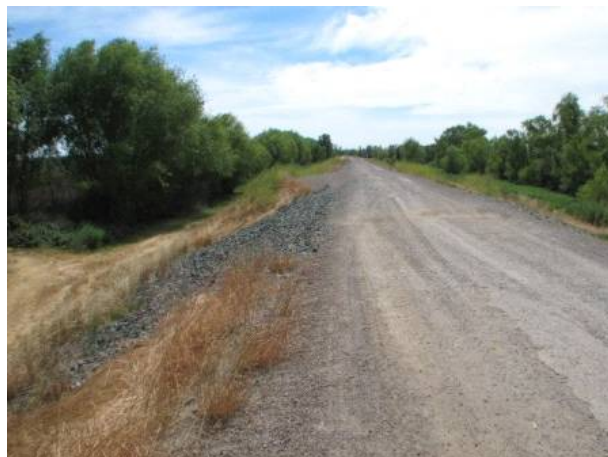
Levee Mile Report Line	12
Start Levee Mile	22.75
End Levee Mile	22.79
Location	Land Side
Category	Earthen Levee
Item	Erosion / Bank Caving

View of the erosion along the landside slope cause by a telephone company underground line.

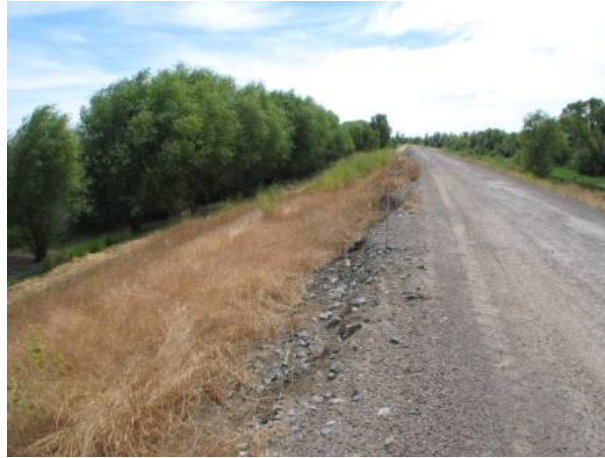
Levee Mile Report Line	13
Start Levee Mile	22.83
End Levee Mile	22.83
Location	Land Side
Category	Earthen Levee
Item	Erosion / Bank Caving

View of the erosion on the landside slope of the levee.

13	22.83	22.83	Earthen Levee	Erosion / Bank Caving	LS	U	Schedule repair of erosion site prior to the next inspection.	39.356457 ° -121.879178 °	39.356457 ° -121.879178 °	2 Y
